## North Coast Regional Water Quality Control Board

Subject: Inspection Report for August 1, 2023, Warrant Inspection of Trinity County Assessor's Parcel Number 019-650-016

File: Cannabis Program Inspections, Trinity County, Rafael Iraheta, CIWQS Place ID 889947

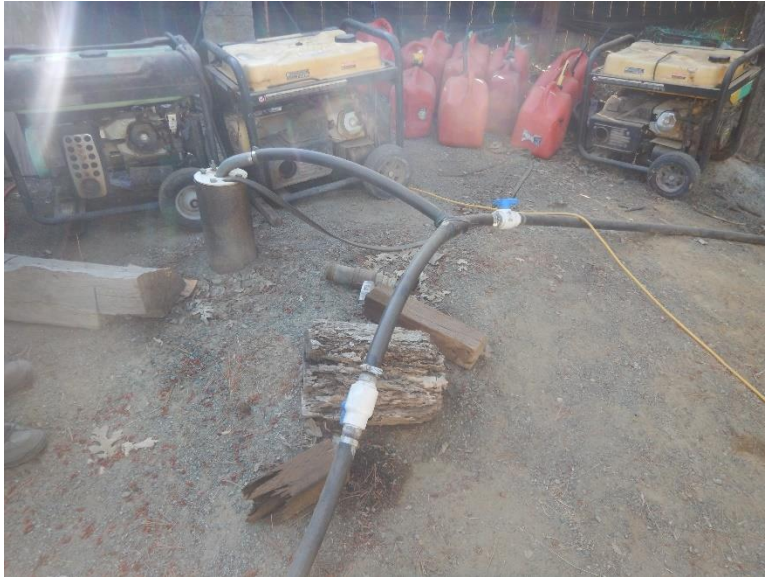
Starting at the top of the property, on the east side, I observed a well, generators, and gas cans (Photo 1). Moving downhill and west I observed bare dirt terraces with cannabis plants in the ground (Photo 2). I observed irrigation runoff from the plants discharging towards Glade Creek (Photo 3). I observed an outhouse discharging human waste to land (Photo 4). I observed multiple burn piles containing plastics and metals (Photos 5 and 6). At the base of the property, I observed two hoop houses constructed partially in the creek, with a gas can nearby and barrels containing dark liquids (Photo 7). I observed fill, rock, and trash placed in the creek, constricting the channel width to 6 feet (Photos 8 and 9). Upstream, I observed more cultivation related waste, and measured a less disturbed channel width of 10 feet (Photo 10). I measured the fill berm

9. Petroleum products and other chemicals: I observed generators stored without adequate secondary containment, and gas cans in the setbacks to Glade Creek.

Photo 1: Well, generators, and gas cans without secondary containment.

3. Retain a qualified professional to assess and stabilize the bare dirt terraces, and fill placed along Glade Creek, and apply for a 401 Water Quality Certification prior to work in a stream.
4. Store and contain all chemicals, including fertilizers and petroleum products, properly to prevent spillage and potential for migration/transport into receiving waters. Store generators in an area with secondary containment.
5. Discontinue burning of trash. Regularly contain and dispose of all waste/ trash at a licensed transfer site. Remove trash from creek.
6. Discontinue use of outhouse discharging to ground. Adhere to Trinity County regulations on human waste management.

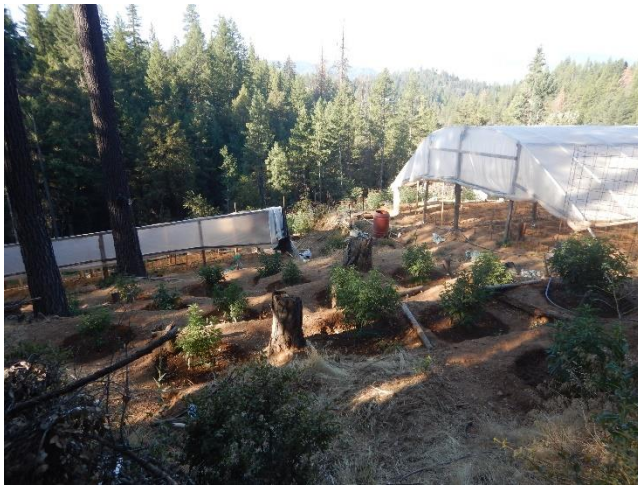
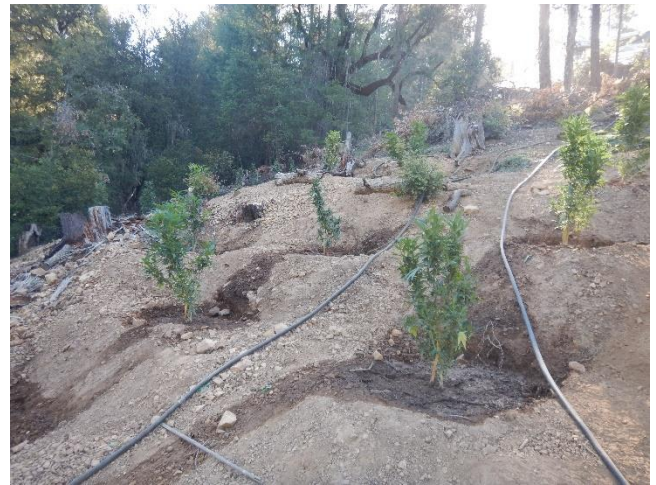
1. Site maintenance, erosion control and drainage features: I observed bare dirt throughout the property with no erosion control practices in place.
2. Stream crossing maintenance and improvement: I did not observe water quality issues associated with stream crossings.

5. Water storage and use: I did not observe water quality issues associated with water storage and use.
6. Irrigation runoff: I observed irrigation runoff from terraced plants perched above Glade Creek.

Photos 2 and 3: Terraces with cannabis plants in the ground, and irrigation runoff.

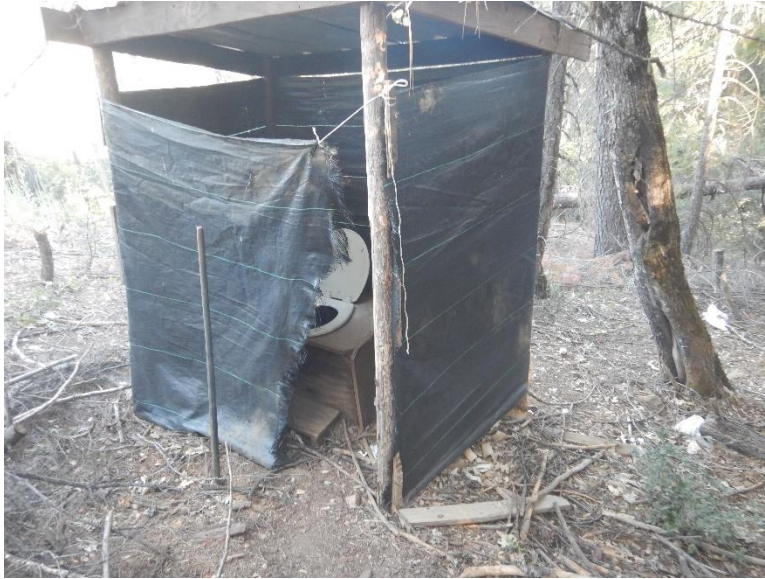
10. Cultivation-related wastes: I observed waste in and adjacent to Glade Creek.
11. Refuse and human waste: I observed refuse, including burn piles, throughout the property. I observed an outhouse discharging human waste to land.

Photo 4: Outhouse discharging human waste to land.

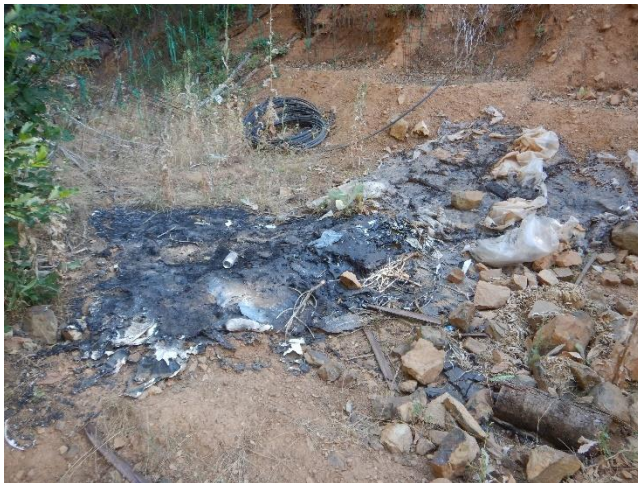
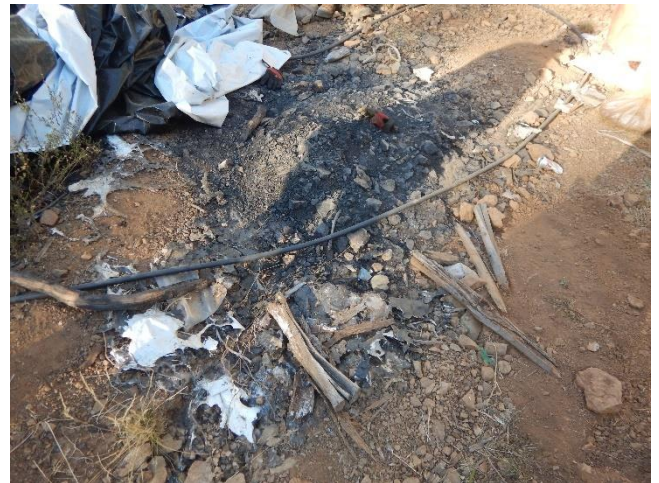
Photos 5 and 6: Burn piles containing domestic and cultivation related waste.

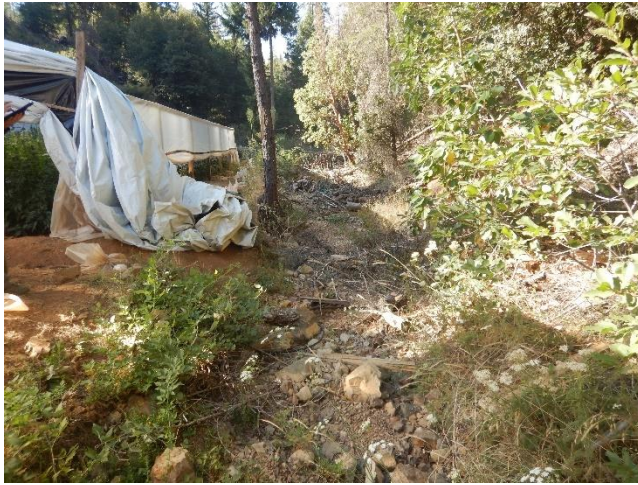
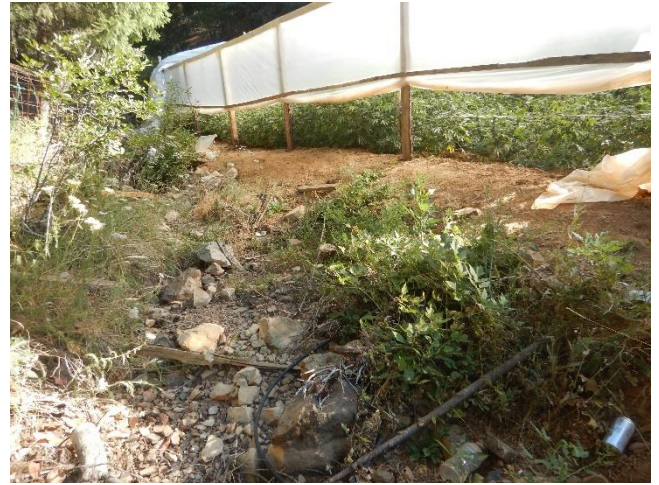
3. Riparian and wetland protection and management: I observed fill, hoop houses, cannabis plants, and trash in Glade Creek and within its setbacks.
4. Spoils management: I did not observe water quality issues associated with spoils management.

#### Recommendations

Photos 8 and 9: Fill, and trash including plastic pipes, plastic bottles, metal cages, and metals cans in Glade Creek.

1. If you and/or your tenant(s) plan to continue commercial cannabis cultivation, enroll for coverage under the State Water Board's Order WQ 2019-0023-DWQ, General Waste Discharge Requirements and Waiver of Waste Discharge Requirements for Discharges of Waste Associated with Cannabis Cultivation Activities.
2. Relocate all cannabis cultivation activities, supplies, and trash outside of the riparian setbacks (50 feet from Class III, 100 feet from Class II, 150 feet from

Class I). Use hand tools to dismantle the hoop houses in Glade Creek and to haul all materials out of the riparian setbacks.

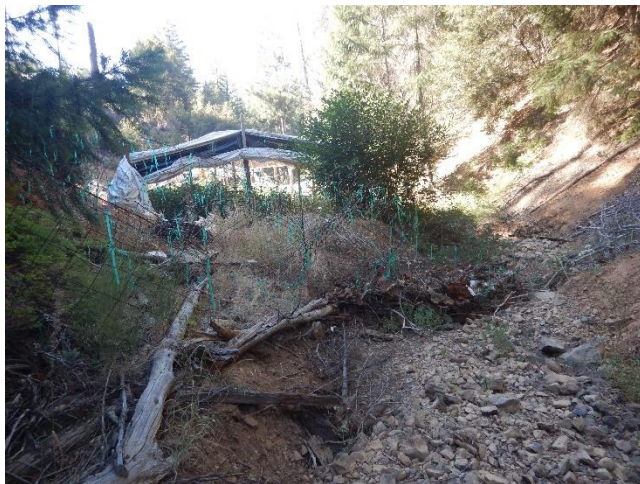
in the creek to be approximately 75 feet long, with depths ranging from half a foot to 3 feet. I left a field notice on the property with the warrant (Photo 11).

Photo 10: View from upstream of cultivation related waste, and hoop houses in creek.
