Subject **Notice of Violation, Transmittal of Inspection Report of July 11, 2023
Inspection of Siskiyou County Assessor's Parcel Number 100-451-030**

Cannabis Water Quality Inspection Report

Thomas Salls Property, Siskiyou APN: 100-451-030, WDID No. 1_47MJ000365

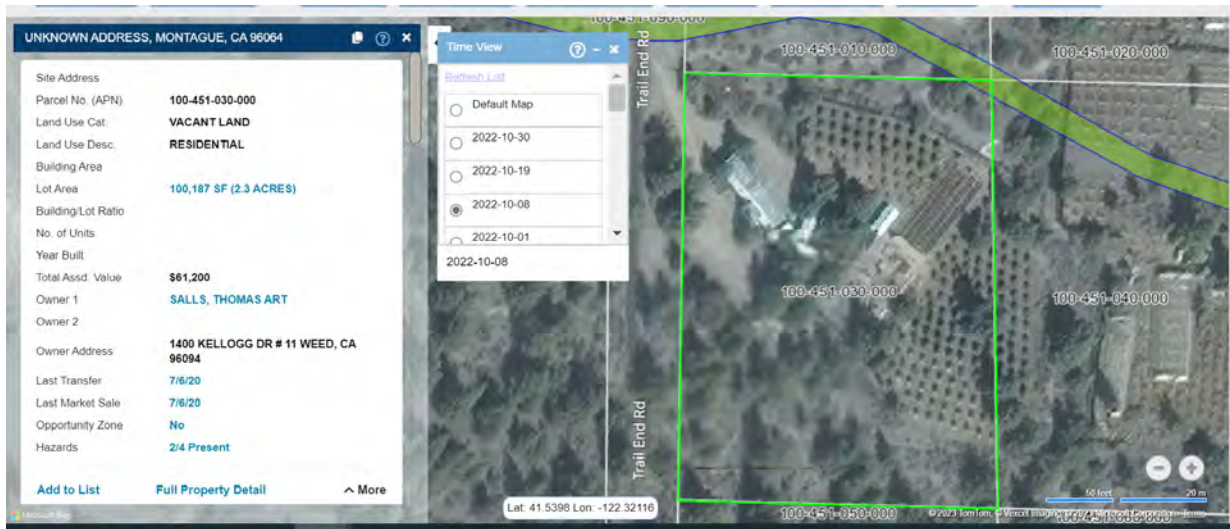
Figure 1. Property ownership and parcel map. The 2.3 Acre Property is located in the southwestern extent of a subdivision in the Whitey Creek Area, east of Big Springs.

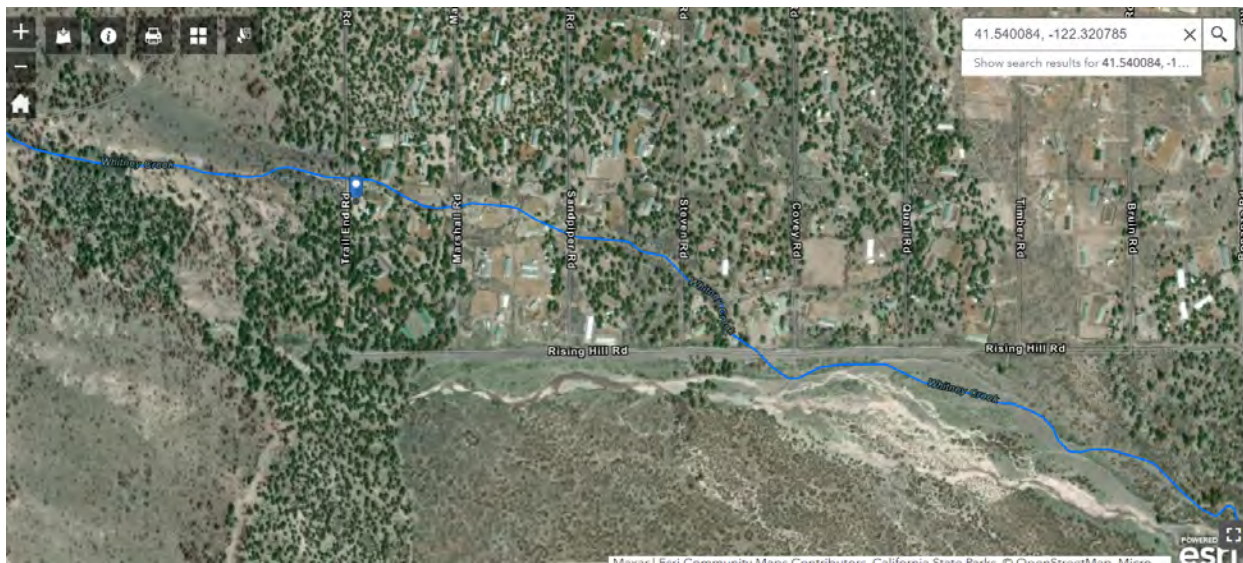
Figure 2. The Property is located adjacent to Whitney Creek, which is fed by runoff from Whitney Glacier located on the north side of Mount Shasta. In the area of the Property, I observed that Whitney Creek has sand substrate and a broad channel migration area which numerous braided channels. A channel runs through the Property and is identified on the NHD layer with a solid blue line symbol as Whitney Creek. A larger stream channel is currently located south of the subdivision extent. Shifts in the historic flow paths of the braided channels appear to have resulted from channel migration and the construction of the subdivision and earthen berms along the southern boundary.

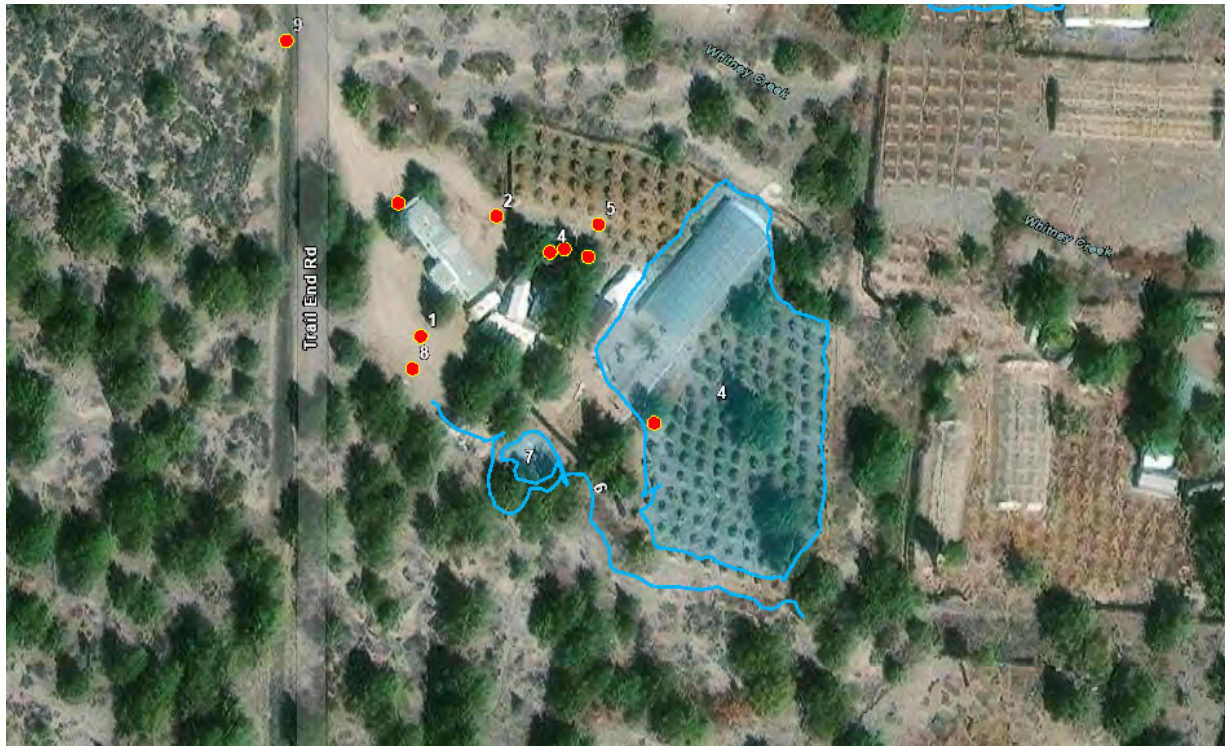
The inspection map is shown in Figure 3 and includes the locations referenced at the following features of concern to water quality.

Figure 3. Inspection Map of the Property with Locations referenced in text.

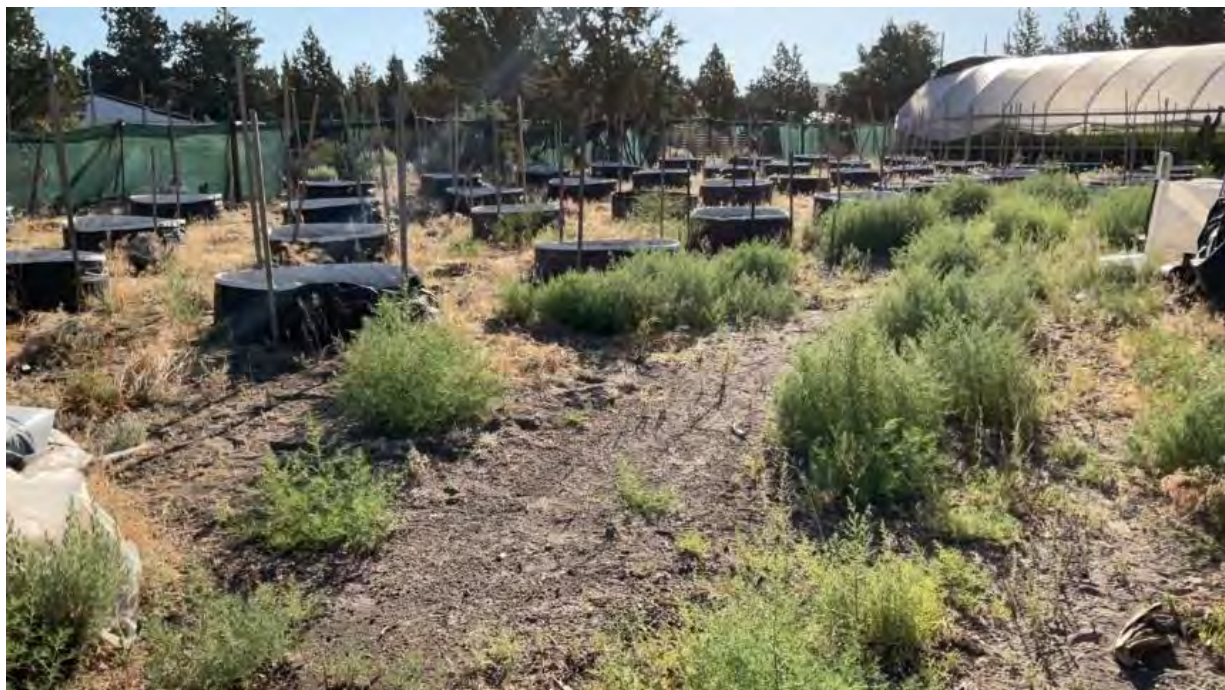
Point Location 2: Cultivation area with inactive outdoor cultivation. Near this area I observed fertilizer and chemical containers stored uncontained next to water tanks.

Figure 4. Cultivation area at location 2.

3. Remove trash from stream channels by hand.
4. Remove cultivation infrastructure and properly dispose of waste including but not limited to trash, fertilizer, pesticide and petroleum containers, plastic tarps and sheeting at a legal facility.

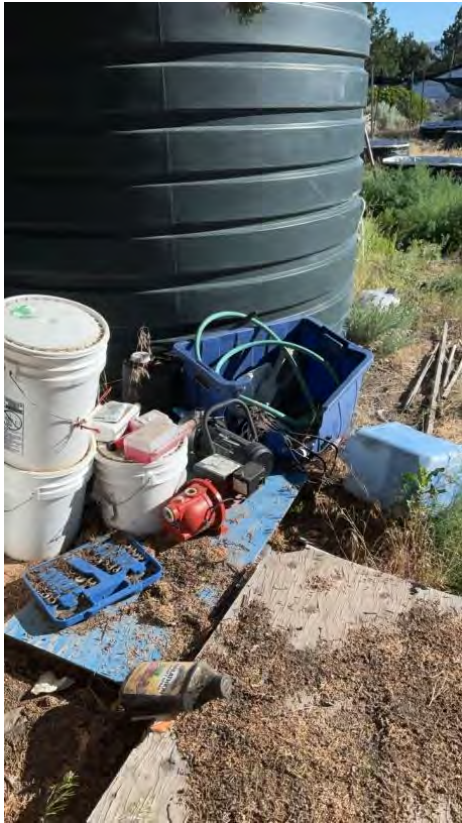
Figure 5. Uncontained fertilizers, chemicals next to water storage tank at location 2.

5. Properly dispose of all pesticides and fertilizers at a legal disposal facility.
6. Properly contain generators, pumps and petroleum products to prevent spillage and release; properly dispose of waste oil at a legal disposal facility.

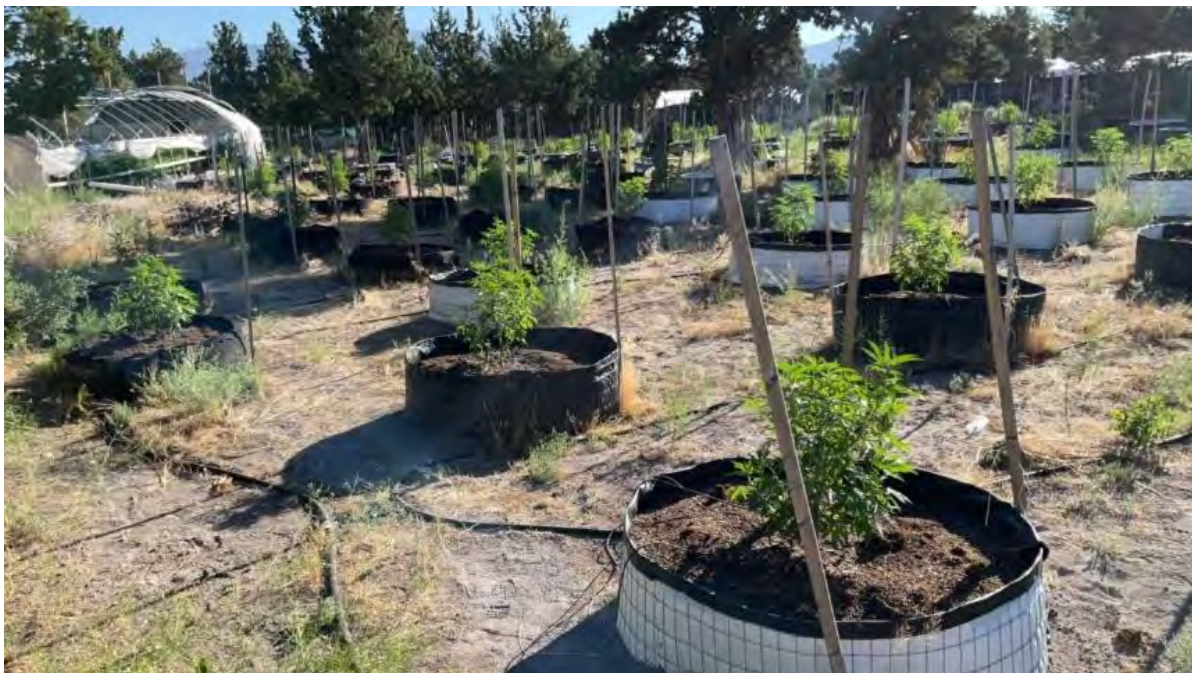
Polygon Location 4: Cultivation area with active outdoor and greenhouse cultivation 20,000 square feet in size. Within the cultivation area I observed the scoured flow path of a watercourse that fed into the larger stream at Line Location 6; the cultivation area is within 13 feet of the bank of the larger watercourse.

Figure 6. Cultivation area with outdoor and greenhouse cultivation at location 4.

1. Cease unauthorized cannabis cultivation.
2. Cease land disposal of household and cultivation-related trash and properly dispose all refuse at a legal disposal facility.

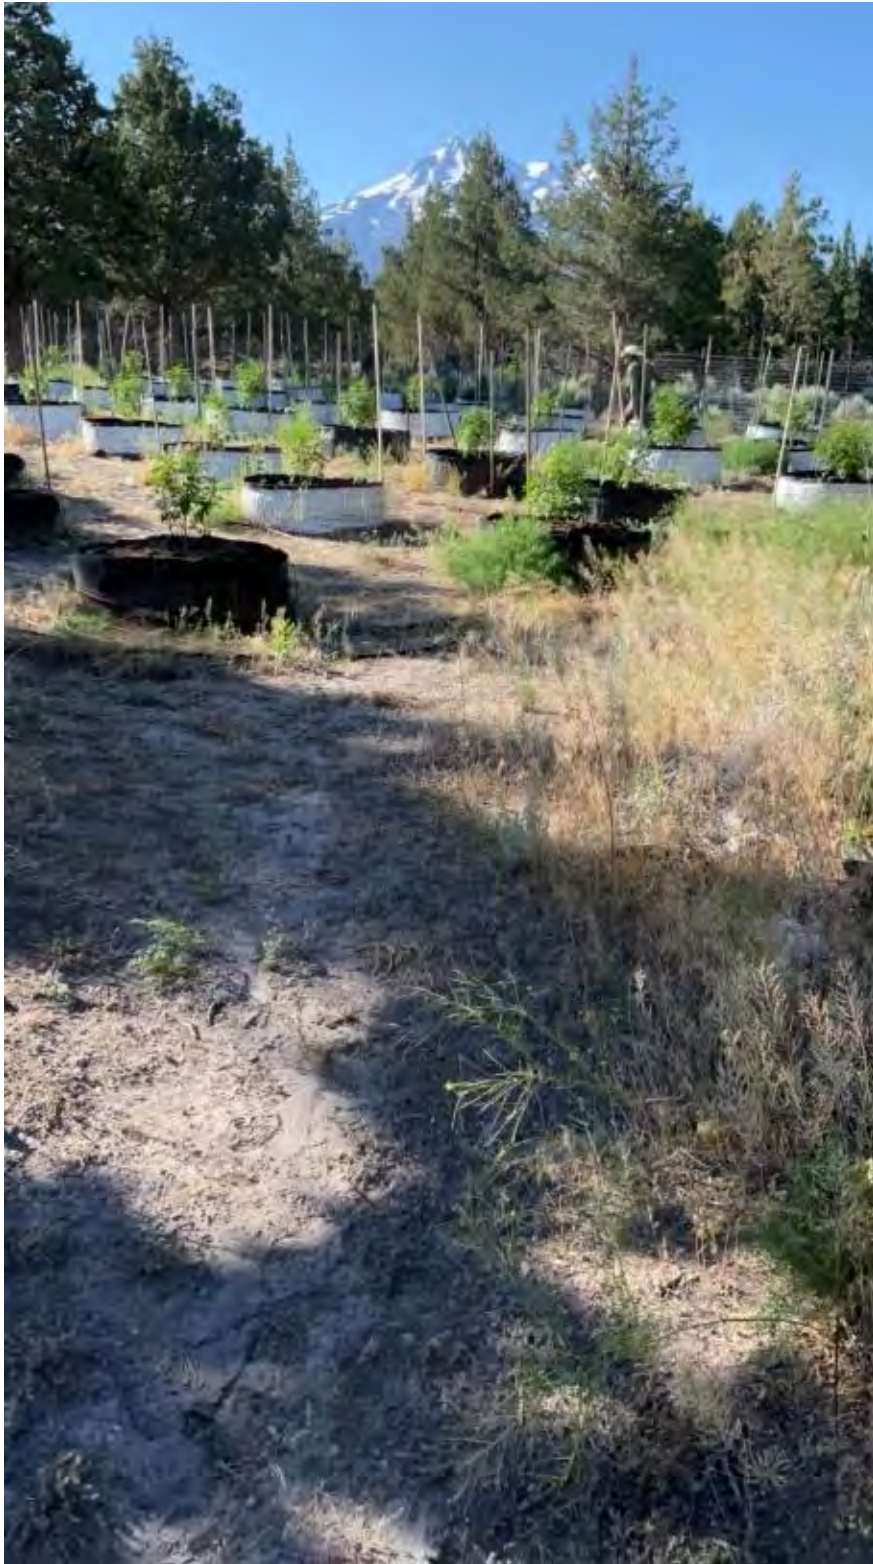
Figure 7. Stream flow path scoured through outdoor cultivation area at location polygon 4.

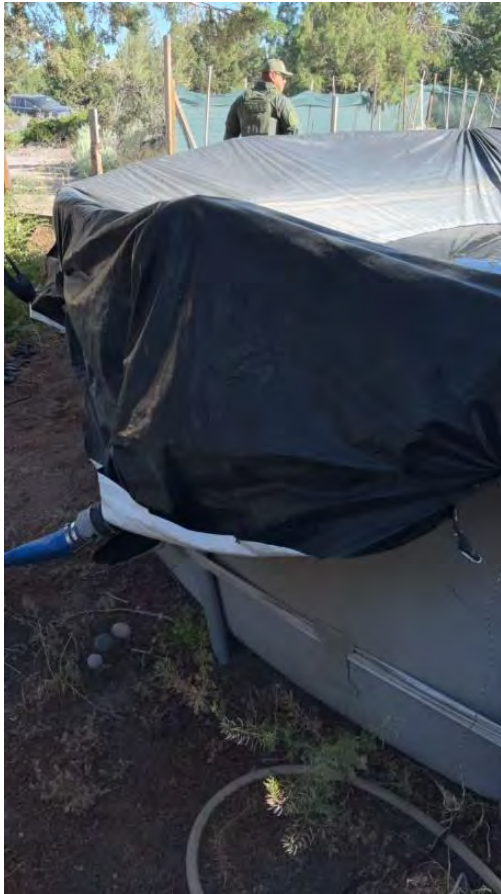
Point location 4: Water storage pool with feed tank.

Figure 8. Water storage tank at point location 4.

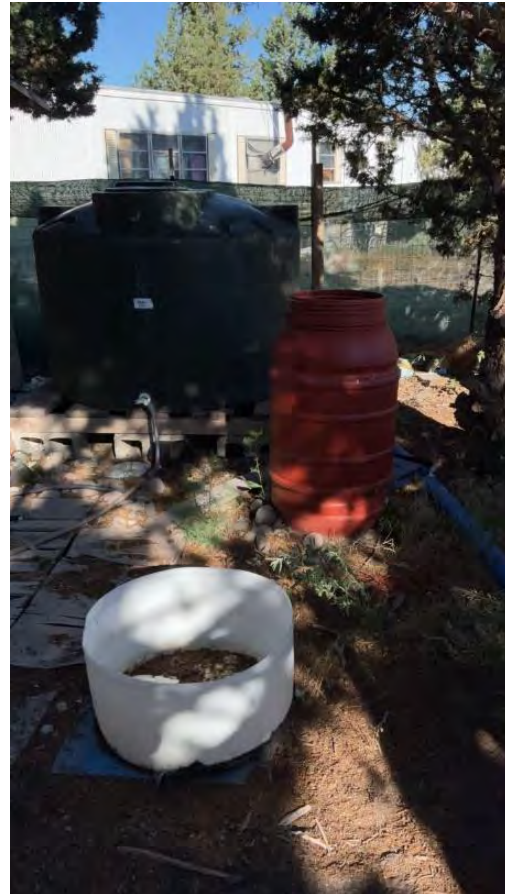
Figure 9. Feed tank at location point 4.

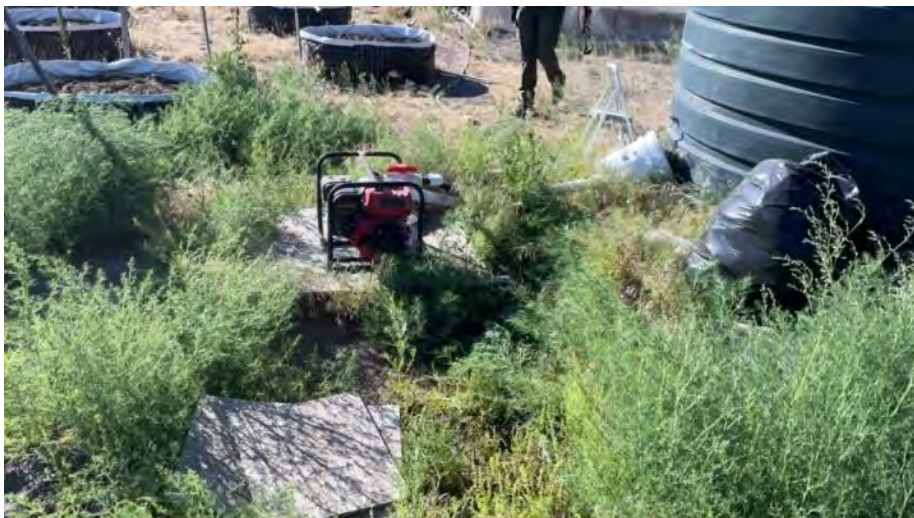
Point Location 5: A generator with dark stains from petroleum products discharged to land. Nearby were a water storage tank and pump.

Figure 10. Water tank and pump at location 5.

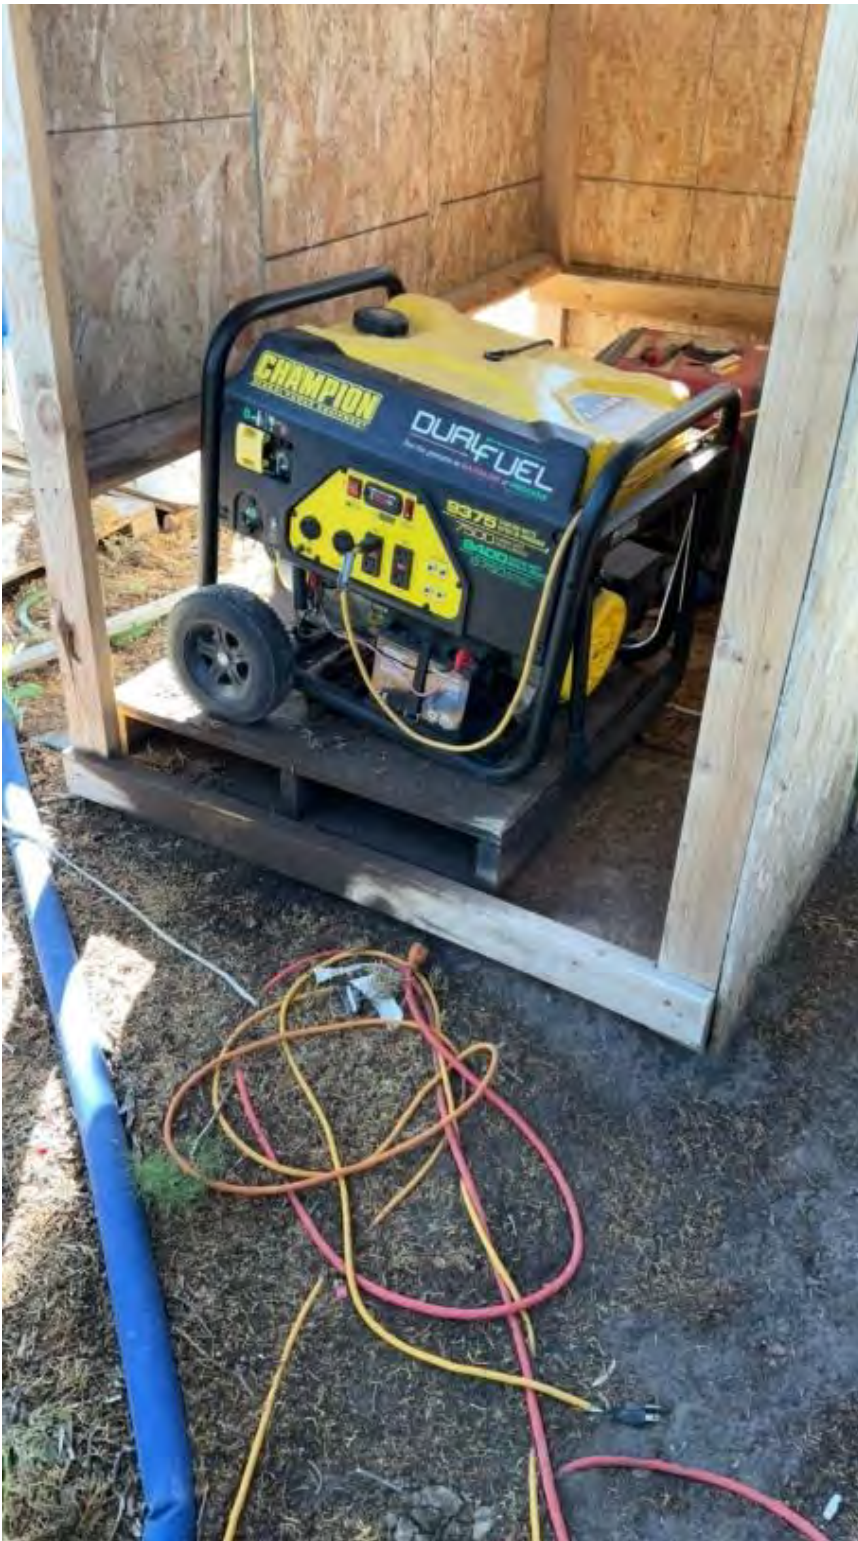
As document in the inspection report, Staff observed discharges of petroleum at Point Location 5 to land and land disposal of trash in a stream channel at polygon location 7, that threaten the quality of waters of the state in violation of Water Code section 13264.

Figure 11. A generator with dark stains from petroleum products discharged to the ground at location 5.

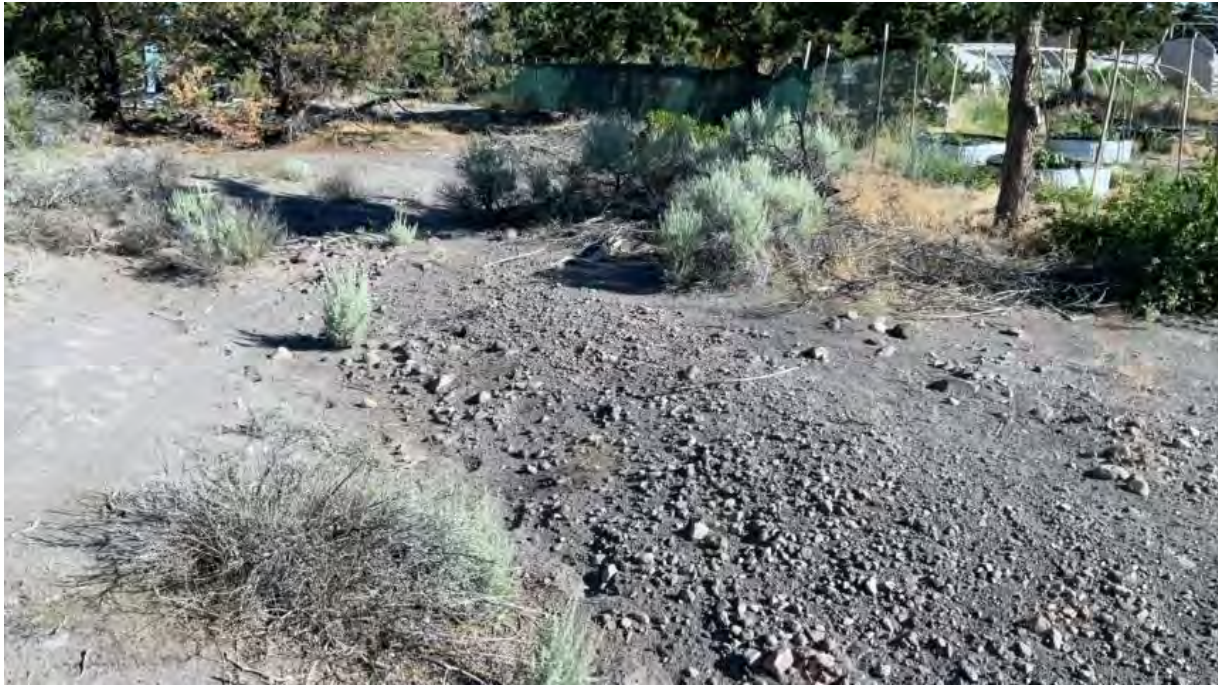
Line Location 6: Along the south side of Property is a larger stream channel that flows east to west through the Property.

Figure 12. A stream channel associated with Whitney Creek runs through the property east to west and is represented on the inspection map as a line feature location 6. The Cultivation area at polygon location 4 is located within approximately 13 feet of the stream channel. A length of three hundred thirty feet of stream channel are encroached upon by the cultivation areas and activities.

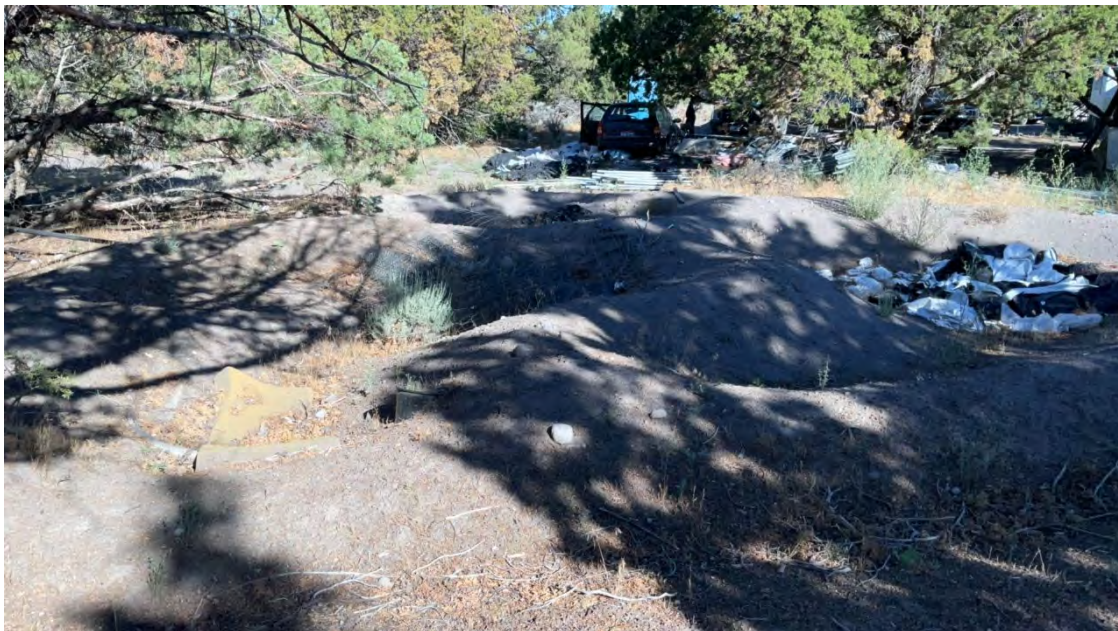
Point Location 7: Trash dug into stream channel. Nearby I observed an accumulation of cultivation related plastic refuse.

Figure 13. The stream has been impacted at polygon location 7 with pits dug and trash buried over a six hundred square foot area.

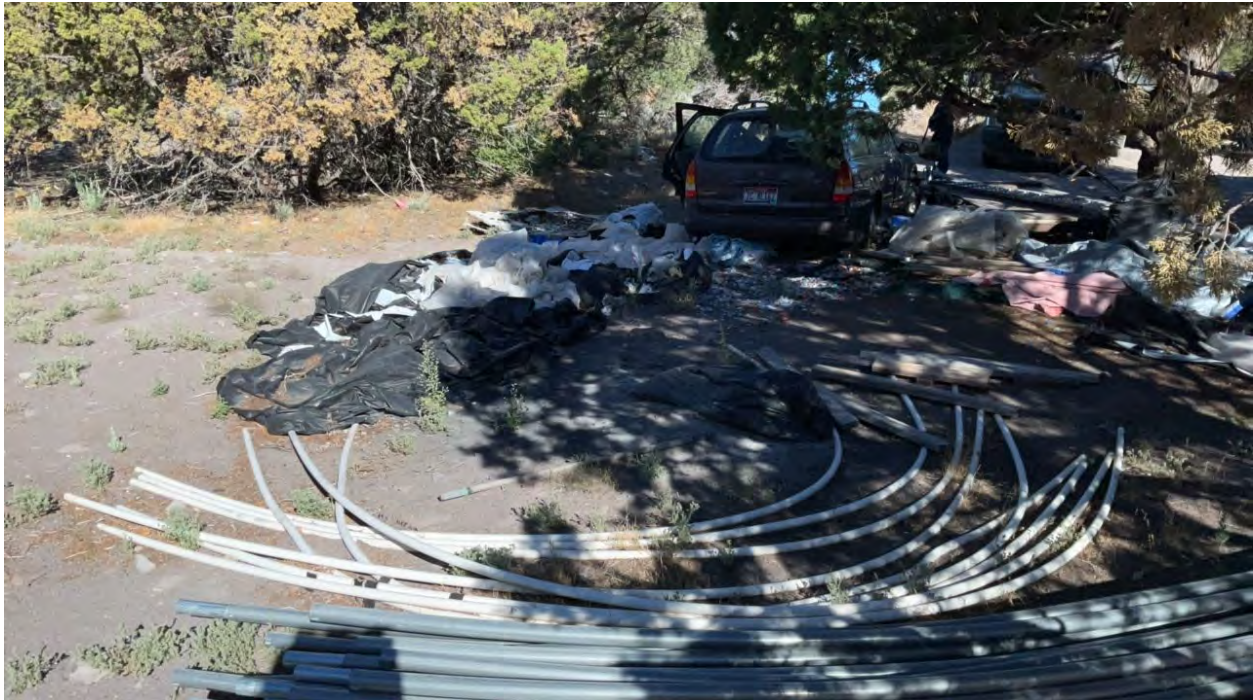
Figure 14. Refuse and cultivation related plastic materials accumulation near stream.

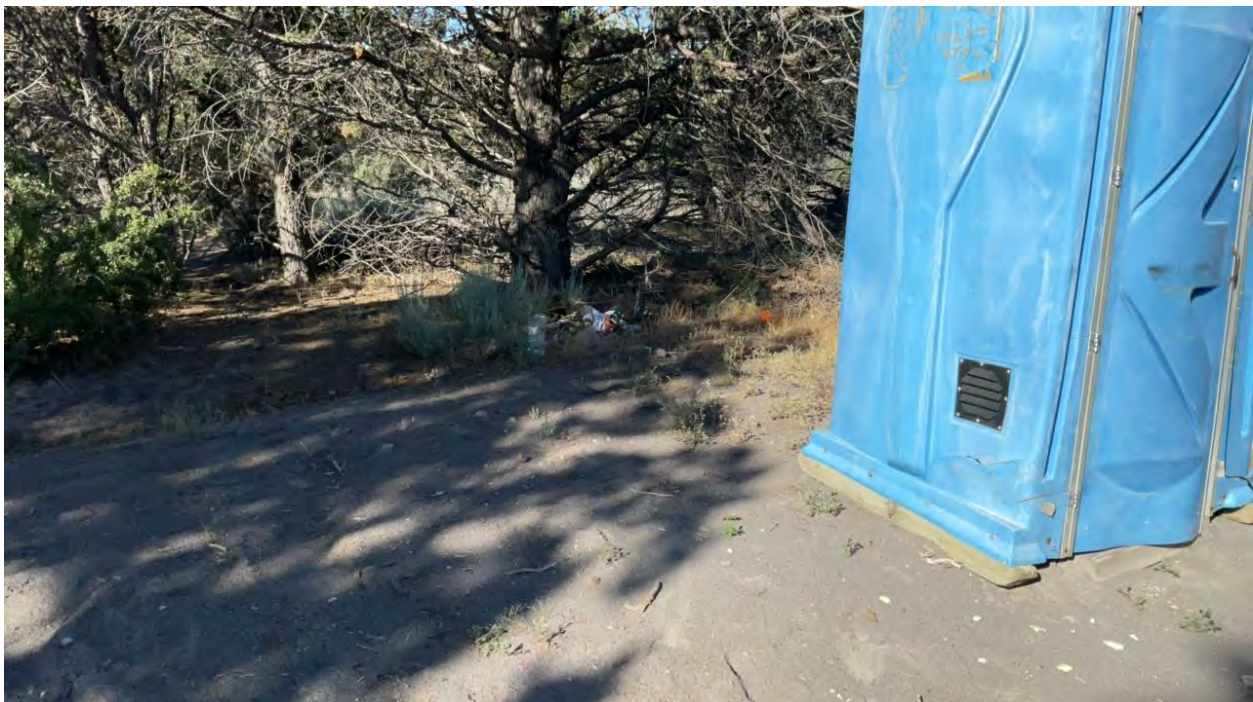
Point Location 8: A porto potty is located near the stream channel.

Figure 15. A porto potty is located near the channel at location 8.

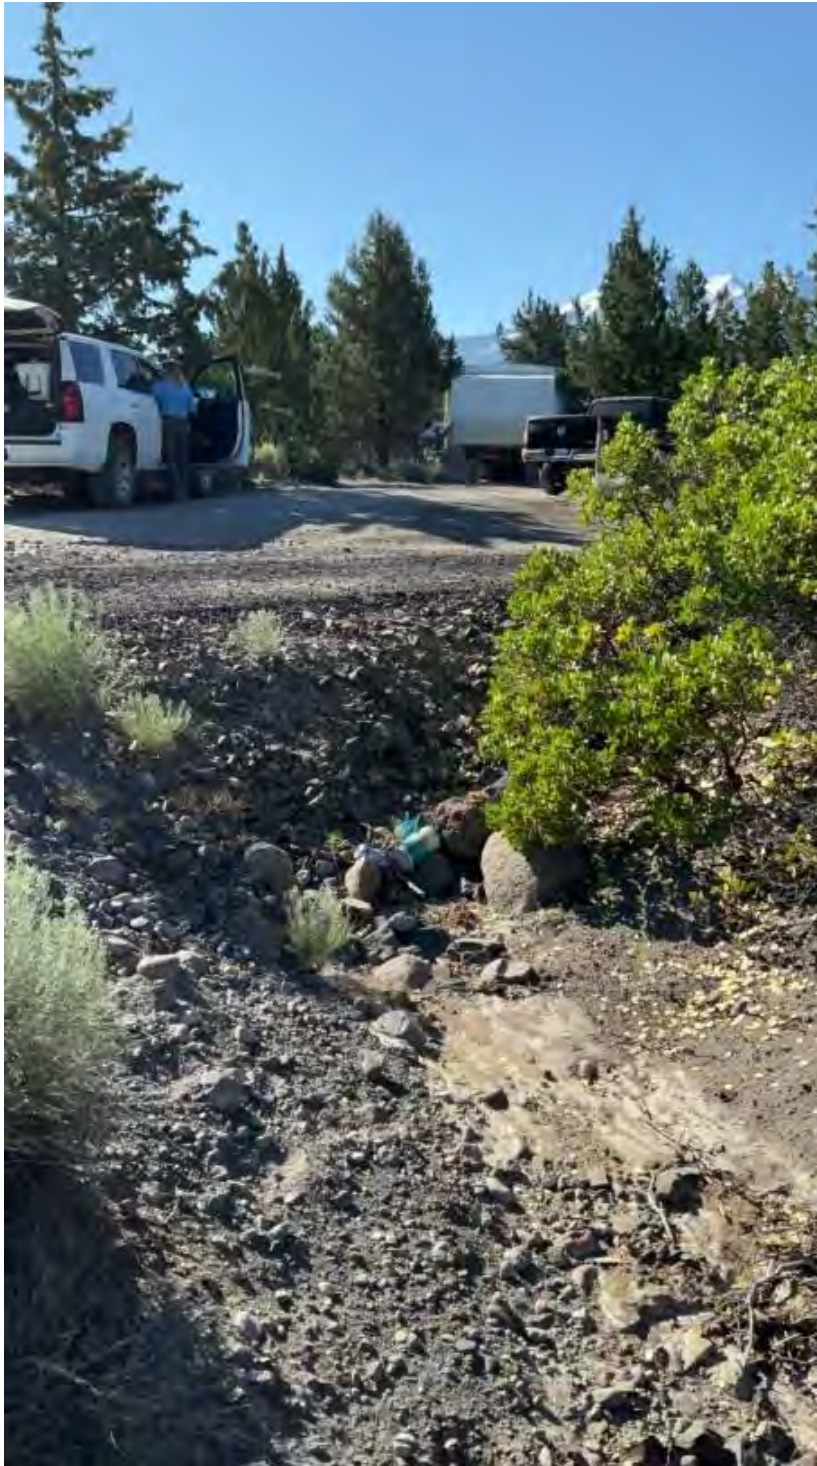
Point Location 9: An unculverted earthen fill watercourse crossing is located on Trail End Road, the access road to the property.

Figure 16. Watercourse crossing of Whitney Creek at location 9 along Trail End Road, used to access the Property, approximately thirty feet north of the mapped parcel boundary. There is no culvert installed in the crossing.
