**Subject: Notice of Violation, Transmittal of Inspection Report of July 19, 2023
Inspection of Mendocino County Assessor's Parcel Number 056-260-05**

**Cannabis Water Quality Inspection Report
Ryan Shields Property, MEN APN 056-260-05**

Inspection Details
Inspection Date & Time	July 19, 2023; 12:15 – 13:27
Address/Location	57722 Registered Guest Road, Laytonville, CA 95454 (39.889750, -123.491721)
County	Mendocino
Assessor's Parcel Number (APN)	056-260-05
Watershed	Eel River Hydrologic Unit, Middle Main Hydrologic Area, Blue Rock Creek watershed, unnamed tributary
Property Owner's Legal Name and Company	Ryan Shields
Mailing Addresses	44911 Highway 101, Laytonville, CA 95454 620 Joseph St, Apt 1, Ukiah, CA 95482 75 N Main St, Willits, CA 95490
Agency Responsible for Warrant	California Department of Fish and Wildlife (CDFW)
Person Responsible for Warrant	Warden Justin Rhoades
Warrant Date	July 19, 2023
Warrant Type	Criminal Search
Lead Inspector Name	Adona White, PE, Water Resources Control Engineer
Office/Regional Board	North Coast Regional Water Quality Control Board
Other Personnel Onsite	Representatives from CDFW and State Water Resources Control Board Division of Water Rights

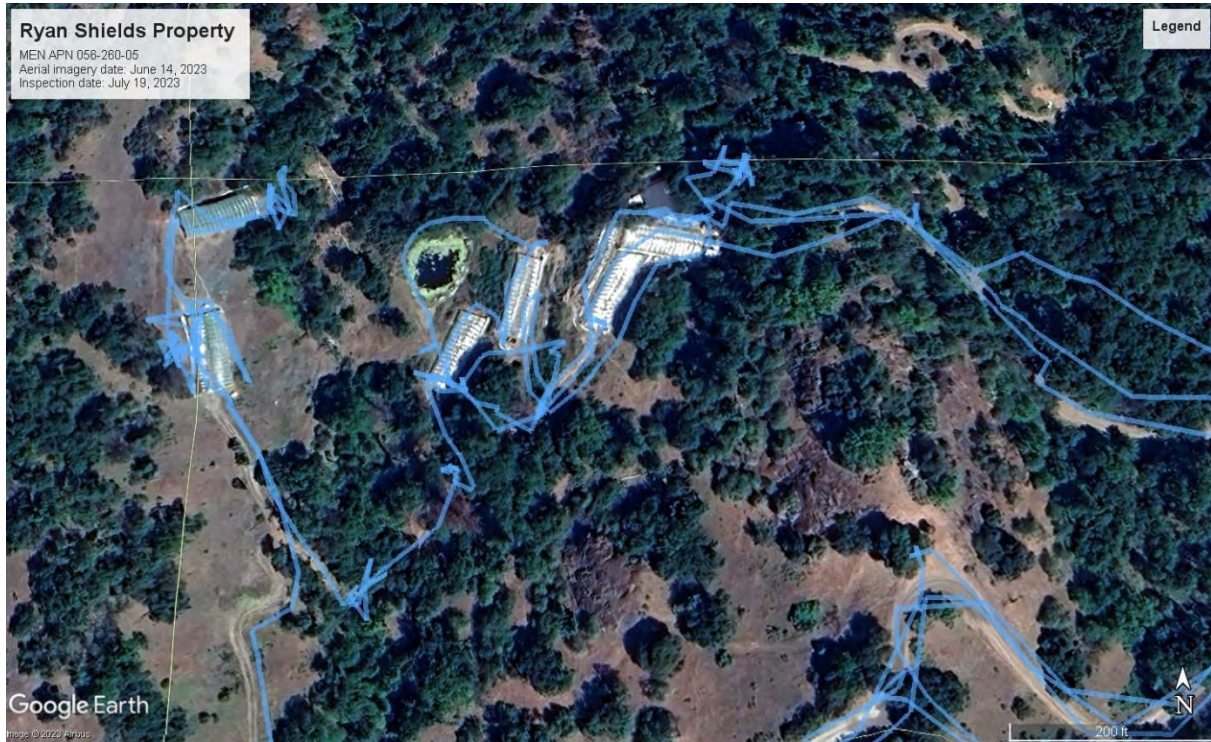
Figure 3. Inspection track.

The inspection map is shown in Figures 3 and 4 and includes the locations referenced below where I made observations of features that may pose a threat to water quality.

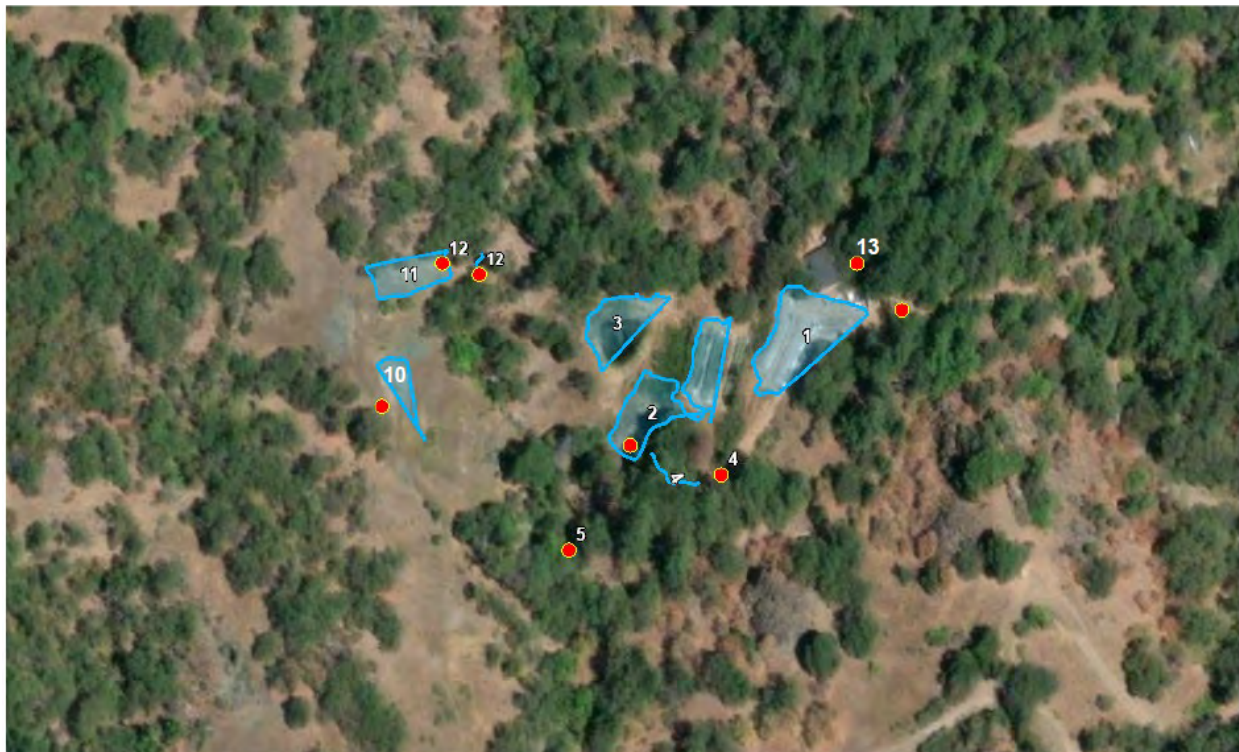
Figure 4. Inspection map on aerial imagery.

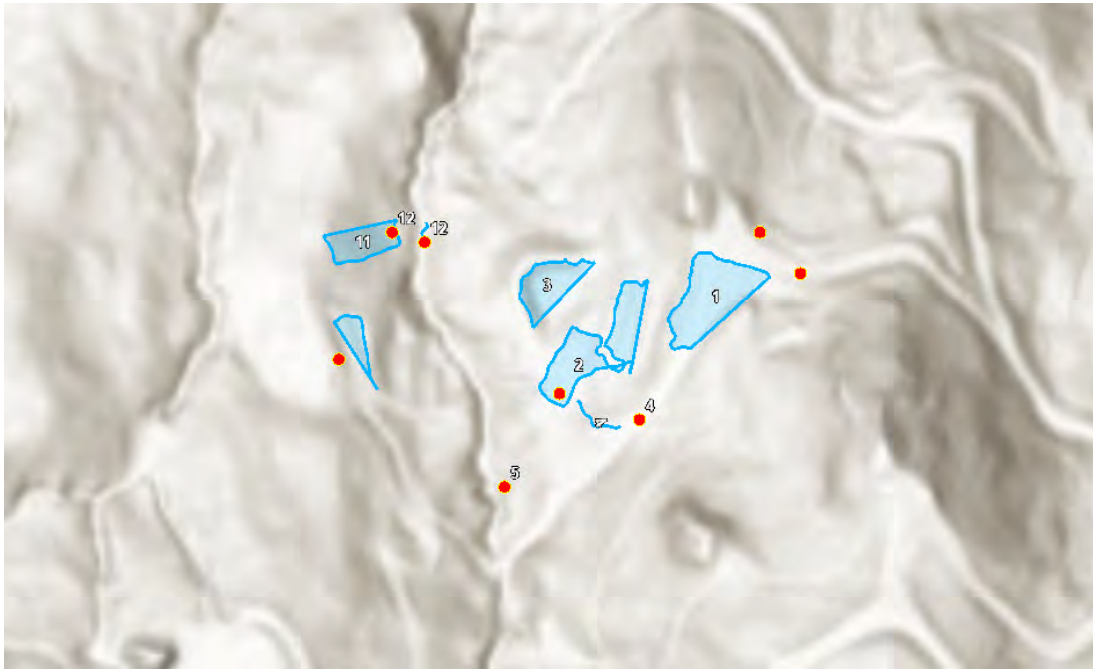
Figure 5. Inspection map on surface terrain imagery.

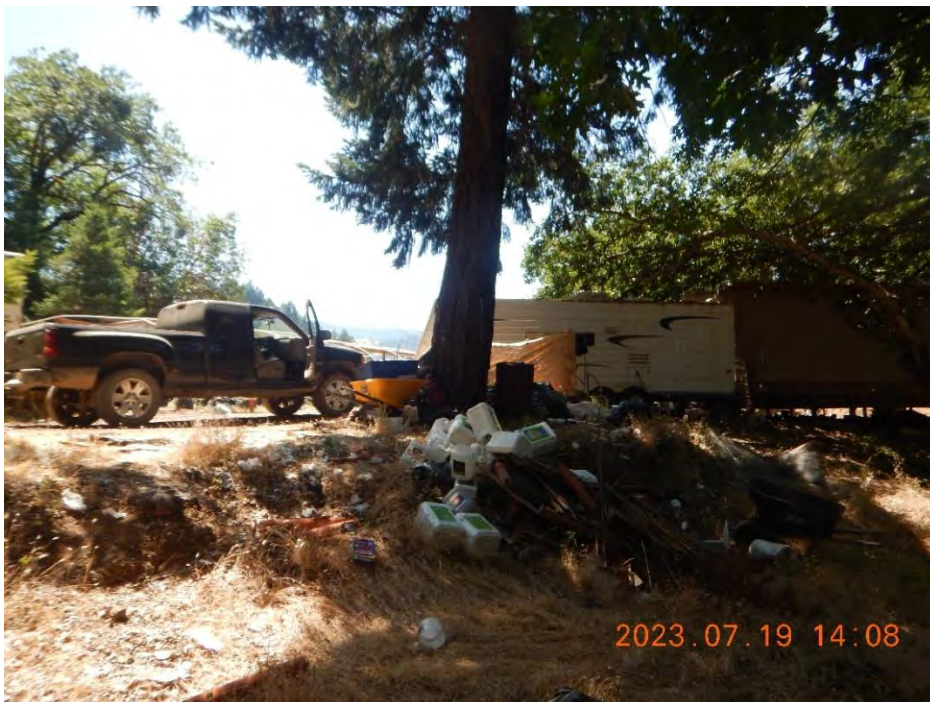
Point 13: At the top of the hill, at the entrance to the Property, there is a structure and an RV used as storage and residence, and an accumulation of cultivation materials including tarps, fertilizer jugs, piping, pots and soil. I observed an open container of waste oil. Discharge pipe from RV is run downslope into a swale. Trash is strewn in the swale. The landing occupied by the RV is built on fill, which toes into the swale.

Figure 6. Point 13. Entrance road to Property arrives to a top area of residential and

cultivation uses.

5. Cleanup potting soil and properly locate and stabilize or remove and dispose of at a legal disposal facility.
6. Prior to cultivating cannabis or developing a property for cannabis cultivation, ensure cannabis cultivation activities are in conformance with state and local requirements. Enroll for coverage under the Cannabis General Order. [Details about enrolling](#) in the Cannabis General Order can be found at: <https://public2.waterboards.ca.gov/mt/Home/Index>

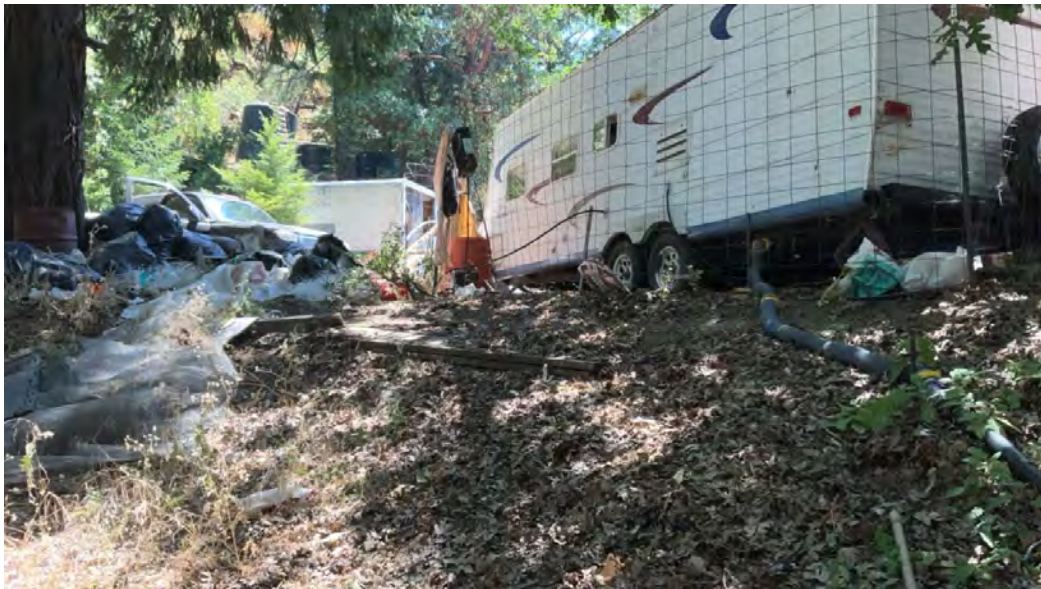
Figure 7. Point 13. RV with waste line into drainage swale.

1. Immediately cease unauthorized cannabis cultivation.
2. Immediately cease waste discharge to land at Point 13.
3. Remove cultivation infrastructure and properly dispose of waste including but not limited to trash, fertilizer, pesticide and petroleum containers, plastic tarps, and sheeting at a legal facility.

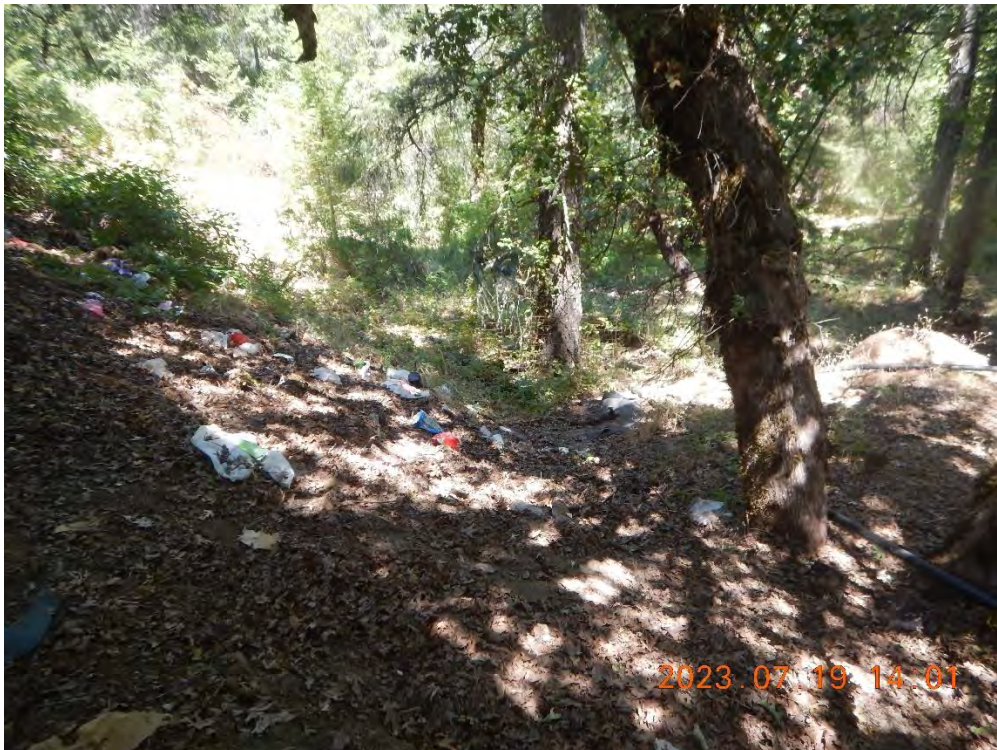
Figure 8. Point 13. Drainage swale is strewn with garbage.

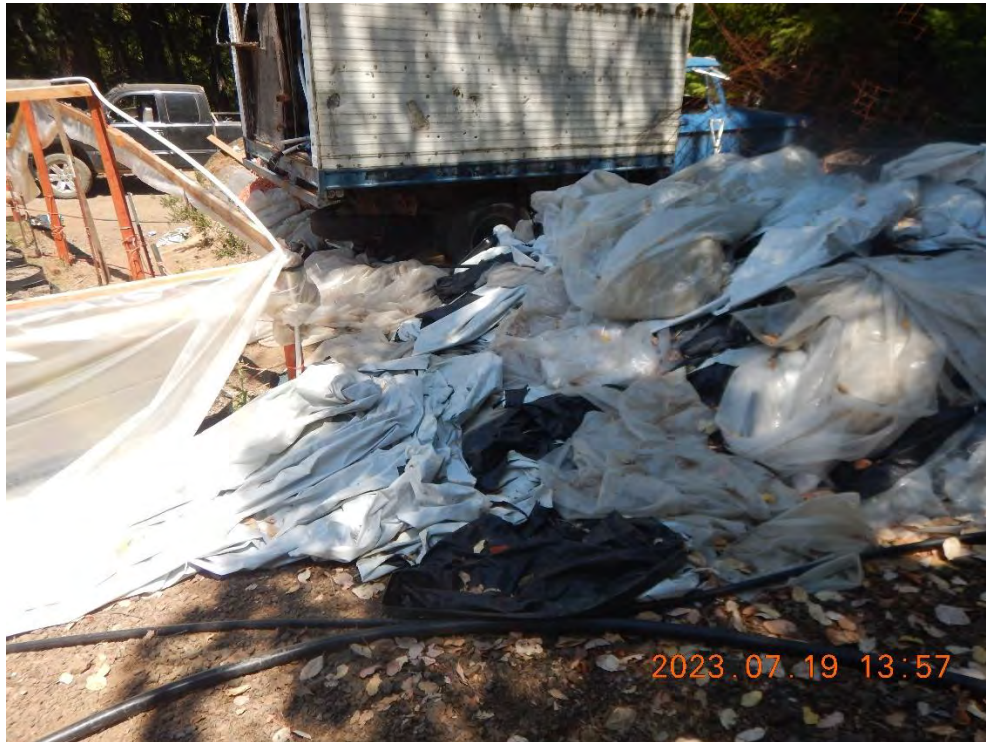
Figure 9. Point 13. Pile of discarded plastic tarps and sheeting.

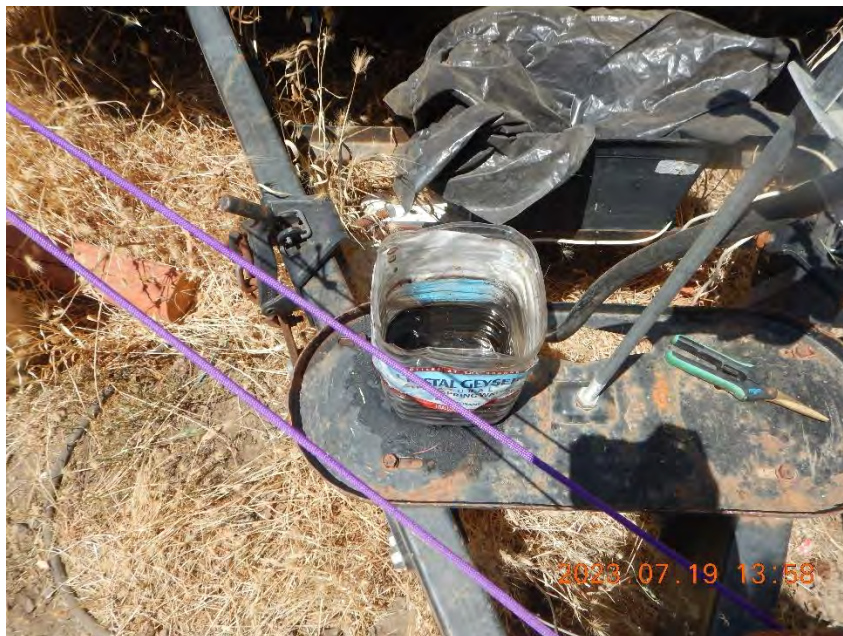
Figure 10. Point 13. Open container of waste oil.

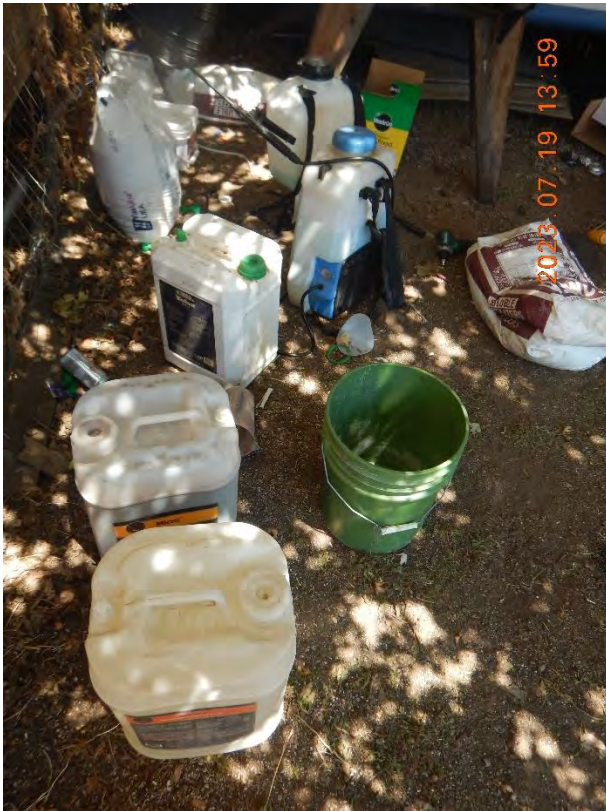
Figure 11. Point 13. Fertilizers and backpack sprayer. Uncontained materials include high concentration, water soluble fertilizers.

4. Cleanup fertilizer containers and feed tanks and prevent discharge of nutrients to land in a manner that threatens water quality. Properly dispose of all pesticides and fertilizers at a legal disposal facility.

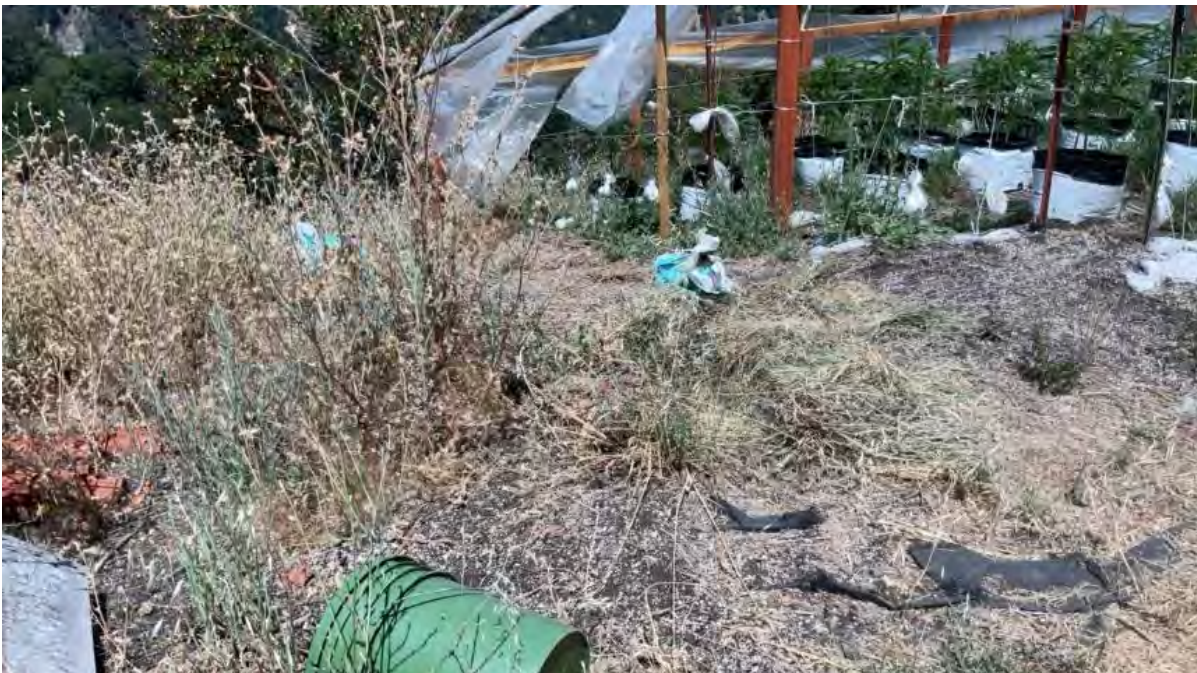
Polygon 1: Cultivation area in greenhouses on slope.

Figure 12. Polygon 1. Active greenhouse cultivation. Uncontained potting soil, plastic,

and containers.

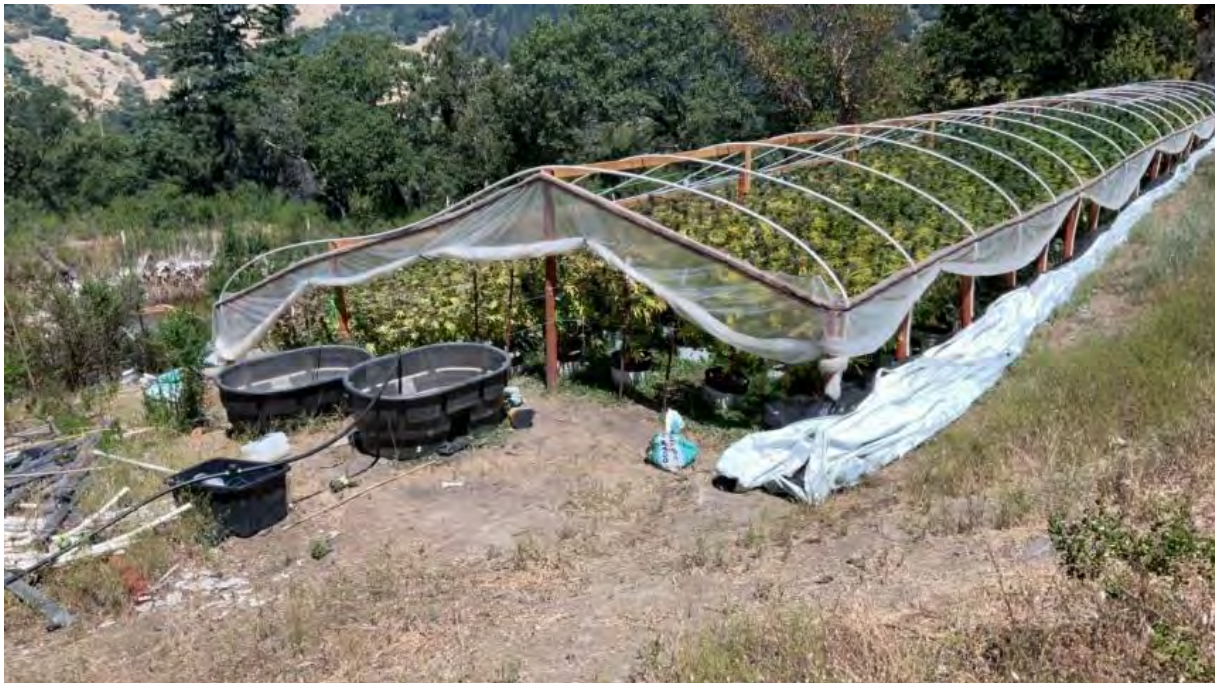
Polygon 2: Cultivation area in greenhouses on slope.

Figure 13. Polygon 2. Active greenhouse cultivation. Open feed troughs.

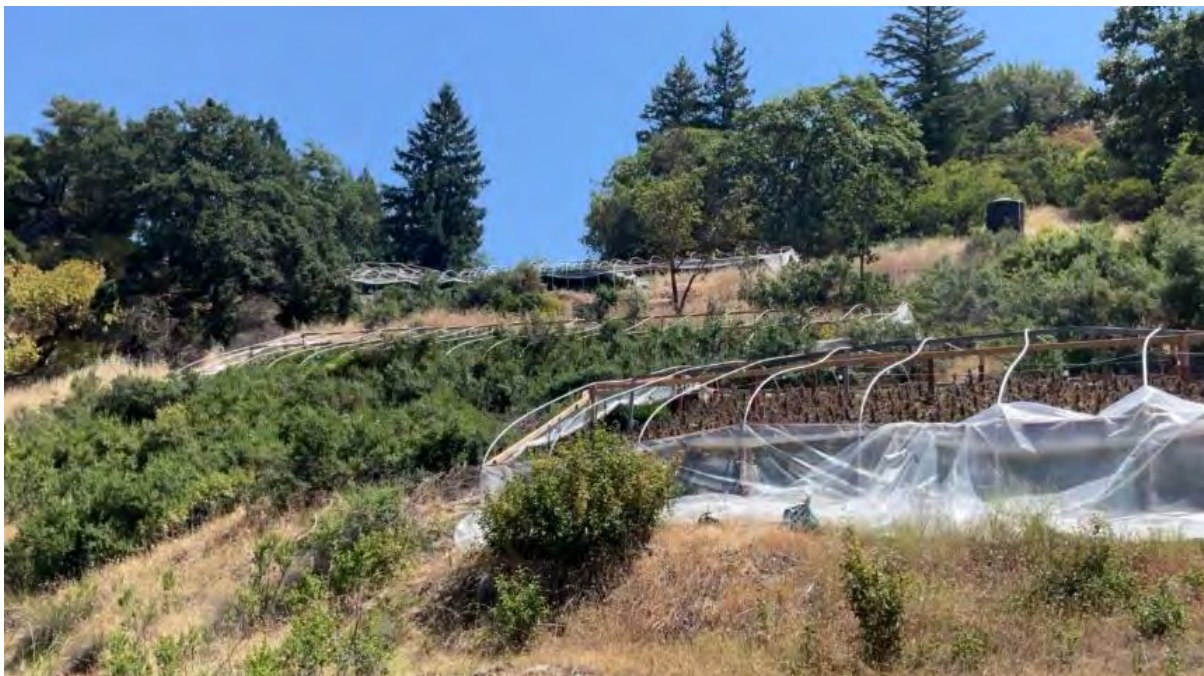
Line 4: Erosional path of watercourse diverted at Point 4, down a steep hillslope to cultivation area Polygon 2, where fertilizers are stored. These conditions pose threat of discharge of sediment and cultivation-related wastes to waters of the state.

Figure 14. Polygon 2. Active greenhouse cultivation. View uphill at terraces from Polygon 3.

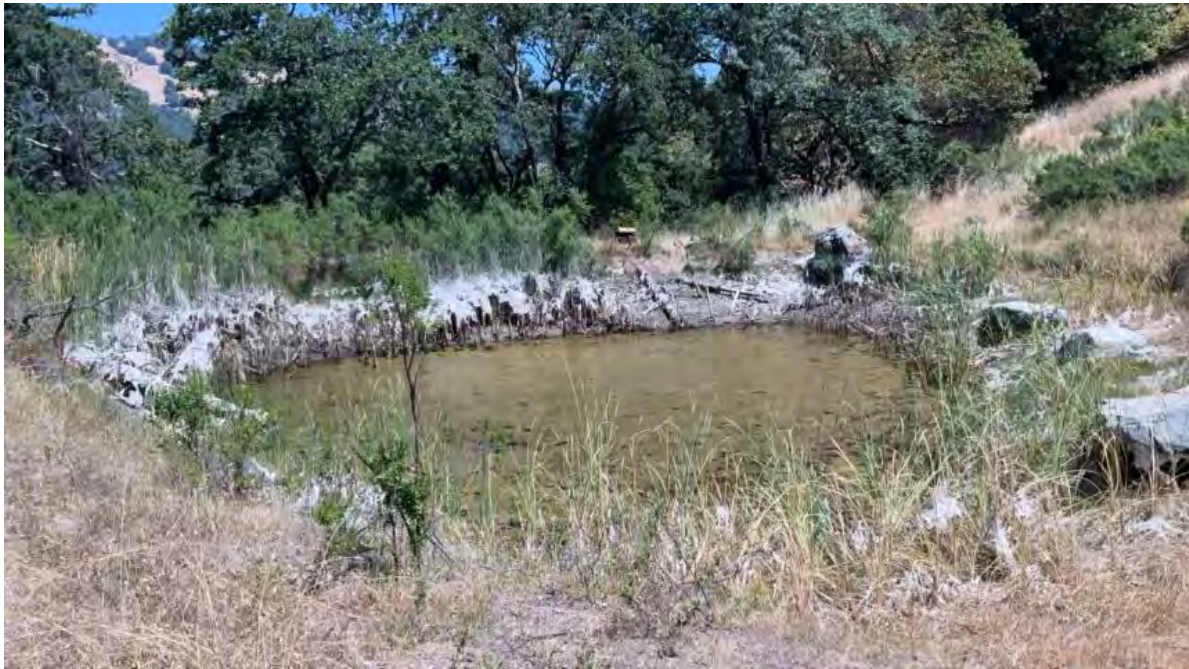
Polygon 3: Unlined excavated water storage pond with earthen berm. No discernable outflow structure.

Figure 15. Polygon 3. Unlined excavated water storage pond with earthen berm. No discernable outflow structure. Built at edge of steep slope.

7. Hire a qualified professional to assess the Property, including but not limited to the features described in this report, to develop a treatment plan to guide that the cleanup and remediation of the assessed features that ensures that will no longer pose a threat of discharge or impacts to the quality of waters of the state. Submit the plan for approval and implement cleanup and restoration work.

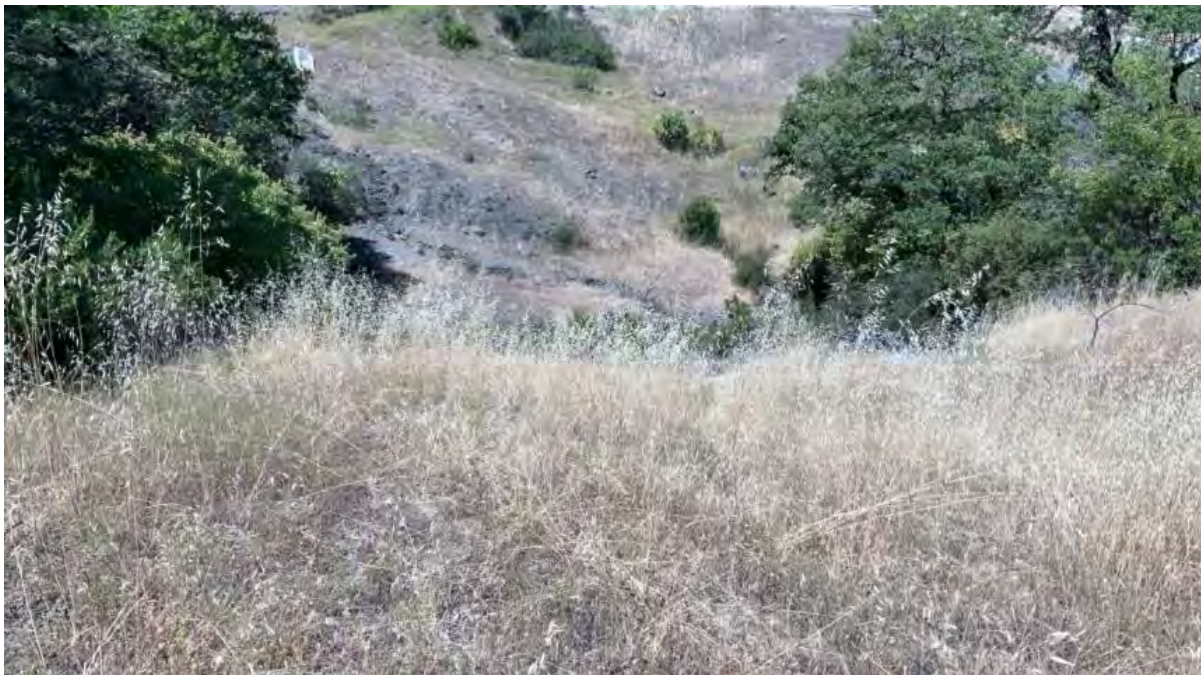
Figure 16. Polygon 3. Pond. A large creek is located below the berm, down a steep slope.

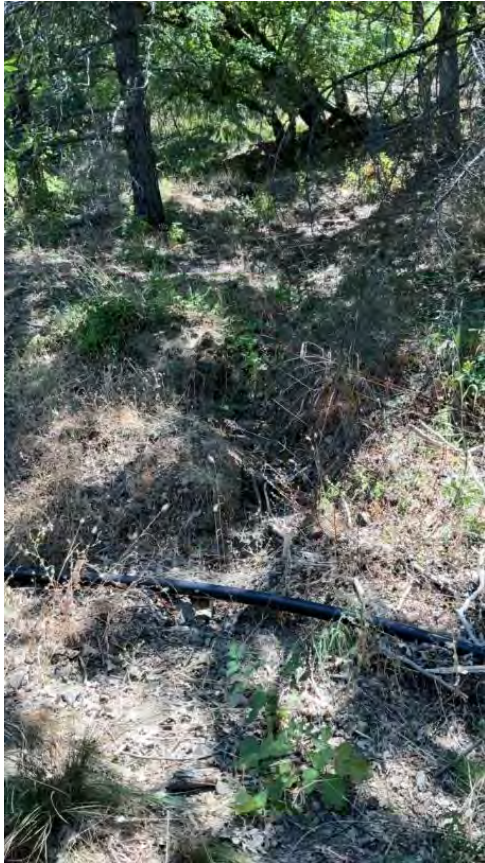
Point 4: Class III watercourse is interrupted by road with no crossing, is diverted down the road and then is dumped over a steep slope.

Figure 17. Point 4. A watercourse drains the slope above in a scoured channel, hits the road where there is no crossing, is rerouted down the slope, hits the cultivation flat at Polygon 2, and runs past the greenhouse. View is looking upslope.

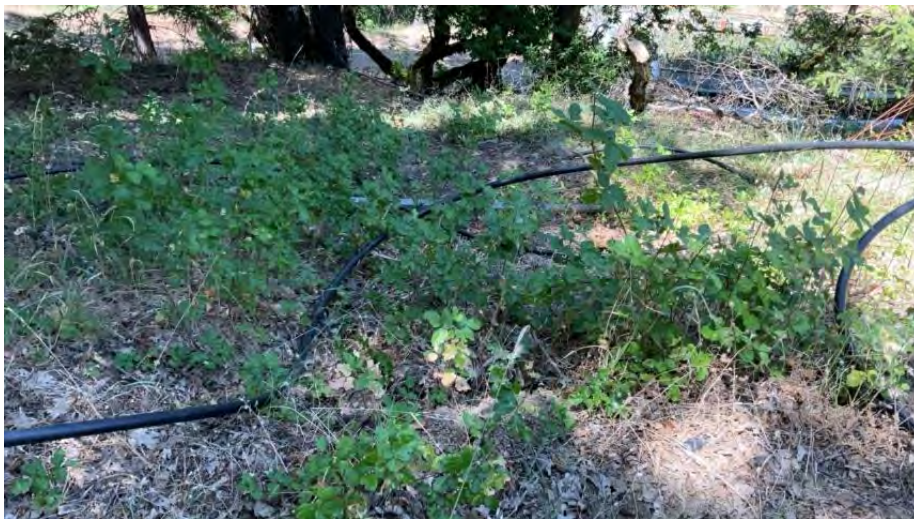
Figure 18. Line 4. Watercourse is diverted down a steep slope toward the cultivation flat of Polygon 2. View is looking downslope.

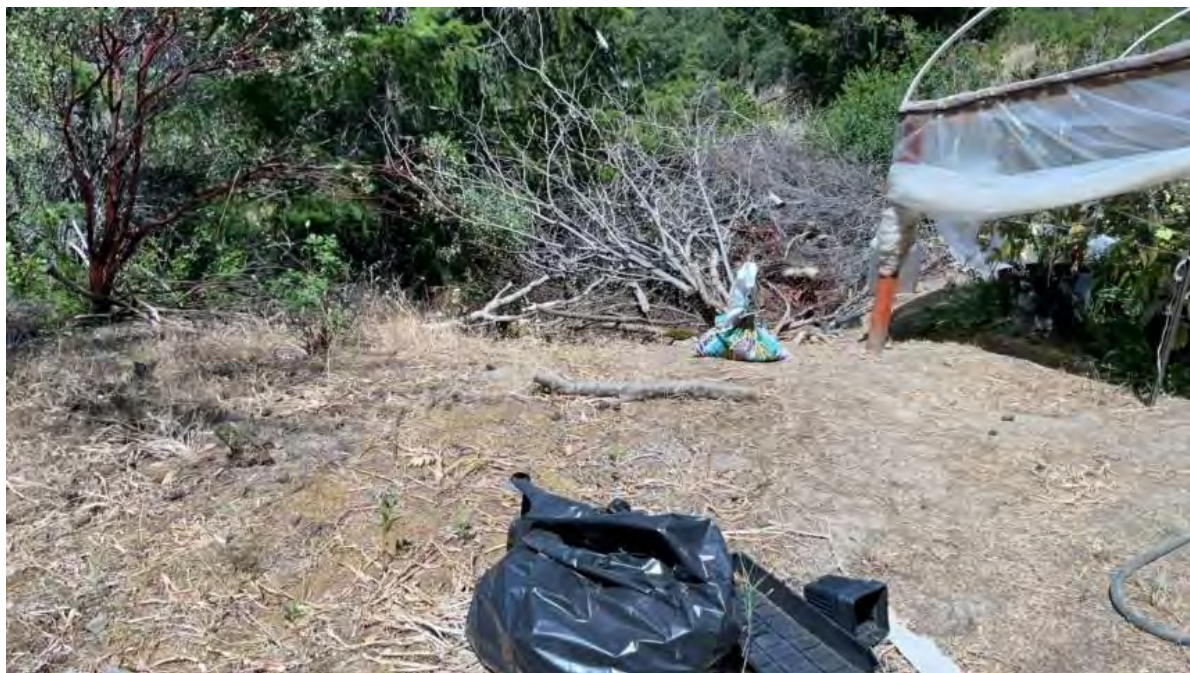
Figure 19. Line 4. Diverted watercourse flows past a greenhouse at Polygon 2.

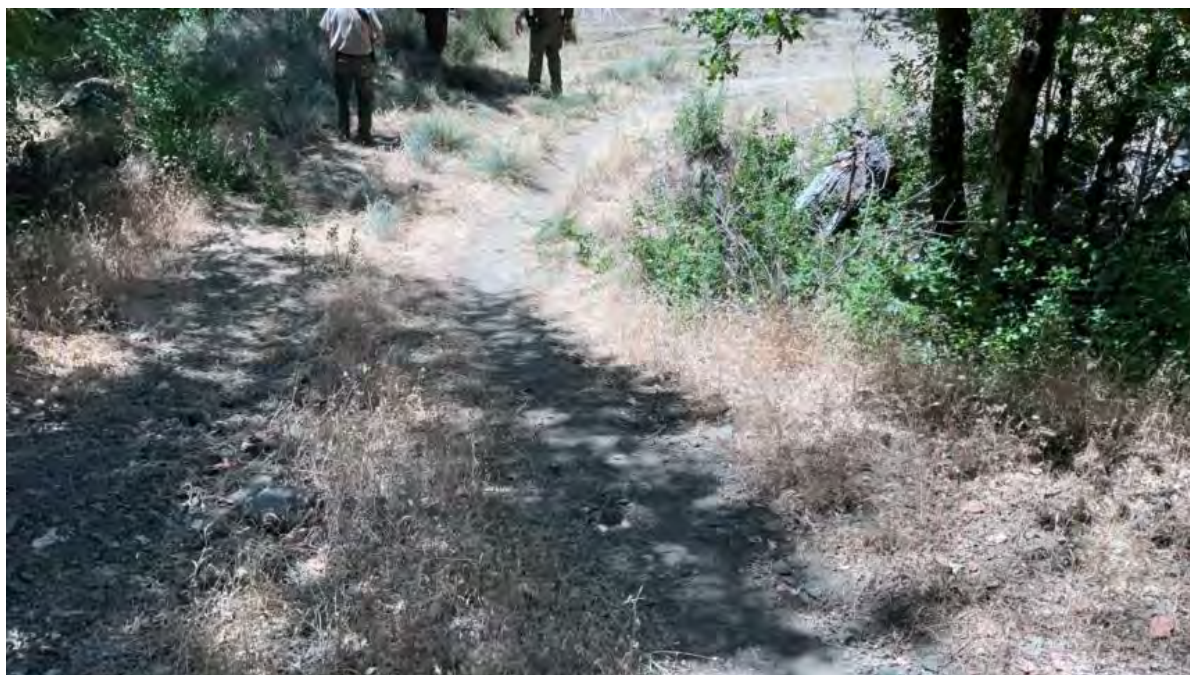
Point 5: Watercourse crossing on access road to west side of blue line watercourse used to access cannabis cultivation areas. The road approach concentrates runoff to the watercourse at the crossing and is a threatened discharge of waste. The 52" culvert is unpermitted.

Figure 20. Point 5. Watercourse crossing on access road to west side of blue line watercourse used to access cannabis cultivation areas. The road approach concentrates runoff to the watercourse at the crossing and is a threatened discharge of waste.

A water quality certification is required prior to conducting instream work.

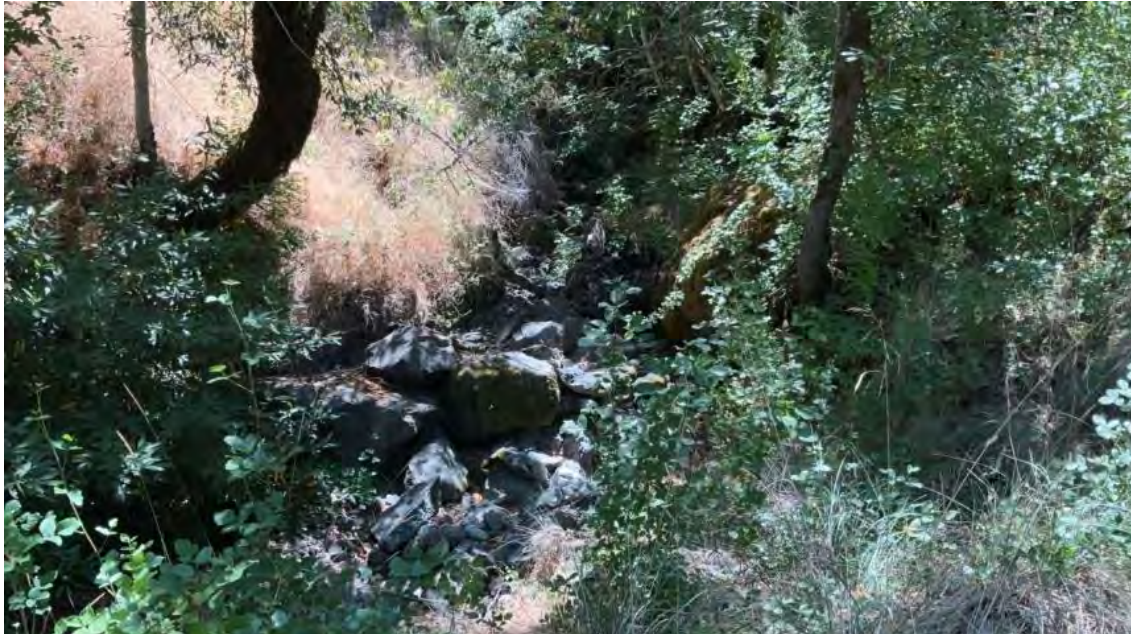
As documented in the inspection report, staff observed evidence of discharges of road-related sediment in violation of Water Code section 13264 for unauthorized discharge of waste to waters of the state at Point 5 and Line 4.

Figure 21. Point 5. Watercourse upstream of crossing.

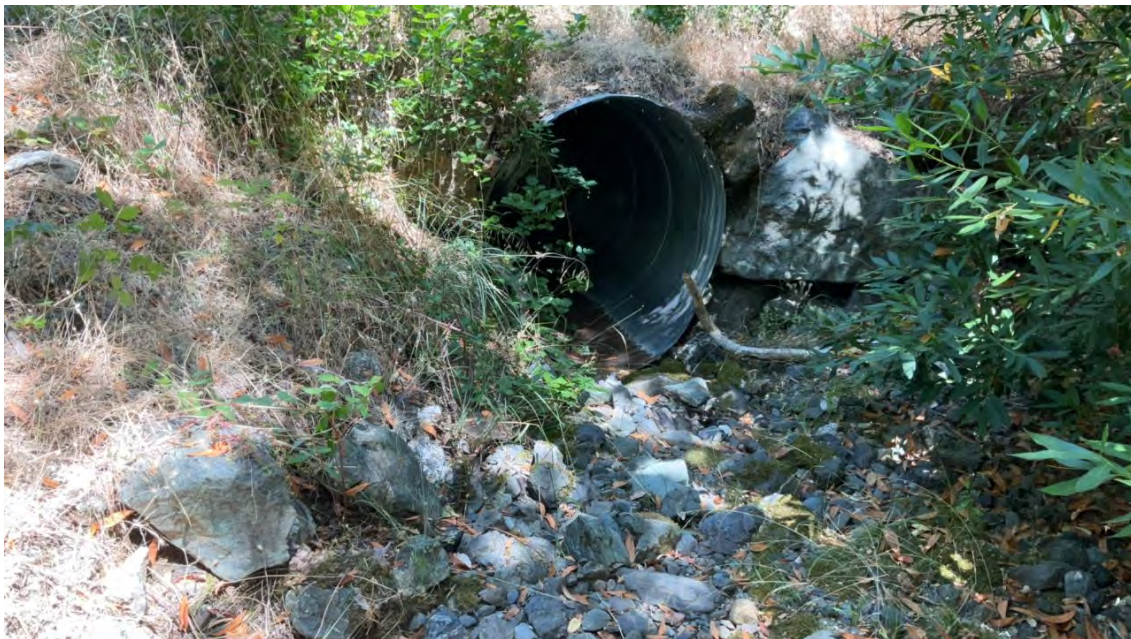
Figure 22. Point 5. Inlet of 52" culvert.

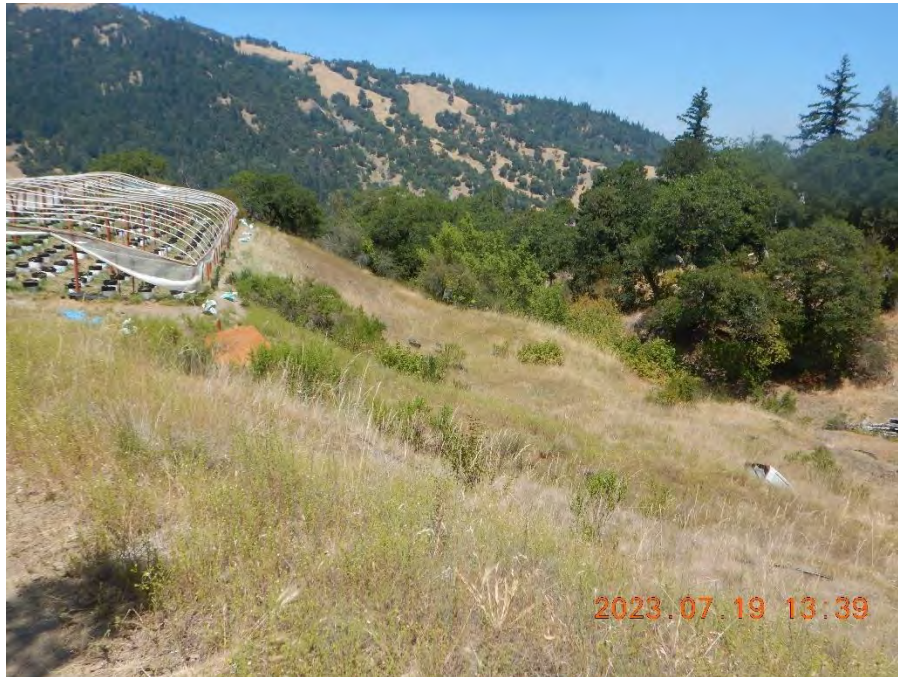
Figure 23. Unlabeled polygon of active greenhouse cultivation on west side of blue line watercourse is seen in foreground.

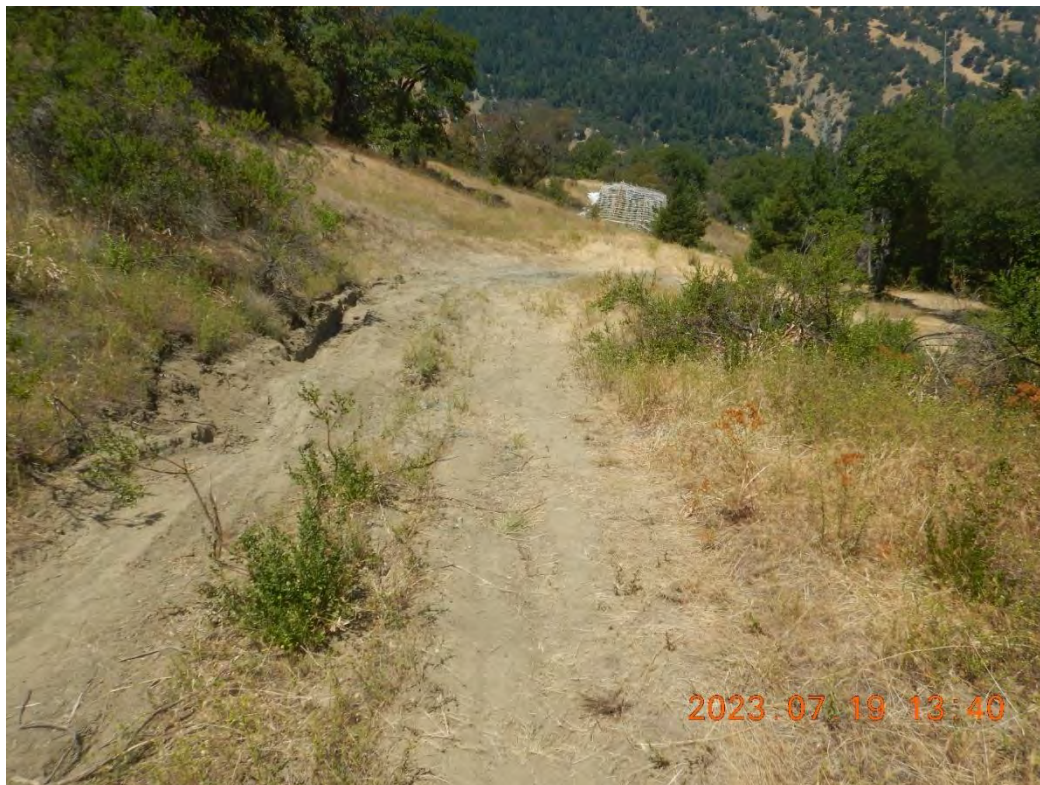
Figure 24. Road to western cultivation areas is rutted and has not been maintained.

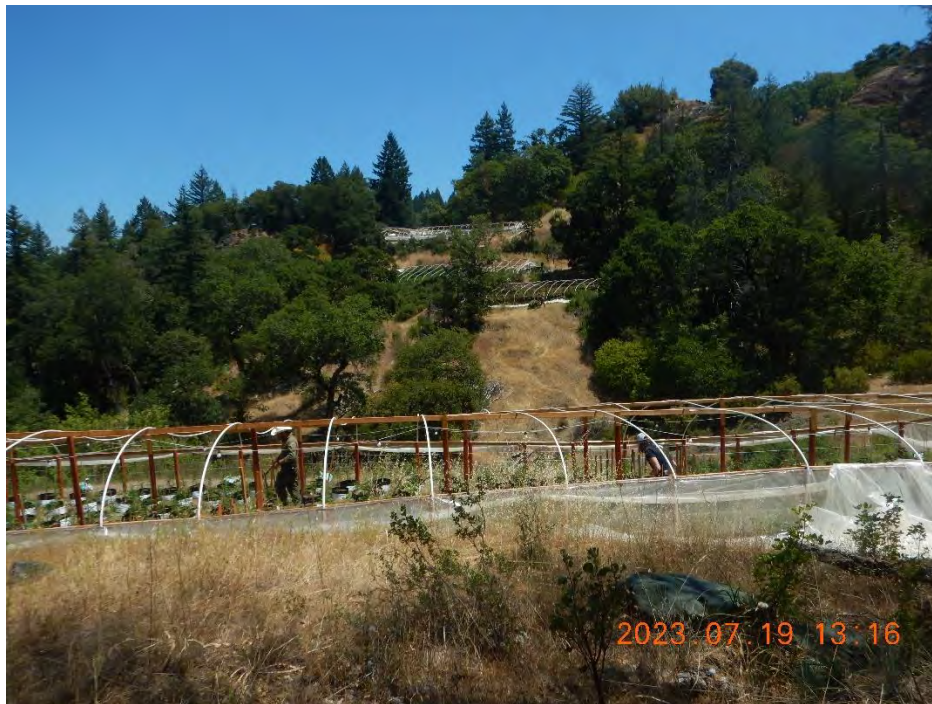
Figure 25. Unlabeled polygon of active greenhouse cultivation on west side of blue line watercourse is seen in foreground. In distance, across the watercourse built on the terraced slope are greenhouses associated with Polygons 1 and 2.

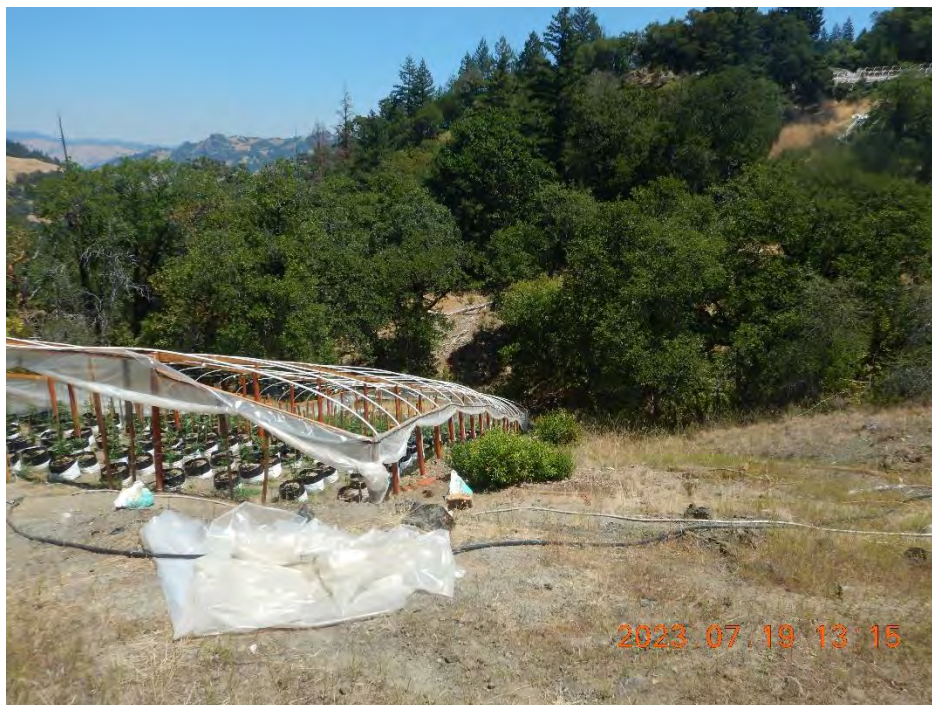
Polygon 11: Cultivation area in greenhouses on west side of the blue line creek. I observed evidence of irrigation runoff from greenhouse to watercourse.

Figure 26. Polygon 11. Greenhouse above watercourse.

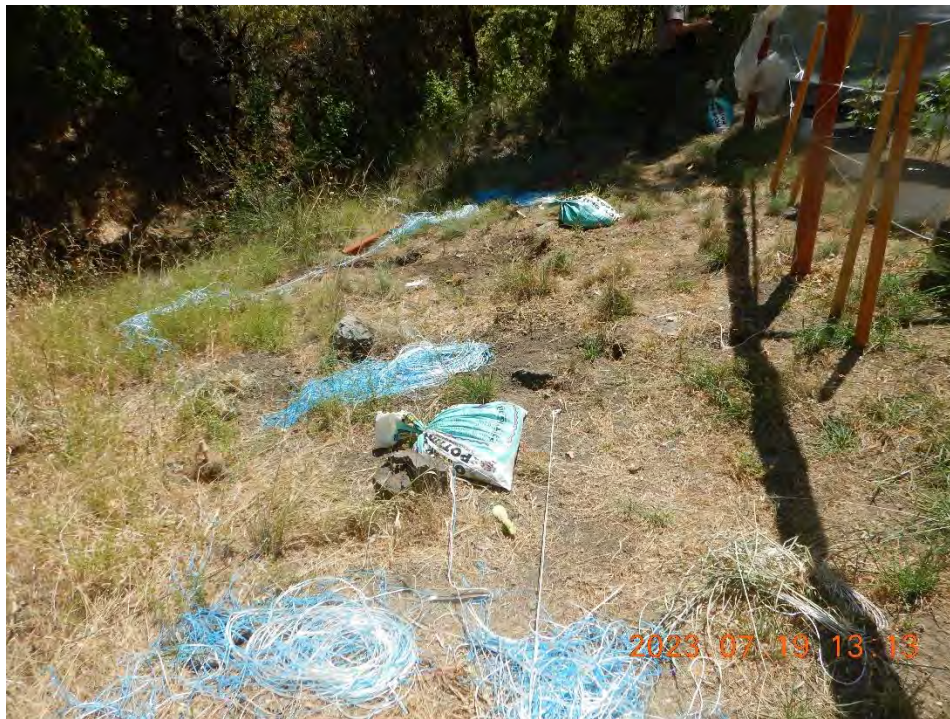
Figure 27. Polygon 11. Greenhouse above watercourse.

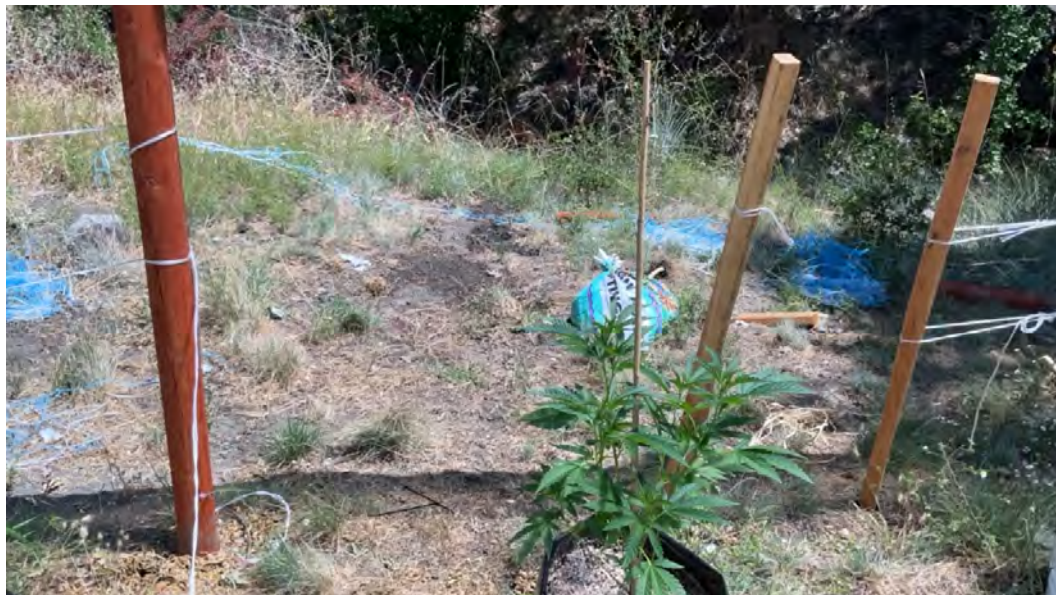
Figure 28. Irrigation runoff from greenhouse at Polygon 11 toward watercourse. The top of bank is visible in the photo at the upper edge of the grass.

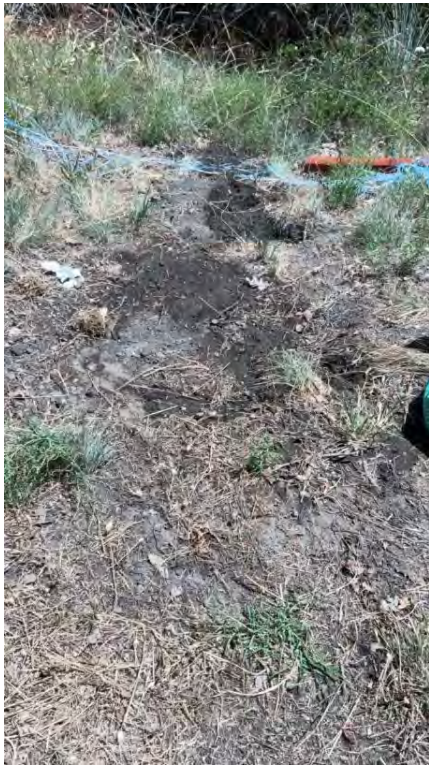
Figure 29. Point 12. Irrigation runoff from greenhouse at Polygon 11 to watercourse.

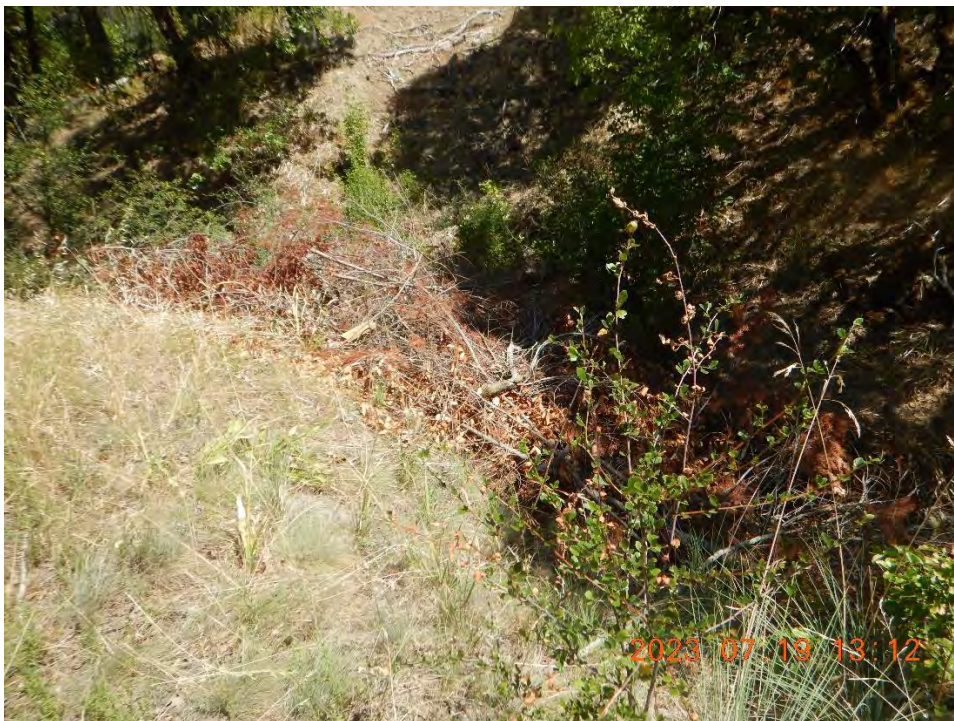
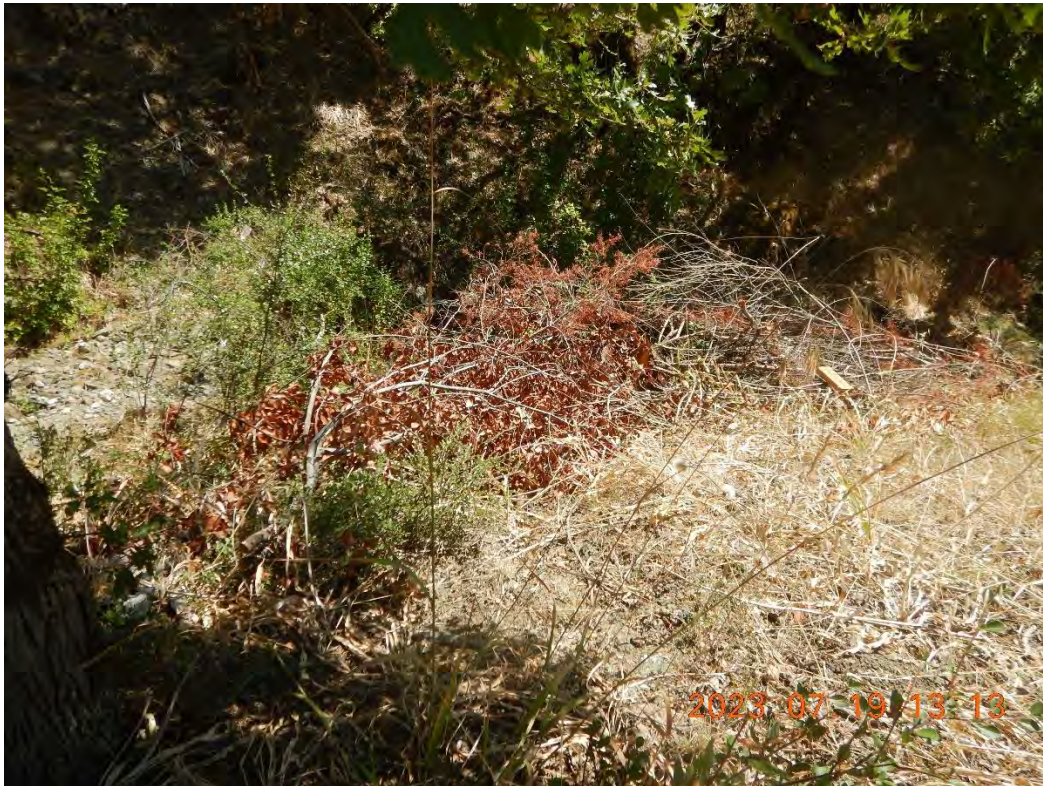
As documented in the inspection report at Line 12, staff observed the placement of slash into a blue line watercourse, in violation of Basin Plan sections 4.2.1. Prohibition 1. Additionally, this discharge was in violation of Water Code section 13264 for unauthorized discharges of waste and section 13350 for discharges in violation of a Regional Water Board prohibition.

Line 12: Slash from clearing the cultivation area at Polygon 11 was placed in the channel of the blue line stream. The slash was placed along the left bank (facing downstream) over a stream length of 30 feet.

Figure 30. Line 12. Slash placed in the channel of a blue line watercourse.

Figure 31. Line 12. Slash placed in the channel of a blue line watercourse.
