**Subject: Notice of Violation, Transmittal of Inspection Report of July 19, 2023
Inspection of Mendocino County Assessor's Parcel Number 056-260-05**

**Cannabis Water Quality Inspection Report
Ryan Shields Property, MEN APN 056-260-05**

Inspection Details
Inspection Date & Time	July 19, 2023; 12:15 – 13:27
Address/Location	57722 Registered Guest Road, Laytonville, CA 95454 (39.889750, -123.491721)
County	Mendocino
Assessor's Parcel Number (APN)	056-260-05
Watershed	Eel River Hydrologic Unit, Middle Main Hydrologic Area, Blue Rock Creek watershed, unnamed tributary
Property Owner's Legal Name and Company	Ryan Shields
Mailing Addresses	44911 Highway 101, Laytonville, CA 95454 620 Joseph St, Apt 1, Ukiah, CA 95482 75 N Main St, Willits, CA 95490
Agency Responsible for Warrant	California Department of Fish and Wildlife (CDFW)
Person Responsible for Warrant	Warden Justin Rhoades
Warrant Date	July 19, 2023
Warrant Type	Criminal Search
Lead Inspector Name	Adona White, PE, Water Resources Control Engineer
Office/Regional Board	North Coast Regional Water Quality Control Board
Other Personnel Onsite	Representatives from CDFW and State Water Resources Control Board Division of Water Rights

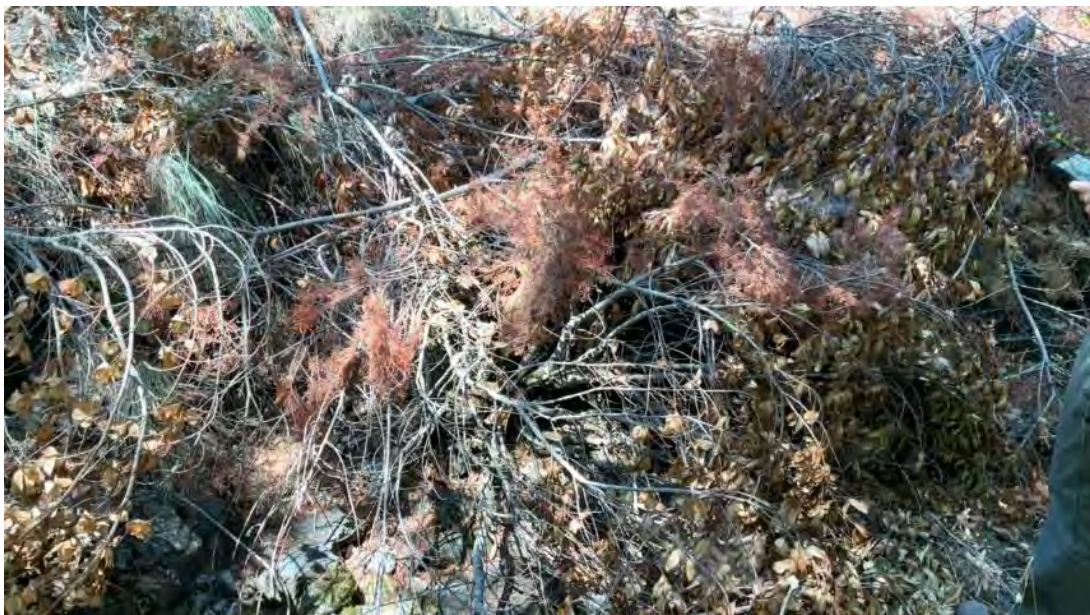
Line 12: Slash from clearing the cultivation area at Polygon 11 was placed in the channel of the blue line stream. The slash was placed along the left bank (facing downstream) over a stream length of 30 feet.

Figure 32. Line 12. Slash placed in blue line watercourse associated with land clearing for cultivation activities. Over 30' of watercourse channel was filled with placed slash pile.

A water quality certification is required prior to conducting instream work.
