North Coast Regional Water Quality Control Board

**Subject Notice of Violation, Transmittal of Inspection Report of July 26, 2023
Inspection of Trinity County Assessor's Parcel Number 011-020-017**

**North Coast Regional Water Quality Control Board
Attachment B**

**Cannabis Water Quality Inspection Report
Uniland Farm LLC, Trinity County APN 011-020-017**

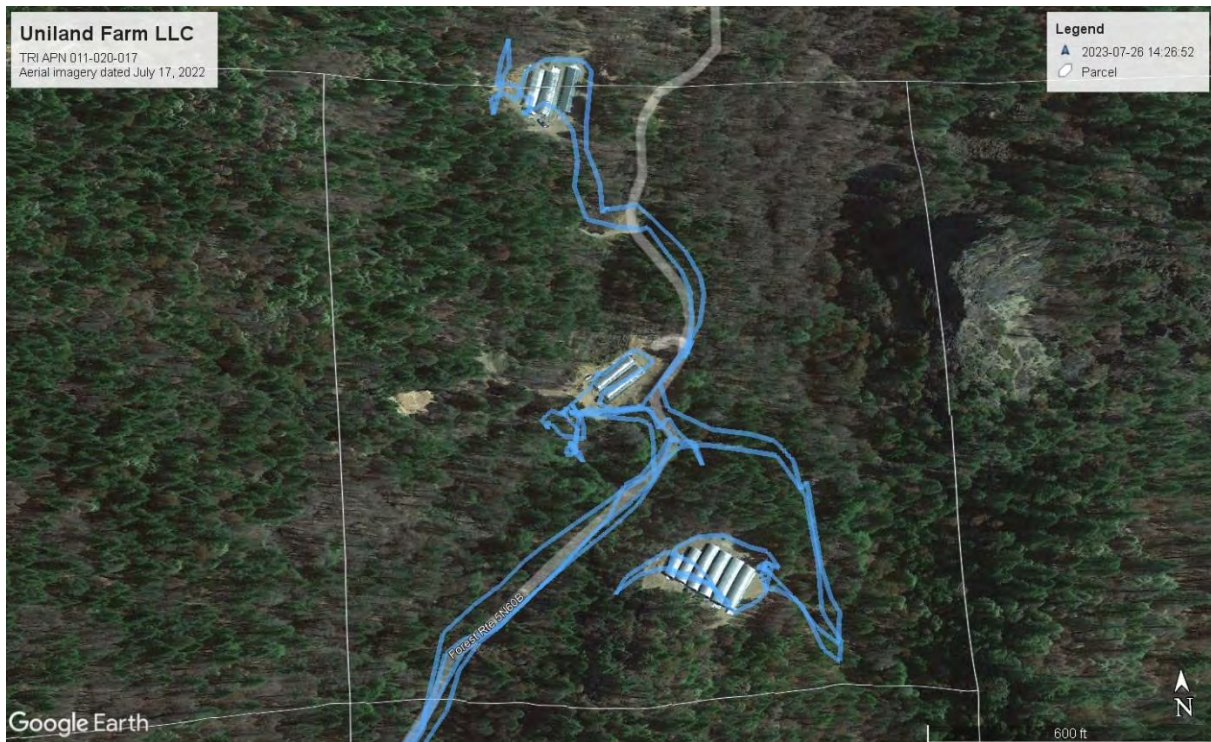
Figure 2. GPS track of my July 26, 2023 inspection route.

The inspection maps are shown in Figures 2 and 3, labeled with the locations described at the following features of concern to water quality.

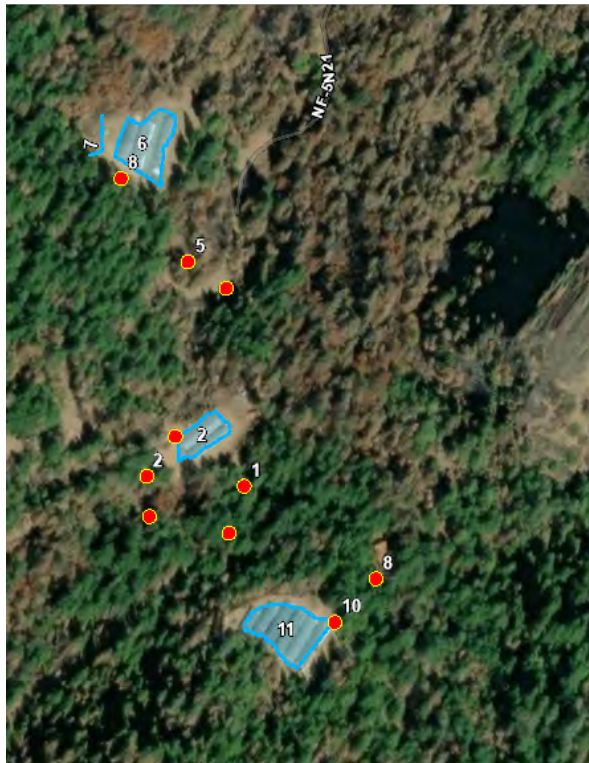
Figure 3. Inspection map with aerial imagery showing the point, line, and polygon feature locations of interest described in the text.

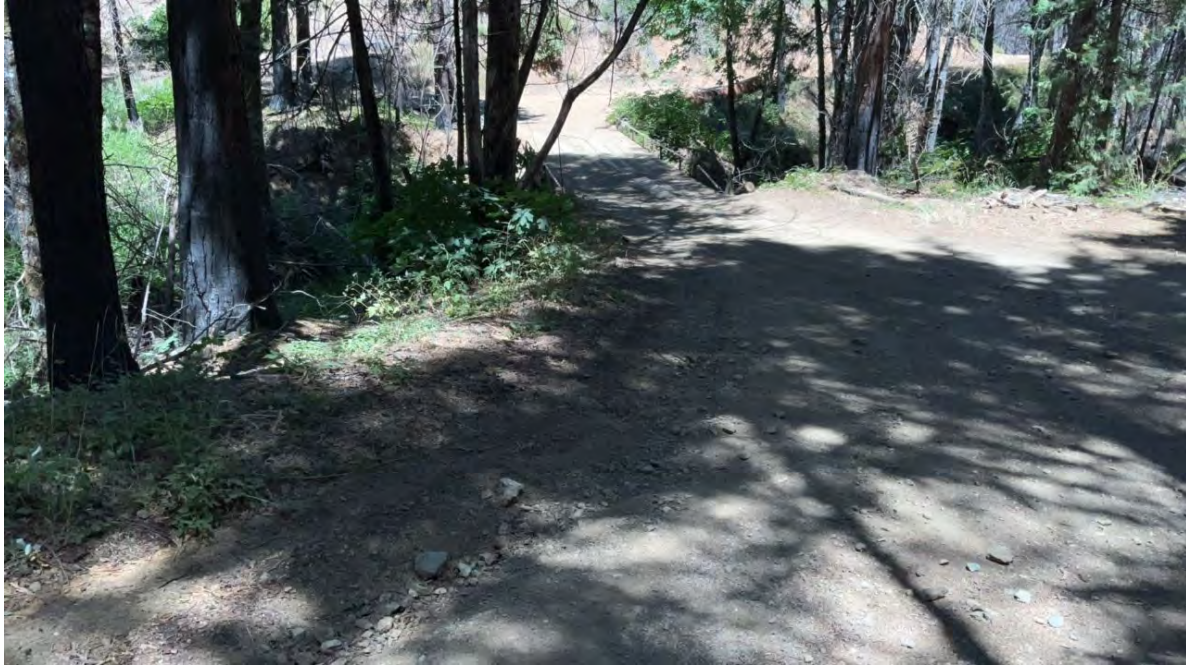
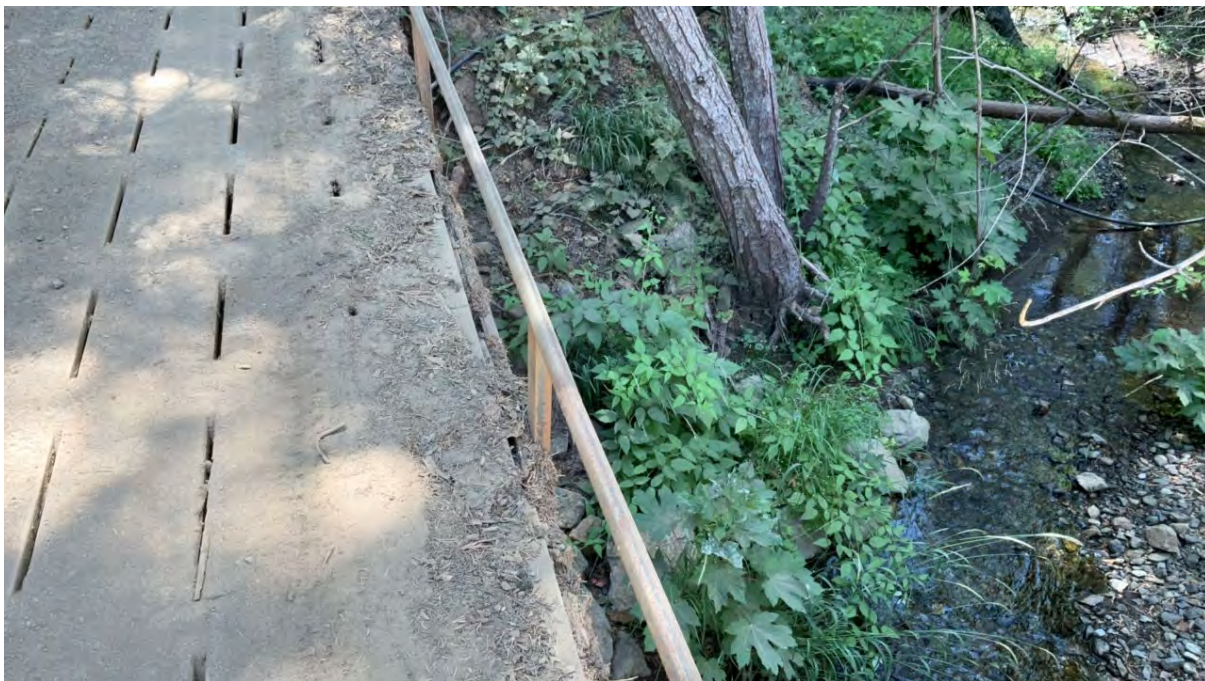
Point Feature 1: Bridge over Cass II watercourse. Threat of sediment delivery from road surface to watercourse associated with concentrated road runoff, lack of hydrologic disconnections and inadequate surfacing.

Figure 6. Point Feature 1 – bridge over Class II watercourse,

Figure 7. Point feature 1 – bridge over Class II.

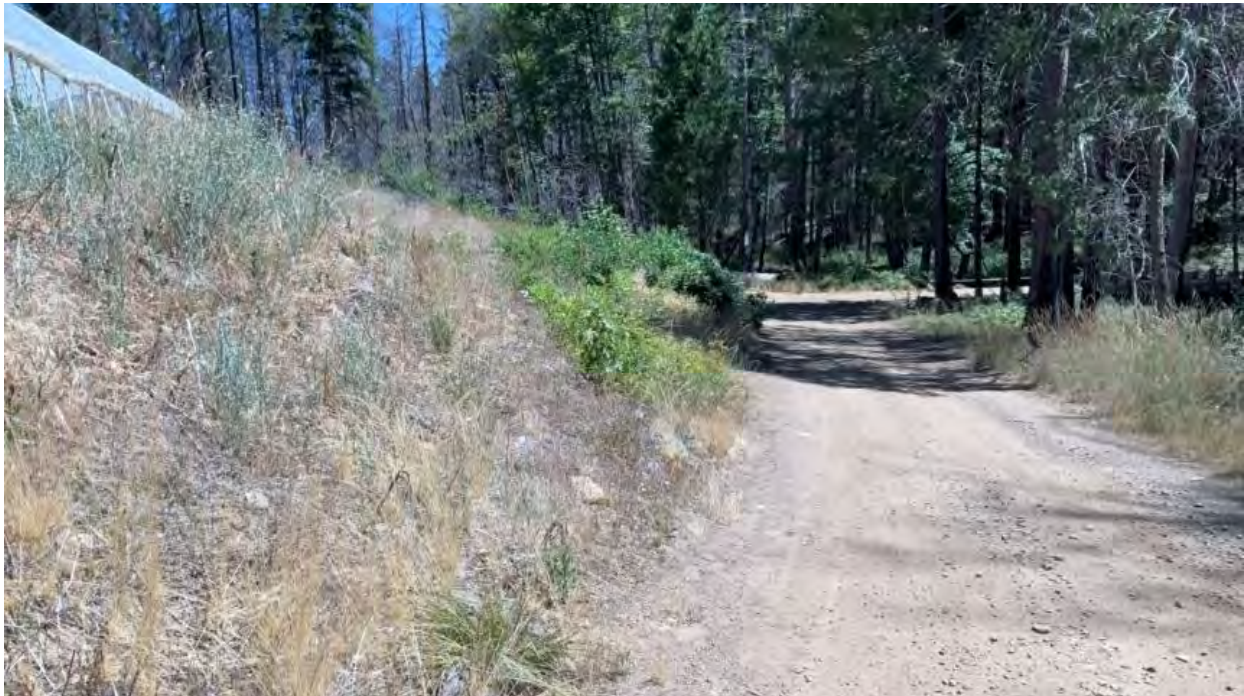
Figure 8. Polygon Feature 2 - Disturbed area associated with cultivation area.

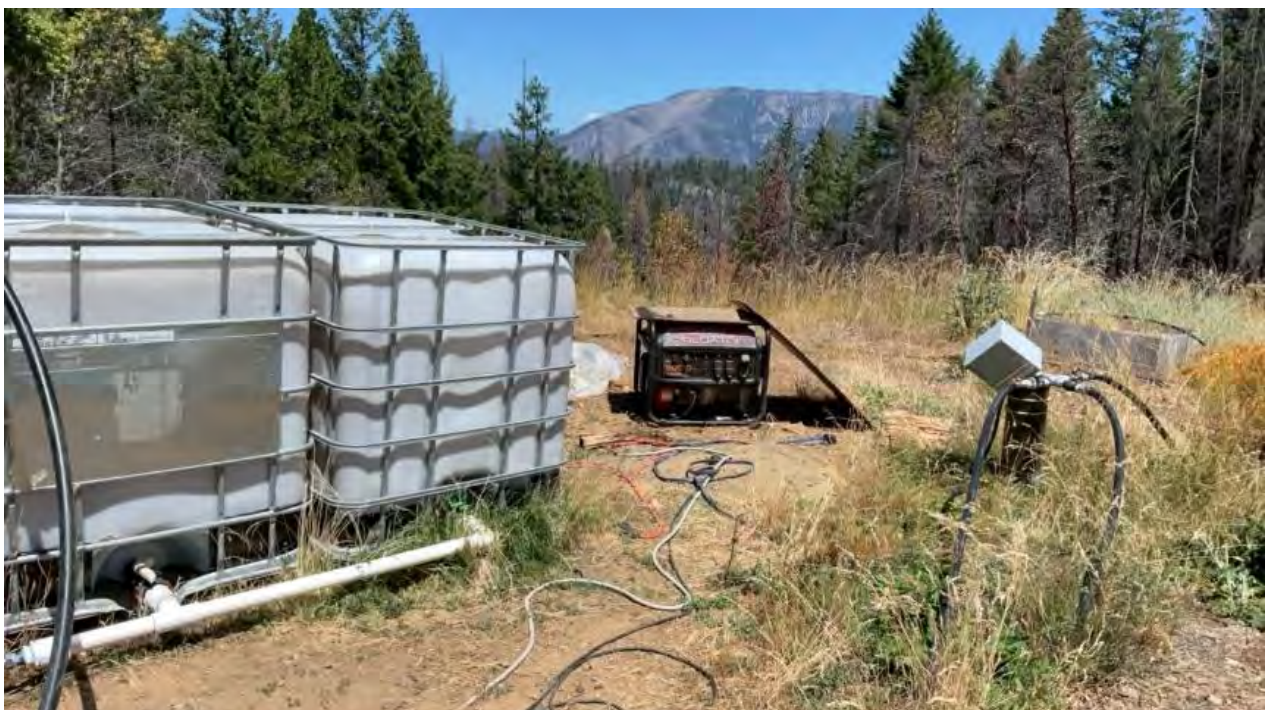
Polygon Feature 2: Cultivation area in greenhouses. A well is located on the western edge of the flat. Within a few feet of the wellhead I observed a gas generator used to pump the well pump and nutrient feed tanks with threat of discharge to land and potential to impact groundwater.

Figure 9. Polygon Feature 2 – Well, generator for pump and feed tanks located at the edge of the cultivation area flat.

3. Handle domestic waste in a manner that is protective of water quality and in conformance with the State Water Board Onsite Waste Treatment Policy.
4. Cleanup fertilizer containers and feed tanks and prevent further discharge of feed water to land in a manner that threatens water quality.

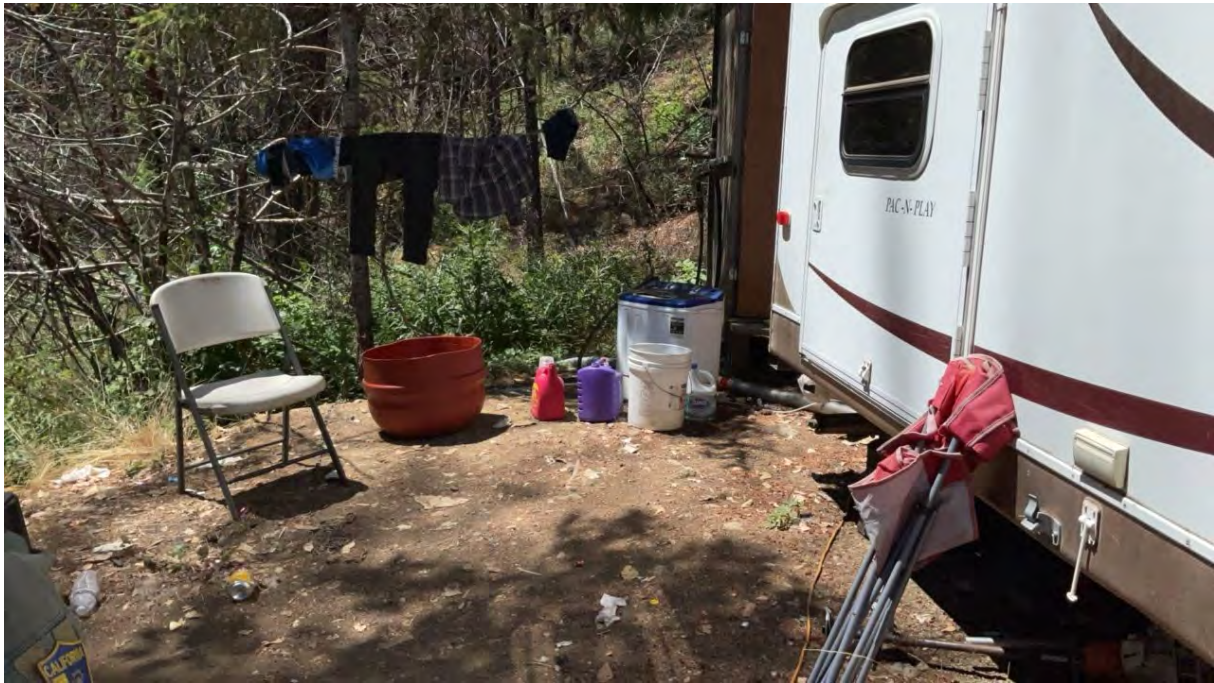
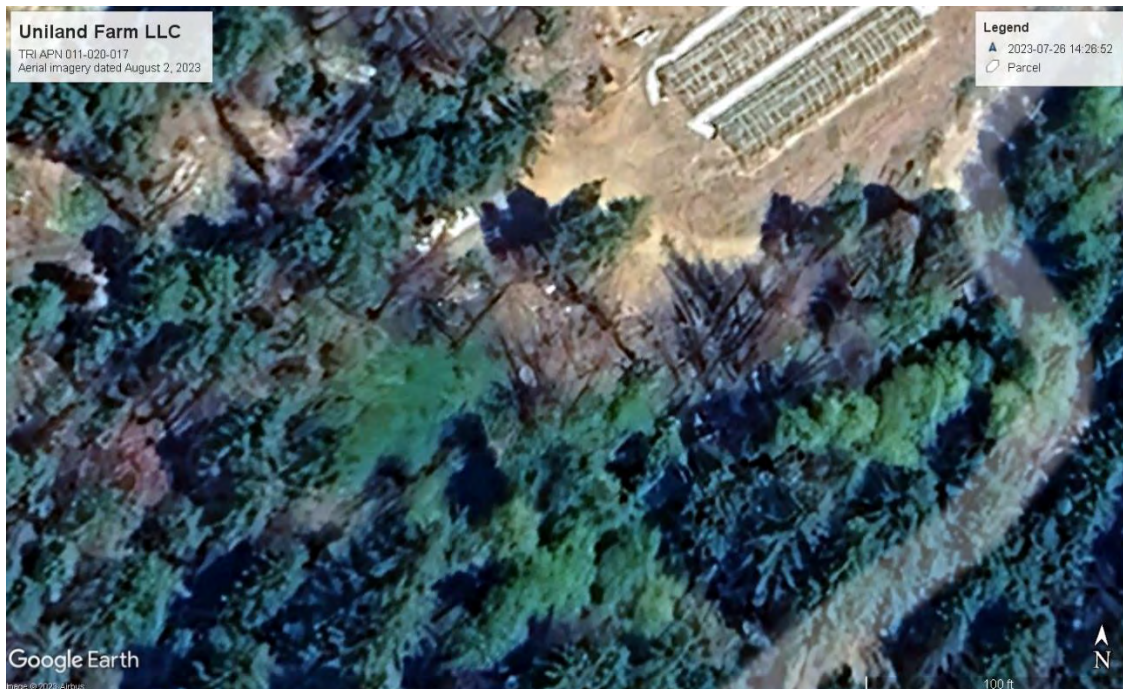
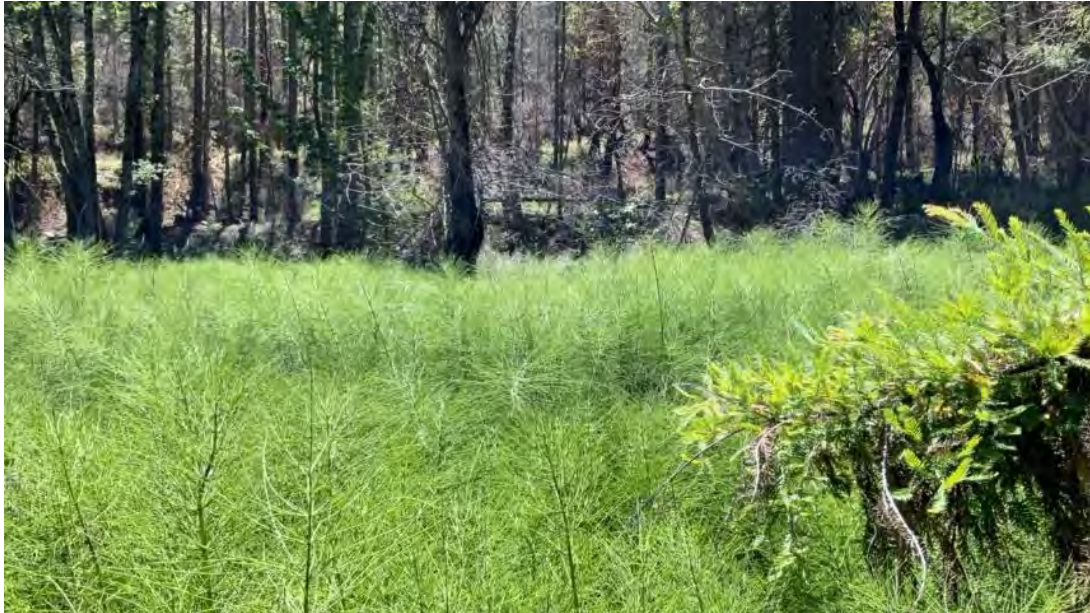
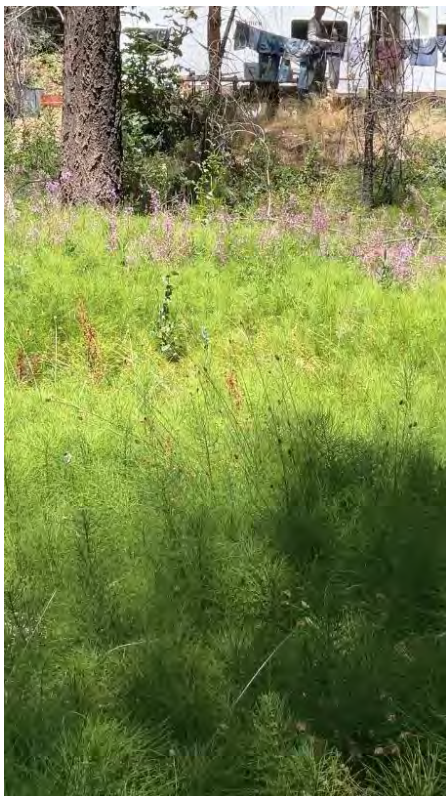
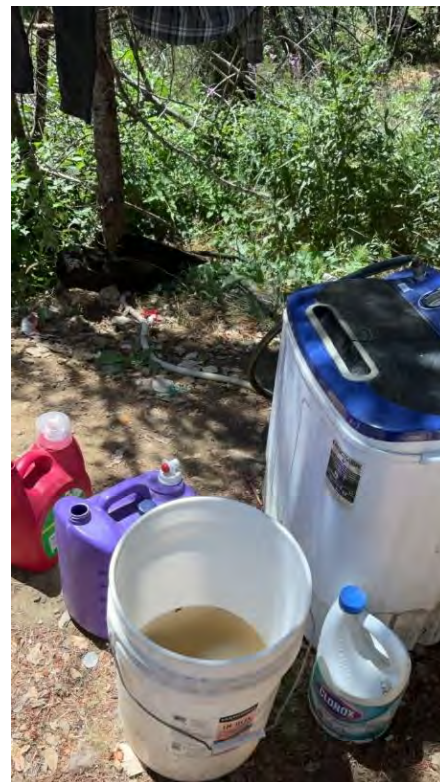
As document in the inspection report, staff observed evidence of discharge of domestic waste at Point Feature 2 where it can impact the quality of waters of the state, in violation of Water Code 13264.

Point Feature 2: Trailer used as residence for worker is located adjacent to Polygon Feature 2 cultivation area. Lines from washing machine and the trailer wastewater (including from toilets, sinks and shower) discharge into the edge of a wetland flat. The flat is dominated by horsetail. I dug a pit in the flat and found red soil at 6" and saturated soil at 8". At the pit, horsetail was dominant with some curly doc and juncus.

Figure 10. Point Feature 2 – Trailer used as residence for worker. Waste lines from the trailer and the washing machine discharge onto the edge of a wetland flat.

Figure 11. Point feature 2 is a trailer used as a residence with domestic waste and washing machine water being discharged into the edge of a wetland flat, visible as a lush green patch in the right center of the photo.

Figure 12. Wetland flat is dominated by horsetail.

Figure 13. Point Feature 2 – domestic waste from trailer residence is discharged to a wetland flat.

Figure 14. Point Feature 2 - Washing machine and associated products, with discharge line to wetland flat.

2. Cease discharges from Point Location to the wetland flat. If activities are proposed in the flat, please provide a wetland delineation of the flat and obtain the required permits prior to initiating activities with the potential impacts to waters of the state.

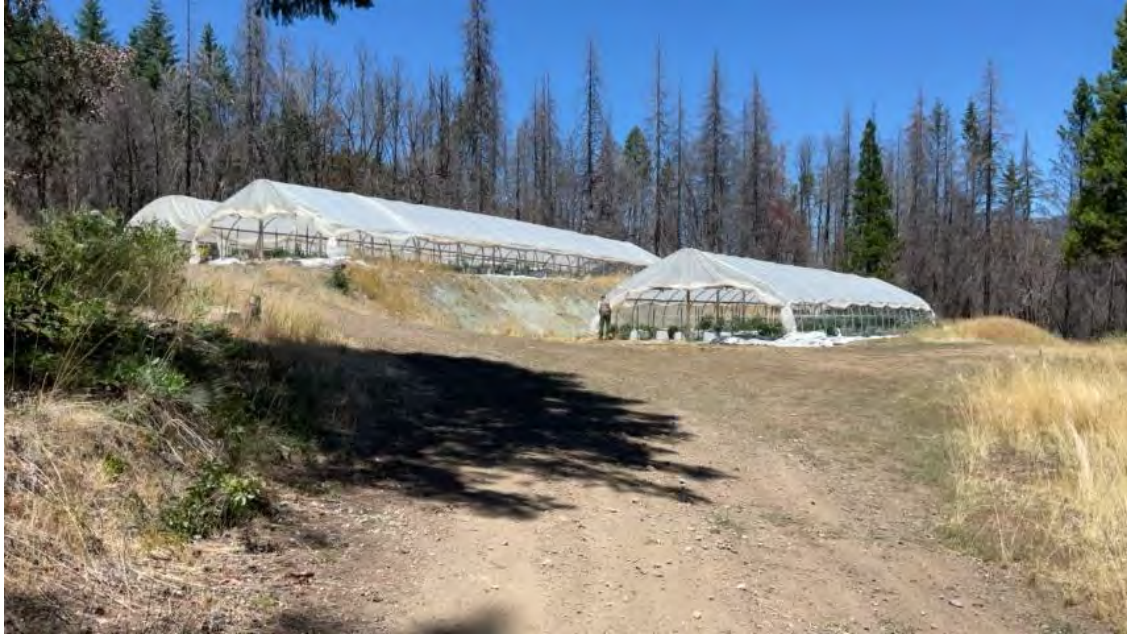
Polygon Feature 6: Cultivation area in greenhouses. Feed tanks with uncontained fertilizers and strewn containers.

Figure 15. Polygon Feature 6 – cultivation area.

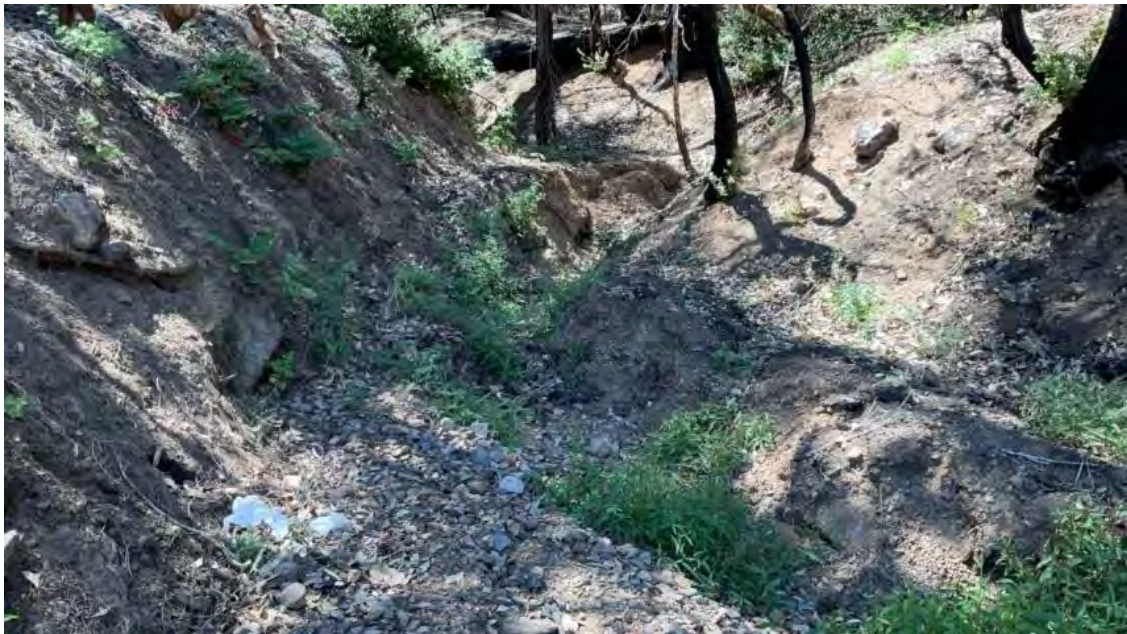
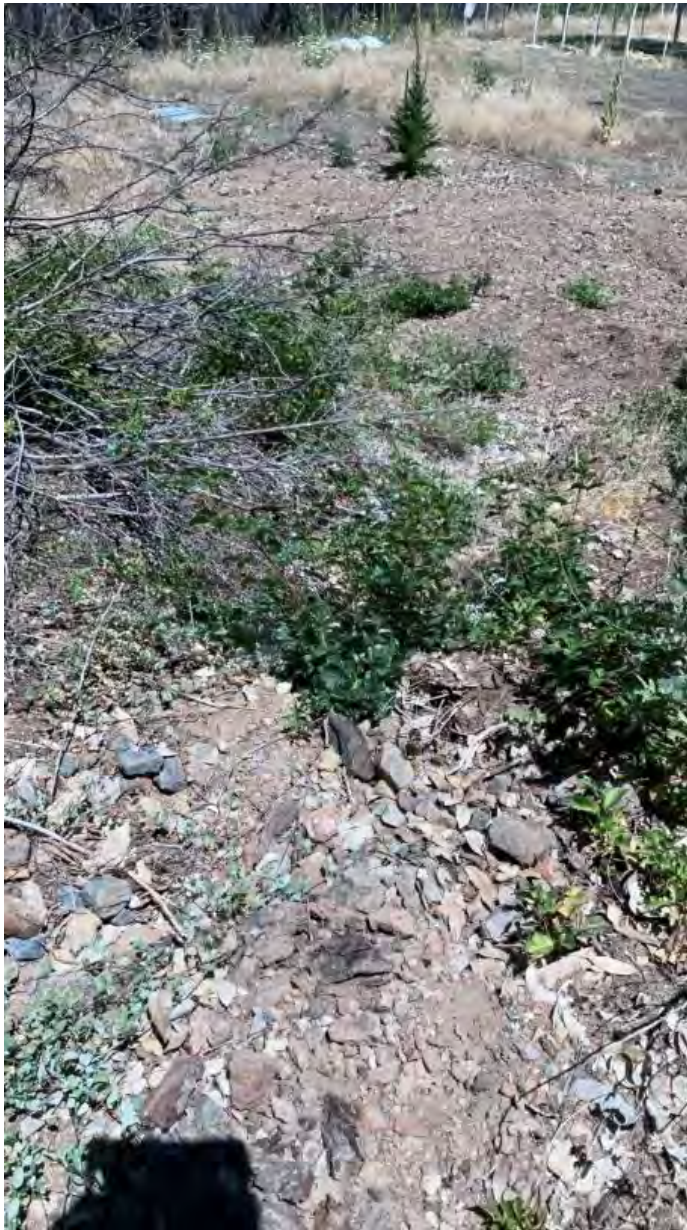
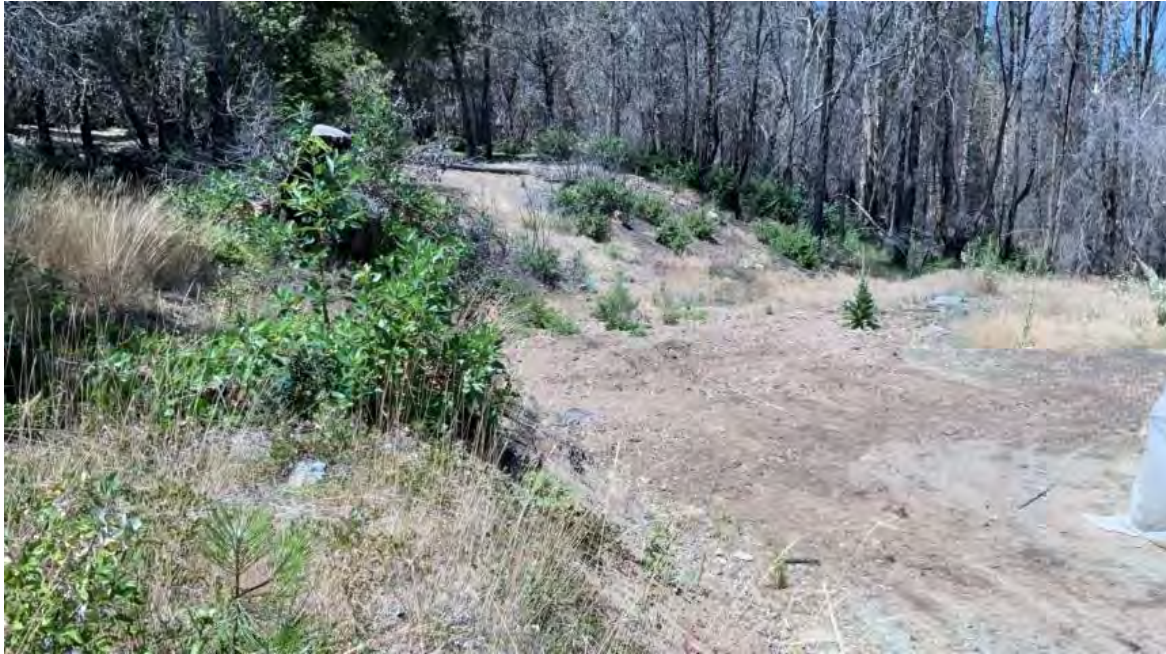
Line Feature 7: Class III watercourse that is interrupted by the edge of the cultivation flat associated with Polygon Feature 6. The flat encroaches on the watercourse and causes changes in channel form and alters sediment loads.

Figure 16. Line Feature 7 - Watercourse looking upstream is steep, incised with a gravel channel.

Figure 17. Line Feature 7 -Sediment deposition on flat from bedload dropped from stream flow.

Figure 18. Line Feature 7 - The greenhouse (Polygon Feature 6) is built 25 feet from the watercourse channel.

As documented in the inspection report, the features at Line Feature 7 are located in surface waters and must be remediated to comply with the Basin Plan and the Water Code, which may require a water quality certification prior to conducting instream work.

5. Remove all fertilizer, petroleum, potting soil, and other cultivation-related materials from within 50 feet of the Class III watercourse along Line Feature 7, including greenhouses and stabilize the disturbed area.

9. Prior to conducting work in waters of the state, submit an application for water quality certification or waste discharge requirements.
10. Ensure cannabis cultivation activities are in conformance with state and local requirements. If cultivation activities cease, remove related infrastructure and cleanup materials and provide photos. If propose to continue to cultivate, provide evidence of county permit and state license.

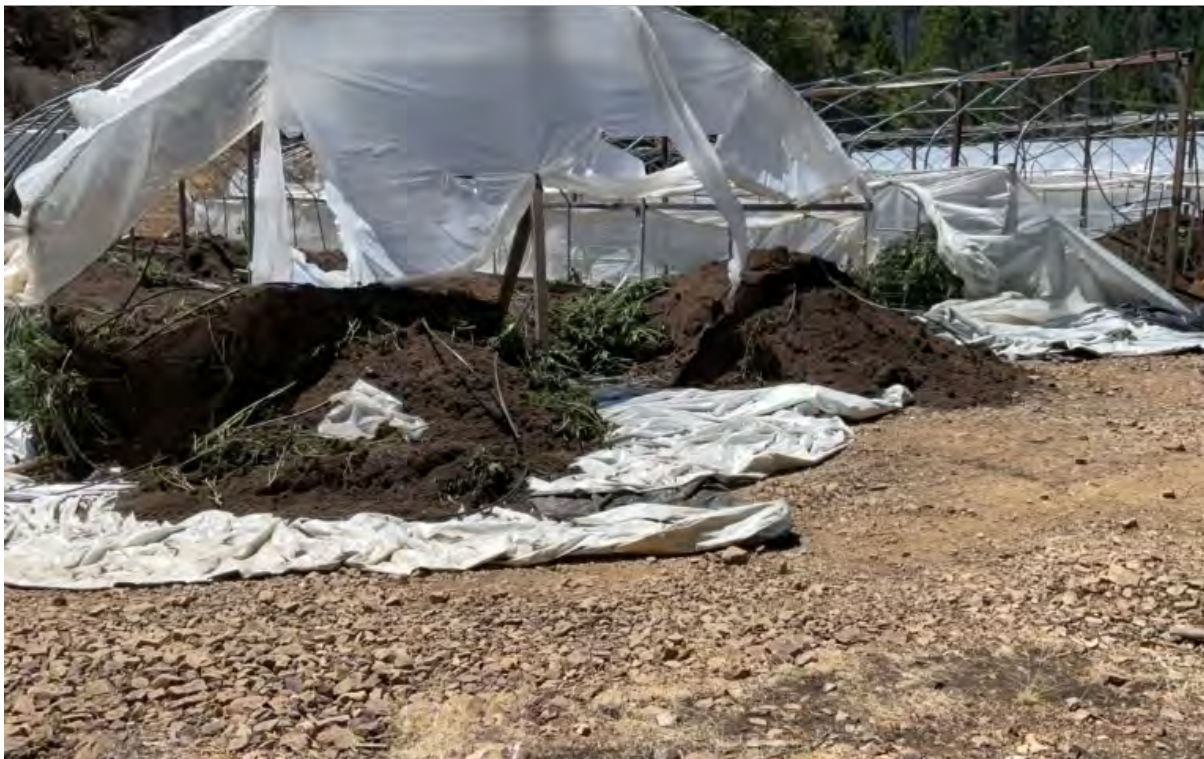
Polygon Feature 11: Approximately 17,000 square feet of greenhouse cultivation on graded flat.

Figure 19. Polygon Feature 11 - cultivation area.

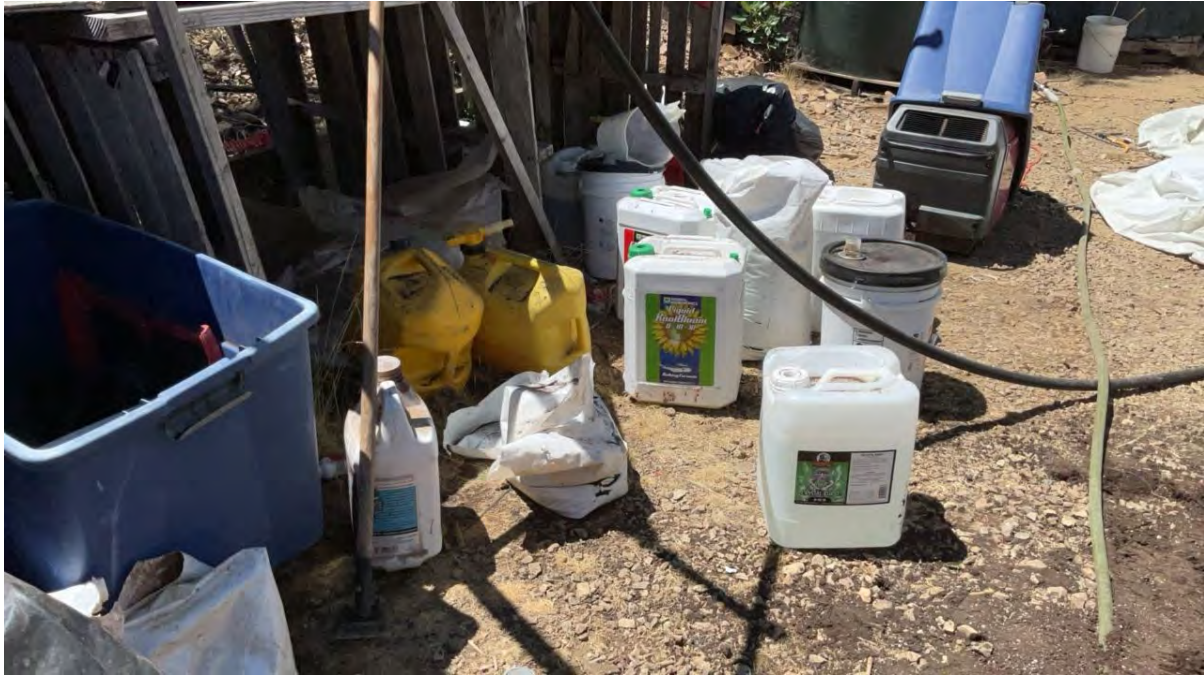
Figure 20. Polygon Feature 11 – fertilizers, generator gas cans, water lines.

1. Cleanup and properly dispose of waste including but not limited to trash, fertilizer, pesticide and petroleum containers, plastic tarps and sheeting at a legal facility.

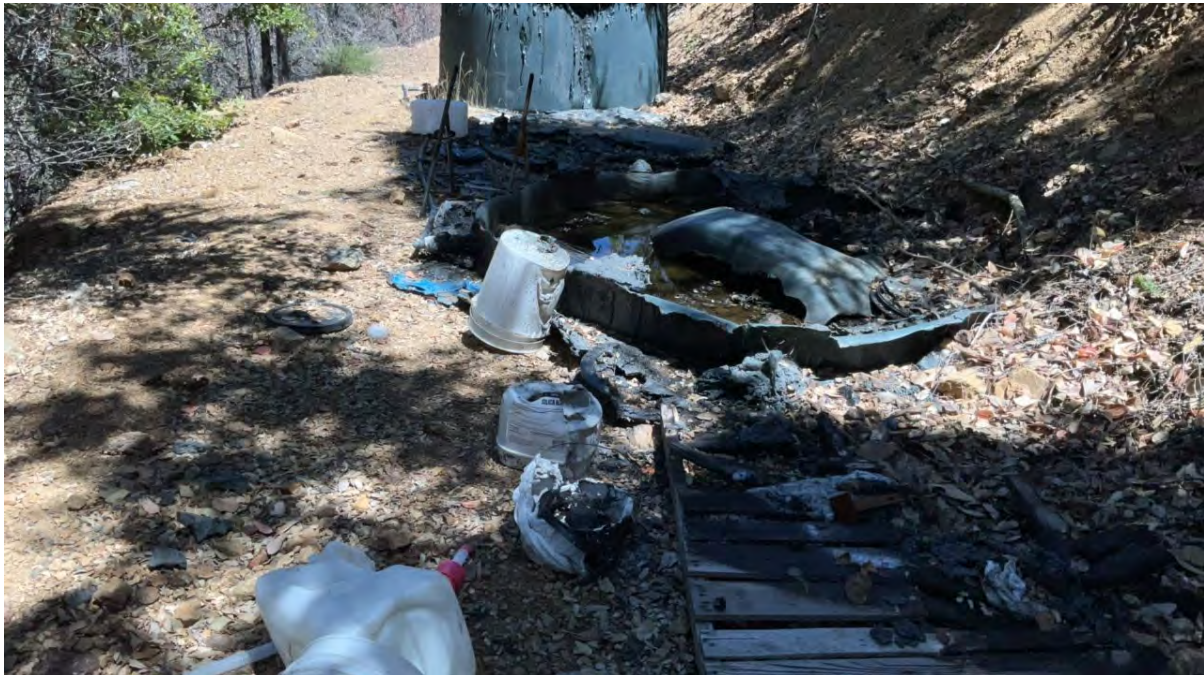
Figure 21. Polygon Feature 11 – water tanks melted from Monument Fire in 2021.
