North Coast Regional Water Quality Control Board

June 22, 2023

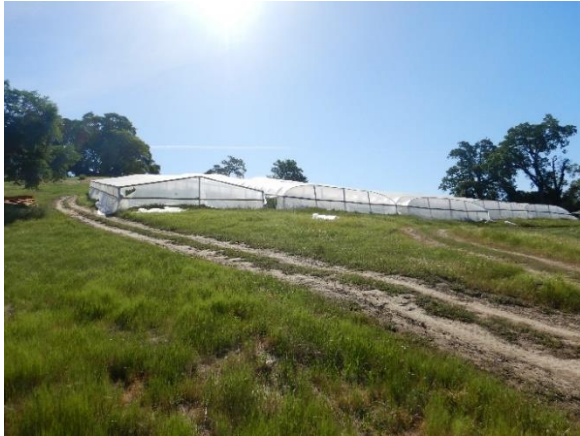
Photo 1 - Cultivation area at WQ2

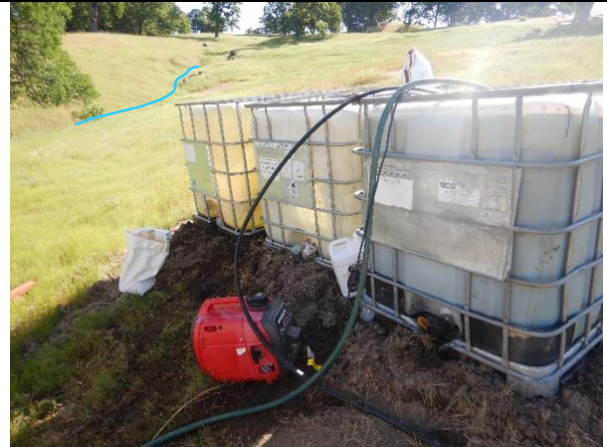
Photo 2 - Water storage tanks, and improperly contained Honda generator within required riparian setback of a stream to the left at WQ6. The blue line represents the approximate location of the stream

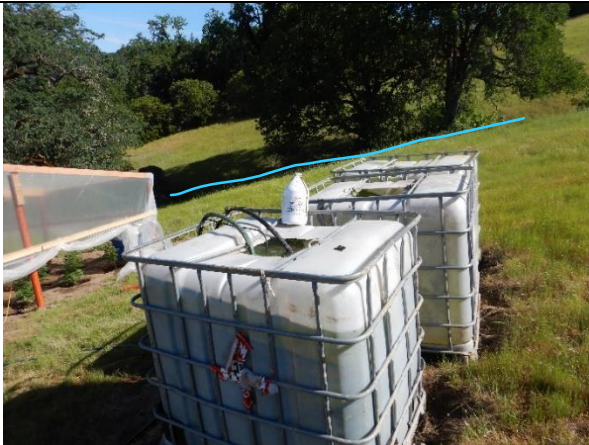
Photo 3 - Cultivation area within setback of a stream at WQ6, the blue line represents the approximate location of the stream

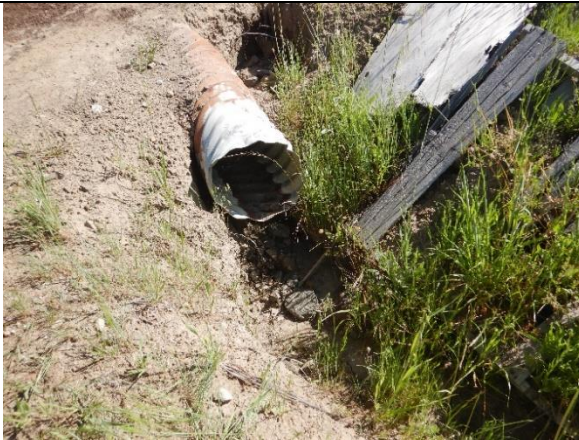
Photo 19 – Outlet of the culvert at WQ13, rusted, failing, and installed high eroding the stream bank

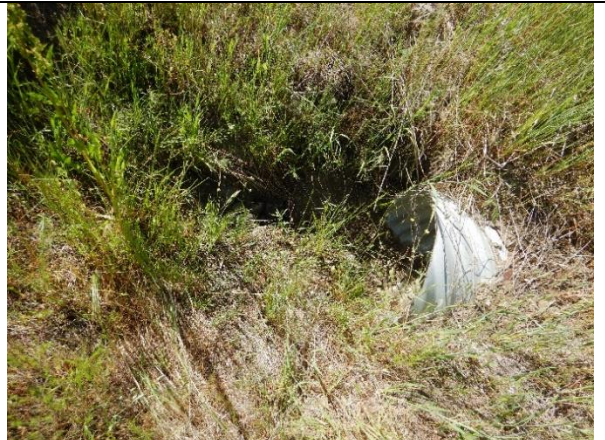
Photo 20 – Inlet of a culverted stream crossing at WQ14, partially clogged

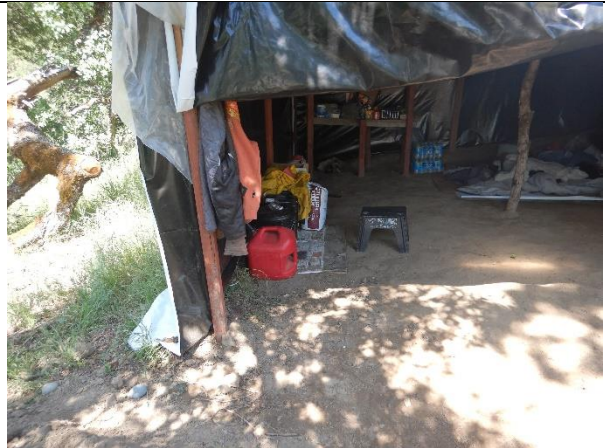
Photo 36 - Improperly stored gasoline near WQ38

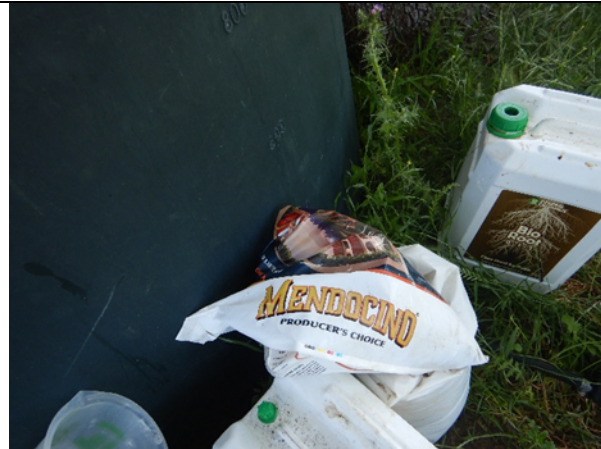
Photo 37 - Uncontained fertilizers at WQ3

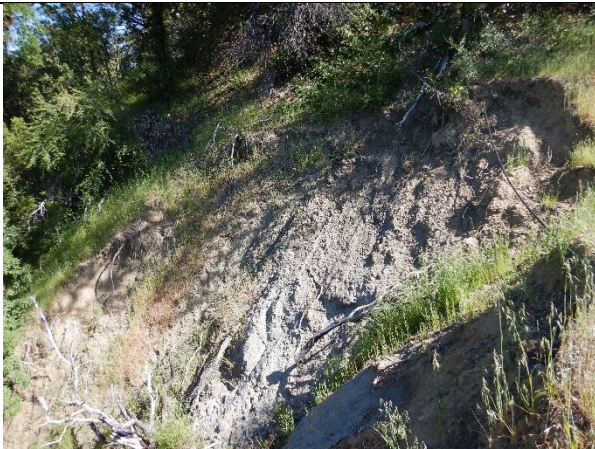
Photo 43 – Slope failure at WQ17

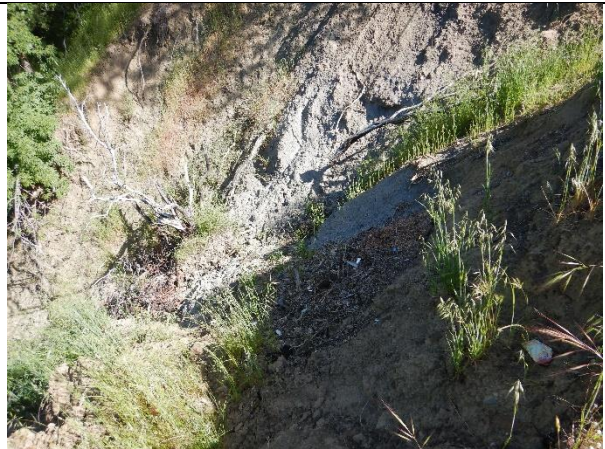
Photo 44 – Trash and plant waste at WQ18

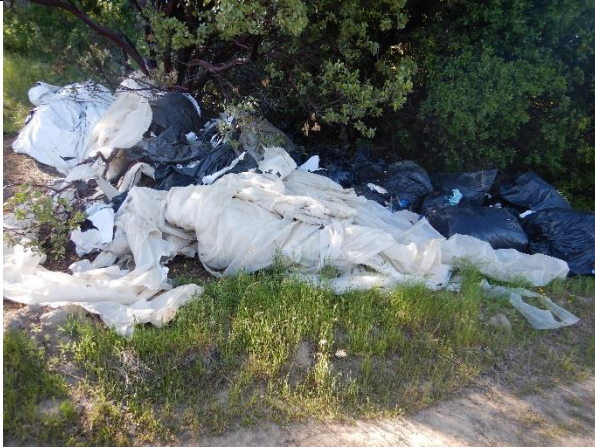
Photo 45 - Improperly disposed trash at WQ1

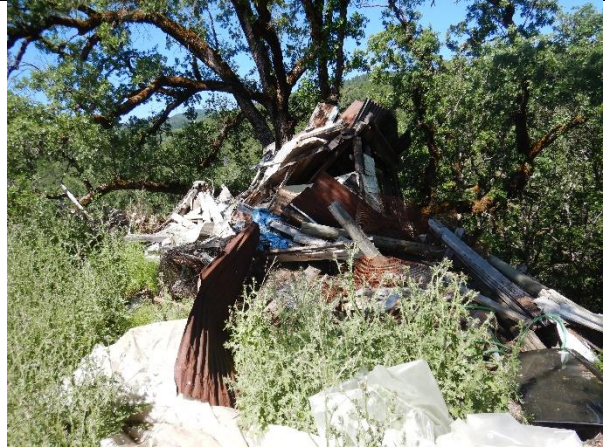
Photo 46 - Metal and plastic pile at WQ26

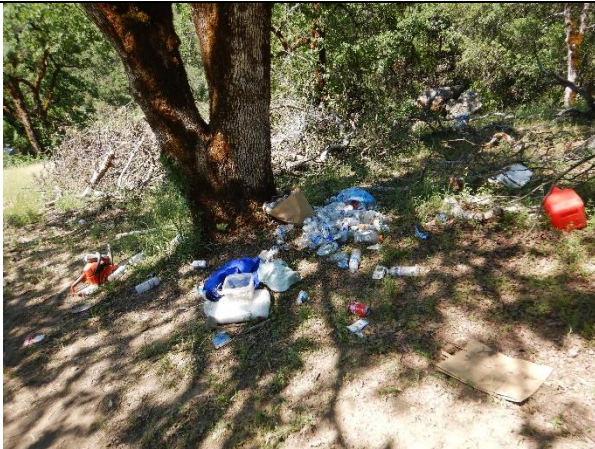
Photo 47 - Improperly disposed trash at WQ33

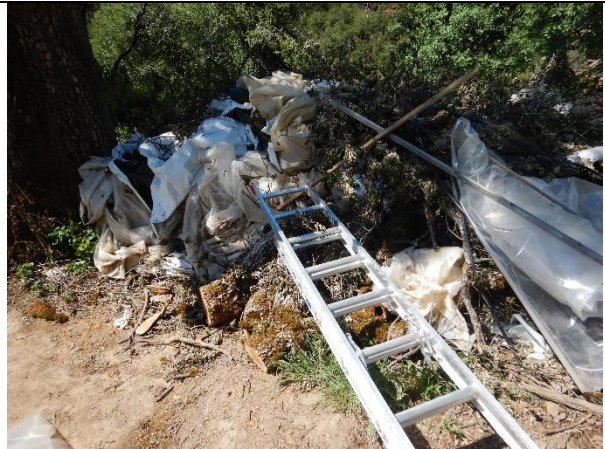
Photo 48 - Wood and plastic pile at WQ37
