North Coast Regional Water Quality Control Board

Subject: Notice of Violation and Transmittal of Inspection Report for May 23, 2023, Inspection of Trinity County Assessor's Parcel Numbers 017-440-018-000 and 017-440-019-000

FACILITIES INSPECTION REPORT

Attachment C - Inspection Photo Log
Photos taken by Kate Hawken on 5/23/23

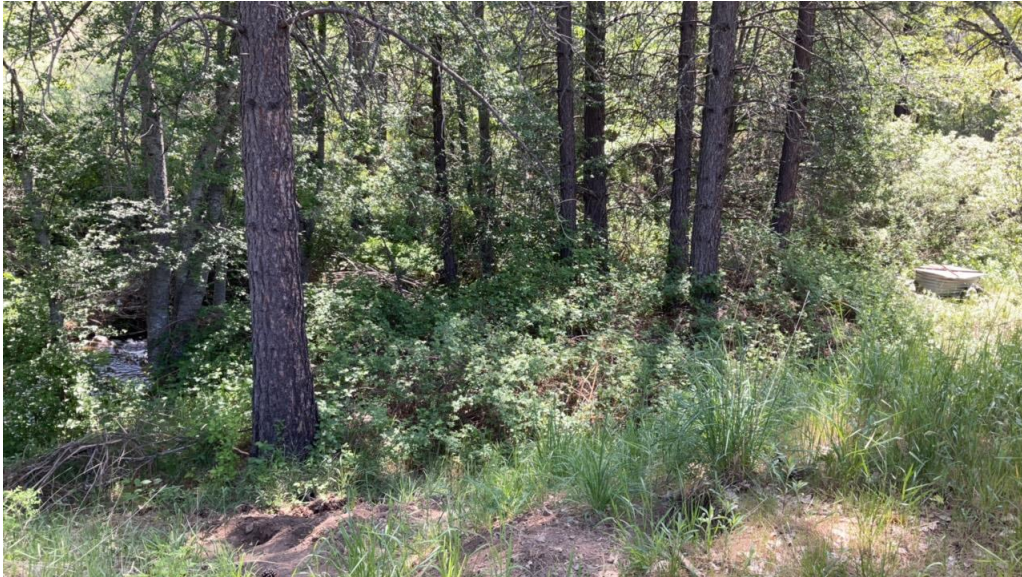
I observed a metal water diversion structure adjacent to Barker Creek (Photo 1). David stated it is used for domestic and irrigation water. I observed a wooden shed, metal shipping container, gravel pile, plastic pipes, wooden pallets, and other cultivation related materials within the riparian setbacks to Barker Creek (Photos 2 and 3). I observed a pond with a black plastic liner constructed at the base of a hill (Photo 4). The pond did not have an outlet or spillway. I observed erosion in the pond berm approximately 89 feet from Barker Creek (Photo 5). I observed a graded flat with four hoop houses, three of which had cannabis plants in pots or raised beds (Photo 6). I observed erosion at the far edge of the cultivation flat (Photo 7).

Photo 1: Metal water diversion structure on right side of photo adjacent to Barker Creek.

1. Enroll for coverage under the State Water Board’s Order WQ 2019-0023-DWQ, General Waste Discharge Requirements and Waiver of Waste Discharge Requirements for Discharges of Waste Associated with Cannabis Cultivation Activities (Cannabis General Order).
2. Relocate cannabis cultivation related infrastructure and materials outside of the 150 foot riparian setback to Barker Creek.
3. Stabilize the eroding edge of the cultivation flat, and revegetate exposed soils, to prevent sediment discharge. Redirect drainage that caused the erosion as necessary.
4. Submit a plan to:
 - a. Reconfigure the pond to comply with riparian setbacks and other applicable requirements of the Cannabis General Order, including installing an appropriate overflow spillway, OR
 - b. Remove the pond liner and fill and compact the area.

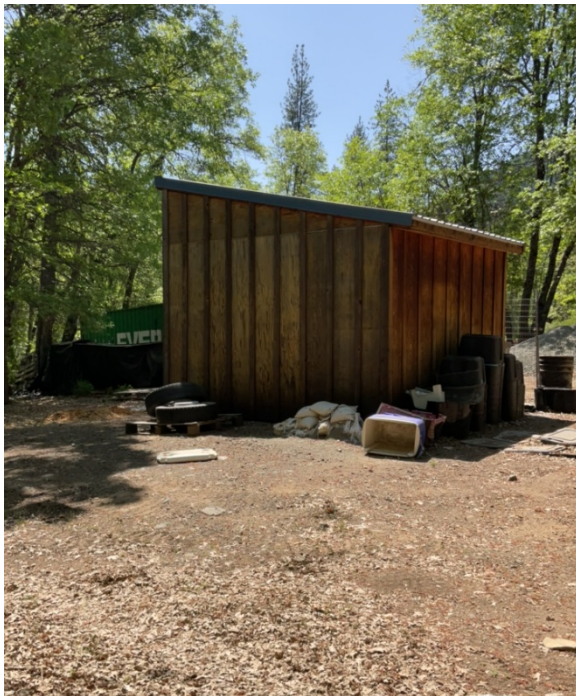
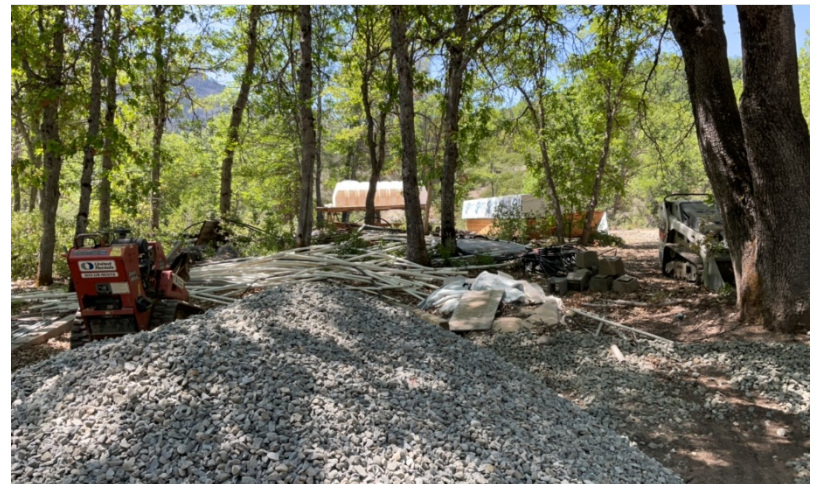
Photos 2 and 3: Wooden shed, metal shipping container, gravel pile, plastic pipes, and other cultivation related materials in riparian setbacks to Barker Creek.

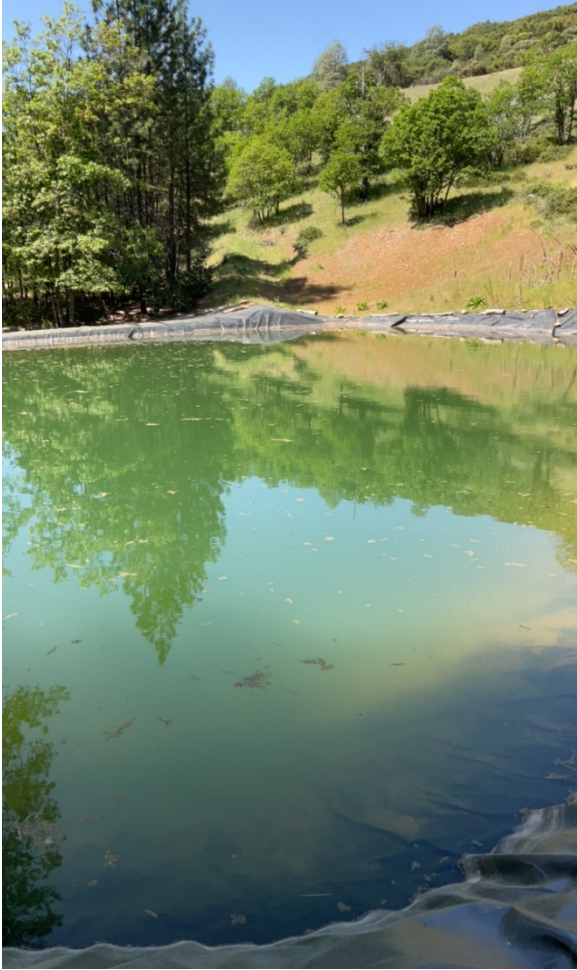
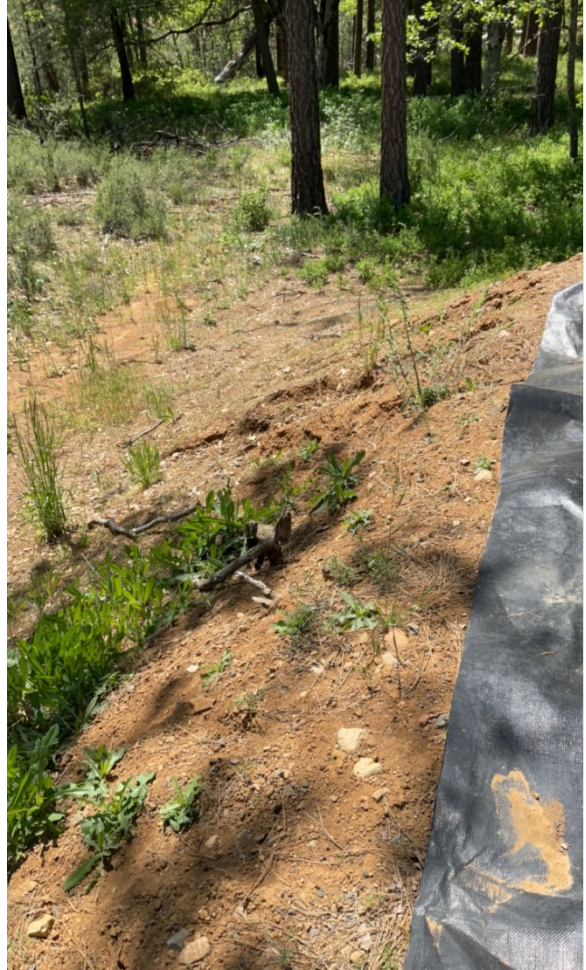
Photos 4 and 5: Pond with black plastic liner capturing hillside runoff. Evidence of overtopping and erosion on the corner nearest to Barker Creek.

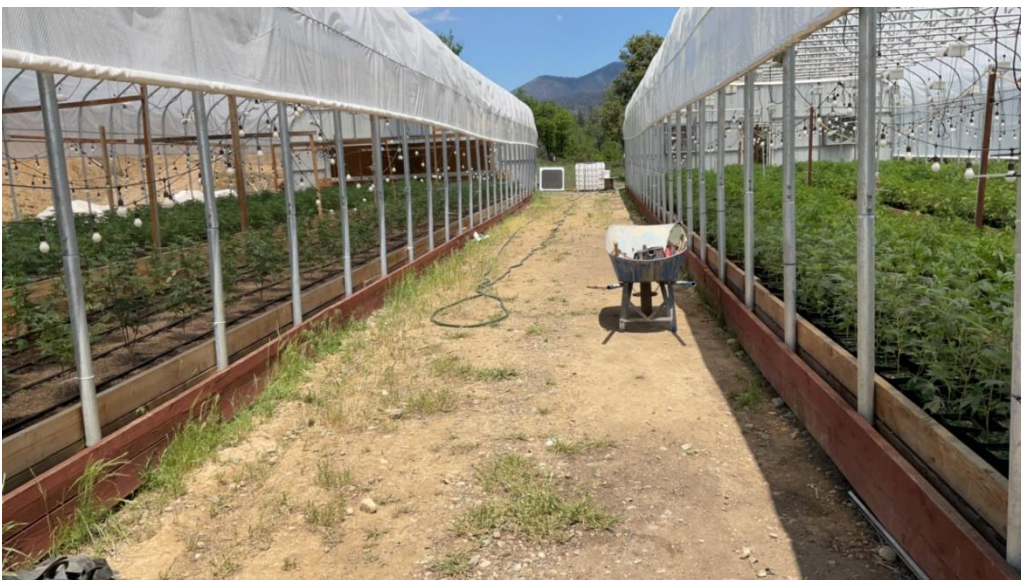
Photo 6: Graded flat with hoop houses containing cannabis plants.

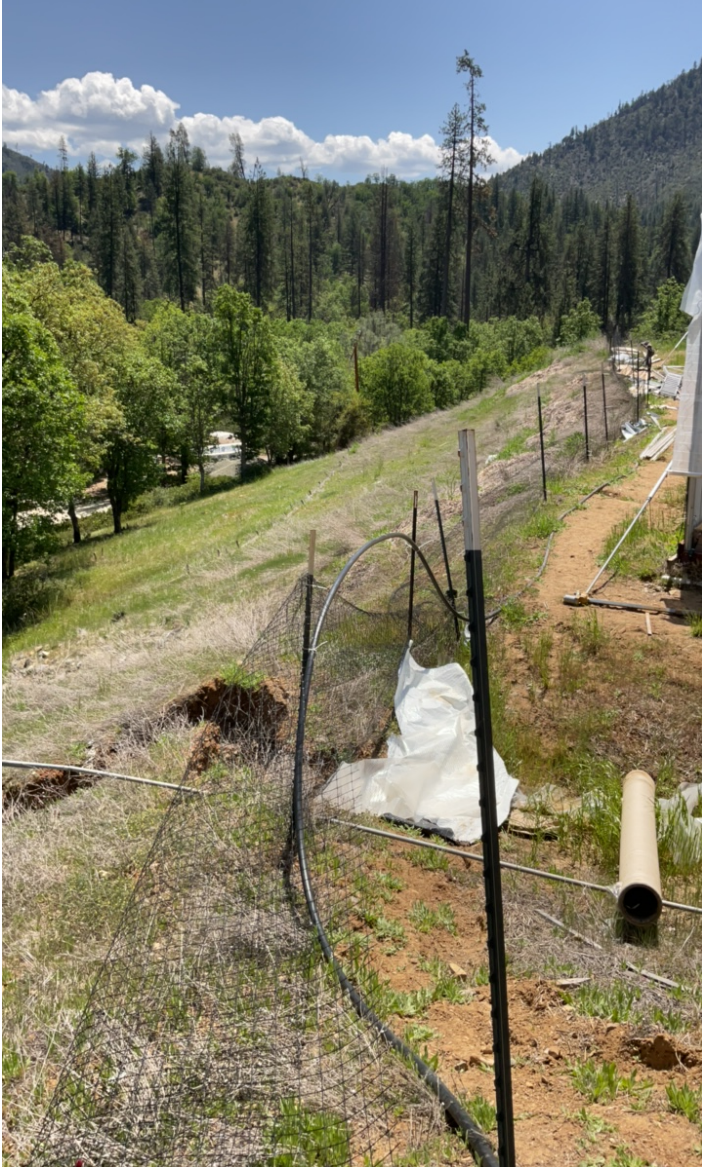
Photo 7: Eroded drainage channel on back edge of cultivation flat.
