North Coast Regional Water Quality Control Board

September 19, 2023

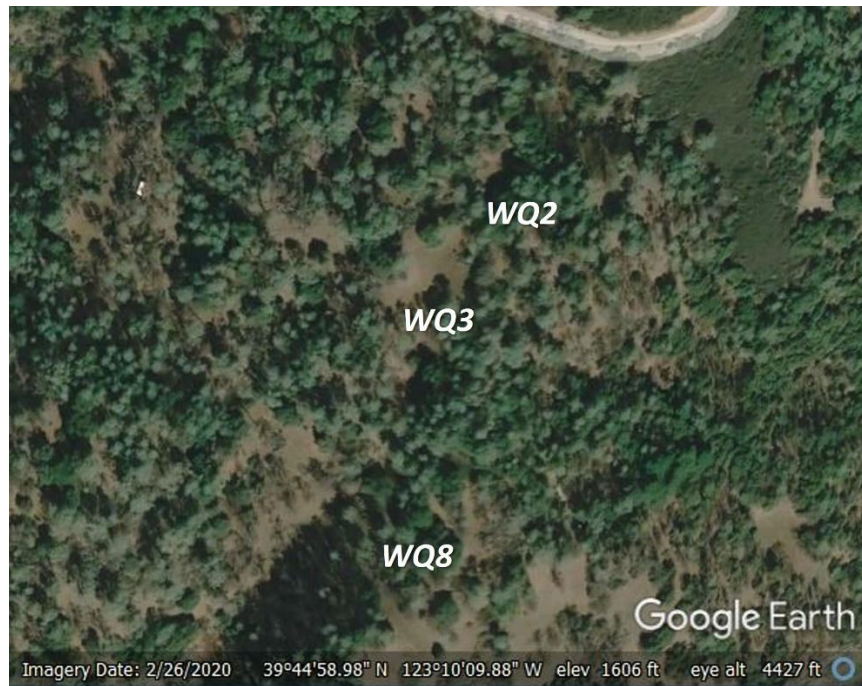
Figure 2—Aerial image of the Property taken on February 26, 2020, obtained from Google Earth. The image shows that the Property was not yet developed for cannabis cultivation at that time.

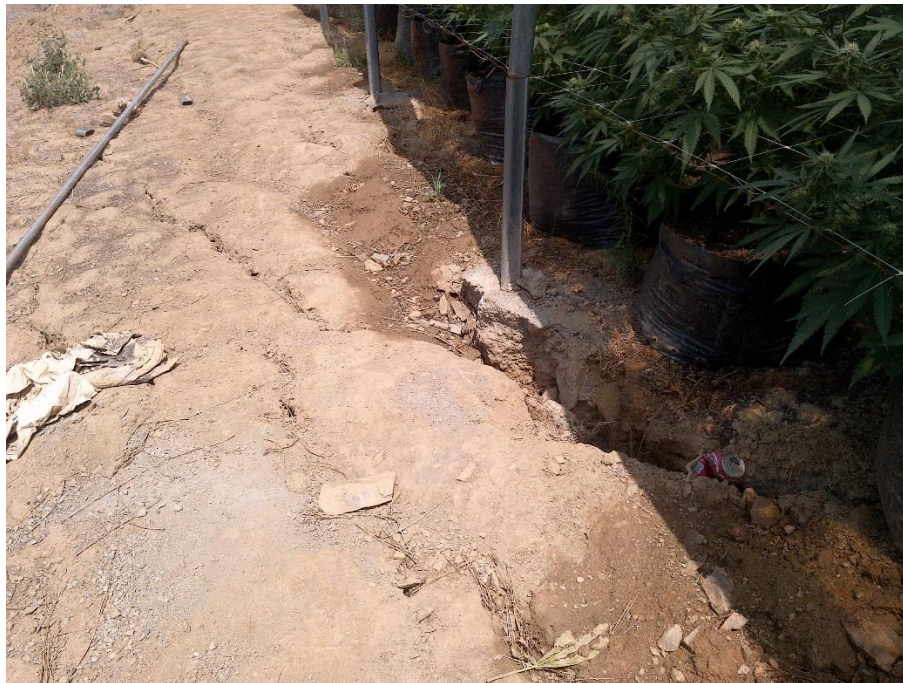
Figure 13—Photo showing the western edge of the cultivation pad located at WQ8. An erosional gully is visible adjacent to cannabis plants in the right of the image and tension cracks are visible in the left of the image.
