Subject: Notice of Violation, Transmittal of Report for May 9, 2023 Inspection of Mendocino County Assessor's Parcel Numbers 032-294-03-00

**Report of May 9, 2023 Warrant Inspection,
Mendocino County
Assessor's Parcel Number (APN) 032-294-03-00 (the "Property")**

File: Cannabis Program Inspections, Mendocino County, 2023, Yesenia and Raul Carrillo, CIWQS Place ID 889633

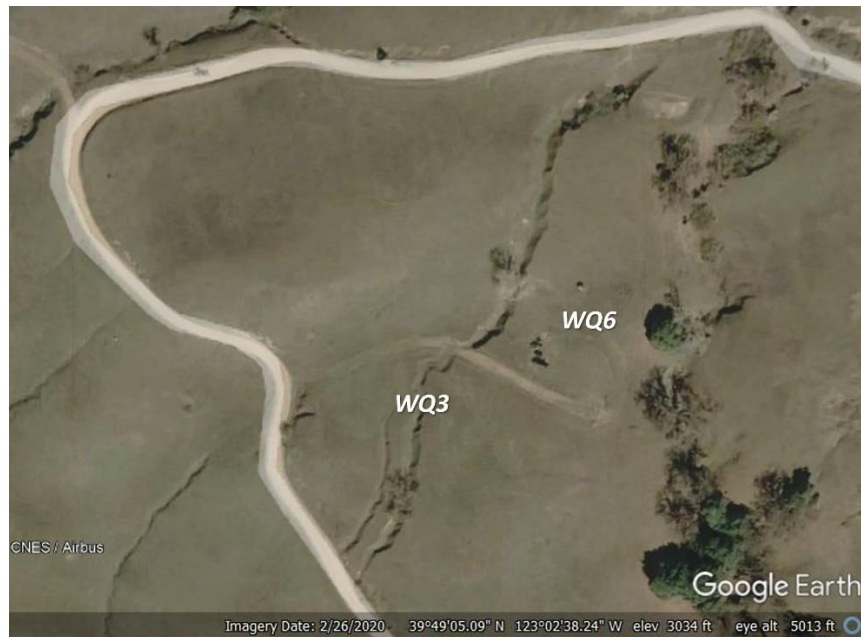
Figure 2—Aerial image of the Property taken on February 26, 2020, obtained from Google Earth. Other than a shared-use road and access driveway, the property appears undeveloped.

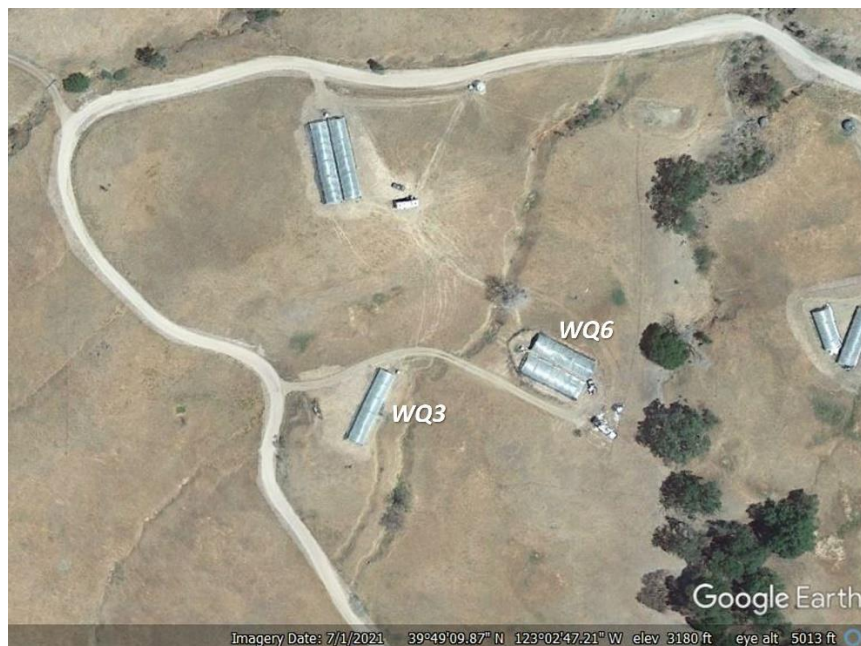
Land Vision records show Yesenia and Raul Carrillo purchased the Property on August 28, 2020. According to review by Staff on August 7, 2023, of aerial imagery available from Google Earth, the greenhouses identified in the inspection report at WQ3 and WQ6 were constructed between February 26, 2020 and July 1, 2021.

Figure 3—Aerial image of the Property taken on July 1, 2021, obtained from Google Earth. Hoop-type greenhouses are visible including the 3,000 square foot greenhouse at WQ3 and the 5,000 square-foot pair of greenhouses at WQ6. The pair of greenhouses in the northern part of the property had been disassembled when the site was inspected on May 9, 2023.

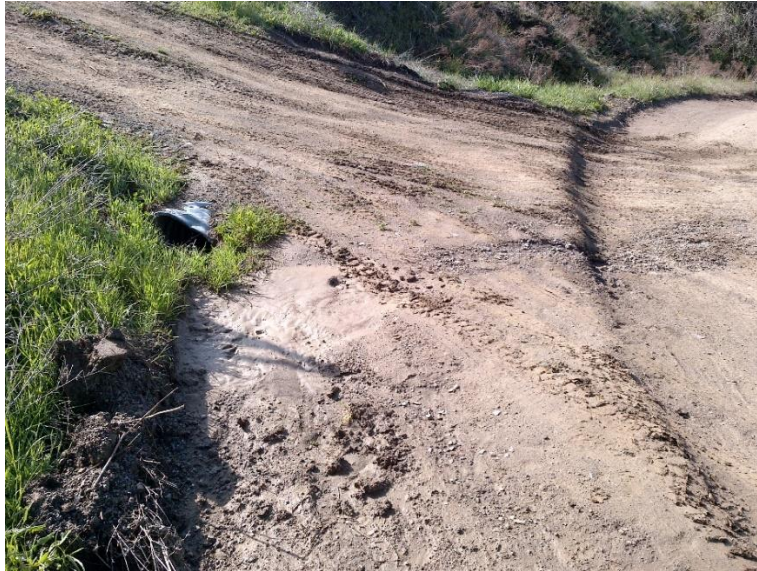
Figure 4—Looking south at WQ1 at the intersection of the gated access to the Property to the left and the shared-use access road to the right. The road has been graded such that stormwater will flow across the road instead of through the culvert pictured in the left of the image.

2. Retain a licensed professional to inventory, assess, all aquatic resources including any wetlands or watercourses that are Waters of the State on the Property, and to develop a workplan and schedule to implement measures to ensure that all developed features, roads and watercourse crossings throughout the Property are corrected, restored, and/or maintained in conditions that comply with the Cannabis Cultivation Policy¹.

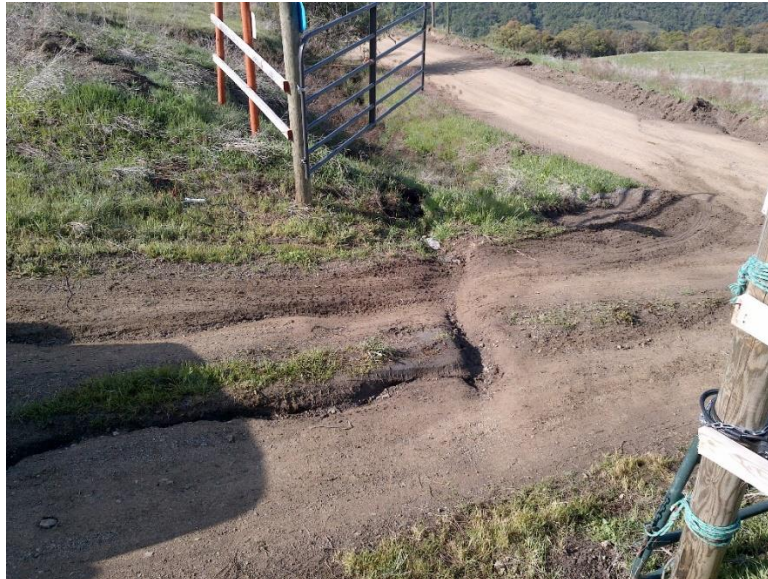
Figure 5—Looking southwest across the gated access to the Property at WQ1. Ruts have eroded into the road-surface.

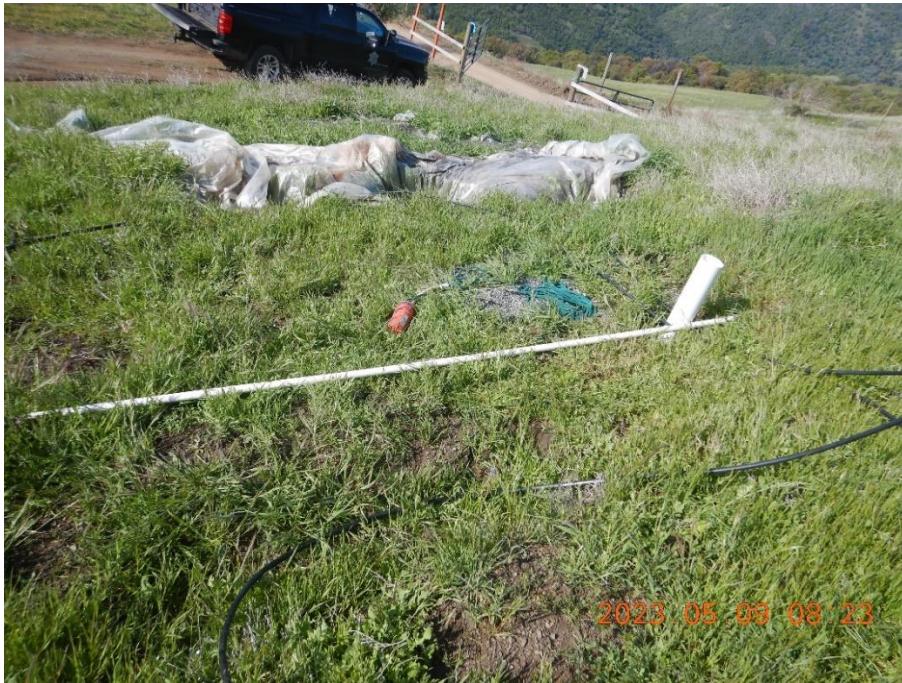
Figure 6—Looking southwest at WQ2. A white pipe protrudes up from the ground in the middle of the image and an orange submersible pump is visible to the left of the white pipe. Plastic sheeting covers holes used to collect water in the top back of the image.

3. Retain a qualified professional to either close or complete the groundwater well at WQ2 according to Mendocino County's well ordinance and well standards.

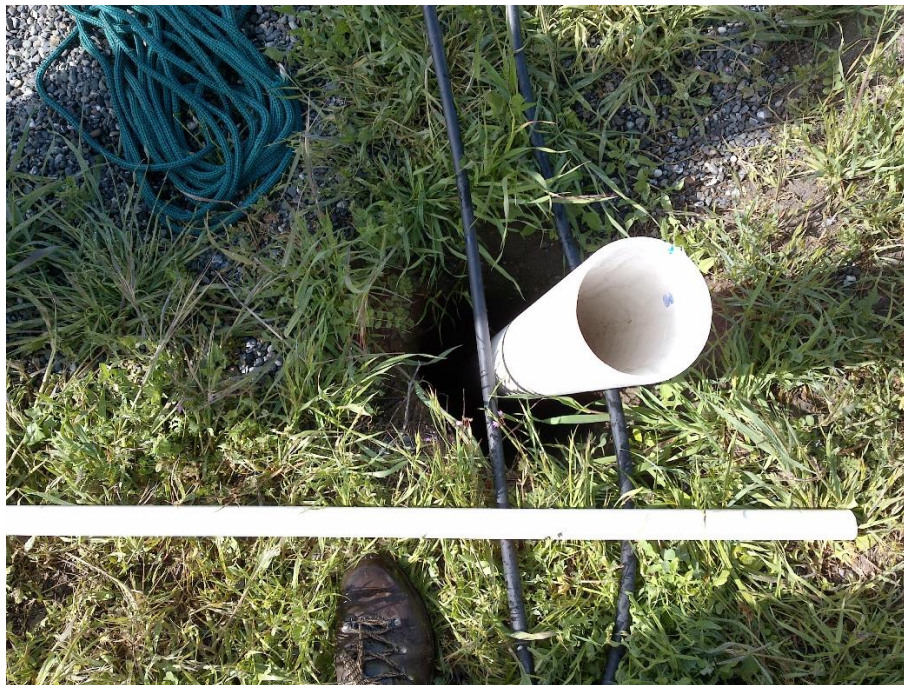
Figure 7—Looking down at a four-inch diameter plastic pipe in a twelve-inch diameter hole at WQ2. The well hole does not have a casing or cap to protect groundwater from any pollutants that could be introduced at the surface.

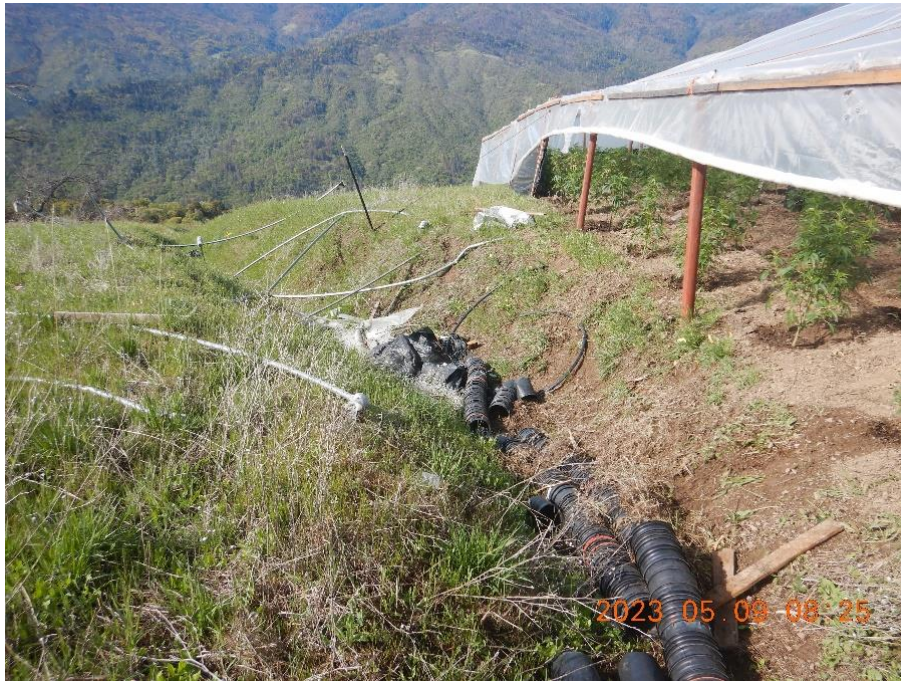
Figure 8—Looking south from WQ3. Cannabis cultivation is occurring adjacent to a watercourse and soil pots and other cultivation waste are within the banks of the watercourse.

1. Immediately collect all refuse and wastes which have discharged and/or threaten to discharge to receiving waters and which can be collected by hand. You are not authorized to use heavy equipment in a water of the state of California (Water of the State) or modify the bed bank or channel of a Water of the State without a permit from the Regional Water Board (see recommendation 6 below). Properly dispose of these wastes at a licensed waste collection facility.

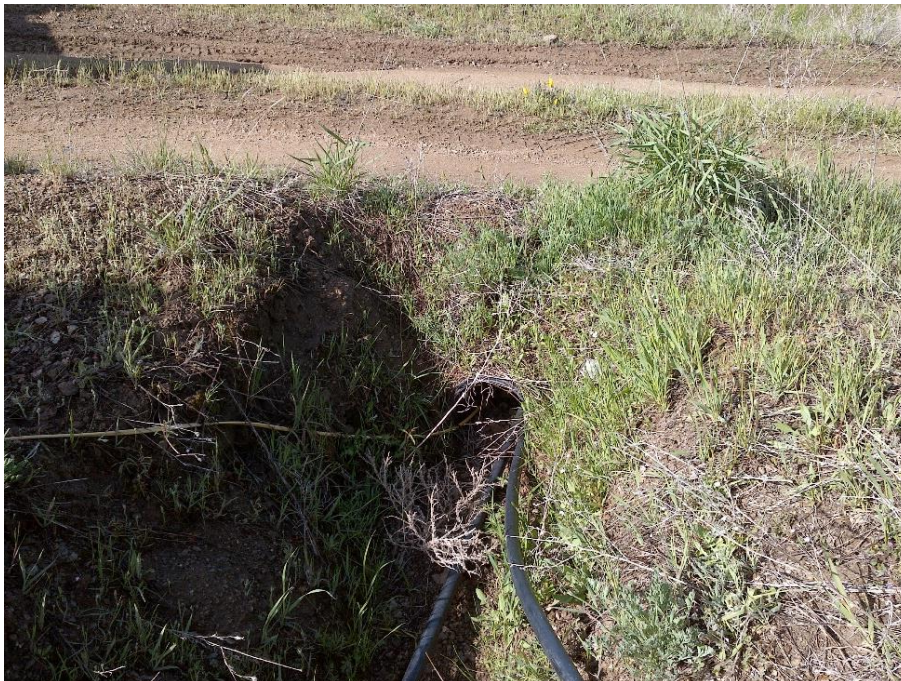
I observed another channel east of, and parallel to, the watercourse passing by WQ3. This channel also discharges to the roadside ditch that discharges to the USGS mapped blue line stream that is tributary to Black Butte River. I walked north along this channel to WQ4, where I observed a ten-inch diameter culverted road crossing that was perched at its outlet. Farther upstream, at WQ5, I observed a small earthen pad extending into the watercourse with a water storage tank placed on the pad. I measured approximately eighteen cubic feet of earthen fill that was placed in the watercourse as part of the pad construction.

Figure 9—Looking southwest at a ten-inch diameter culverted watercourse crossing at WQ4. The watercourse upstream and to the back of the photographer is approximately three-feet wide.

As documented in the inspection report, there is a stream crossing at WQ4 and alterations to the bed and bank of the watercourse at WQ5 which must be corrected to comply with the Basin Plan. The work to correct these violations will require a water quality certification/waste discharge requirements prior to conducting instream work.

6. Prior to conducting work in a Water of the State, submit an application and pay the required application fee for a Water Quality Certification/Waste Discharge Requirement³:

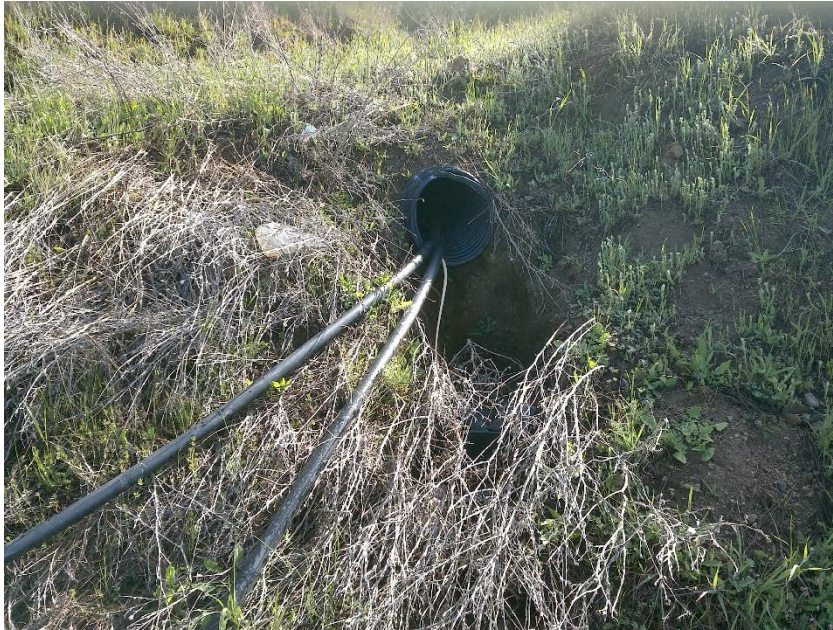
Figure 10—Looking north at culverted watercourse crossing at WQ4. The culvert is perched approximately two feet above the channel bed.

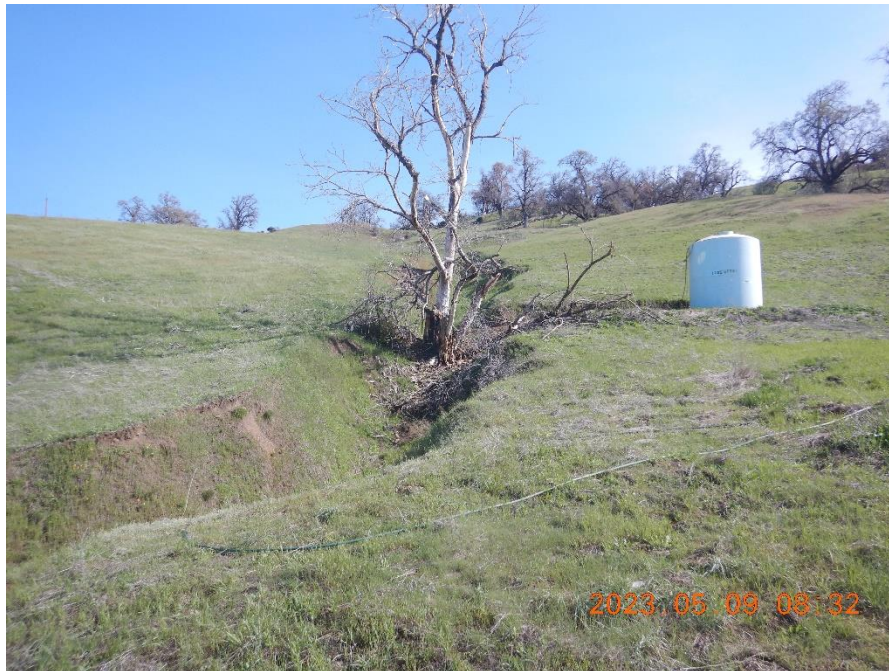
Figure 11—Looking upstream from WQ4. A pad with a water tank is visible adjacent to the watercourse at WQ5. A standing dead tree is visible in the middle of the watercourse.

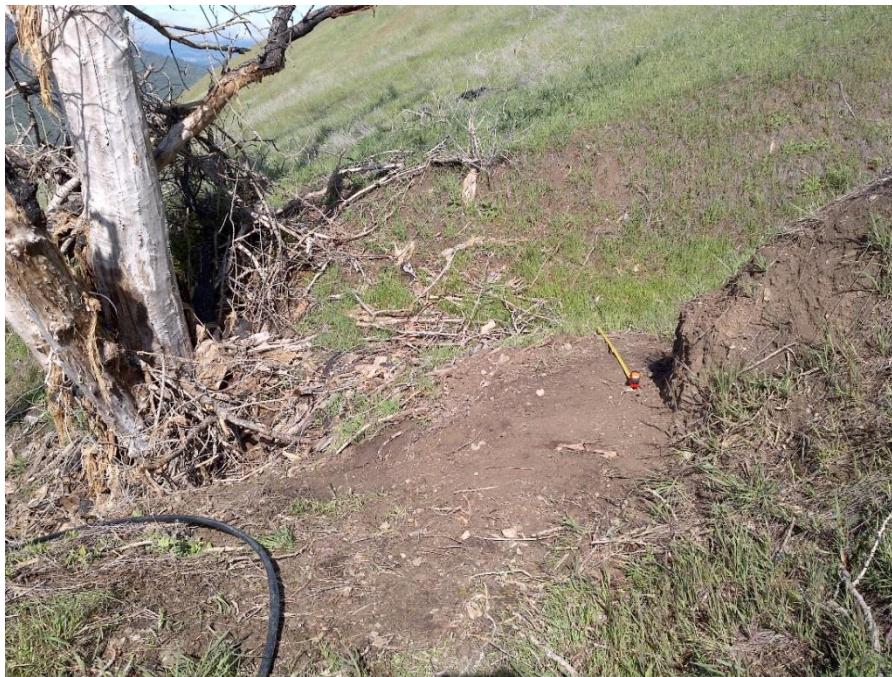
Figure 12—Looking west where an earthen pad extends into the watercourse at WQ5. The dead tree in the left of the image is also visible in the previous image. Approximately 18 cubic feet of earthen fill has been placed into the channel; a patch six feet square averaging six inches deep.

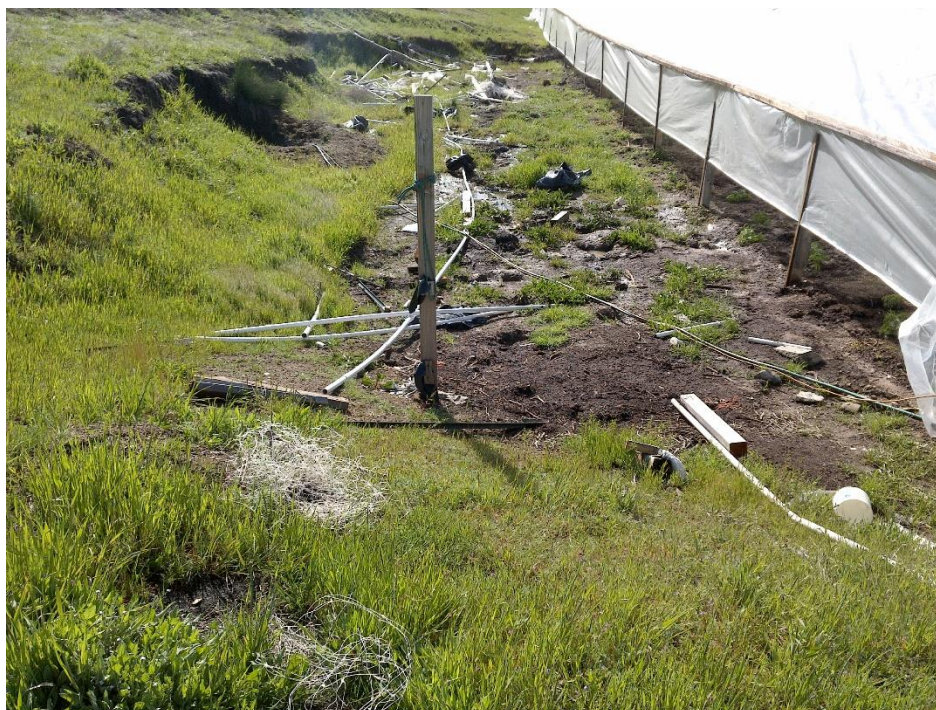
Southeast of WQ5, I observed a 5,000 square foot greenhouse on an earthen pad that had been cut into the hillslope at WQ6. I observed cannabis cultivation wastes including plastic netting scattered around the greenhouse. I observed a human habitation area southeast of WQ6 with uncontained refuse. The area of uncontained refuse appears east of the mapped boundary in Figure 1, but it is west of a fence marking the property boundary in the field.

Figure 13—Looking east along the northern edge of the pair of greenhouses at WQ6. Plastic netting and other cultivation wastes are visibly scattered around the area.

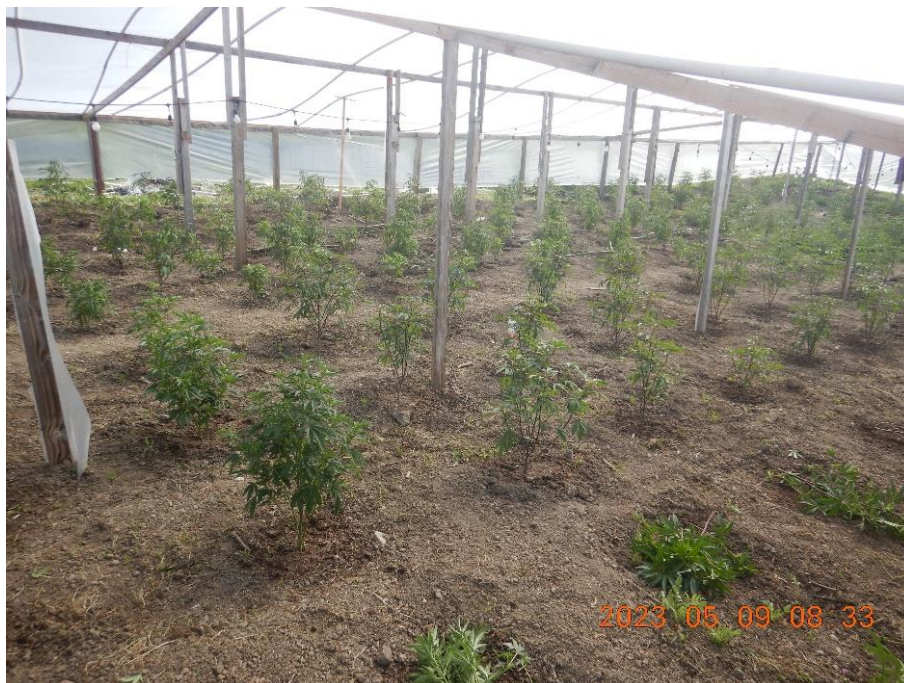
Figure 14—Looking inside greenhouses at WQ6. Cannabis plants are growing in the earthen floor.

4. Dispose of all development and restoration-related earthen spoils in a manner to prevent/minimize transport and delivery to receiving waters.
5. Prior to cultivating cannabis or developing a property for cannabis cultivation, enroll for coverage under the Cannabis General Order².
