Subject: Notice of Violation, Transmittal of Report for May 9, 2023 Inspection of Mendocino County Assessor's Parcel Numbers 032-293-15-00

**Report of May 9, 2023 Warrant Inspection,
Mendocino County
Assessor's Parcel Number (APN) 032-293-15-00 (the "Property")**

File: Cannabis Program Inspections, Mendocino County, 2023, Yesenia and Raul Carrillo, CIWQS Place ID 889632

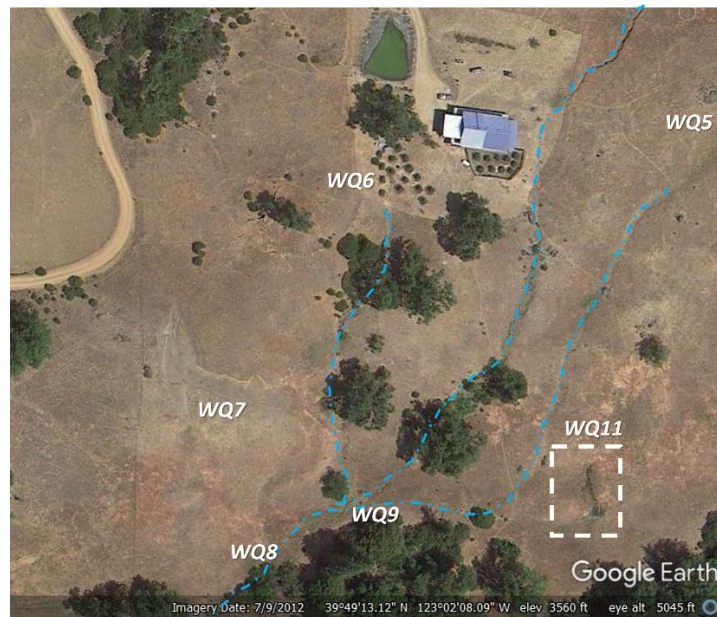
Figure 2—Aerial image of southern portion of the Property taken on July 9, 2012, obtained from Google Earth. The area south of a residence pictured in the top of the image appears undeveloped. A dashed blue line identifies a watercourse originating in the middle of the image and passing through the bottom of the image. A white dashed box identifies the location of a wetland.

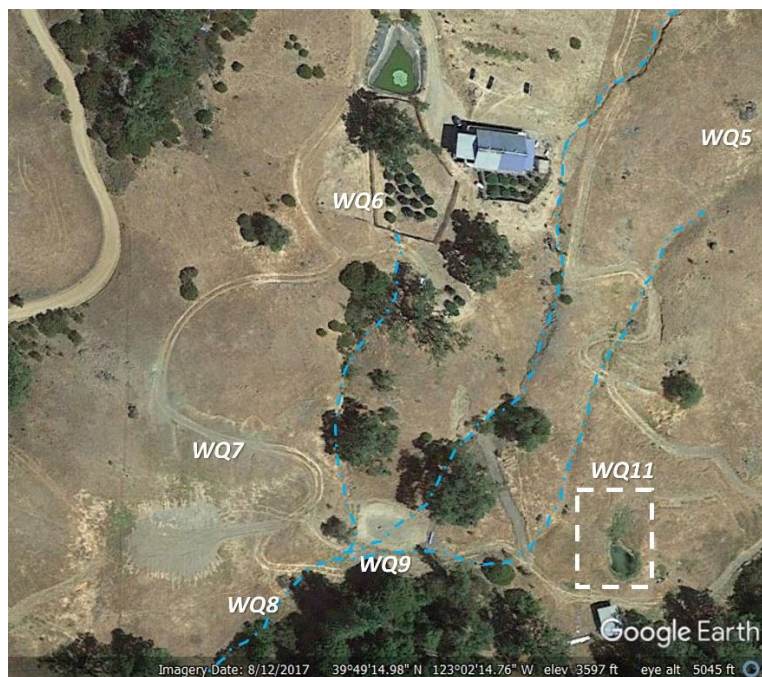
Figure 5— Aerial image of southern portion of the Property taken on August 12, 2017, obtained from Google Earth. A reservoir appears constructed on the stream at WQ9 in the bottom of the image and a pad appears in the lower left of the image.

2. Retain a licensed professional to inventory, assess, all aquatic resources including wetlands and watercourses that are Waters of the State on the Property, and to develop a workplan and schedule to implement measures to ensure that all impacted features, including the onstream reservoir at WQ9 and dredged wetlands at WQ11 are restored and that all developed features, roads and watercourse crossings throughout the Property are corrected, restored, and/or maintained in conditions that comply with the Cannabis Cultivation Policy¹.

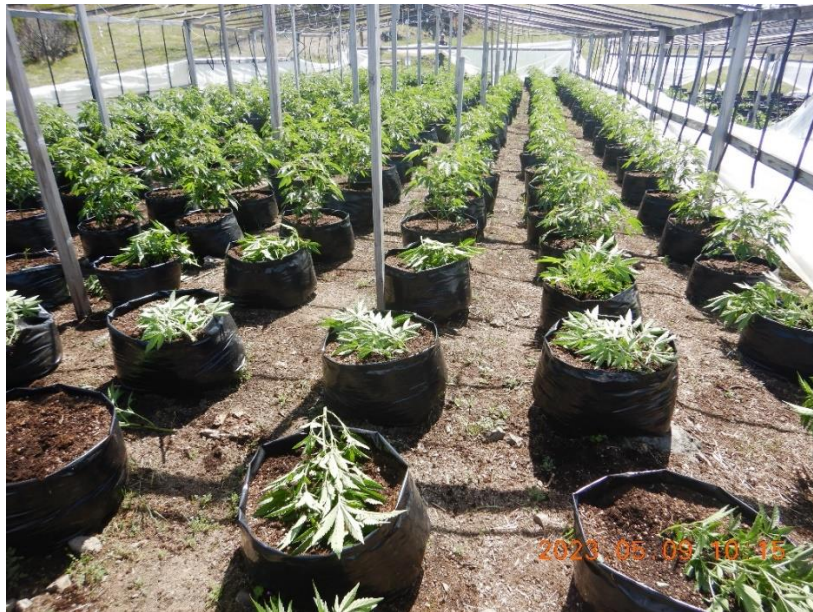
Figure 8—Cannabis plants growing in soil bags resting on permeable ground within a greenhouse at WQ1.

3. Dispose of all development and restoration-related earthen spoils in a manner to prevent/minimize transport and delivery to receiving waters.
4. Prior to cultivating cannabis or developing a property for cannabis cultivation, enroll for coverage under the Cannabis General Order².

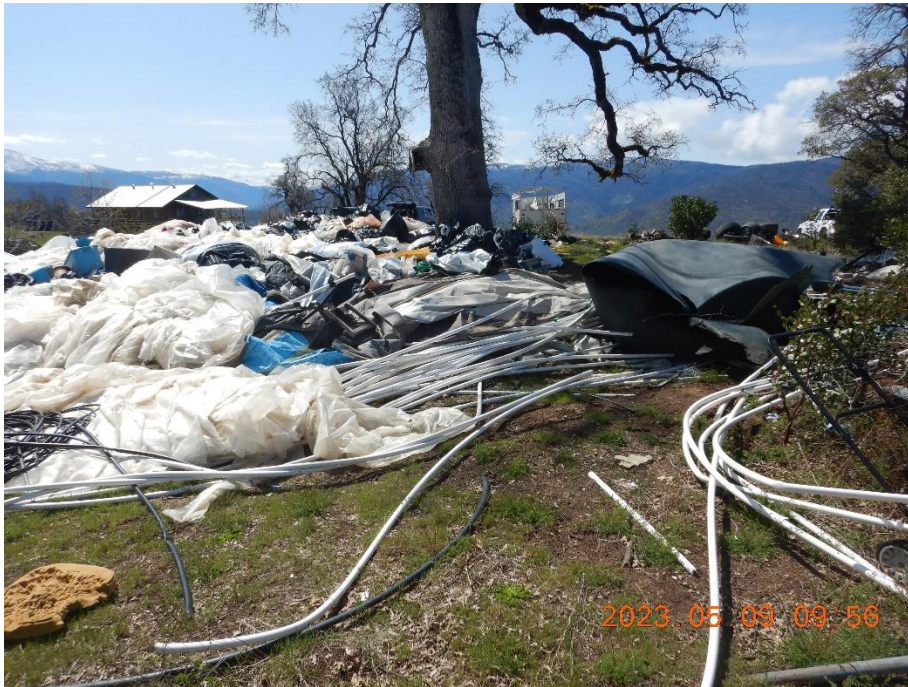
At WQ3, I observed a large area where waste was being collected and sorted. At WQ4, I observed a road fording a watercourse with pooled water on the road surface. The road leads to a greenhouse at WQ5 that covers an area of 6,000 square feet. I observed a graded earthen pad at WQ6 with fabric soil bags from past cultivation. I observed a partially blocked, 12-inch diameter culvert directed into a watercourse on the downslope side of the pad, but I did not find the culvert inlet upslope of the pad. I observed cannabis cultivation waste including plant stalks, slash and wire mesh within the channel downstream from the pad.

Figure 10—Trash including plastic sheeting and pipe in pile at WQ3.

1. Immediately collect all refuse and wastes which have discharged and/or threaten to discharge to receiving waters and which can be collected by hand. You are not authorized to use heavy equipment in a water of the State of California (Water of the State) or modify the bed bank or channel of a Water of the State without a permit from the Regional Water Board (see recommendation 5 below). Properly dispose of these wastes at a licensed waste collection facility.

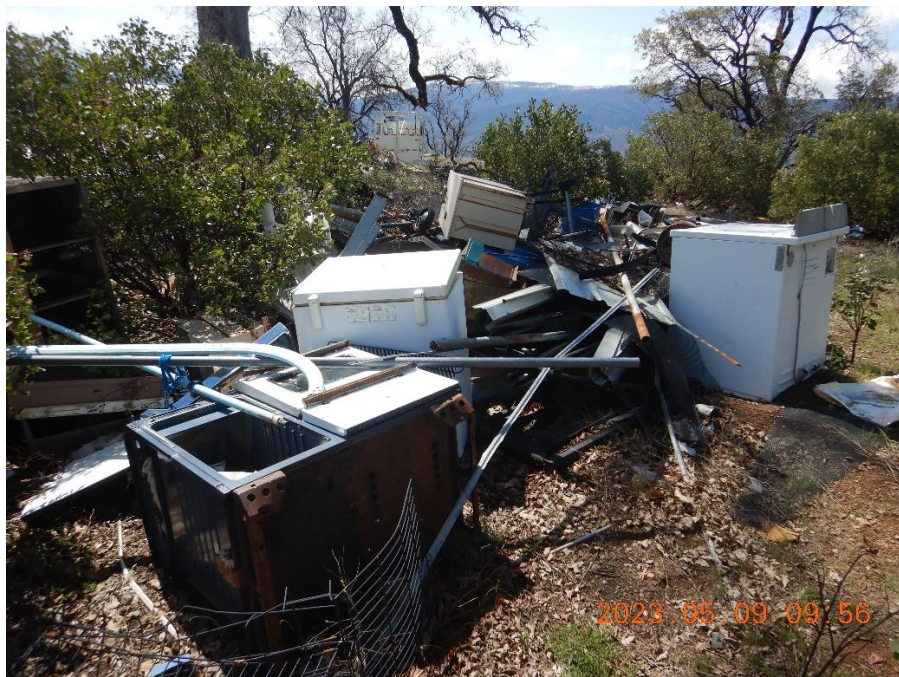
Figure 11— Trash including scrap metal and several old appliances at WQ3.

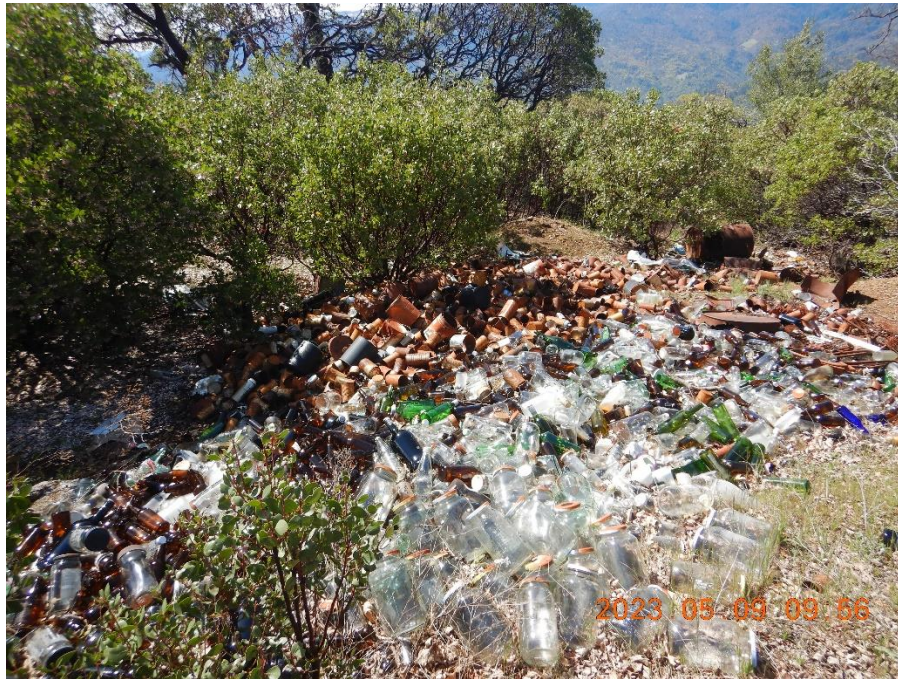
Figure 12— Trash including glass bottles and metal cans in pile at WQ3.

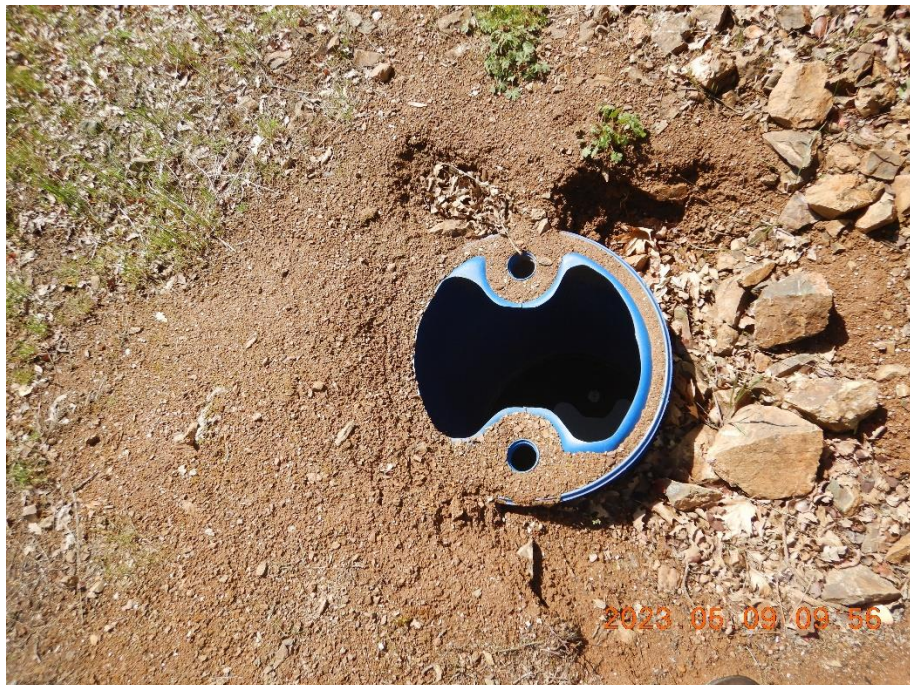
Figure 13— Buried plastic drum within area of large trash pile at WQ3.

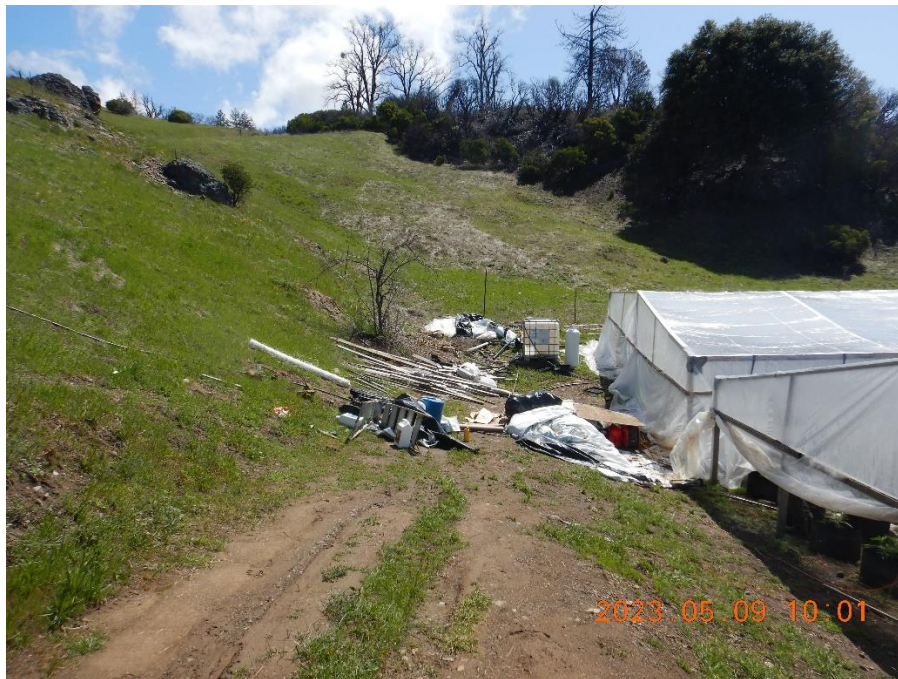
Figure 15—Looking east at northern side of greenhouse located at WQ5.

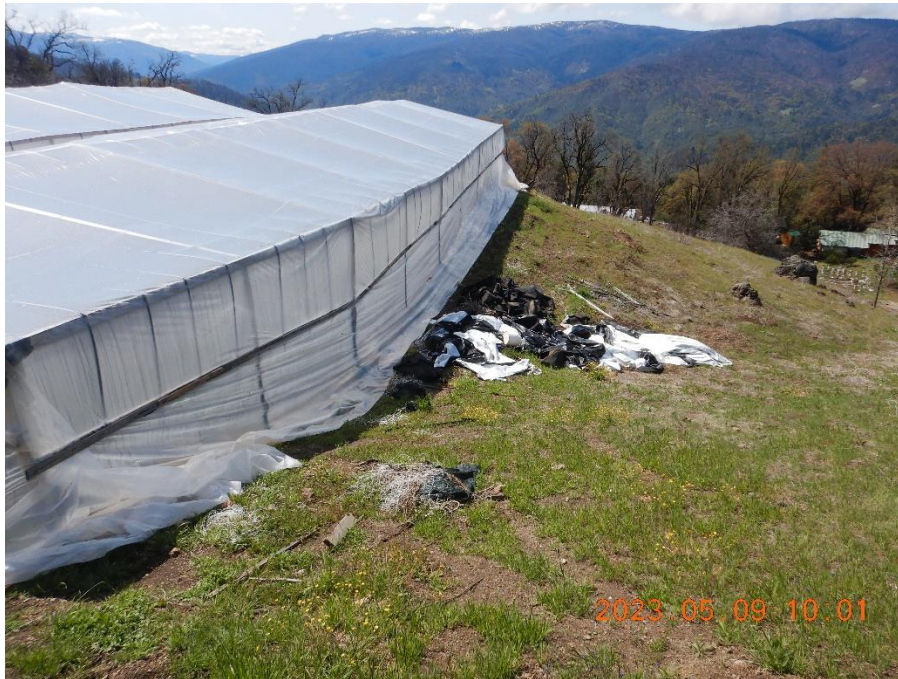
Figure 16— Looking south from northwest corner of greenhouse located at WQ5. A topographic swale visible in the right of the image connects to a watercourse with a defined bed and bank channel out of view to the right of the image.

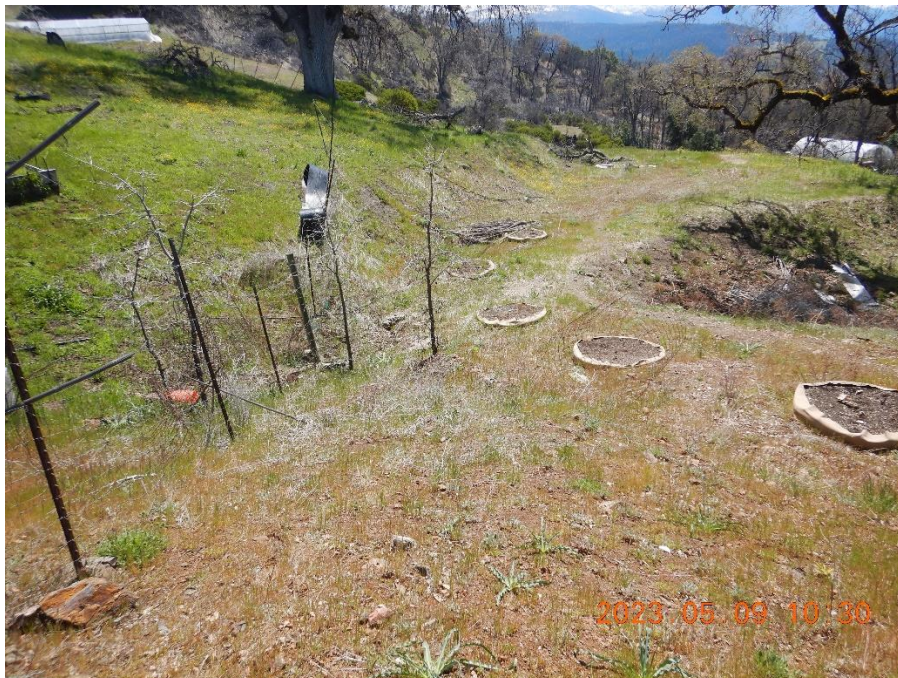
Figure 17—Earthen pad filling watercourse at WQ6. Fabric soil bags show past outdoor cannabis cultivation on pad. Waste slash, wire mesh and other trash are within the channel downstream in the right of the image.

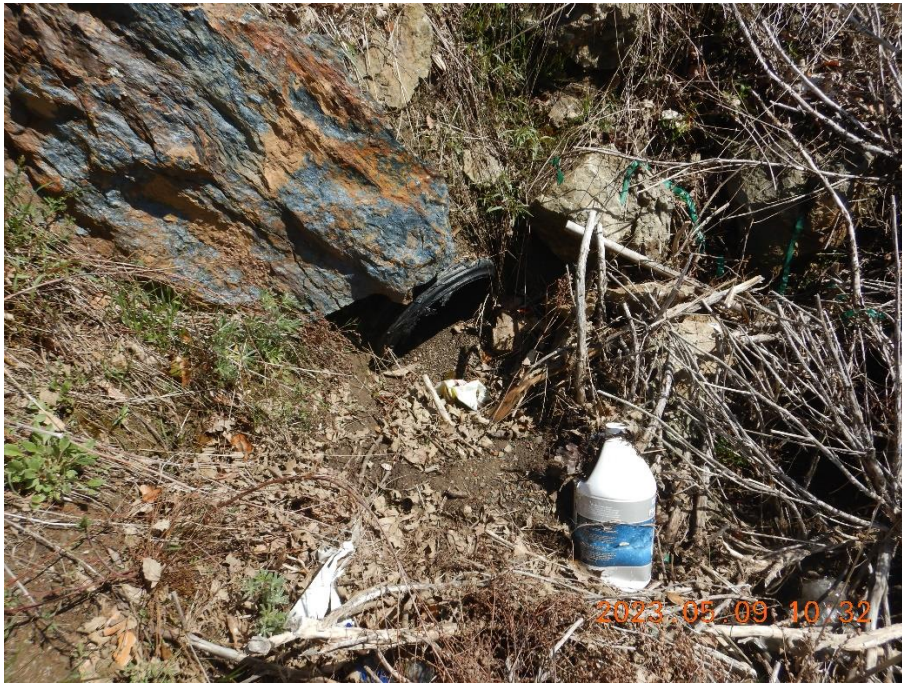
Figure 18—Partially buried culvert outlet at WQ6 among cultivation waste including plant stalks and plastic containers.

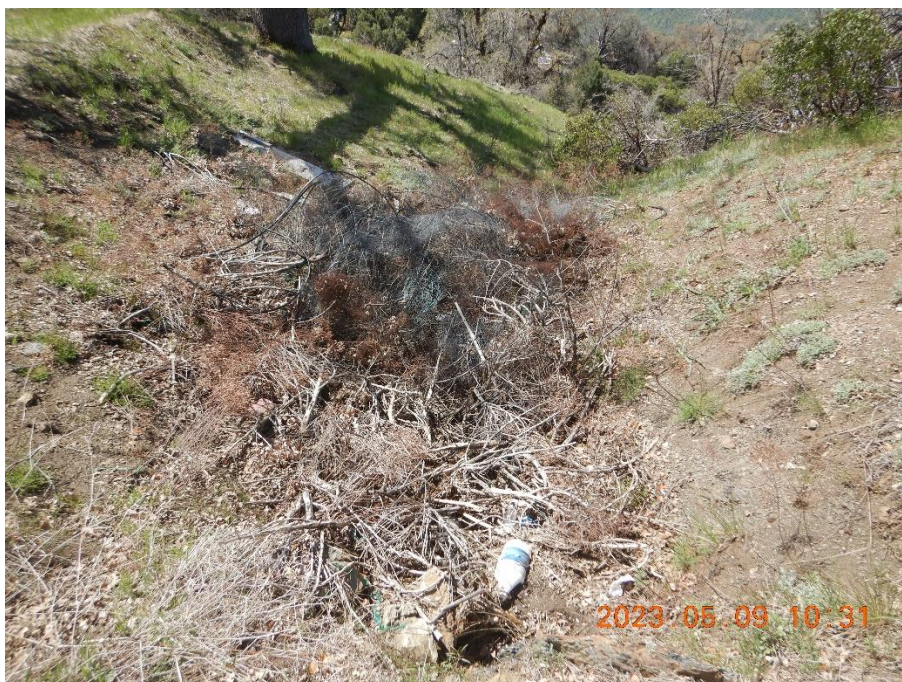
Figure 19—Looking south along watercourse at WQ6.

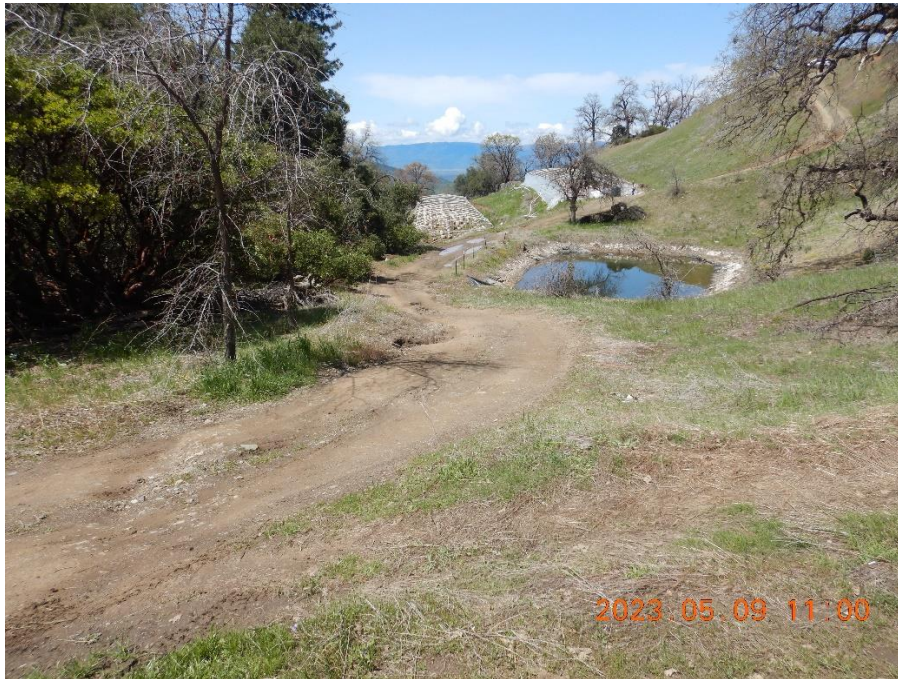
Figure 22—Looking west toward reservoir at WQ9 and greenhouses at WQ8. The topography is shaped such that flowing water from the stream behind the photographer would enter the road and flow into the reservoir in the upper right of the image.

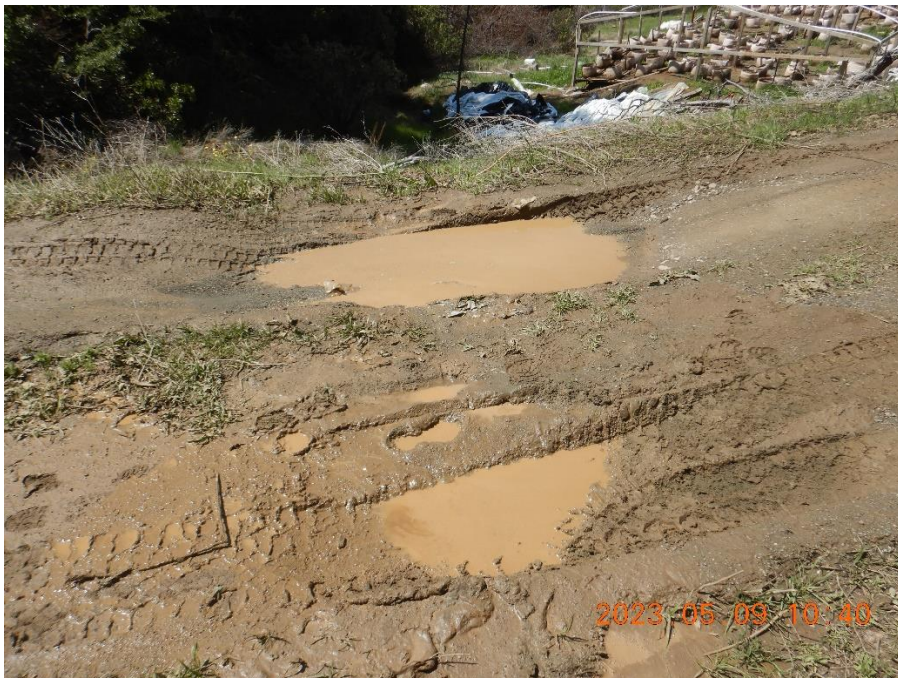
Figure 23—Water on top of the reservoir's impounding berm. The topography is shaped such that the stream channel approaching the reservoir from the northwest would bypass the reservoir and flow over the road at this location.

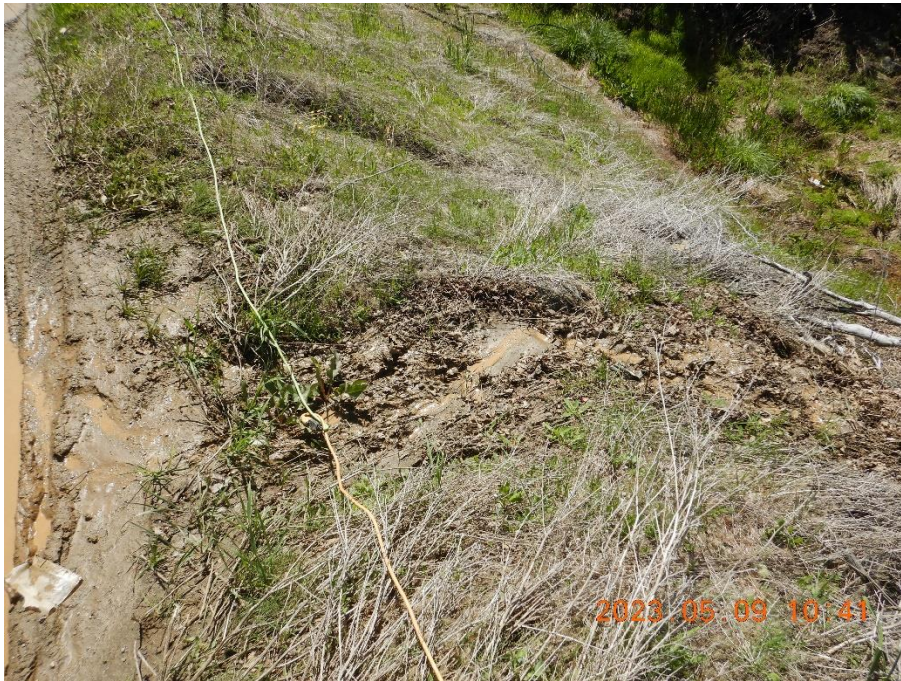
Figure 24—Sediment laden water from road surface pictured in previous image, flowing towards the USGS mapped blueline stream out of view to the right of the image.

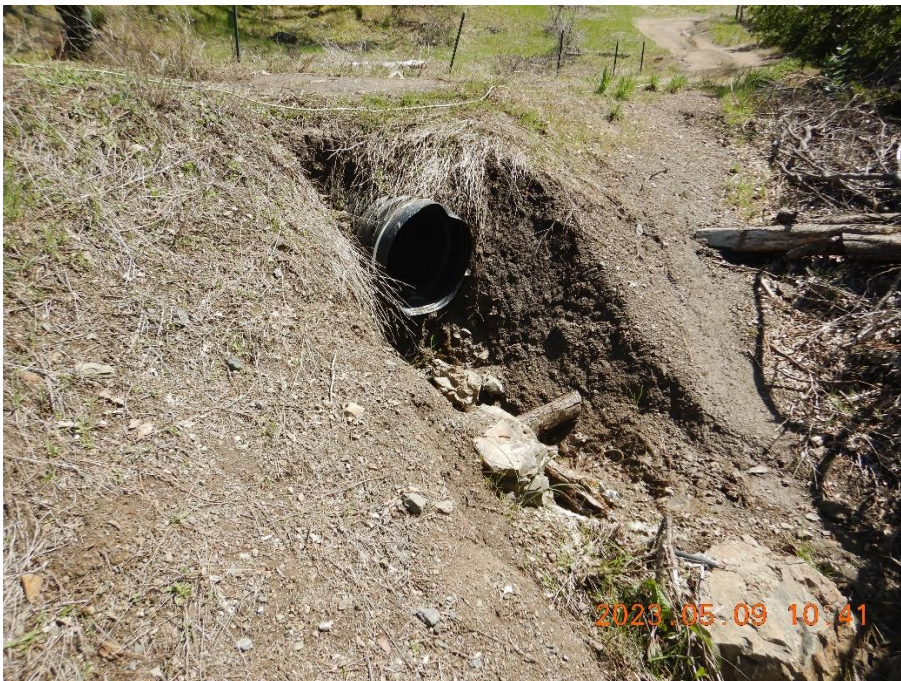
Figure 25—Reservoir outlet drain at WQ9 directed toward USGS mapped blueline stream out of view to the right of the image. The outlet pipe is 20-inches in diameter and lacks armor which has resulted in erosion and downstream transport of the earthen fill.

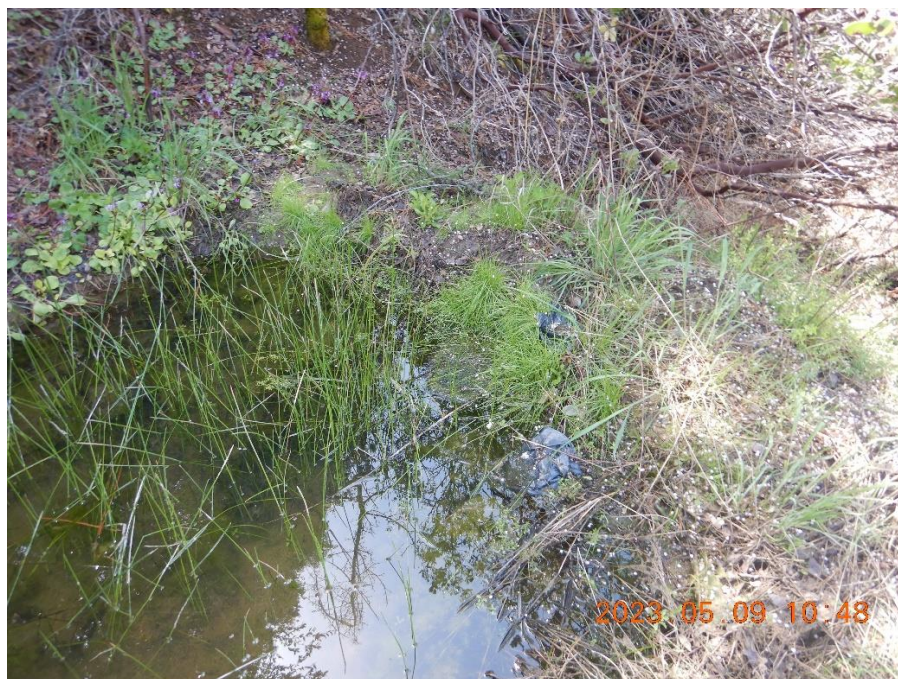
I observed waste potting soils damming the watercourse at WQ10, in an area that appears south of the property boundary mapped in Figure 1; however, I suspect that the waste came from the cannabis cultivation occurring on the subject Property because there is a clear fence separating this Property from the property to the south and it did not appear to be easy to access to the waste discharge location from the southern property. At WQ11, I observed plastic sheeting in the wetland that the below Aerial Images indicate was dredged between July 9, 2012 and May 30, 2014. South of WQ11, I observed another greenhouse covering an area of approximately 5,000 square feet.

Figure 27—Used potting soil, identifiable by white speckles of perlite, damming watercourse at WQ10.

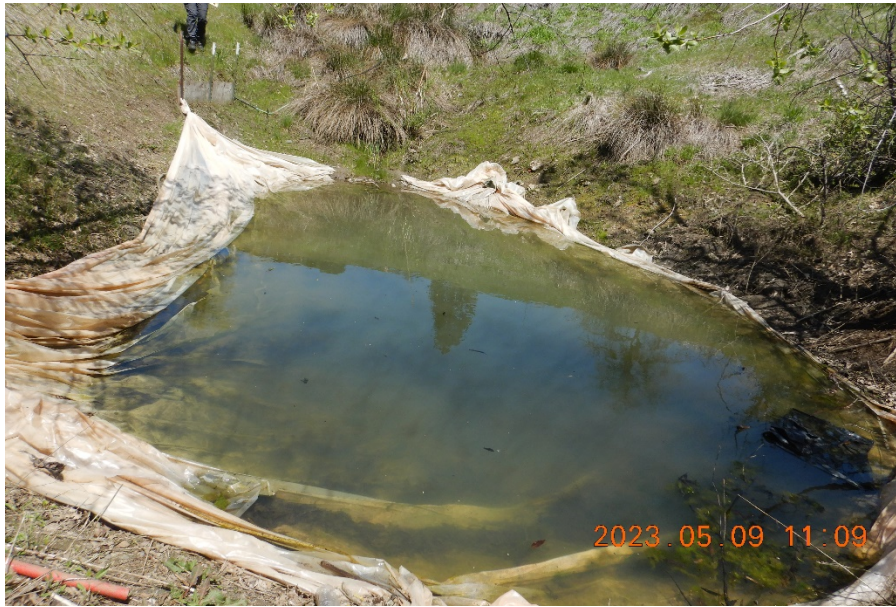
Figure 28—Plastic sheet covering dredged wetlands at WQ11.
