North Coast Regional Water Quality Control Board

Subject: Notice of Violation, Transmittal of Report for July 20, 2023 Inspection of Mendocino County Assessor's Parcel Numbers 032-520-08-05, and Recommendation to Respond within 30 days

Report of July 20, 2023 Warrant Inspection, Mendocino County

Assessor's Parcel Number (APN) 032-520-08-05 (the "Property")

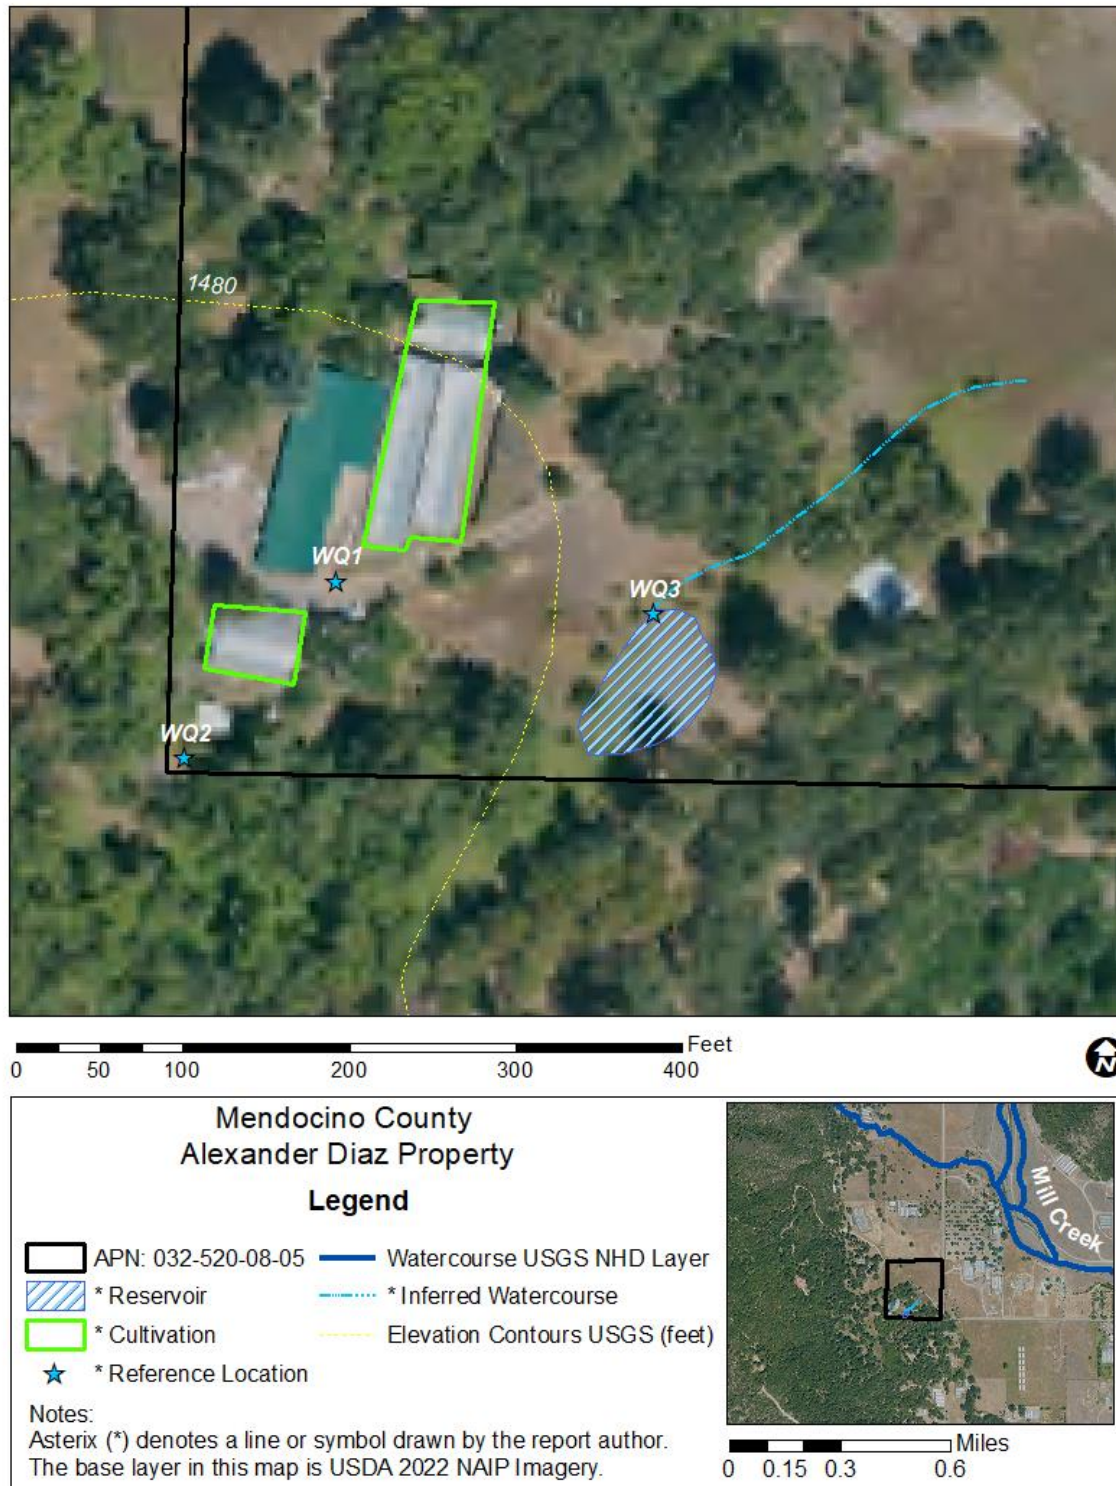
Figure 1—Aerial image/map showing inspection points discussed in this report.

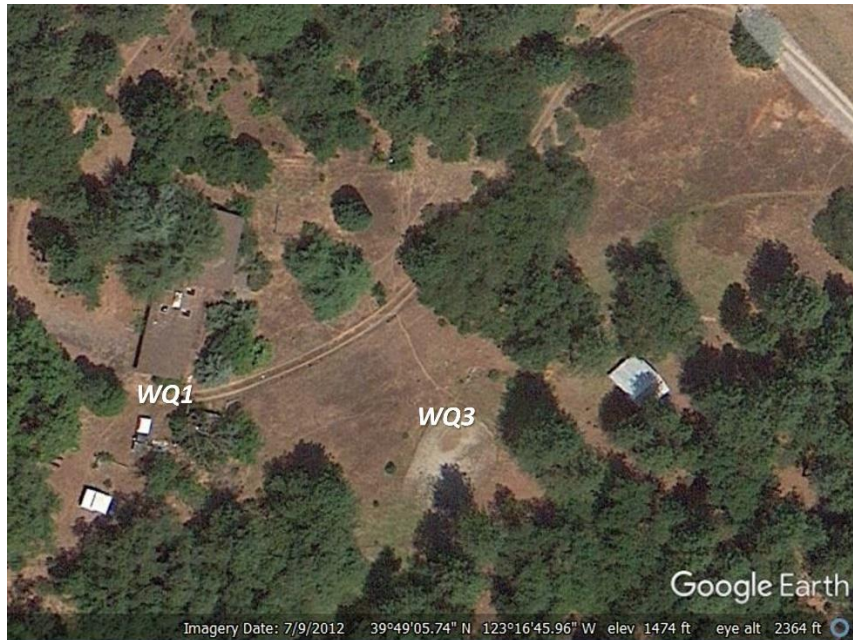
Figure 2—Aerial image of the Property taken on July 9, 2012, obtained from Google Earth. The image does not show any signs of cannabis cultivation activities at WQ1, but the reservoir at WQ3 is visible.

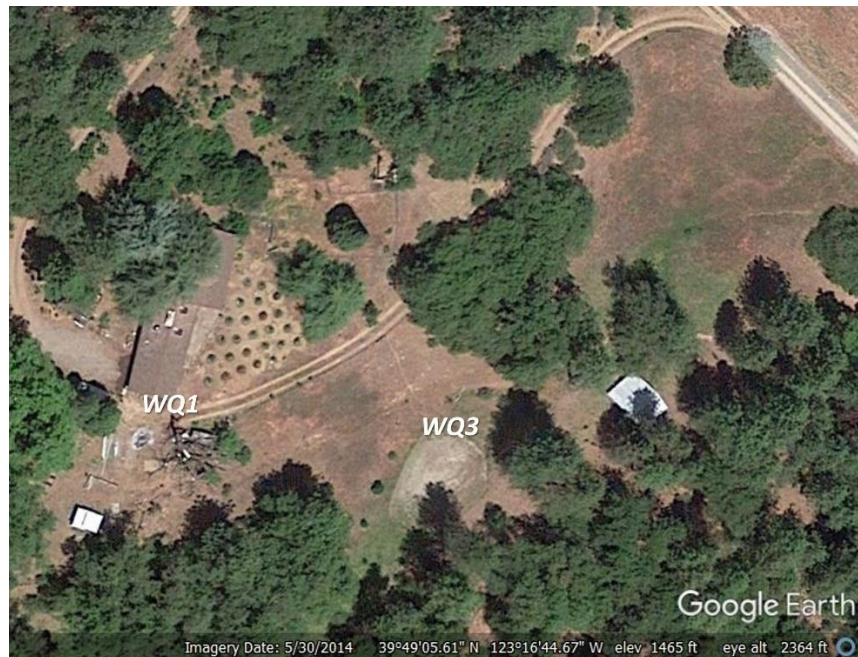
Figure 3—Aerial image of the Property taken on May 30, 2014, obtained from Google Earth. The image shows evenly spaced plants in the vicinity of WQ1 that resembles the size and spacing of outdoor cannabis cultivation.

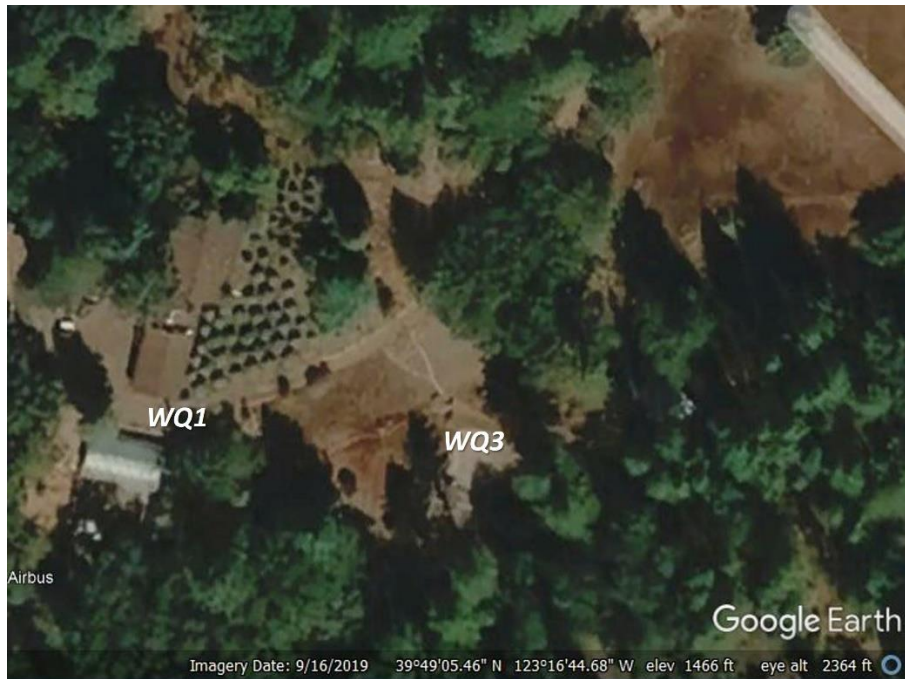
Figure 4—Aerial image of the Property taken on September 16, 2019, obtained from Google Earth. The image shows a hoop-type greenhouse southwest of WQ1.

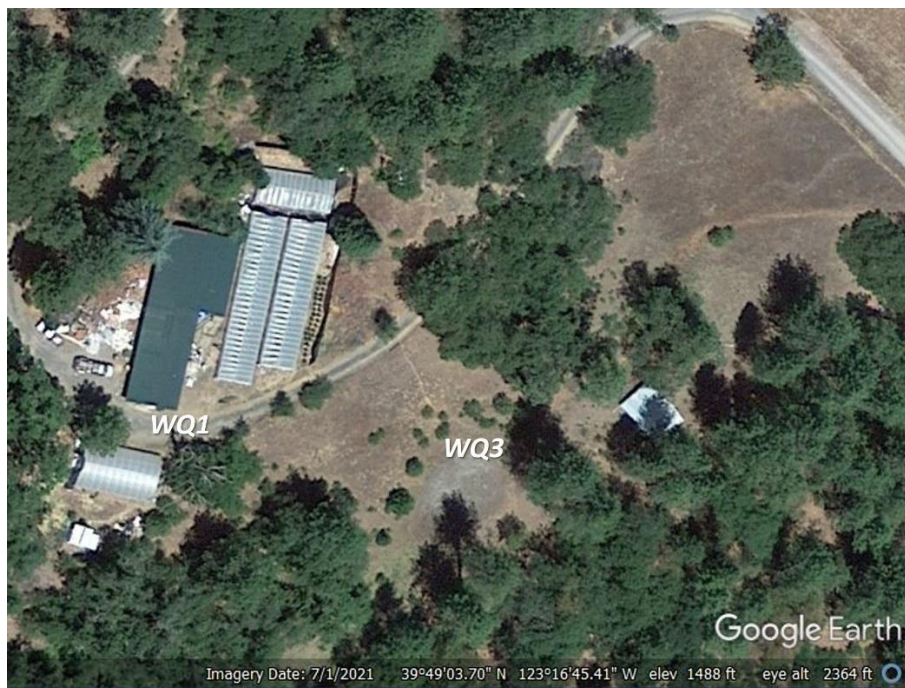
Figure 5—Aerial image of the Property taken on July 1, 2021, obtained from Google Earth. The image shows hoop-type greenhouses north of WQ1.

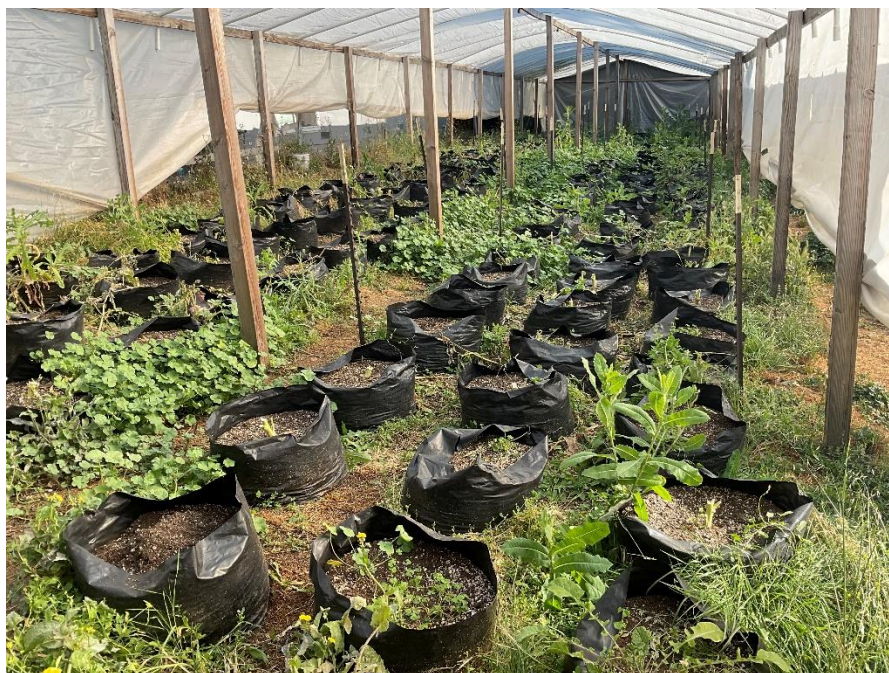
Figure 6—Photo looking inside greenhouse north of WQ1. Soil bags are aligned in rows on the earthen ground. Plant stalks are visible protruding from the soil where cannabis plants had been recently cut.

1. Retain a qualified professional to develop a workplan and schedule to implement measures to ensure that all developed features, including the reservoir at WQ3, are corrected, restored, and/or maintained in conditions that comply with the Cannabis Cultivation Policy¹.
2. Prior to cultivating cannabis or developing a property for cannabis cultivation, enroll for coverage under the Cannabis General Order².

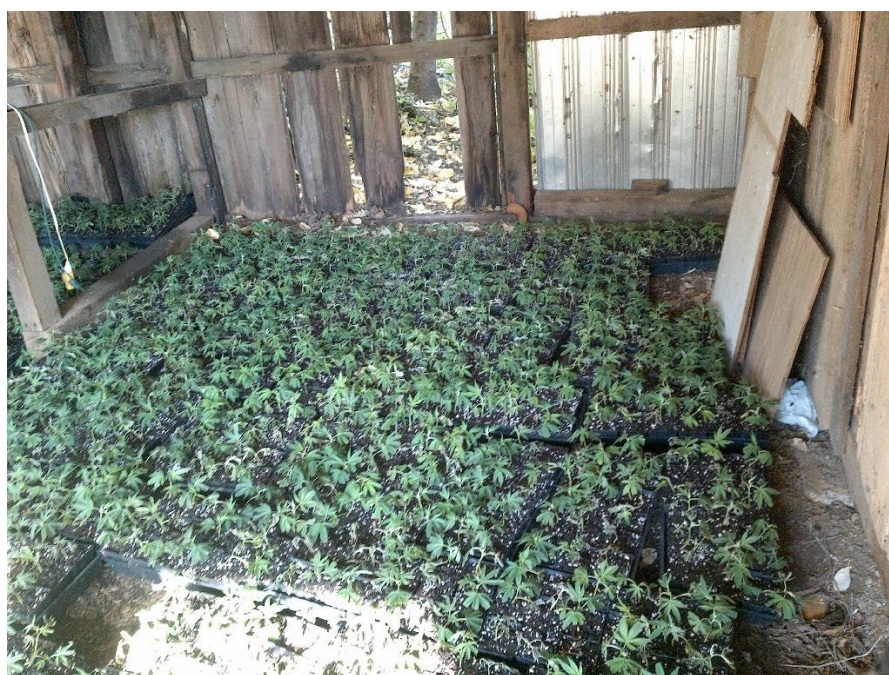
Figure 7—Photo looking at many small immature cannabis plants in a shed to the southwest of WQ1.

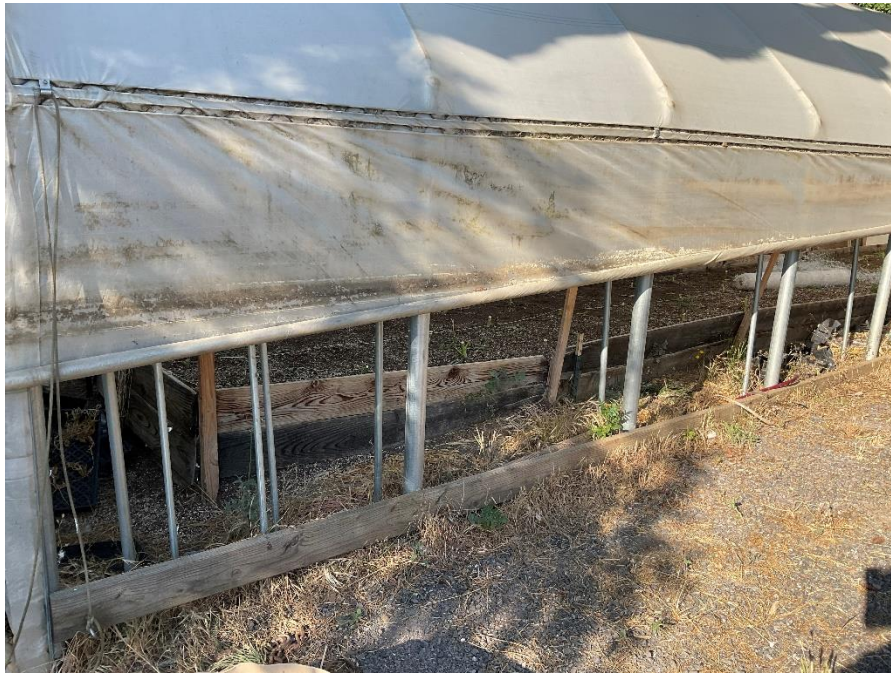
Figure 8—Photo looking through the side of a greenhouse south of WQ1. Plant stalks are visible sticking out of raised garden beds inside the greenhouse.

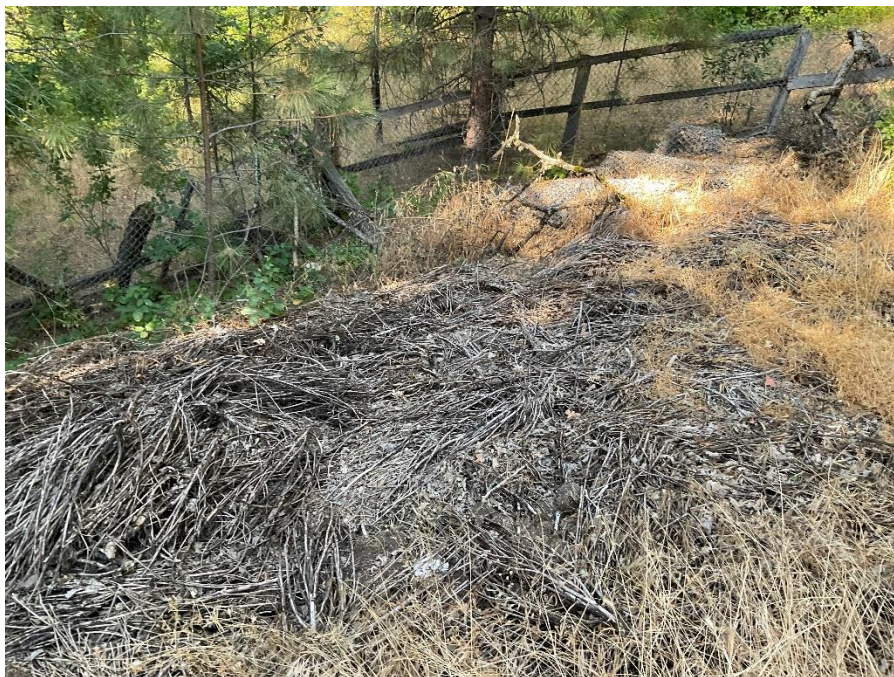
Southwest of the shed, at WQ2, I observed a pile of waste cannabis stalks that had begun to decompose. I walked to the east and observed a small shallow reservoir at WQ3. I observed two side-by-side five-inch diameter pipes draining the northern edge of the reservoir. I observed a scour-hole where the outlet pipes discharged and I measured the dimensions of the hole with a tape measure to be three feet wide, three feet deep and eight feet long. I observed a shallow intermittent channel continuing northeast from the reservoir for a few hundred feet before dissipating. I did not observe any evidence to suggest that the channelized flow would continue to a receiving watercourse.

Figure 9—Pile of waste cannabis stalks in at WQ2.

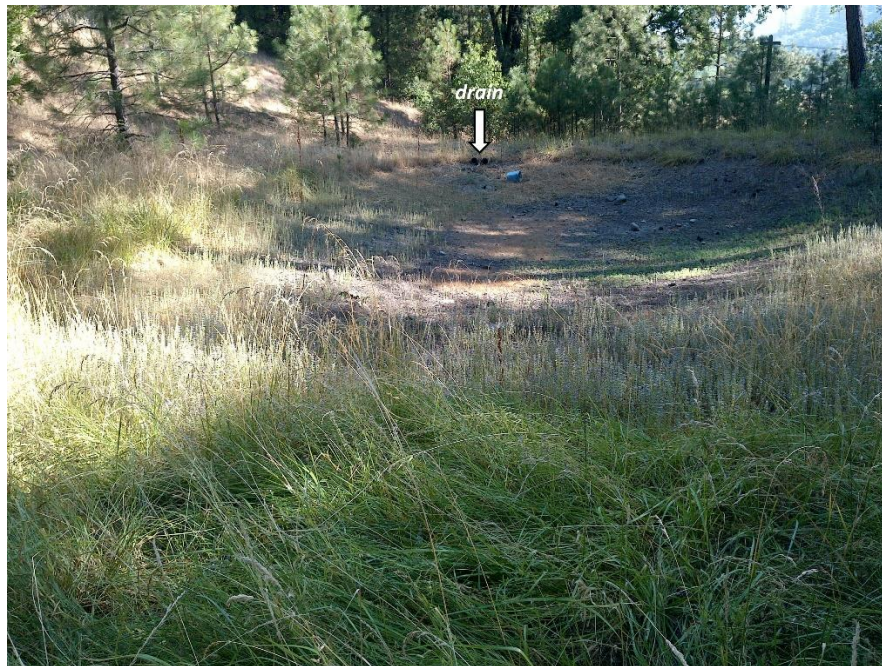
Figure 10—Photo of a shallow reservoir at WQ3. An arrow identifies the location of two five-inch diameter drainpipes.

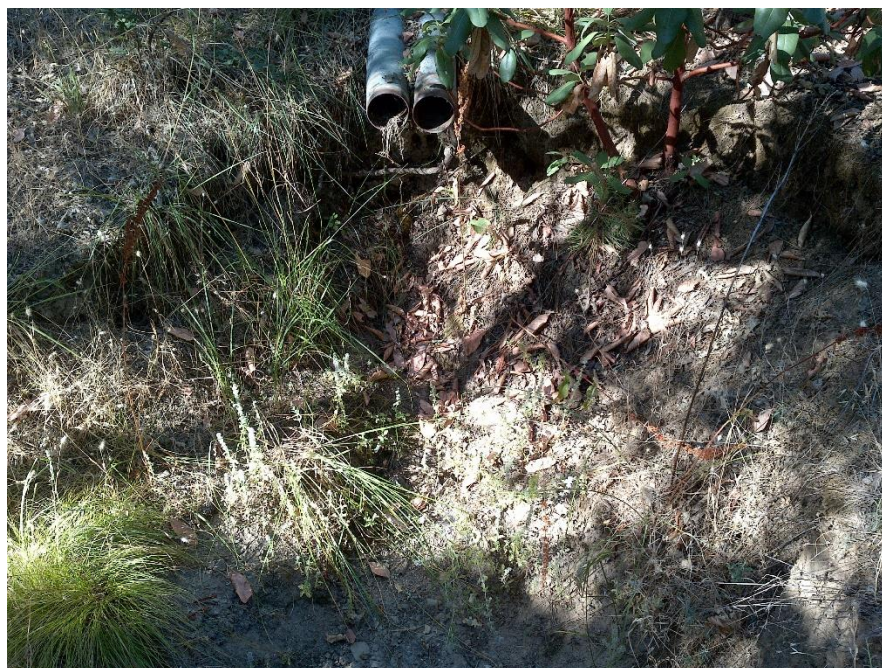
Figure 11—Photo looking at the drainpipe outlets located WQ3. A void has formed in the unarmored buttress at the discharge location.
