Subject: **Notice of Violation and Transmittal of Report for July 18, 2023
Inspection of Mendocino County Assessor's Parcel Numbers 047-060-24-00**

**Report of July 18, 2023 Warrant Inspection,
Mendocino County
Assessor's Parcel Number (APN) 047-060-24-00 (the "Property")**

File: Cannabis Program Inspections, Mendocino County, 2023, Flat Garden and Top Nursery, CIWQS Place ID 852950

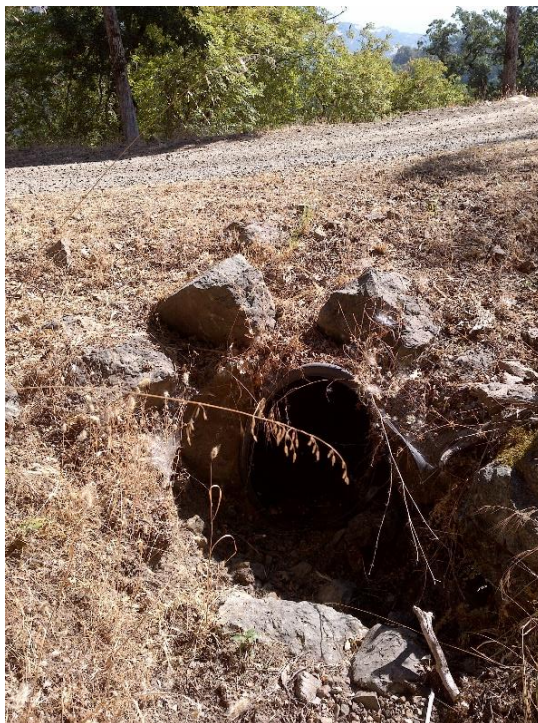
Figure 2—Photo showing the inlet to a 24-inch diameter culverted stream crossing at WQ1.

5. Prior to conducting work in a Water of the State, including any work in streams, ponds, or wetlands such as that at WQ1, WQ2, WQ3, WQ4, WQ6, WQ7 and north of WQ8, submit an application and pay the required application fee for a Water Quality Certification/Waste Discharge Requirement²:

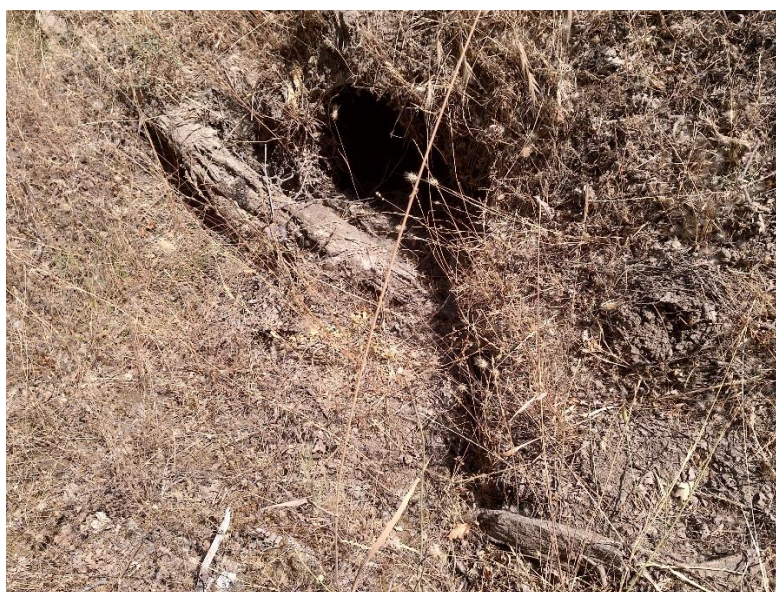
Figure 3—Photo showing inlet to 18-inch diameter culvert at WQ2. The inlet is partially blocked by woody debris and dry vegetation.

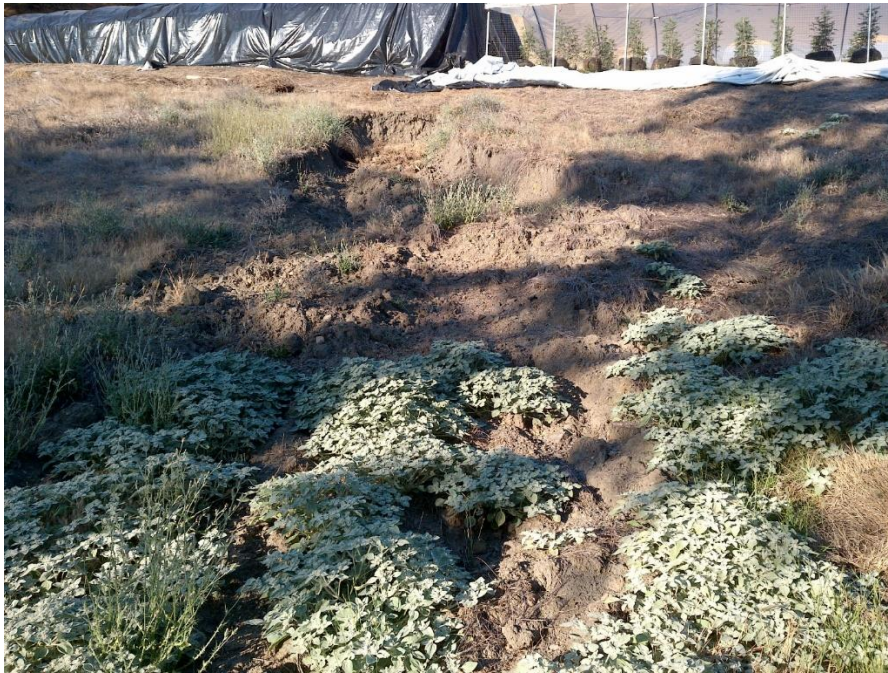
I observed another culverted watercourse crossing downslope from a cultivation area in the vicinity of WQ3. I observed a concave-up erosional feature, the top of which I measured with a tape measure to be 14 feet from the northern edge of the greenhouse. I observed the scarp connecting to the channel upstream from the culvert and I observed sediment from the scarp deposited into the channel. I observed that the watercourse downslope from the road has a well-defined bed and bank, and I followed the watercourse down to WQ4 where I observed waste cannabis plant material in the watercourse. The 2020 SMP identifies the WQ3 crossing as a ditch relief culvert, RS2, and the location of the cultivation pad upslope as a potential nursery suggesting that the cultivation pad had not yet been developed when the 2020 SMP was drafted. The 2020 SMP states that erosional control measures are needed on the hillside above the culvert to minimize sediment discharge downhill.

Figure 4—Photo looking southwest in the vicinity of WQ3. Hoop-type greenhouses are visible in the top of the image and an erosional scarp is visible downslope from the cultivation area, between the greenhouses and the photographer.

3. Reclassify the Property's enrollment under the Cannabis General Order from Low Risk to High Risk to reflect that the cannabis cultivation facilities at WQ3 and WQ8 are within required setbacks.

4. Retain a qualified professional to develop a Disturbed Area Stabilization Plan and required permit applications to move all cannabis cultivation activities outside of required setbacks and restore any disturbed areas within setbacks to comply with the Cannabis Cultivation Policy¹.

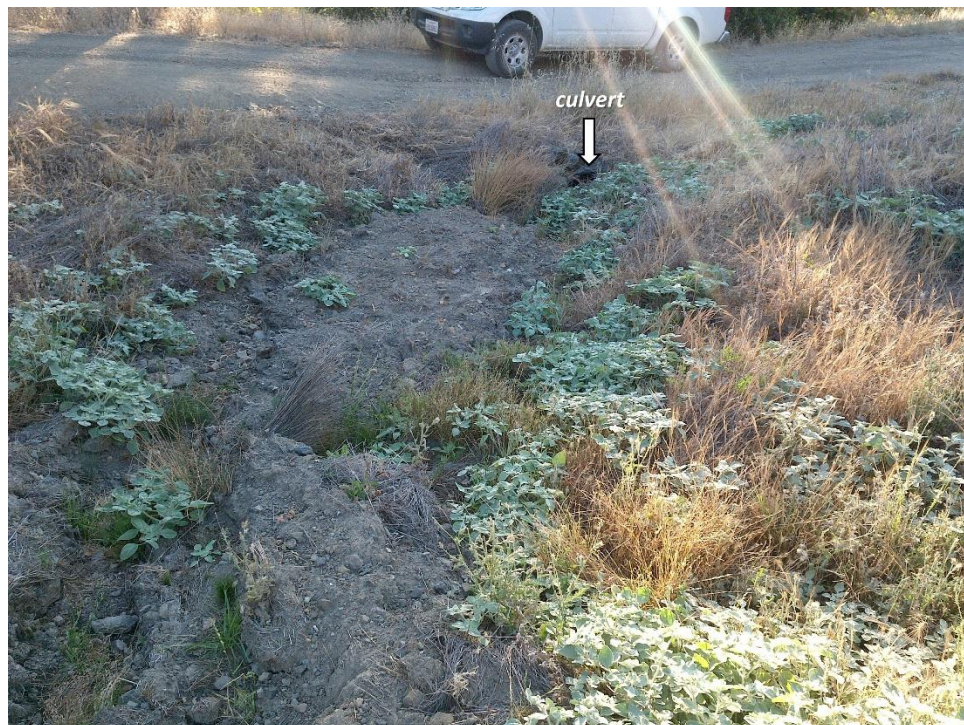
Figure 5—Photo looking east and downslope towards WQ3 from the same location as the previous image. Lobes of sediment are visible between the photographer and a culvert inlet marked by an arrow in the top middle of the image.

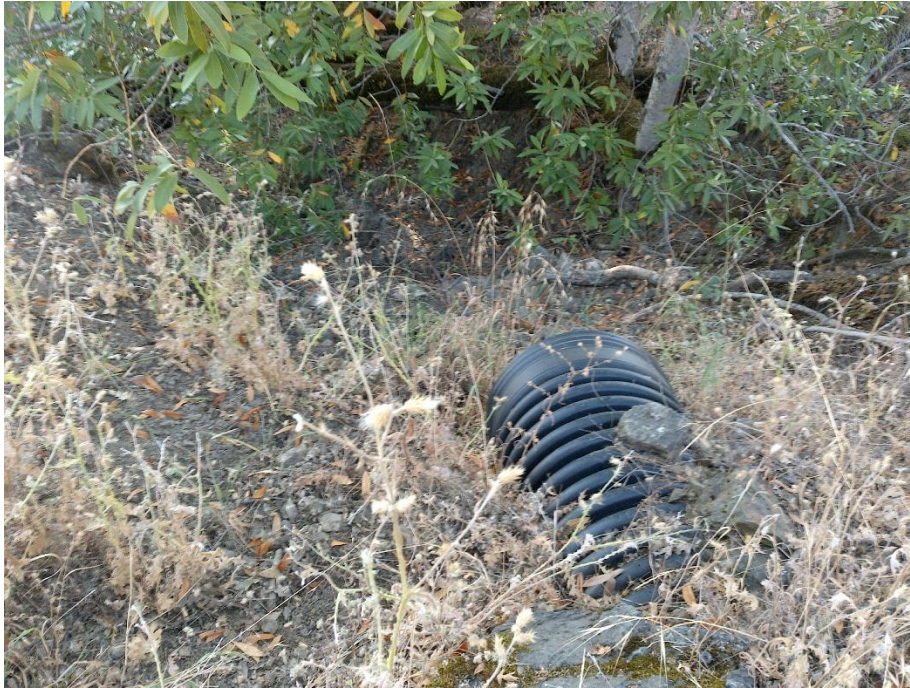
Figure 6—Photo showing the outlet of the 18-inch diameter culvert at WQ3, the inlet of which is pictured in the previous image. A receiving watercourse, tributary to Feliz Creek, is visible in the top of the image.

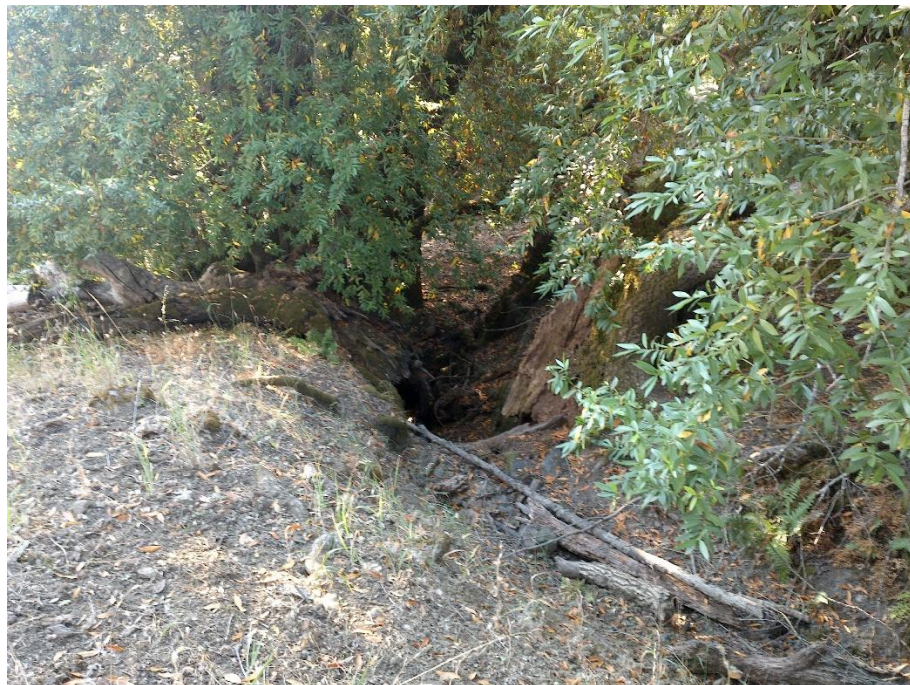
Figure 7—Photo looking northeast at watercourse downstream from WQ3.

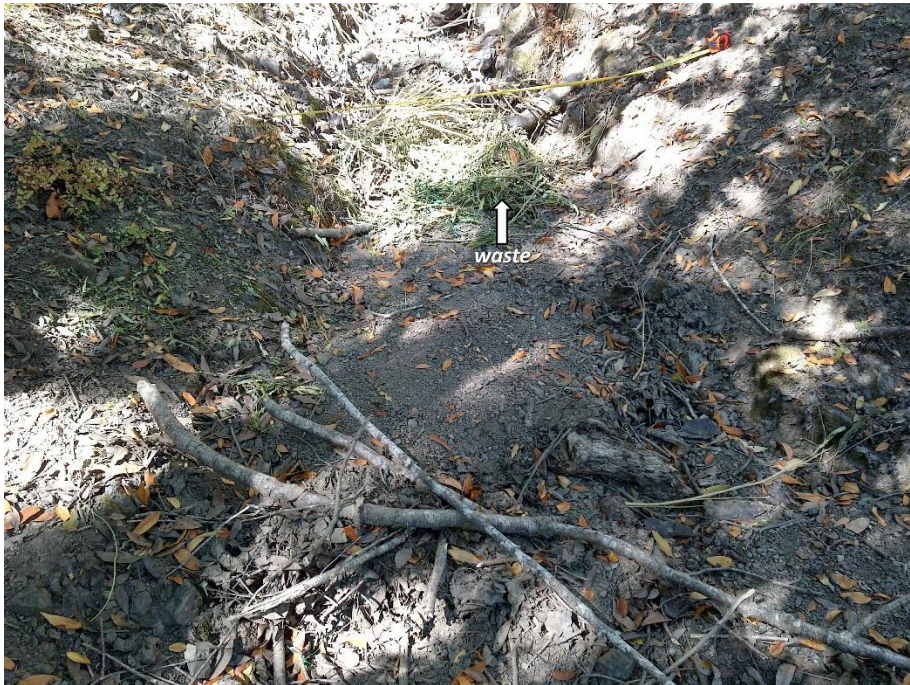
Figure 8—Photo, looking upstream, showing waste cannabis plants, marked by an arrow, in watercourse at WQ4. The report author measured the local channel width of 4.5 feet with the tape measure visible in the top of the image.

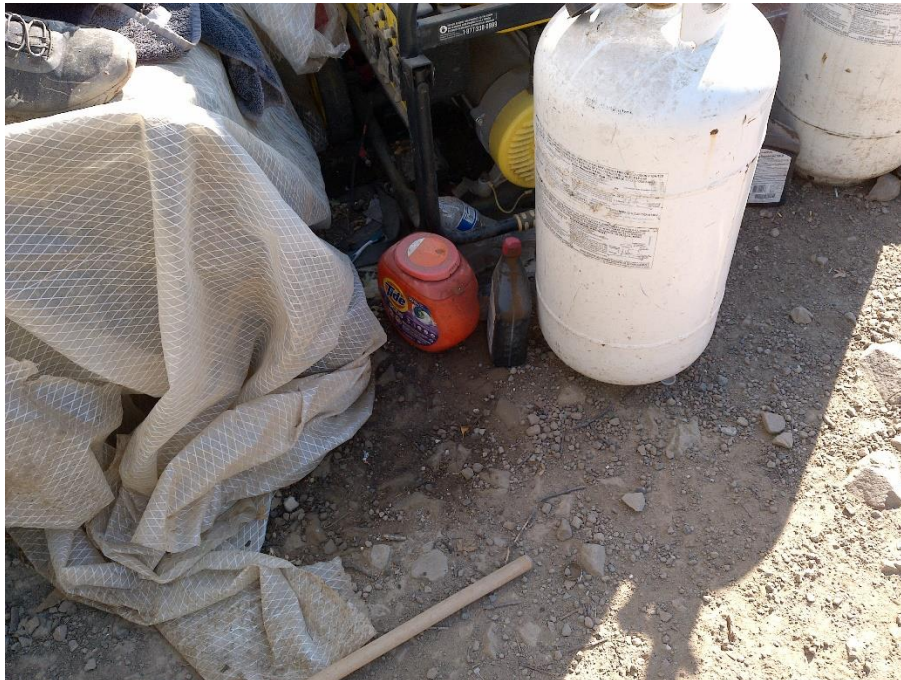
At WQ5, I observed a generator and fuels storage area without secondary containment. I observed that the earthen ground in the vicinity of the petroleum product storage area was darker than surrounding areas and I detected the odor of motor oil emitting from the ground. The 2020 SMP notes that petroleum products were stored improperly, directly on the ground, without secondary containment. The 2020 SMP proposed relocating all petroleum products to an appropriate storage facility by the Summer of 2021.

Figure 9—Generator and motor oil stored at WQ5 without secondary containment. The earth in the vicinity of the petroleum product storage area is darker than surrounding areas.

1. Immediately collect all petroleum products that threaten to spill, including those in the vicinity of WQ5, and haul away to a licensed waste disposal facility or store in accordance with the Cannabis Cultivation Policy¹.

2. Retain a qualified professional to investigate the extent of contaminated soil associated with spilled petroleum products at WQ5 and develop a workplan and schedule for cleaning up the spill.

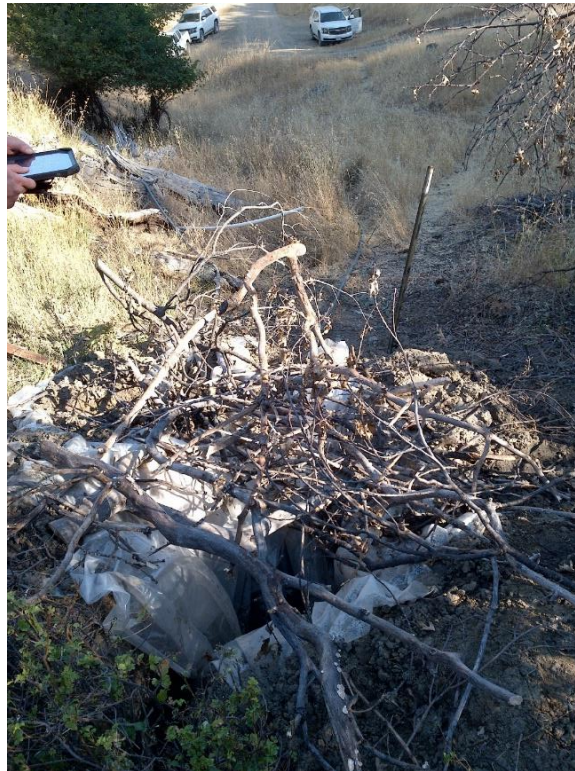
At WQ6, I observed a spring that had been excavated and lined with plastic sheeting. I measured the depth of excavation to be four feet with a tape measure and estimated that water filled the bottom foot of the excavation. I followed the preferential path that surface water would flow from the spring at WQ6 to a reservoir at WQ7 and observed intermittent scour marks along the way. I observed a 15-inch diameter outfall pipe exiting the reservoir to the southwest. The area below the reservoir outfall was partially armored with woody debris. The 2020 SMP notes that if the pond is kept, the outlet culvert would need to be upgraded.

Figure 10—Photo showing a developed spring at WQ6. The spring has a four-foot-deep hole lined with plastic sheeting and one foot of standing water in the bottom.

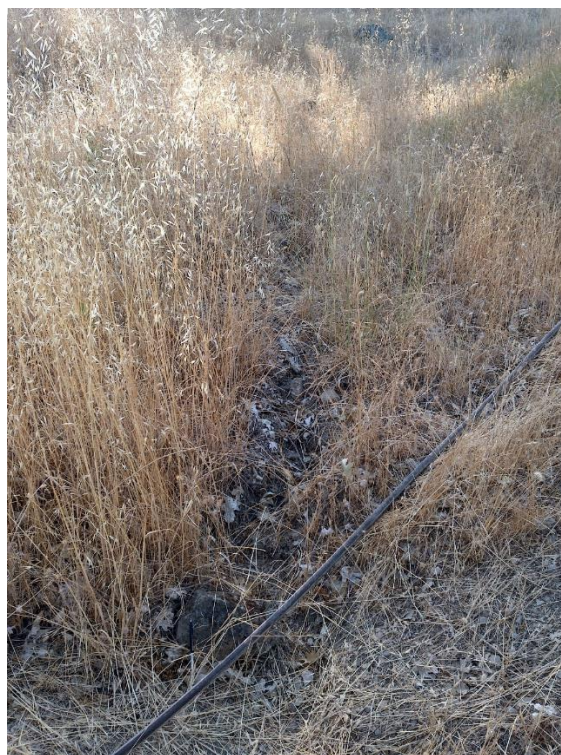
Figure 11—Photo showing section of intermittent channel between WQ6 and WQ7

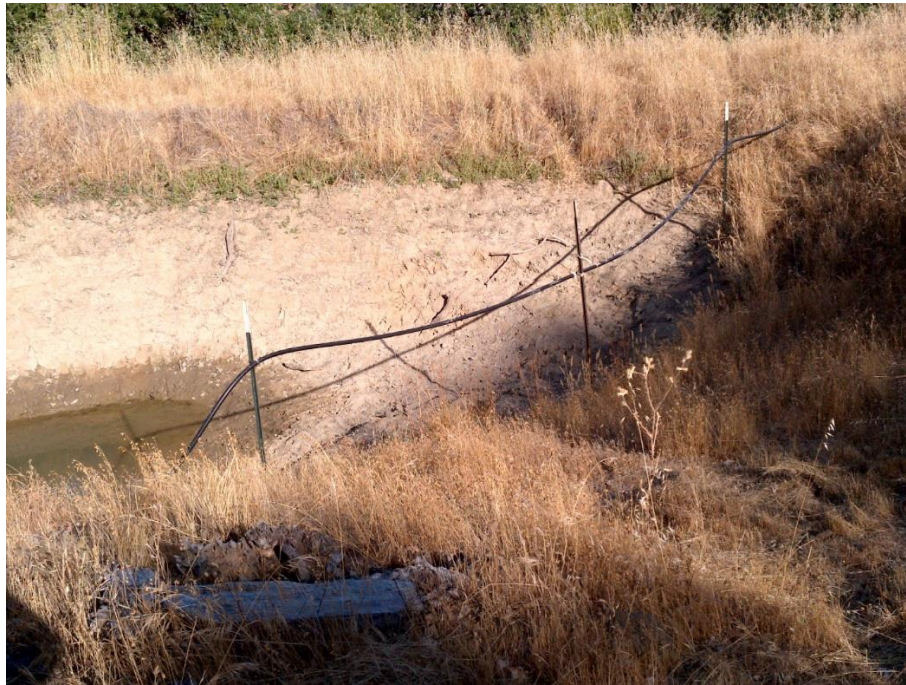
Figure 12—Photo looking north at eastern edge of pond located at WQ7.

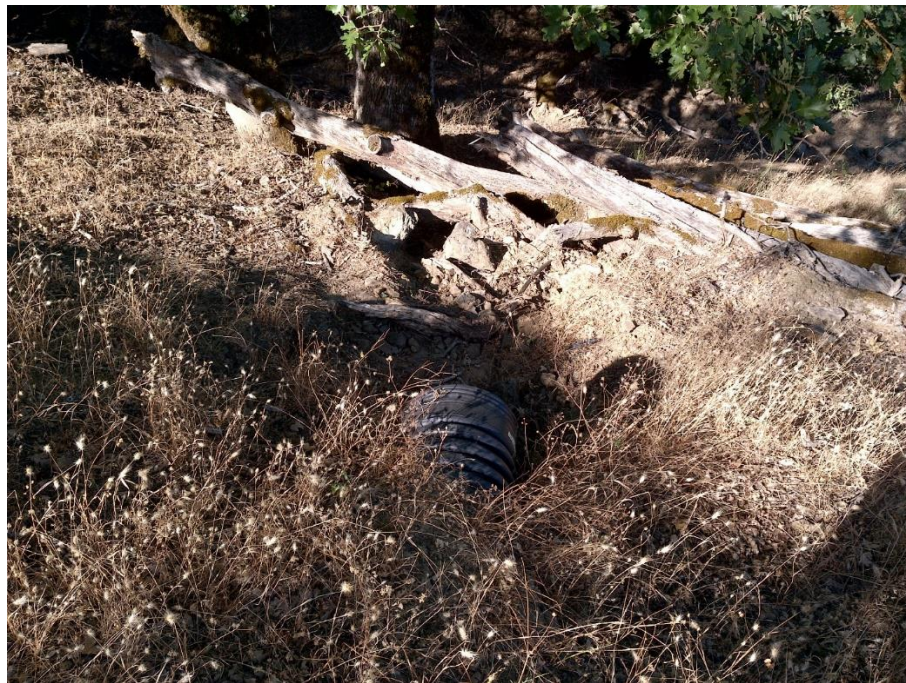
Figure 13—Photo looking west at pond outlet at WQ7. The Pipe drains onto a pile of woody debris.

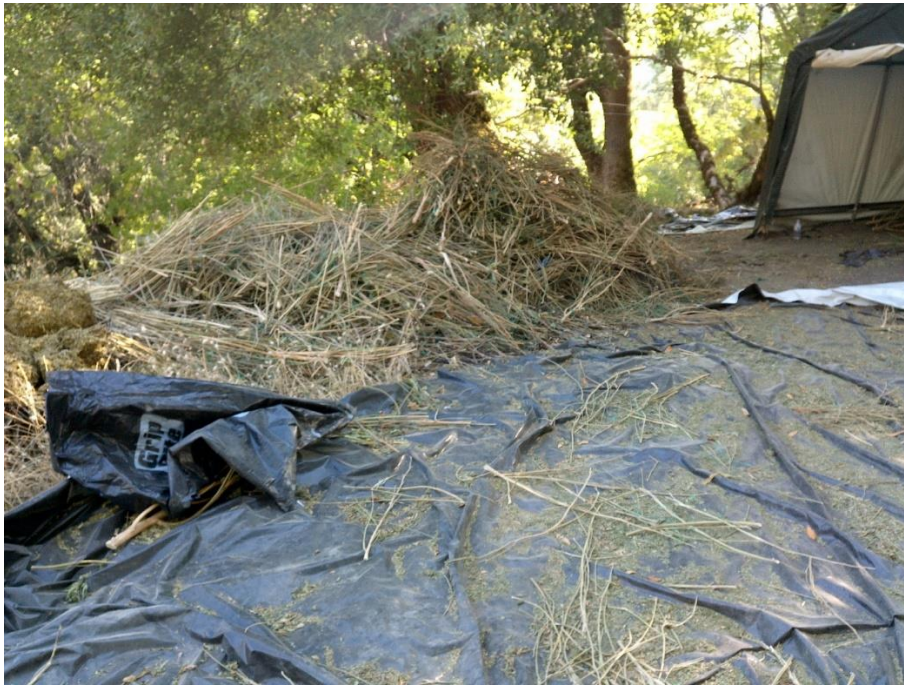
At WQ8 I observed a cannabis plant trimming area located within required setbacks to a headwater stream. The 2022 SMP identifies a storage shed near this location.

Figure 14—Photo of waste cannabis stalks at cannabis trimming area located at WQ8.

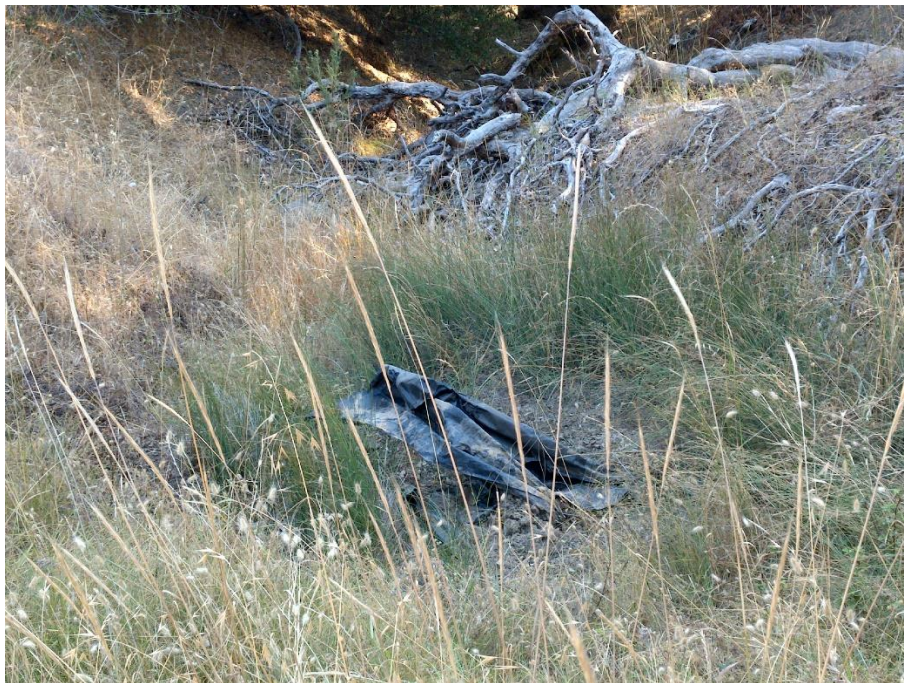
Figure 15—Photo looking north at the head of a watercourse, visible in the top of the image, located at WQ8.
