**Subject: Notice of Violation, Transmittal of Report for July 20, 2023 Inspection of Mendocino County Assessor's Parcel Numbers 34-010-46-00, 034-010-67-00, and 034-010-68-00, and Recommendation to Respond within 30 days**

### **Report of July 20, 2023 Warrant Inspection, Mendocino County**

**Assessor's Parcel Number (APN) 034-010-46-00, 034-010-67-00, and 034-010-68-00  
(the "Property")**

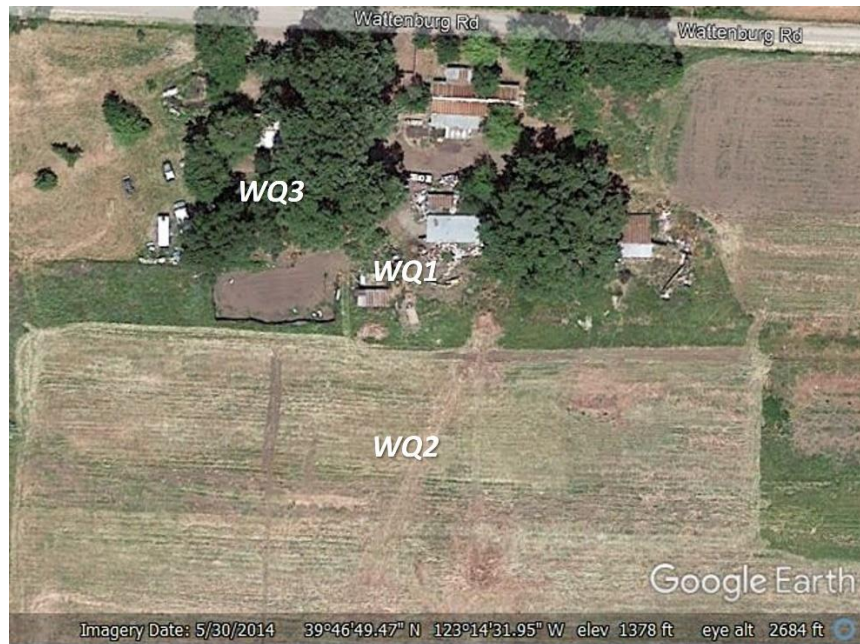
*Figure 2—Aerial image of the Property taken on May 30, 2014, obtained from Google Earth. The image shows structures in the northern part of the Property and a plowed field in the southern part of the Property.*

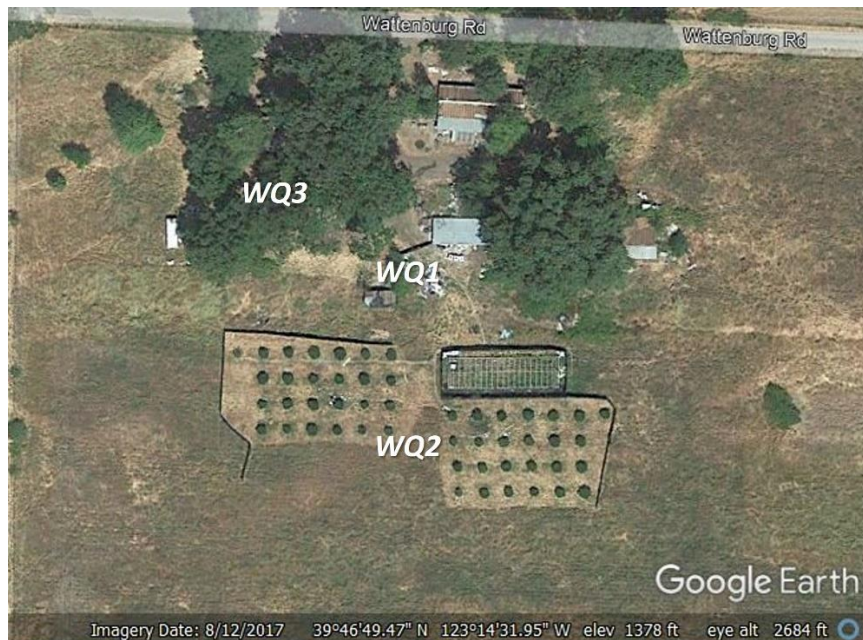
*Figure 3—Aerial image of the Property taken on August 12, 2017, obtained from Google Earth. The image shows a hoop-type greenhouse and rows of regularly spaced plants that are similar in size and pattern to that of commonly observed outdoor cannabis cultivation.*

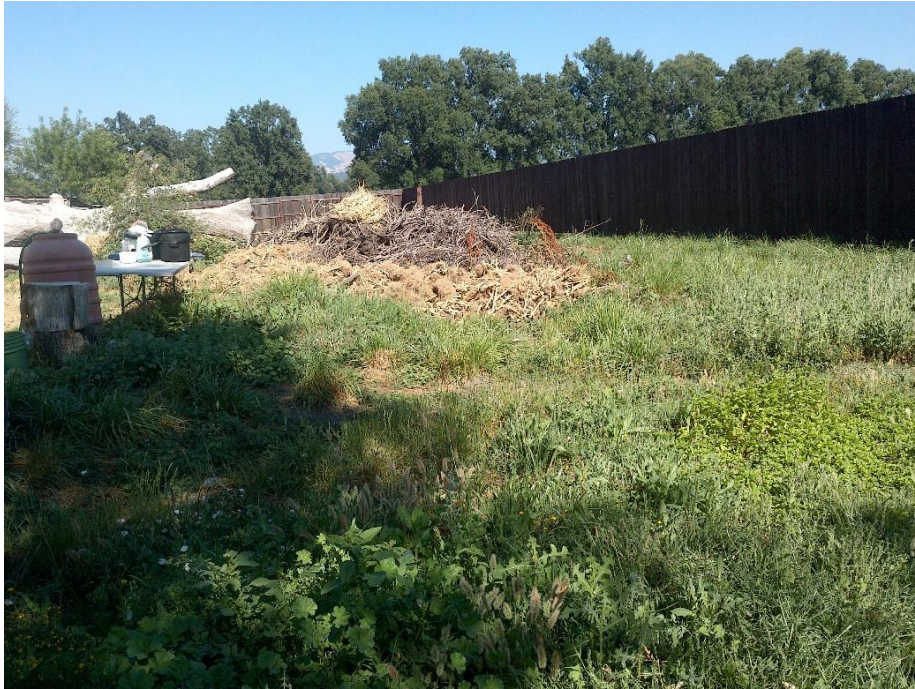
The inspection was associated with a criminal search warrant, and I viewed only portions of the Property. See the above Inspection Map and below Aerial Imagery and Photo Appendix for locations and details about features of concern to water quality. I entered the Property from the north and observed a large pile of cannabis cultivation waste, including plant stalks and root balls in potted growth medium, at WQ1. I continued walking south and observed cannabis plants growing fully outdoors and within greenhouses in a fenced area of the property exceeding one-acre in size. At WQ2 I observed a nutrient mixing tank that was full of liquid.

*Figure 4—Looking east from WQ1 at a pile of cannabis cultivation waste including plant stalks and root balls in potted growth medium.*

1. Collect and dispose of all cannabis cultivation waste in a manner consistent with the requirements of the Cannabis Cultivation Policy<sup>1</sup>.
2. Prior to cultivating cannabis or developing a property for cannabis cultivation, enroll for coverage under the Cannabis General Order<sup>2</sup>.
3. Retain a qualified professional to either close or repair the groundwater well at WQ3 according to Mendocino County's well ordinance and well standards.

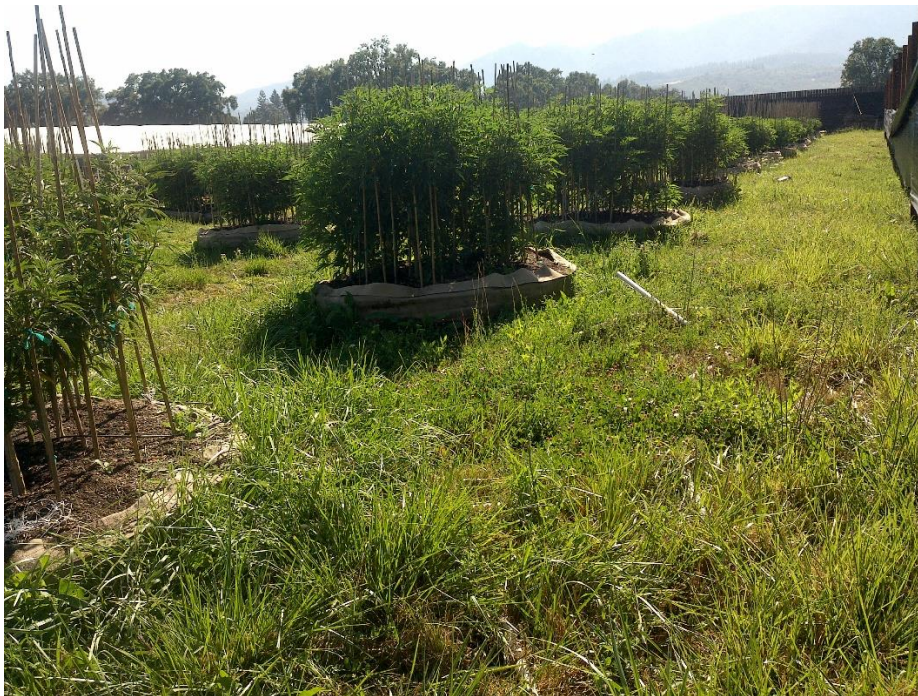
*Figure 5—Looking west from WQ2 at cannabis growing outdoors in raised garden beds. A greenhouse is visible in the top left of the image.*

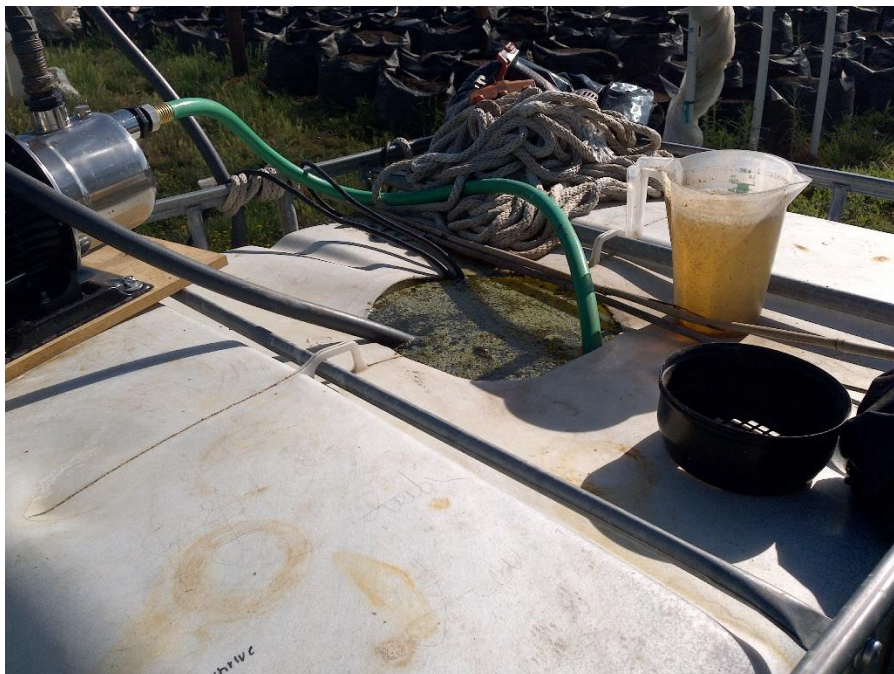
*Figure 6—Photo of a nutrients mixing tank at WQ2. The tank is full of liquid and algae is visible growing in the liquid.*

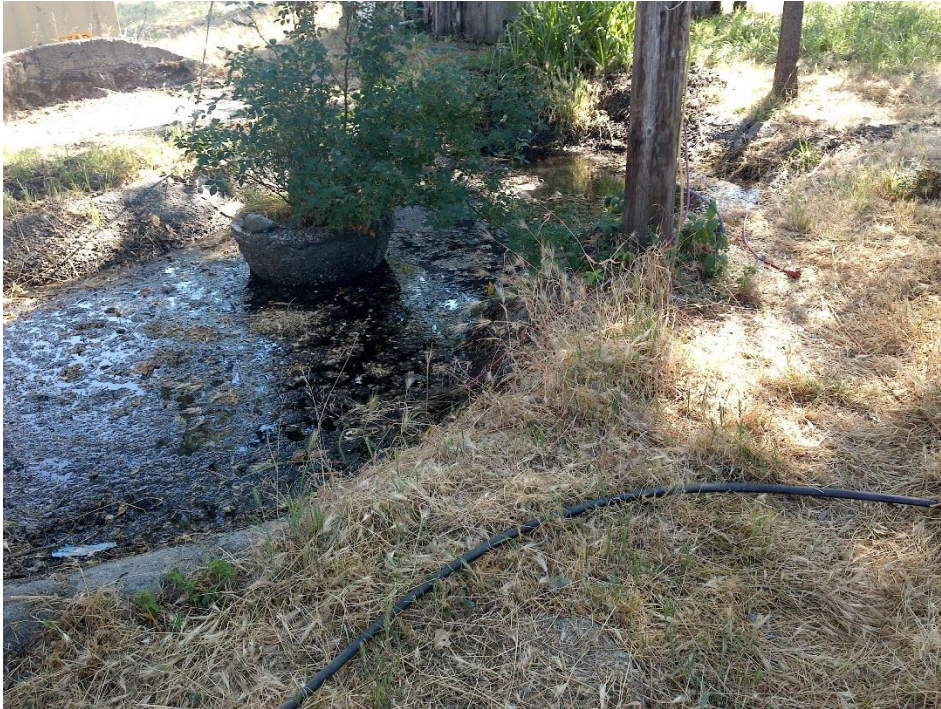
*Figure 8—Photo of concrete lined pool. The well-shed at WQ3 is barely visible in the top-center of the image.*
