North Coast Regional Water Quality Control Board

Subject: Notice of Violation, Transmittal of Report for July 18, 2023 Inspection of Mendocino County Assessor's Parcel Numbers 176-030-08-00, and Requirement to Respond within 30 days

**Report of July 18, 2023 Warrant Inspection,
Mendocino County
Assessor's Parcel Number (APN) 176-030-08-00 (the "Property")**

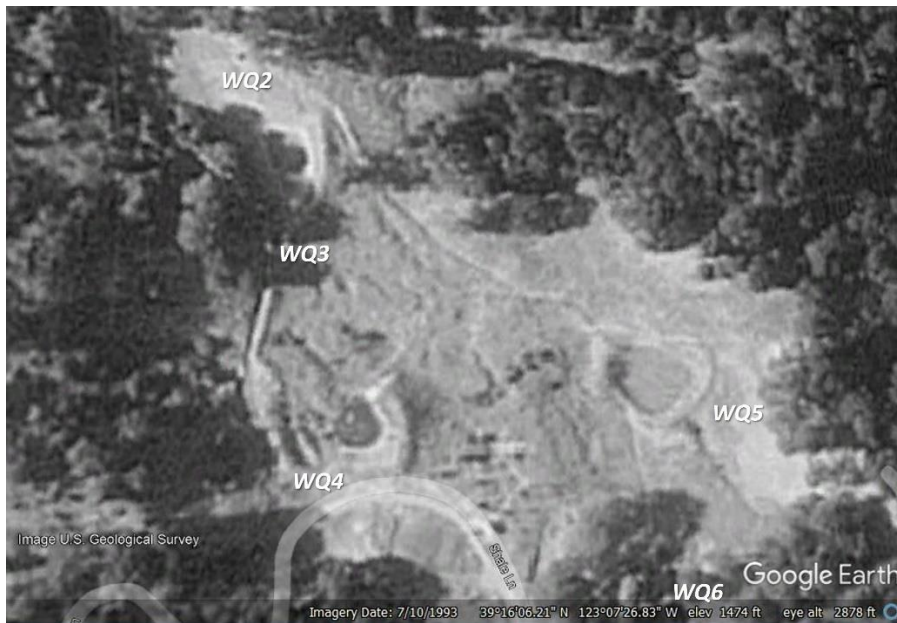
Figure 2—Aerial image of the Property taken on July 10, 1993, obtained from Google Earth. The image shows the reservoirs in the vicinity of WQ3, WQ4 and WQ5 were present during this time.

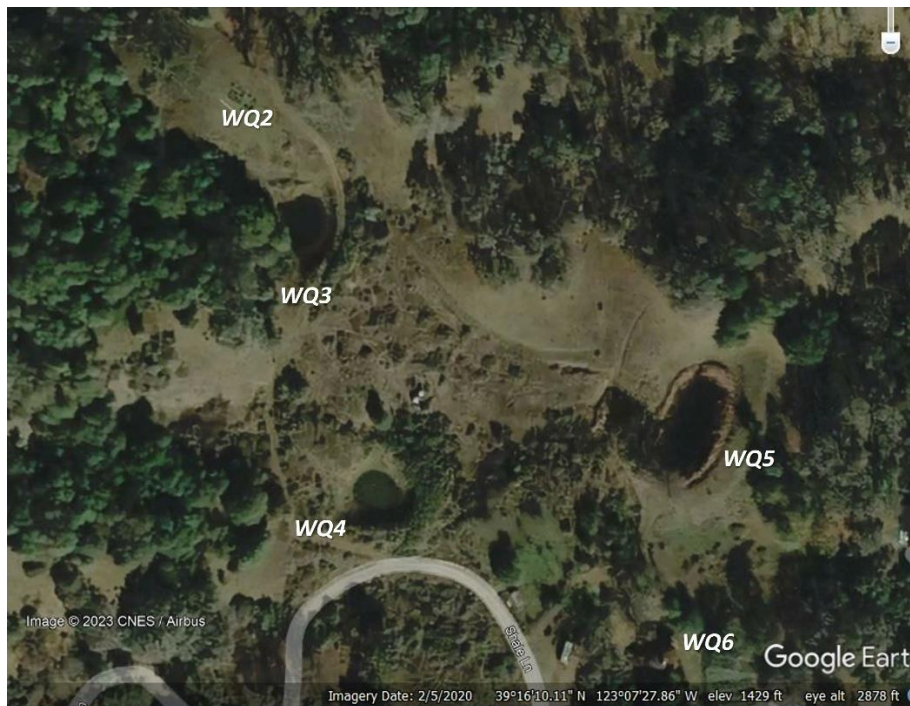
Figure 3—Aerial image of the Property taken on February 5, 2020, obtained from Google Earth. The hoop-type greenhouses observed in later imagery at WQ2 and WQ6 are not present in this image.

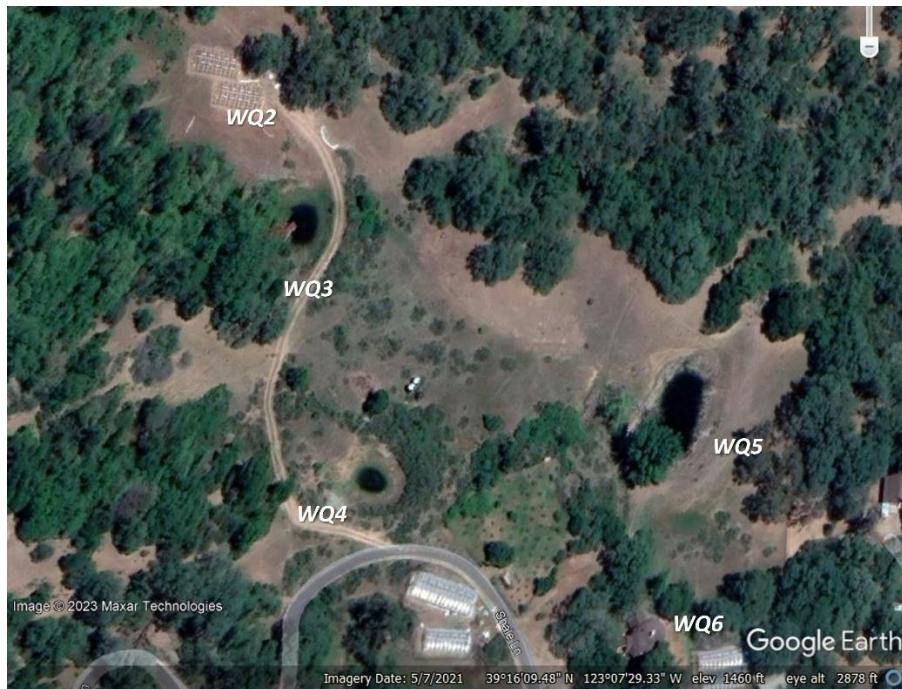
Figure 4—Aerial image of the Property taken on May 7, 2021, obtained from Google Earth. Hoop-type greenhouses are visible at WQ2 and WQ6.

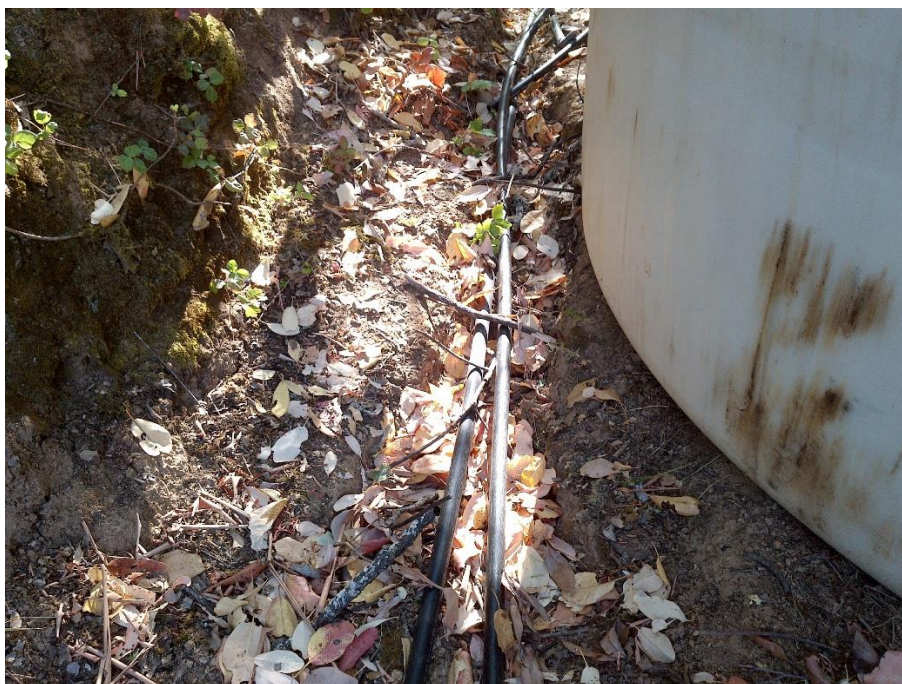
The inspection was associated with a criminal search warrant, and I viewed only portions of the Property. See the above Inspection Map and below Aerial Imagery and Photo Appendix for locations and details about features of concern to water quality. I entered the Property from the east and drove to the northern part of the Property. At WQ1 I observed water tanks installed on a dirt road. The road was shaped such that stormwater would concentrate on the road surface and I observed rills undercutting the water tanks. Earthen material eroded from the road surface threatened to be discharged north to an unnamed tributary to the East Fork Russian River during future precipitation events.

Figure 5—Photo looking at the ground adjacent to water tanks at WQ1. A channel/rill is visible with black plastic tubing laying in the rill.

2. Dispose of all development and restoration-related earthen spoils in a manner to prevent/minimize transport and delivery to receiving waters.
3. Prior to cultivating cannabis or developing a property for cannabis cultivation, enroll for coverage under the Cannabis General Order¹.
4. Prior to conducting work in a Water of the State, submit an application and pay the required application fee for a Water Quality Certification/Waste Discharge Requirement²
5. Dispose of all development and restoration-related earthen spoils in a manner to prevent/minimize transport and delivery to receiving waters.

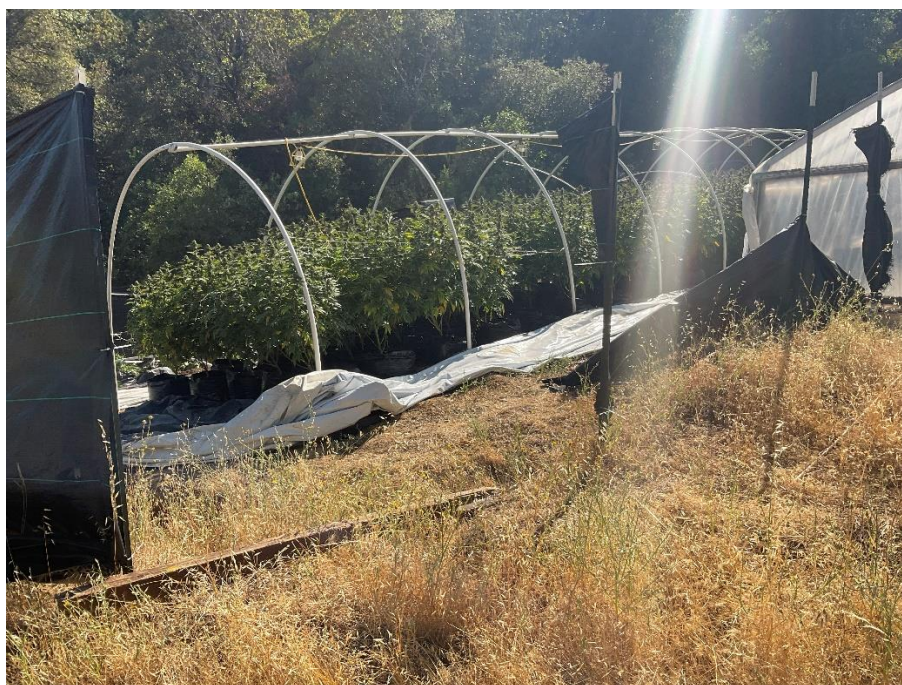
At WQ2 I observed hoop-type greenhouses with growing cannabis plants covering an area in excess of 4,000 square feet. At the southeastern edge of the cultivation area, I observed a channel which was shaped such that any stormwater or irrigation runoff would drain directly to the reservoir to the south. I walked across the reservoir's berm and observed that the reservoir's drainpipe, located at WQ3, was shallowly buried and the impounding berm had eroded around the edges of the pipe. I did not observe where the outfall pipe drained to, nor did I observe other cracks in the impounding berm which was densely vegetated with woody brush.

Figure 6—Cannabis plants growing below a plastic framed structure at WQ2. A fence covered with a black plastic sheet is visible in the left of the image.

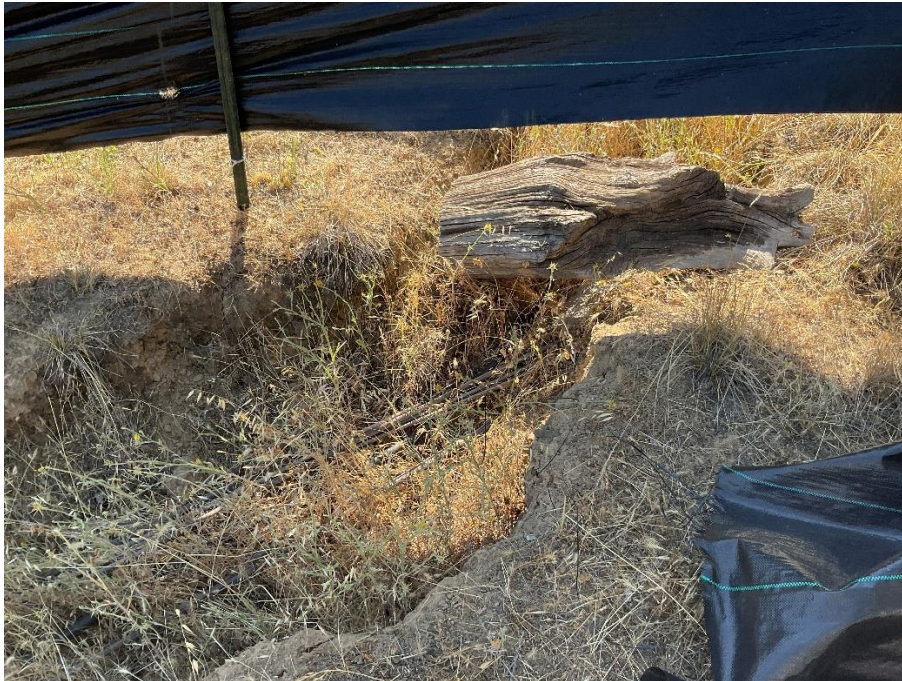
Figure 7—Bottom of fence pictured in the previous image at WQ2. A channel is visible passing under the fence.

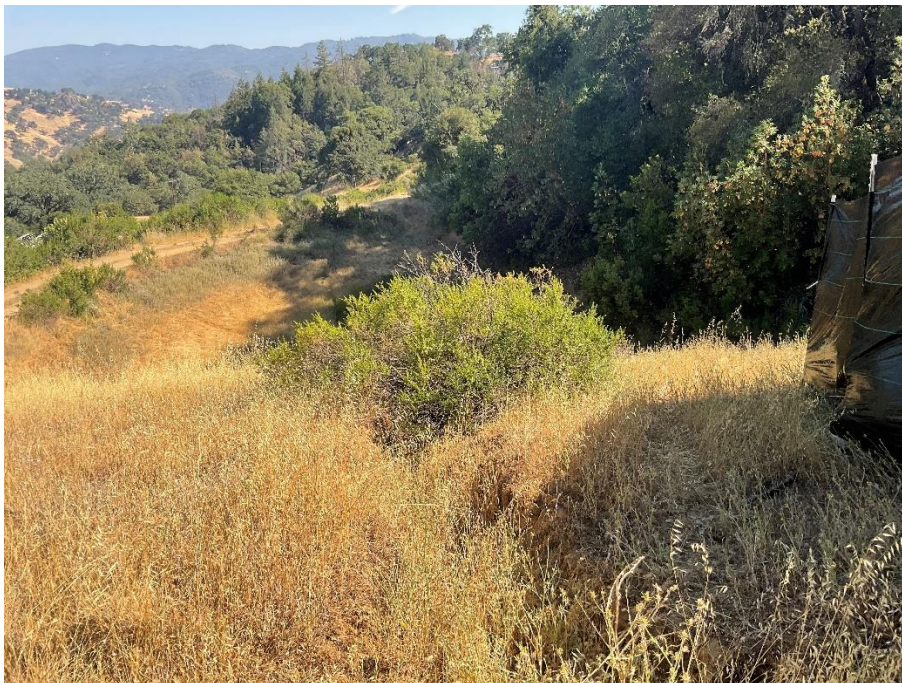
Figure 8—Looking south from WQ2 along channel pictured in previous image. The channel connects to the reservoir in the middle of the image. A road passing over the reservoir's berm, located at WQ3, is visible in the top left of the image.

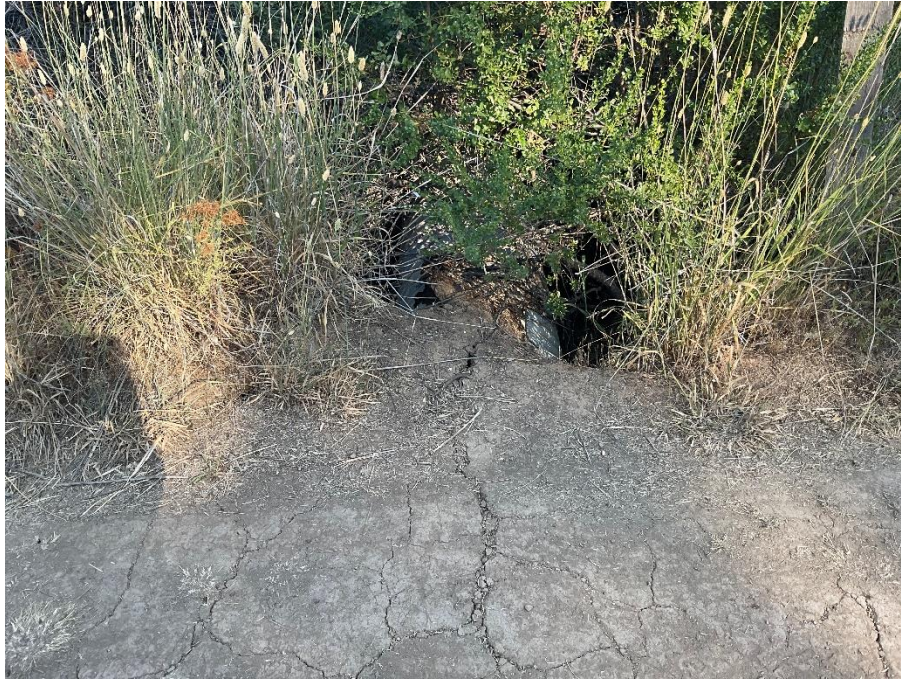
Figure 9—Photo looking at the reservoir’s outlet, located at WQ3, from the road passing over the reservoir’s berm. The outlet pipe is shallowly buried and there are voids in the dam berm surrounding the outlet pipe.

1. Retain a licensed professional to certify that the reservoir impoundments at WQ3, WQ4 and WQ5 meet, or specify necessary work to ensure that the impoundment will meet, the following standards:
 - a. Interior and exterior embankment slopes are no steeper than a 2:1 ratio
 - b. 90% compaction of earthen slopes
 - c. No discernible cracks in any portion of the berm.
 - d. Designed, constructed, and maintained to ensure a 2-foot elevational freeboard above the outflow structure.
 - e. The outflow structure must have a minimum capacity adequate to accommodate the expected 100-year peak inflow plus debris.
 - f. The overflow outlet must promote the dispersal and infiltration of flow and prevent channelization downstream.
 - g. A stability analysis must demonstrate that the factor of safety for the critical slope is at least 1.5 under dynamic conditions and include a description of the

method used to calculate the factor of safety and a description of the assumptions used in the stability analysis.

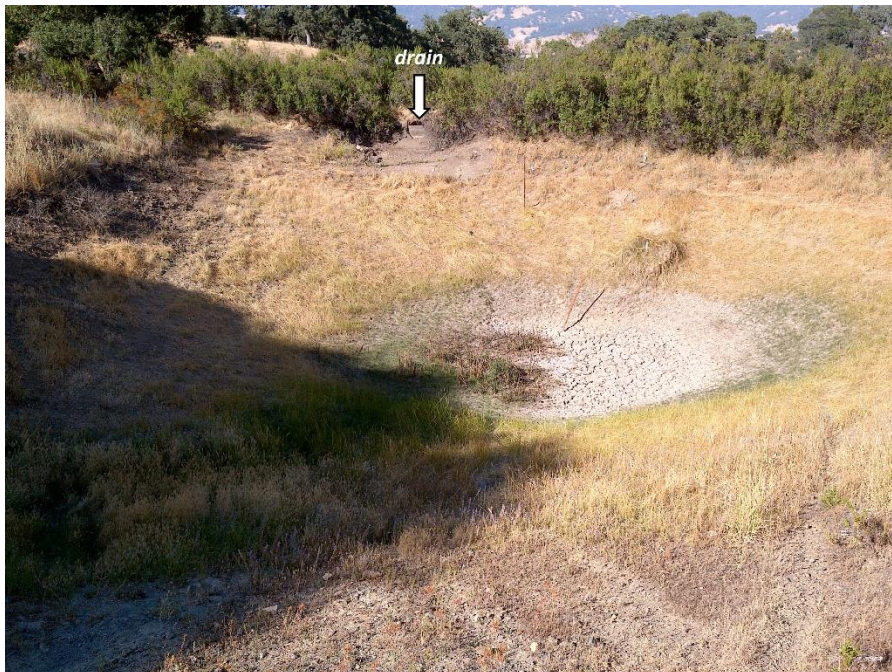
At WQ4 I observed another reservoir with no water. The drainpipe was closed-off with wooden boards and the impounding berm was densely vegetated with woody brush. I did not observe where the outfall pipe drained to, nor did I observe any cracks in the impounding berm. At WQ5 I observed a larger reservoir that still had water in it. I observed the inlet to the reservoir which was encased in concrete and the pipe top was eighteen inches below the dam crest. The pipe discharged into a channel below the impounding berm. South of the reservoir, at WQ6, I observed more hoop-type greenhouses covering an area exceeding 2,000 square feet.

Figure 10—Looking east across reservoir from WQ4. The reservoir drain is visible at the top of the image. The reservoir’s outboard face is densely vegetated with woody brush.

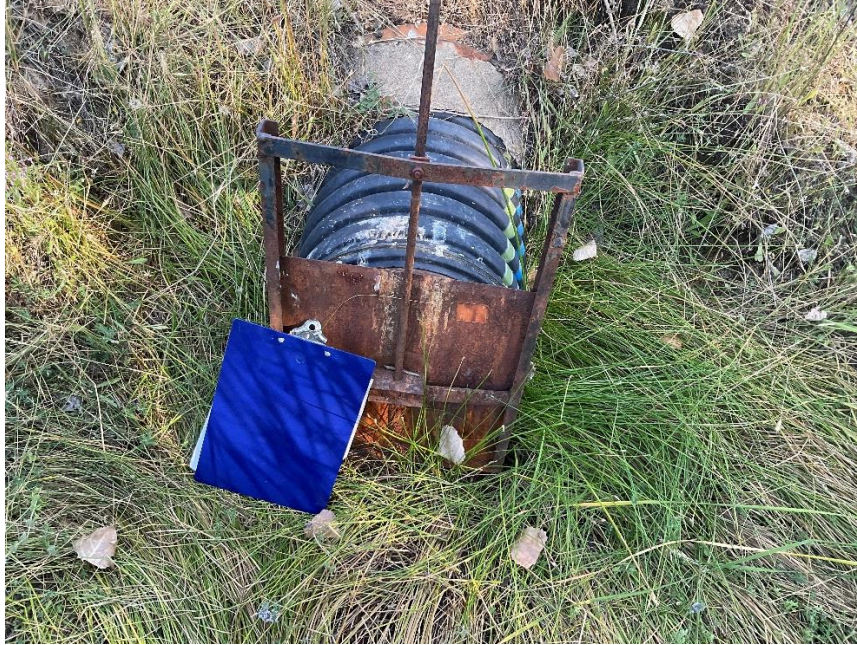
Figure 11—Looking at the inlet for the reservoir drain at WQ5 from within the reservoir’s berm. The drainpipe is eighteen inches in diameter and the top of the drainpipe is approximately eighteen inches below the dam crest. The drainpipe is blocked by a rusted gate valve.
