**Subject: Notice of Violation, Transmittal of Report for August 23, 2023 Inspection of Mendocino County Assessor's Parcel Number 034-100-37-00, and Recommendation to Respond within 30 days**

**Report of August 23, 2023 Warrant Inspection,  
Mendocino County  
Assessor's Parcel Number 034-100-37-00 (the "Property")**

File: Cannabis Program Inspections, Mendocino County, 2023, Gary Greer, CIWQS  
Place ID 890274

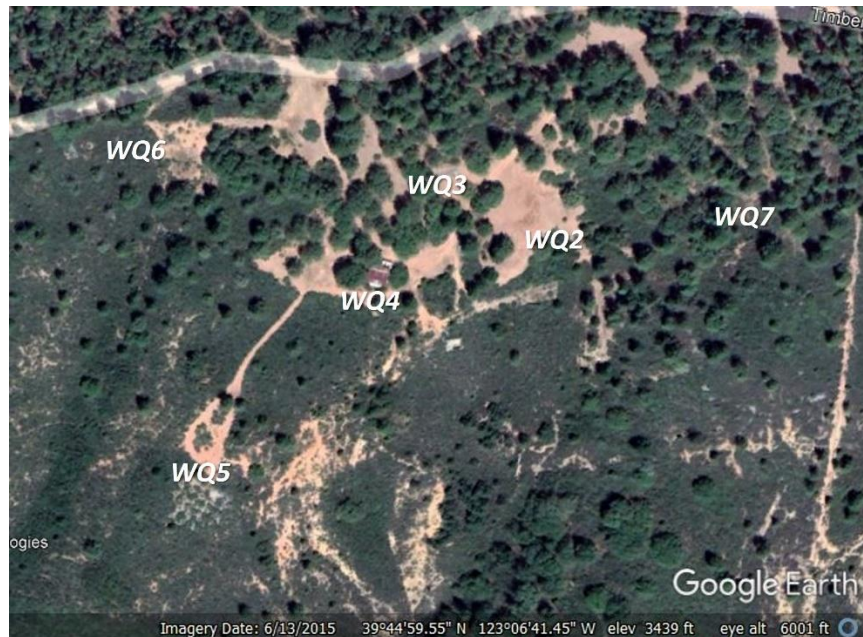
*Figure 2—Aerial image of the Property taken on June 13, 2015, obtained from Google Earth. The image shows raised garden beds interspersed with native vegetation south of WQ5. The size, shape and location of the garden beds matches the cannabis cultivation observed in this area during the August 23, 2023 inspection.*

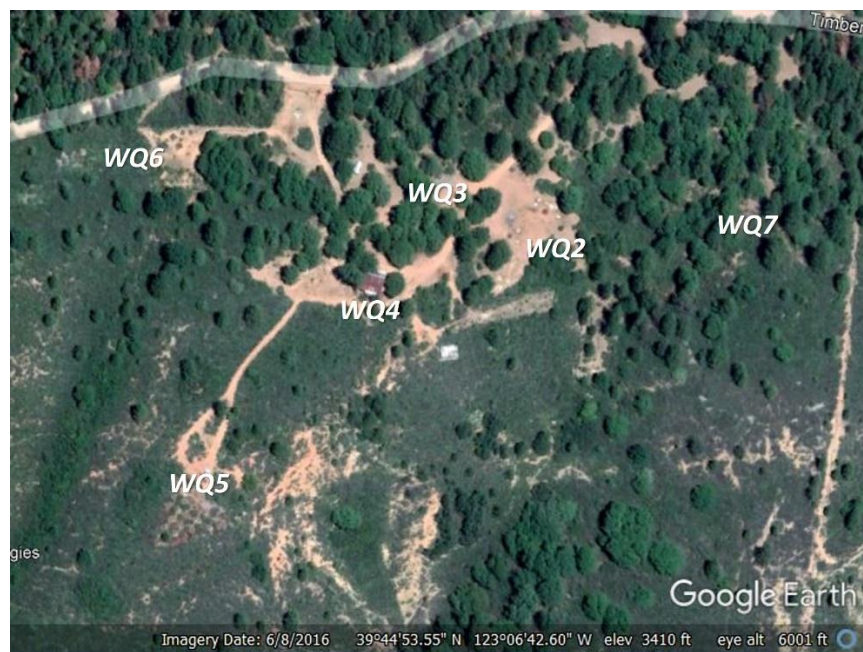
*Figure 3—Aerial image of the Property taken on June 8, 2016, obtained from Google Earth. The image shows a half-dozen light colored circles north of WQ2 at the locations of future outdoor cannabis cultivation.*

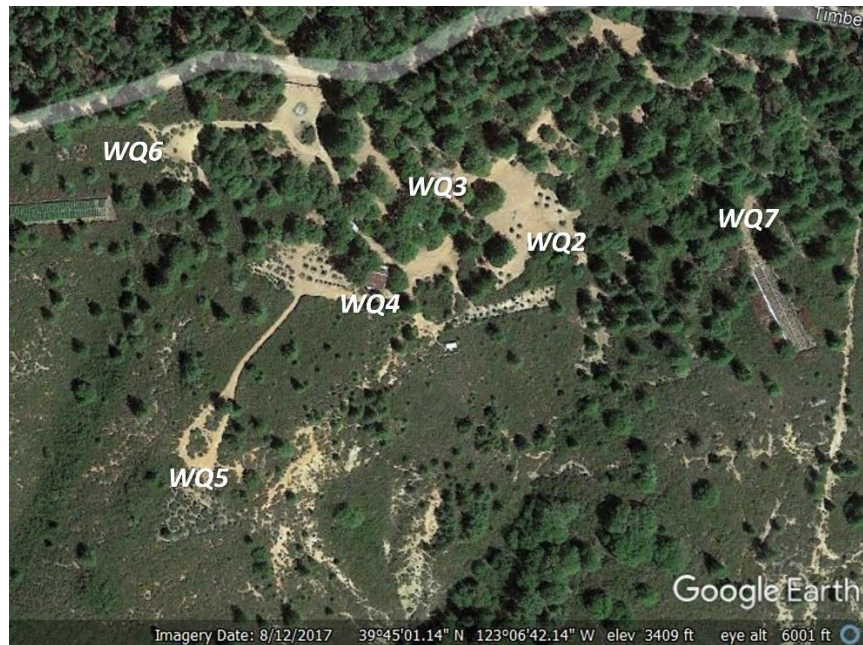
*Figure 4—Aerial image of the Property taken on August 12, 2017, obtained from Google Earth. The image shows the frames of hoop-type greenhouses where staff observed cannabis cultivation during the August 23, 2023 inspection west of WQ6 and south of WQ7.*

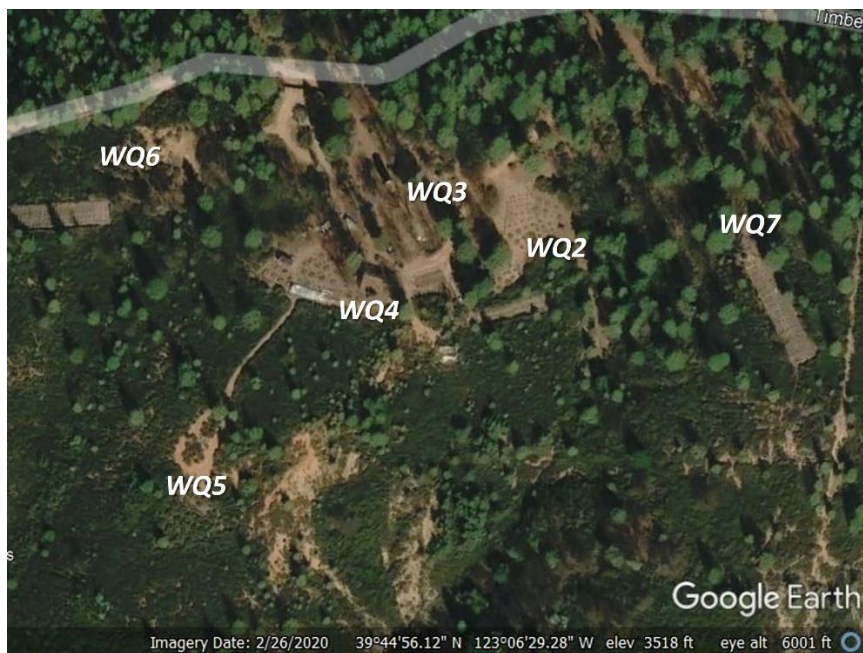
*Figure 5—Aerial image of the Property taken on February 26, 2020, obtained from Google Earth. The image shows the frames of hoop-type greenhouses where staff observed cannabis cultivation during the August 23, 2023 inspection both east and west of WQ4 and south of WQ2.*

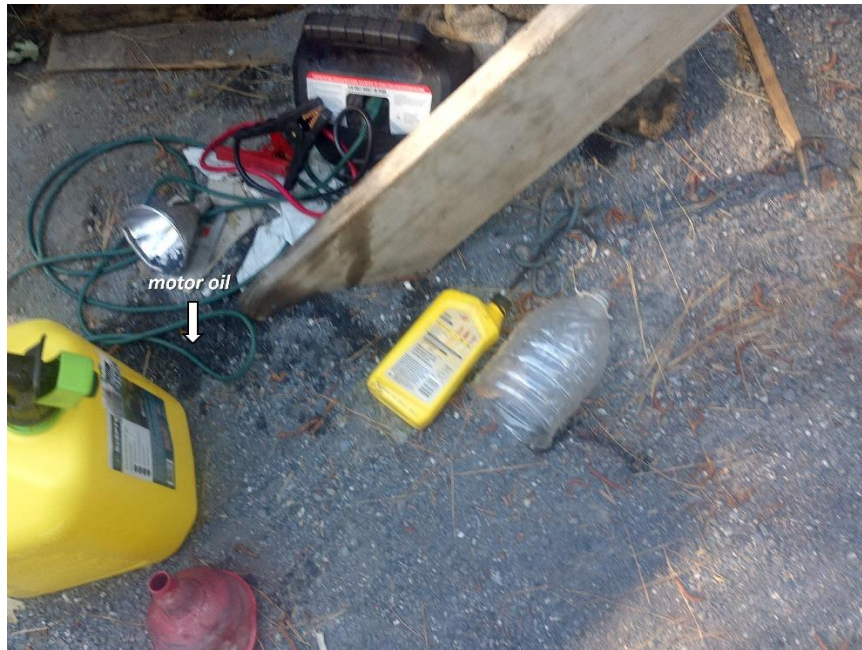
I entered the Property from the northeast corner and observed a groundwater well at WQ1. I observed a generator powered by petroleum products next to the well. The generator did not have adequate secondary containment to intercept spilled fuel or oil, and I observed a darkened patch of soil where fuel or motor oil had discharged to land. I walked west to WQ2, where I observed cannabis plants being grown in hoop-type greenhouses and completely outdoors in raised garden beds. At WQ2 I observed a small shed with a flush toilet.

*Figure 6—Photo looking at the ground near the groundwater well at WQ1. A used motor oil container and funnel are resting on the permeable earthen ground next to a darkened patch of soil where motor oil has discharged to land.*

1. Immediately cease the discharge of sewage to land at WQ2, WQ4 and WQ6, implement corrective actions, and obtain the appropriate county permit for the disposal of on-site wastewater (i.e., septic system permit).
2. Immediately collect all petroleum products that threaten to spill and haul away to a licensed waste disposal facility or store in accordance with the Cannabis Cultivation Policy<sup>1</sup>.
3. Retain a qualified professional to investigate the extent of contaminated soil associated with the spilled petroleum products, including those in the vicinity of

WQ1, WQ3 and WQ7, and develop a workplan and schedule for cleaning up the spills.

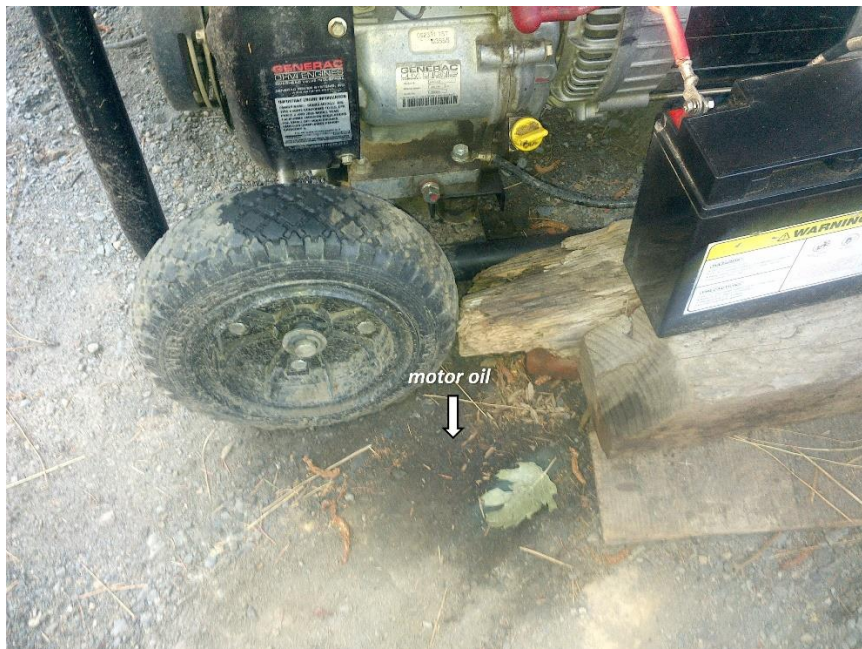
*Figure 7—Photo looking at the ground below a generator at WQ1. The generator does not have secondary containment and the ground below the generator is visibly darkened where motor oil has discharged to land.*

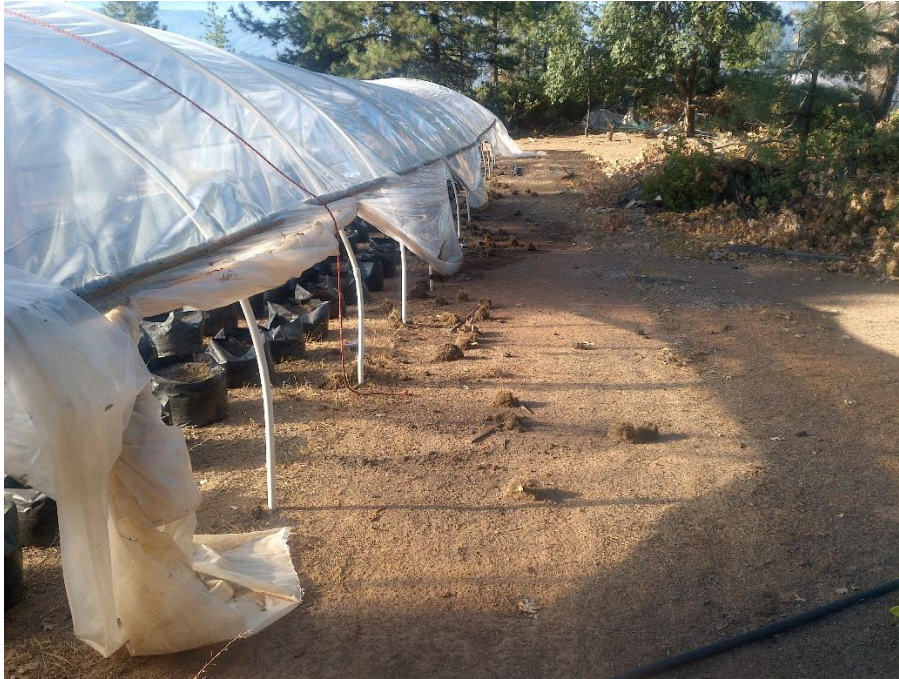
*Figure 8—Photo showing a hoop-type greenhouse in the vicinity of WQ2. Root balls from cannabis plants are scattered on the ground next to the greenhouse.*

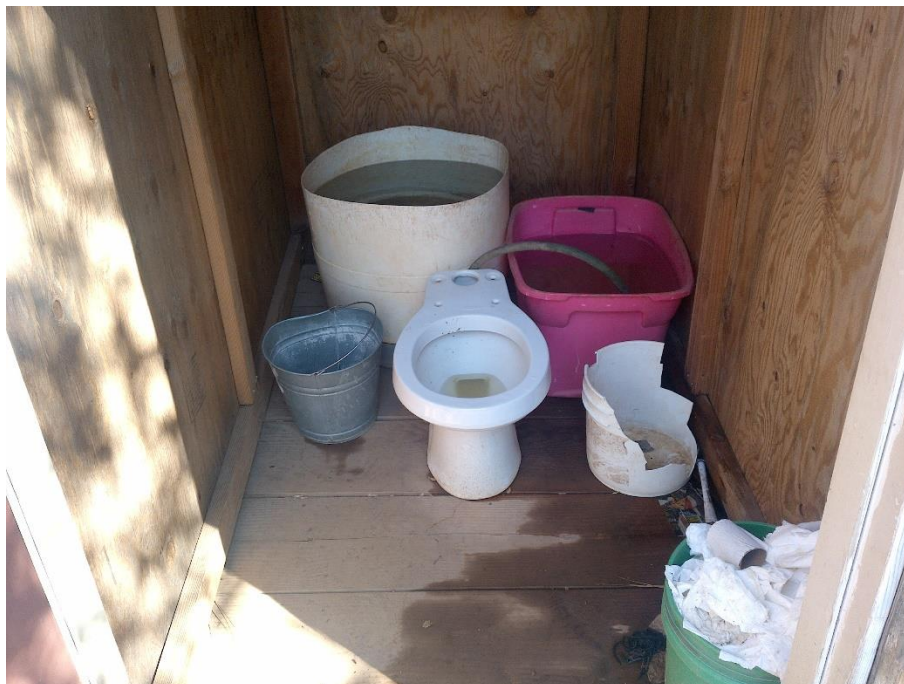
*Figure 9—Photo showing a flush toilet located in a small wooden structure in the vicinity of WQ2.*

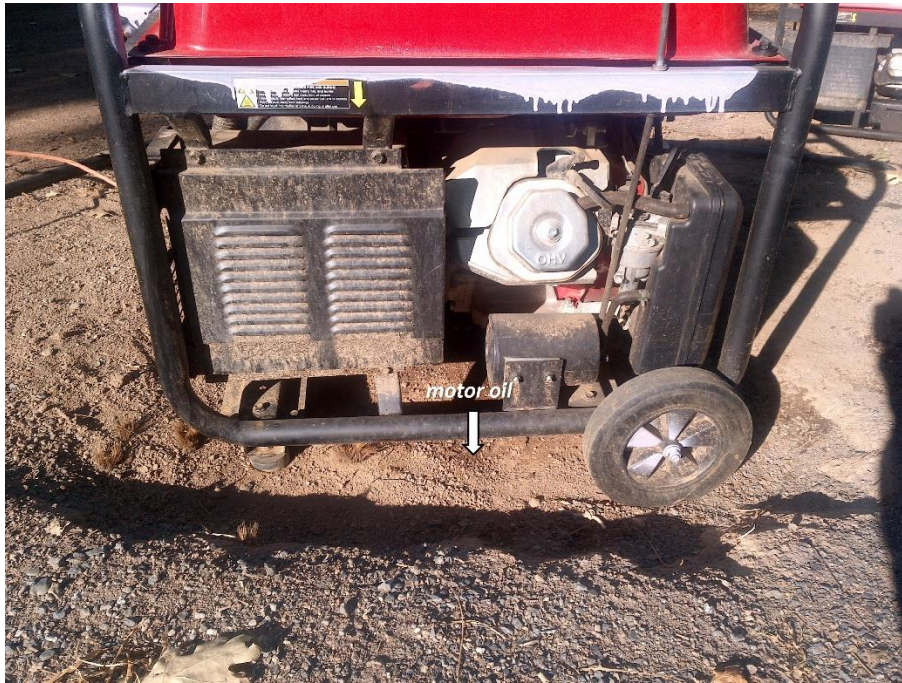
West of WQ2, at WQ3, I observed another generator powered by petroleum products that did not have adequate secondary containment to intercept spilled fuel or oil, and I observed a darkened patch of soil where fuel or motor oil had discharged to land. I walked south to WQ4 where I observed more cannabis plants being grown in hoop-type greenhouses and completely outdoors in raised garden beds. I walked south to WQ5 where I observed raised garden beds with growing cannabis plants interspersed among native shrubs. In total, I observed approximately a half-acre of cannabis cultivation on the Property. I walked back north and observed a trailer at WQ6. I observed the sewage lines coming from the trailer leading to an area of manzanita bushes nearby.

*Figure 10—Photo looking at the ground below a generator at WQ3. The generator does not have secondary containment and the ground below the generator is visibly darkened where motor oil has discharged to land.*

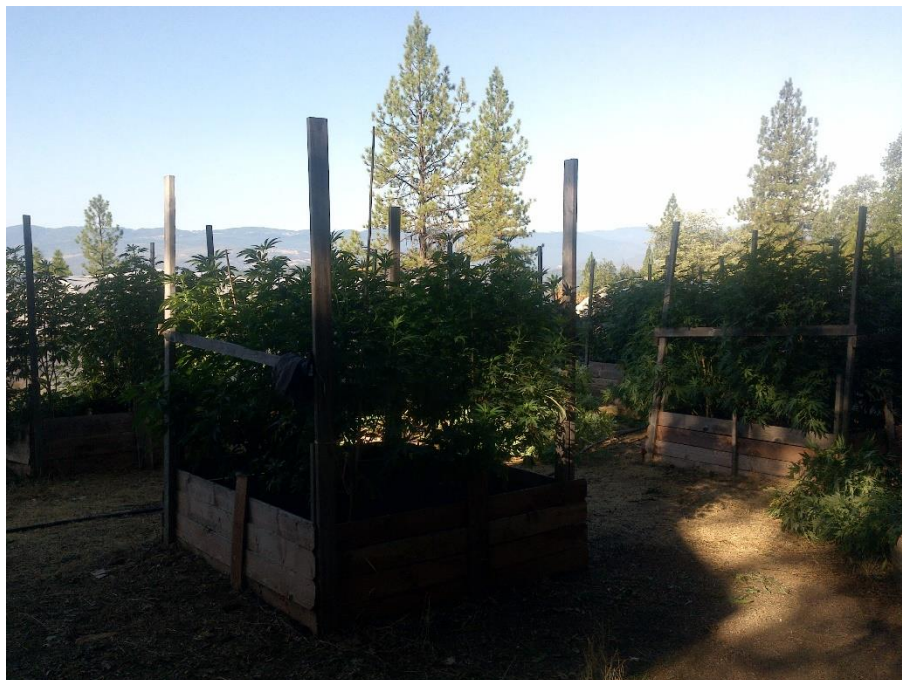
*Figure 11—Photo showing cannabis plants growing in raised garden beds in the vicinity of WQ4.*

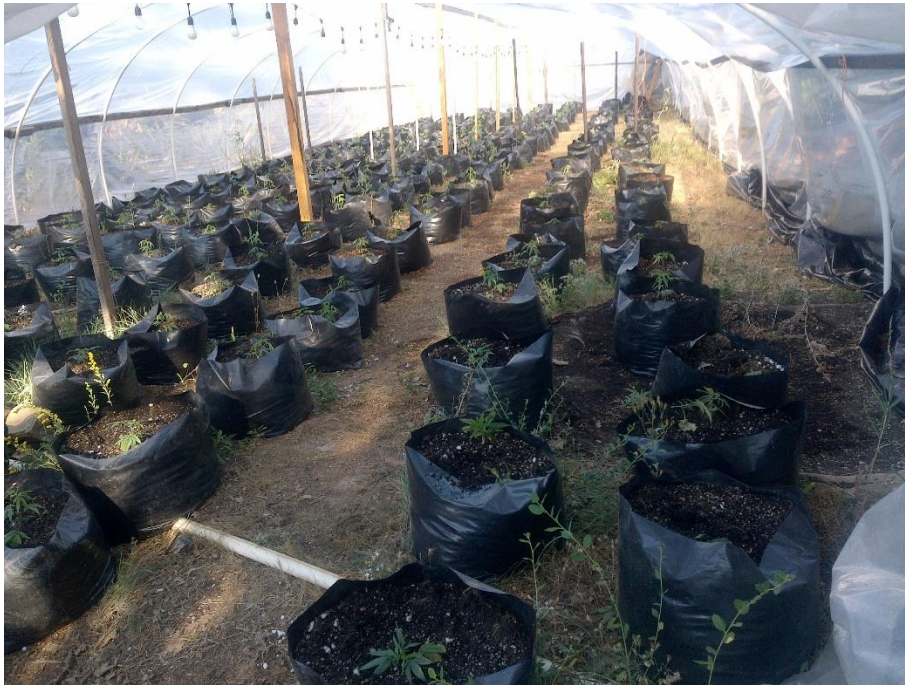
*Figure 12—Photo showing small cannabis plants growing in plastic soil bags within a small hoop-type greenhouse in the vicinity of WQ4.*

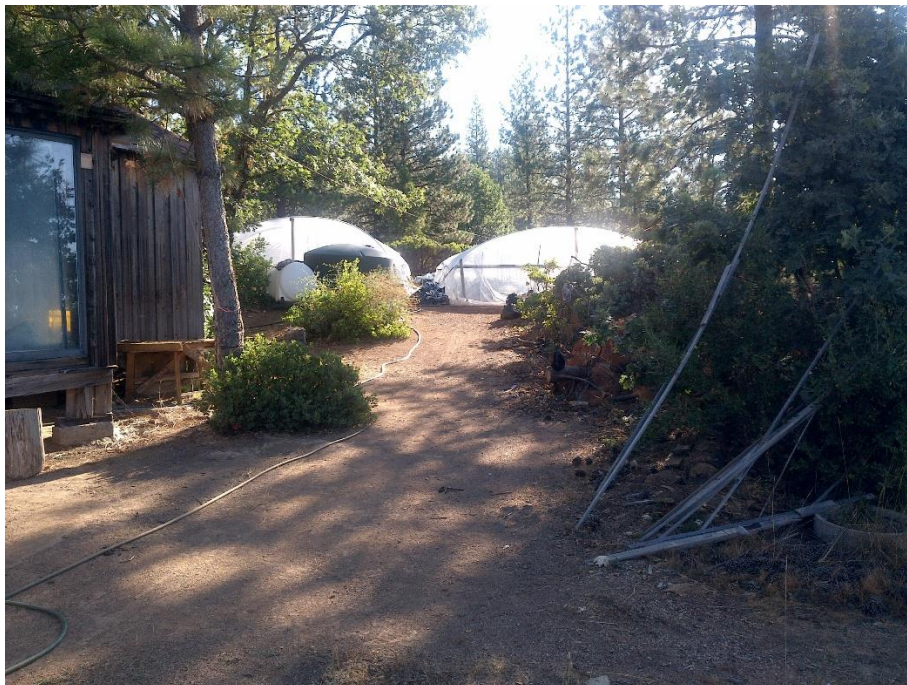
*Figure 13—Photo showing a residential structure and two hoop-type greenhouses in the vicinity of WQ4.*

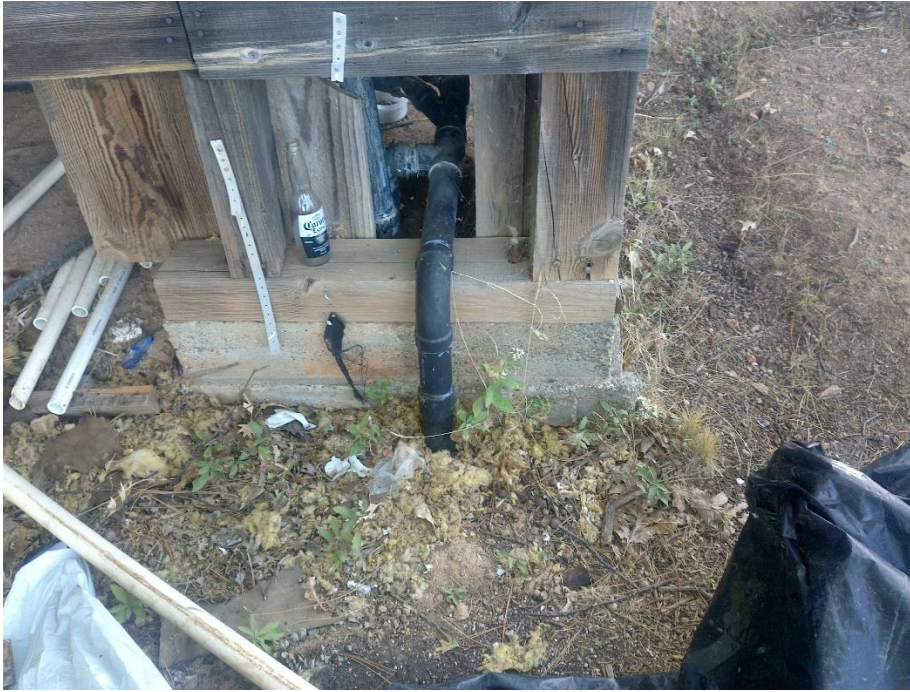
*Figure 14—Photo showing where the sewage line exiting the structure at WQ4 enters the ground.*

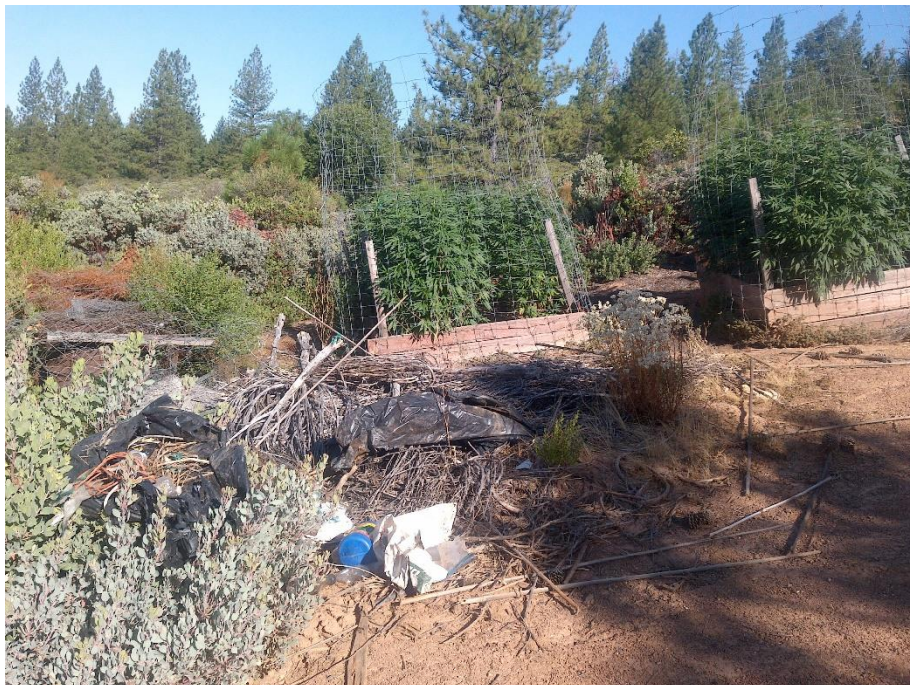
*Figure 15— Photo showing cannabis plants growing in raised garden beds in the vicinity of WQ5.*

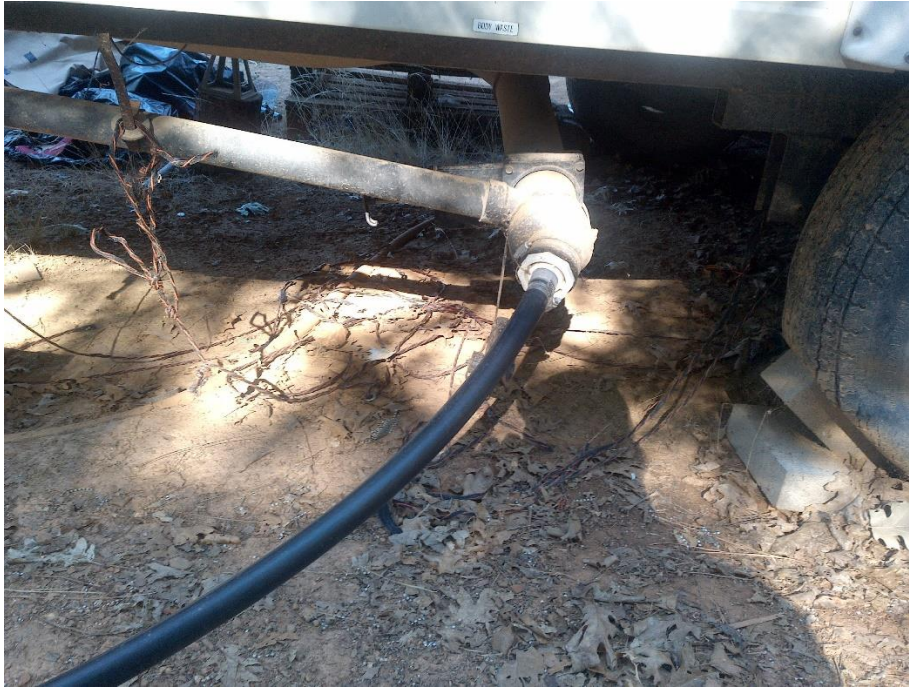
*Figure 16—Photo showing black plastic tubing connected to the sewage drain lines below a trailer at WQ6.*

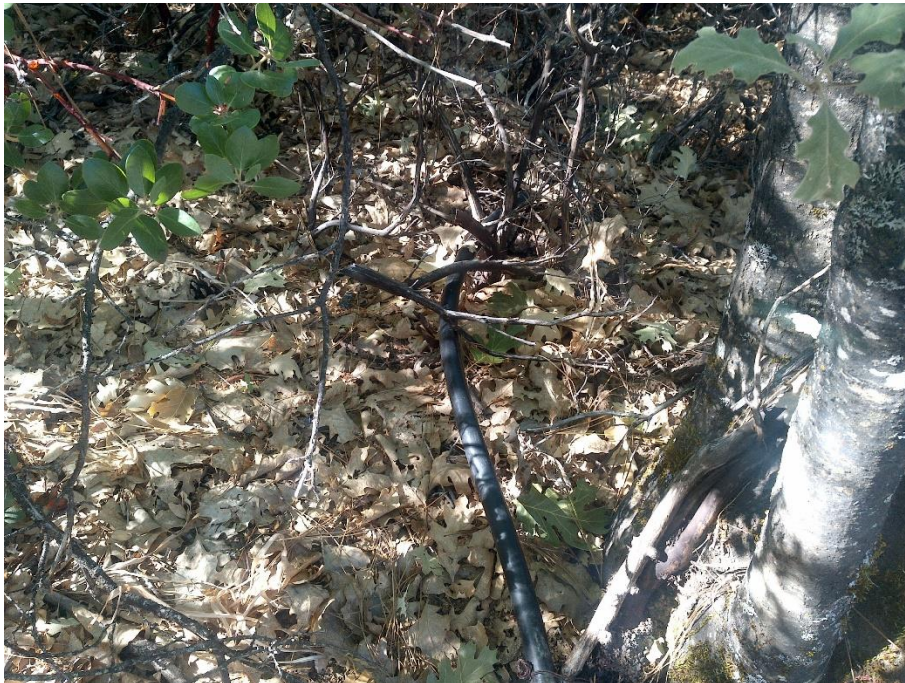
*Figure 17—Photo showing black plastic tube, pictured in previous image, directed toward bushes in the vicinity of WQ6.*

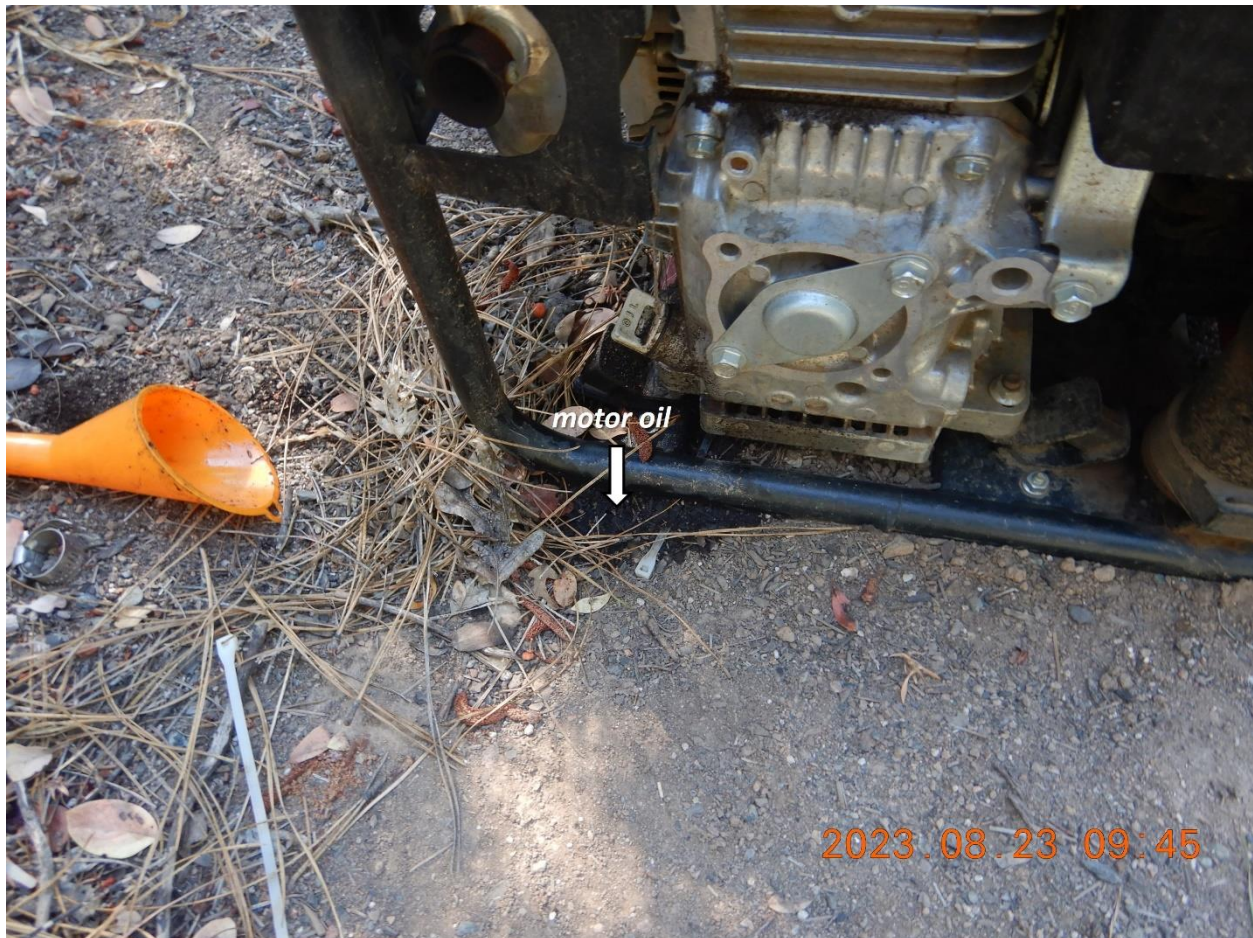
I then walked east to WQ7 where I observed another generator powered by petroleum products that did not have adequate secondary containment to intercept spilled fuel or oil, and I observed a darkened patch of soil where fuel or motor oil had discharged to land.

*Figure 18—Photo looking at the ground below a generator at WQ7. The generator does not have secondary containment and the ground below the generator is visibly darkened where motor oil has discharged to land.*
