North Coast Regional Water Quality Control Board

**Subject: Notice of Violation, Transmittal of Report for October 13, 2023
Inspection of Mendocino County Assessor's Parcel Number 166-110-30-00, and Recommendation to Respond within 30 days**

**Report of October 13, 2023 Warrant Inspection,
Mendocino County
Assessor's Parcel Number 166-110-30-00 (the "Property")**

File: Cannabis Program Inspections, Mendocino County, 2023, Zhen Ping Huang,
CIWQS Place ID 890920

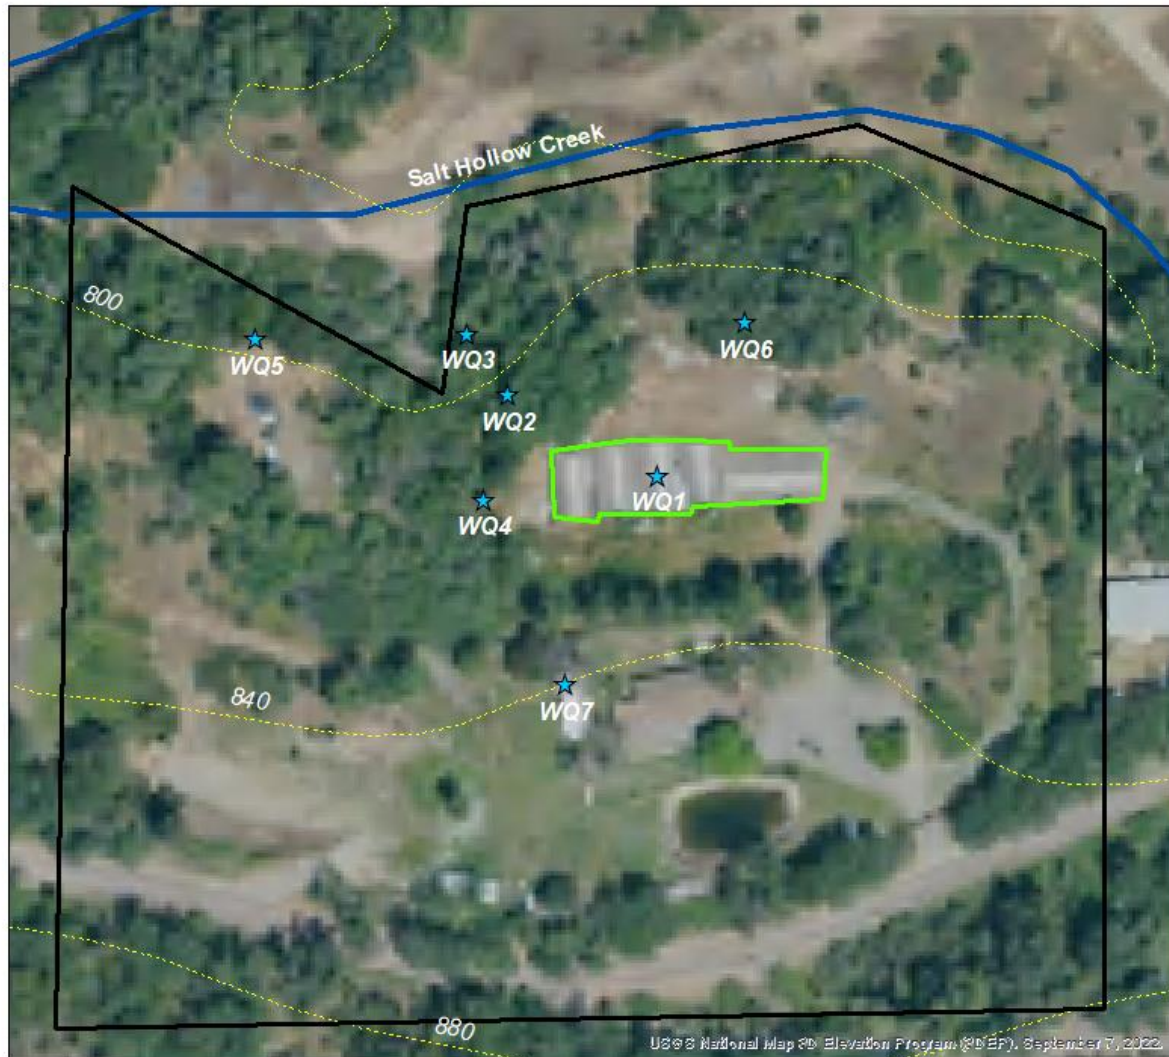
Figure 1—Aerial image/map showing inspection points discussed in this report.

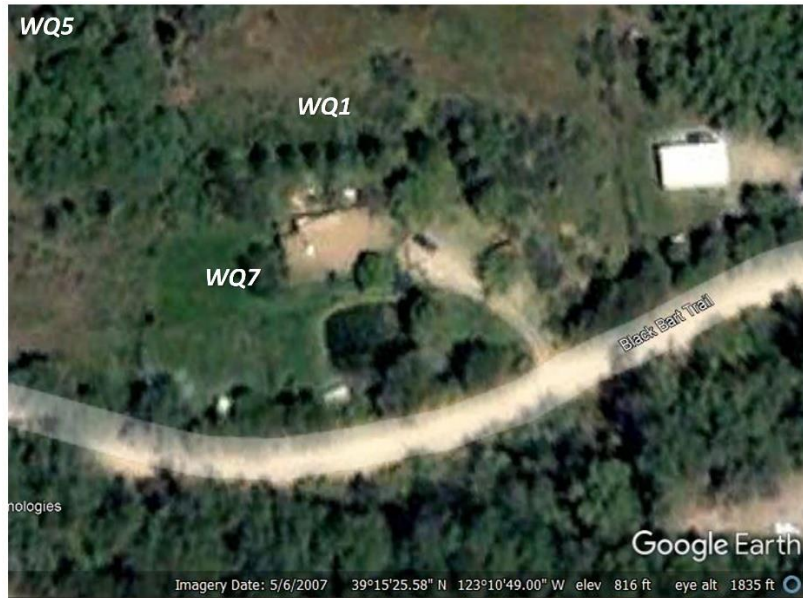
Figure 2—Aerial image of the Property taken on May 6, 2007, obtained from Google Earth. Cultivation areas at WQ1 and WQ5 appear indistinguishable from the surrounding vegetated areas suggesting that they had not yet been developed. The trailer visible in the Inspection Map at WQ7 is not visible in this image.

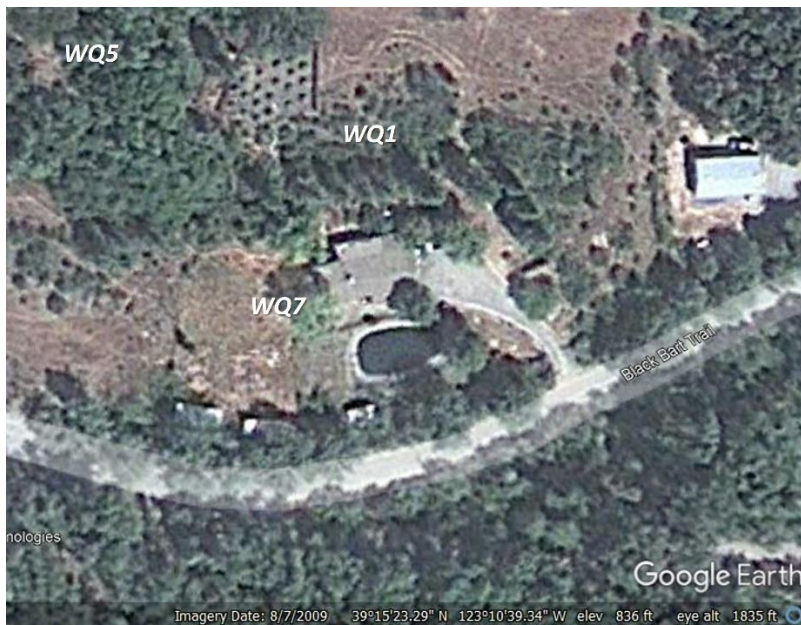
Figure 3—Aerial image of the Property taken on August 7, 2009, obtained from Google Earth. Arrays of circles matching the pattern of outdoor cannabis cultivation are visible west of WQ1, but the area in the vicinity of WQ5 appears indistinguishable from the surrounding vegetated areas. The trailer visible in the Inspection Map at WQ7 is not visible in this image.

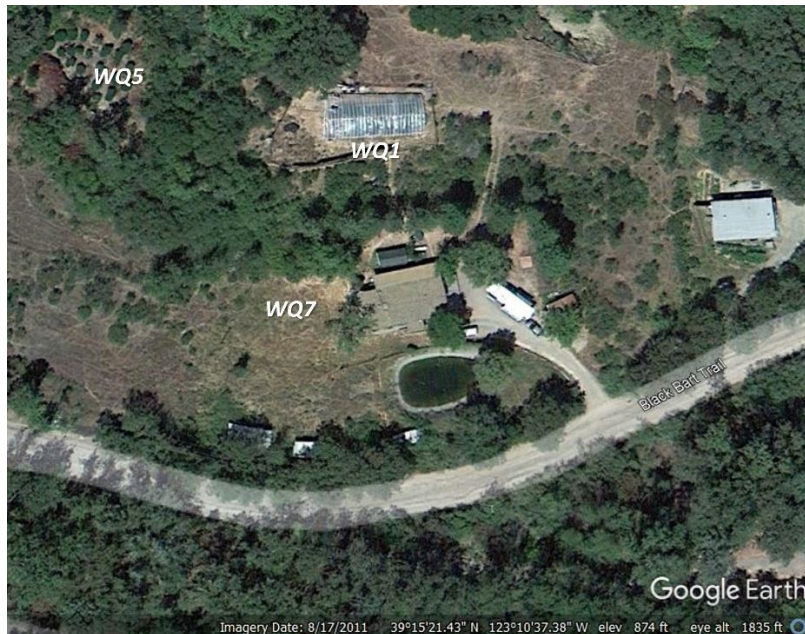
Figure 4—Aerial image of the Property taken on August 17, 2011, obtained from Google Earth. A hoop-type greenhouse is visible in the vicinity of WQ1 and arrays of circles matching the pattern of outdoor cannabis cultivation are visible in the vicinity of WQ5. The trailer visible in the Inspection Map at WQ7 is not visible in this image.

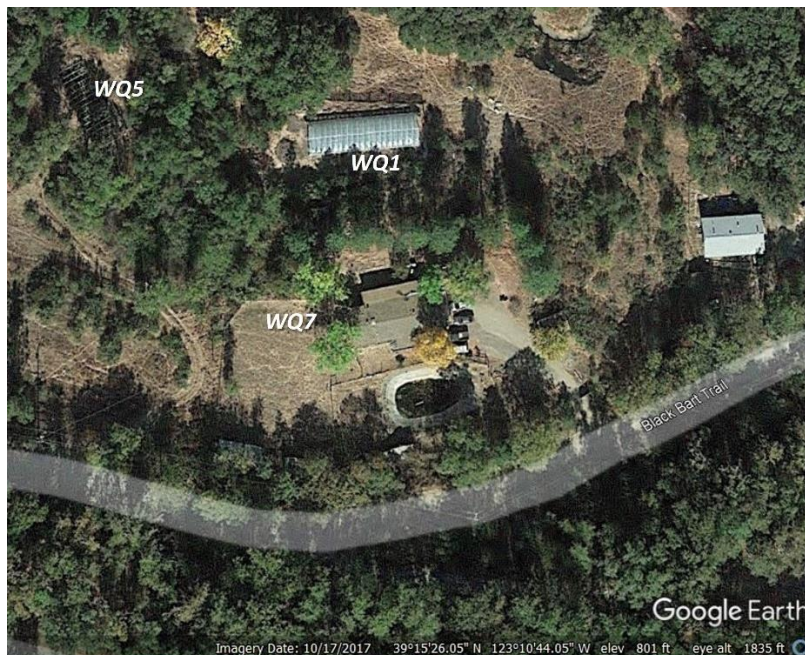
Figure 5—Aerial image of the Property taken on October 17, 2017, obtained from Google Earth. Hoop-type greenhouses are visible in the vicinity of WQ1 and WQ5. The trailer visible in the Inspection Map at WQ7 is not visible in this image.

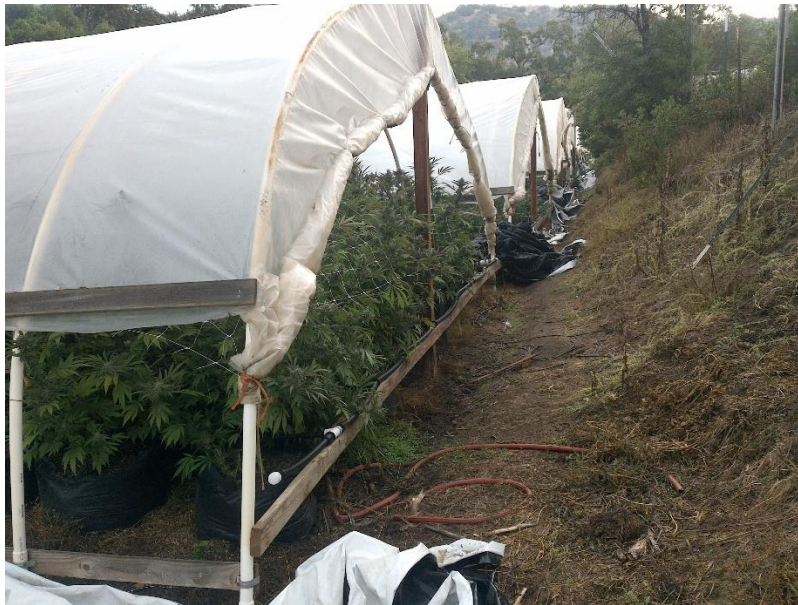
I entered the Property from the south and walked to a cultivation pad at WQ1. I measured the area covered with greenhouses using Google Earth's ruler polygon tool, which resulted in an area greater than 4,000 square feet. I observed cannabis cultivation waste including potting soils, plastic netting and plant material disposed of on a hillslope northwest of the cultivation area in the vicinity of WQ2. I observed that the cultivation waste extended to an area on the left (south) bank of Salt Hollow Creek and I measured the distance between the waste and the channel bank at WQ3 with a tape measure resulting in a distance of 15 feet.

Figure 6—A photo looking east from the southwestern corner of the cultivation area located at WQ1. Cannabis plants are visible growing in black plastic bags located in the greenhouses.

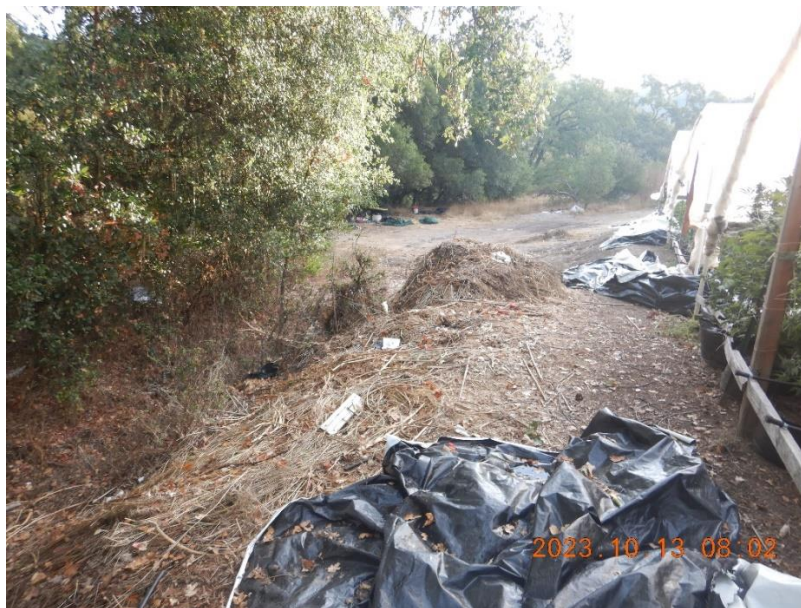
Figure 7—A photo looking east from the northwestern corner of the cultivation area located at WQ1. Cannabis plants are visible growing in the greenhouse in the right of the image.

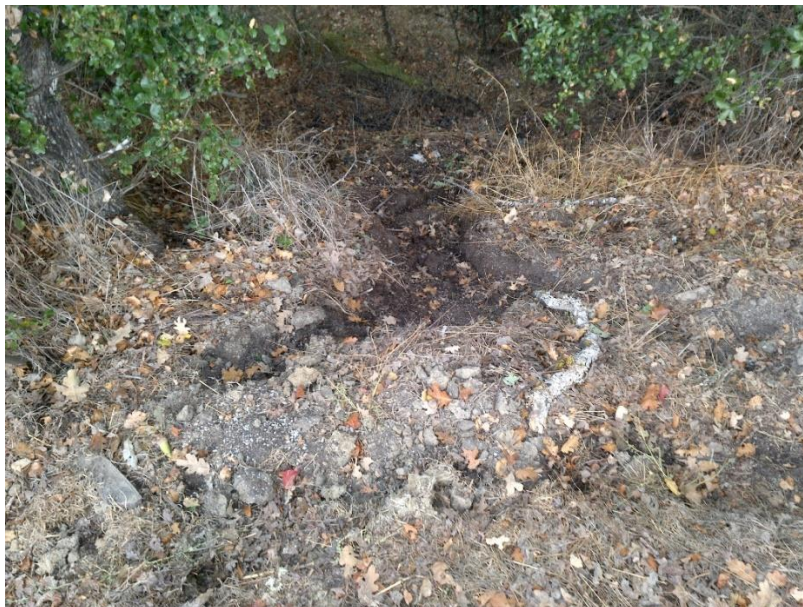
Figure 8—A photo looking north towards WQ2 from the northwestern corner of the cultivation area located at WQ1. Cannabis cultivation waste, identifiable by white speckles from the perlite in imported potting soils, is visible on the hillslope.

1. Immediately collect all refuse and waste which have discharged and/or threaten to discharge to receiving waters and which can be collected by hand. You are not authorized to use heavy equipment in a water of the State of California (Water of the State) or modify the bed bank or channel of a Water of the State without a permit from the Regional Water Board (see recommendation 8 below). Properly dispose of these wastes at a licensed waste collection facility.
2. Immediately retain a qualified professional with experience developing stormwater pollution prevention plans to identify threatened discharges to Waters of the State on the Property, and to develop a workplan and schedule to implement best management practices to prevent these discharges.

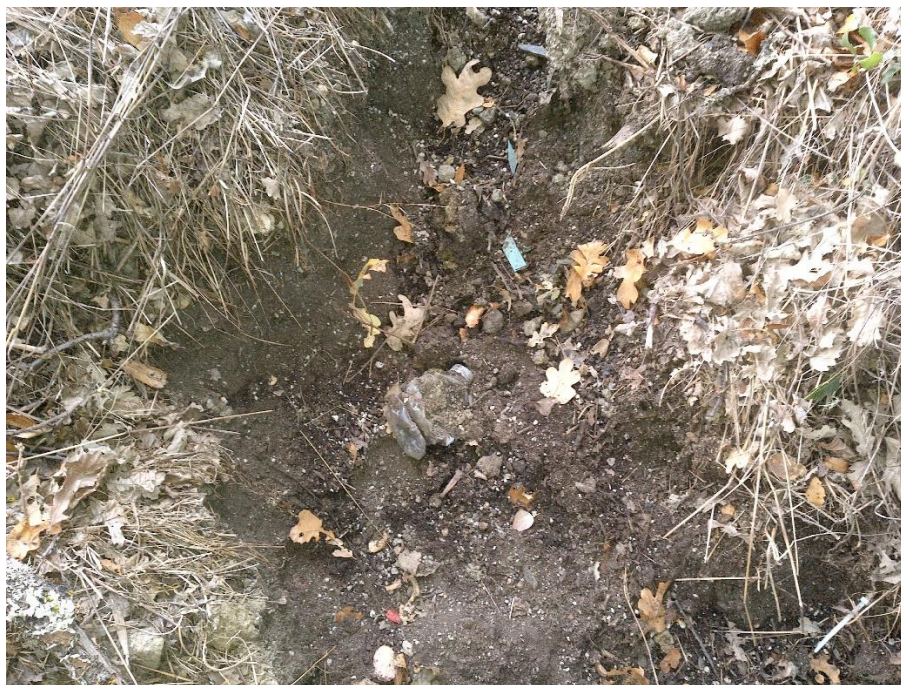
Figure 9— A photo showing a closer view of the waste potting soils pictured in the previous image in the vicinity of WQ2. A crushed plastic bottle is partially buried in the middle of the image.

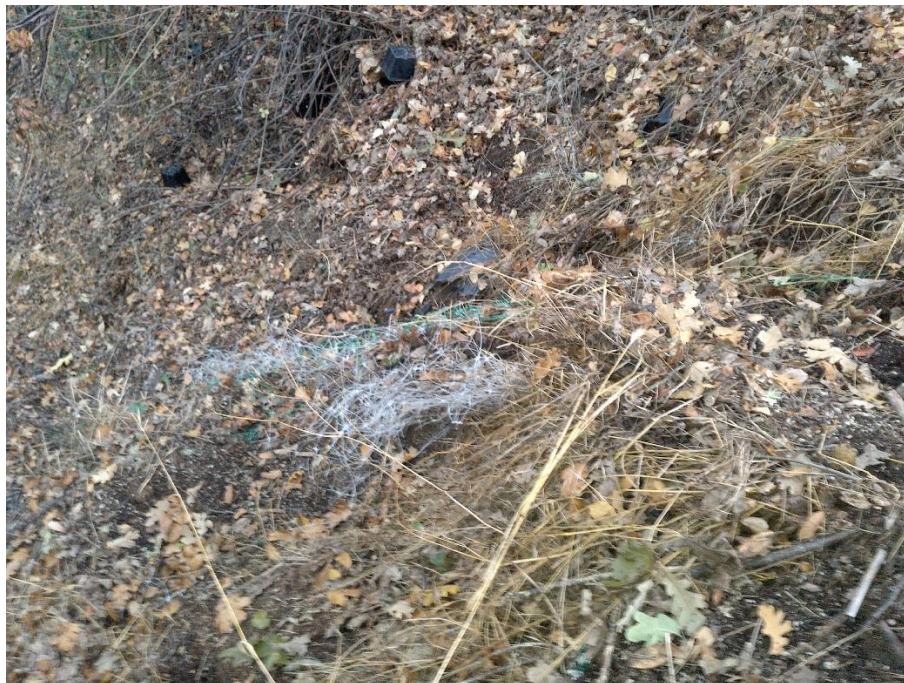
Figure 10— A photo showing plastic netting and plant pots on the hillslope above Salt Hollow Creek in the vicinity of WQ2.

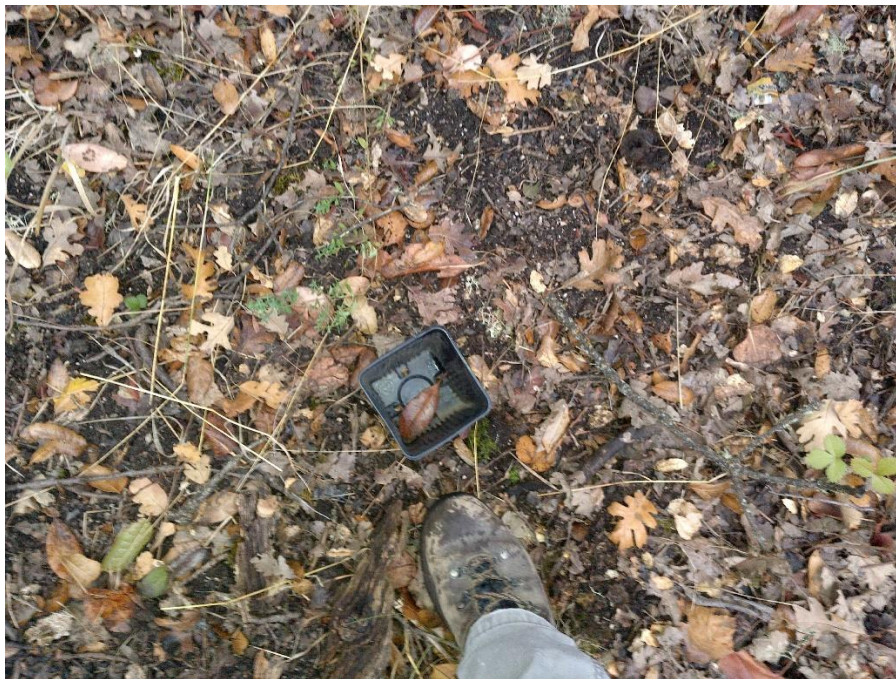
Figure 12— A photo showing a plastic plant pot 15 feet from the left (south) bank of Salt Hollow Creek in the vicinity of WQ2. White speckles of perlite are visible on the ground surrounding the pot showing that the imported soils had spread to within 15 feet of Salt Hollow Creek.

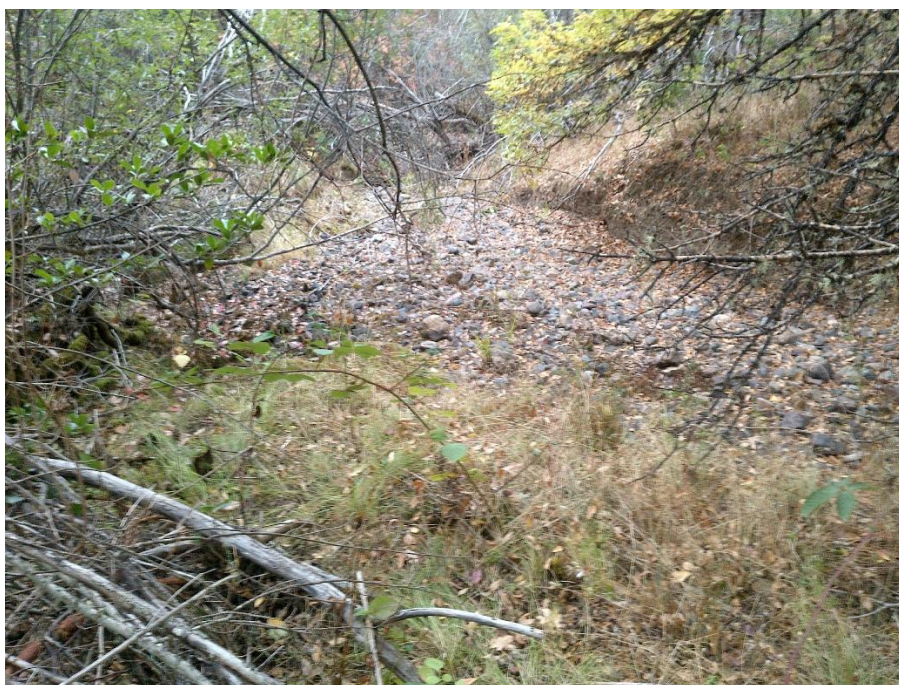
Figure 13— A photo looking west and downstream along Salt Hollow Creek at WQ3. The channel has distinct banks, a bed comprised of large cobbles and small boulders and a width of approximately ten feet at this location.

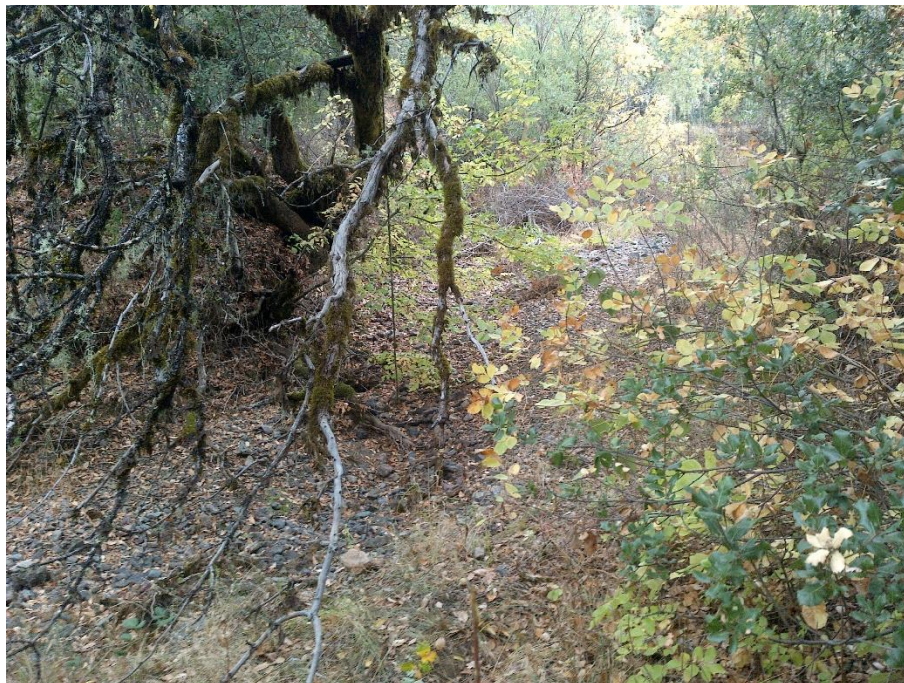
Figure 14— A photo looking east and upstream along Salt Hollow Creek at WQ3.

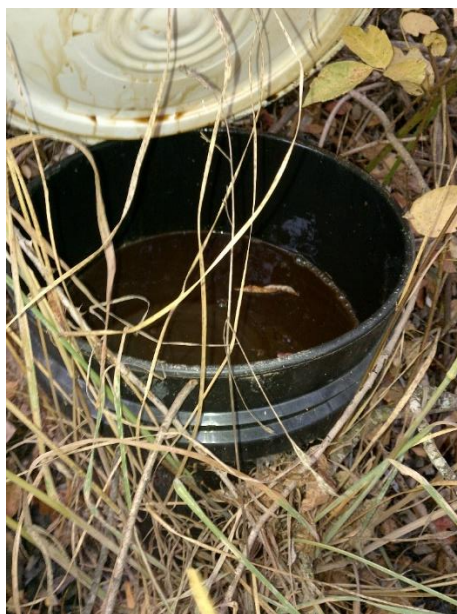
I walked back south to the cultivation pad and then west and observed an unlabeled five-gallon bucket containing a dark oily substance at WQ4. I continued west crossing a tributary to Salt Hollow Creek and observed a legacy cultivation pad at WQ6. I did not observe a greenhouse or growing cannabis plants at WQ5, but I observed that the pad was covered with perlite and a degraded wattle lined the northern edge of the pad.

Figure 15—A photo showing the lid being lifted off of a five-gallon bucket of oily substance at WQ4.

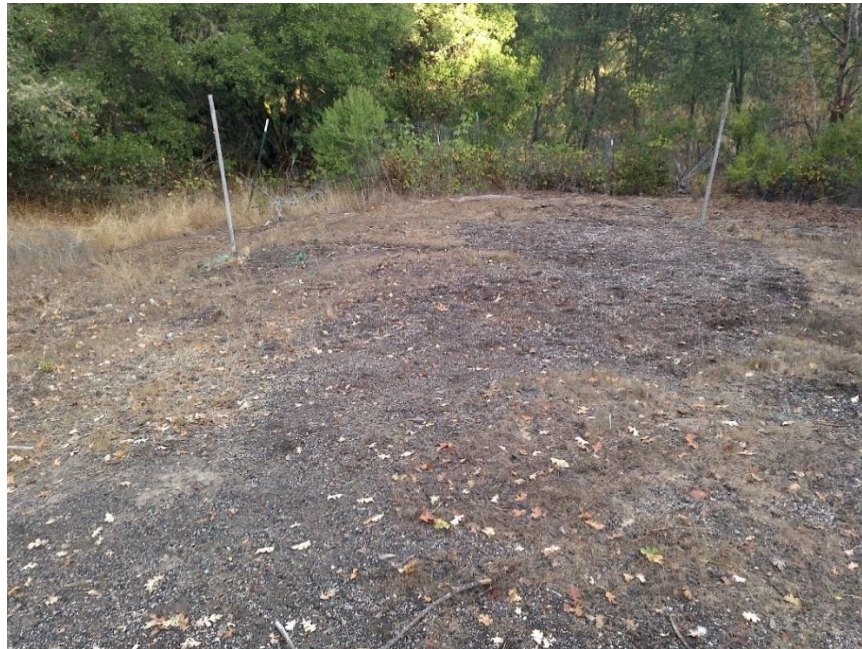
Figure 16—A photo looking north across an inactive cultivation pad at WQ5. White speckles of perlite are visible on the pad and a thin wattle is barely visible in the middle top of the image.

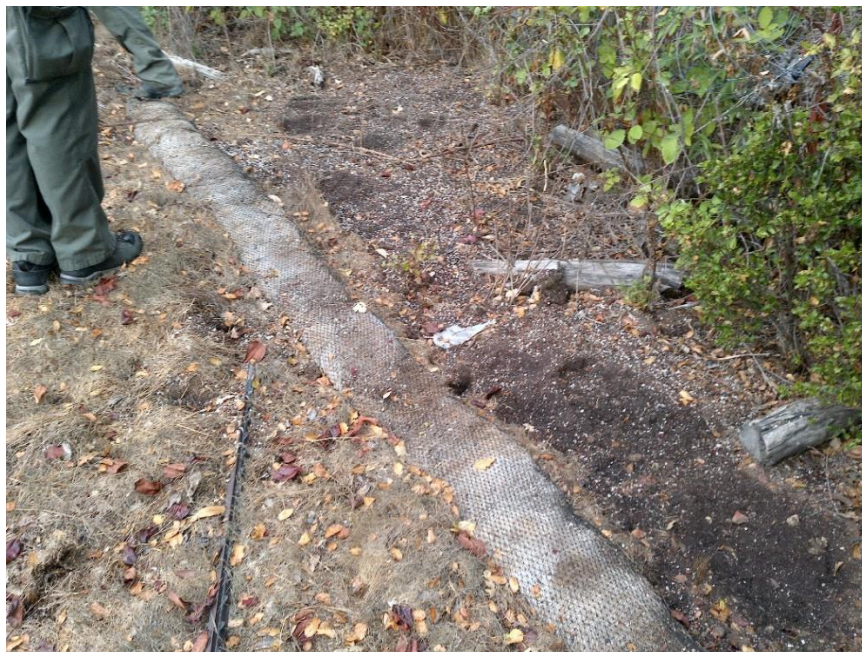
Figure 17—A photo looking northwest at the thin wattle pictured in the previous image at WQ5. The cultivation pad is to the left of the wattle and Salt Hollow Creek is to the right of the wattle. Imported potting soils, identifiable by the white speckles of perlite and dark color, are also visible on the right side of the wattle. The wattle has degraded such that stormwater may flow over the wattle.

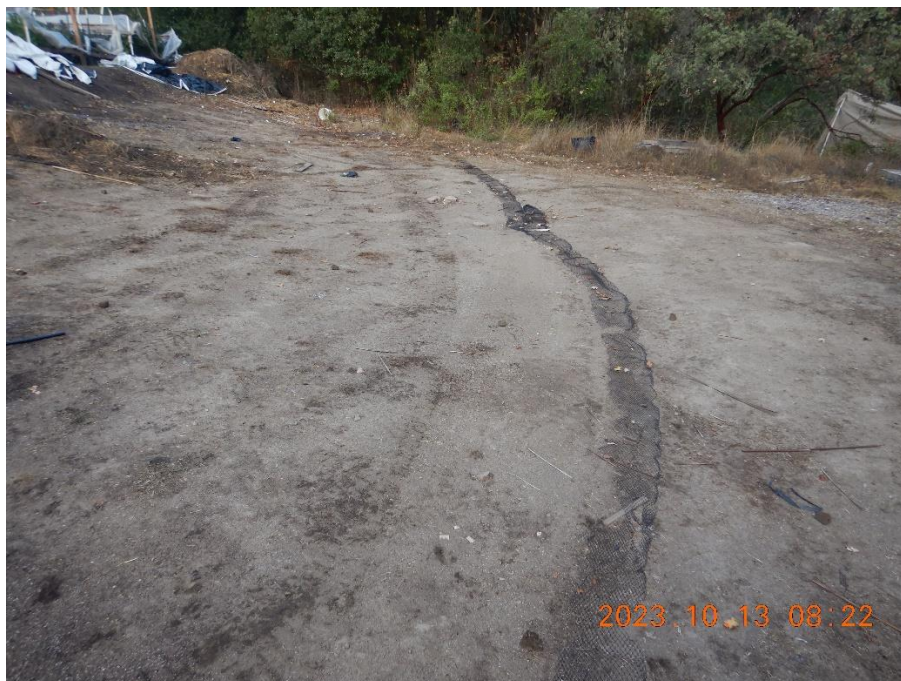
I walked back east to the cultivation pad at WQ1 and observed that the northern edge of the pad was bare earth susceptible to erosion by stormwater. I observed uncontained plastic pots, sheeting, and other waste at WQ6. I observed plastic netting similar to that used for constructing wattles, but I did not observe any effective management measures that would prevent stormwater from transporting waste from the cannabis cultivation area to Salt Hollow Creek.

Figure 18—A photo looking west at an area of bare earth south of WQ6. The greenhouses at WQ1 are visible in the top left of the image and empty black plastic netting is visible in the middle of the image.

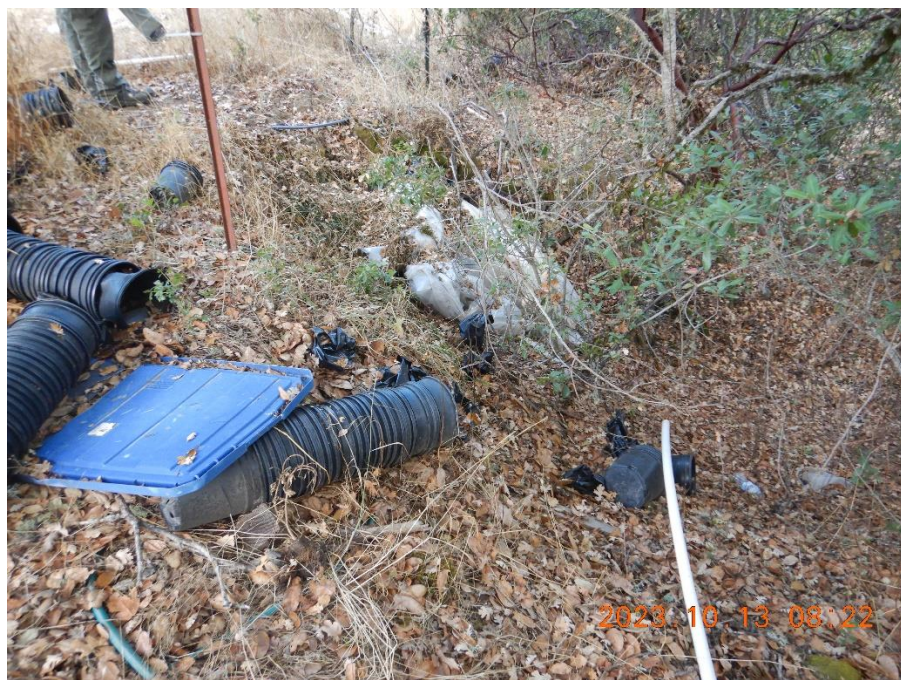
Figure 19—A photo showing uncontained plastic pots, sheeting, and other waste at WQ6.

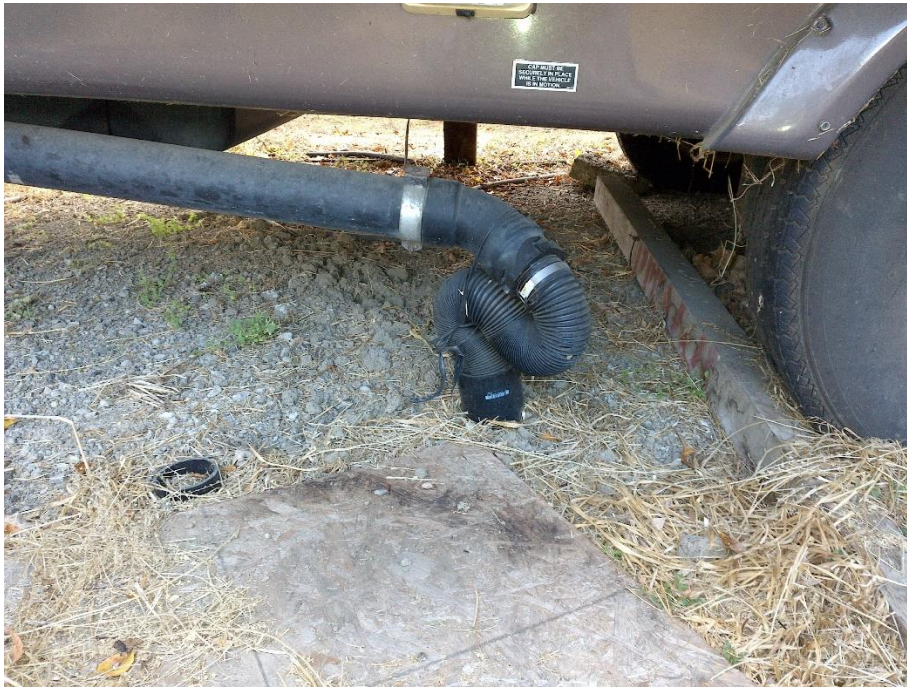
I walked along a road to a trailer at WQ7 and observed a black sewage line connected to a pipe protruding from the ground. In this vicinity, Warden Ramirez advised me that there were illegal pesticides inside, but near the entrance of, the structure east of WQ7. I took a picture of the inside of the structure while standing outside and was able to identify a bottle of BIOFOS Metamidofos from the picture.

Figure 20—A photo showing the sewage drain line from a trailer being directed into a pipe in the ground at WQ7.

3. Immediately cease the discharge of sewage to land at WQ7, implement corrective actions, and obtain the appropriate county permit for the disposal of on-site wastewater (i.e., septic system permit).

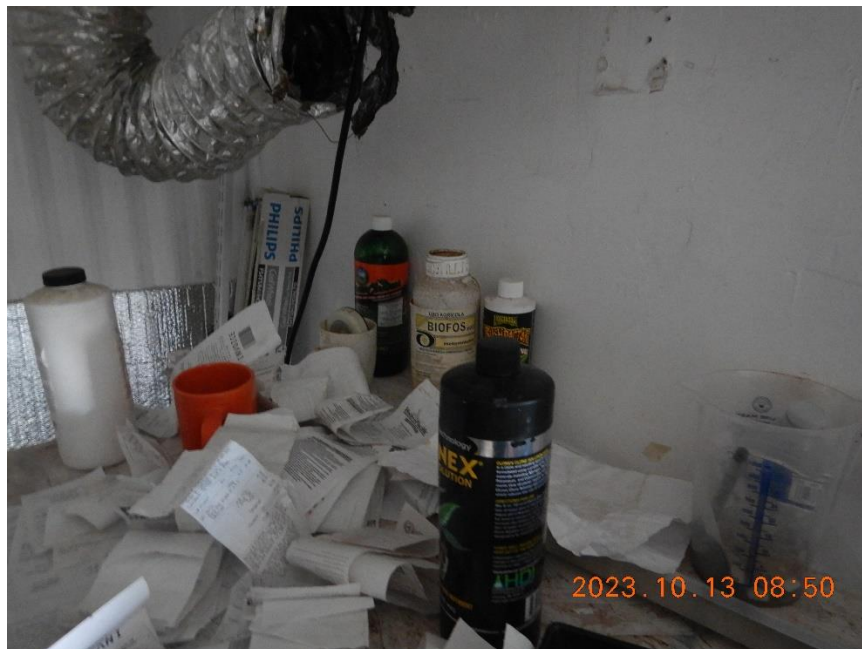
Figure 21—A photo looking at a bench inside a structure east of WQ7. The photographer is standing outside the structure. The photo shows a container of BIOFOS Metamidofos pesticide, which is not permitted for use in the United States.

4. Immediately cease use of illegal pesticides and dispose of all remaining pesticides and contaminated materials properly at a licensed waste disposal facility.
