## North Coast Regional Water Quality Control Board

September 27, 2023

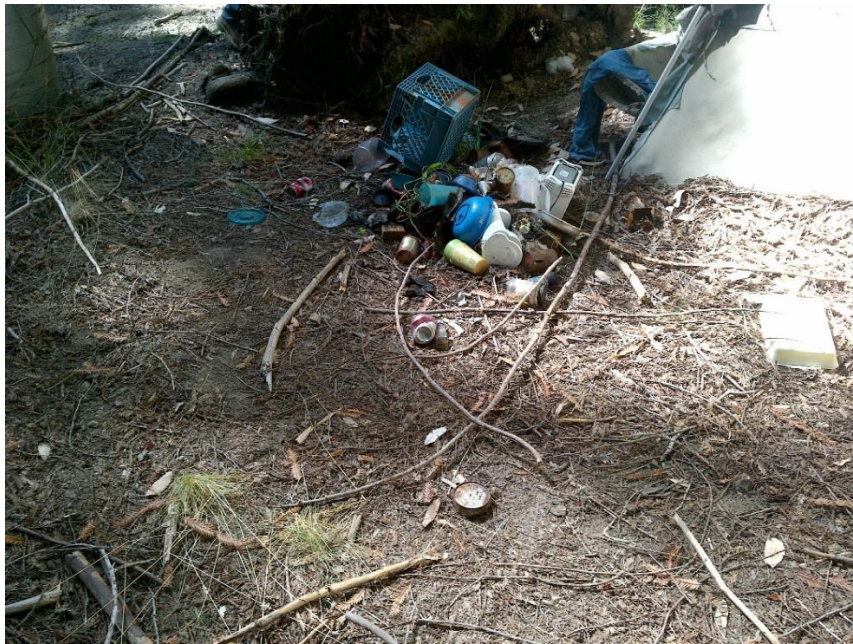
*Figure 2—Photo showing waste outside of a tent at WQ1. The waste includes small electrical appliances. A watercourse is barely visible in the top left of the image.*
