## North Coast Regional Water Quality Control Board

**Subject: Notice of Violation, Transmittal of Report for July 18, 2023 Inspection of Mendocino County Assessor's Parcel Numbers 149-260-05-00, and Requirement to Respond within 30 days**

**Report of July 18, 2023 Warrant Inspection,  
Mendocino County  
Assessor's Parcel Number (APN) 149-260-05-00 (the "Property")**

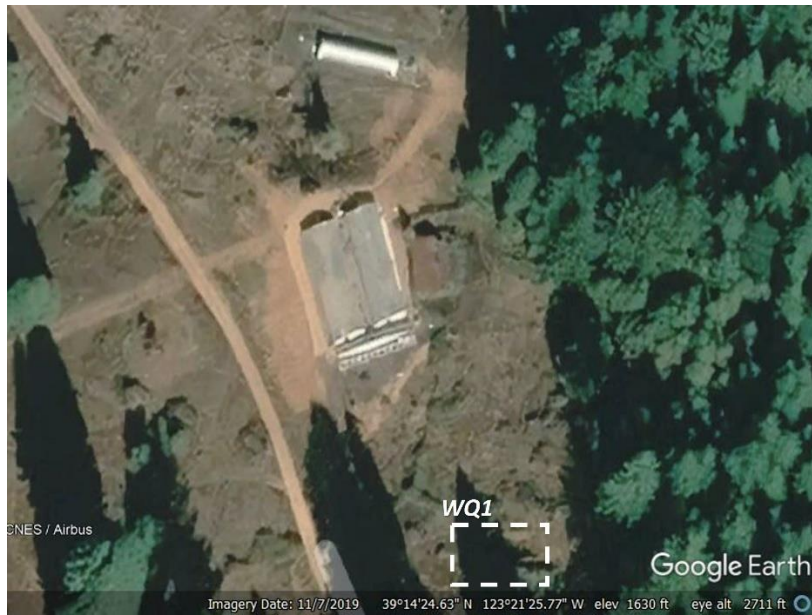
*Figure 4— Aerial image of middle eastern portion of the Property taken on November 7, 2019, obtained from Google Earth. Three hoop-type greenhouses, that were not present in earlier imagery, are visible next to a pre-existing barn in the middle of the image.*

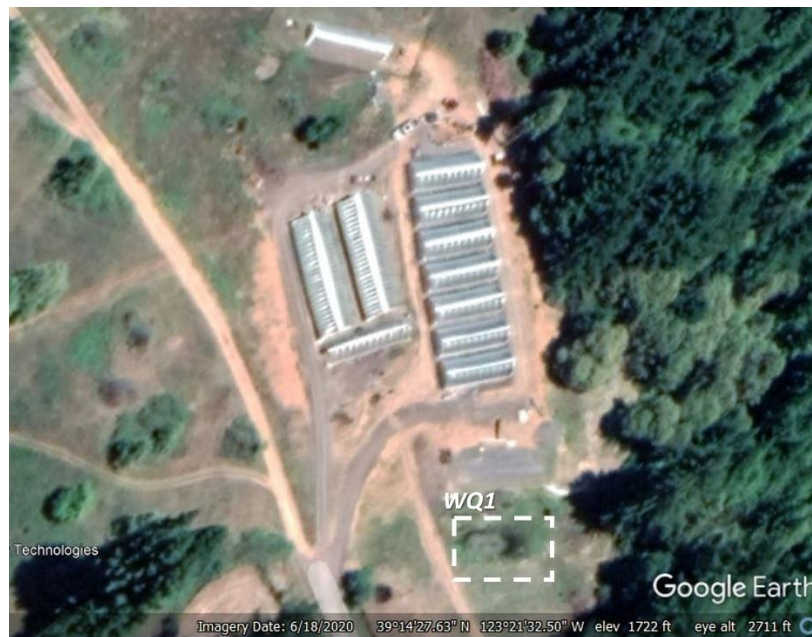
*Figure 5—Aerial image of middle eastern portion of the Property taken on June 18, 2020, obtained from Google Earth. The barn visible in the earlier images has been removed and a row of seven hoop-type greenhouses have been added in its place extending north, east and south of the previously developed area.*

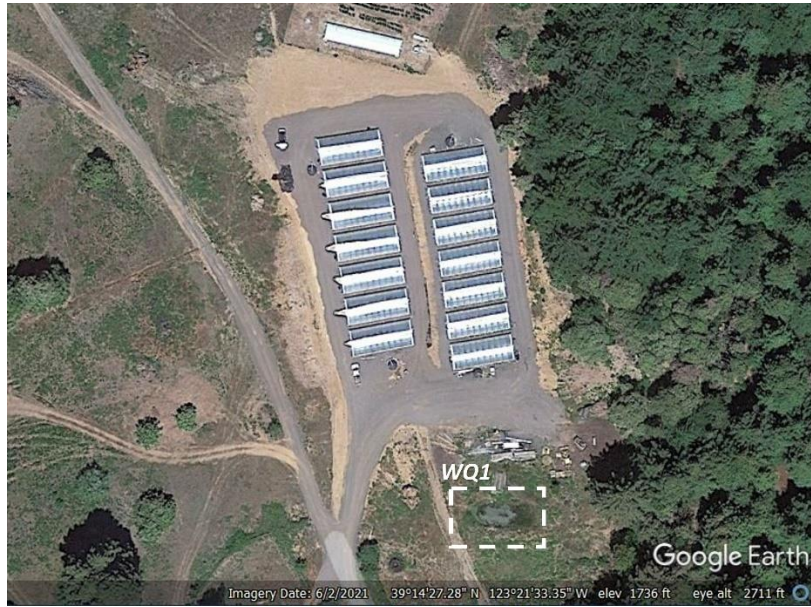
*Figure 6— Aerial image of middle eastern portion of the Property taken on June 2, 2021, obtained from Google Earth. The three hoop-type greenhouses first visible on November 7, 2019, have been replaced with a row of seven smaller greenhouses and an enlarged pad extends the developed area in all directions.*

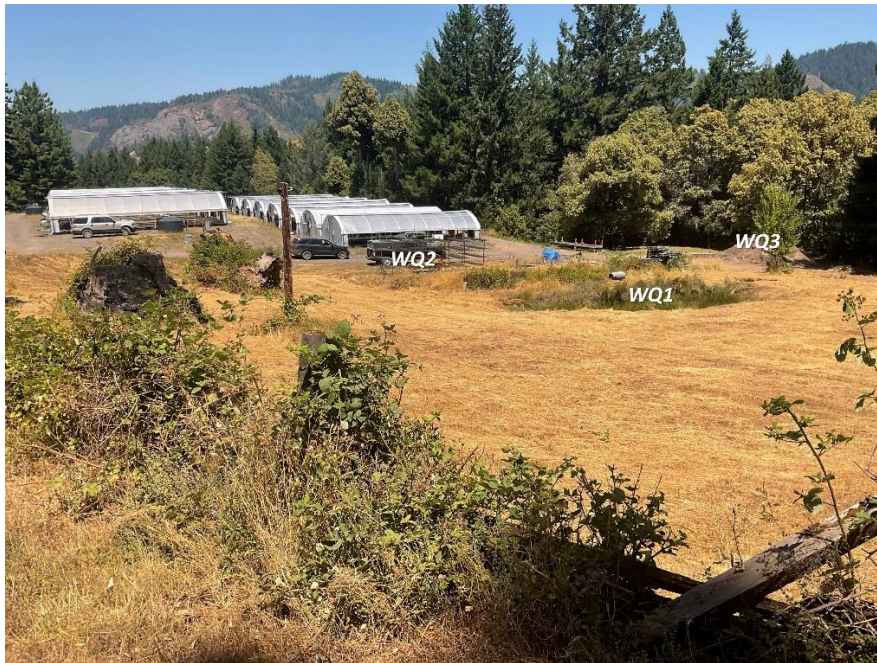
I entered the Property from the southeast and drove to a parking area near WQ1 where I observed a pond with plants from the genus *Juncus* growing around the pond's fringe. Review of aerial imagery shows that the pond pre-dates the development of the area and is likely a natural feature. I observed cannabis plants growing in greenhouses on a graded pad at WQ2, less than 100 feet north of the pond and associated wetlands. I also observed a pile of potting soil uncovered at WQ3, also less than 100 feet from WQ1.

*Figure 7—Photo looking north. Pond and associated wetland are visible at WQ1 in the middle of the image, a parking area and cannabis cultivation greenhouses are within 100 feet of the wetlands in the middle left of the image at WQ2, and a pile of potting soils is uncovered within 100 feet of the wetlands in the right of the image at WQ3.*

3. Retain a qualified professional to inventory/delineate and assess, all aquatic resources including any wetlands and watercourses that are Waters of the State on the Property, including the pond/wetlands at WQ1, and to develop a workplan and schedule to move all cannabis cultivation activities outside of required setbacks and restore any disturbed area within setbacks to comply with the Cannabis Cultivation Policy.

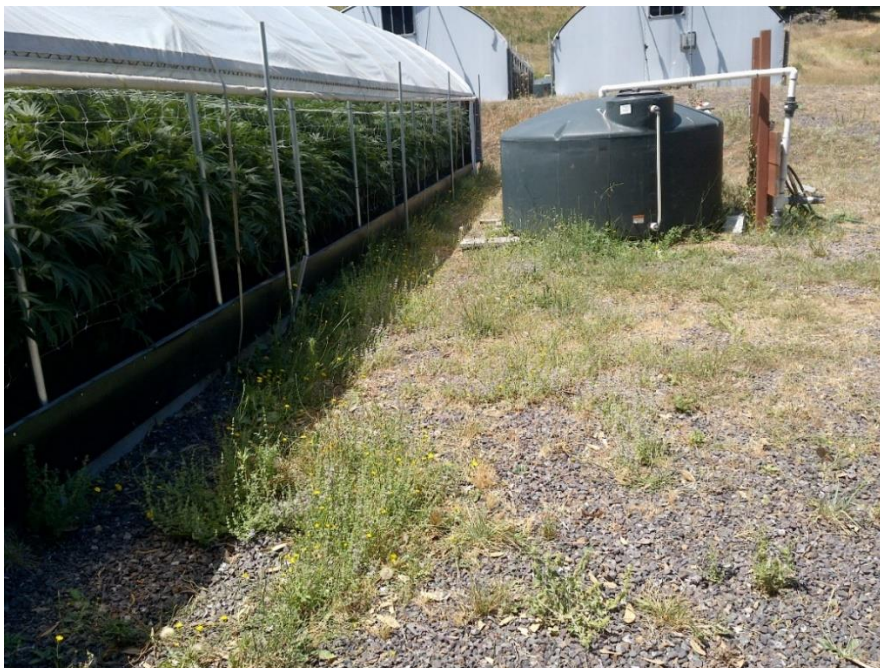
*Figure 8—Looking west from the northeast corner of the cultivation area. Growing cannabis plants are visible through the side of one of the greenhouses.*

5. Prior to cultivating cannabis or developing a property for cannabis cultivation, enroll for coverage under the Cannabis General Order<sup>2</sup>.
6. Prior to conducting work in a Water of the State, including the pond/wetlands at WQ1, submit an application and pay the required application fee for a Water Quality Certification/Waste Discharge Requirement<sup>3</sup>:

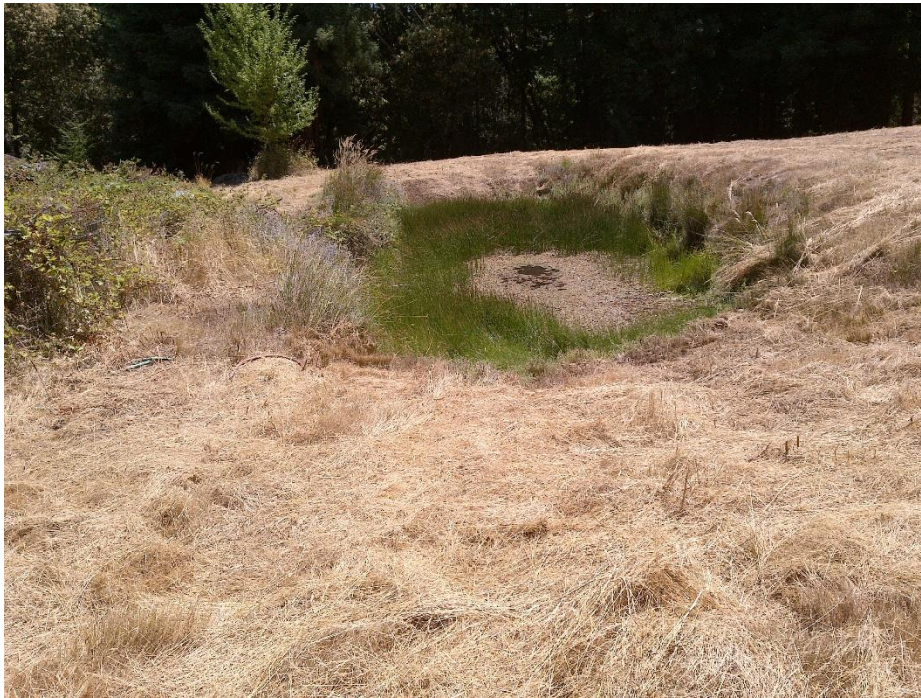
*Figure 9—Looking east at pond and wetlands located at WQ1. Plants from the genus Juncus are visible growing around the fringe of the pond.*

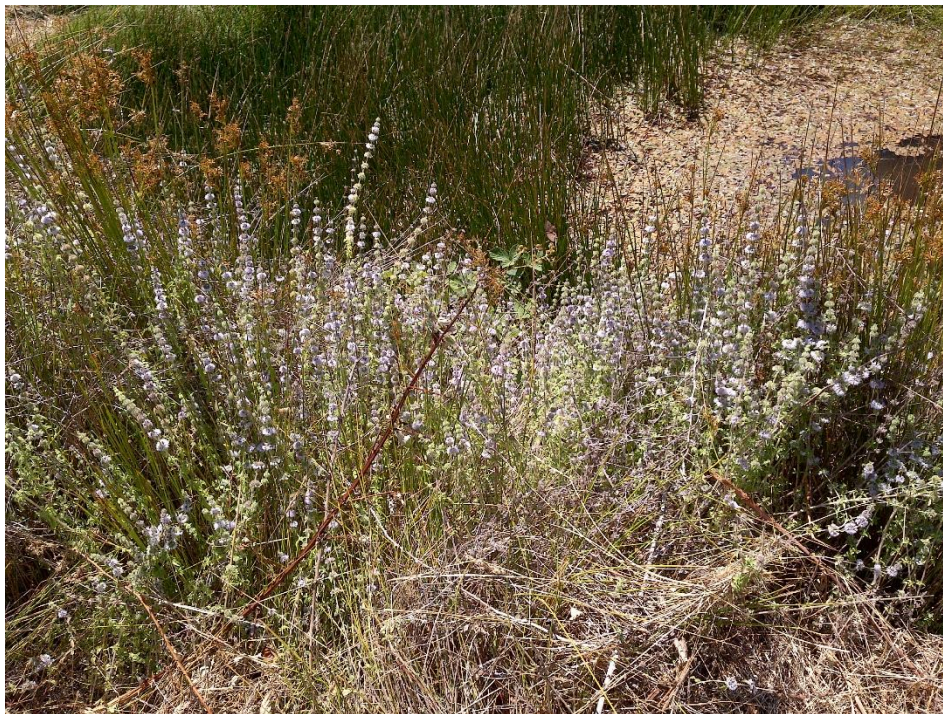
*Figure 10—A closer view of the vegetation pictured along the fringes of the pond at WQ1. Plants from the genus Juncus are visible in the back of the image.*

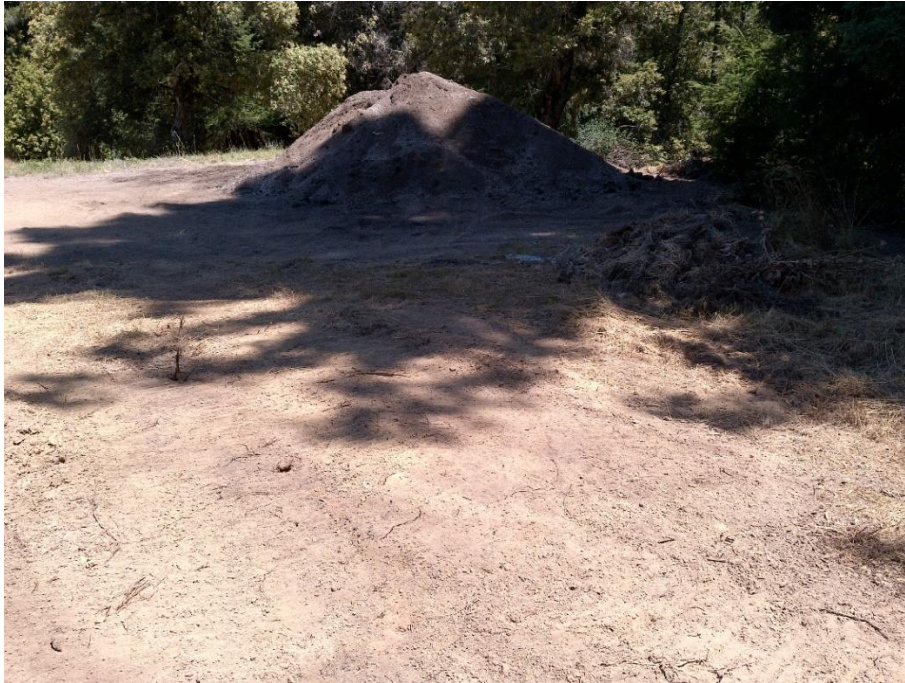
*Figure 11—Looking west at pile of potting soils located at WQ3. The pile of is approximately five feet tall at the center and covers a circular area with an approximate radius of ten feet.*

4. Dispose of all development and restoration-related earthen spoils in a manner to prevent/minimize transport and delivery to receiving waters.

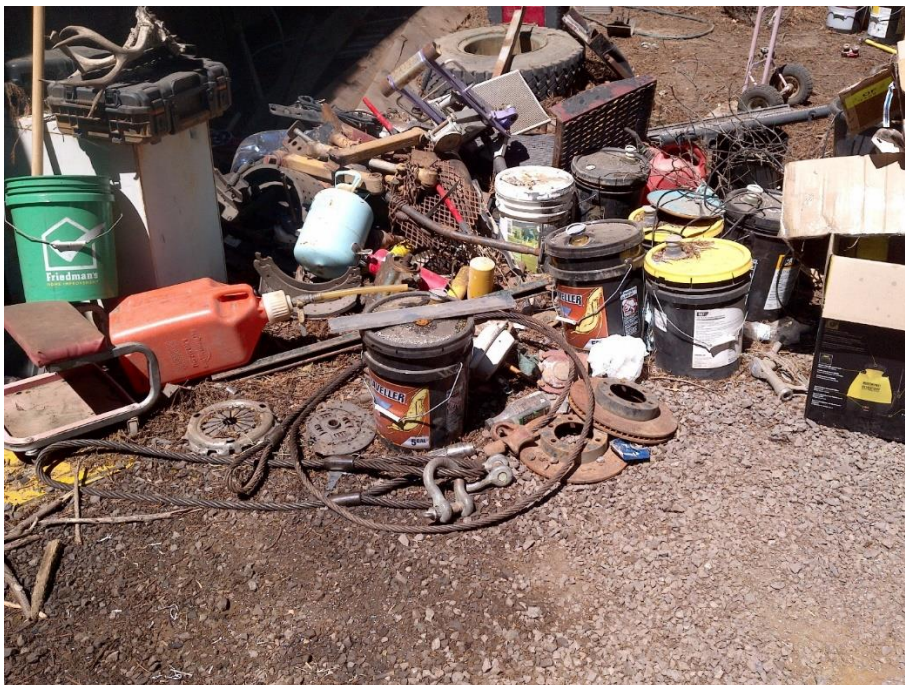
I walked south to WQ4 where I observed several areas where petroleum products were being stored and used without secondary containment. I also observed several locations where petroleum products had discharged to ground.

*Figure 12—Picture of petroleum products in five-gallon buckets without secondary containment ground in the vicinity of WQ4. A thin layer of gravel covers the earthen ground. The ground to the left of the image is darker in color apparently from spilled petroleum products.*

1. Immediately collect all petroleum products that threaten to spill, including those in the vicinity of WQ4, and haul away to a licensed waste disposal facility or store in accordance with the Cannabis Cultivation Policy<sup>1</sup>.

2. Retain a qualified professional to investigate the extent of contaminated soil associated with the spilled petroleum products and develop a workplan and schedule for cleaning up the spill.

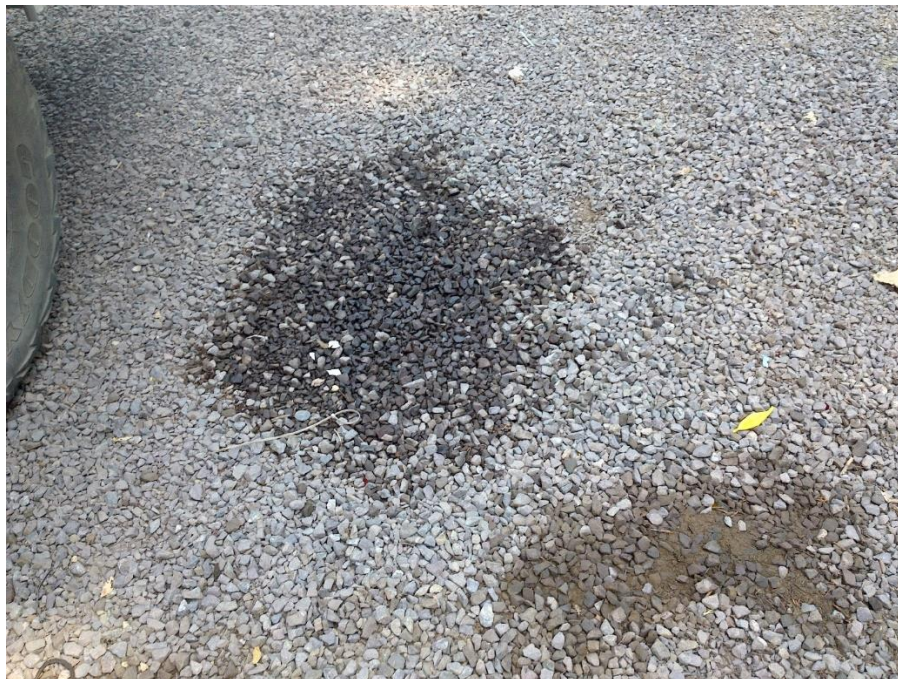
*Figure 13—Patches of oil-stained ground at WQ4. The earthen ground is covered by a layer of permeable rock.*

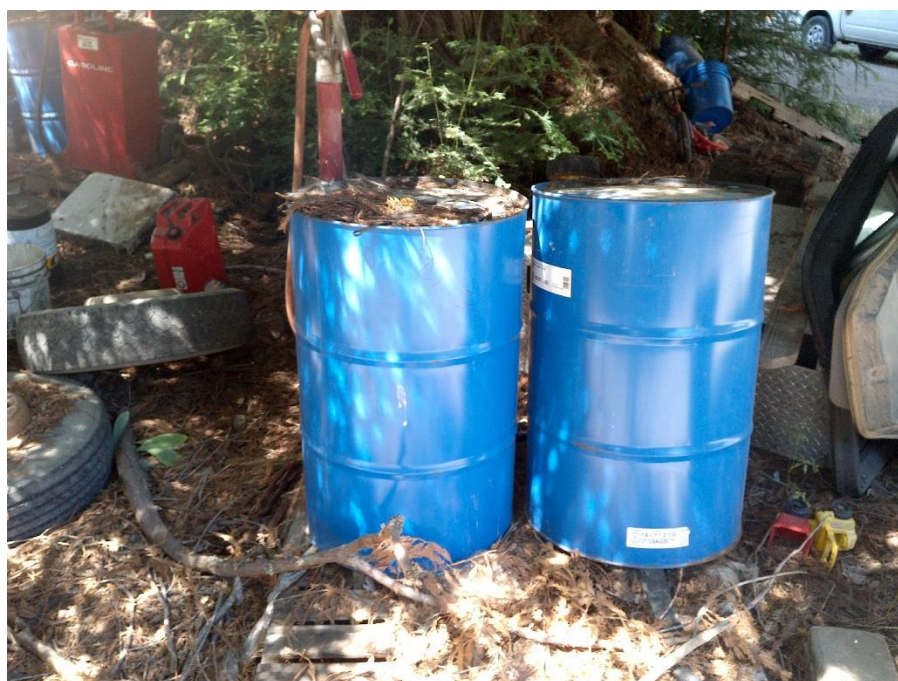
*Figure 14—Two of many 55-gallon drums without secondary containment in the vicinity of WQ4. A pipe and hose are connected to the drum in the middle left suggesting that there are intended fluid transfers at its current location.*
