Subject: Notice of Violation, Transmittal of Report for August 23, 2023 Inspection of Mendocino County Assessor's Parcel Number 034-100-48-00, and Recommendation to Respond within 30 days

**Report of August 23, 2023 Warrant Inspection,
Mendocino County
Assessor's Parcel Number 034-100-48-00 (the "Property")**

File: Cannabis Program Inspections, Mendocino County, 2023, Karla Navarrete, CIWQS Place ID 890275

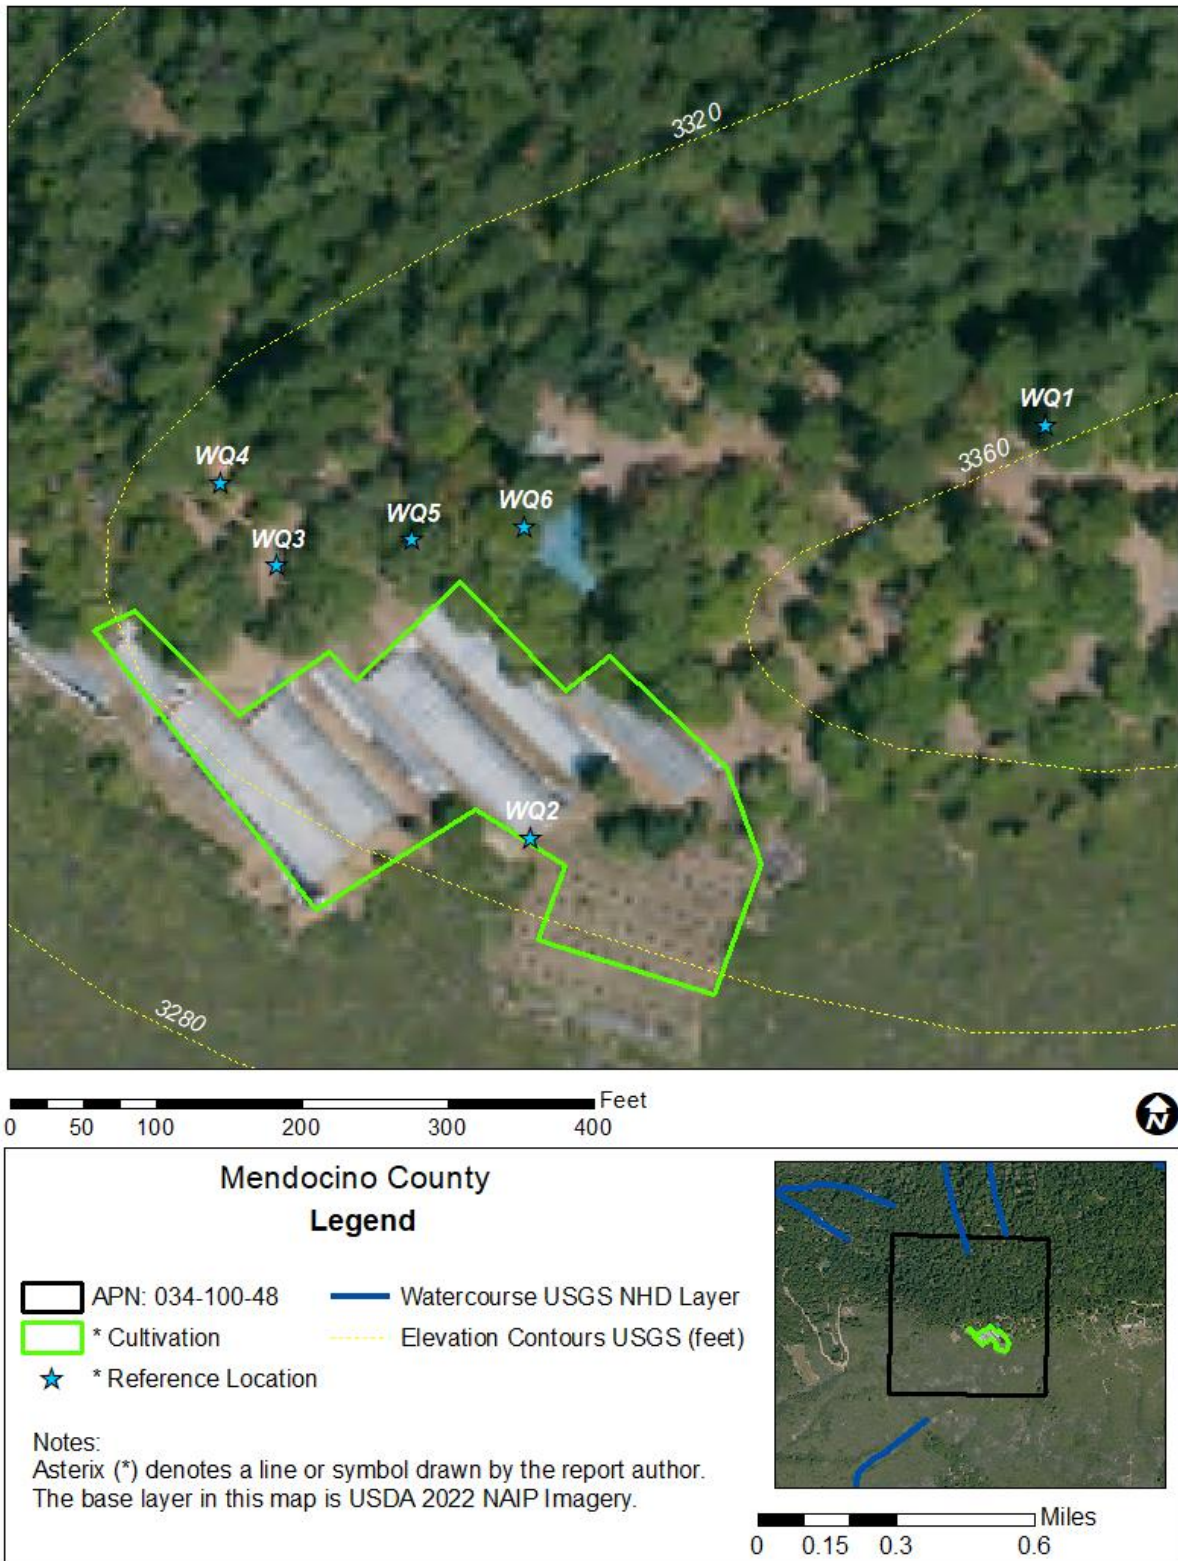
Figure 1—Aerial image/map showing inspection points discussed in this report.

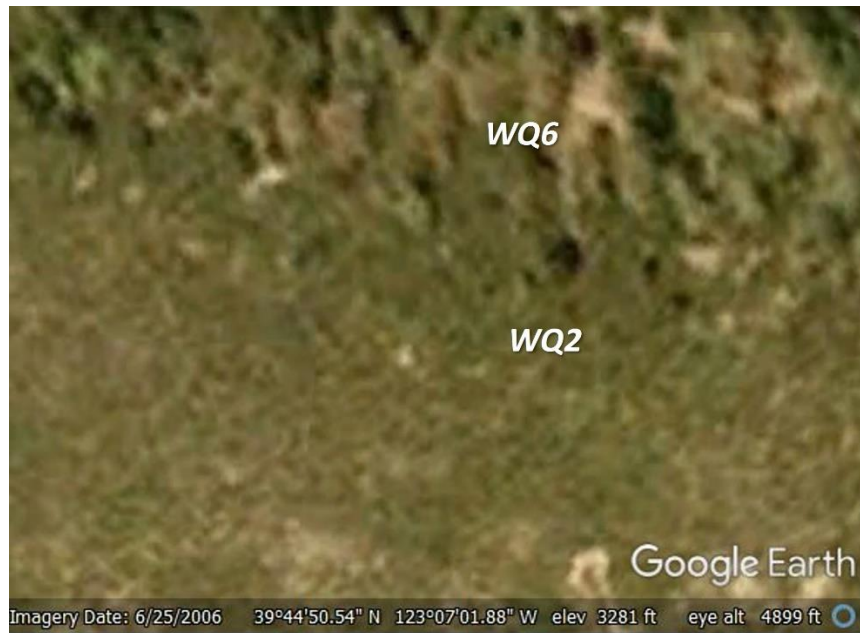
Figure 2—Aerial image of the Property taken on June 25, 2006, obtained from Google Earth. The image shows uniform vegetation cover suggesting that the Property had not yet been developed for cannabis cultivation.

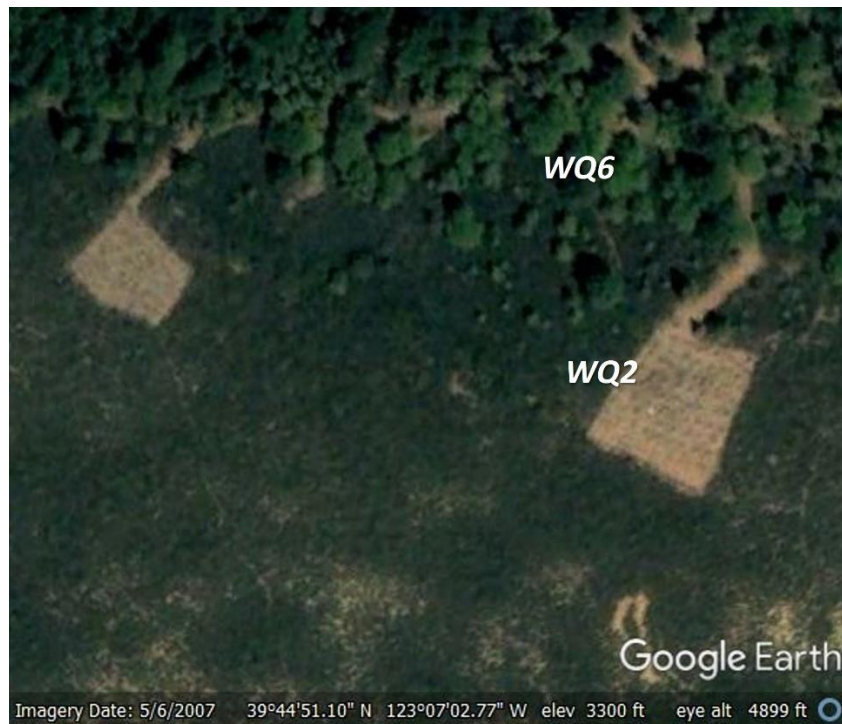
Figure 3—Aerial image of the Property taken on May 6, 2007, obtained from Google Earth. The image shows two cleared areas, including a rectangle area in the vicinity of WQ2.

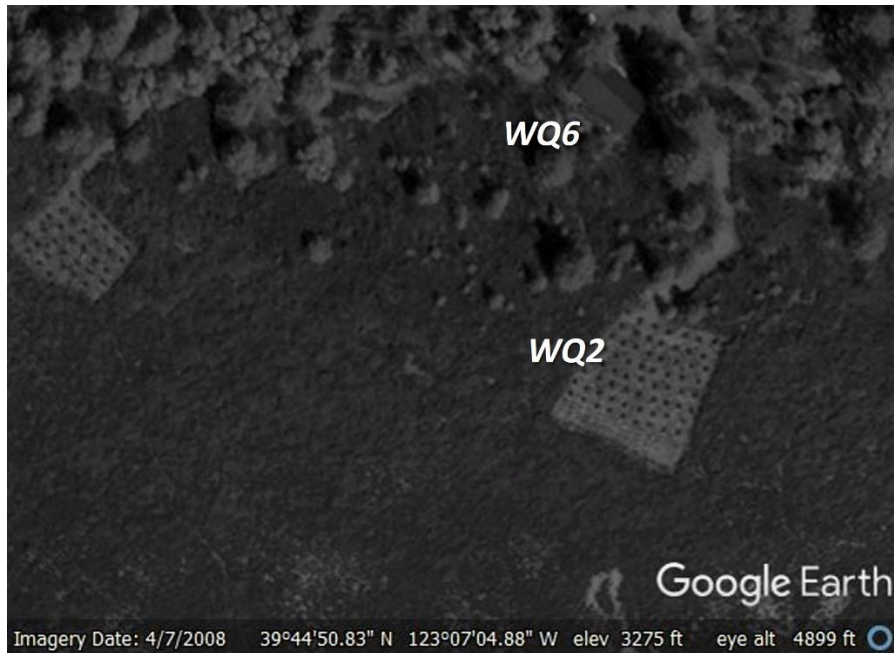
Figure 4—Aerial image of the Property taken on April 7, 2008, obtained from Google Earth. The image shows areas of circles in the previously cleared areas that are consistent in size, shape and pattern of arrays of outdoor cannabis cultivation.

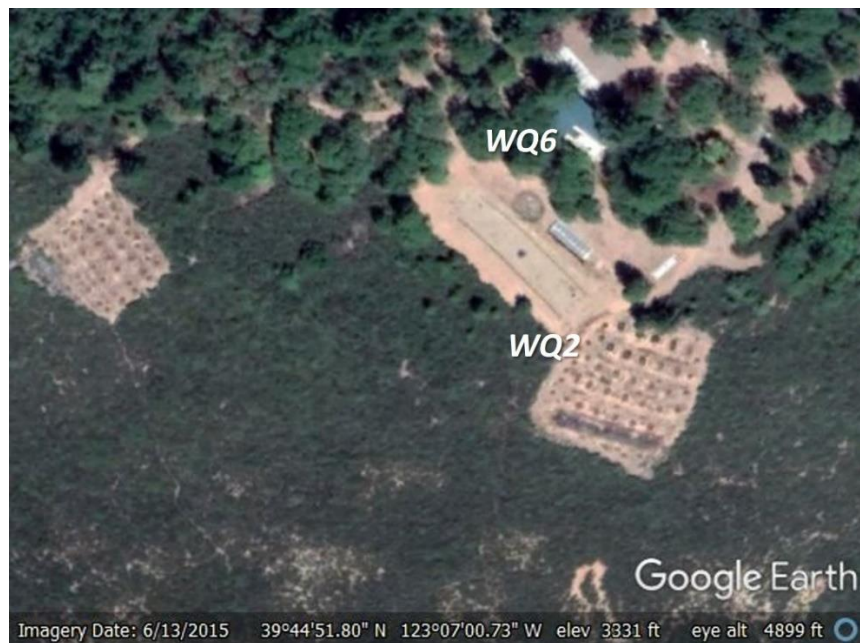
Figure 5—Aerial image of the Property taken on June 13, 2015, obtained from Google Earth. The image shows a cleared area south of WQ6 with a rectangular frame at the location of where a hoop-type greenhouse was observed during the August 23, 2023 inspection.

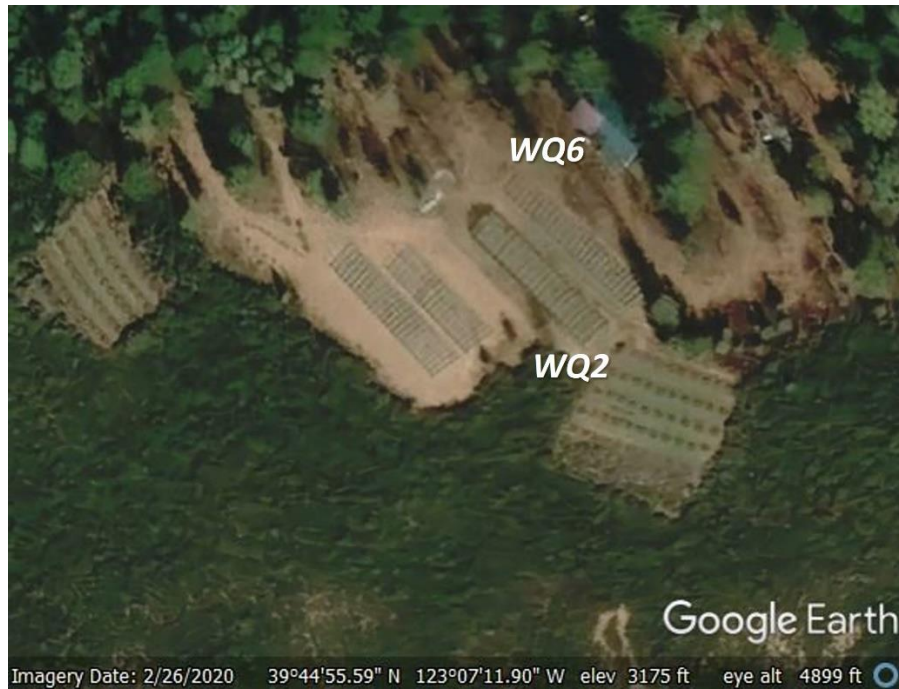
Figure 6—Aerial image of the Property taken on February 26, 2020, obtained from Google Earth. The image shows additional clearing and hoop-type greenhouses west of WQ2.

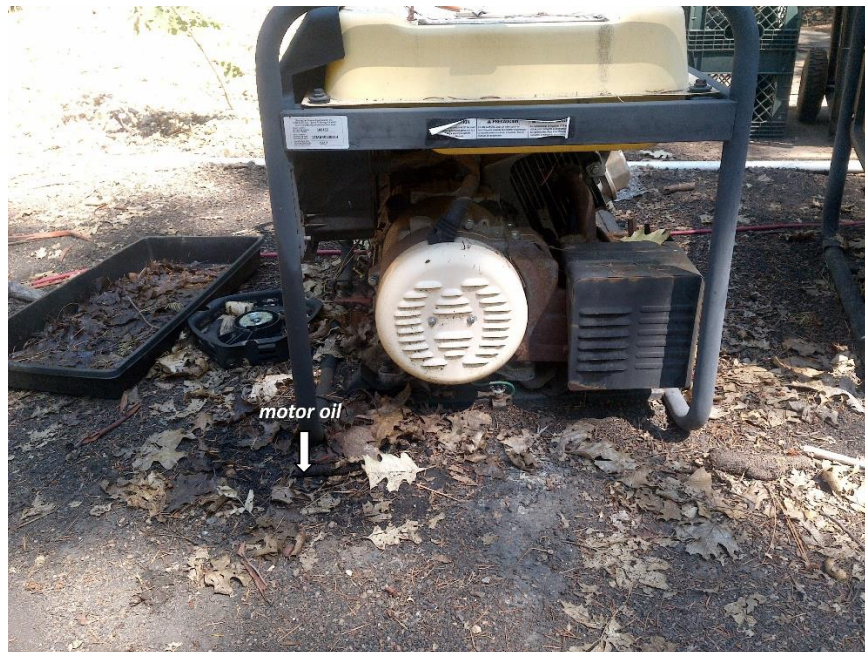
I entered the Property from the east and observed several petroleum-fueled generators located at WQ1. I observed that the generators lacked secondary containment and the permeable earthen ground below one of the generators was darker than the surrounding soils, suggesting motor oil had discharged to land at this location. I walked west and observed a cannabis cultivation area exceeding a half-acre in size with plants growing in raised garden beds and within hoop-type greenhouses.

Figure 7—Photo looking at a petroleum-fueled generator located at WQ1. The generator does not have secondary containment. The permeable earthen ground below the generator is dark where motor oil has discharged to land.

1. Immediately collect all petroleum products that threaten to spill and haul away to a licensed waste disposal facility or store in accordance with the Cannabis Cultivation Policy¹.
2. Retain a qualified professional to investigate the extent of any contaminated soil associated with spilled petroleum products, including the spill in the vicinity of WQ1, and develop a workplan and schedule for cleaning up the spill.
3. Immediately collect all refuse and waste. Cease burning of refuse and waste. Properly dispose of these wastes at a licensed waste collection facility or in another manner that complies with the Cannabis Cultivation Policy¹.
4. Prior to cultivating cannabis or developing a property for cannabis cultivation, enroll for coverage under the Cannabis General Order².

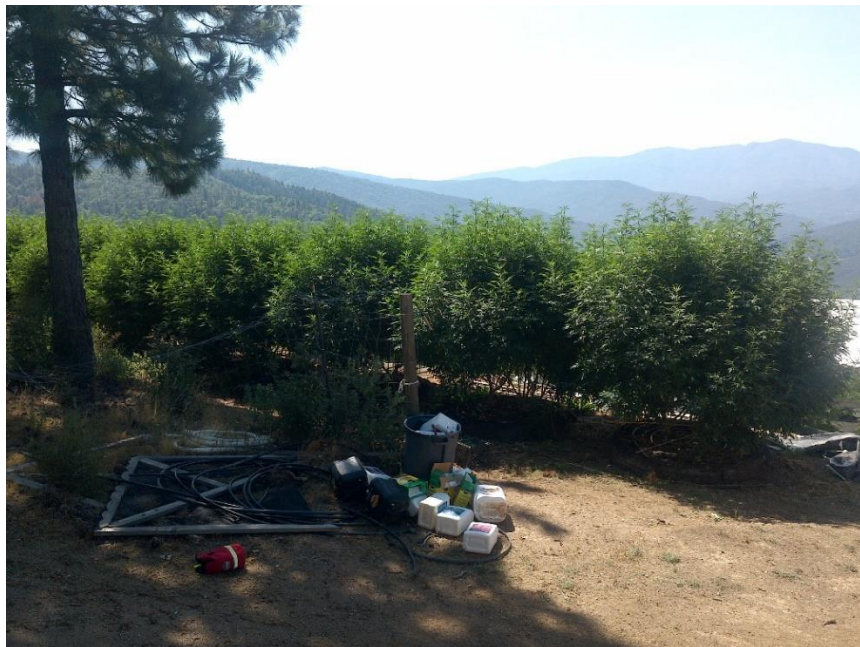
Figure 8—Photo looking south at cannabis cultivation area in the vicinity of WQ2. The photo shows a row of cannabis plants growing in raised garden beds. The white plastic top of a hoop-type greenhouse is visible in the middle right of the image.

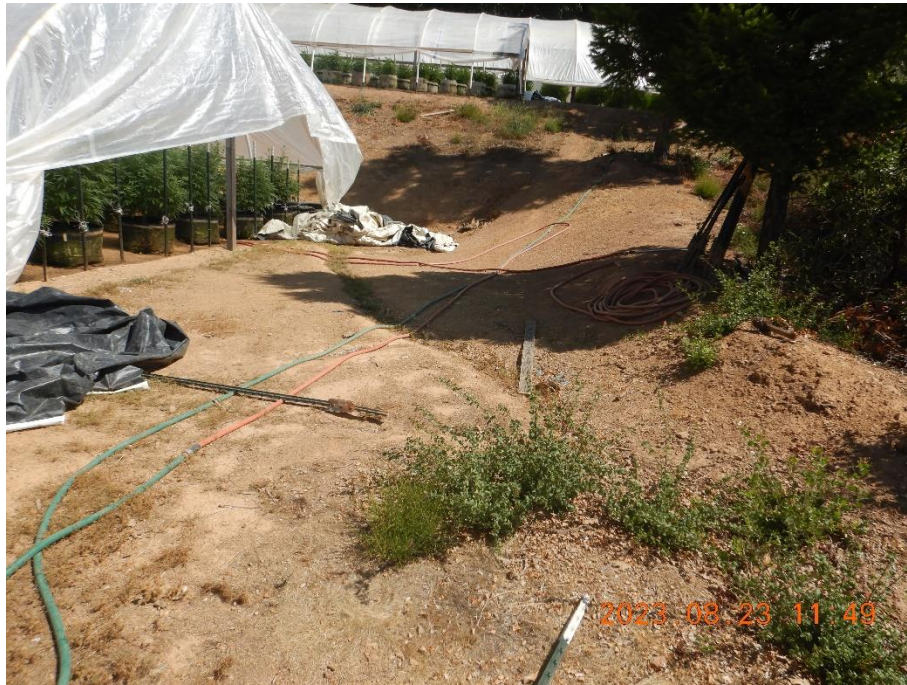
Figure 9—Photo looking north at area with terraced hoop-type greenhouses in the vicinity of WQ2. Rows of cannabis plants are visible growing inside the greenhouses.

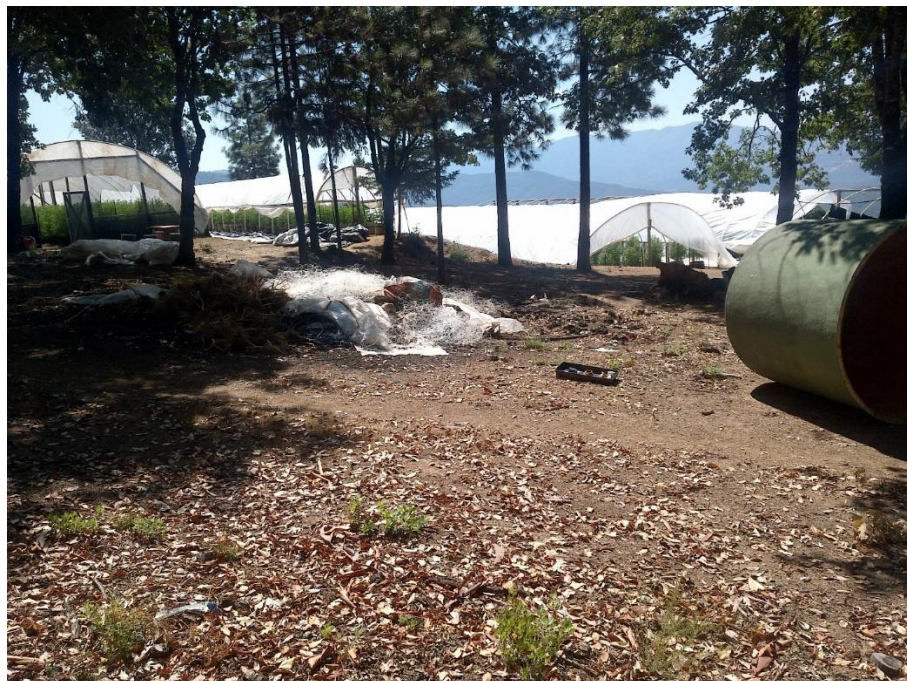
West of the cultivation area, I observed a pile of cannabis cultivation waste at WQ3 including cannabis plant root balls, plastic netting, and plastic soil bags. I observed a shallowly excavated hole at WQ4 filled with domestic waste. I observed a pile of burned refuse at WQ5 including metal rods, quart sized cans and canisters designed for holding pressurized substances. Behind a building at WQ6, I observed many unlabeled 55-gallon drums. One of the drums had a pump and hose connected enabling fluid transfers at a location without secondary containment.

Figure 10—Photo looking southeast towards terraced rows of hoop-type greenhouses. A pile of cannabis cultivation waste, located at WQ3, is visible in the middle left of the image. The pictured waste includes cannabis plant root balls, plastic netting and plastic soil bags.

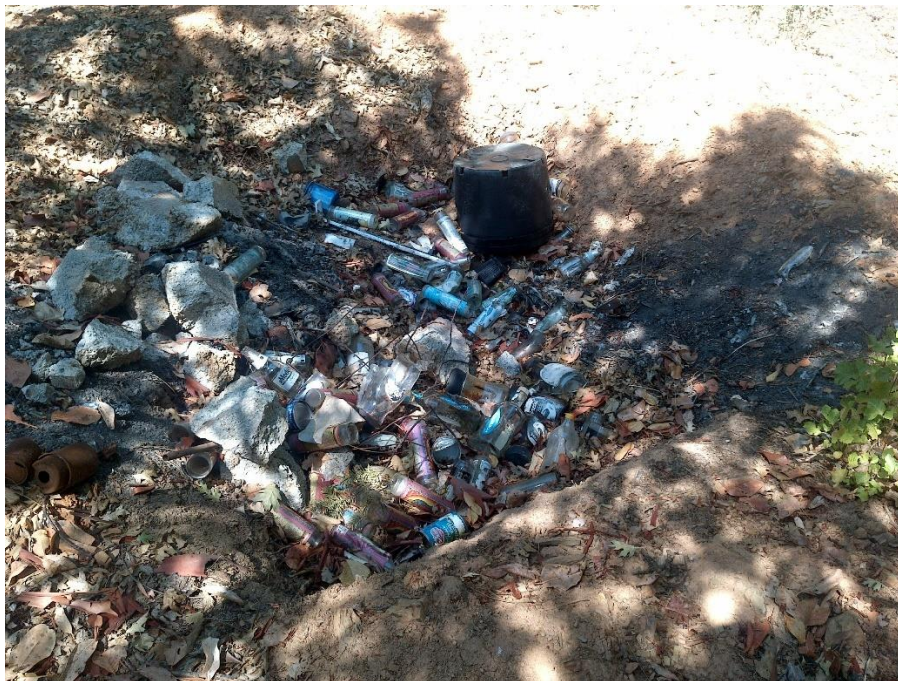
Figure 11—Photo showing refuse placed in a shallowly excavated hole at WQ4.

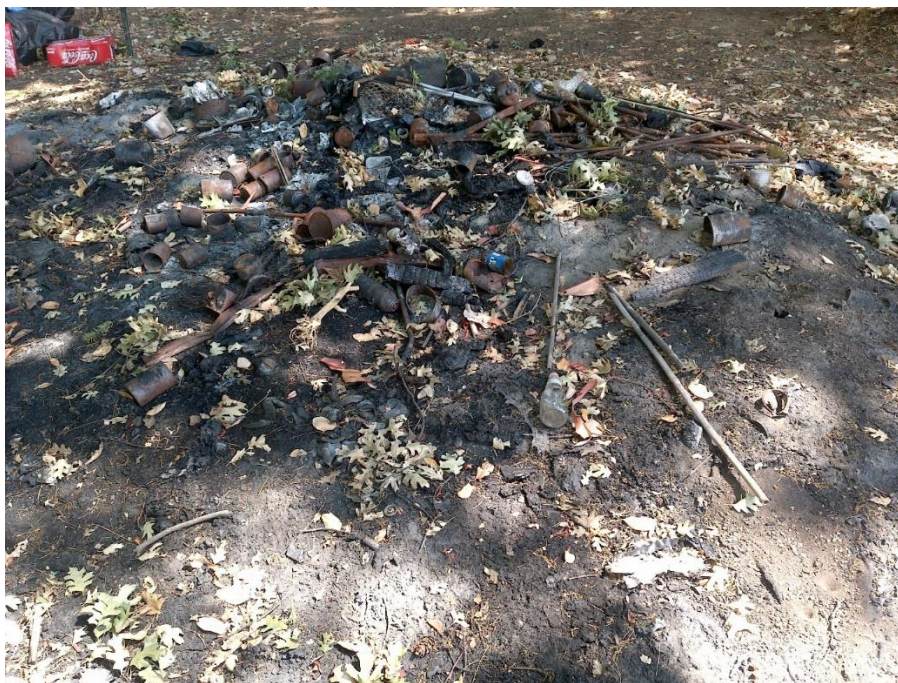
Figure 12—Photo showing pile of burned refuse at WQ5. The burned waste includes metal rods, quart sized cans and canisters designed for holding pressurized substances.

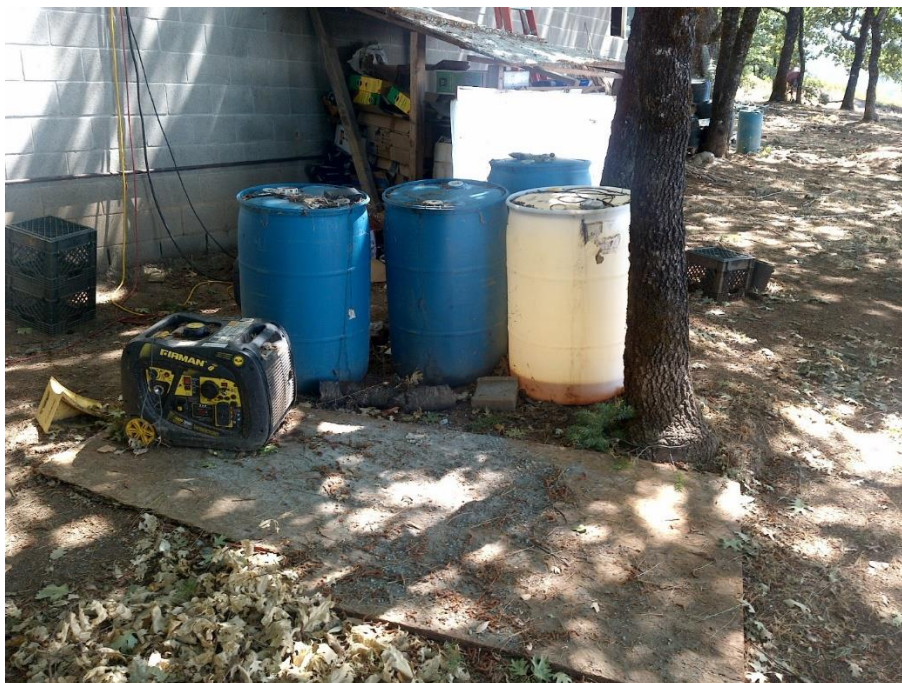
Figure 13—A photo showing several 55-gallon drums without labels behind a building in the vicinity of WQ6.

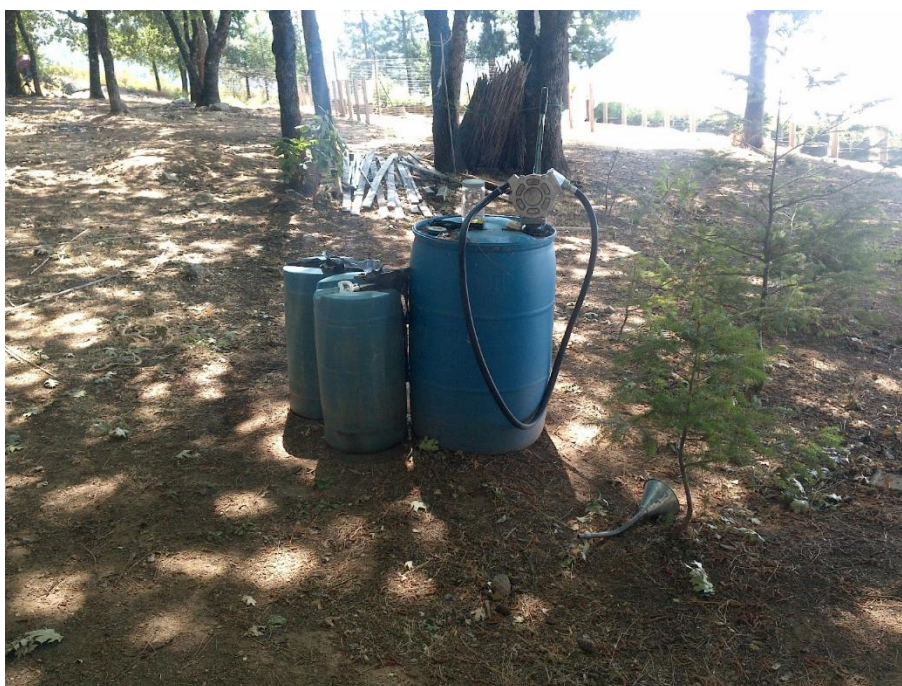
Figure 14—Photo showing a 55-gallon drum without secondary containment in the vicinity of WQ6. A pump and hose are connected to the drum enabling fluid transfers at this location.
