Subject: Notice of Violation, Transmittal of Report for August 22, 2023 Inspection of Mendocino County Assessor's Parcel Numbers 034-290-22-00 and 034-290-27-00, and Recommendation to Respond within 30 days

**Report of August 22, 2023 Warrant Inspection,
Mendocino County
Assessor's Parcel Numbers 034-290-22-00 and 034-290-27-00
(the "Property")**

File: Cannabis Program Inspections, Mendocino County, 2023, Silvano Viscanio,
CIWQS Place ID 890271

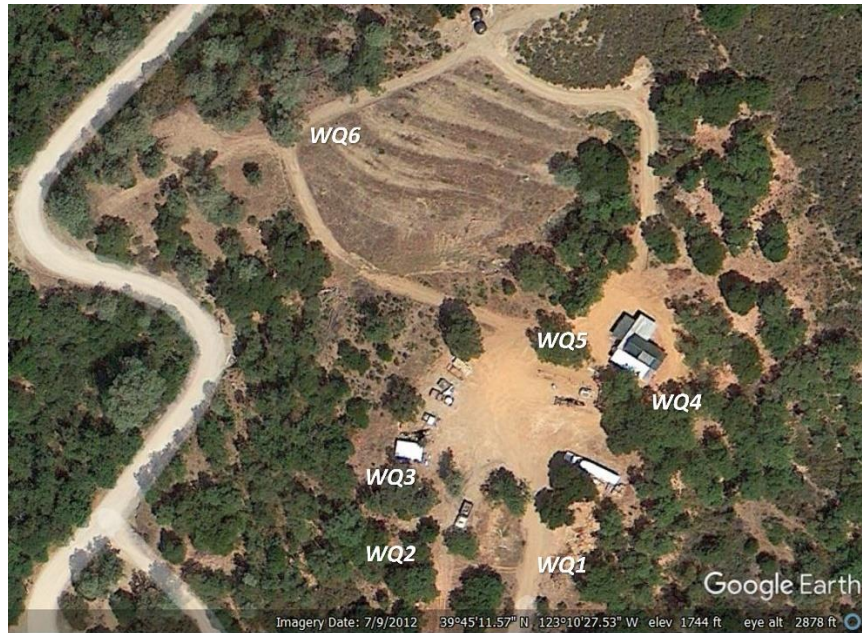
Figure 2—Aerial image of the Property taken on July 9, 2012, obtained from Google Earth. The image shows that the hillslope east of WQ6 has been terraced and a structure is present on the pad east of WQ5.

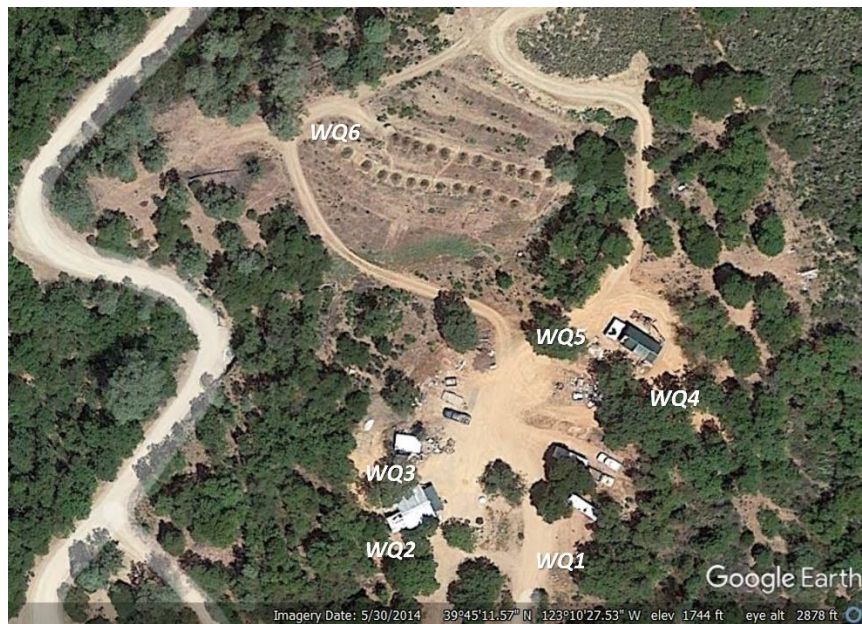
Figure 3—Aerial image of the Property taken on May 30, 2014, obtained from Google Earth. The image shows a pattern of circles on the terraced hillslope east of WQ6 that is consistent with cannabis cultivation and a newly constructed structure between WQ2 and WQ3.

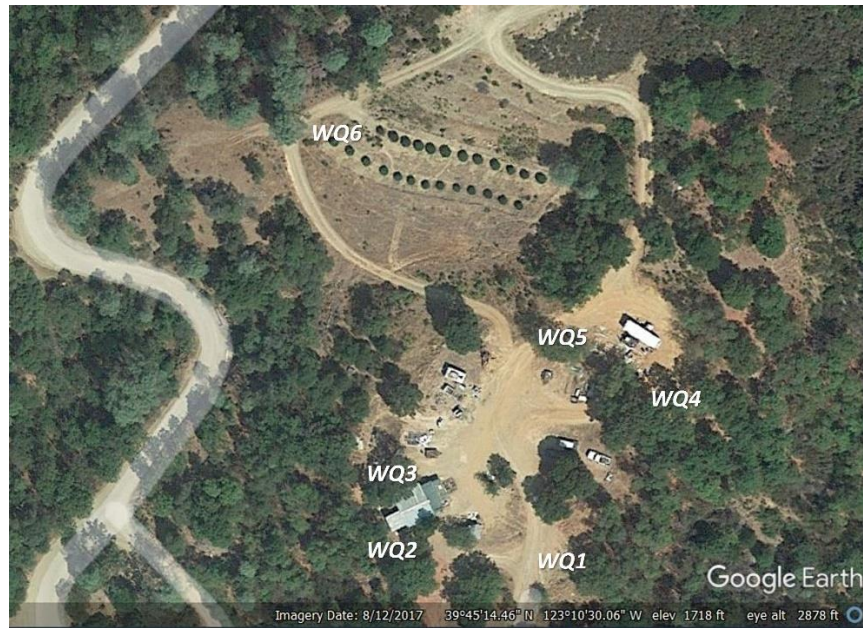
Figure 4—Aerial image of the Property taken on August 12, 2017, obtained from Google Earth. The image shows continued cultivation on the terraced hillslope east of WQ6.

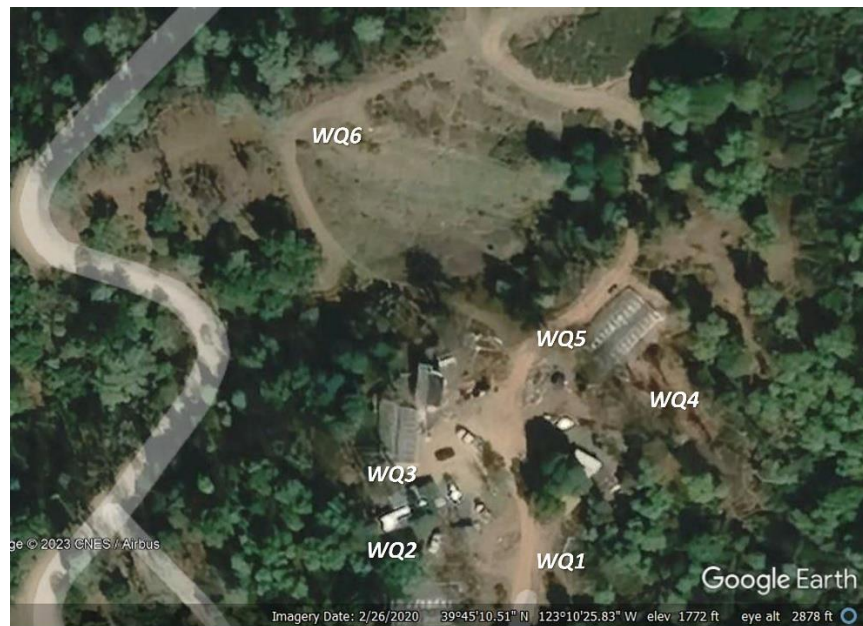
Figure 5—Aerial image of the Property taken on February 26, 2020, obtained from Google Earth. The image shows that the structure between WQ2 and WQ3 has been replaced with hoop-type greenhouses and additional hoop-type greenhouses have been constructed north of WQ3 and south of WQ2.

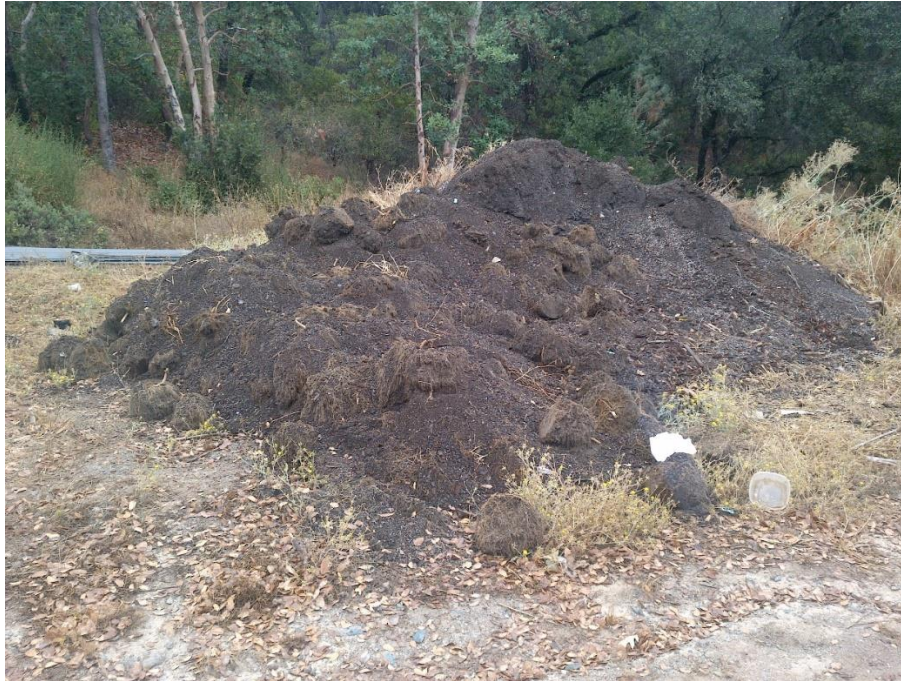
I entered the Property from the south and observed a pile of waste potting soils uncontained at WQ1. I observed a watercourse less than 100 feet east of the soil pile. In the vicinity of the soil pile, I observed erosional rills on the surface of the dirt access road. West of the access road, at WQ2, I observed a residential structure that appears from historical aerial imagery to have been constructed between 2012 and 2014. I observed that the sanitary sewer lines exiting the structure entered a partially buried tank with an open pipe on the side. Sewage had collected in the open pipe and in a visible pile for dozens of feet downslope.

Figure 6—Photo looking southeast at a pile of uncontained waste potting soils at WQ1. A watercourse runs from north to south out of view and less than 100 feet behind the soil pile.

1. Immediately cease the discharge of sewage to land, implement corrective actions, and obtain the appropriate county permit for the disposal of on-site wastewater (i.e., septic system permit).
2. Immediately collect all refuse and waste which have discharged and/or threatens to discharge to receiving waters and which can be collected by hand. You are not authorized to use heavy equipment in a water of the state or modify the bed bank or channel of a water of the state without a permit from the Regional Water Board (see

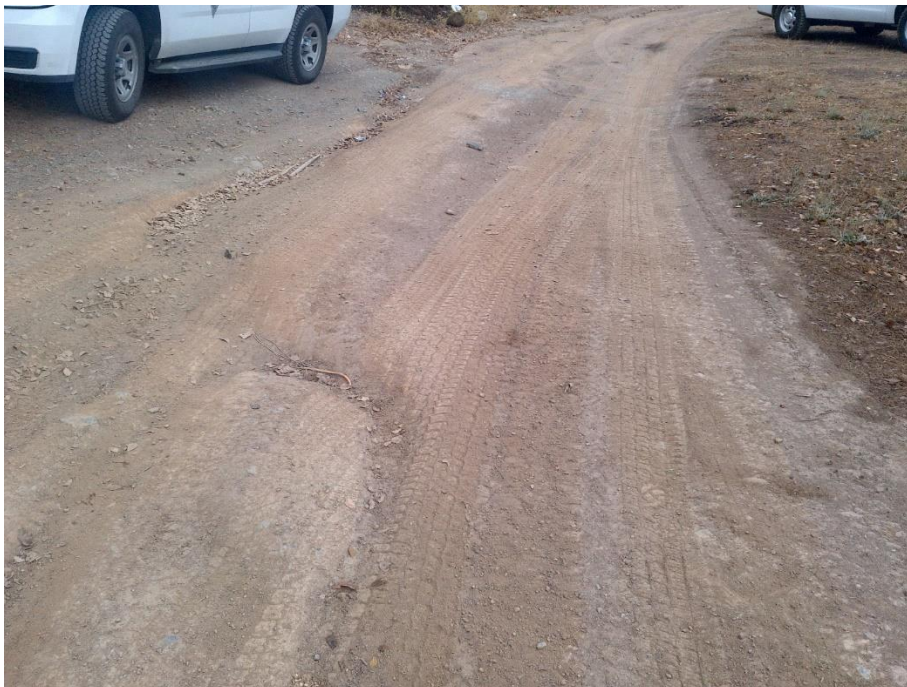
Figure 7—Photo of the dirt road in the vicinity of WQ1. Erosional rills are visible on the road surface.

3. Retain a licensed professional to inventory, assess, all aquatic resources including watercourses that are Waters of the State on the Property, and to develop a workplan and schedule to implement measures to ensure that all developed features, roads and watercourse crossings throughout the Property are corrected, restored, and/or maintained in conditions that comply with the Cannabis Cultivation Policy¹.
4. Dispose of all development and restoration-related earthen spoils in a manner to prevent/minimize transport and delivery to receiving waters.
5. Prior to cultivating cannabis or developing a property for cannabis cultivation, enroll for coverage under the Cannabis General Order².
6. Prior to conducting work in a Water of the State, submit an application and pay the required application fee for a Water Quality Certification/Waste Discharge Requirement³

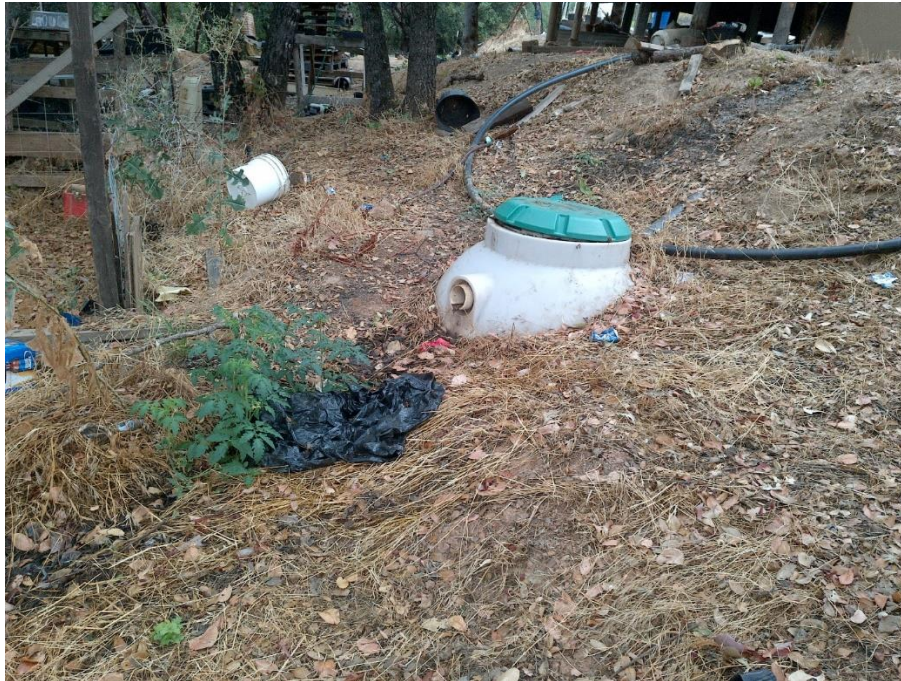
Figure 8—Photo of sewage tank at WQ2. Sewage pipes from the structure in background of image flow into tank. A pipe exiting the tank is open and human waste is visible on the pipe and on the ground next to the tank.

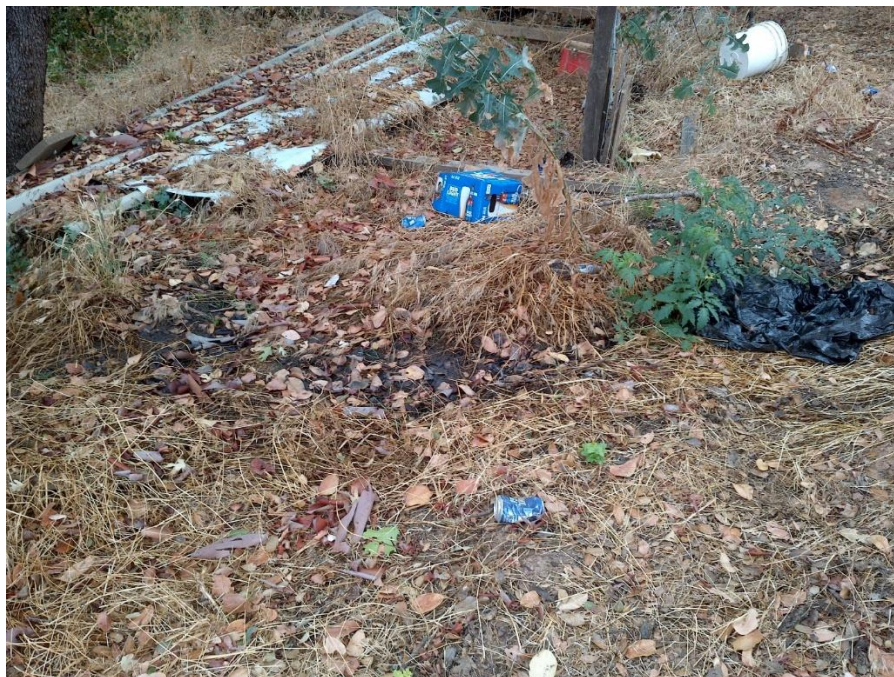
Figure 9—Photo showing the area downstream from discharging tank pictured in the previous image. The black plastic bag in the right of the image is visible in both pictures. A path of darkened soil marks the location where sewage has discharged.

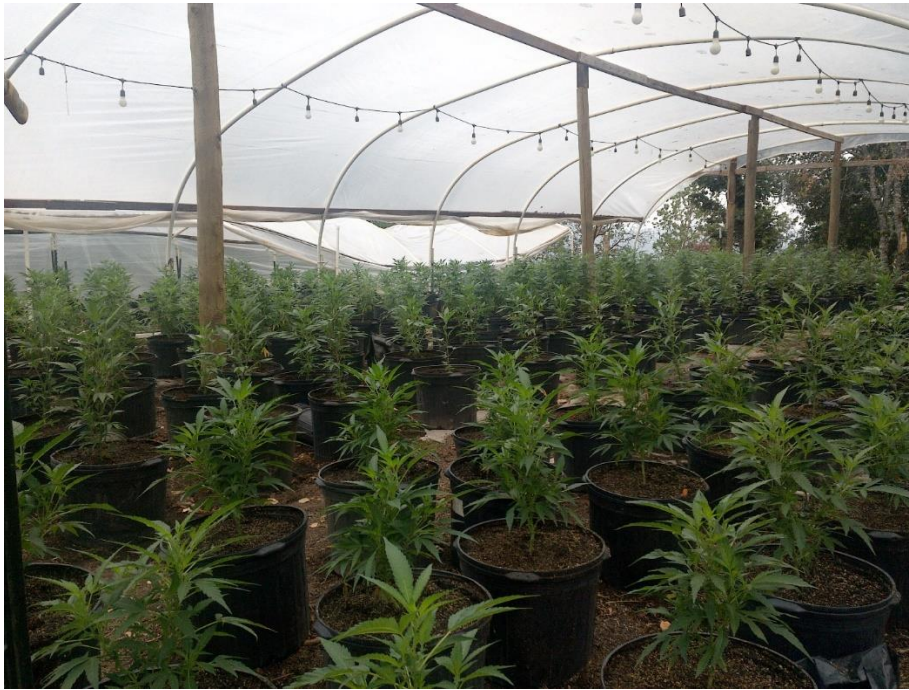
Figure 10—Photo showing cannabis plants growing in black plastic pots inside a hoop-type greenhouse south of WQ2.

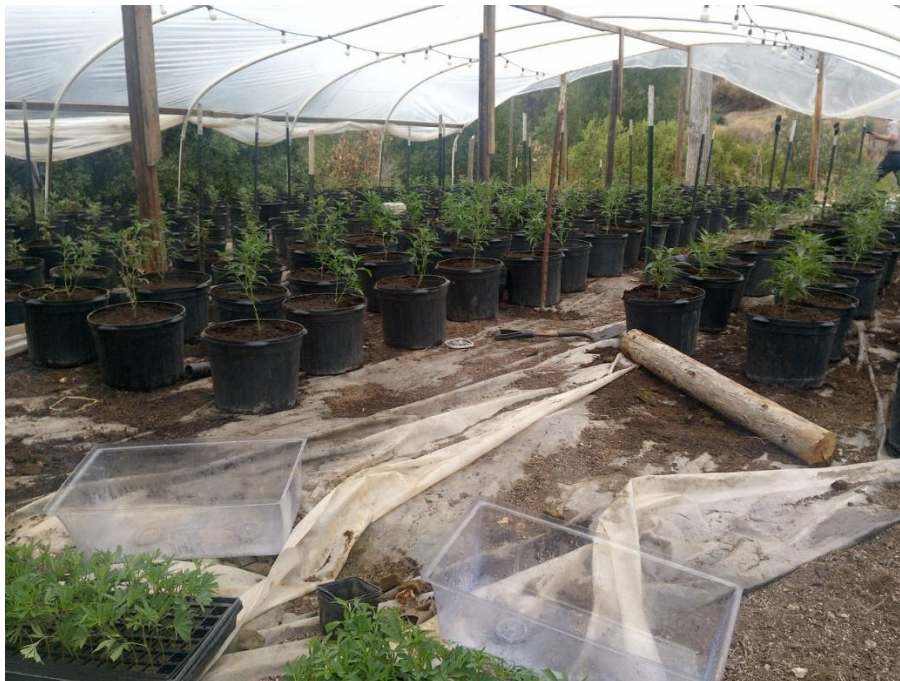
South of the sewage tank, I observed a hoop-type greenhouse covering an area of at least 1,200 square feet with cannabis plants growing in plastic pots. North of the structure, at WQ3, I observed another hoop-type greenhouse covering an area of at least 1,200 square feet with cannabis plants growing in plastic pots. To the east of WQ3, at WQ4, I observed a shallowly excavated hole filled with refuse. North of the hole, at WQ5 I observed more hoop-type greenhouses with cannabis plants growing in raised garden beds. The greenhouses cover an area of approximately 2,000 square feet on top of a graded pad. The northeast edge of the pad was cut into the hillside forming near vertical slopes. I observed piles of uncontained potting soils in the vicinity of WQ5.

Figure 11—Photo showing cannabis plants growing in black plastic pots inside a hoop-type greenhouse at WQ3.

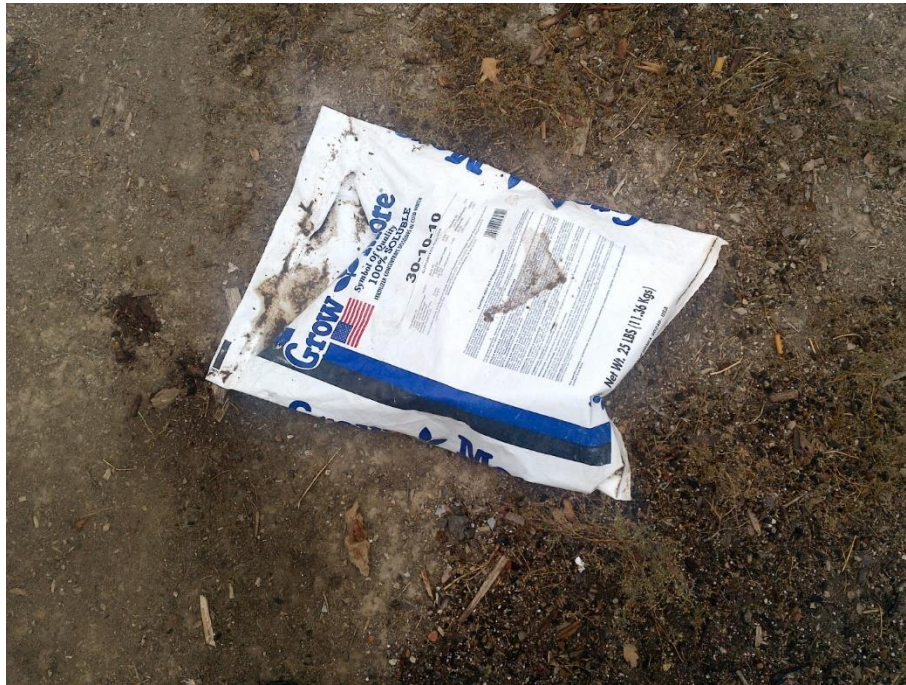
Figure 12—Photo showing a bag of high-concentration, water-soluble nutrients on the ground in the vicinity of WQ3.

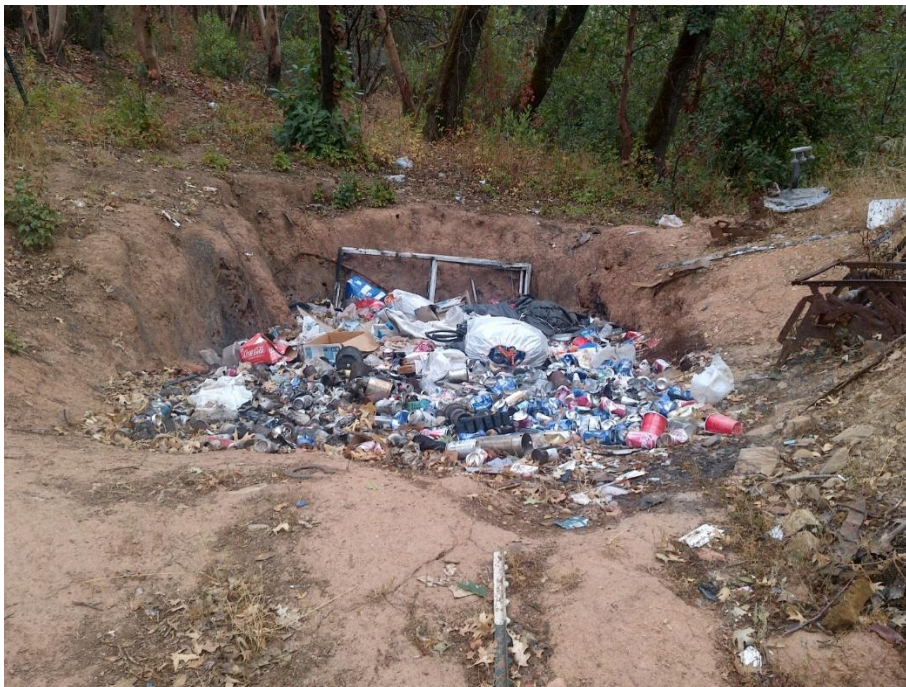
Figure 13—Photo showing refuse placed in a shallowly excavated hole at WQ4.

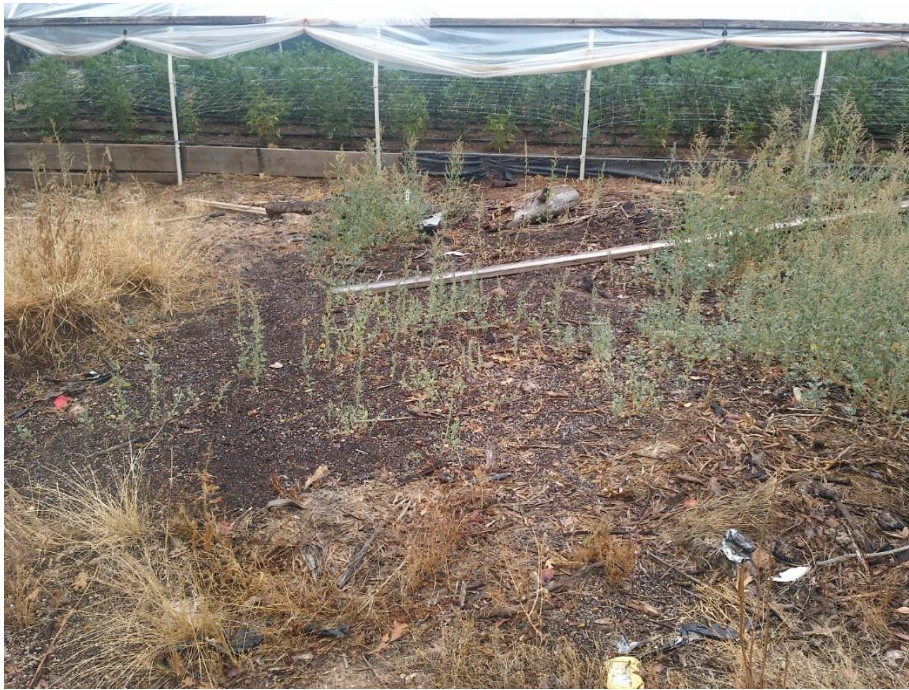
Figure 14—Photo of hoop-type greenhouse occupying the pad at WQ5. Cannabis plants are visible growing in raised garden beds inside the greenhouse.

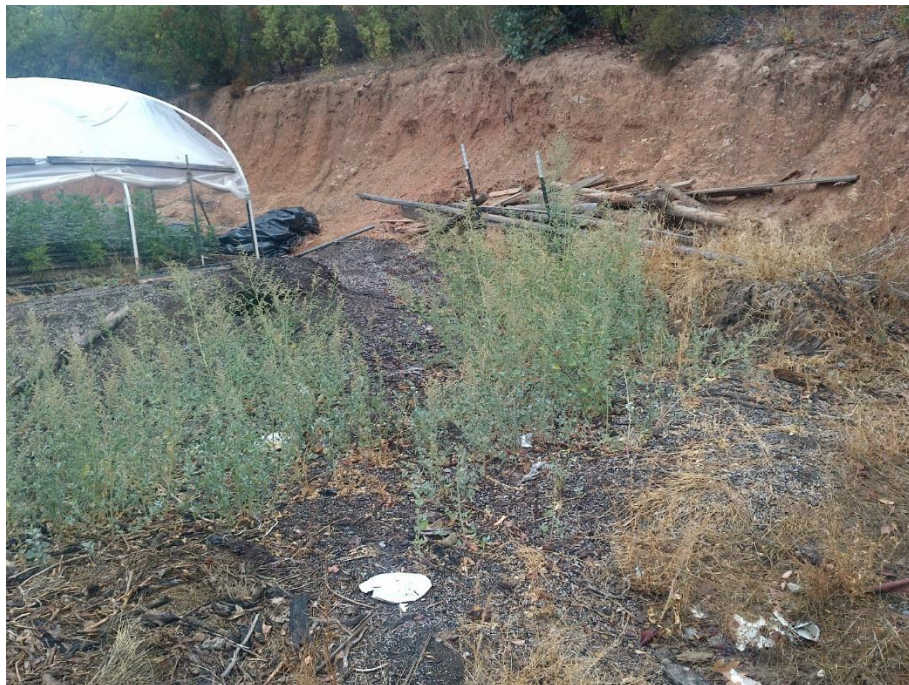
Figure 15—Photo of hoop-type greenhouse at WQ5. The back of the image shows near-vertical slopes where the pad was cut into the hillside. The foreground shows a pile of waste potting soils, identifiable from the white speckles of perlite contained in the soils.

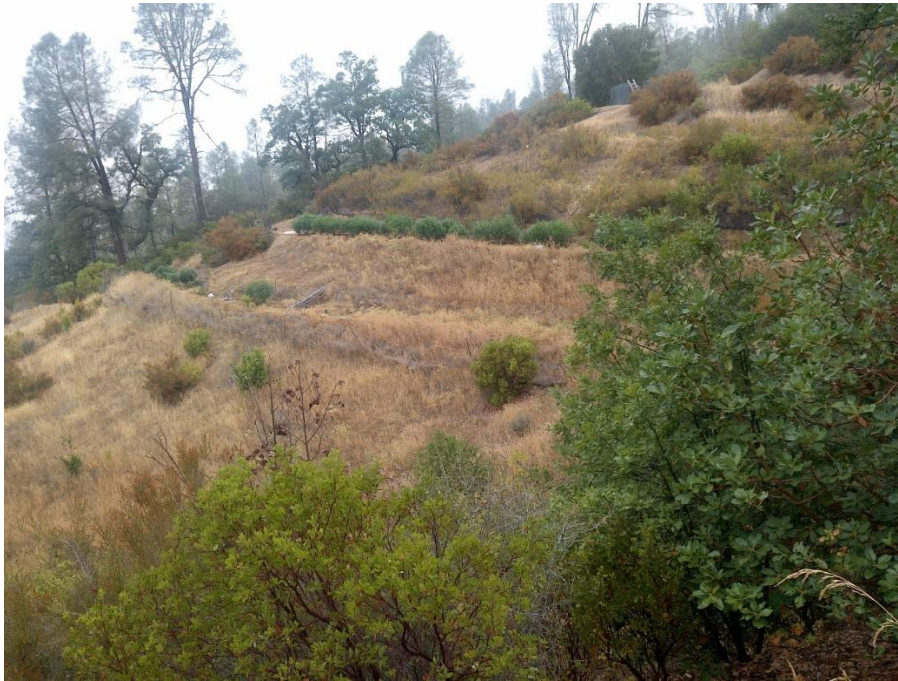
Figure 16—Photo looking northwest at the terraced outdoor cultivation area at WQ6. Approximately a dozen cannabis plants are visible growing on the top row, and a few are visible growing on the second row.

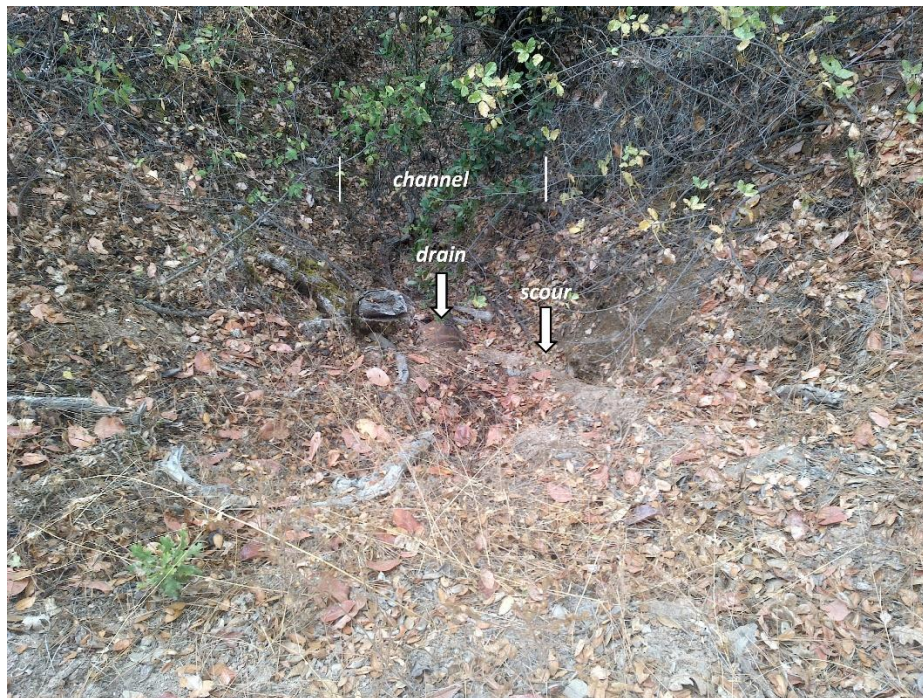
Northwest of WQ5, I observed a terraced outdoor cultivation area with two rows of cannabis plants at WQ6. I walked to the eastern edge of the terraced cultivation area and then north along a road to WQ7 where I observed a watercourse culverted under the road. The culvert was significantly narrower than the channel downstream and I observed scour marks on the road prism above the pipe indicating that stormwater flows had exceeded the capacity of the culvert and begun eroding the road prism.

Figure 17—Photo looking downstream at a watercourse crossing located at WQ7. A rusted 12-inch diameter corrugated metal pipe is identified as the drain in the middle of the image. The pipe is significantly narrower than the channel downstream and scour marks are visible on the road prism above the pipe.

As documented in the inspection report, at least one stream crossing must be corrected to comply with the Basin Plan. The work to correct this violation will require a water quality certification/waste discharge requirement prior to conducting instream work.

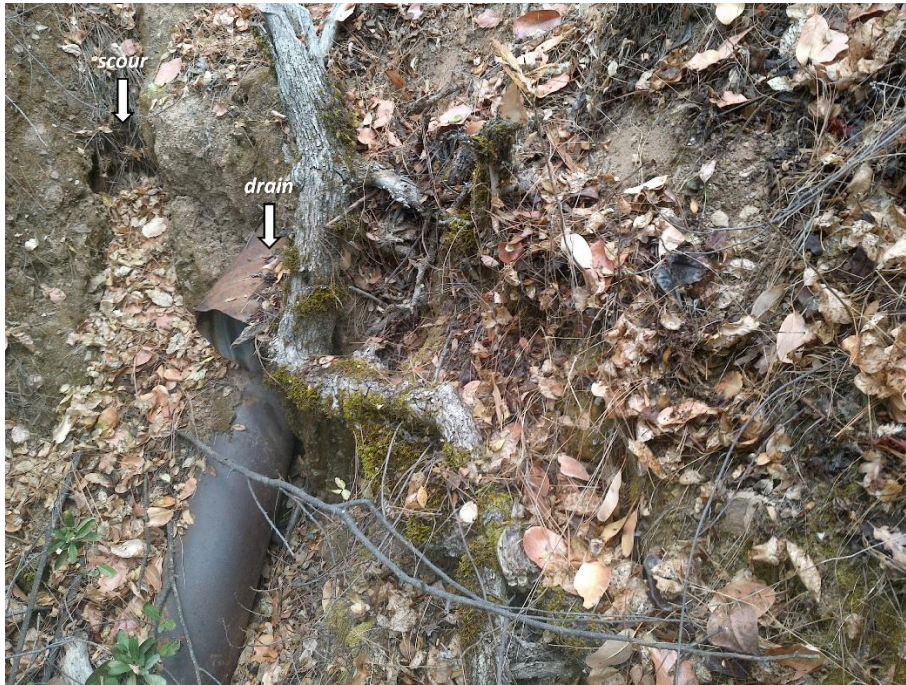
Figure 18—Photo looking upstream from the left bank at the culvert outlet at WQ7. The picture shows the same drain and scour marks as in the other image but from a different angle.

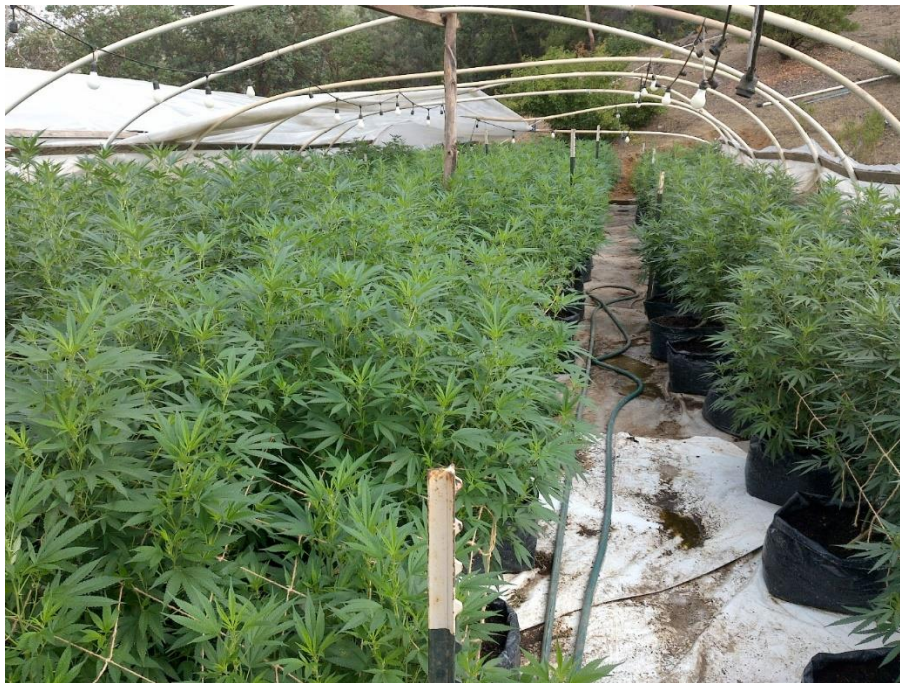
Figure 19— Photo showing cannabis plants growing in black plastic bags inside a hoop-type greenhouse at WQ8.

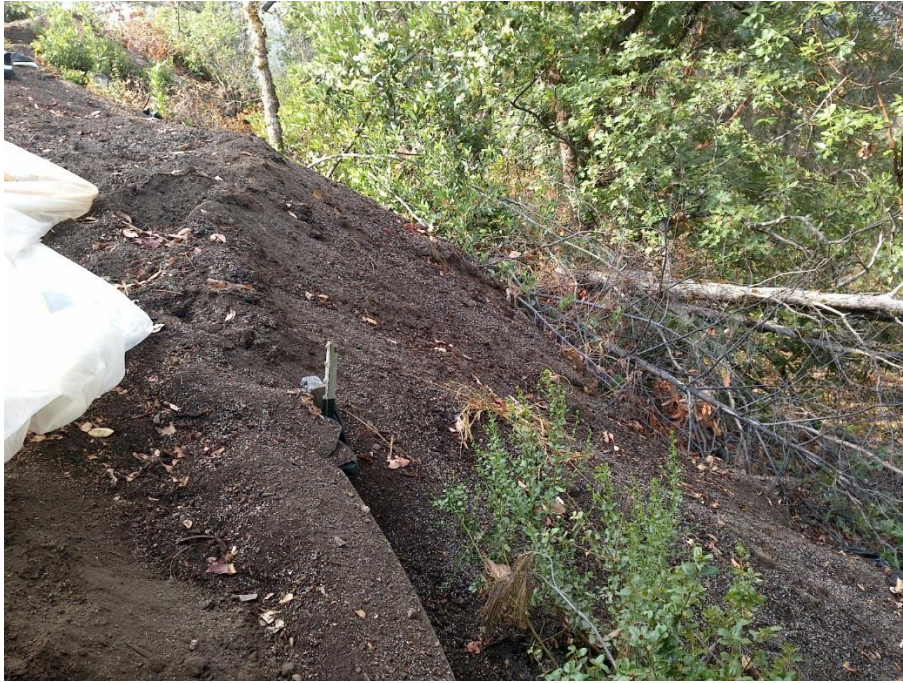
I then returned to the southern property entrance and drove to a separate entrance near the northwestern portion of the Property. At WQ8 I observed hoop-type greenhouses covering 3,000 square feet of a graded pad. I observed waste potting soil disposed on the downslope edges of the pad in addition to other cultivation waste including plastic netting.

Figure 20—Photo of the western edge of the cannabis cultivation pad located at WQ8. Waste potting soils, identifiable from the white speckles of perlite contained in the soils, cover the downslope side of the pad.

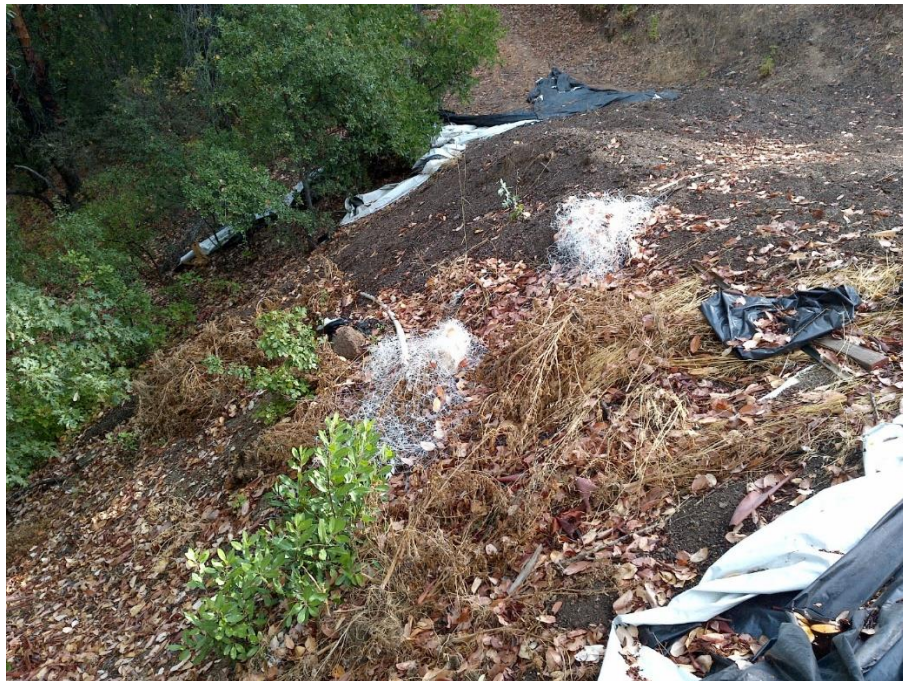
Figure 21—Photo showing uncontained plastic netting and plastic tarps in the vicinity of WQ8.
