**Subject: Notice of Violation, Transmittal of Report for August 23, 2023 Inspection of Mendocino County Assessor's Parcel Number 034-100-25-00, and Recommendation to Respond within 30 days**

**Report of August 23, 2023 Warrant Inspection,  
Mendocino County  
Assessor's Parcel Number 034-100-25-00 (the "Property")**

File: Cannabis Program Inspections, Mendocino County, 2023, Alfredo Vizcaino, CIWQS Place ID 890276

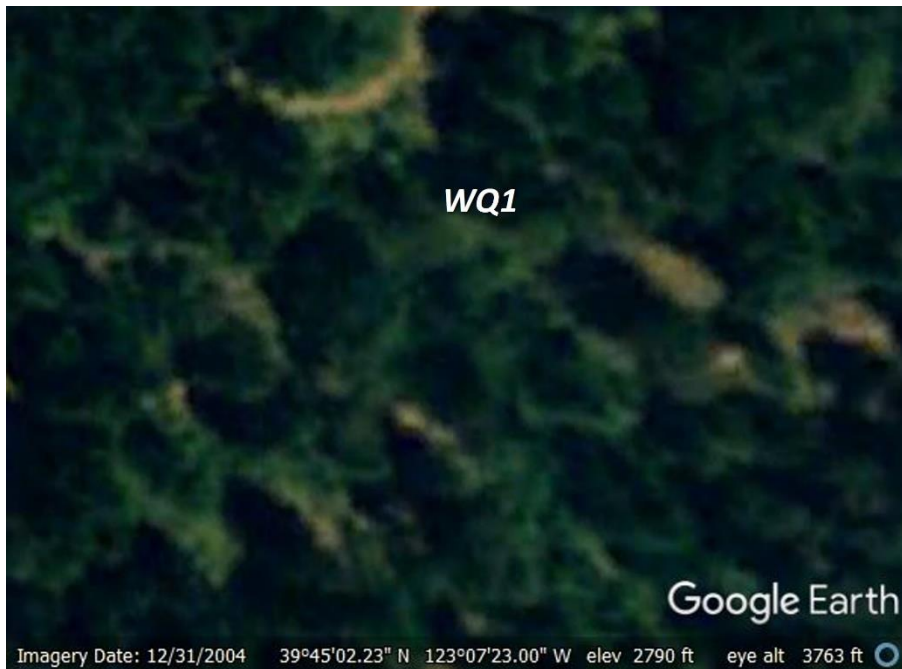
*Figure 2—Aerial image of the Property taken on December 31, 2004, obtained from Google Earth. The onstream reservoir identified at WQ1 is not apparent in the image.*

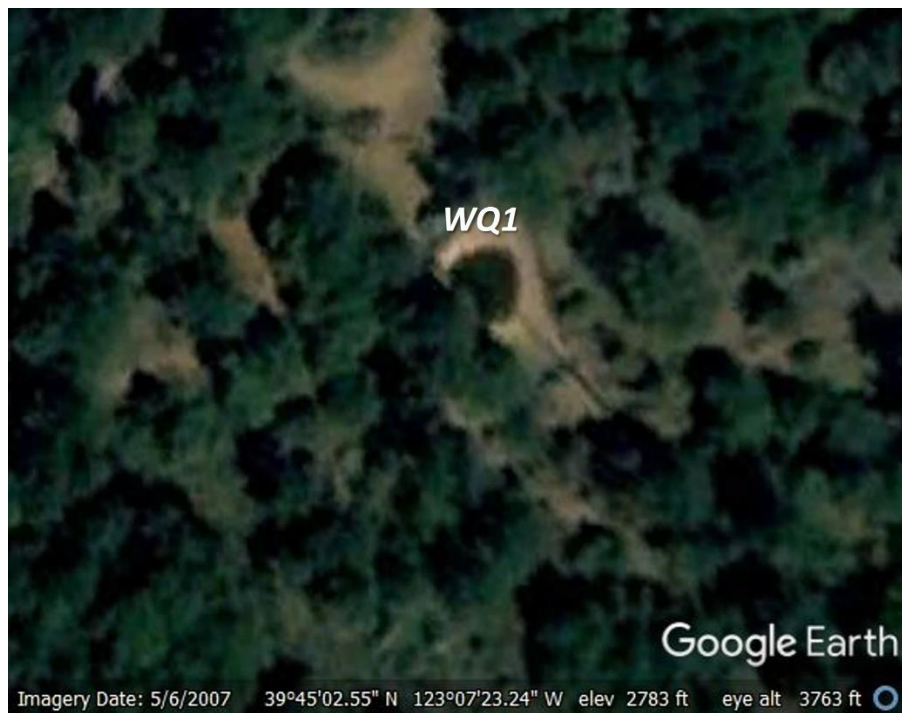
*Figure 3—Aerial image of the Property taken on May 6, 2007, obtained from Google Earth. The onstream reservoir identified at WQ1 is apparent in the image.*

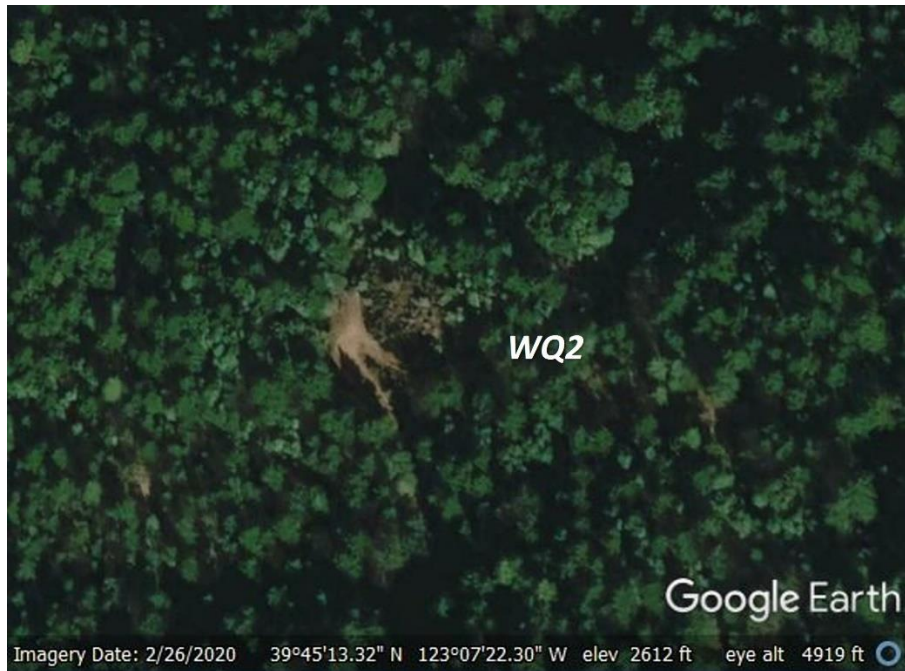
*Figure 4—Aerial image of the Property taken on February 26, 2020, obtained from Google Earth. The image shows the area where staff observed a cultivation pad at WQ2. The area appears forested in this image.*

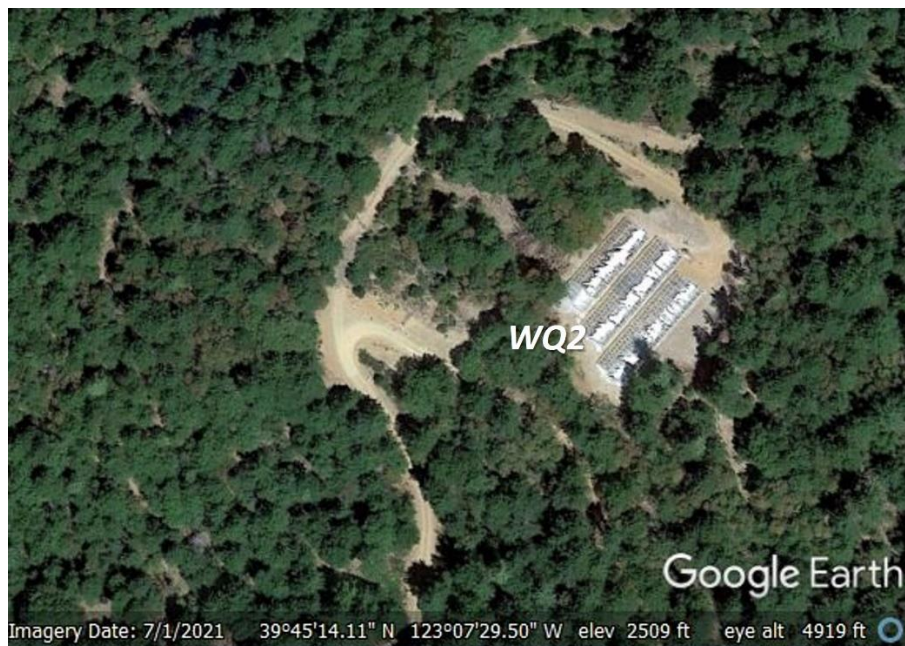
*Figure 5—Aerial image of the Property taken on July 1, 2021, obtained from Google Earth. The image shows a cultivation pad with three hoop-type greenhouses at WQ2*

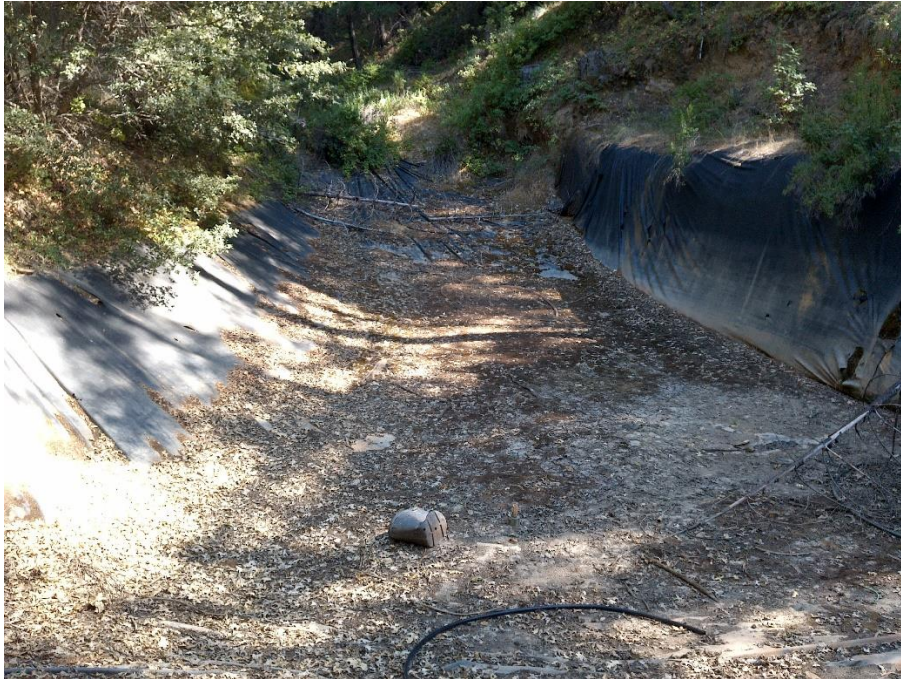
I entered the Property from the south and stopped in the vicinity of WQ1. I observed a rectangular area encompassing a watercourse that had been excavated and an earthen dam had been constructed at WQ1 making an onstream reservoir. I observed that the reservoir's drainpipe had been shallowly buried in the berm, allowing for less than two feet of freeboard if the reservoir was filled. I observed that the reservoir's drainpipe was not long enough to transport all outflow beyond the tow of the berm.

*Figure 6—Photo looking south at onstream reservoir located at WQ1. The reservoir is dry and lined with a black material.*

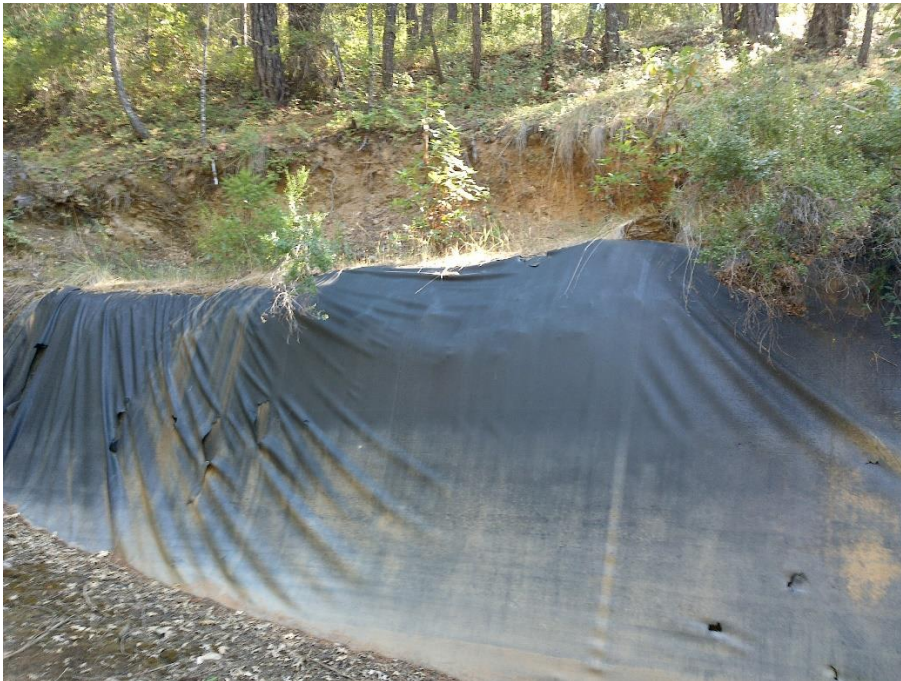
*Figure 7—Photo looking at the west bank of the reservoir located at WQ1. The reservoir wall appears to be excavated into a hillslope and is nearly vertical.*

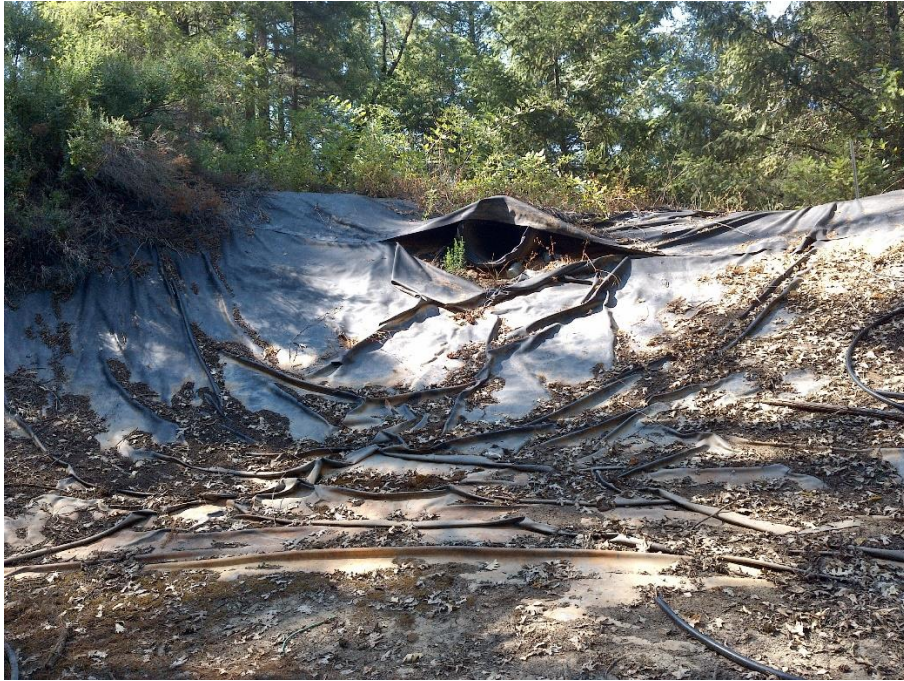
*Figure 8—Photo looking north at reservoir outlet at WQ1.*

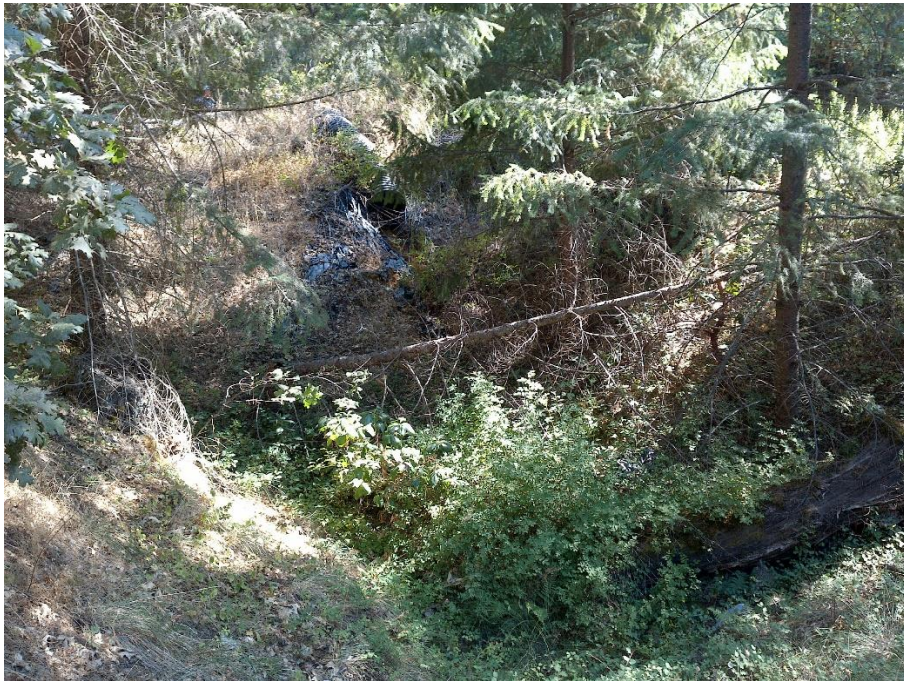
*Figure 9—Photo looking south at reservoir outlet at WQ1. The outlet pipe discharges onto the earthen dam embankment.*

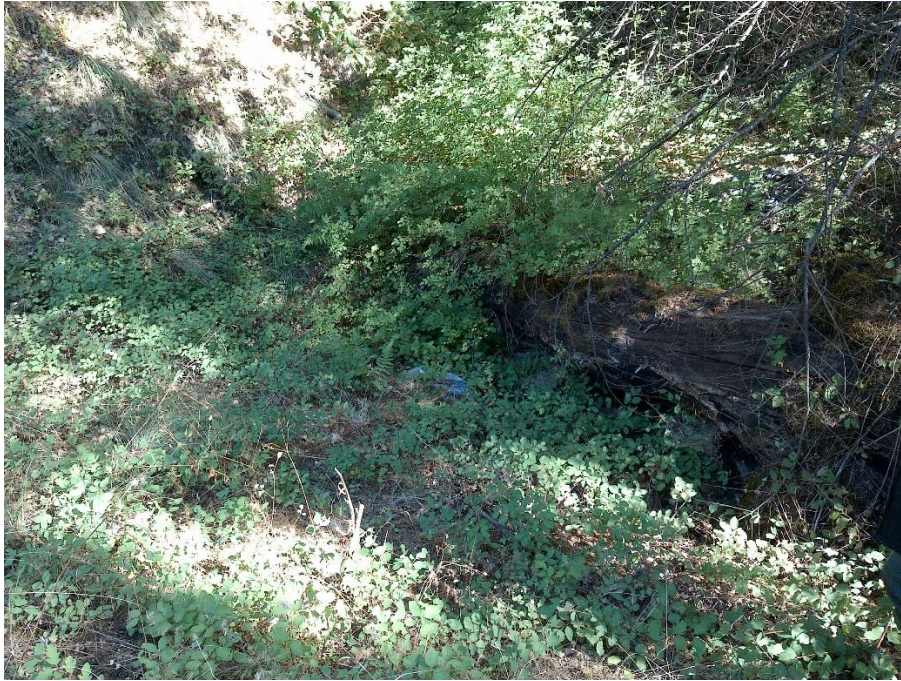
Downstream from the reservoir, I observed a culvert inlet that was blocked by a fallen tree. I walked to the opposite side of the road and observed that sediment had deposited in the bottom of the pipe and in the receiving channel, which decreased the culverts capacity for transporting water by approximately 80 percent.

*Figure 10— Photo looking south and upstream at a corrugated metal pipe inlet visible in the middle of the image. The reservoir outlet, pictured in the previous figure, is out of view in the back right of this image. The culvert inlet is blocked by a fallen tree.*

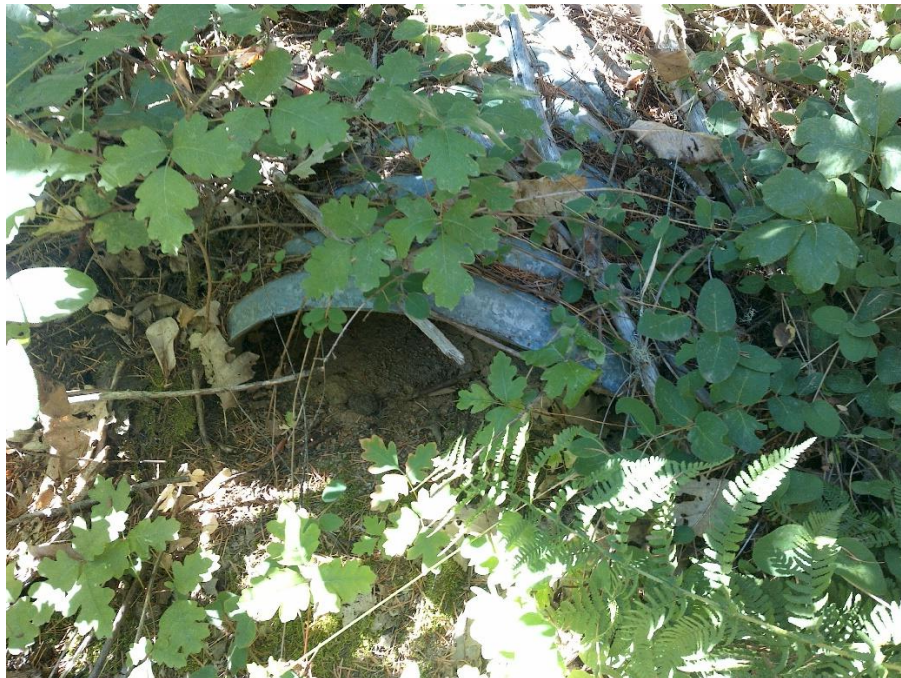
*Figure 11—Photo looking south and upstream at a corrugate metal pipe outlet. Sediment has deposited in the bottom of the pipe decreasing its capacity for transporting water by approximately 80 percent.*

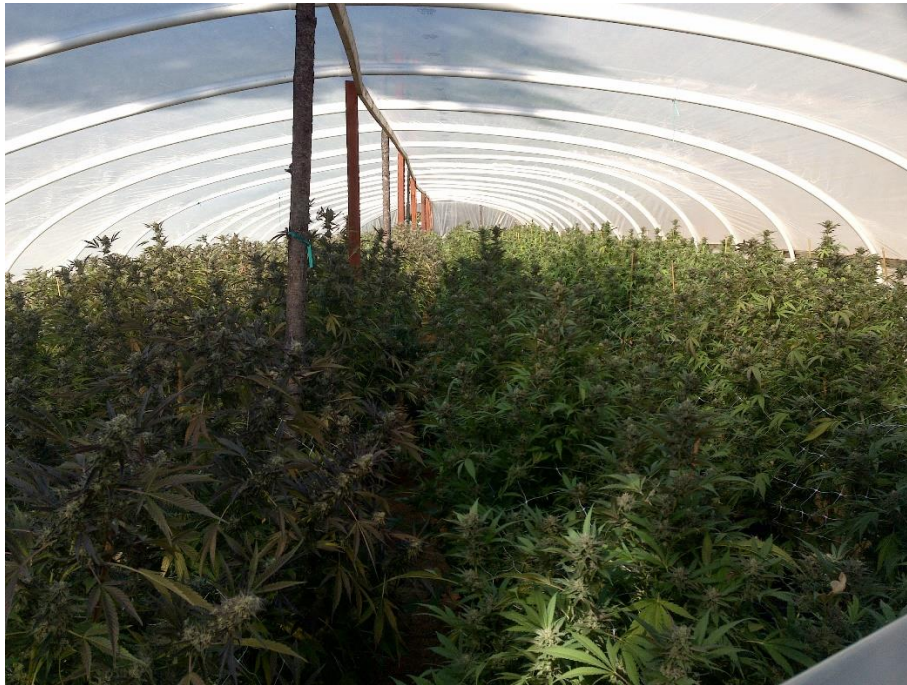
*Figure 12—Photo showing cannabis plants growing inside a hoop-type greenhouse located at WQ2.*

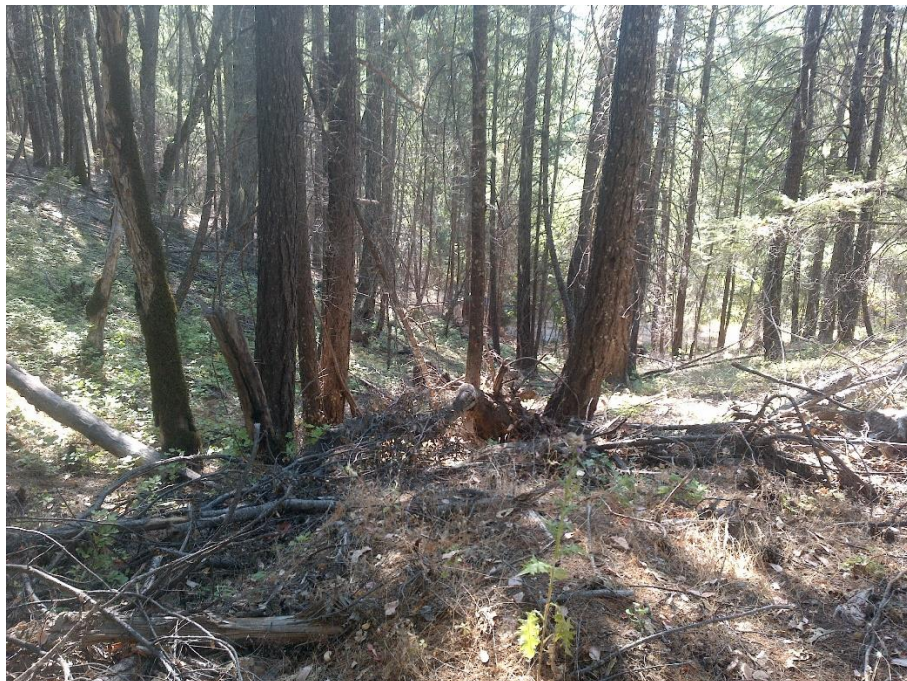
*Figure 13—Photo taken from WQ3 looking west toward WQ4. The photo shows a topographic swale with its long axis passing from the left to center of the image.*

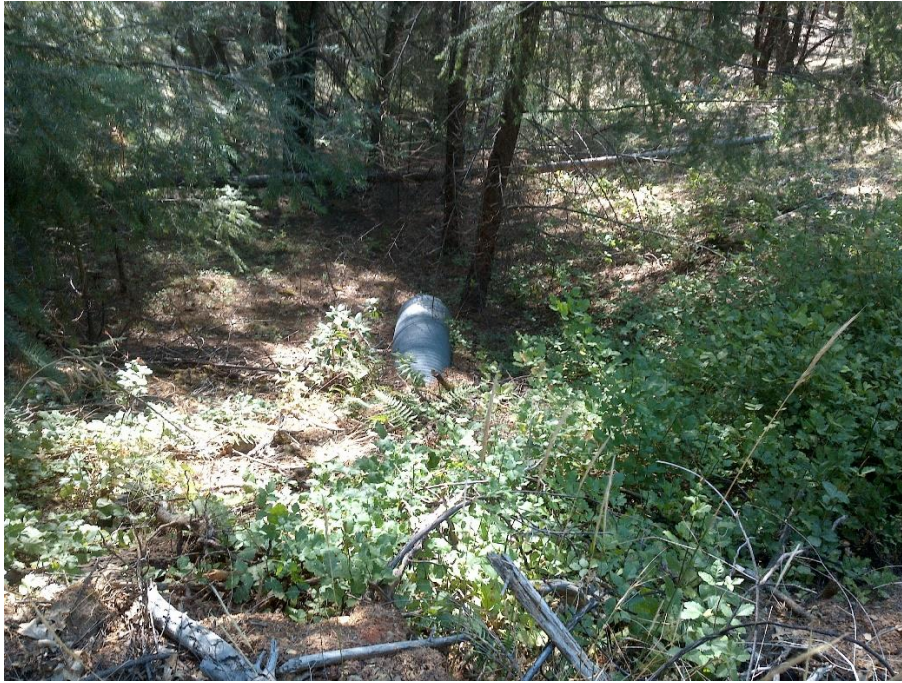
*Figure 14—Photo looking west and down gradient at a corrugated metal pipe located at WQ4. The presence of vegetation and the accrual of overlying leaf litter suggests that the culvert was installed years earlier.*

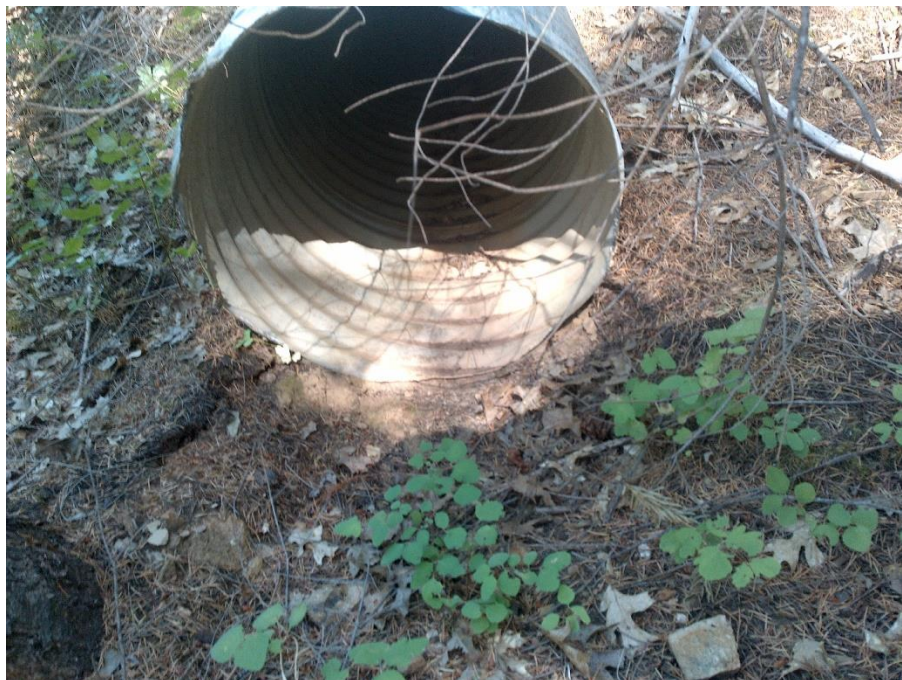
*Figure 15—Photo looking up-gradient at the outlet of a 24-inch diameter corrugated metal pipe at WQ4. The pipe discharges onto the forest floor and there is no sign of erosion or channel formation suggesting the culvert is only subjected to relatively small flowrates.*

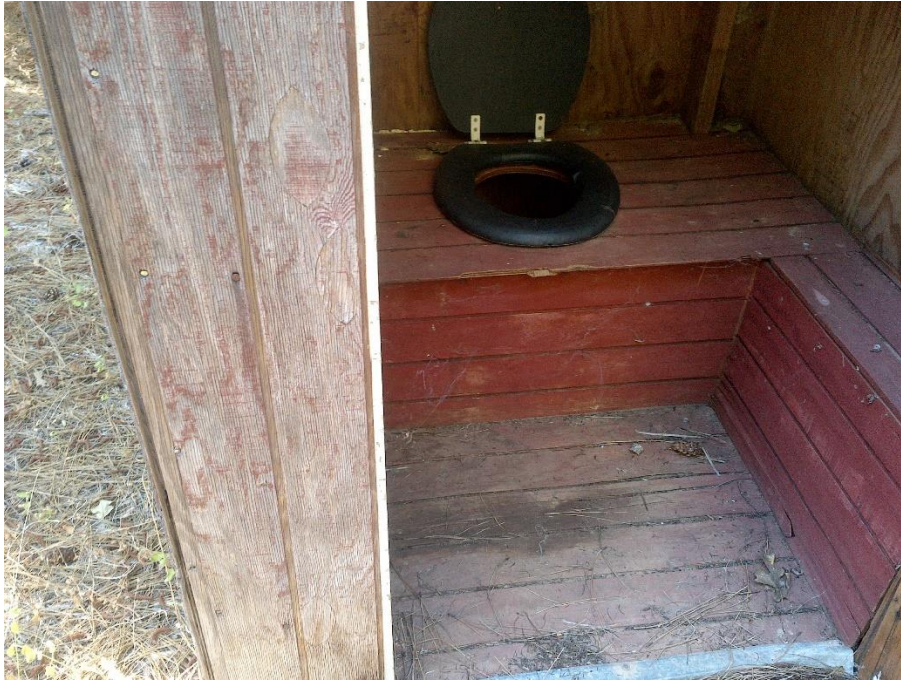
*Figure 16—Photo showing small structure with pit-toilet located near to a residential structure at WQ5.*

1. Immediately cease the discharge of sewage to land, implement corrective actions, and obtain the appropriate county permit for the disposal of on-site wastewater (i.e., septic system permit).
2. Retain a licensed professional to inventory, assess, any aquatic resources including springs, wetlands and watercourses that are Waters of the State on the Property, and to develop a workplan and schedule to implement measures to ensure that all impacted features, including the onstream reservoir at WQ1, are restored and that all developed features, roads and watercourse crossings throughout the Property are corrected, restored, and/or maintained in conditions that comply with the Cannabis Cultivation Policy<sup>1</sup>.
