## North Coast Regional Water Quality Control Board

### CLEANUP AND ABATEMENT ORDER

No. R1-2025-0054

Subject Property: Del Norte County Assessor's Parcel Number (APN) 140-130-028-000

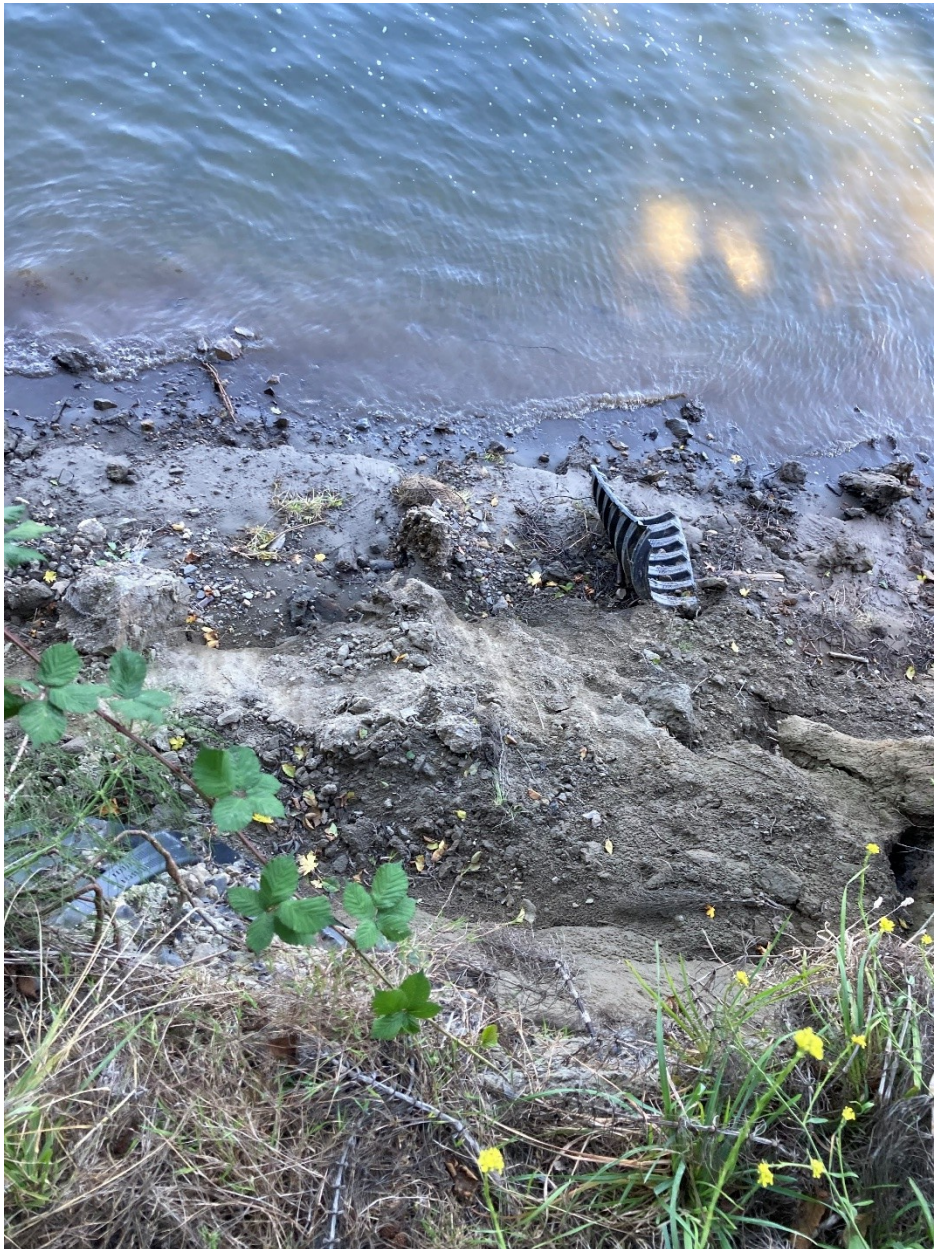
Photo No. 1 – IMG 1169

Del Norte County Environmental Health Division staff observed the riverbank erosion and OWTS failure, including a section of the leach field infiltrator at the bottom of the riverbank. According to these observations, the Discharger and, as a result, shall upon order of the North Coast Water Board clean up the waste or abate the effects of the waste, or, in the case of threatened pollution or nuisance, take other necessary remedial action, including, but not limited to, overseeing cleanup and abatement efforts as described below in this order. (Water Code §13304)

1. By October 24, 2025, pump all wastes from the septic tanks associated with the failed OWTS and provide receipts and photographic confirmation of implementation to the North Coast Water Board.
2. By October 24, 2025, complete all work to clean up and properly dispose of all wastewater system components and other infrastructure that have broken off and already discharged or threaten to discharge to waters of the state and provide receipts and photographic confirmation of implementation to the North Coast Water Board.
3. By October 24, 2025, disconnect the failed OWTS from receiving wastewater flow from any source, including but not limited to any buildings, recreational

4. By October 24, 2025, disable any components of the failed OWTS that, if activated, would cause the contents of the tanks to be pumped out or move from the tanks to the dispersal components of the OWTS and provide receipts and photographic confirmation of implementation to the North Coast Water Board.
5. By November 15, 2025 and on the 15<sup>th</sup> of each calendar month thereafter until notified in writing by the Regional Board Executive Officer, provide photo documentation to the North Coast Water Board of the condition of the bank of the Klamath River at the location of the exposed OWTS components and of the OWTS dispersal field itself, including any additional OWTS components that have been exposed by erosion or fallen into the Klamath River or its channel.

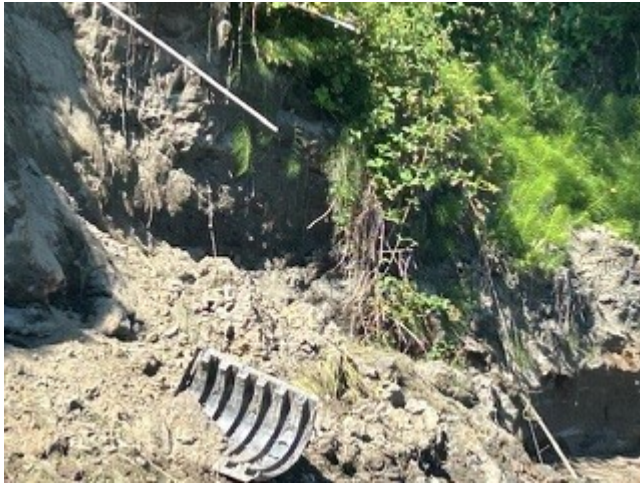
Photo No. 1

On September 16, 2025, the North Coast Water Board received a complaint regarding alleged unauthorized discharges of domestic waste to waters of the state. On September 16, 2025, a representative from the Del Norte County Environmental Health Division visited the Property and documented site conditions that included riverbank erosion and onsite wastewater treatment system (OWTS) failure (Attachment A – Del Norte County Environmental Health Division 9/16/25 Site Photos). On September 24, 2025, the complainant provided photos of the Property taken on August 19, 2025, to the North Coast Water Board (Attachment B – Complainant 8/19/25 Site Photos).
