STATE OF CALIFORNIA  
THE RESOURCES AGENCY  
DEPARTMENT OF WATER RESOURCES  
NORTHERN DISTRICT

**WATERSHED MANAGEMENT  
FOR  
UNSTABLE AND ERODIBLE AREAS  
IN NORTH COASTAL CALIFORNIA**

Prepared for the U.S. Environmental Protection Agency  
and the State Water Resources Control Board  
October 1982

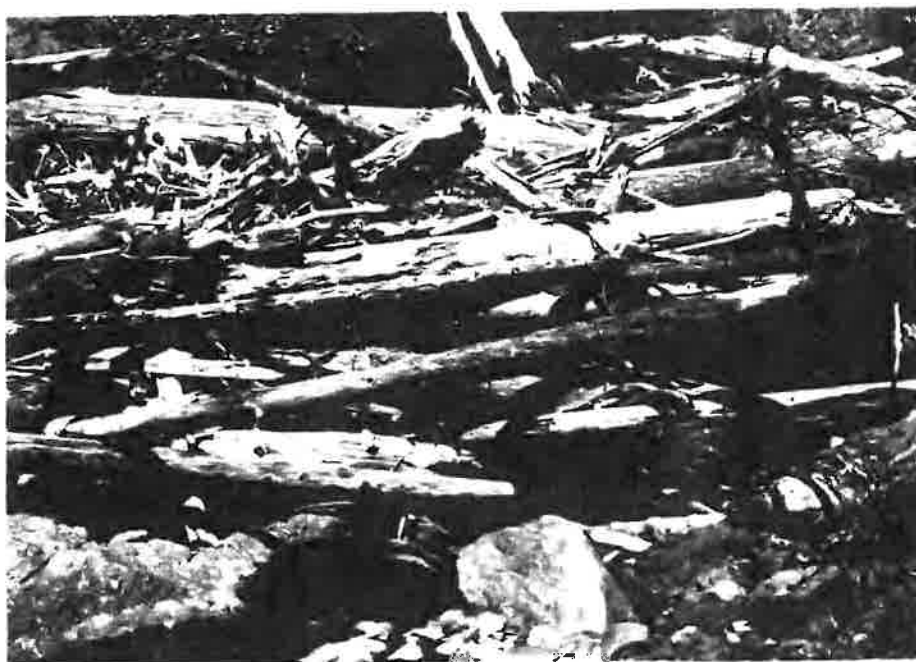
Photograph 2. Numerous log jams and barriers prevent anadromous fish from using most of Grouse Creek and its tributaries. These streams support mostly a resident fishery.

these streams have been so severely damaged (Photograph 2) over time that even when fish habitat conditions improve and log jams are removed, the tributary remains under-used by the remaining limited stocks of fish. This problem has been discussed at length by many authors and will not be treated further here. For more information on the Klamath River fishery, please see the following authors: ESA (1980), Rankel (1980), U. S. Fish and Wildlife Service (USFWS) (1979), Buer (1981), Kesner (1977), Snyder (1931), and USFWS (1960).

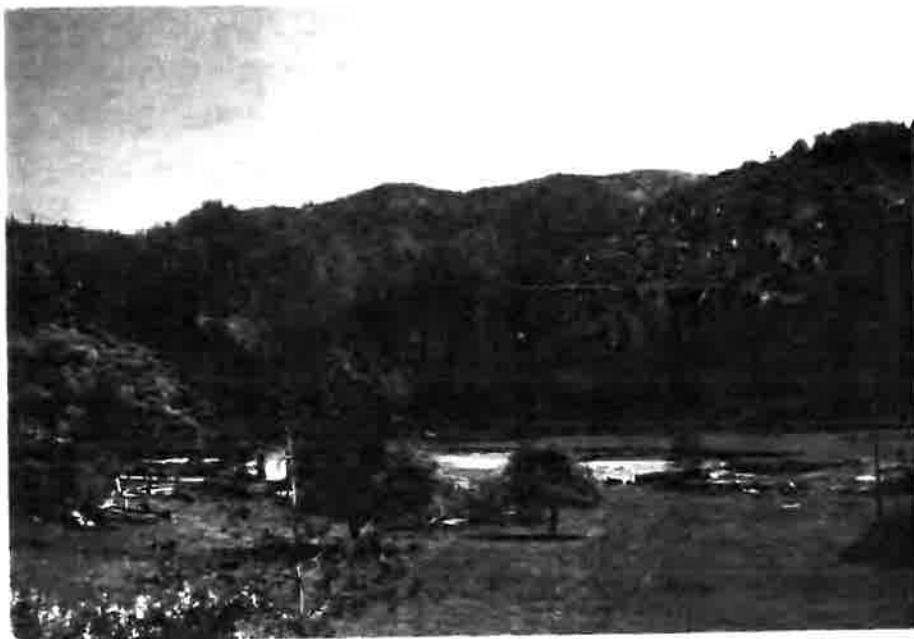
Photograph 3. The lower five miles of Turwar Creek has most of the anadromous salmonid habitat in the watershed.

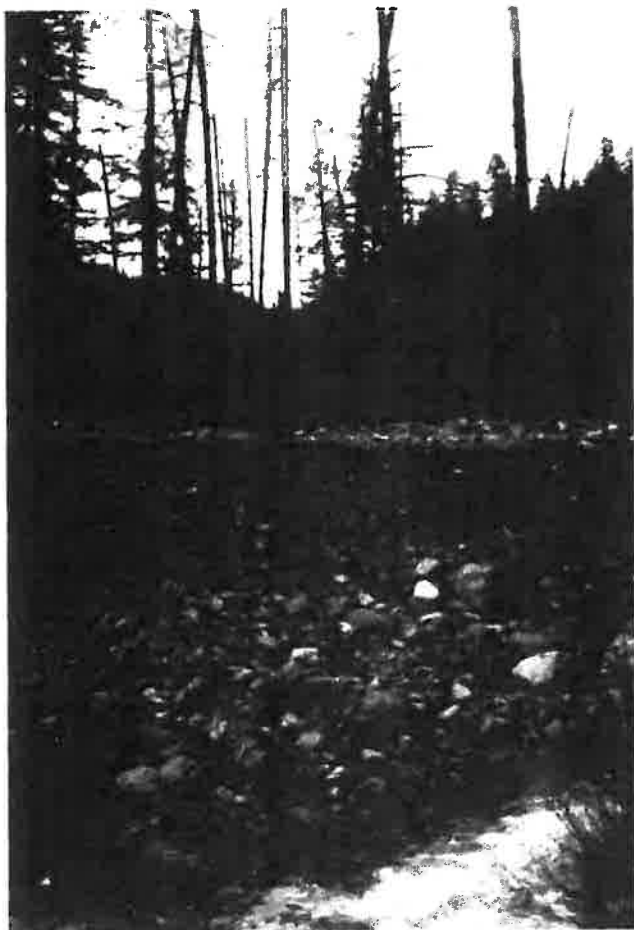
Photograph 4. Large amounts of sand, gravel, and debris were deposited in Crouse Creek and its tributaries during the 1964 flood.

Two major problems facing the Grouse Creek fishery are the slow recovery of the watershed and the stream channel since the flood (Photograph 4) and continued clearcutting of large areas on geologically sensitive terrain. Stream profiles for Grouse Creek are shown in Figure 5.

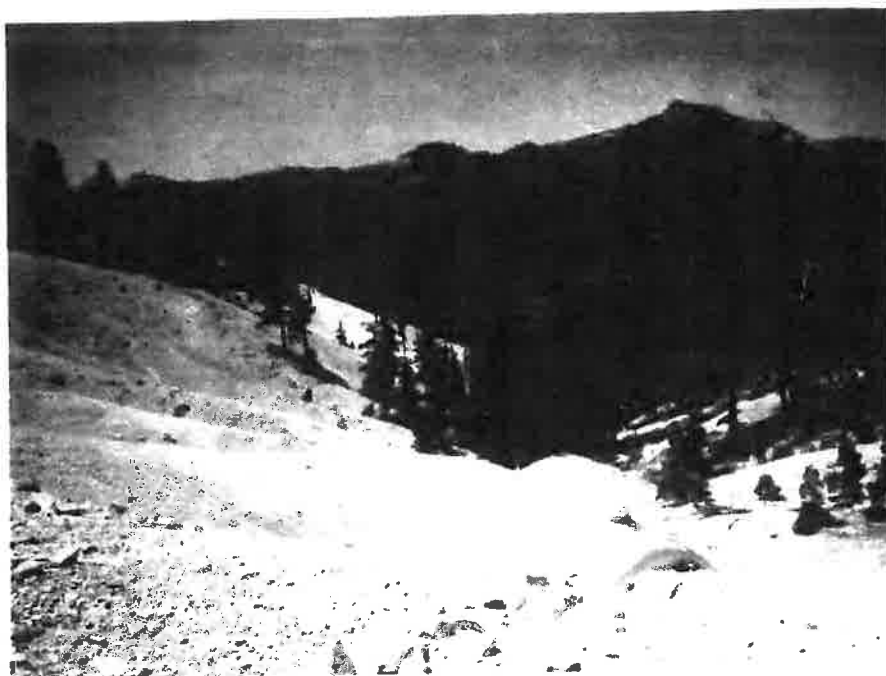
Photograph 5. "Serpentinite barrens" in the Rattlesnake Creek terrane. Rocks in the foreground are highly sheared serpentinite and greenstone. The peak in the background is Chimney Rock, a massive monolith of greenstone.

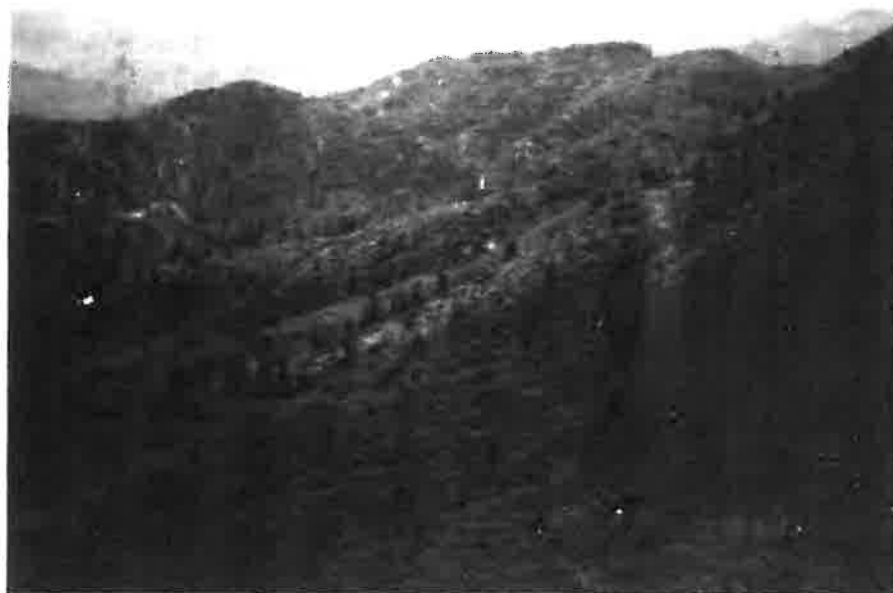
Photograph 7. Looking north along the eastern edge of the Turwar Creek basin. The South Fork fault parallels the edge of Red Mountain, approximately at the break in slope. Numerous landslides have occurred along the fault, such as the one in the foreground.

The Coast Ranges are separated from the Klamath Mountains to the east by an east-dipping thrust fault named the South Fork fault by Irwin (1974) (Photograph 7). The most common geologic unit in the Coast Ranges is the Franciscan complex. These sedimentary, metamorphic, and volcanic rocks were formed in a deep marine environment. In general, the degree of metamorphism and age of the Franciscan decreases towards the west. The degree of metamorphism is most easily recognized by the degree of schistosity and deformation. The rock subunits are separated on this basis into textural zones that are generally bounded by east-dipping thrust faults.

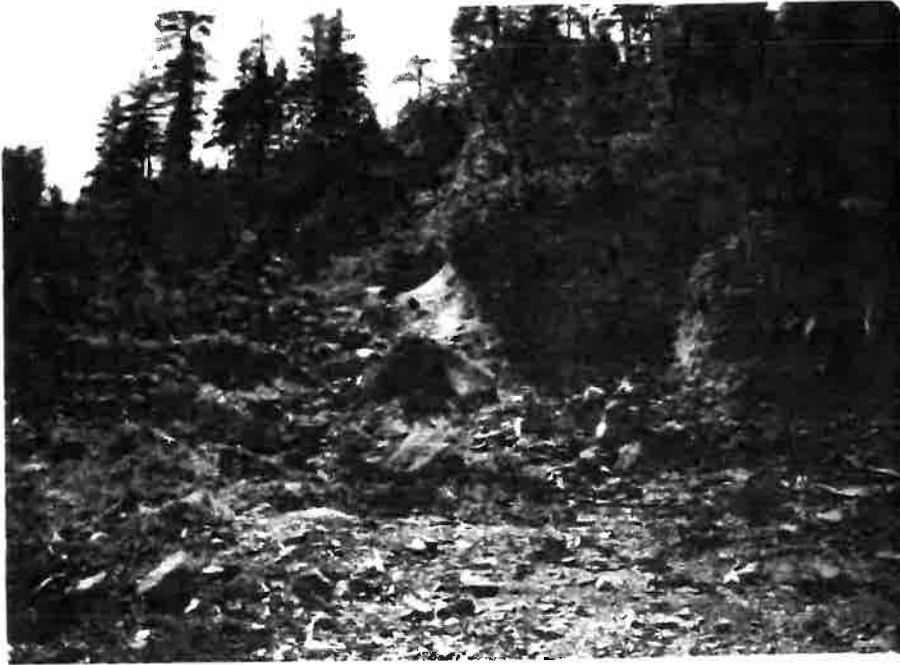
Photograph 8. The head scarp region of a translational-rotational slide. The slide occurred in deeply weathered ultramafic rocks on Red Mountain in Blue Creek.

- 1) Translational-Rotational Slide (Photograph 8). A combination slide that is characterized by a rotational, or slump-type failure in the head region and translational movement in the main slide mass. The failure plane is generally deep and the slide mass is generally cohesive when compared to a debris slide of similar size.
- 2) Debris Slide. Slow-to-rapid downslope movement of predominantly unconsolidated and incoherent debris (a combination of earth, soil, rock, and organic matter), in which the mass slides and rolls forward along a relatively shallow failure plane. These slides occur most often along streams (Photograph 9) and typically form steep, unvegetated scarps in the head region and irregular, hummocky deposits (when present) in the toe region.
- 3) Debris Flow/Torrent Tracks. These are formed by extremely rapid movement of debris-laden water. They are commonly caused by a

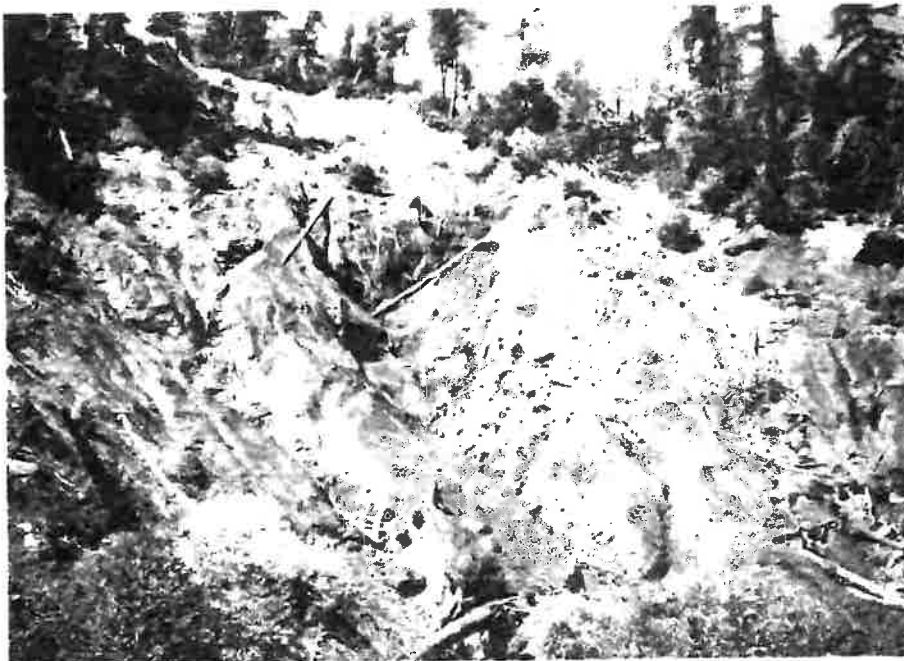
Photograph 9. A large debris slide along Grouse Creek. The scar continues to ravel and erode long after initial failure.

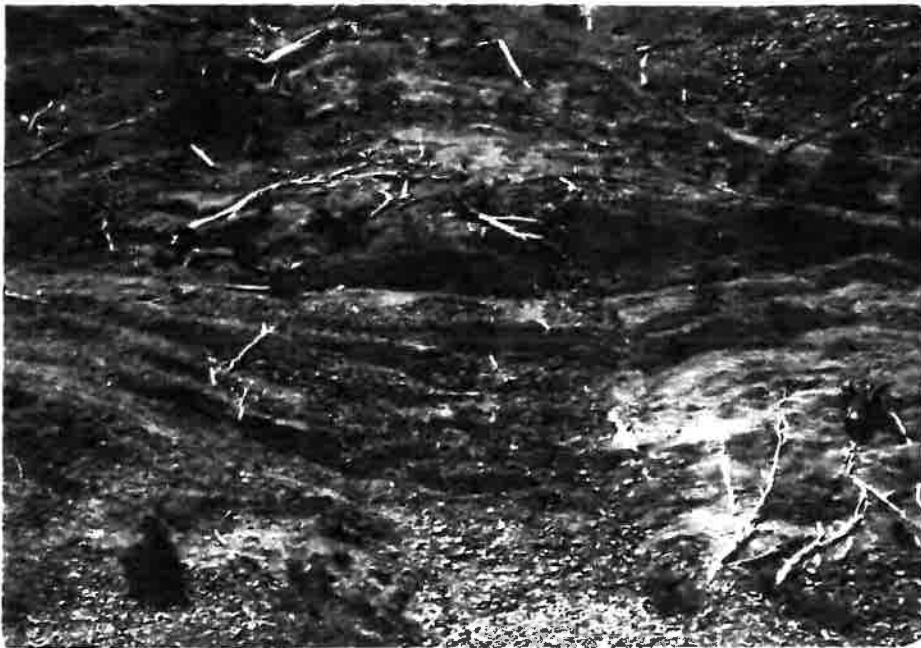
Photograph 10. Toe region of a large earthflow in the Grouse Creek basin. Note the hummocky ground, uprooted vegetation, and the general lack of revegetation 15 years after the last major movement.
