Update on Post-Fire Monitoring Current State of Knowledge and Future Planning

Item 9

September 6, 2018

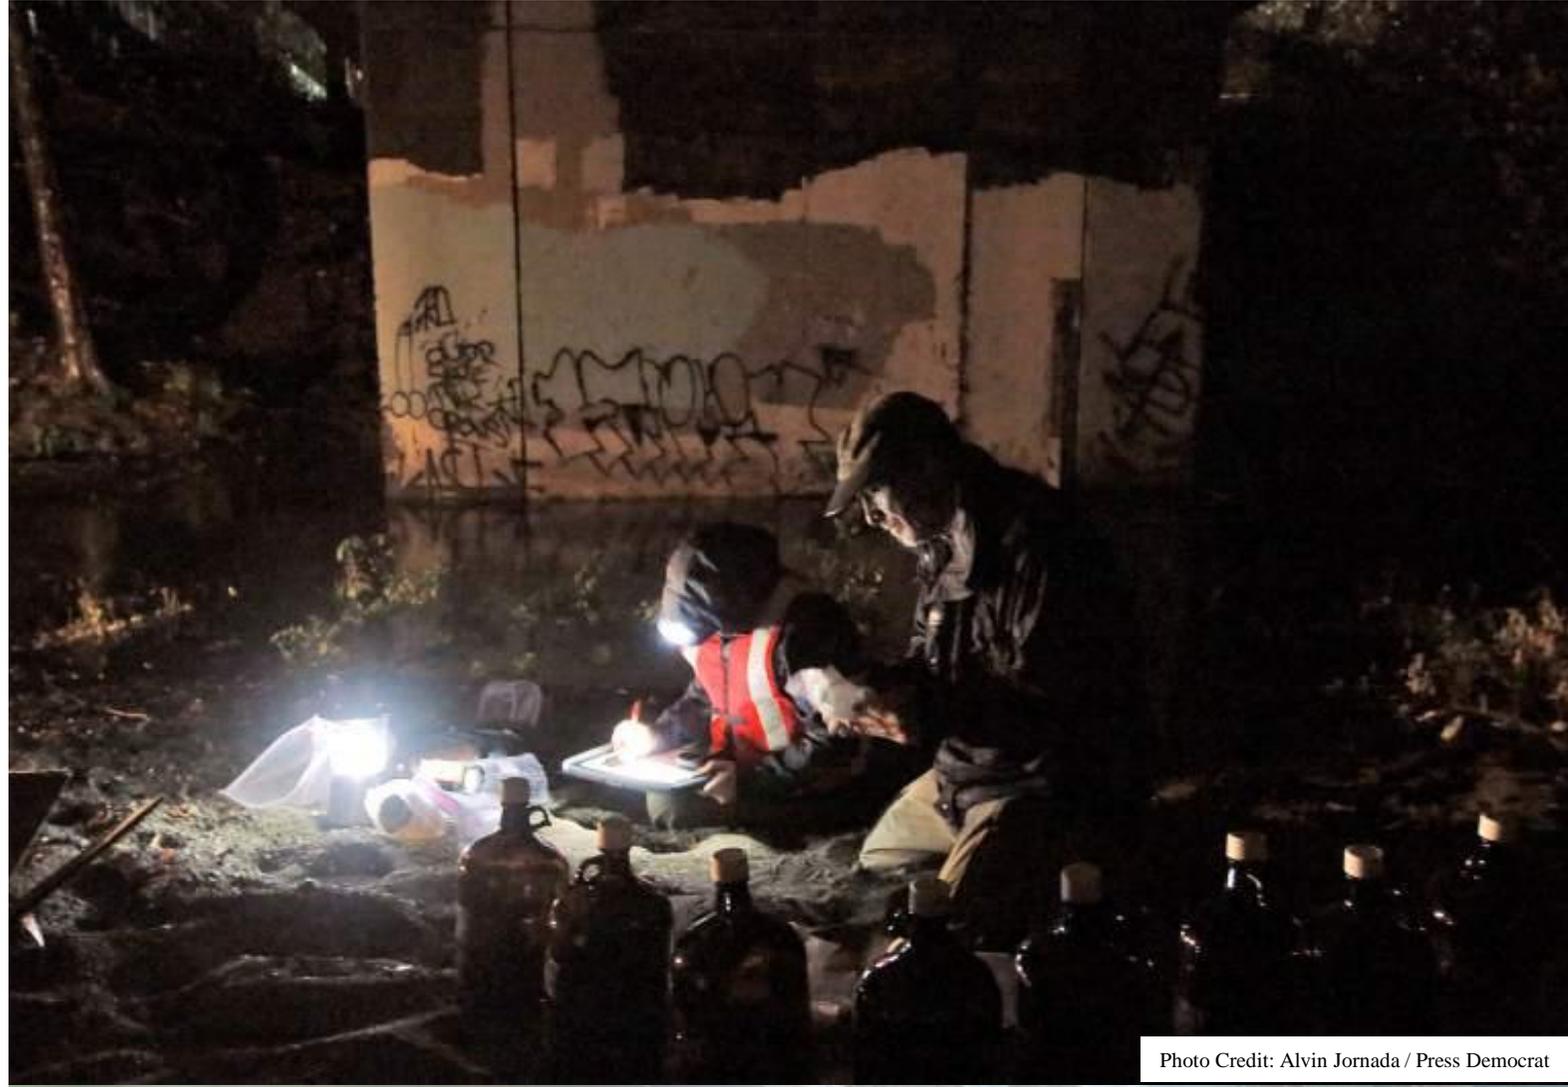
Surface Water Monitoring Plan

(Winter 17/18)

Regional Water Board staff assessed potential impacts to surface waters downstream of burned areas by monitoring surface water quality. Samples were collected at four locations within the Mark West Creek watershed (Fig. 1). The first set of samples was collected on November 1st, prior to any storm events as a baseline dataset. Three subsequent sampling events were timed to collect samples in conjunction with storm runoff events on Nov. 8, Nov. 15 and March 22 (Fig. 3).

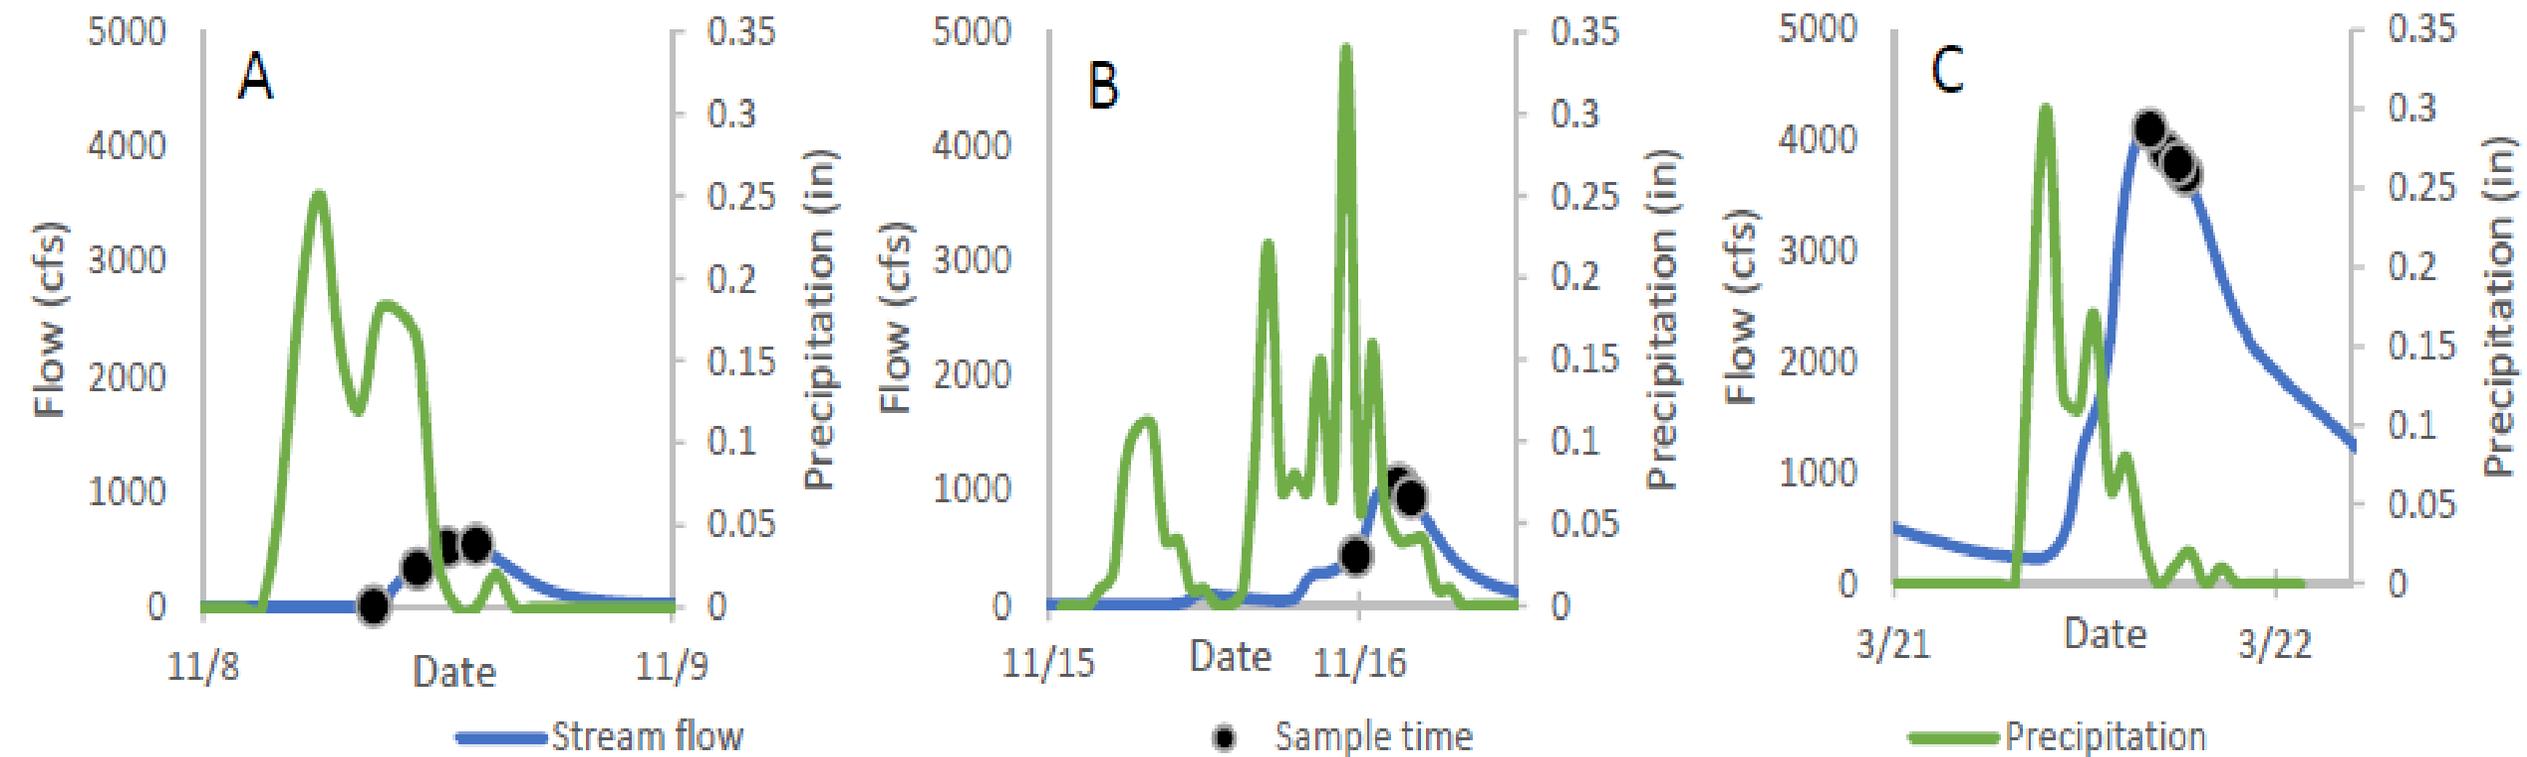
Figure 3. Hydrographs showing stream flow and precipitation vs. sample time for (A), a 1.36" storm on Nov. 8-9, (B), a 1.95" storm on Nov. 15-16, and (C), a 1.21" storm on March 22. Flow data was collected from the USGS flow gauge on Santa Rosa Creek at Willowside Road, USGS Gage #11466320. Precipitation data was collected from the Santa Rosa CalFire weather station.

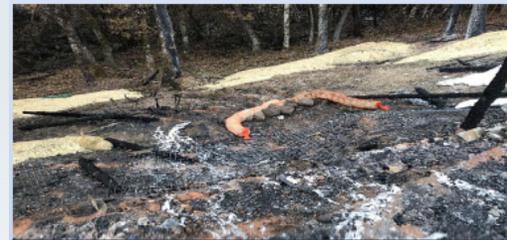
Figure 2. BMP controls installed downslope of a burned structure.

During storm events, surface waters may be affected as rain carries pollutants away from burned areas. Research shows that fire affected areas in Southern California contained increased concentrations of contaminants including nutrients (e.g. nitrates and phosphorus), polycyclic aromatic hydrocarbons (PAHs), copper, zinc, mercury, lead, and other metals^{3,4}. Several of these pollutants, especially metals, can be detrimental to human health and toxic to aquatic life. Many pollutants often attach to suspended particles and enter the water as runoff. Therefore, high flows can transport sediment bound pollutants to creeks and downstream to the Russian River. To minimize this transport of pollutants, Regional Water Board staff worked with local partners to implement post-fire best management practices (BMPs) in an effort to mitigate pollutants entering surface water during post-fire storm events (Fig. 2).

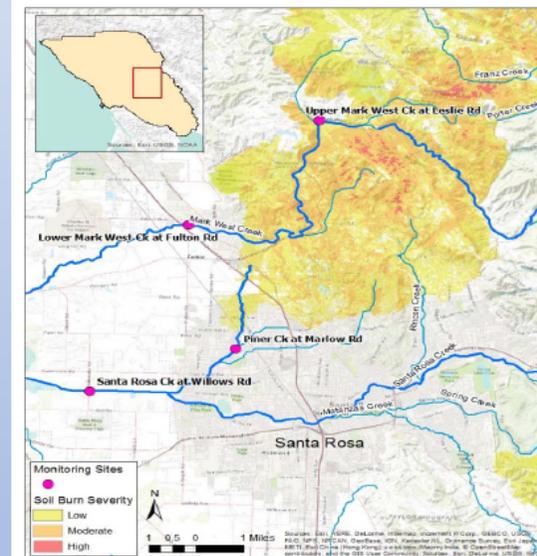
Figure 1. Post-fire water quality monitoring sites on Mark West Creek, Piner Creek, and Santa Rosa Creek.

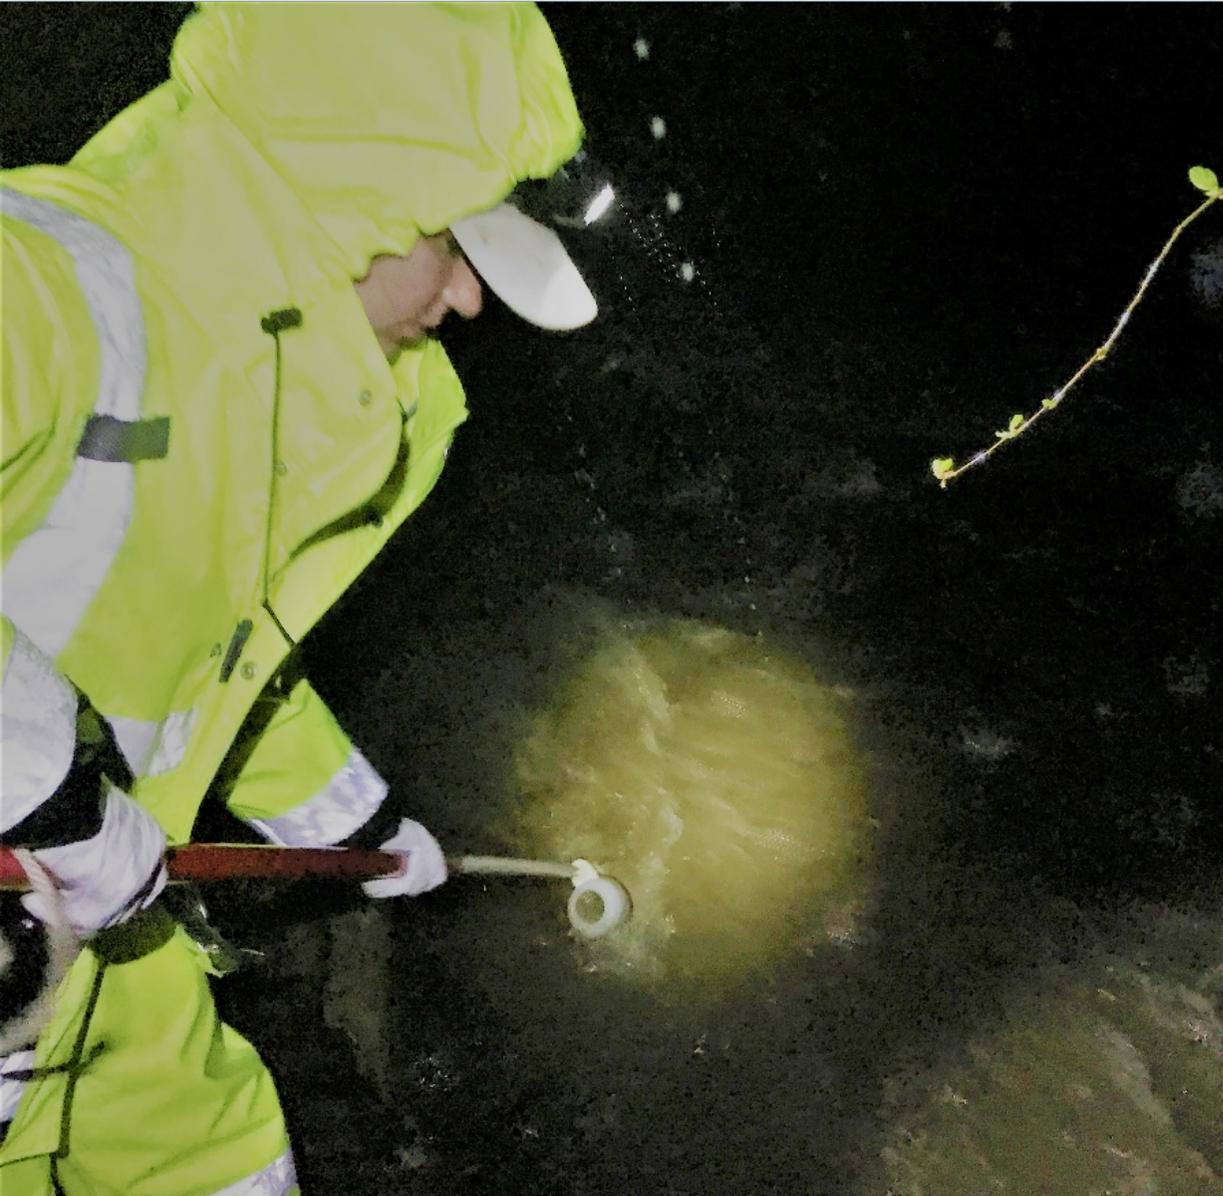
FACT SHEET
Napa Valley Post-Fire Water Quality Monitoring

Monitoring Results
The fact sheet collected samples from the sites in Fig. 1 on four consecutive periods (twice during the beginning of the first storm of the season, and again during three subsequent "ordinary" storms). A sampling event was defined as a minimum rainfall of 0.1 in. in a 24-hour period. Precipitation and flow rates for the 8 of the first 10 storms are reported in Fig. 2. More information on the San Francisco Bay Water Board's report for monitoring plan is available [here](#).

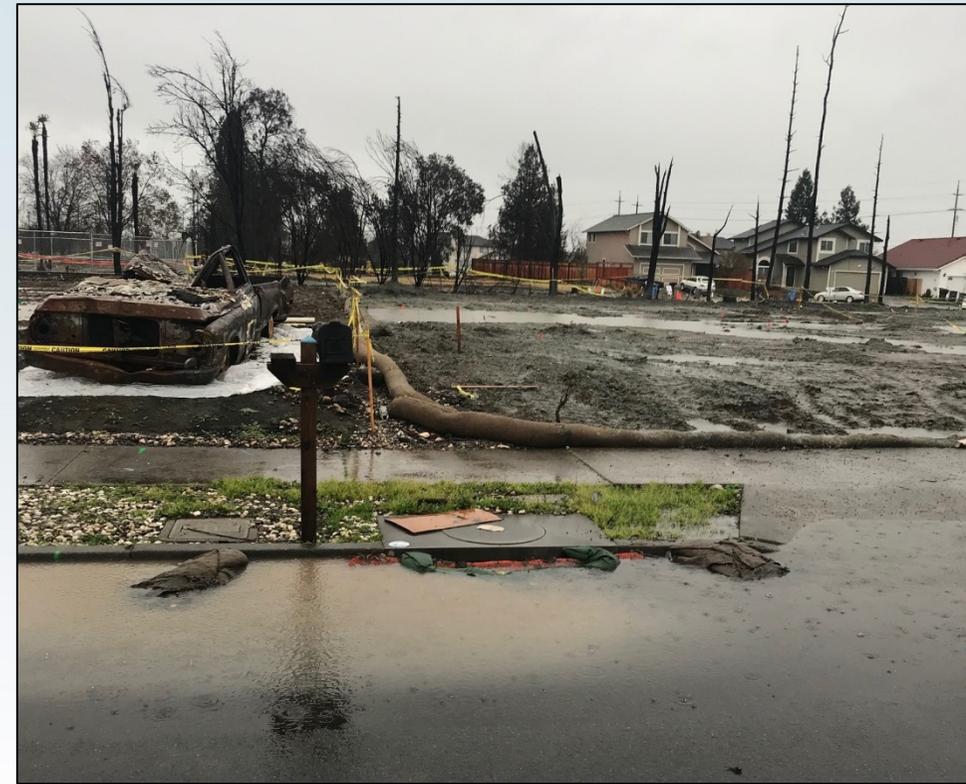
- First Flush Monitoring
 - Grab samples from five locations in the storm drain system in Coffey Park
 - *Constituent levels were found to be consistent with typical first flush levels and consistent with Regional Board findings in receiving water*

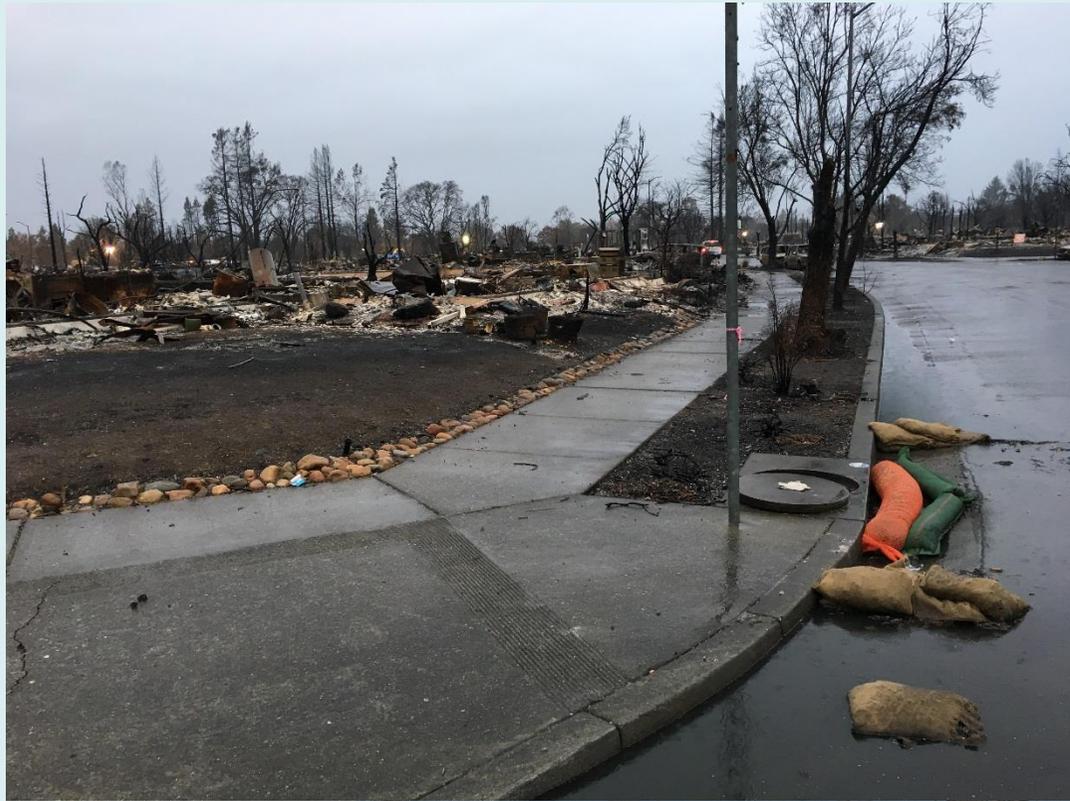
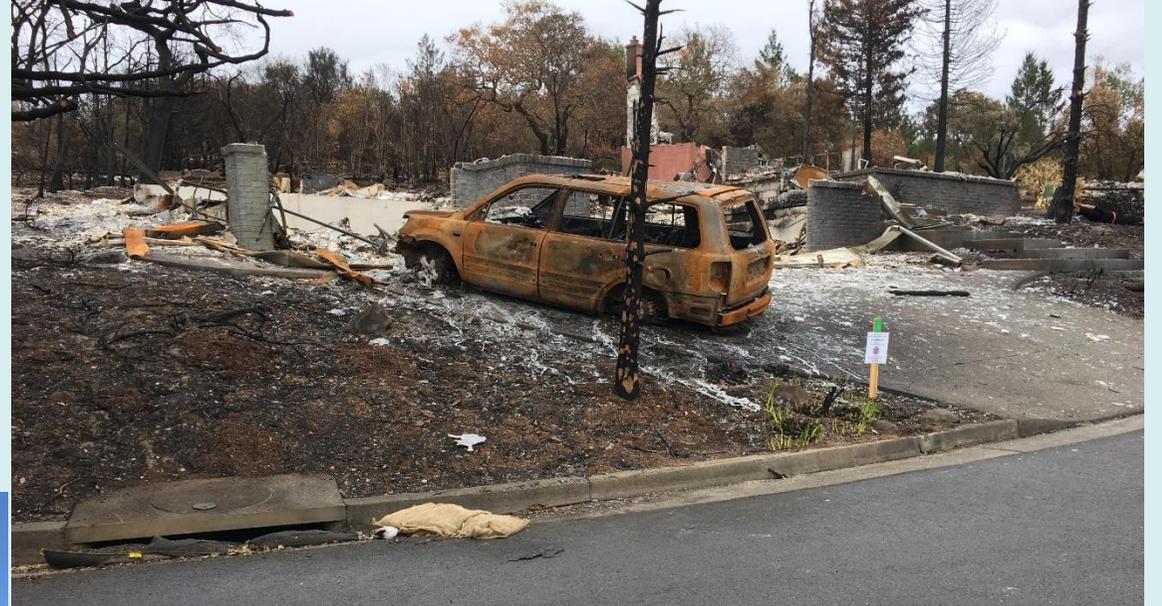
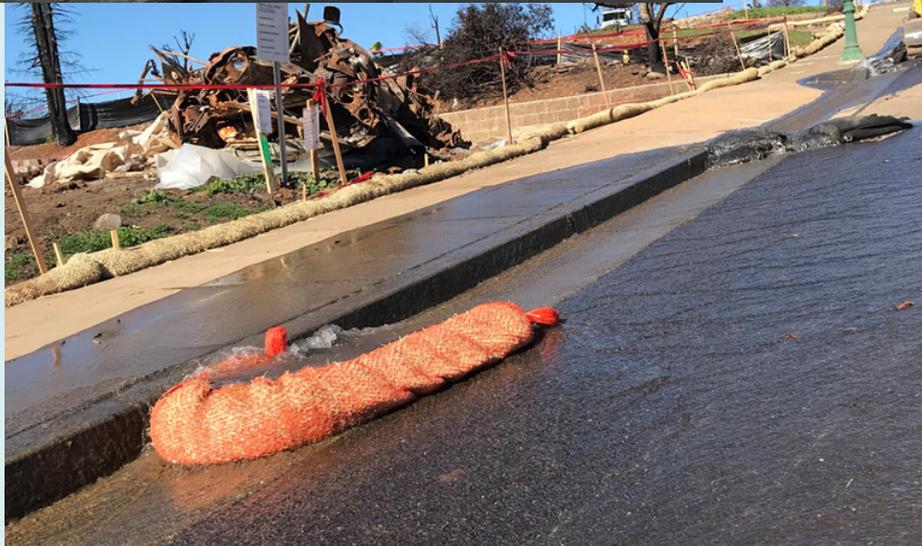
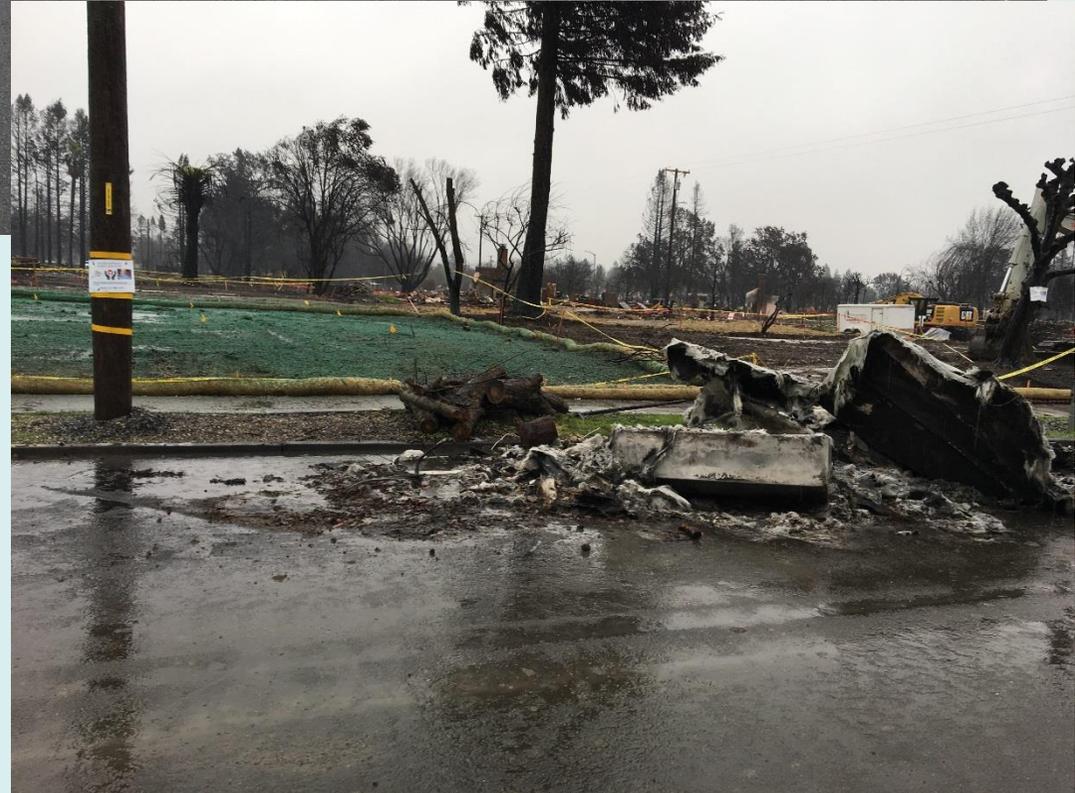
- BMP Effectiveness Study
 - Evaluated effectiveness of three different configurations of gravel bag and wattle configurations
 - Grab samples from upstream and downstream of installed BMPs in different configurations
 - *All three BMP configurations functioned similarly.*
 - *BMPs reduced constituent levels by approximately an order of magnitude*

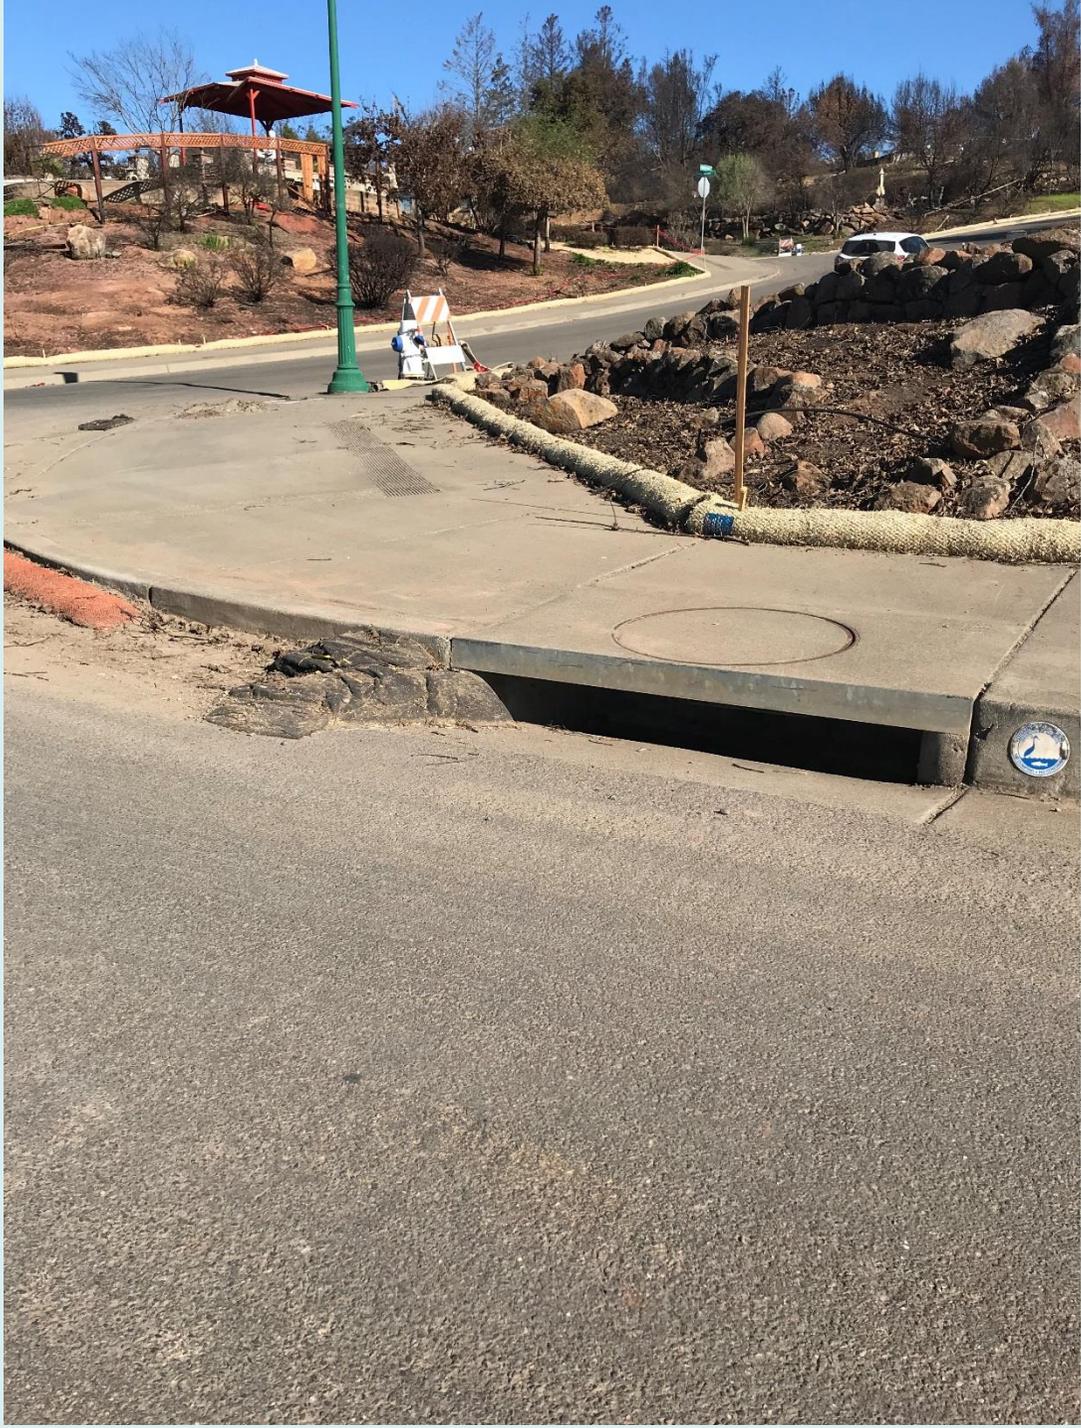
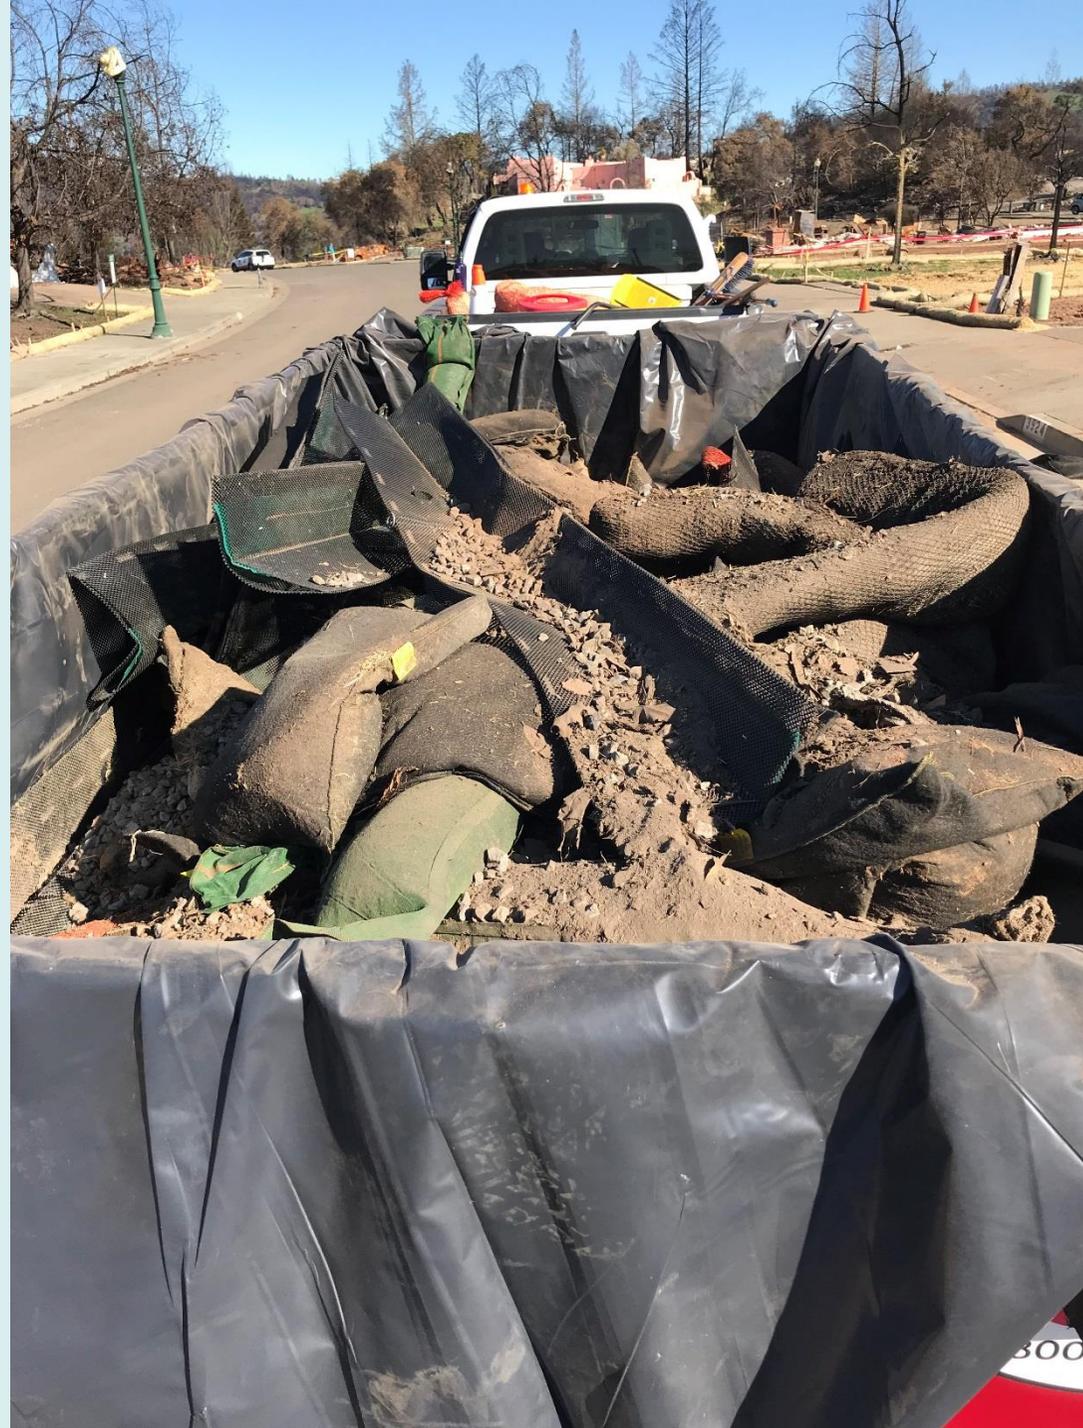
- Post Debris Removal Sampling
 - Conducted in coordination with in-stream sampling by Regional Board on March 22, 2018
 - Grab samples from five locations in the storm drain system in Coffey Park
 - *Constituent levels shifted to those generally consistent with transport in sediment and consistent with Regional Board findings in receiving water*

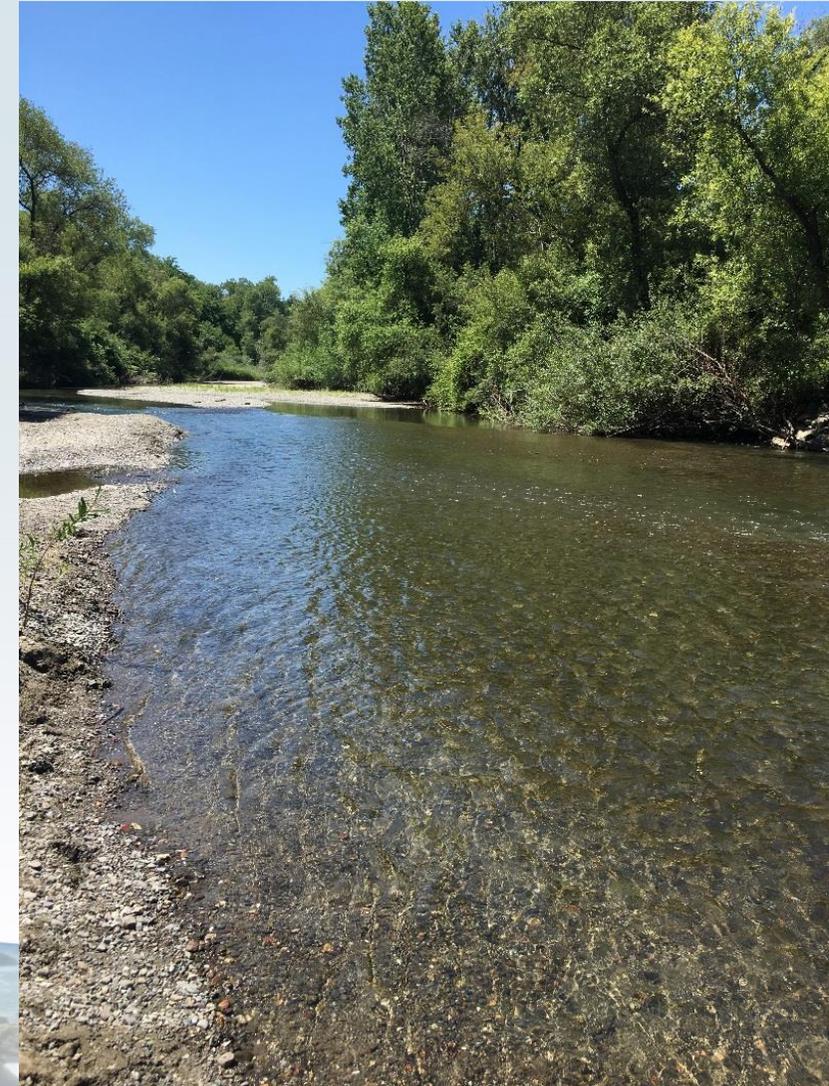
- Baseline
 - Ten locations sampled on October 19, 2017
- Wet Season
 - Post-Storm Events (4) – Eleven locations
 - Dry Conditions (5) – Wohler / Mirabel
- Dry Season
 - Monthly (4) – Five locations
 - Biweekly (3)– Two locations

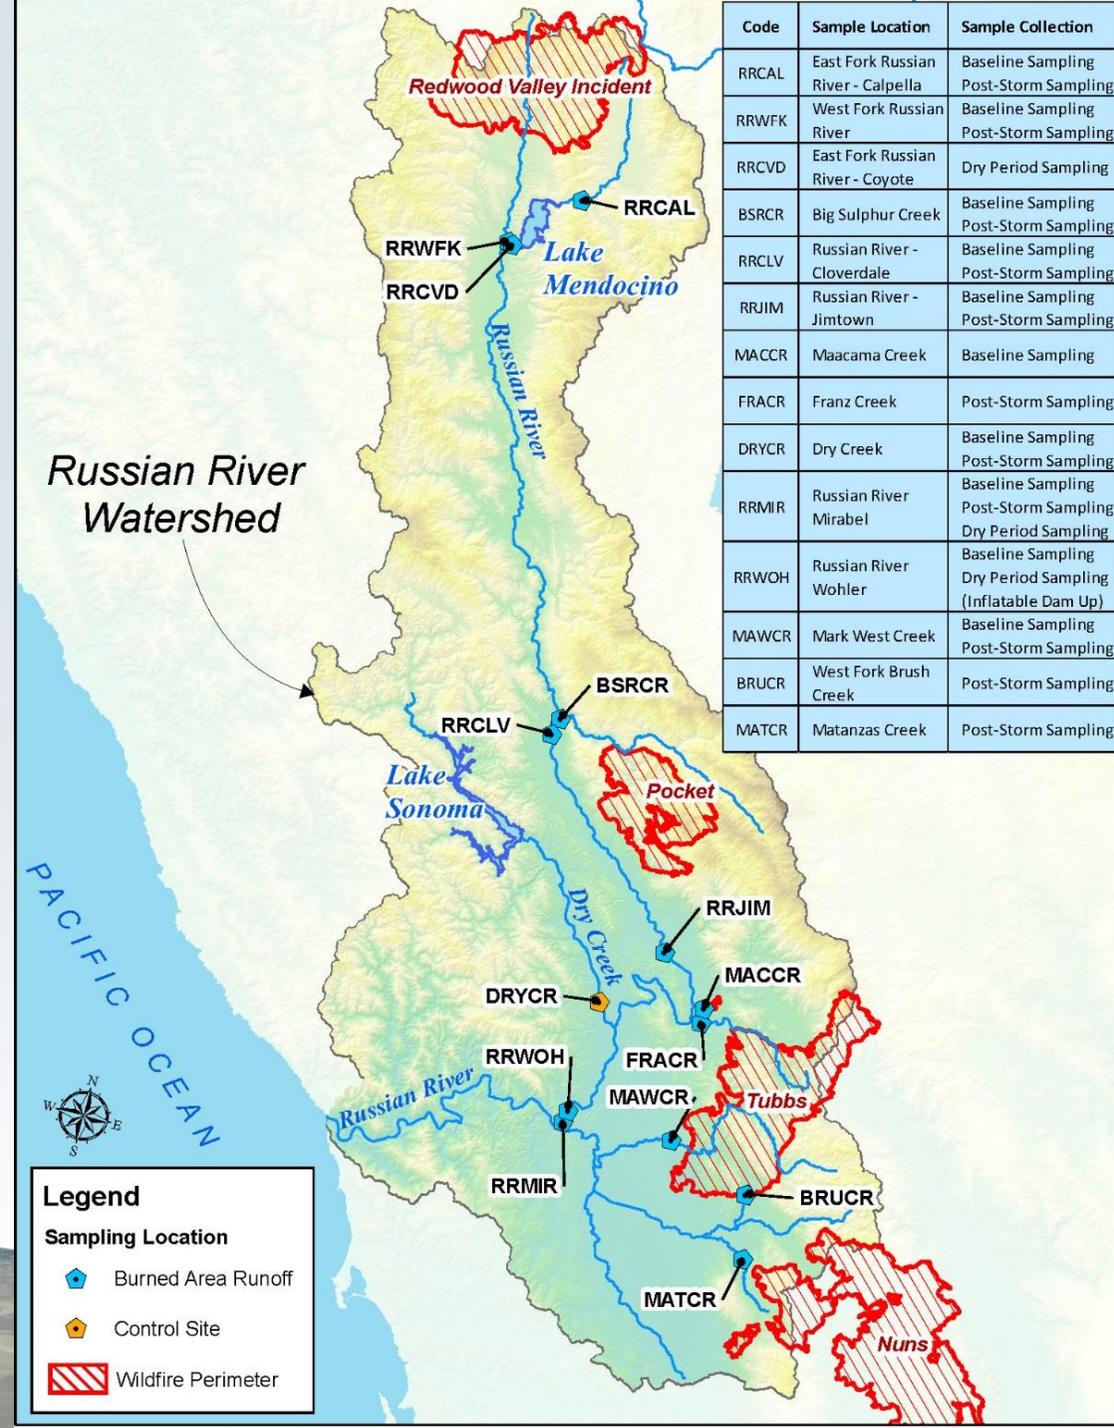
Sampling Program Sites

- Wet Season
 - Mainstem (3 sites)
 - Tributaries (8 sites)
- Dry Season
 - East Fork & Dry Creek
 - Wohler & Mirabel

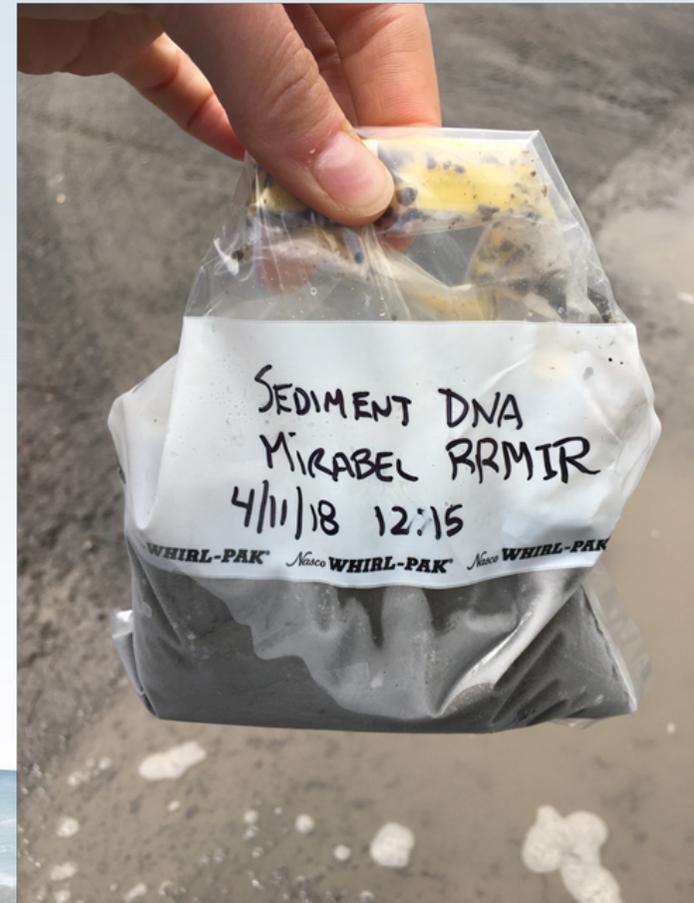
Sediment Sampling

- Characterize changes in microbial populations at streambed
- Parameters
 - Sediment Microbiome DNA
 - Carbon
 - Nitrogen
 - Mercury

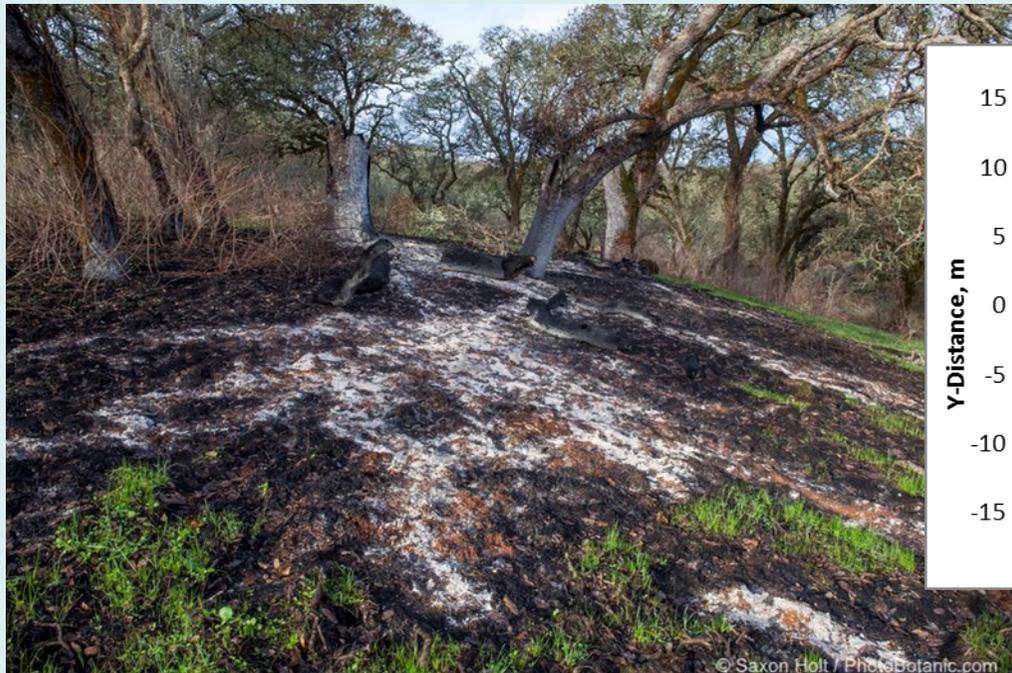
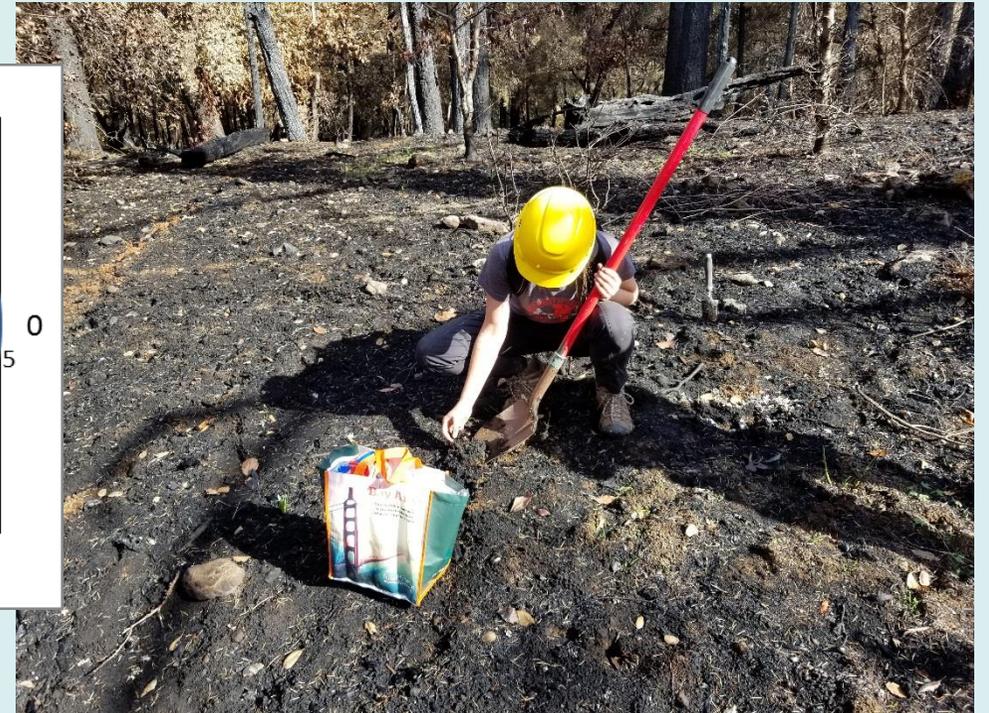
Ash Sampling and Characterization

- Collect bulk ash samples
 - Pepperwood Preserve, McCullough Ranch, Shiloh Regional Park
 - Ash leachate experiments
 - DOC and mercury release concerns

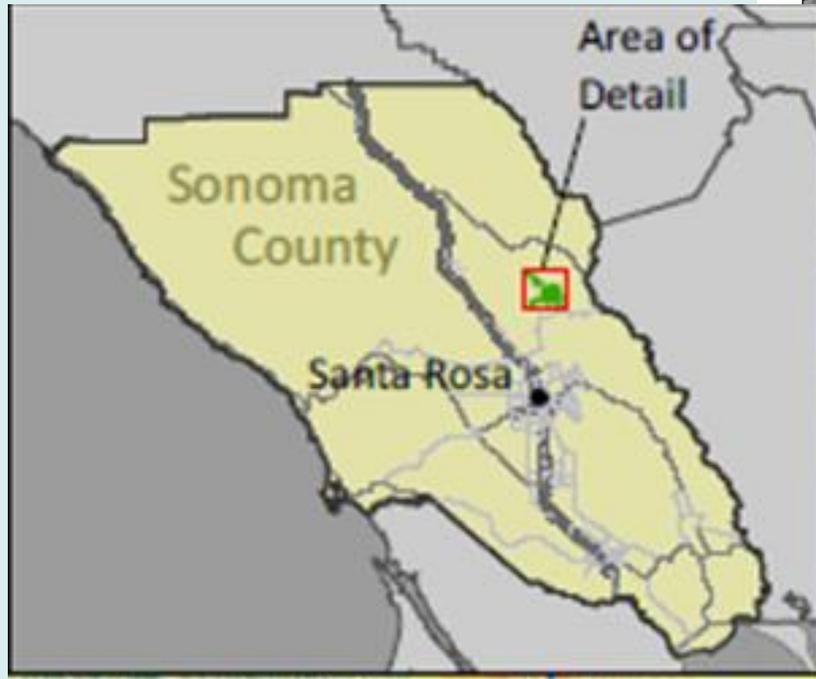
Tubbs Fire Official Perimeter, preliminary dozer lines and unburned regions October 2017

Supression

- Observed Dozer Lines

Preliminary Satellite Observations

- Unburned regions

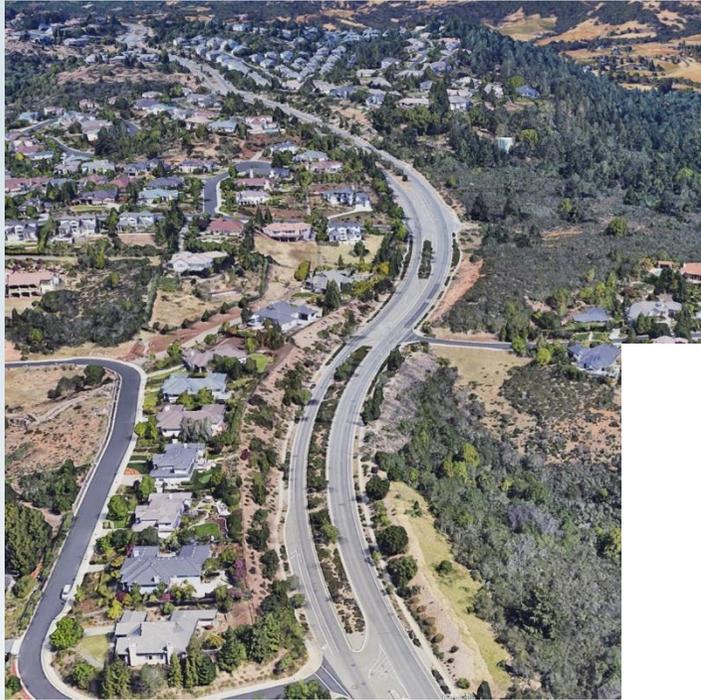
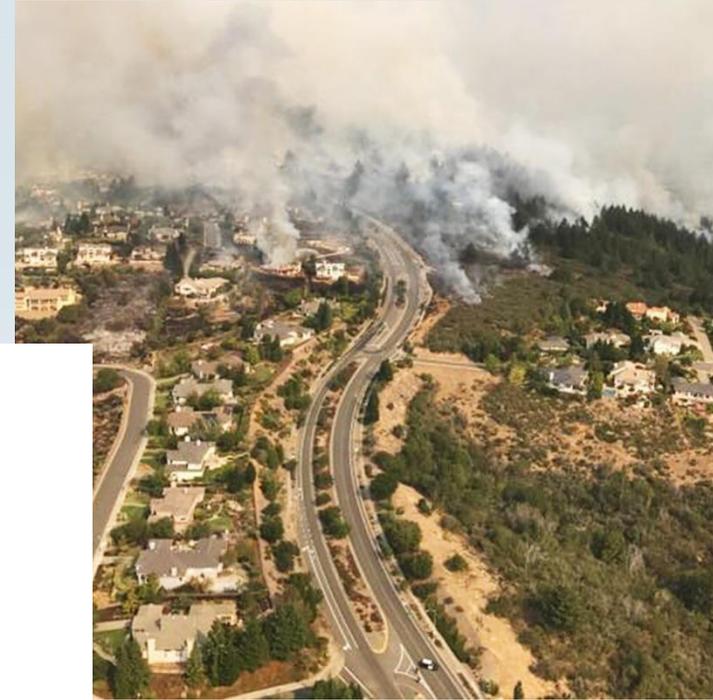
How are our watersheds projected to respond in terms of runoff and erosion?

TUBBS FIRE Watershed Emergency Response Team FINAL REPORT

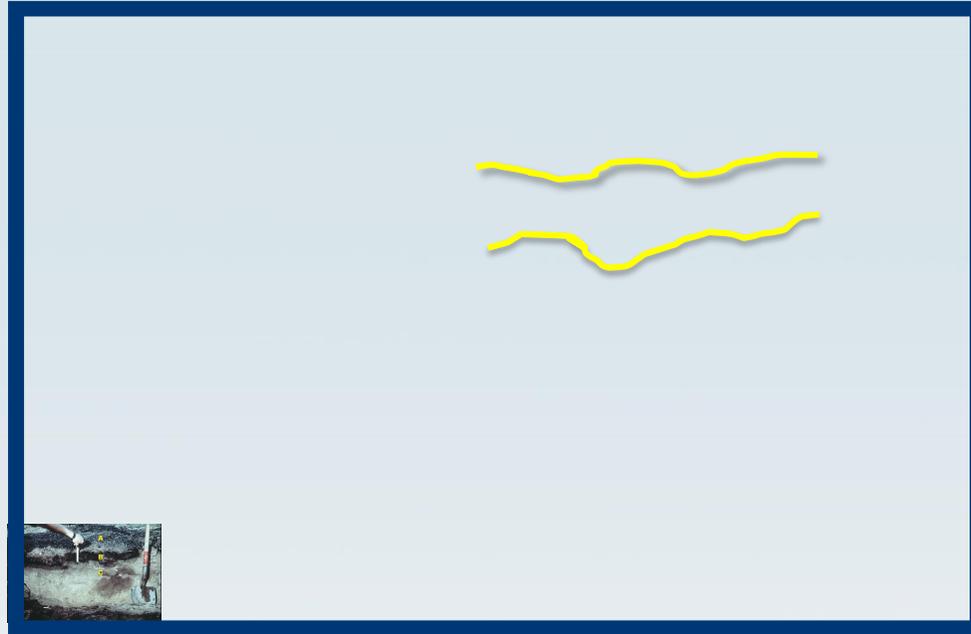
Figure 2.8—The “tin roof” effect on burned chaparral watersheds as described by earlier watershed researchers include (A) the wettable ash and carbon surface layer, (B) the discontinuous water repellent layer, and (C) the wettable subsoil. (After DeBano 1969).

How fire affects soil characteristics: sealing and **hydrophobicity**

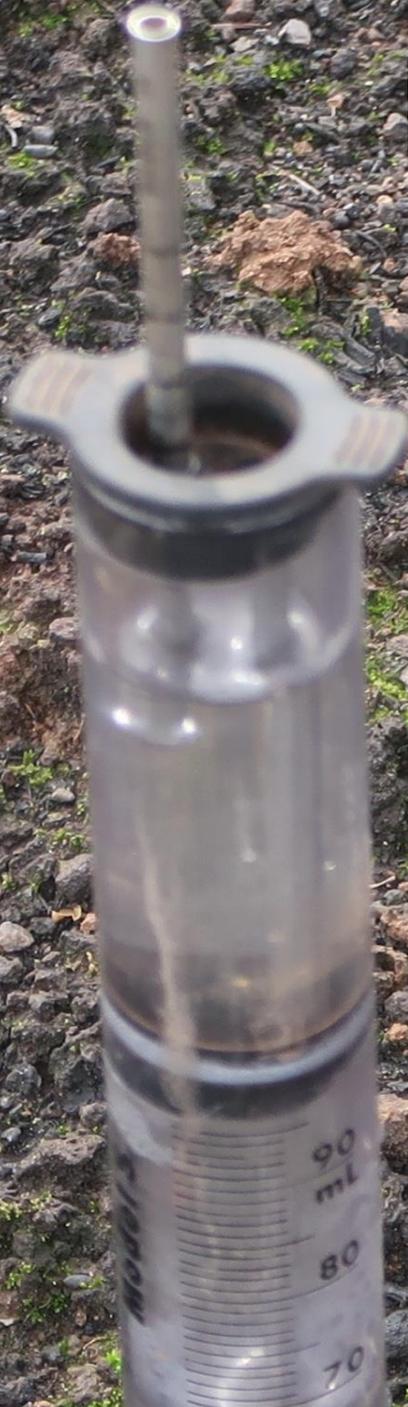
Franciscan mélange, deciduous Oak forest
