Update on Post-Fire Monitoring Current State of Knowledge and Future Planning

Item 9

September 6, 2018

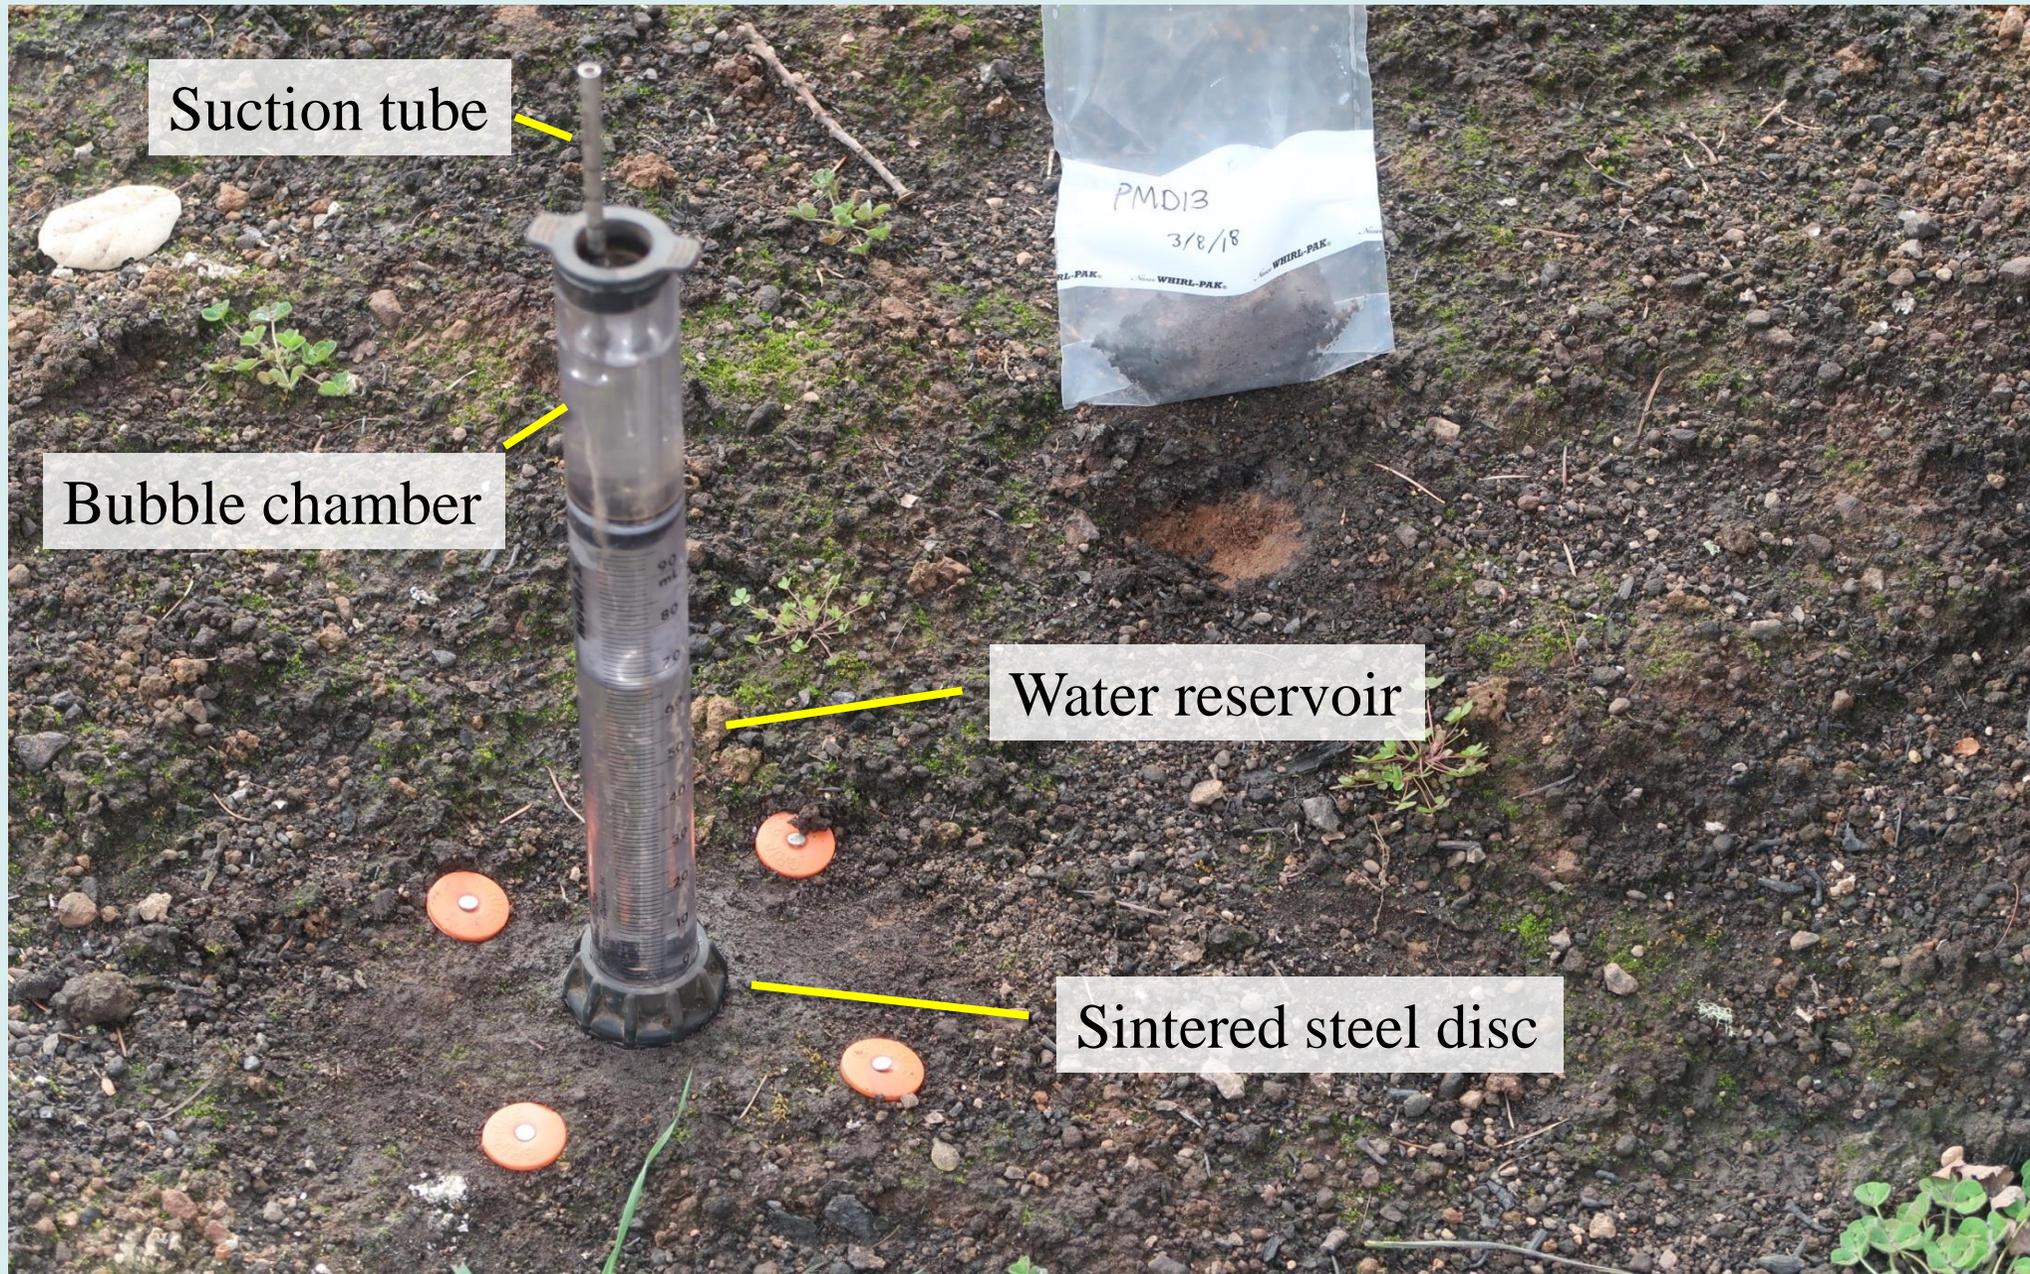
Infiltration monitoring: tension-disk infiltrometers

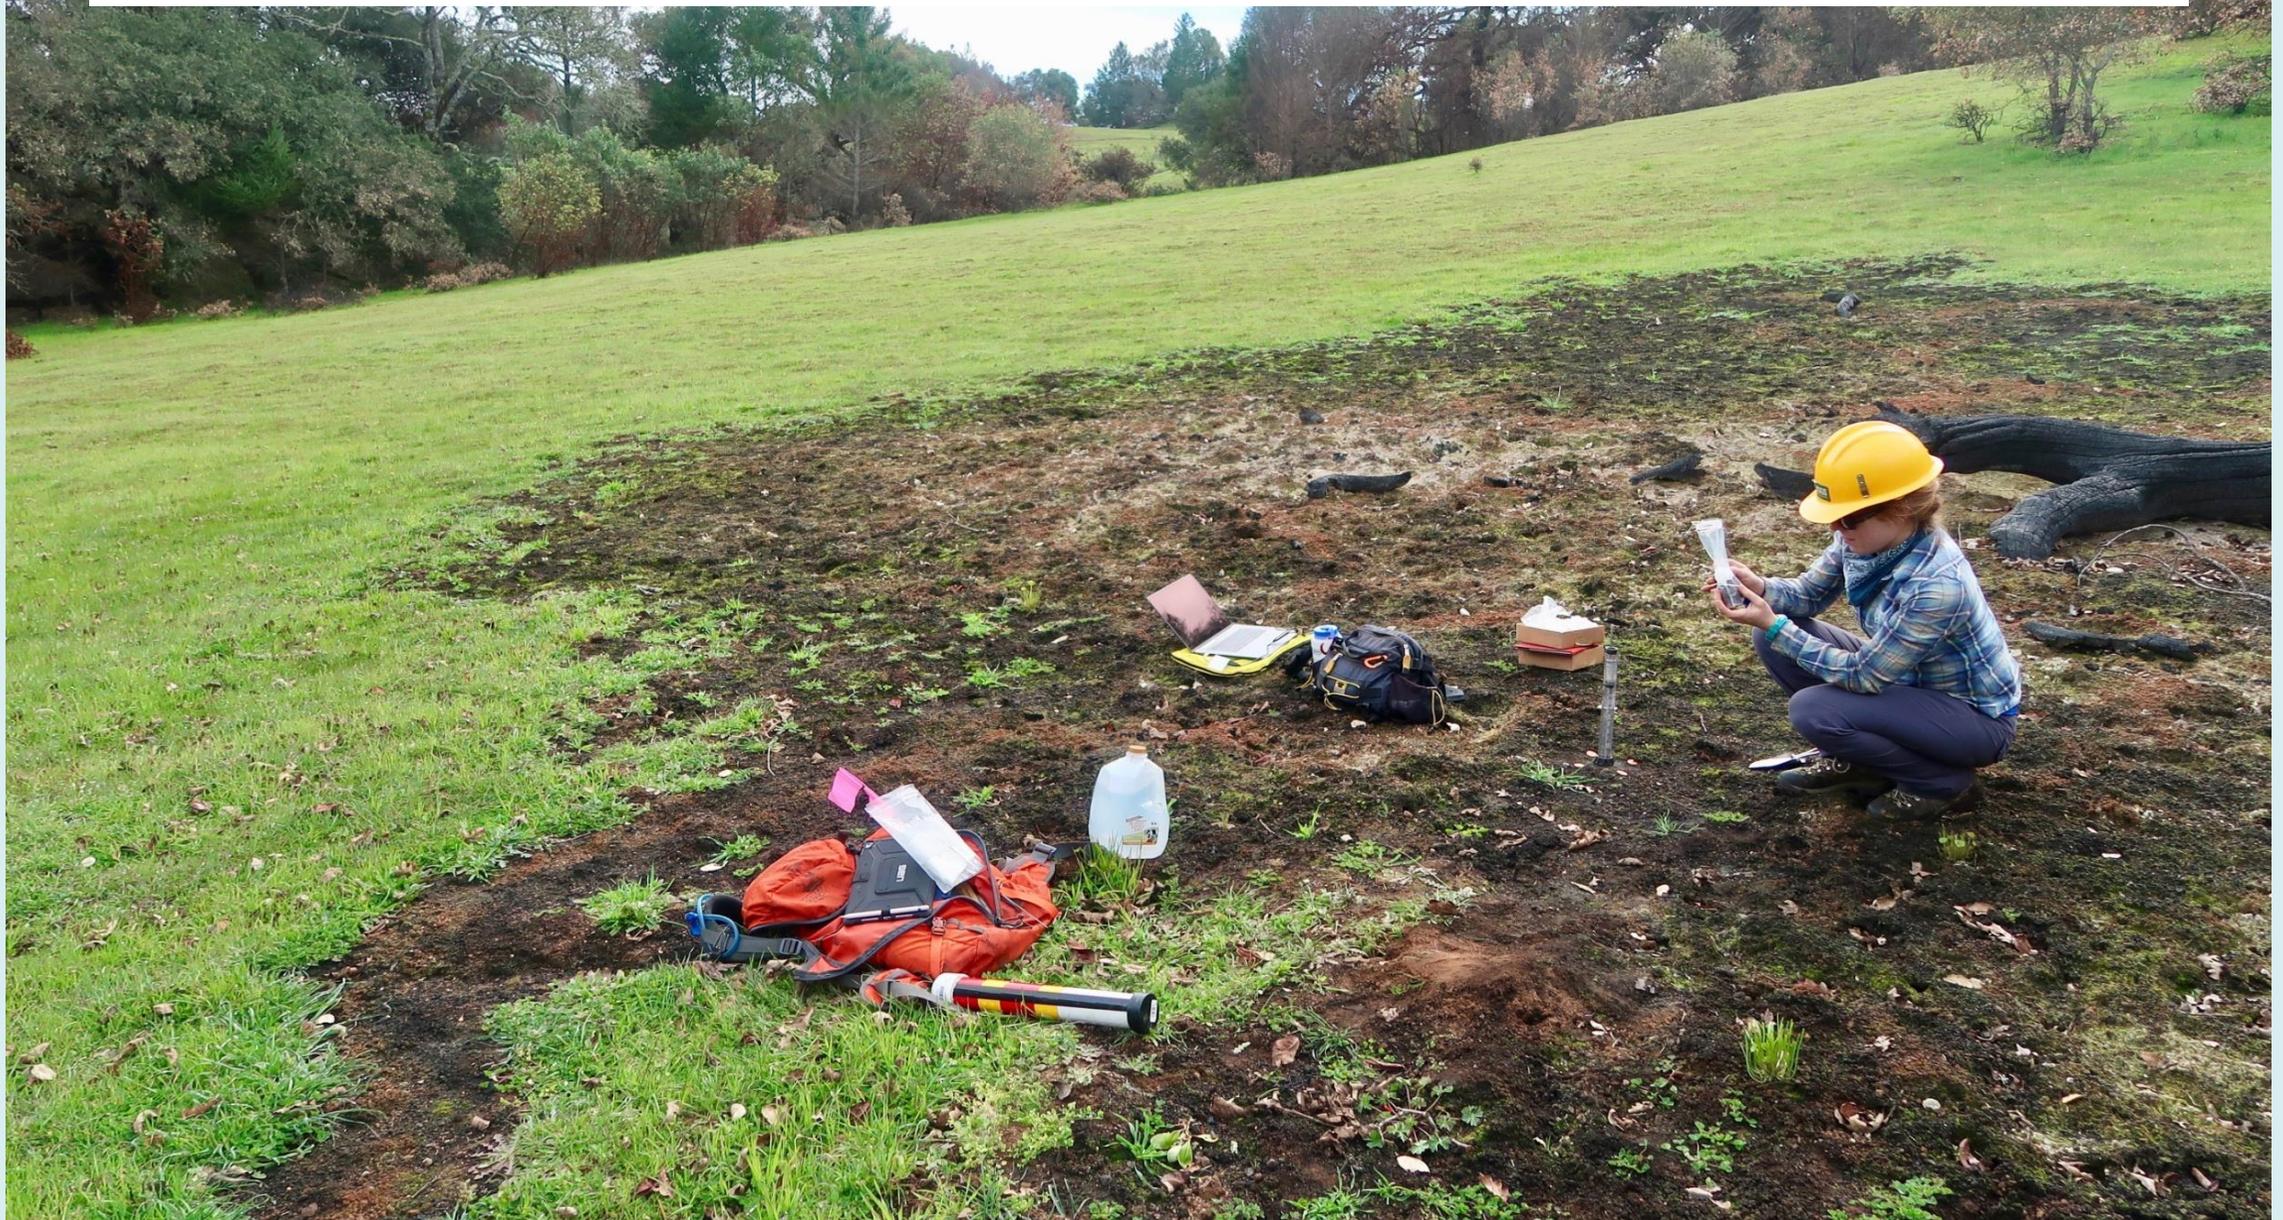
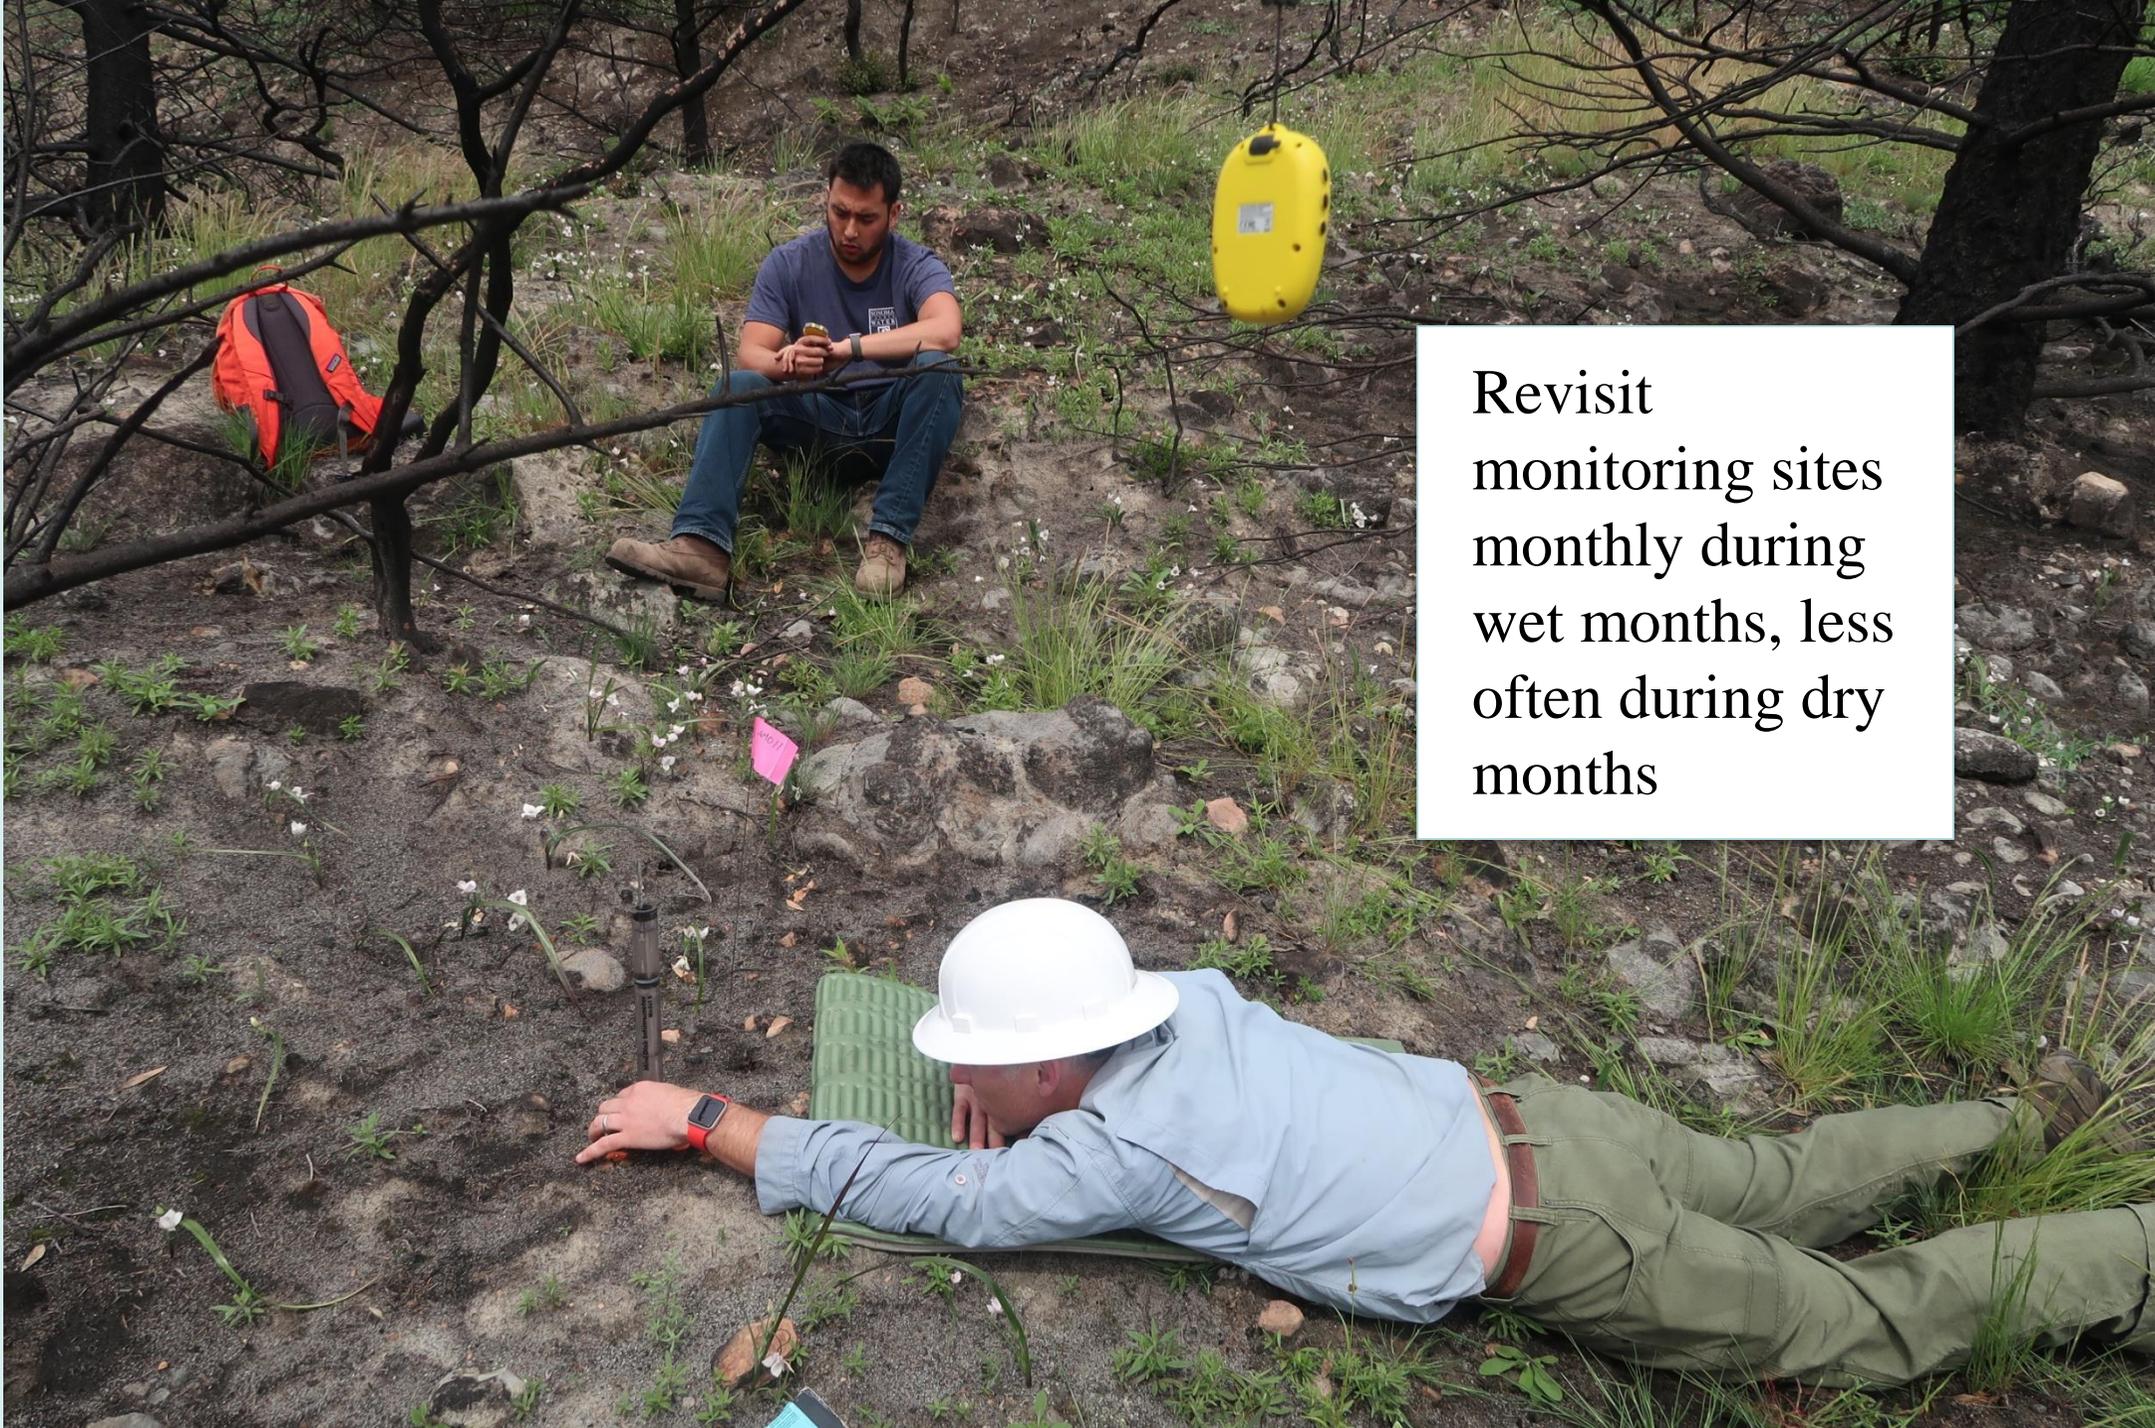
What does soil hydrologic recovery look like?

Revisit
monitoring sites
monthly during
wet months, less
often during dry
months

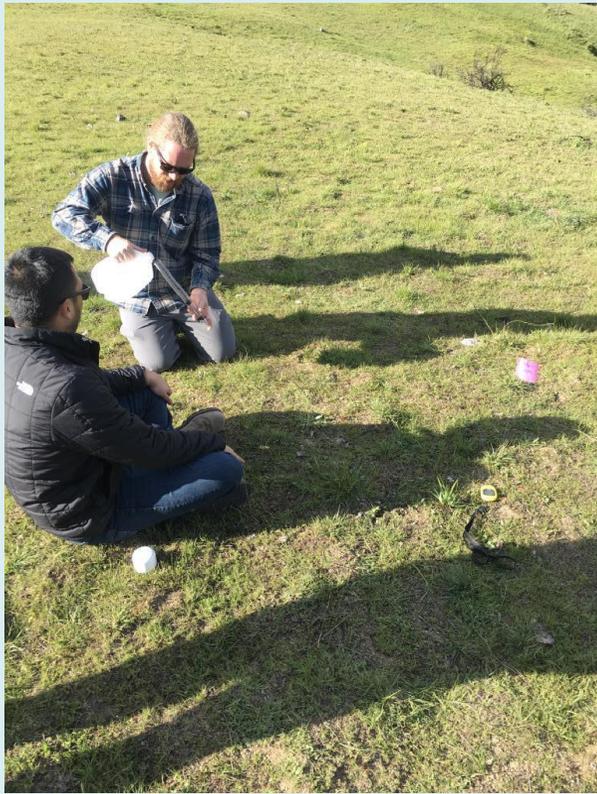
Potential soil sealing after 2017/2018 rainy season

How do soil macro-pores (cracking, etc) impact recovery?

Site PMD01 (Franciscan mélange grassland) changes over time

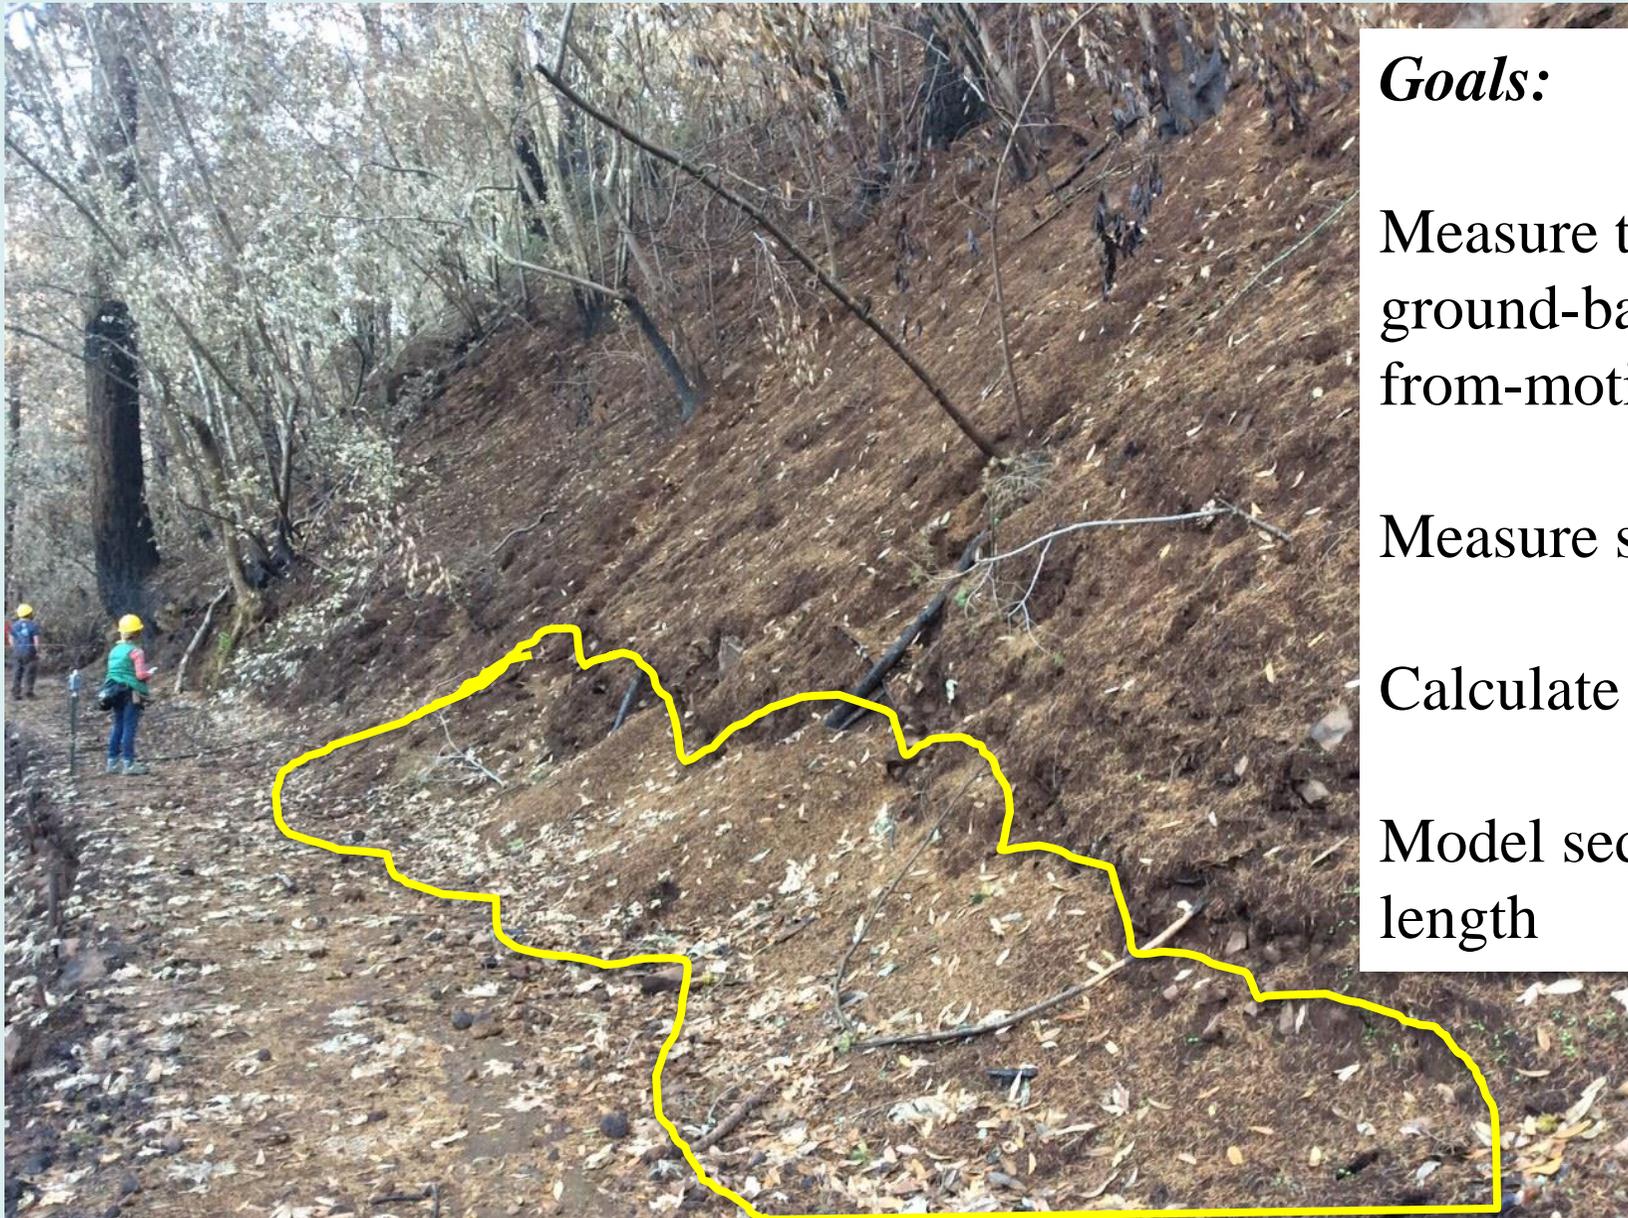
Calculating hillslope sediment flux and stream loading

Goals:

Measure talus cone volumes using ground-based LiDAR or structure-from-motion

Measure source area and slope

Calculate hillslope sediment flux law

Model sediment loading per stream length

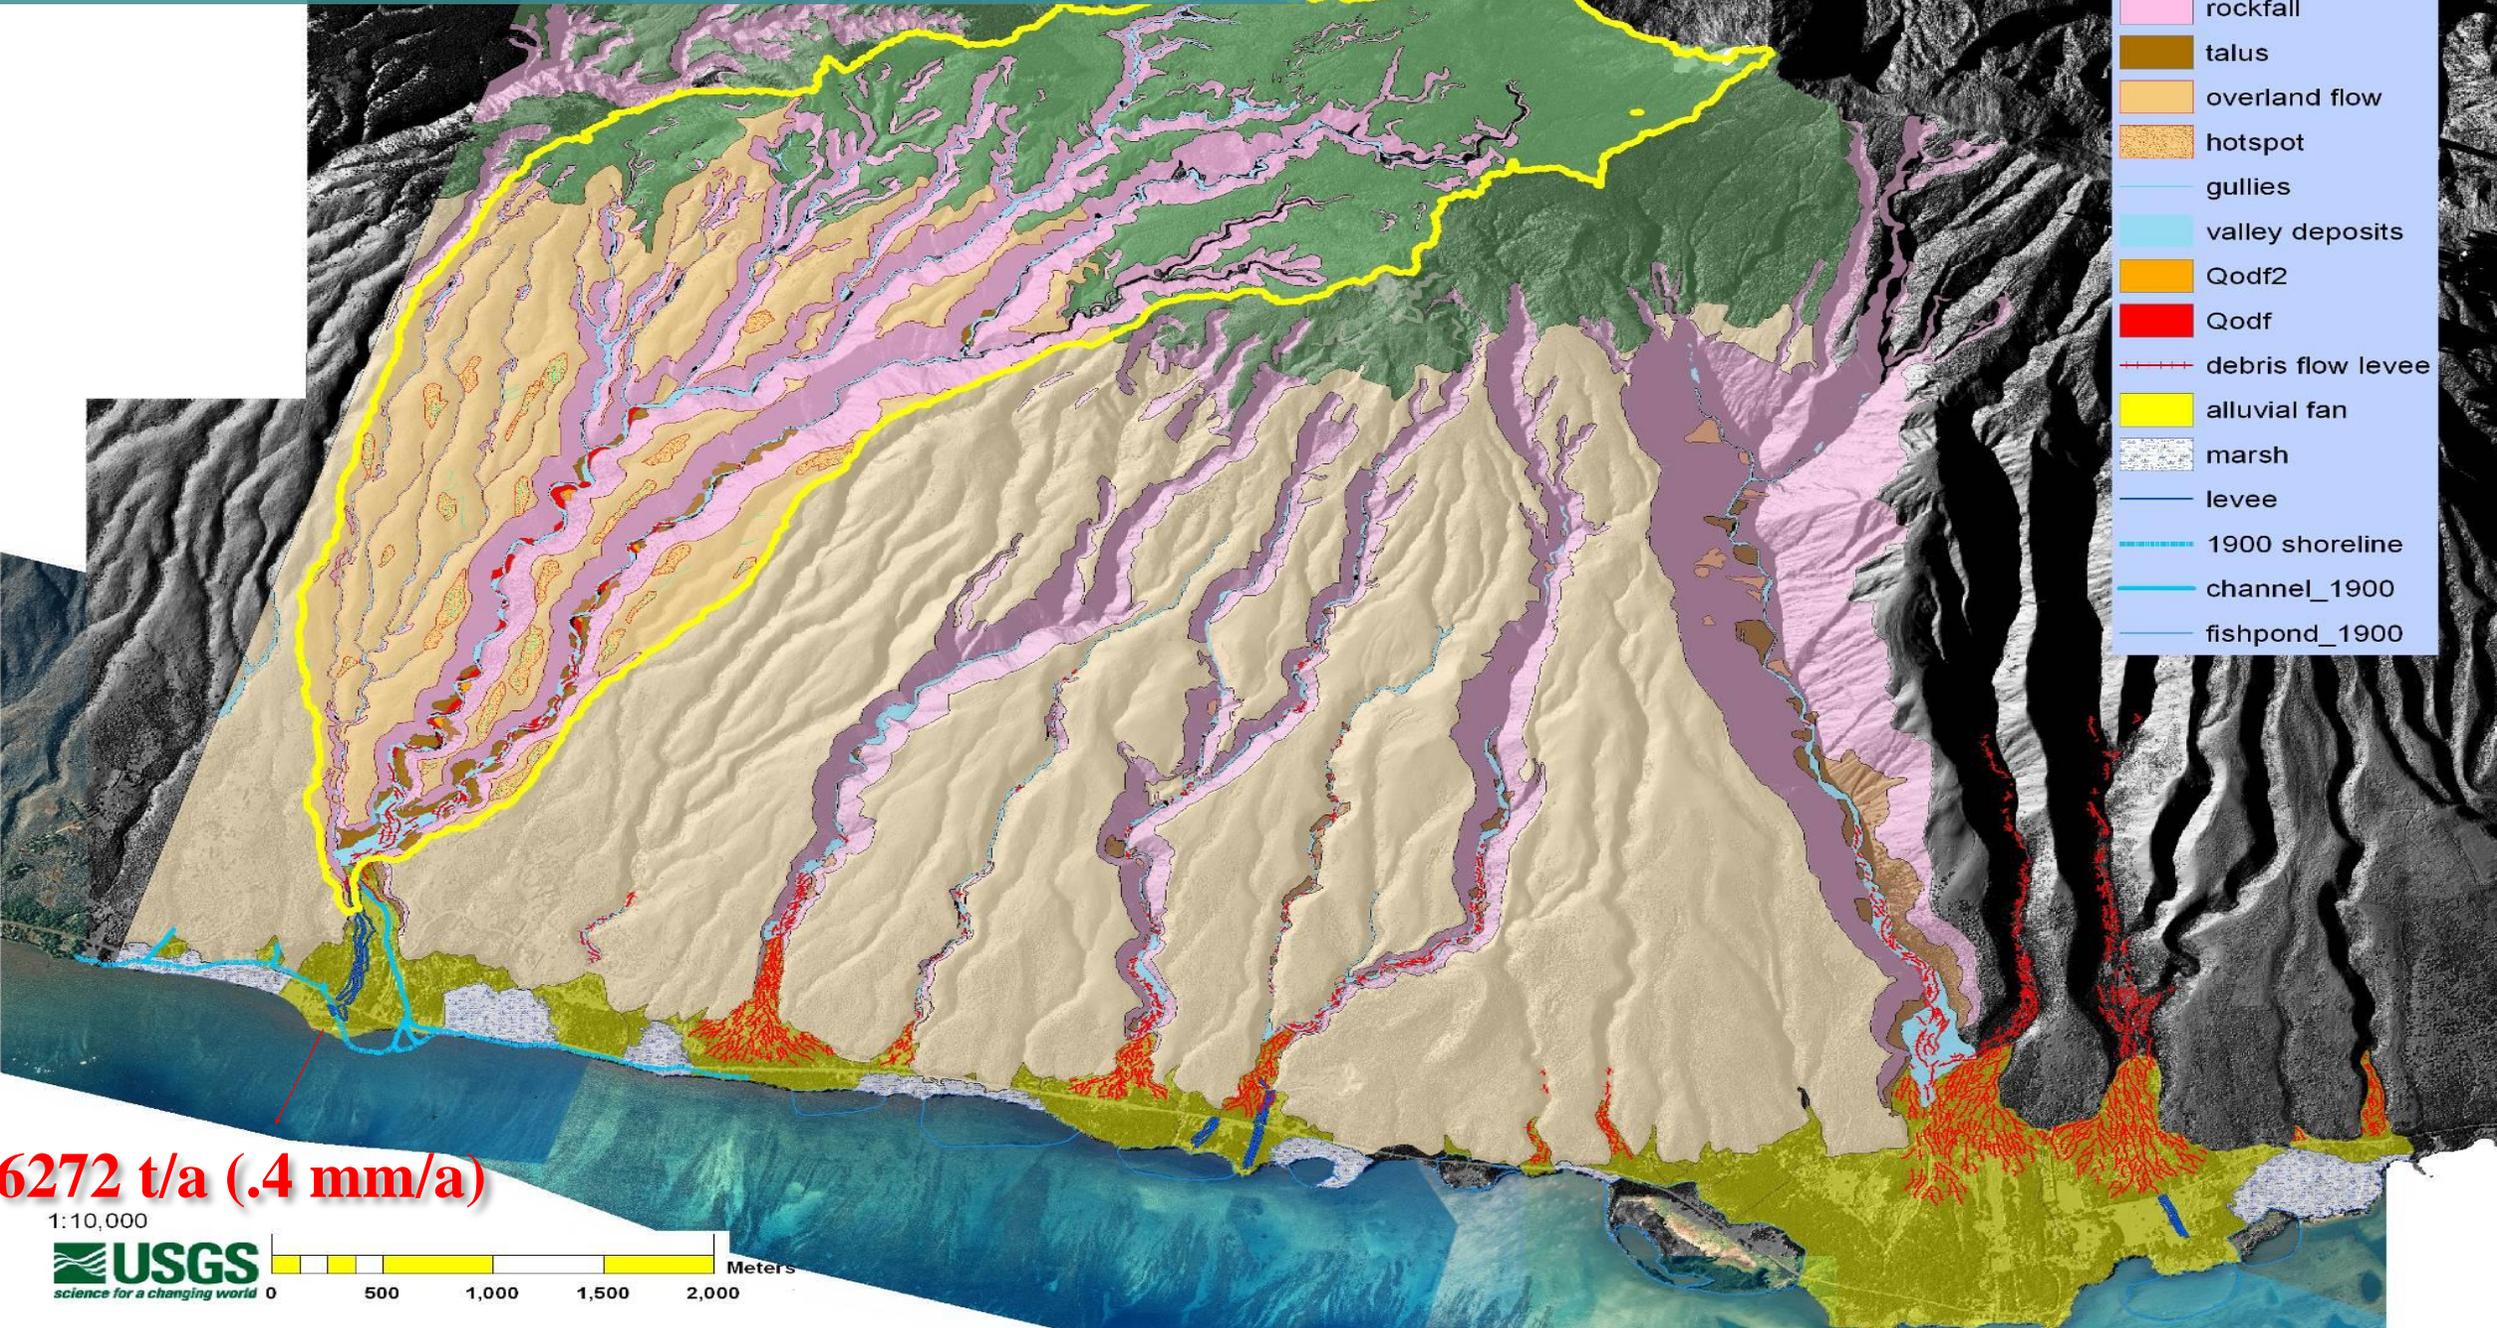
Geomorphic Process map

- soil creep
- rockfall
- talus
- overland flow
- hotspot
- gullies
- valley deposits
- Qodf2
- Qodf
- debris flow levee
- alluvial fan
- marsh
- levee
- 1900 shoreline
- channel_1900
- fishpond_1900

6272 t/a (.4 mm/a)
