**STATE OF CALIFORNIA  
REGIONAL WATER QUALITY CONTROL BOARD  
NORTH COAST REGION**

**[PROPOSED] ORDER NO. R1-2020-0040  
for Administrative Civil Liability**

**In the Matter of:  
Sonoma Luxury Resort LLC  
Saggio Hills Development Project Site (a.k.a. Montage Healdsburg)  
16840 Healdsburg Avenue, Healdsburg, CA 95448**

**Administrative Civil Liability Complaint No. R1-2020-0027  
Amending Complaint No. R1-2020-0009  
WDID NO. 1B06169WNSO (401 Cert)  
WDID NO. 1 49C375878 (CGP)**

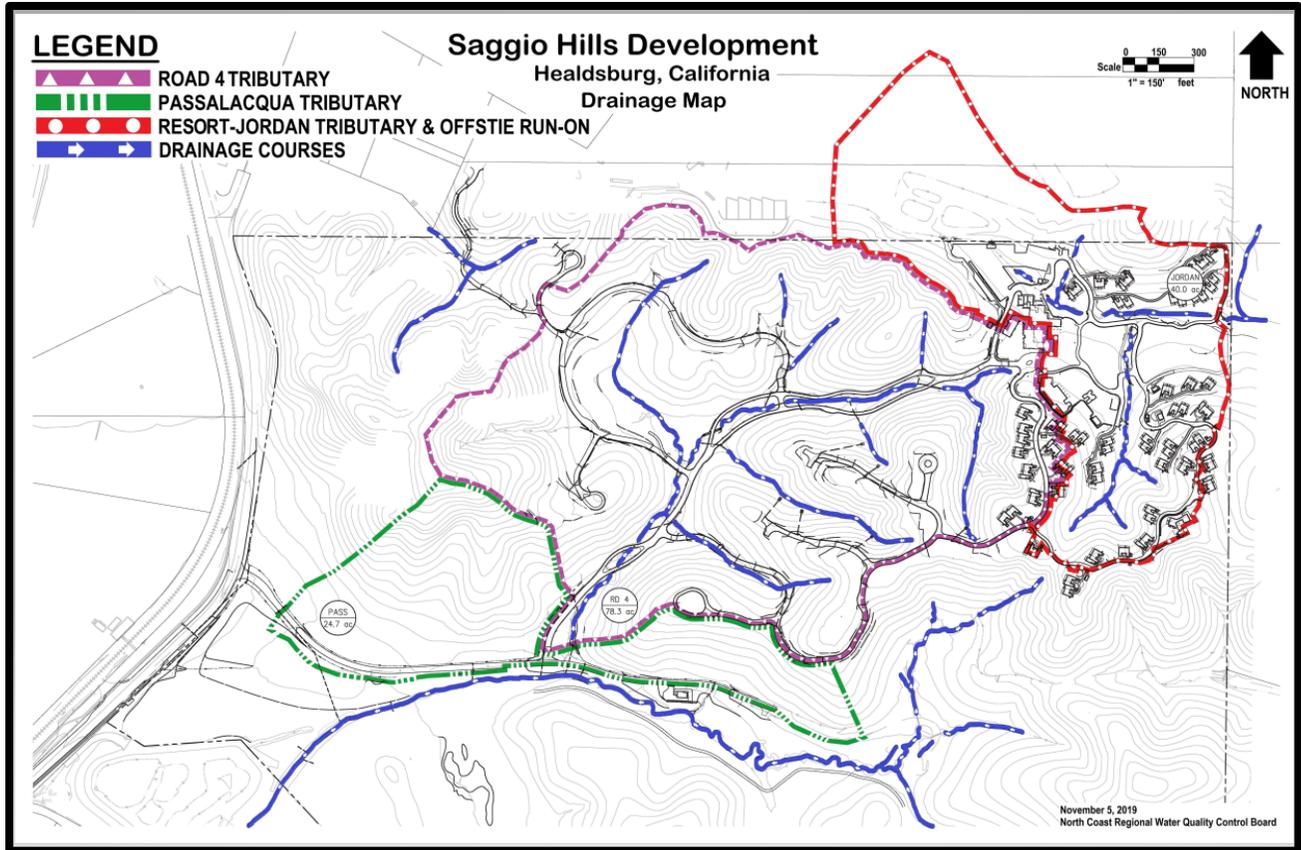
Figure 1. Saggio Hills construction site.

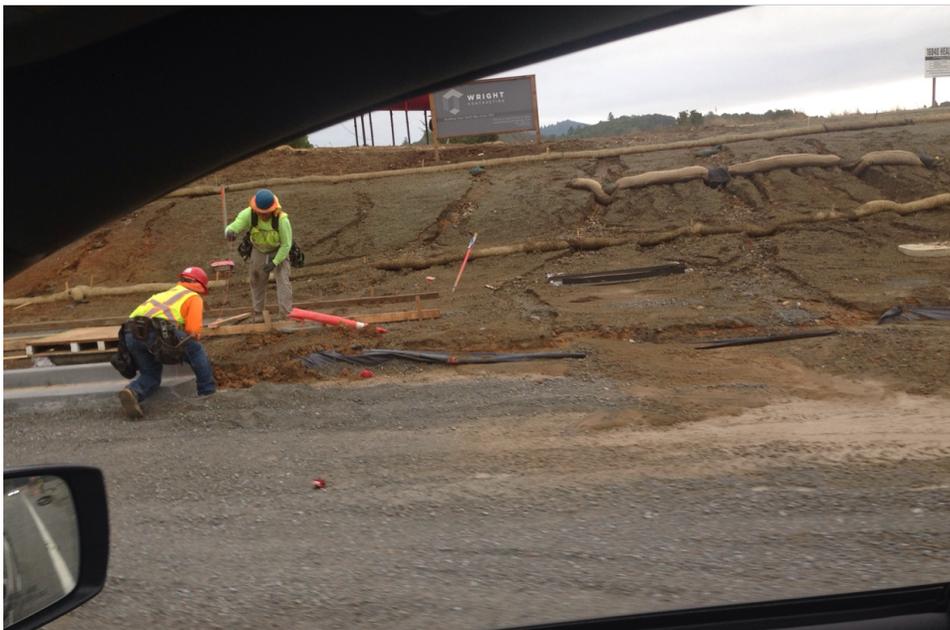
On October 3, 2018, Regional Water Board staff drove by the Site during a rainfall event and observed a portion of the Site from Healdsburg Avenue. Staff observed a bare, steep slope with several erosional rills or gullies (Violation 2: inadequate soil cover; D.2.) with intermittent wattles and silt fences that were undercut by erosion or overrun with sediment (Violation 1: BMPs not effectively reducing/preventing pollutants; B.5.e.). The slope did not have continuous or effective linear sediment controls at the base (Violation 4: inadequate linear sediment controls; E.4) showing evidence of drainage and sediment transport onto and across an adjacent active area (Violation 5: inadequate run-on/runoff control; F). Staff observed sediment that had been tracked from this area onto Healdsburg Avenue (Violation 3: inadequate perimeter control; E.1.). Collectively, this snapshot captured an overall failure to maintain adequate erosion, sediment, and turbidity control BMPs.

*Figure 2. View of failed BMPs. Insufficient ground cover, and sediment in street (Healdsburg Avenue) after storm event. Photograph taken on October 3, 2018.*

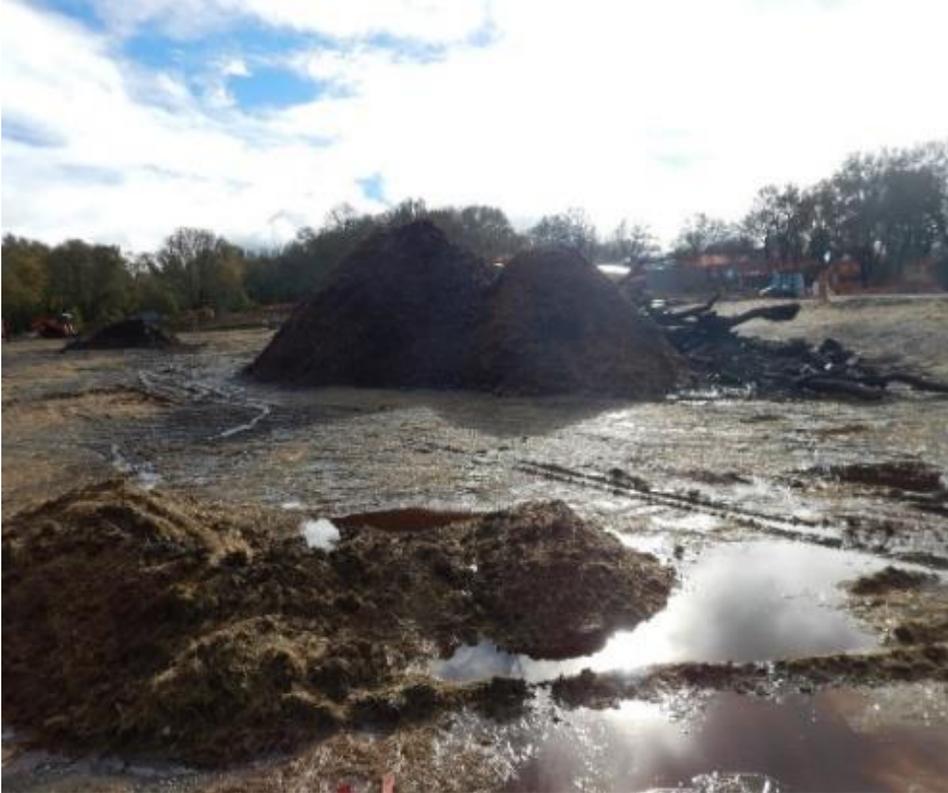
Staff observed two uncovered, uncontained stockpiles in the rain; one of wood waste with nearby puddles of discolored water (note image below), and one of gravel and fine-grained material adjacent to a drainage channel.

*Figure 3. Uncovered, uncontained wood waste*

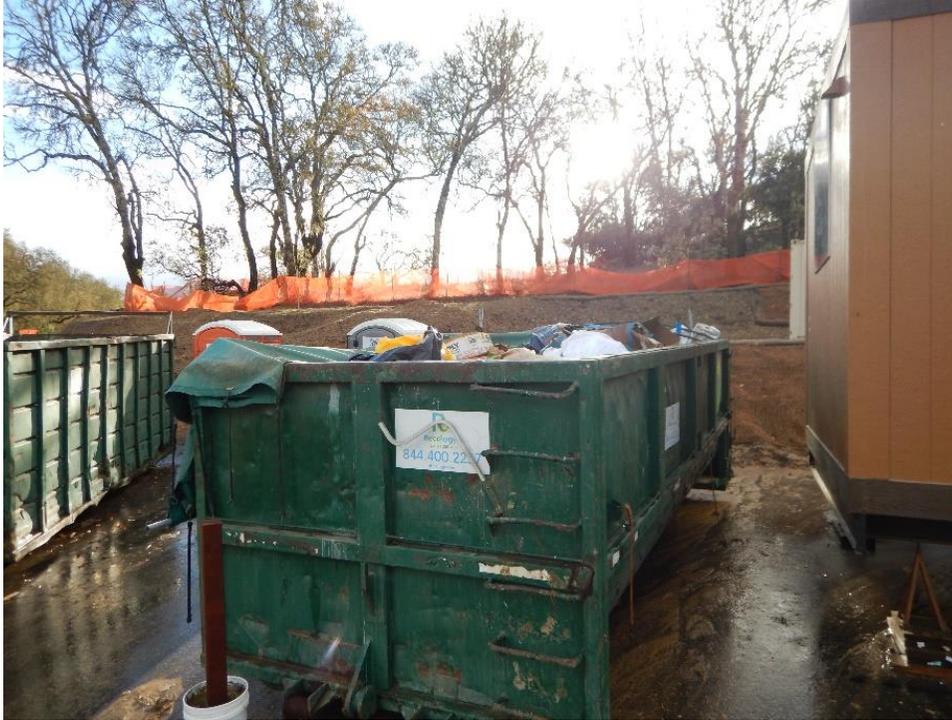
The circumstances of the violation indicate a substantial potential for harm given that the waste bin was uncovered during a rain event and the overall lack of adequate or effective pollution control BMPs on the Site at that time increases the likelihood that any waste, leachate, or contaminated rainwater could migrate or be transported into receiving waters and adversely impact water quality and beneficial uses. Accordingly, staff assigned a Potential for Harm of Moderate to this violation.

*Figure 4. Uncovered waste disposal bin.*

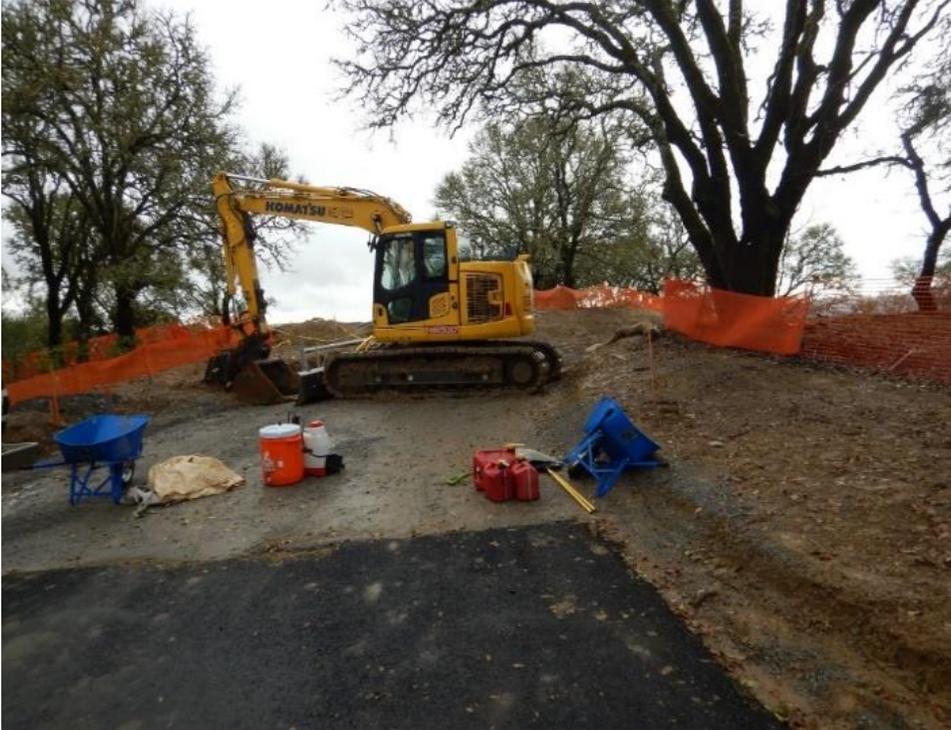
As seen in the picture below, gas cans were sitting on a sediment-covered road during a rain event. These circumstances, in addition to the conditions throughout the rest of the Site at the time, increase the likelihood that any chemicals spilled or leaked throughout the Site would come into contact with runoff and be transported into receiving waters, posing a substantial threat to water quality and beneficial uses. As a result, staff assigned a Potential for Harm factor of Moderate.

*Figure 5. Gas cans on the ground in the rain.*

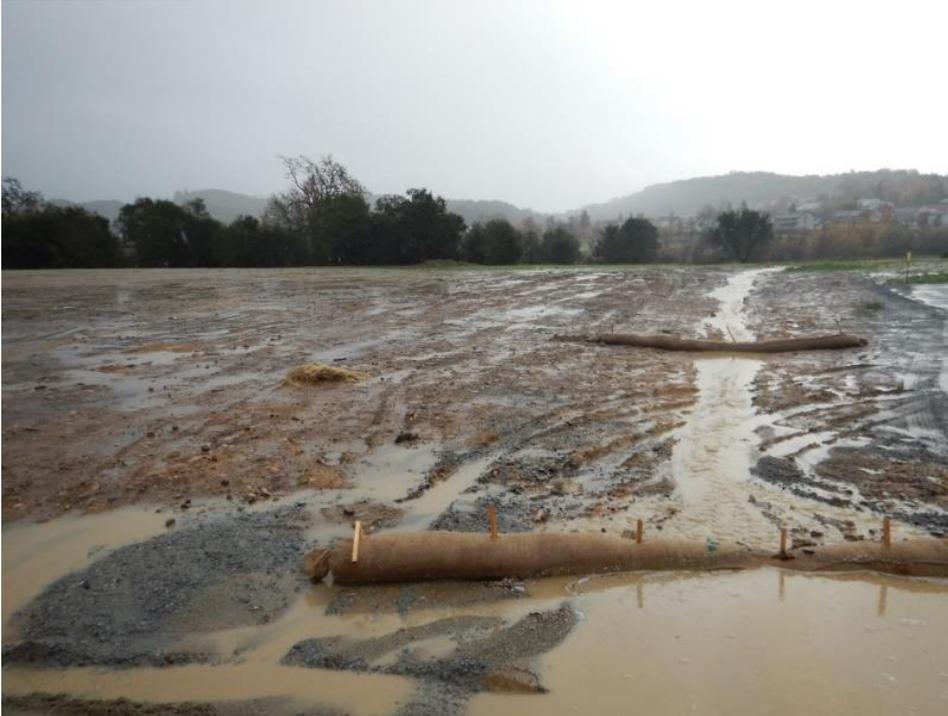
During the November 29 through December 4, 2018, inspections, staff observed 118 locations where BMPs were not effective in reducing or preventing pollutants in storm water discharges. In addition, storm water runoff samples collected by staff during the November 29, 2018, inspection showed turbidity levels as high as 896 NTU, well above the 250 NTU as a numeric action level (NAL) in the CGP that triggers additional pollution control requirements for Risk Level 3 sites.

*Figure 6. Ineffective Sediment control BMPs resulting in turbid, sediment-laden storm water runoff.*

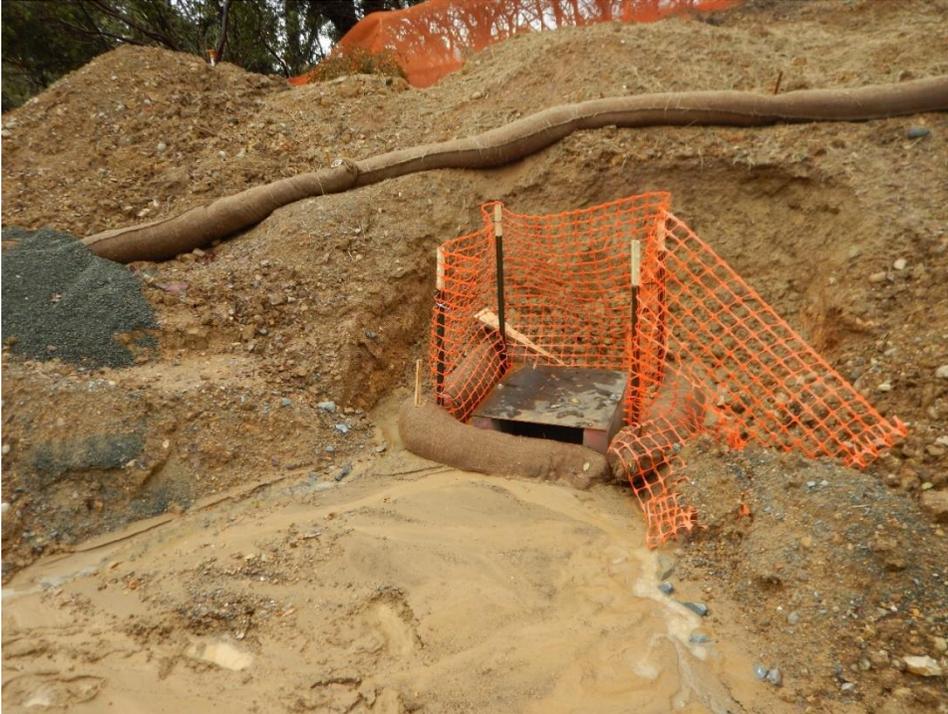
During the November 29 through December 4, 2018, inspections, staff observed 77 inactive areas with unprotected or ineffectively covered bare soil that was susceptible to erosion and exposed to the elements.

*Figure 7. Sediment control BMPs inadequate to prevent erosion and overwhelmed by sediment deposition resulting from sediment-laden runoff.*

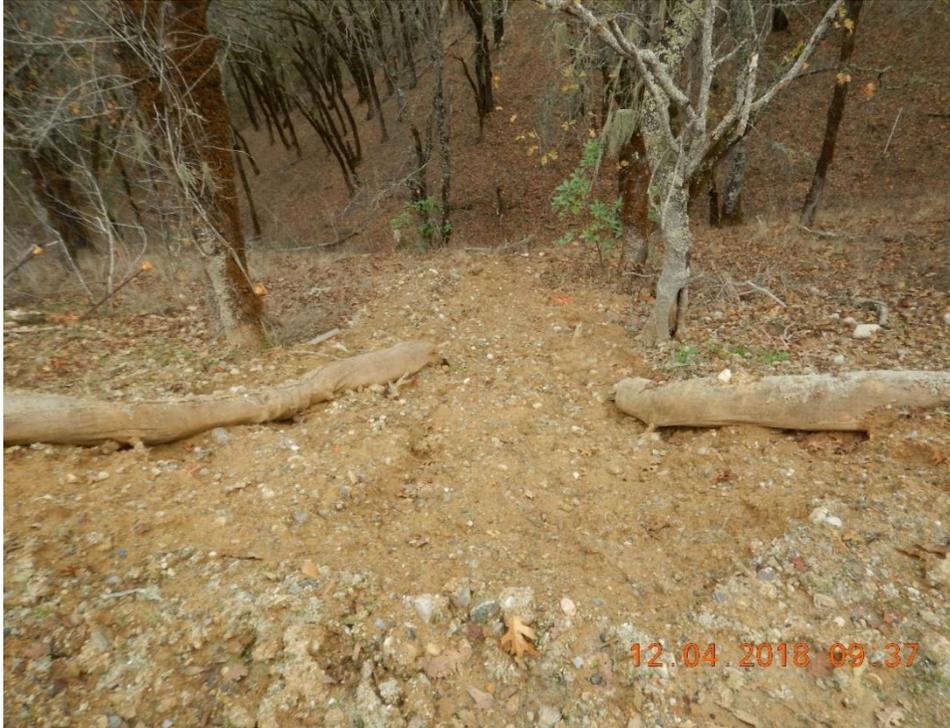
During the November 29 through December 4, 2018, inspections, staff observed 50 locations with inadequate perimeter controls, allowing pollutants to migrate or be transported off the Site.

*Figure 8. Sediment from Road 5 has breached the single perimeter wattle and discharged to the hillslope below. An unnamed tributary to Foss Creek is located approximately 75 feet downslope.*

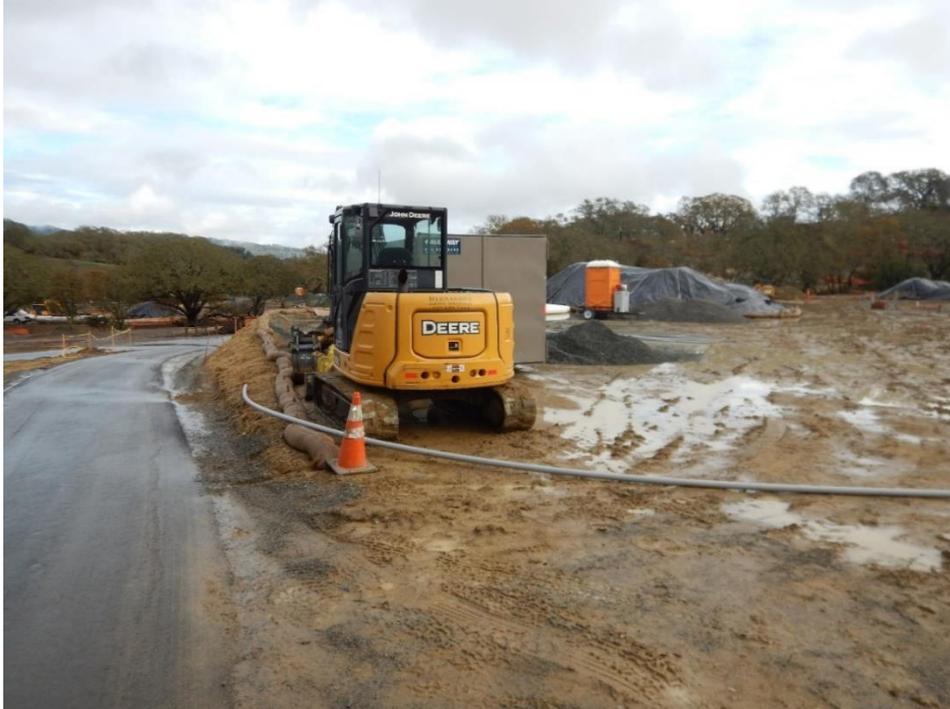
During the November 29 through December 4, 2018, inspections, staff observed 5 areas within the Site under active construction where erosion or sediment controls were non-existent or ineffective. Throughout the Site, staff observed bare, exposed, erodible, and eroding soil; turbid runoff; and sediment-laden runoff entering waterway. BMPs, where present, were either improperly installed, inadequate for the nature or scale of the discharges, rendered ineffective, or some combination thereof.

*Figure 9. Disturbed soil where resort area was under active construction; lack of effective erosion or sediment control BMPs.*

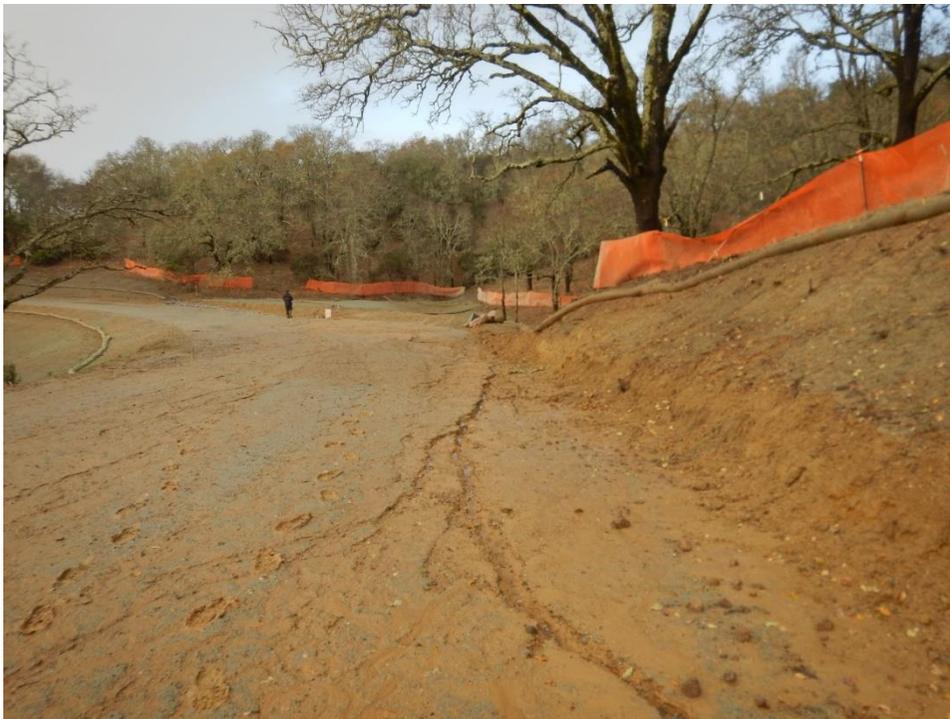
During the November 29 through December 4, 2018, inspections, staff observed 96 locations lacking adequate linear sediment controls at the toe or break in a slope. Erosion and drainage controls were non-existent or ineffective on slopes throughout the Site and were compounded by the lack of linear sediment controls. As a result, eroded sediment and large volumes of high-velocity runoff were free to travel across the Site, overwhelming ineffective BMPs and discharging into receiving waters.

*Figure 10. No linear sediment controls along the base of this roadside slope. Signs of gullying on the road.*

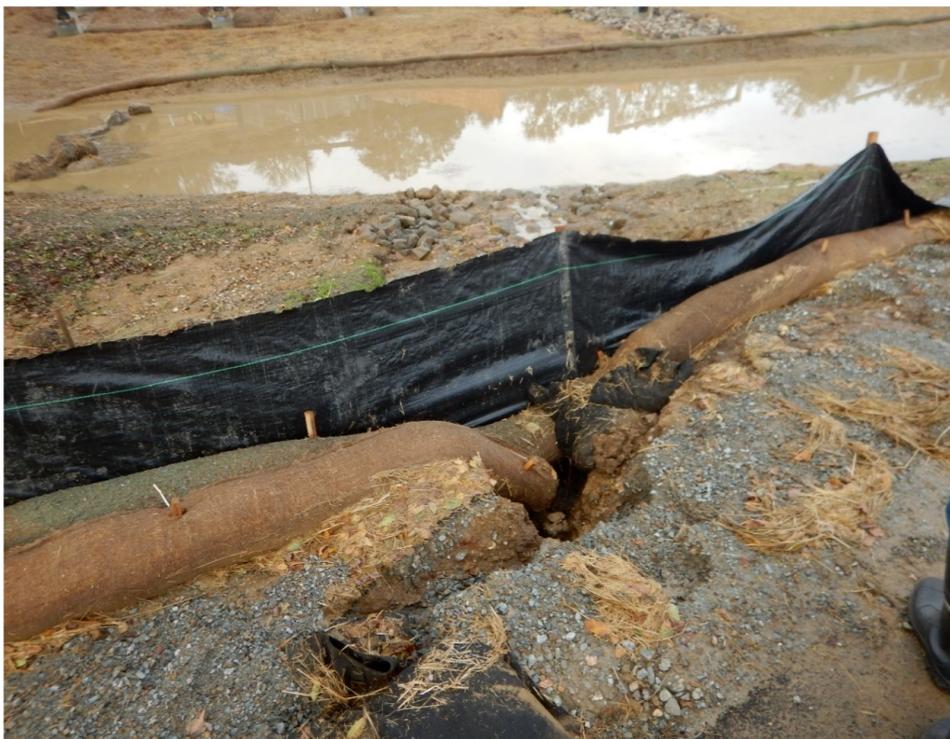
*Figure 11. Erosional gully underneath wattle and silt fence; creek in the background.*

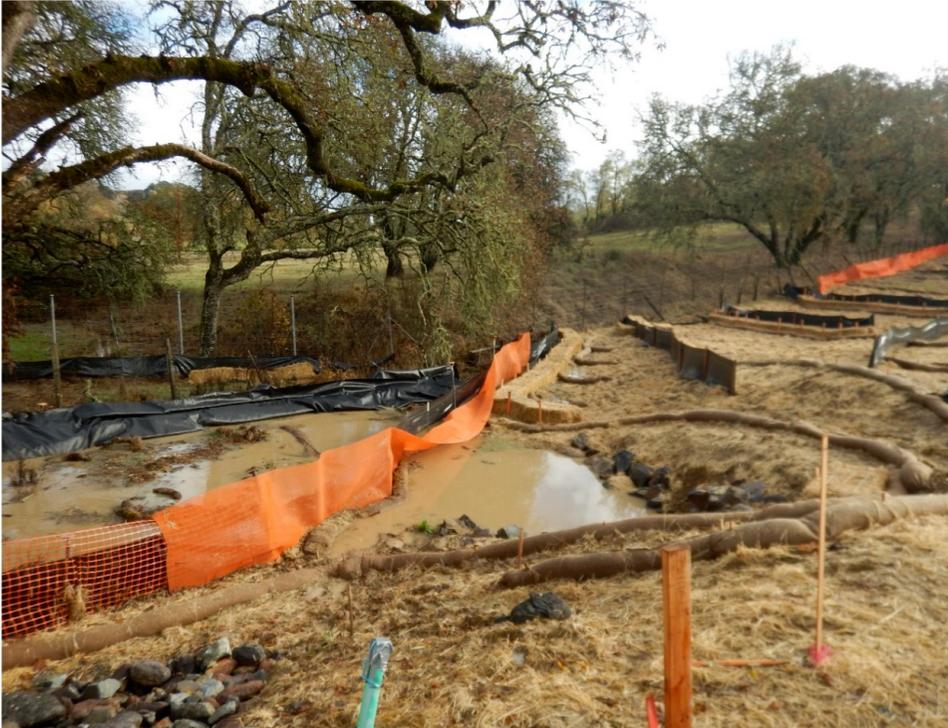
*Figure 12. While several types of erosion and sediment controls are present at this location, the resort area lacked effective controls to prevent highly turbid runoff to the unnamed tributary (shown on left of photo) to Jordan Pond*

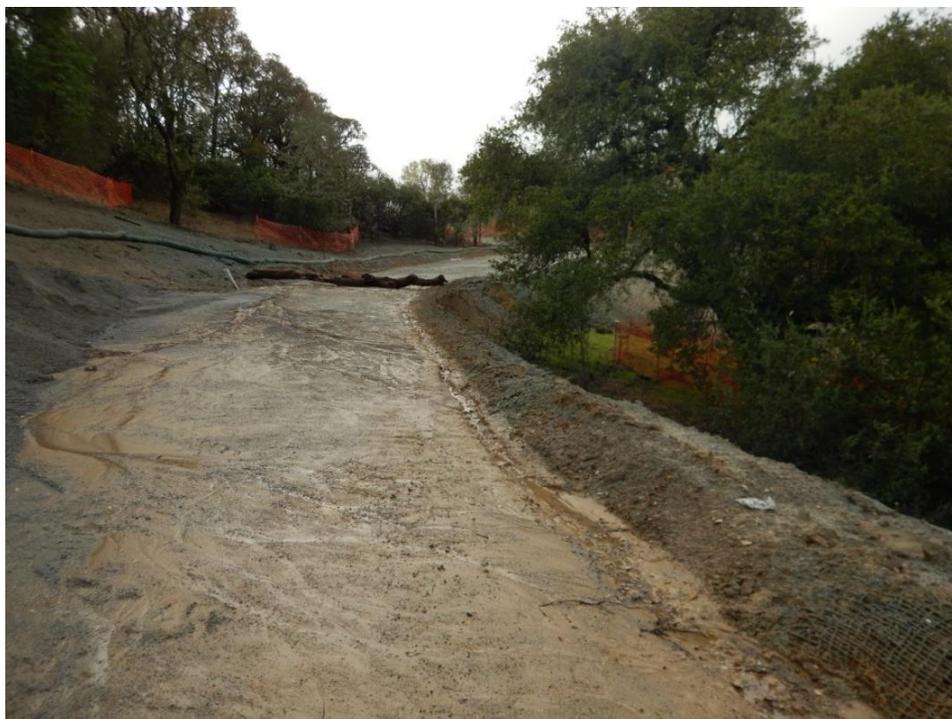
During the November 29 through December 4 inspections, staff observed 71 locations where run-on or runoff was not effectively controlled resulting in million gallons of sediment laden storm water discharging from the Site.

*Figure 13. Road segment with adjacent unprotected slope and signs of uncontrolled runoff.*

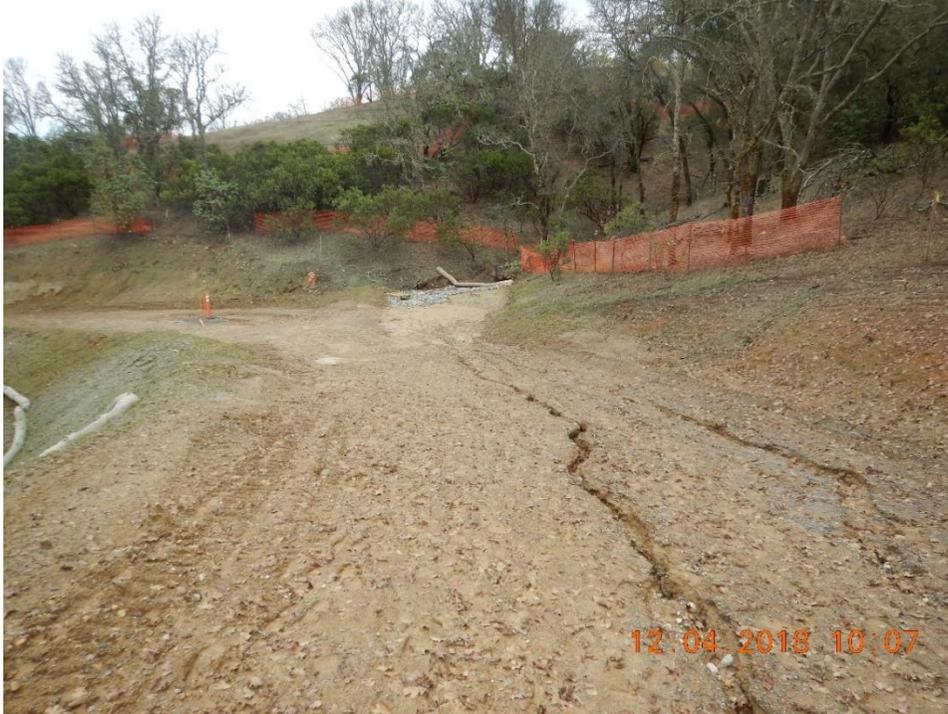
When effectively implemented, run-on and runoff controls can segregate clean or less polluted water from pollutants and more polluted water to control or minimize the amount of polluted storm water generated on a site and the amount of pollutants discharged from a site. With deficient run-on and runoff controls and widespread lack of effective pollution prevention BMPs throughout the Site, it is likely that most of the storm water that landed on or flowed across the disturbed portions of the Site became contaminated by sediment and other pollutants and discharged from the Site into receiving waters. The Potential for Harm associated with this violation is Major because the characteristics of the violation present an egregious threat to beneficial uses and the circumstances of the violation indicate a very high potential for harm.

*Figure 14. Road segment with no erosion and sediment control BMPs. Signs of gullying on the road.*

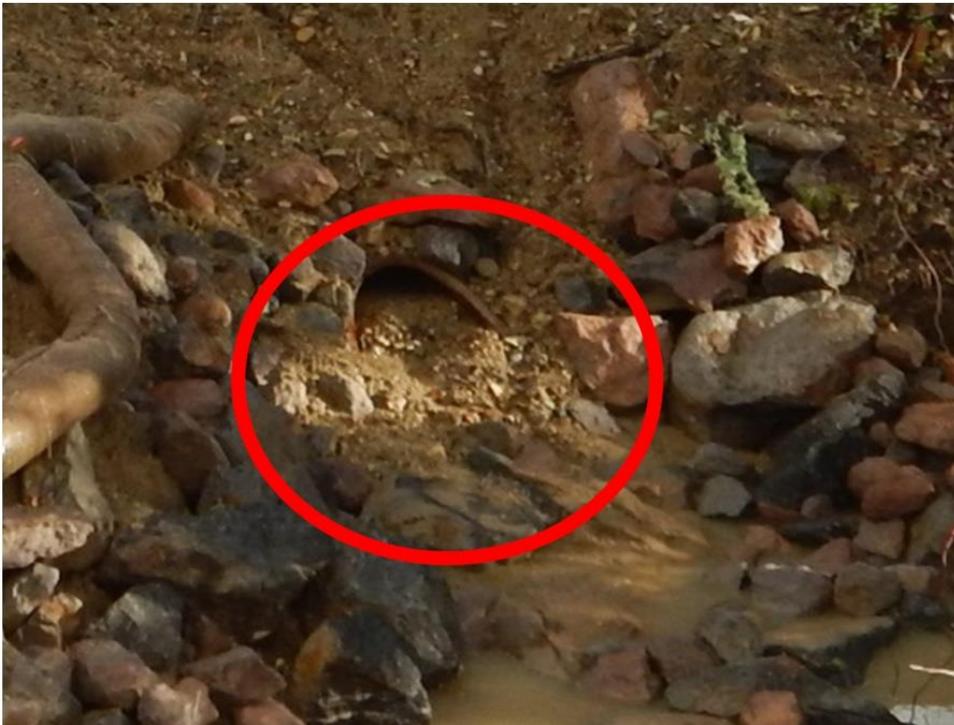
*Figure 15. Significant sediment discharge at the culvert outfall that drains the upper resort area.*

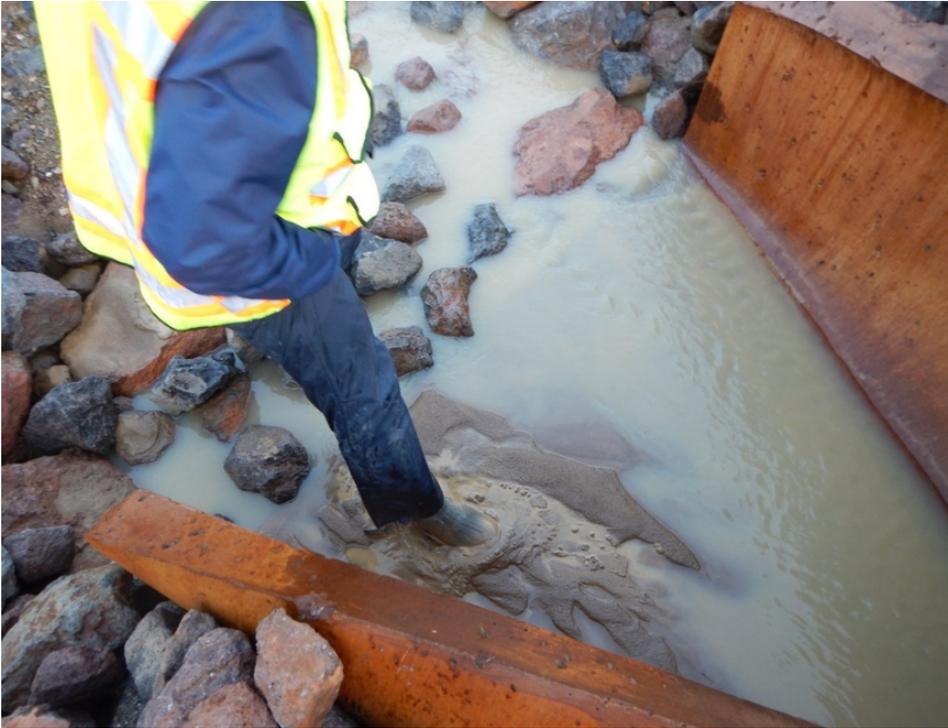
*Figure 16. Significant sediment deposition within Foss Creek culvert inlet.*

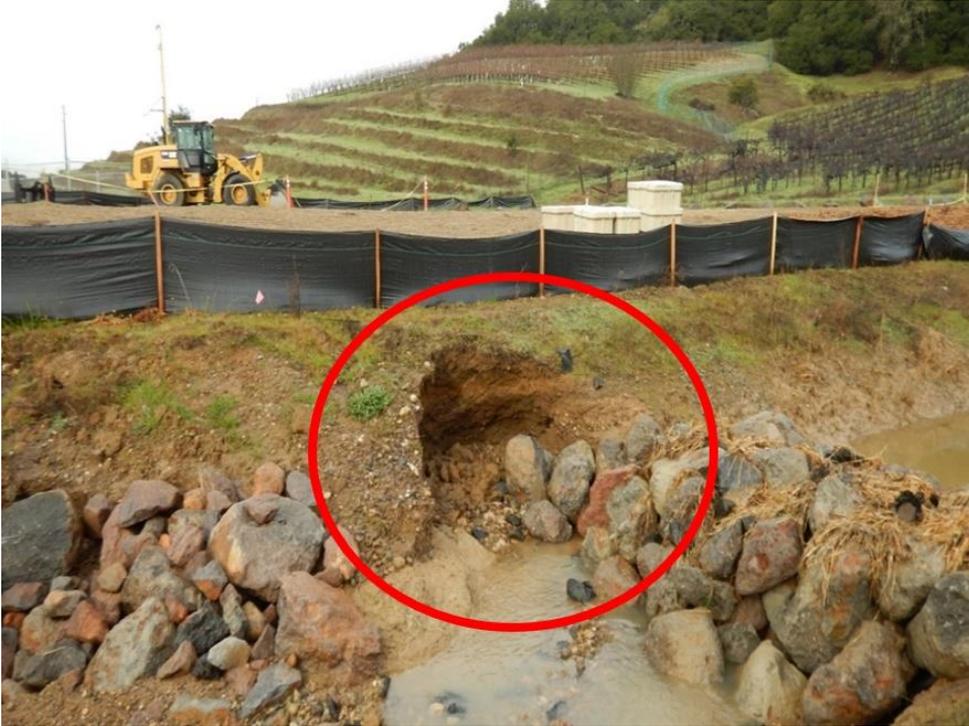
*Figure 17. Lack of erosion and sediment controls in this inactive area resulted in stream bank failure that led to sediment deposition within Foss Creek*

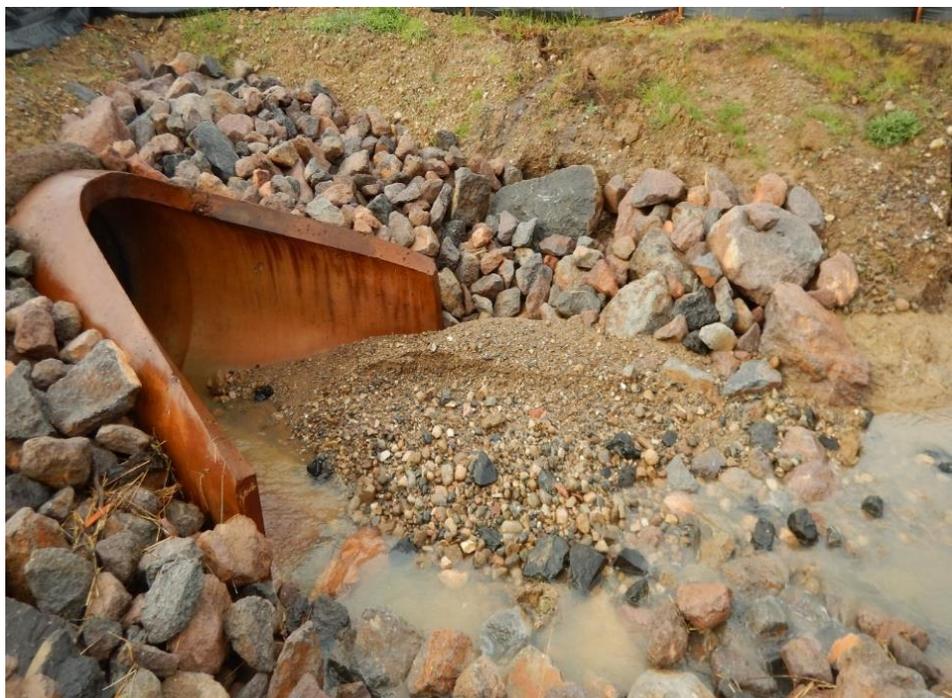
*Figure 18. Downstream from Figure 14, large sediment deposit within Foss Creek as a result of the slope failure along the creek bank.*

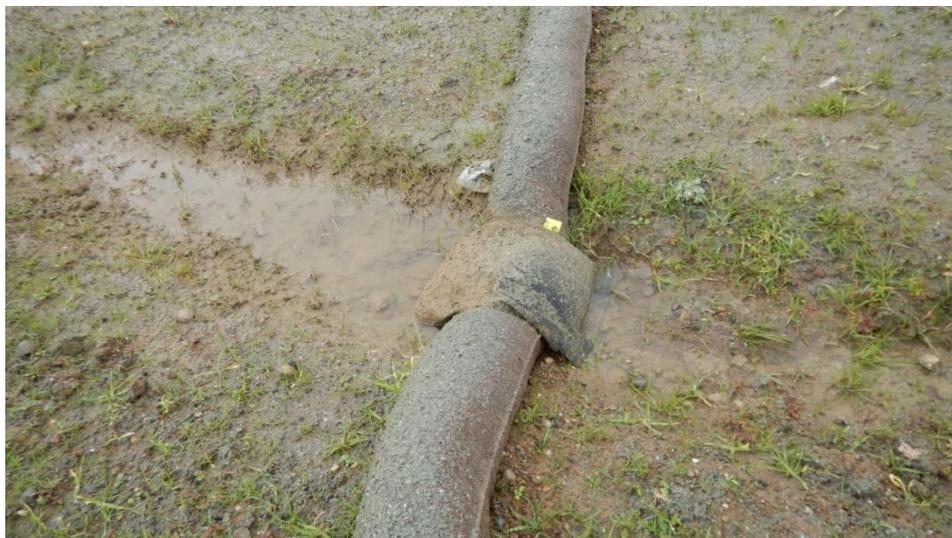
As noted above, staff observed only a limited portion of the Site on January 7, 2019 but observed inadequate erosion and sediment control BMPs and ineffective soil cover at two inactive areas along the lower portion of the Site and within Foss Creek. There were no erosion control blankets on the slopes that failed, resulting in the large sediment deposit shown in Figure 18, above. The applied hydroseed was not sufficiently established to effectively reduce soil erosion. Additionally, straw had not been uniformly applied in conjunction with the hydroseed, as described in the site-specific SWPPP.

*Figure 19. Ineffective soil cover contributing to erosion. The combination of BMPs for erosion, sediment, and turbidity controls on the Site was not adequate to prevent erosion and sedimentation.*

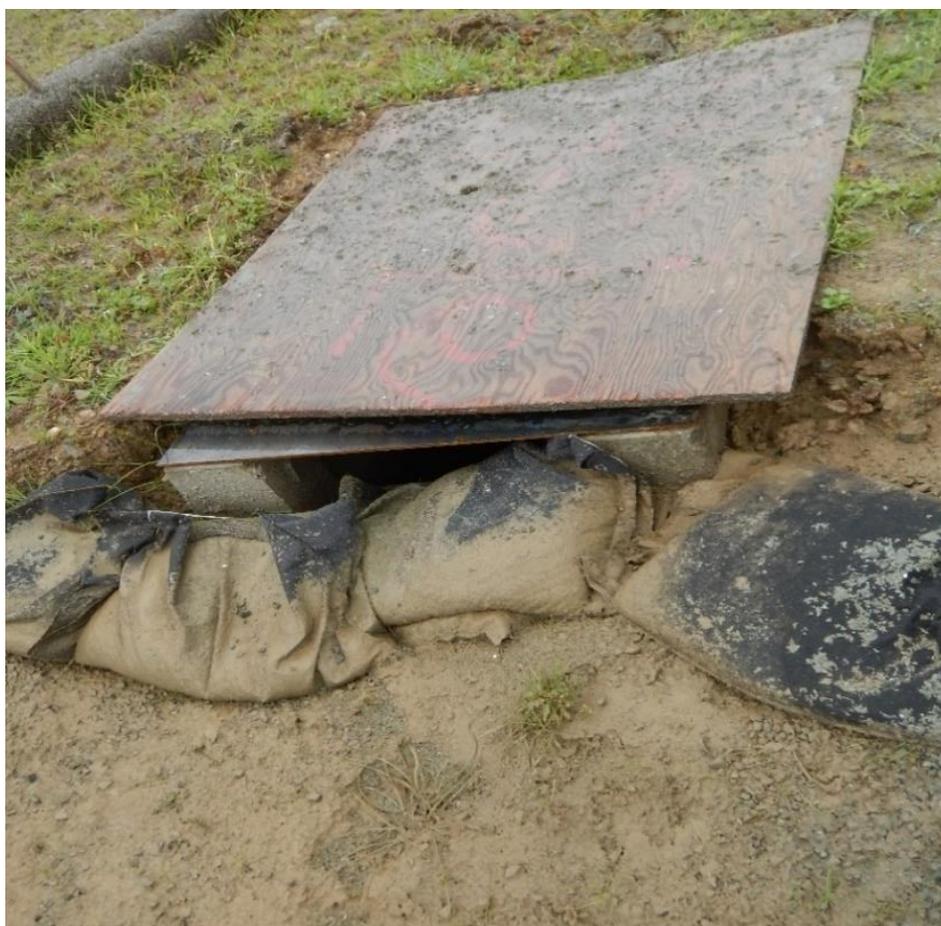
*Figure 20. Farther downstream of Figure 19 above, the silt deposits show that sediment-laden water impounded sufficiently to overtop the center bag.*

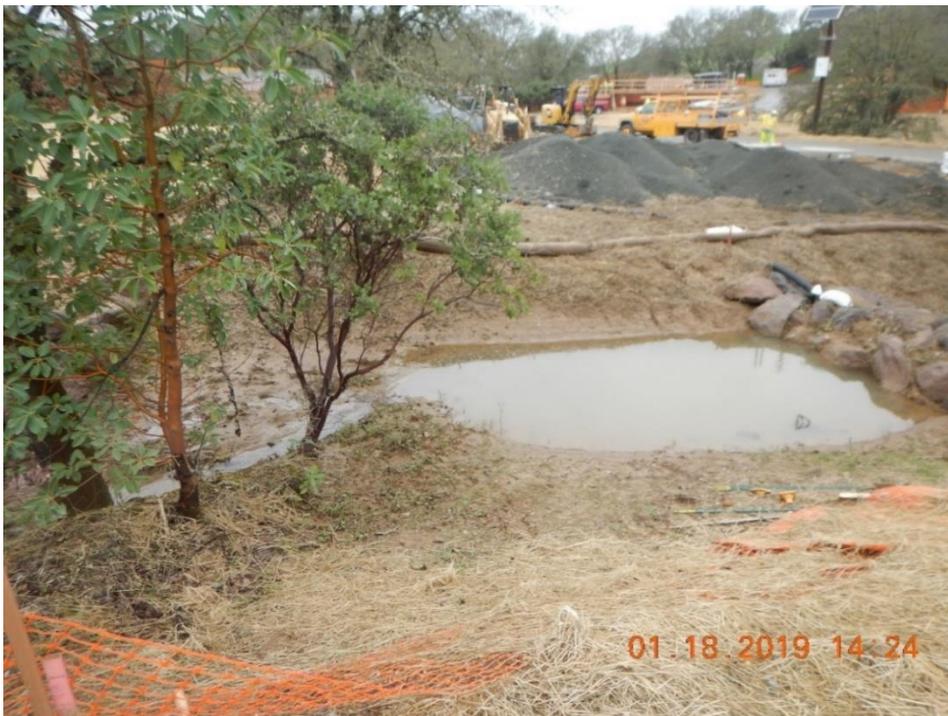
Though staff observed only two uncovered, uncontained construction material stockpiles during the January 18 inspection, both were exposed to the elements and showed signs of leaching of pollutants near receiving waters. Staff observed and photographed a pool of discolored water that had gathered under one of the stockpiles.

*Figure 21. Uncovered stockpile near top of a stream/drainage channel bank. Creek in the foreground.*

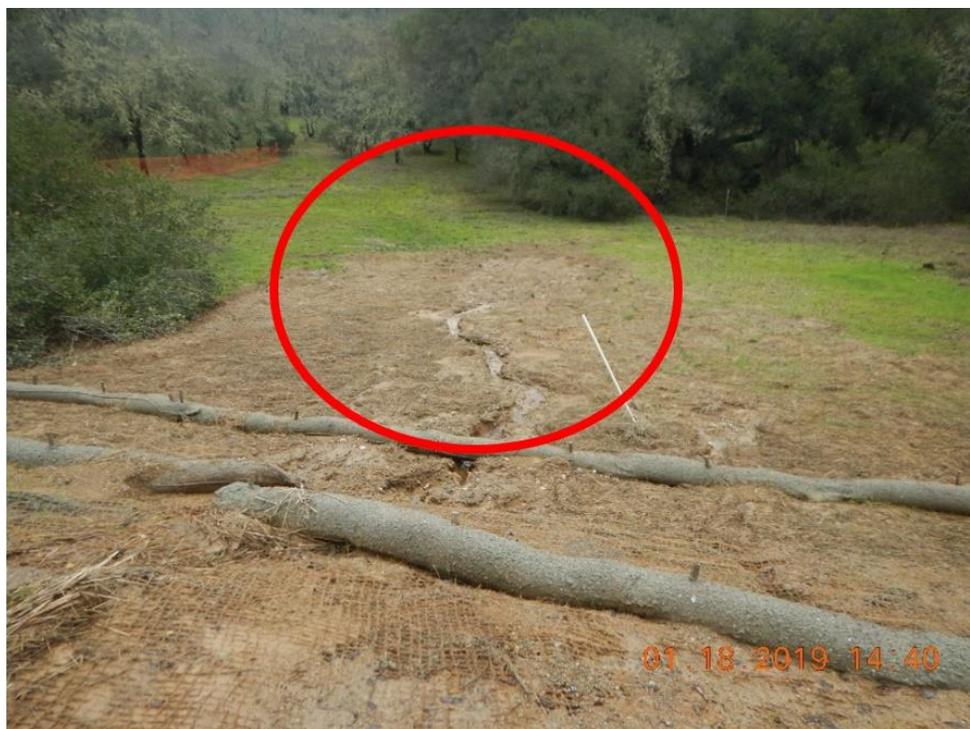
Staff observed four locations throughout Road 8 that had disturbed soil that had not been effectively covered and overwhelmed BMPs that needed maintenance on the January 18, 2019, inspection.

*Figure 22. Sediment deposition beyond the undermined and overwhelmed BMPs; insufficient maintenance of erosion and sediment control BMPs.*

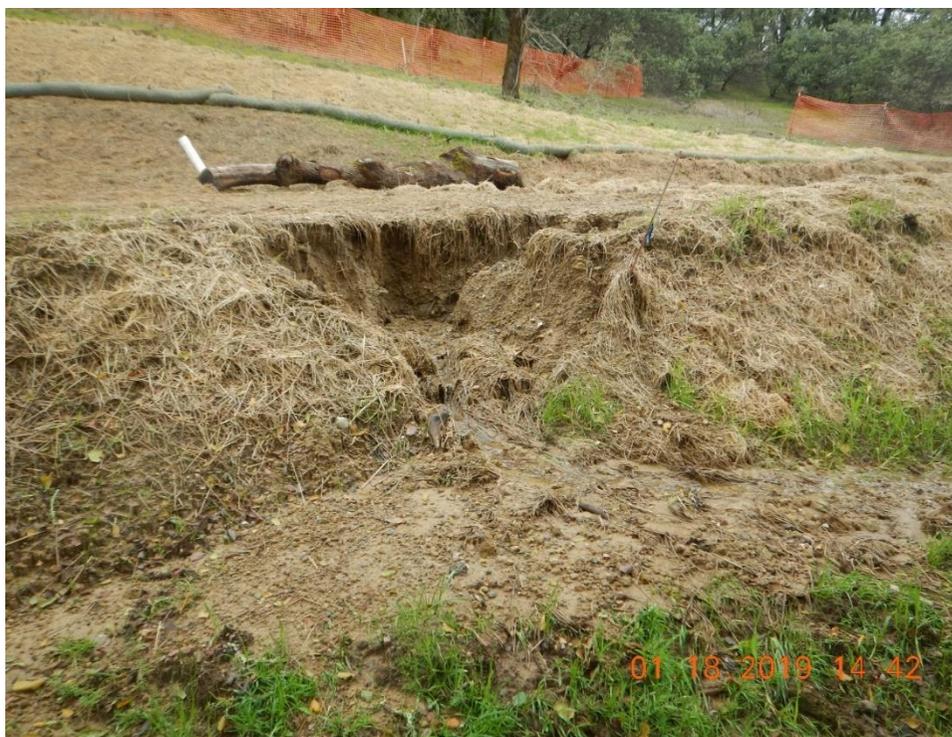
As mentioned above, there was extensive disturbed soil at the Site, requiring diligent maintenance over the continuing rainy season. Ineffective soil cover was observed at four locations along Road 8. Where disturbed soil was not effectively covered, and where BMPs were not maintained it was susceptible to erosion and transport to receiving waters, presenting an egregious threat to beneficial uses. The circumstances of the violation occurring during a continuing rainy season and the extensiveness of the disturbed soil indicate a very high potential for harm. Therefore, Potential for Harm for this violation was Major.

*Figure 23. Ineffective erosion and sediment controls on slope resulting in bank failure and evidence of sediment transport in the foreground.*

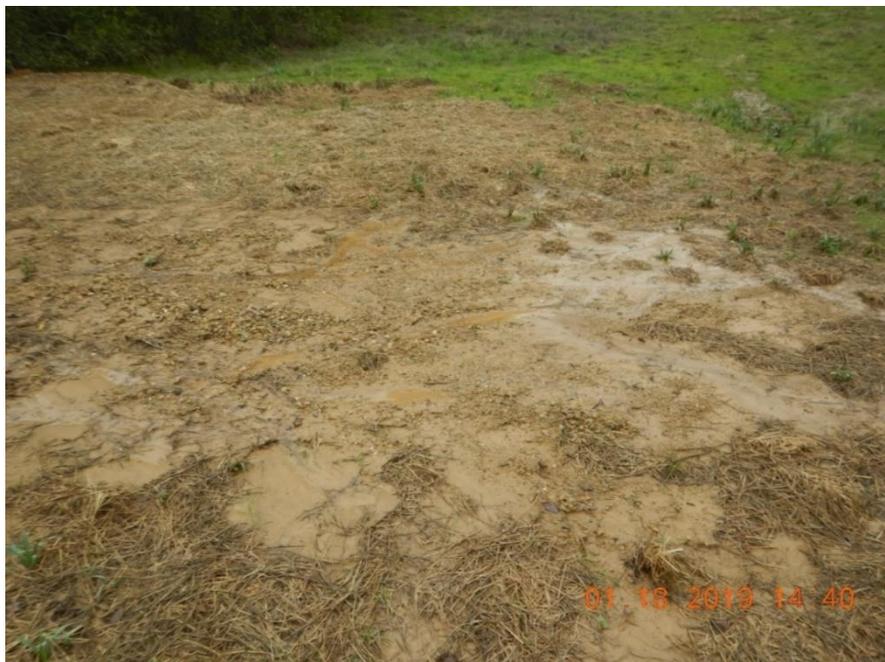
During the January 18 inspection, staff observed four areas lacking sufficient perimeter controls, allowing pollutants to migrate or be transported off the Site.

*Figure 24. Lack of perimeter controls downhill from disturbed soil areas.*

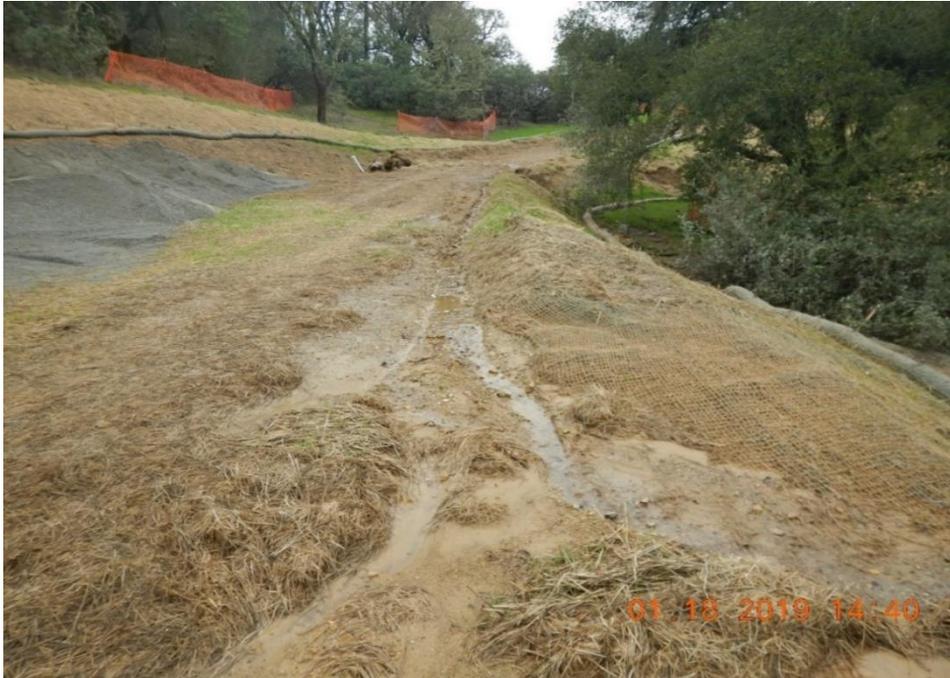
During the January 18, 2019 inspection, staff observed four locations lacking effective linear sediment controls at the toe or break in a slope. Erosion and drainage controls were non-existent or ineffective on slopes throughout the Site.

*Figure 25. Lack of effective linear sediment controls at the toe or break in a slope.*

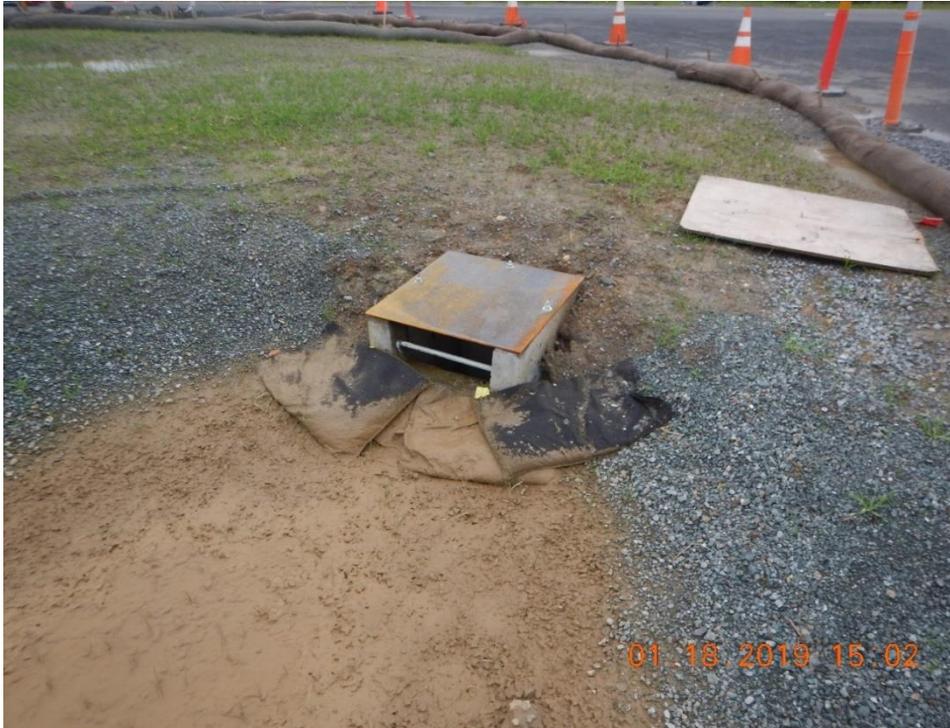
During the January 18, 2019 inspection, staff observed five locations where run-on or runoff was not effectively controlled.

*Figure 26. The sediment trap is inadequate and needs maintenance; sediment has overtopped the gravel bags and discharged sediment-laden runoff to the storm drain system that discharges to Foss Creek*

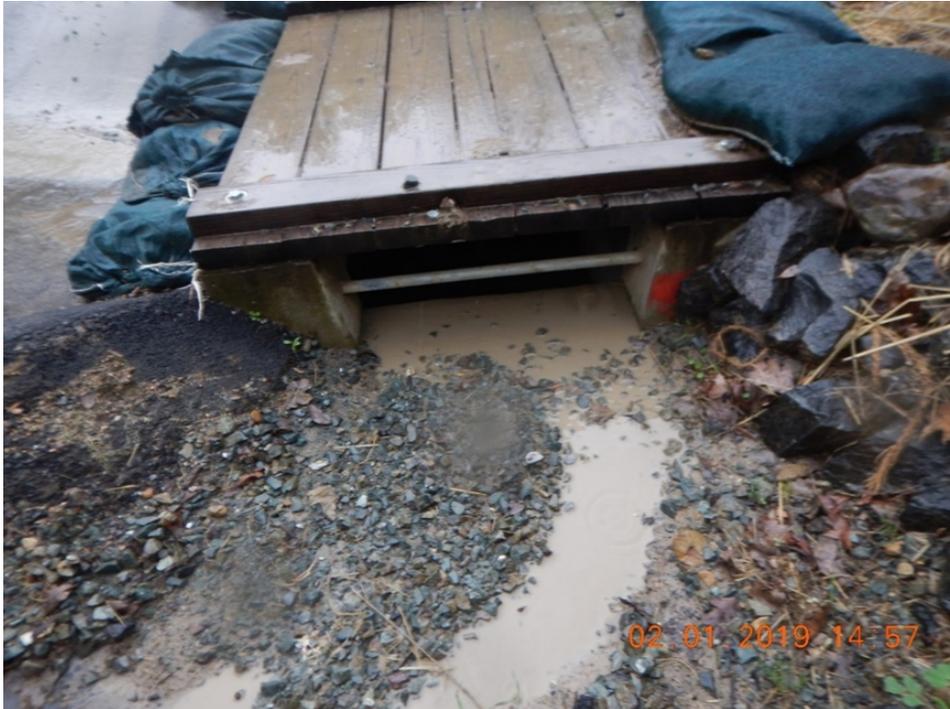
*Figure 27. Turbid storm water runoff entering drain inlet that discharges to Foss Creek*

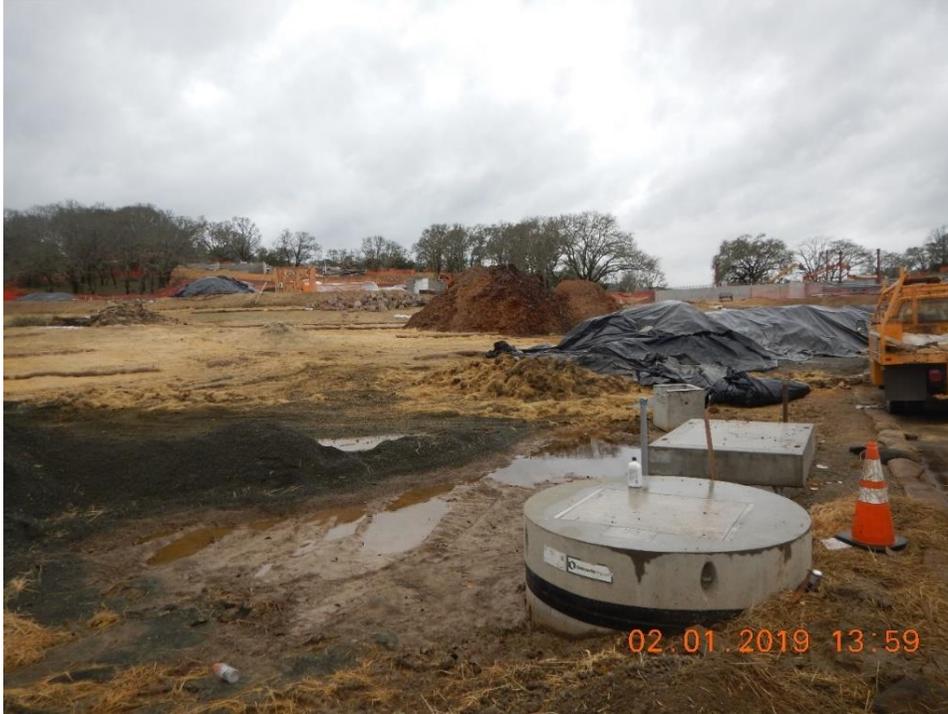
On February 1, 2019, staff observed an area with several material stockpiles that continued to remain uncovered and uncontained, with nearby puddles of discolored water.

*Figure 28. Stockpiles, some covered, some uncovered. Discolored water. Heavy equipment tracks in the mud.*
