**STATE OF CALIFORNIA  
REGIONAL WATER QUALITY CONTROL BOARD  
NORTH COAST REGION**

**[PROPOSED] ORDER NO. R1-2020-0040  
for Administrative Civil Liability**

**In the Matter of:  
Sonoma Luxury Resort LLC  
Saggio Hills Development Project Site (a.k.a. Montage Healdsburg)  
16840 Healdsburg Avenue, Healdsburg, CA 95448**

**Administrative Civil Liability Complaint No. R1-2020-0027  
Amending Complaint No. R1-2020-0009  
WDID NO. 1B06169WNSO (401 Cert)  
WDID NO. 1 49C375878 (CGP)**

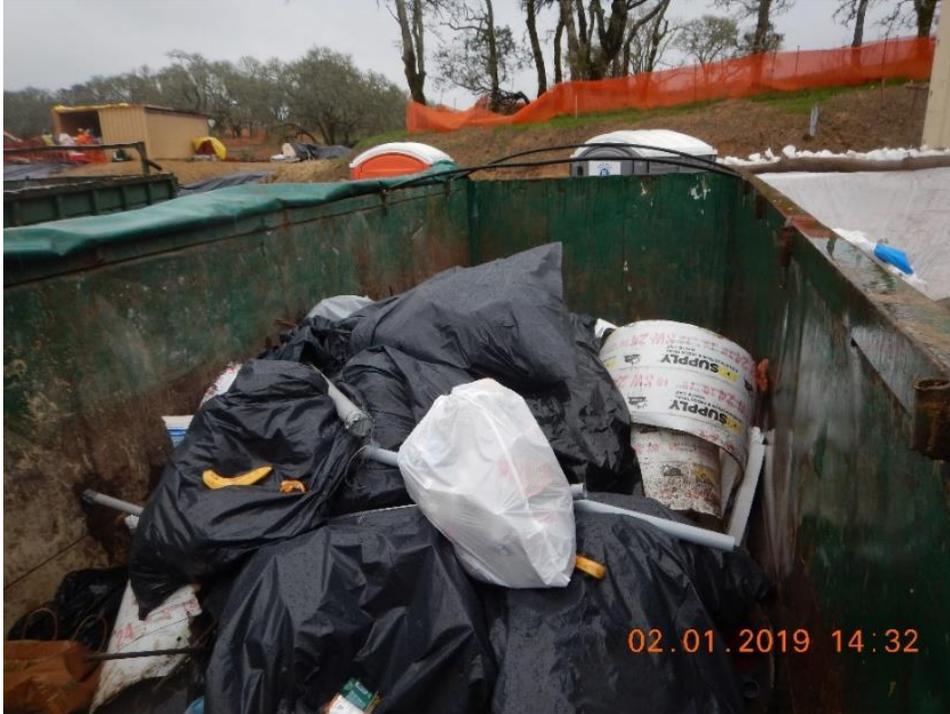
*Figure 29. Partially filled waste bin, uncovered, during rainfall.*

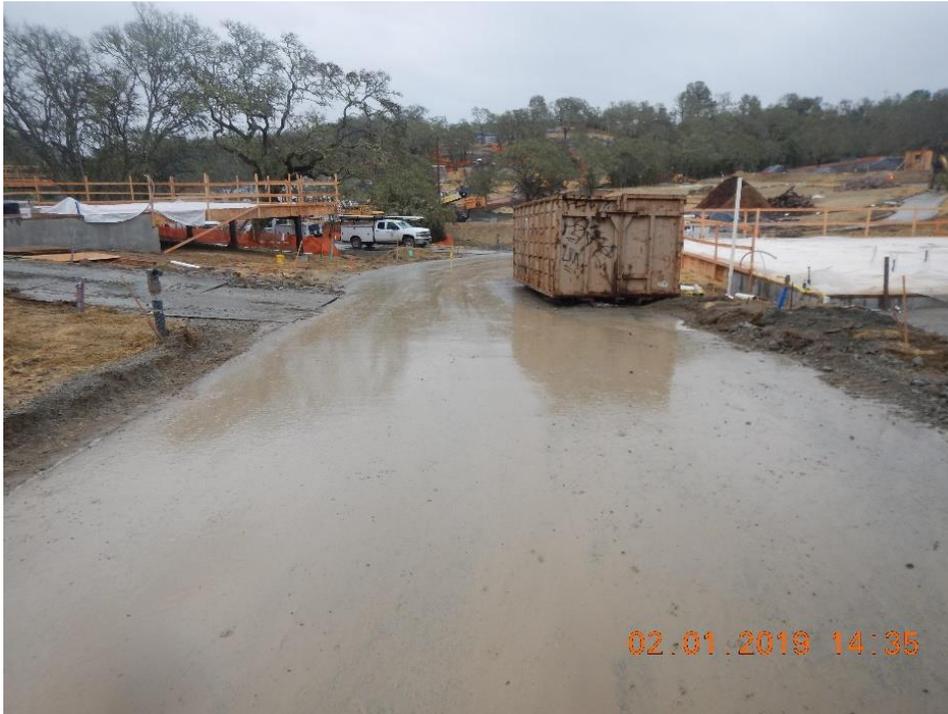
*Figure 30. Mud on paved roads continues to result in discharges of sediment-laden runoff.*

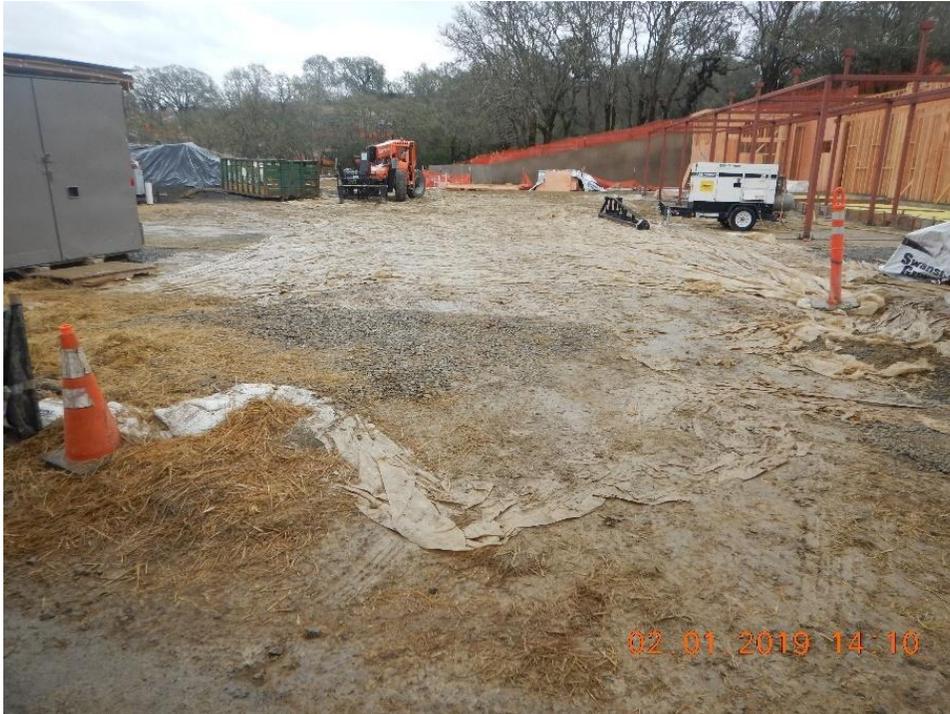
Figure 31. Ineffective erosion and lack of sediment controls in this inactive area.

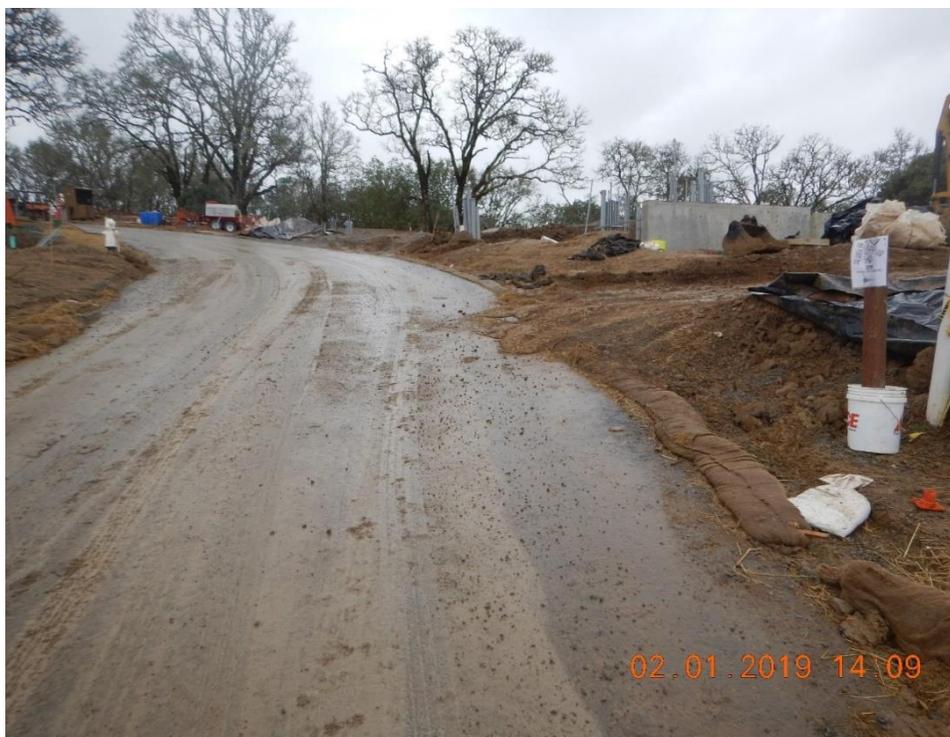
*Figure 32. Sediment control BMPs observed do not effectively contain soil within the active construction area.*

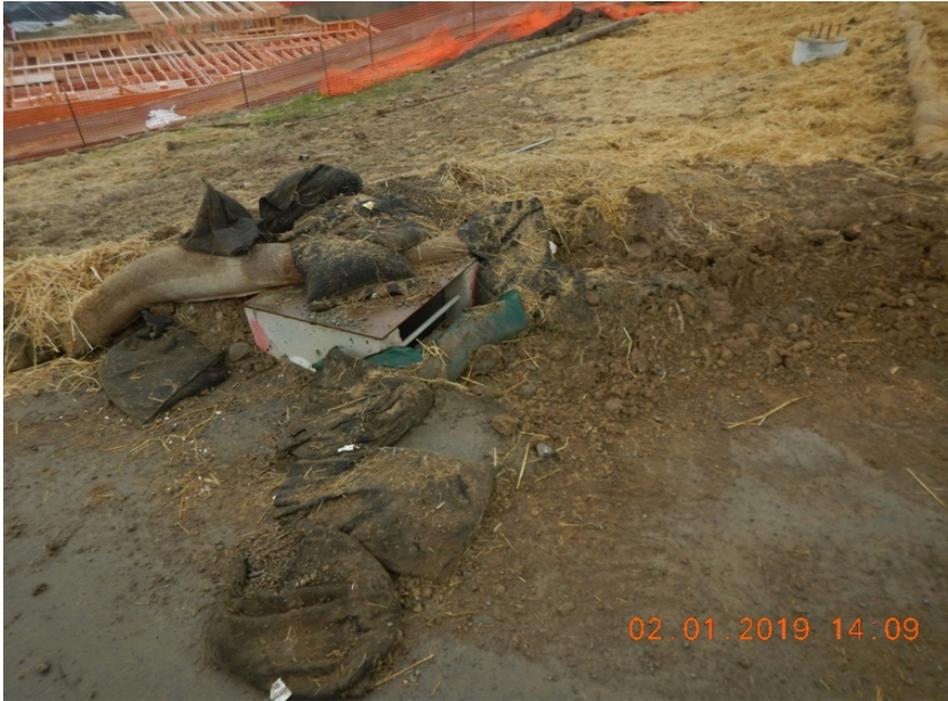
*Figure 33. Sediment from the adjacent work area is overflowing onto the roadway and into the drain inlet.*

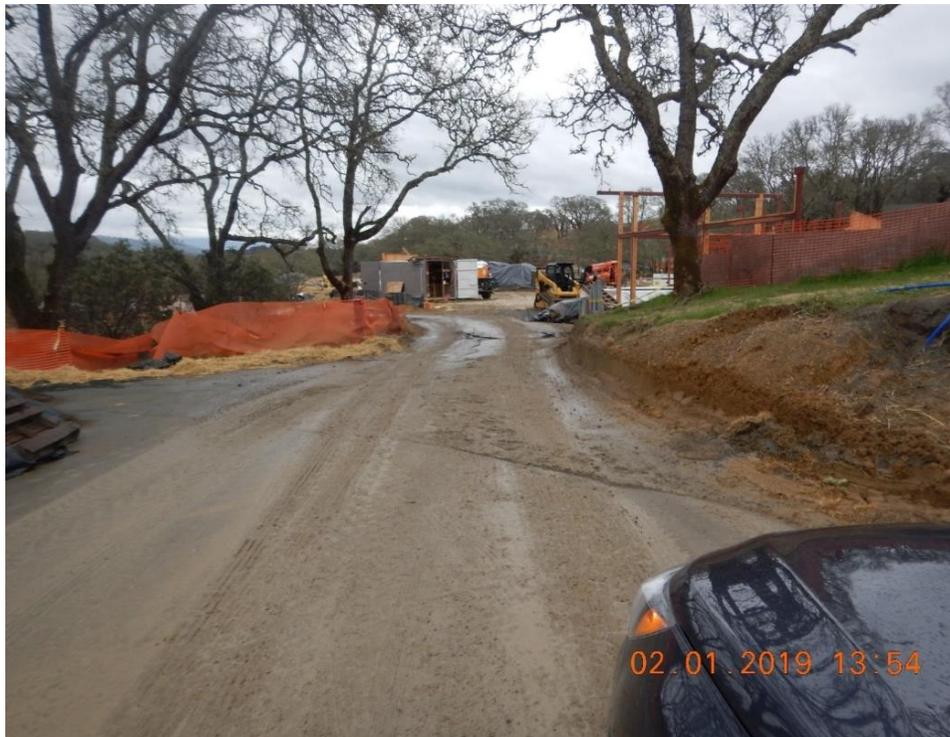
*Figure 34. The cut slope adjacent to the roadway lacks erosion or sediment control measures either on the slope or at its toe.*

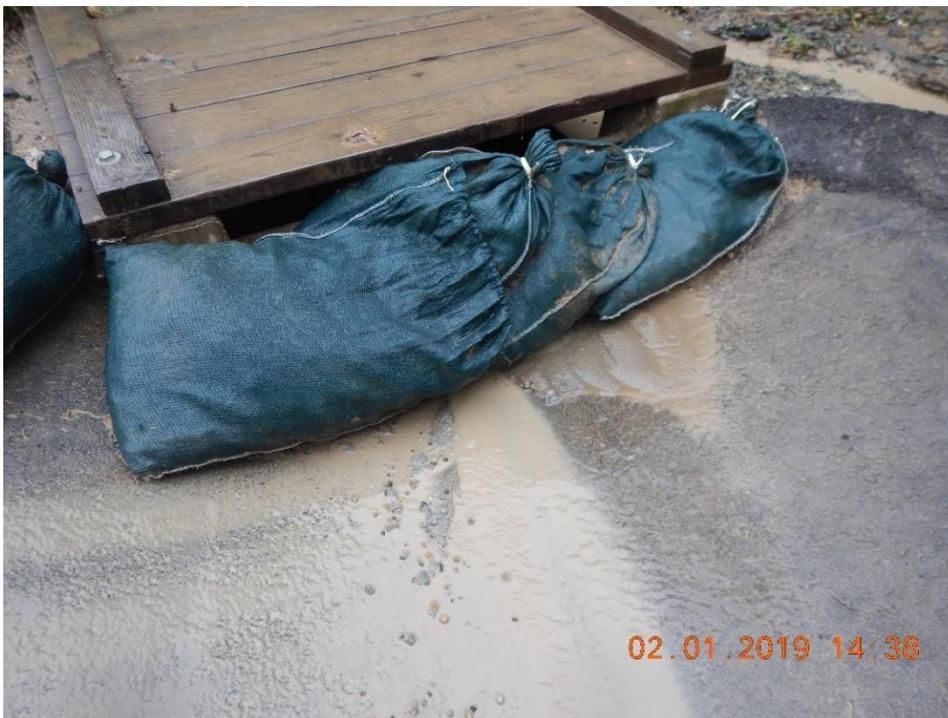
*Figure 35. This check dam is not correctly positioned to effectively capture or remove pollutants from storm water runoff.*

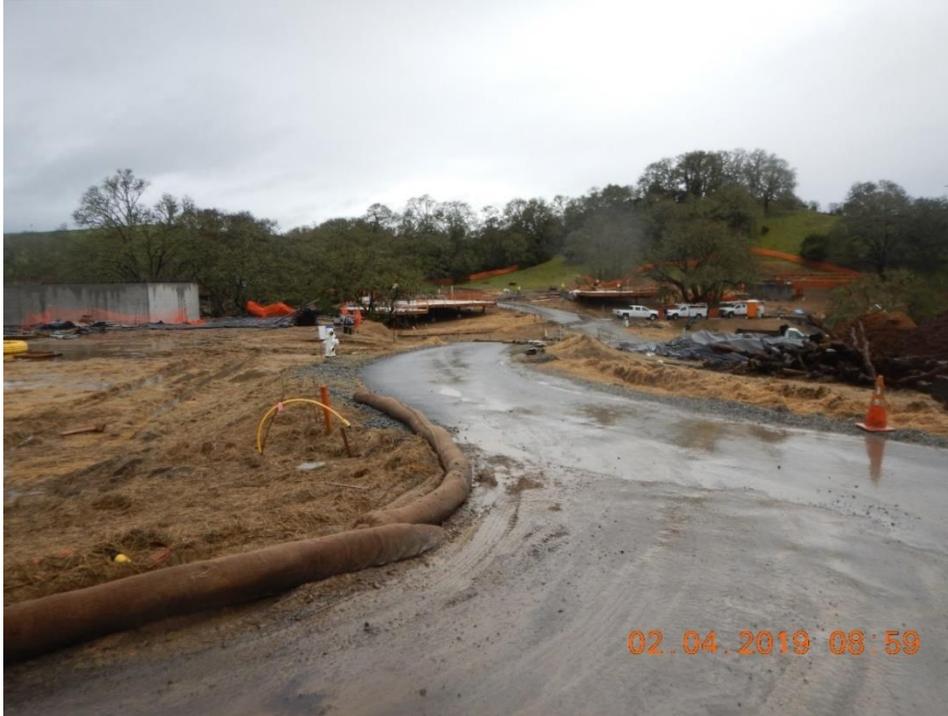
*Figure 36. Poor maintenance of BMPs, and lack of BMPs to keep the paved roads clean continues to result in discharges of sediment-laden runoff to the drainage system.*

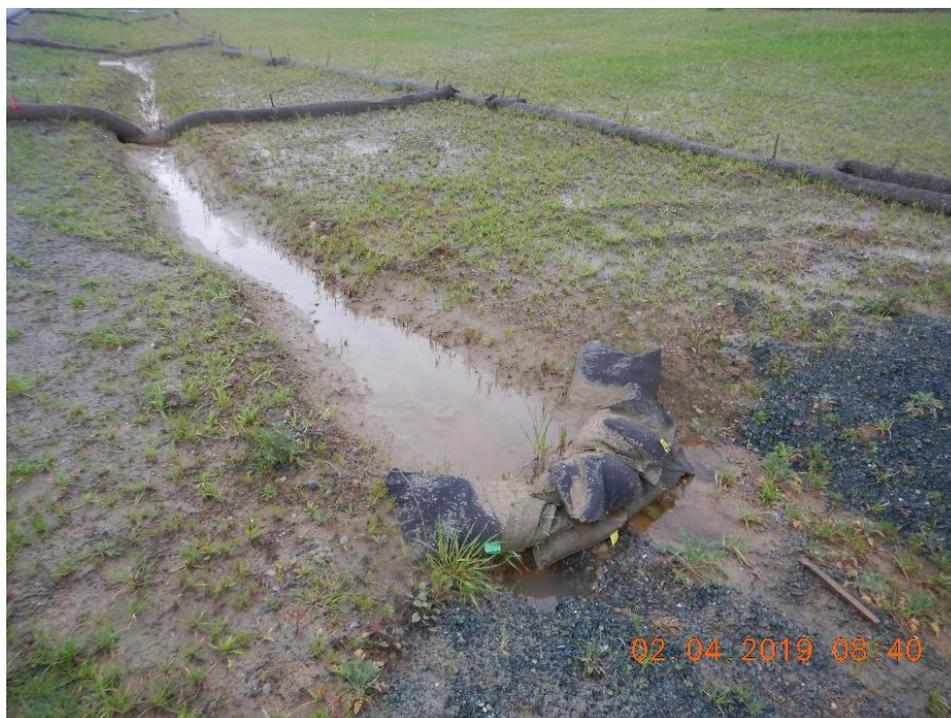
*Figure 37. Erosion controls (hydroseed and straw soil cover) are not adequate or established enough to prevent sediment-laden runoff to the storm drain system that discharges to Foss Creek.*

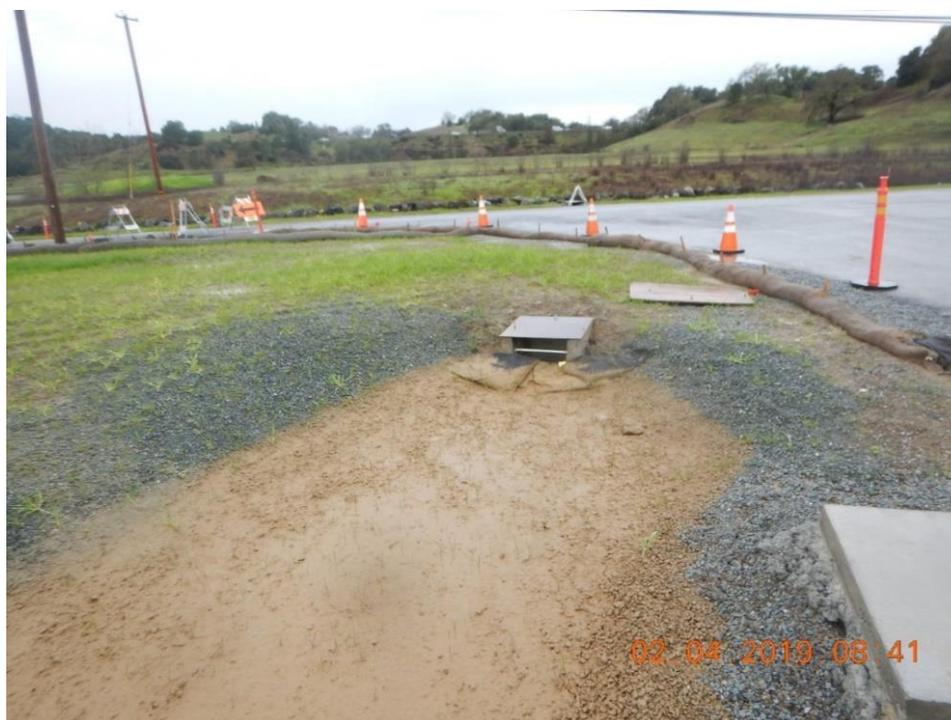
*Figure 38. Downstream of Figure 37 above, sediment has overtopped the gravel bags and discharged sediment-laden runoff to the storm drain system that discharges to Foss Creek.*

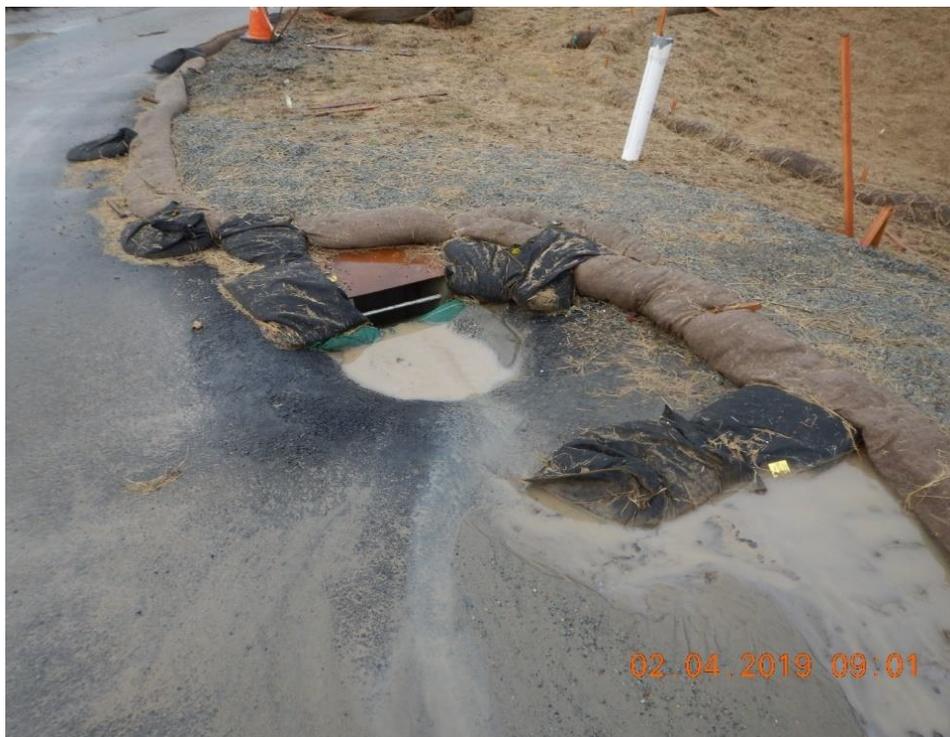
*Figure 39. Sediment controls near the drainage inlet are not effectively reducing or preventing pollutants in storm water discharges.*

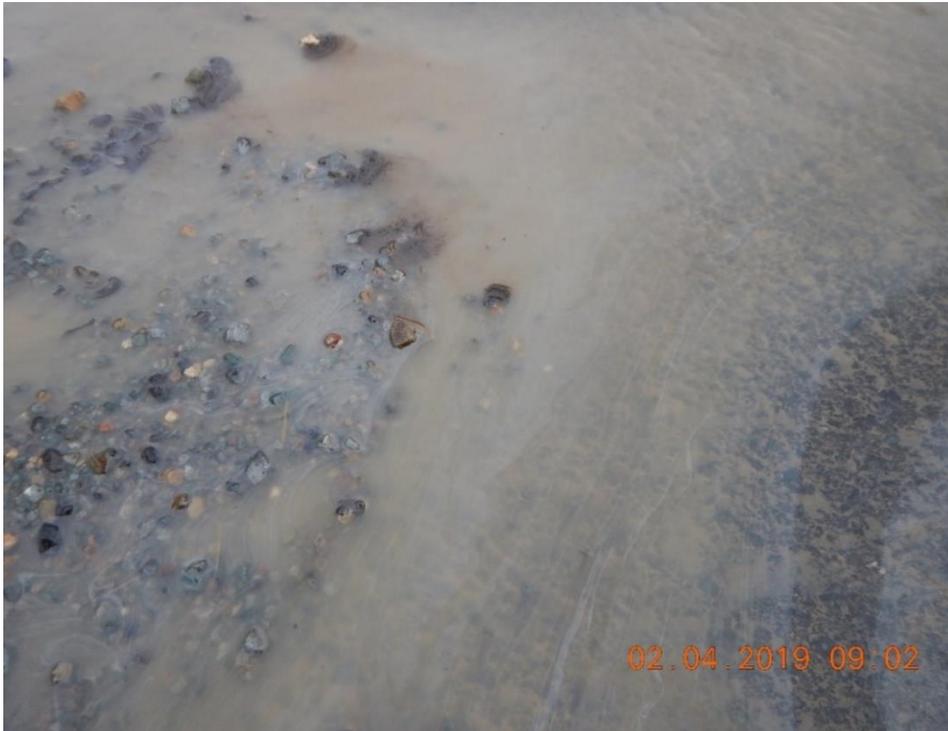
*Figure 40. Oil sheen and turbid water on road surface in the resort area was observed flowing into the storm drain inlet in Figure 38.*

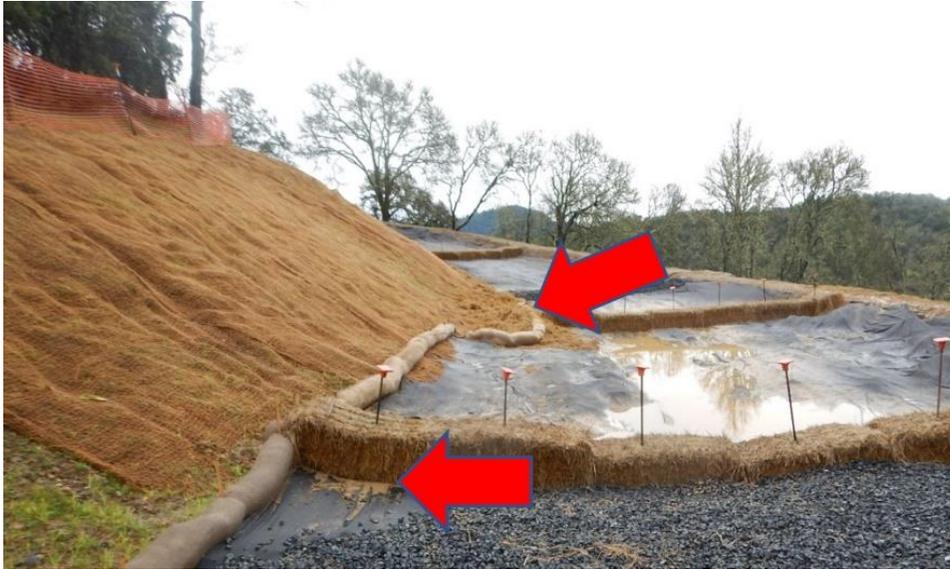
*Figure 41. Note slumping slope on roadway. Turbid water is visible emerging from the left side of the first straw bale berm in the foreground. This turbid water eventually discharged to an unnamed tributary to Foss Creek.*

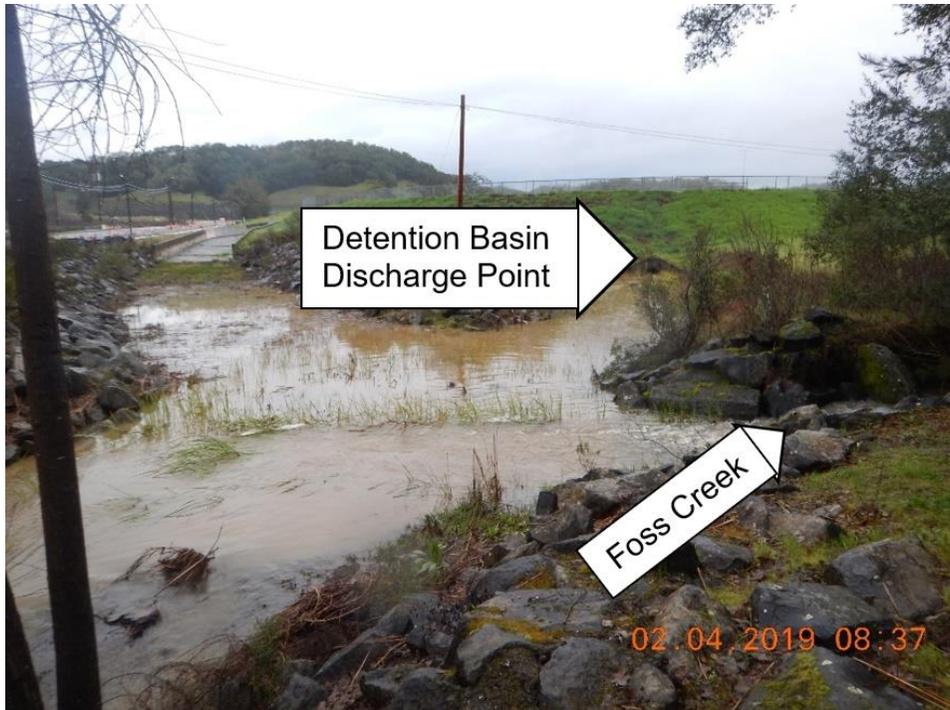
*Figure 42. Discharge point from the City's detention basin which is receiving flow from the Site and delivering turbid water to Foss Creek.*

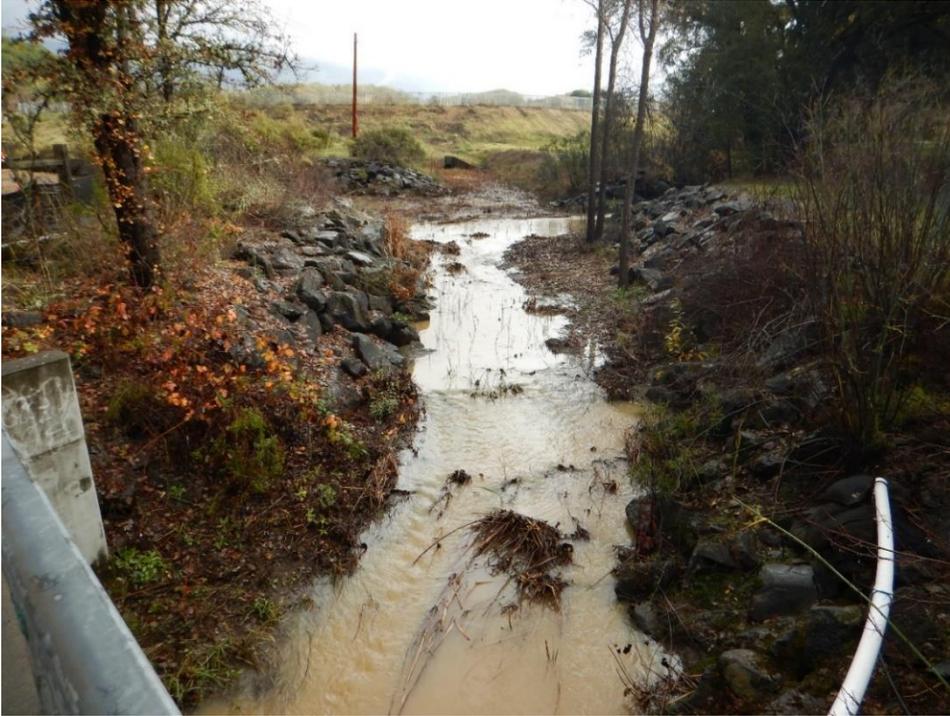
*Figure 43. November 29, 2018. Foss Creek Bridge on Healdsburg Avenue downstream of Site. In route to the Site, staff noticed Foss Creek was highly turbid.*

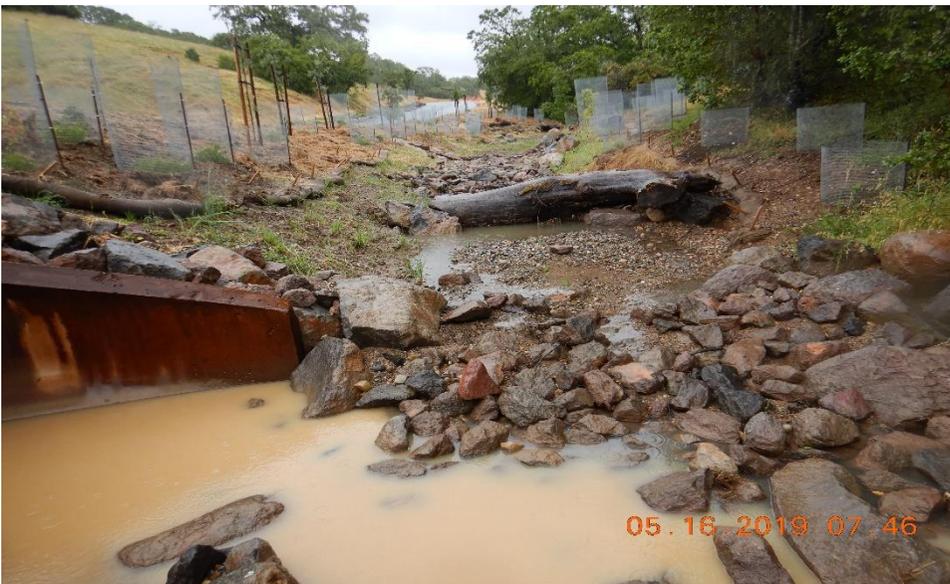
*Figure 44. Foss Creek at the confluence of the tributaries affected by Site construction activities.*

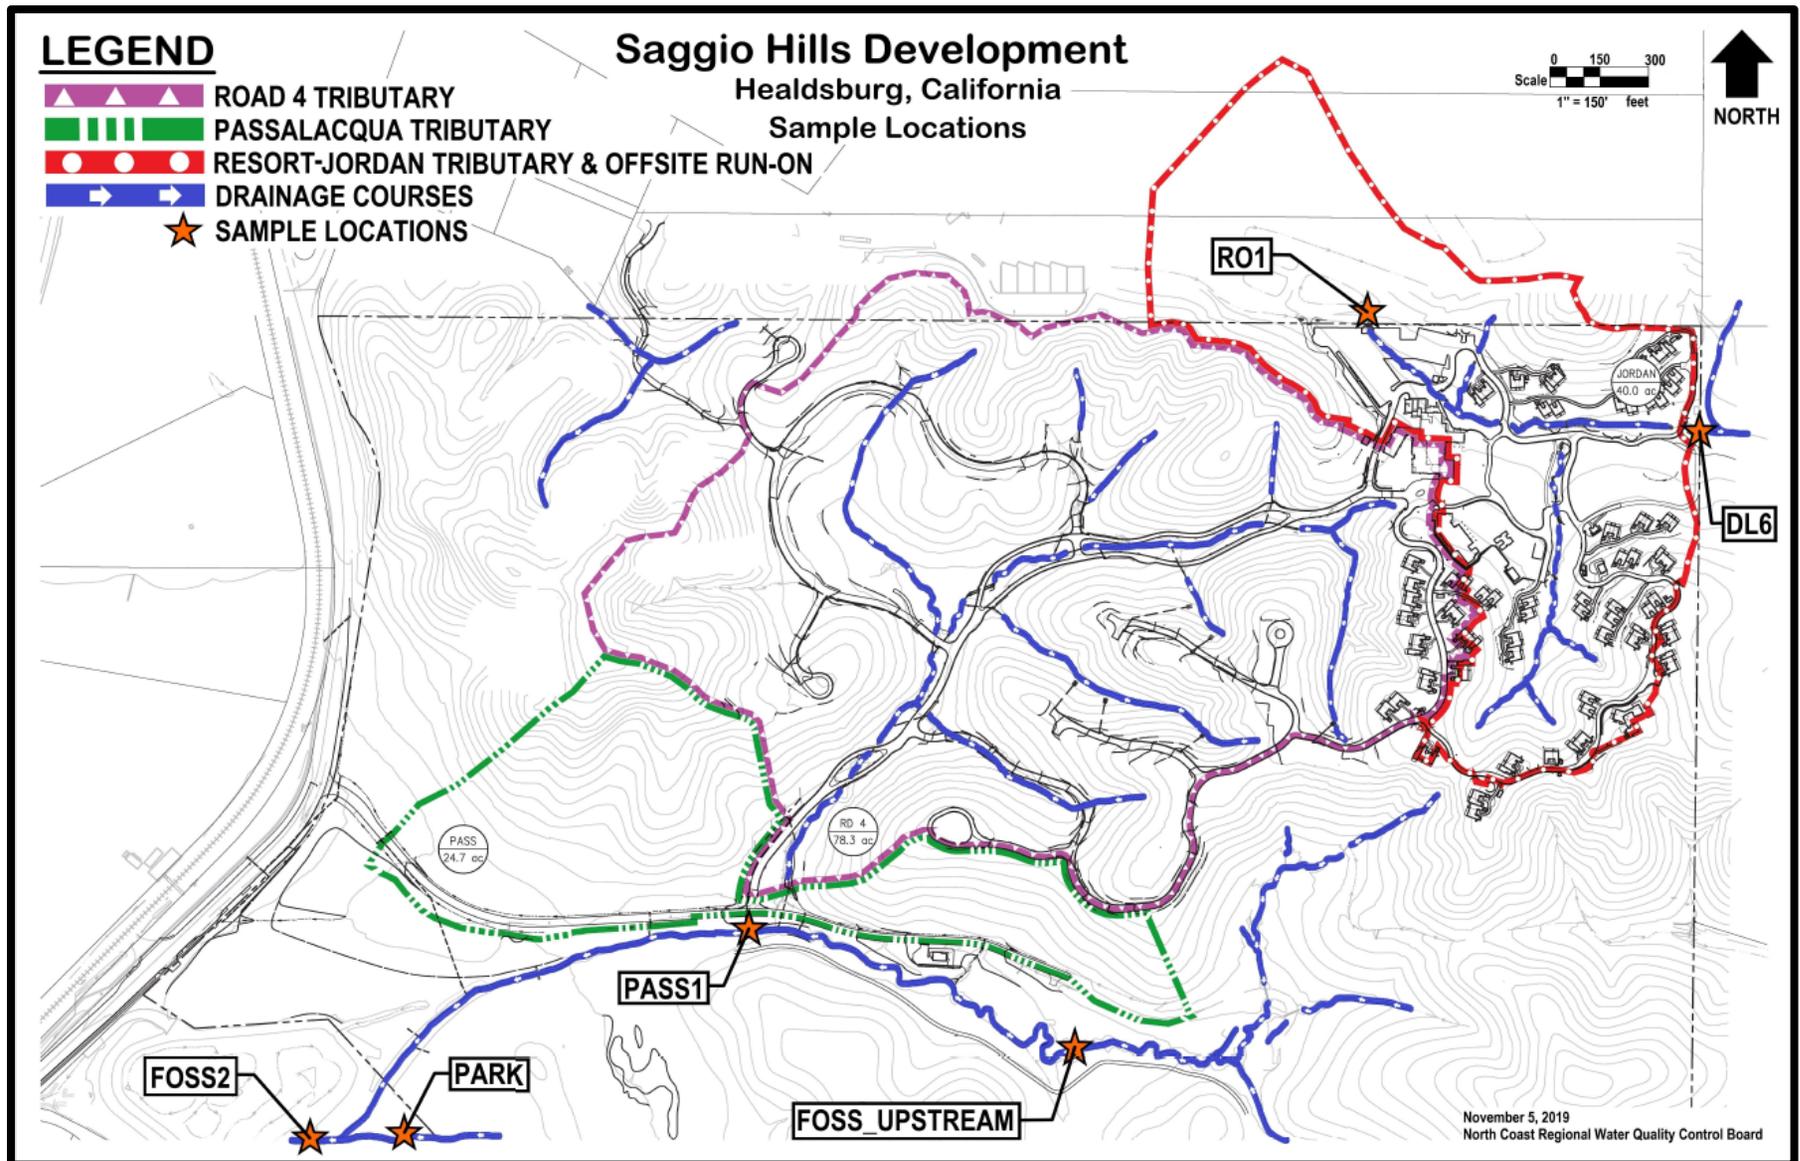
Figure 45. Saggio Hills receiving water monitoring program paired sample locations.

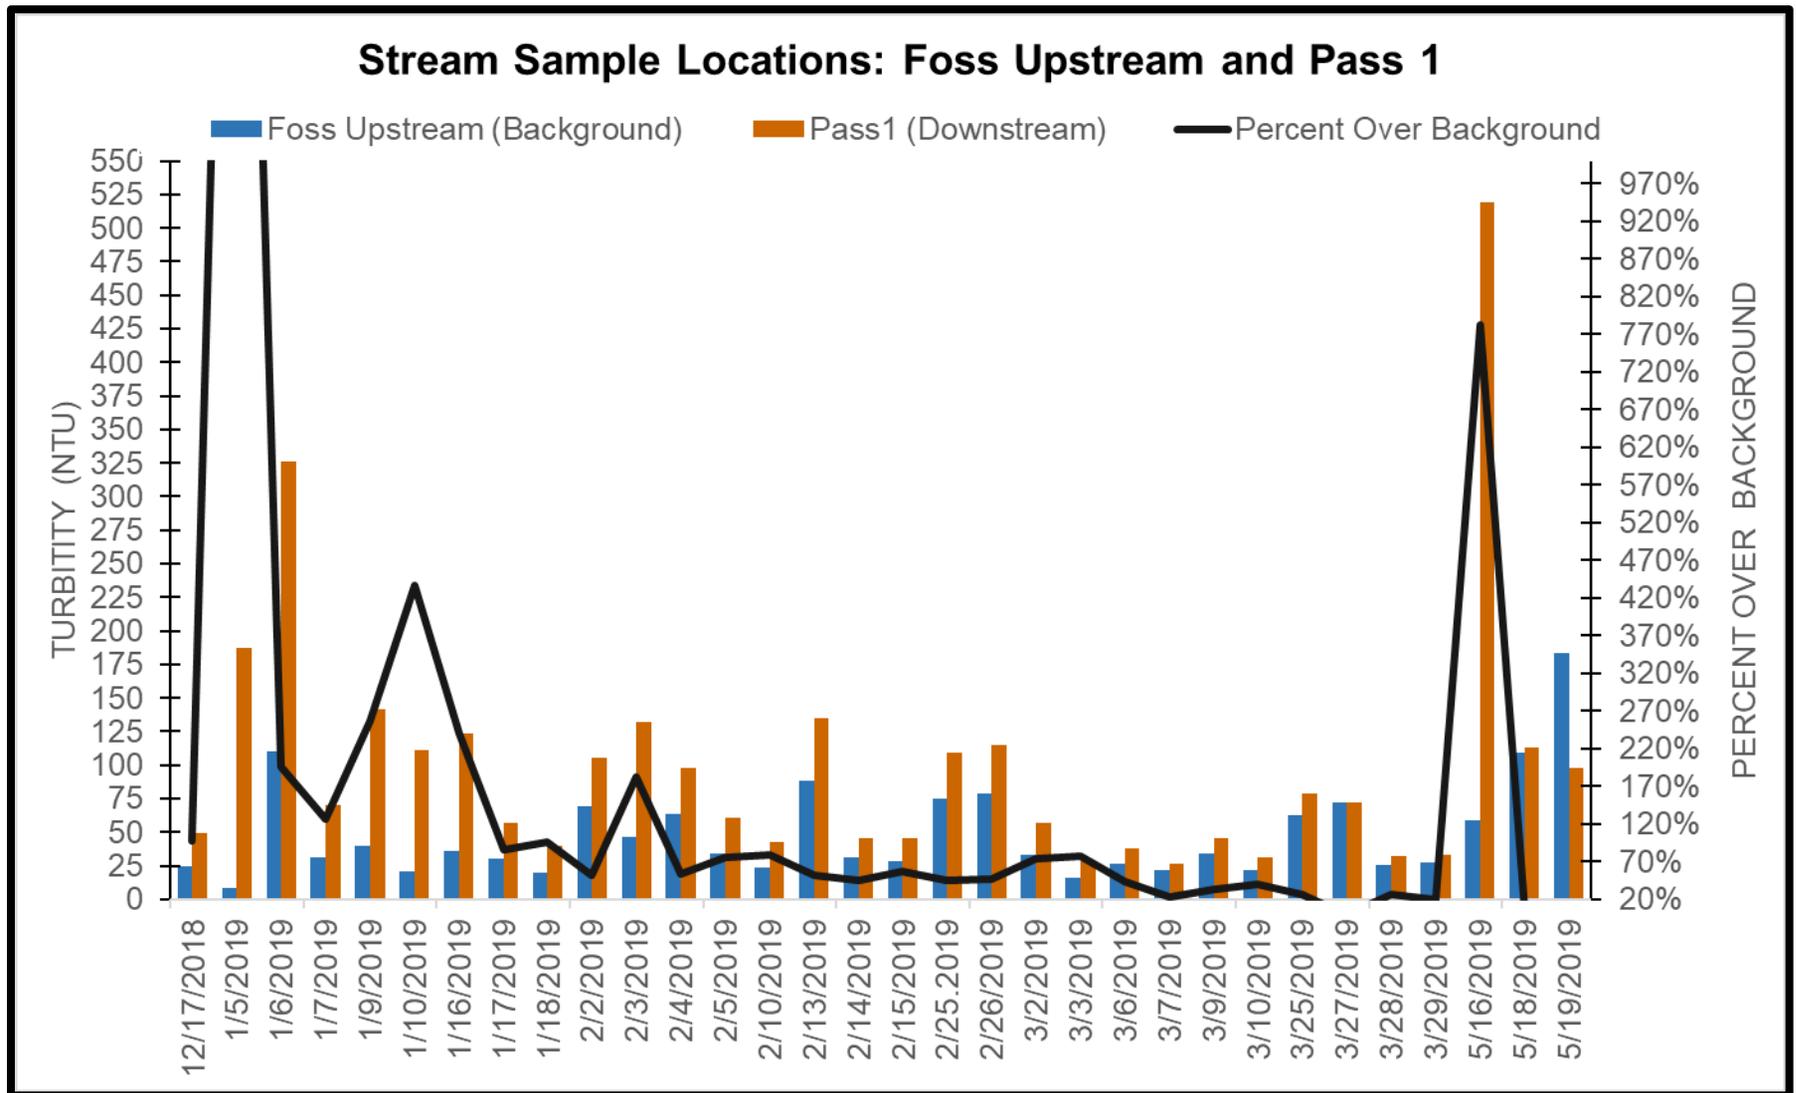
Figure 46. Saggio Hills receiving water monitoring program turbidity results for paired samples in Foss Creek; Foss Upstream (background) and Pass1 (downstream). Note: for viewing purposes the percent over background scale excludes the peak from the January 5, 2019 exceedance of 2,197 percent over background.

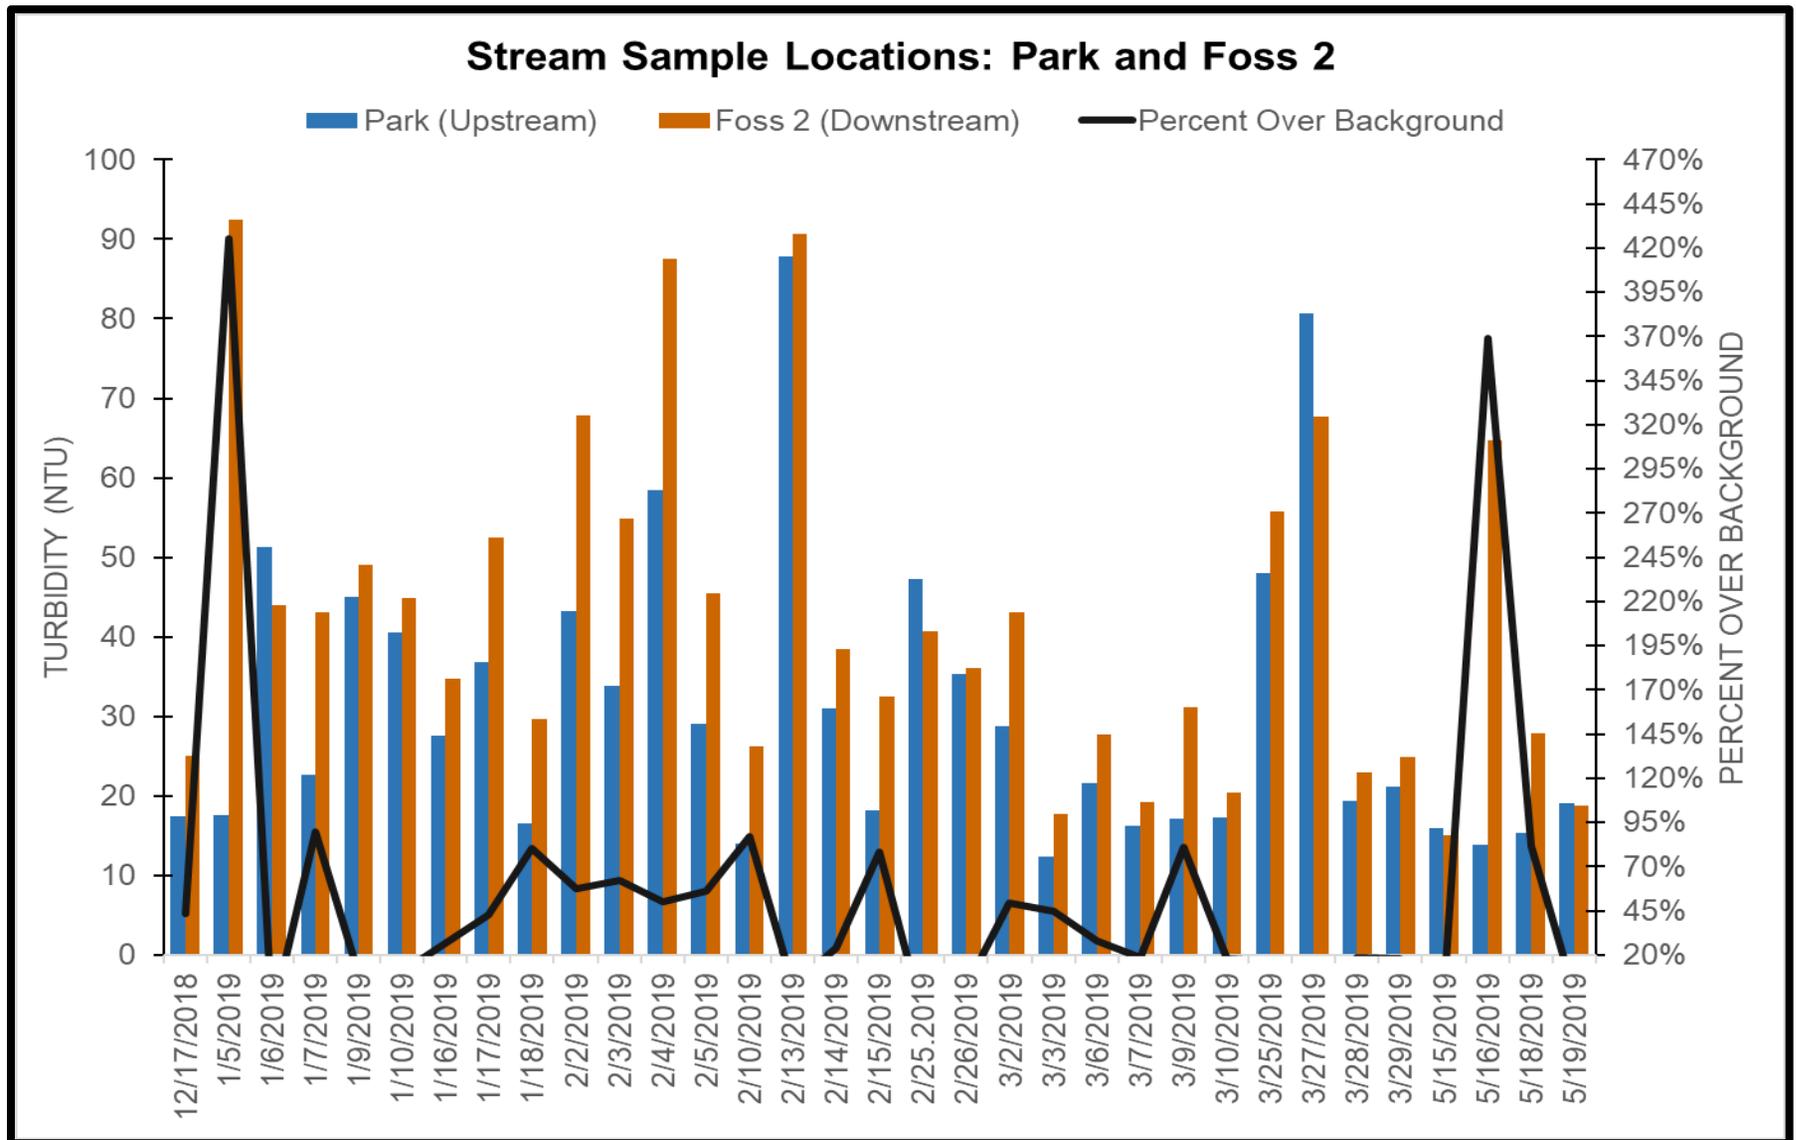
Figure 47. Saggio Hills receiving water monitoring program turbidity results for paired samples in Foss Creek; Park (background) and Foss 2 (downstream).

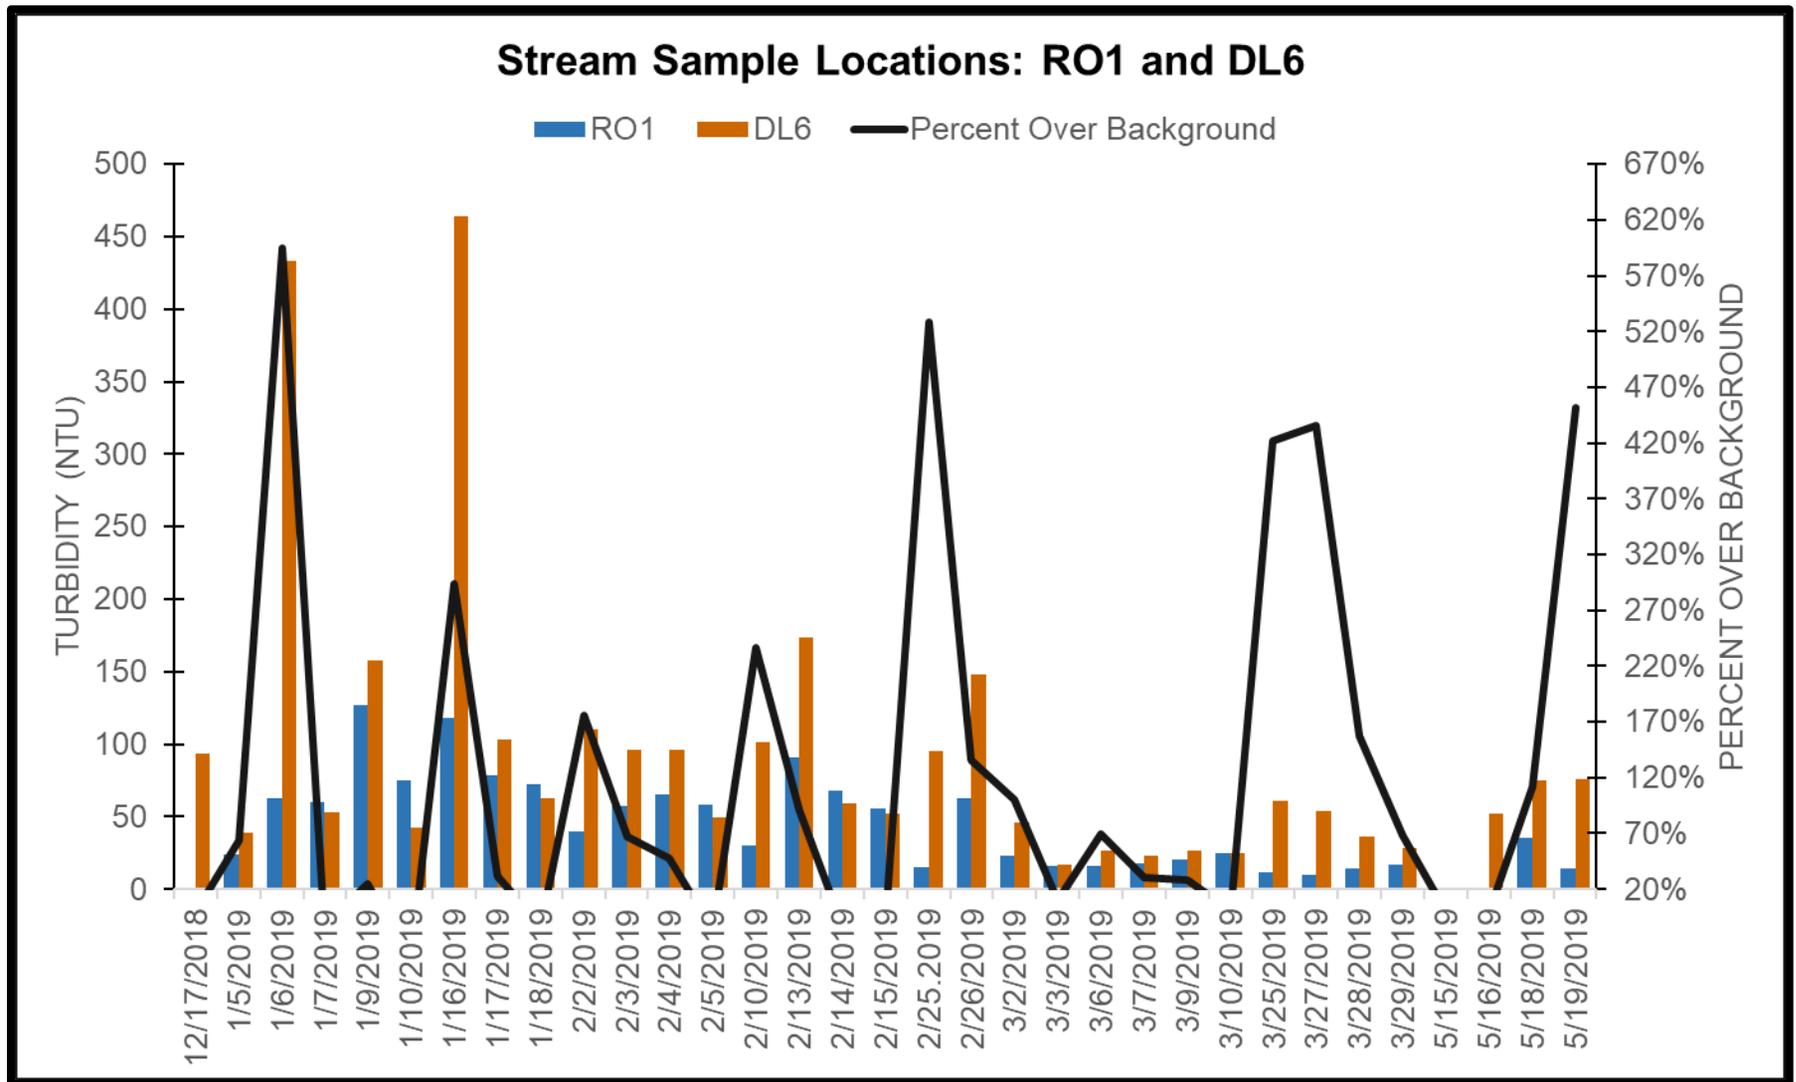
Figure 48. Saggio Hills receiving water monitoring program results for paired samples in tributary to Lytton Creek; R01 (upstream background) and DL6 (downstream).

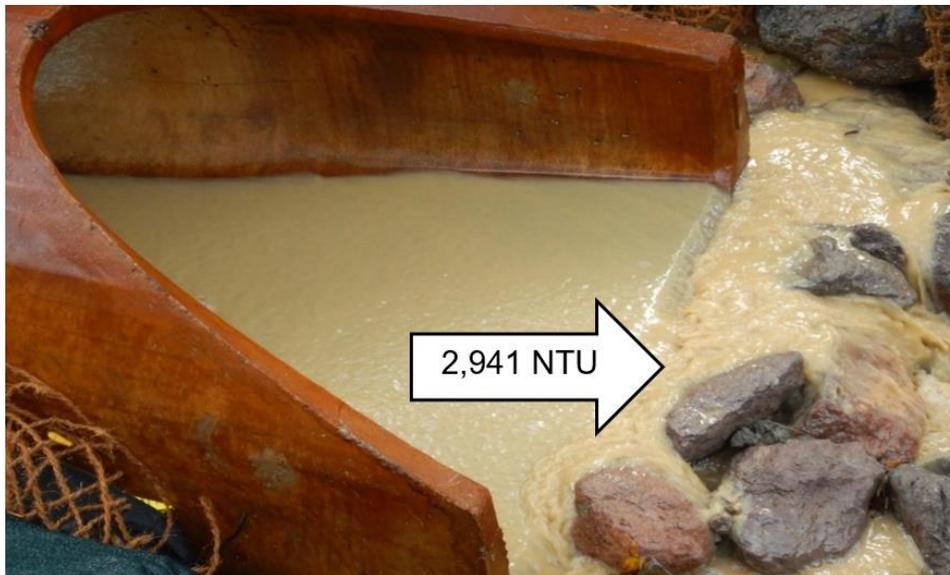
*Figure 49. Highly turbid water (2,941 NTU) in stream due to failure by the Discharger to implement BMPs along Road 5. November 29, 2018.*
