Subject: Enrollment of THP 1-07-183HUM (Unit 4) in the Elk River WWDR, "Tier II"

THP No. 1-07-183 HUM (South Lake View) Unit # 4

THP: South Lake View THP 07-183 Unit # 4 3-23-09

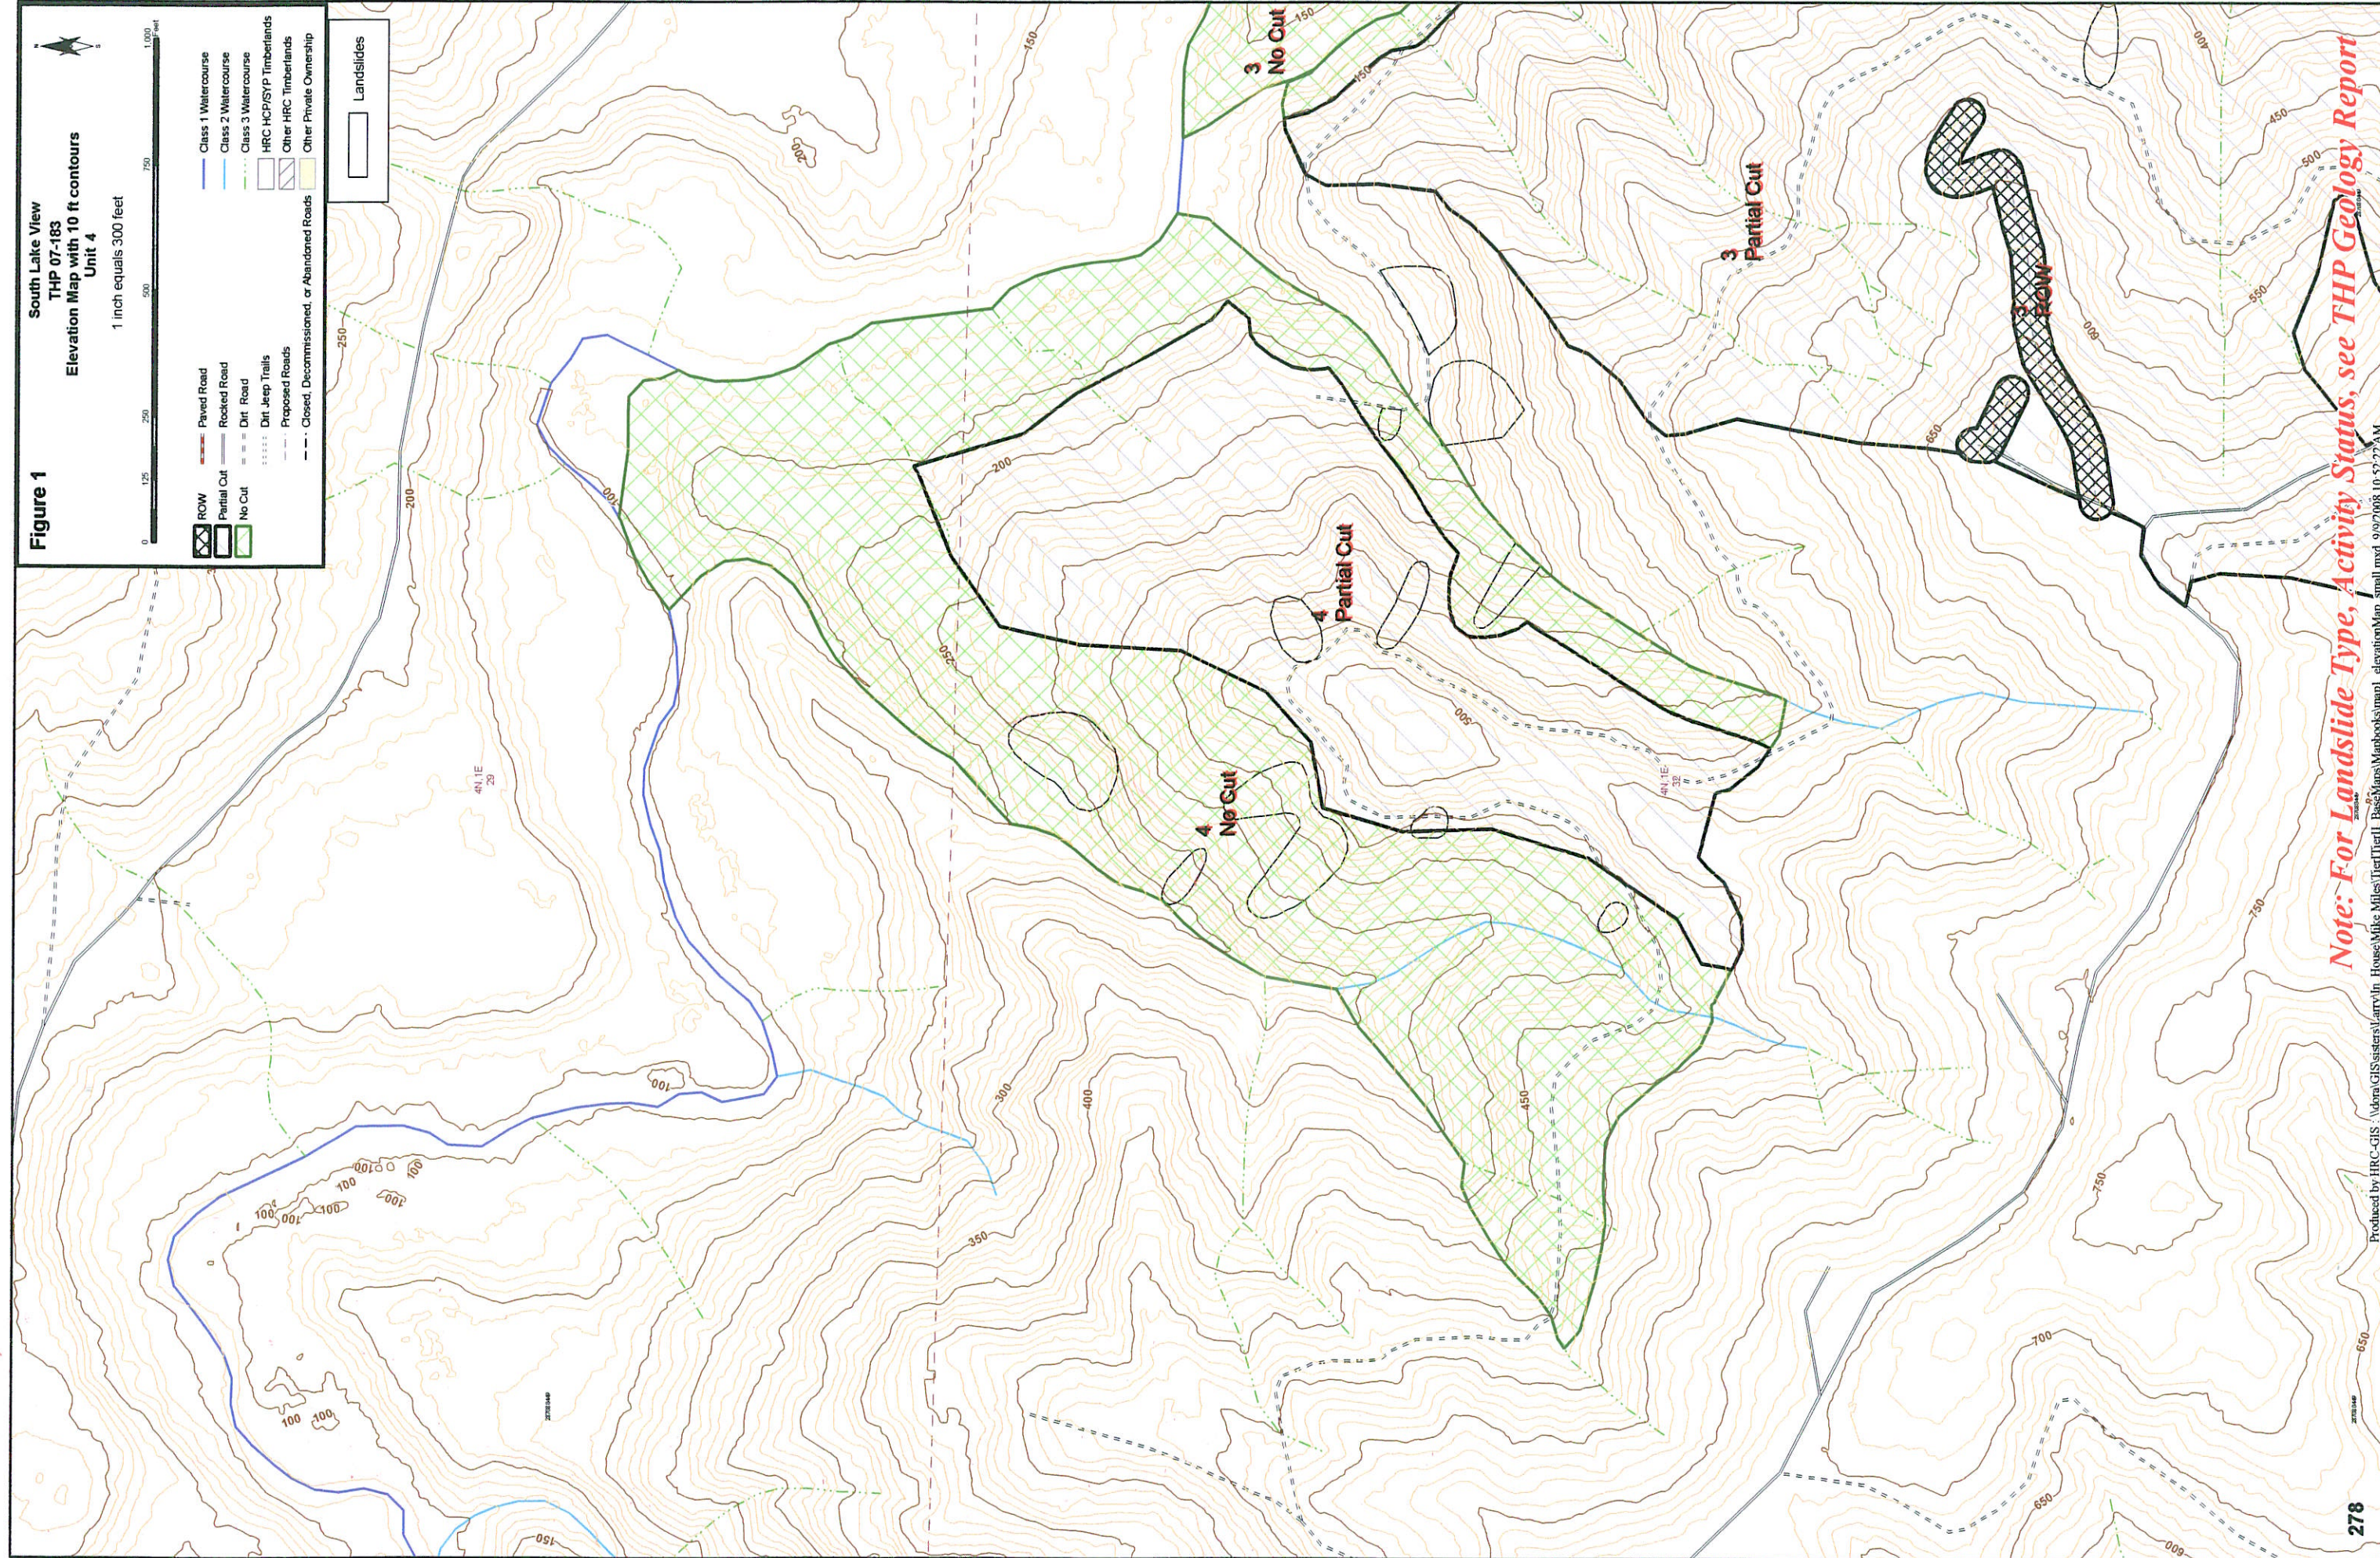
Figure 2
 South Lake View
 THP 07-183
 Shalstab 10 mnts grid / Slope Class Map
 Unit 4

Review of Figure 2 (Hillslope Shade) shows no correlation between surface morphology and the Figure 3, unit wide deep seated landslide. At best, the northeastern facing slopes directly upslope of the north fork of elk river slightly resemble morphology consistent with very old and weathered mass wasting. The Figure 6 landslide located in the southwestern corner of the unit is somewhat visible. Its weathered expression suggests that the landslide is very old. The hillslope shade shows the prominent watercourses to be well entrenched with moderate to steeply inclined flanking slopes.

Several areas of elevated SHALSTAB (Value 2) are located within the unit. These areas tend to occur in groups of 2 to 3 pixels and are located throughout the lower elevations of the unit. Some are concentrated along, parallel with and straddle the no harvest RMZ of the eastern Class II watercourse. The remaining value 2 areas are located on north-facing slopes that drain to the north fork of Elk river. No protection was afforded the areas of elevated SHALSTAB that lie outside the harvest exclusion zones during THP development. This is due to an absence of indicators that correspond to potentially unstable areas.

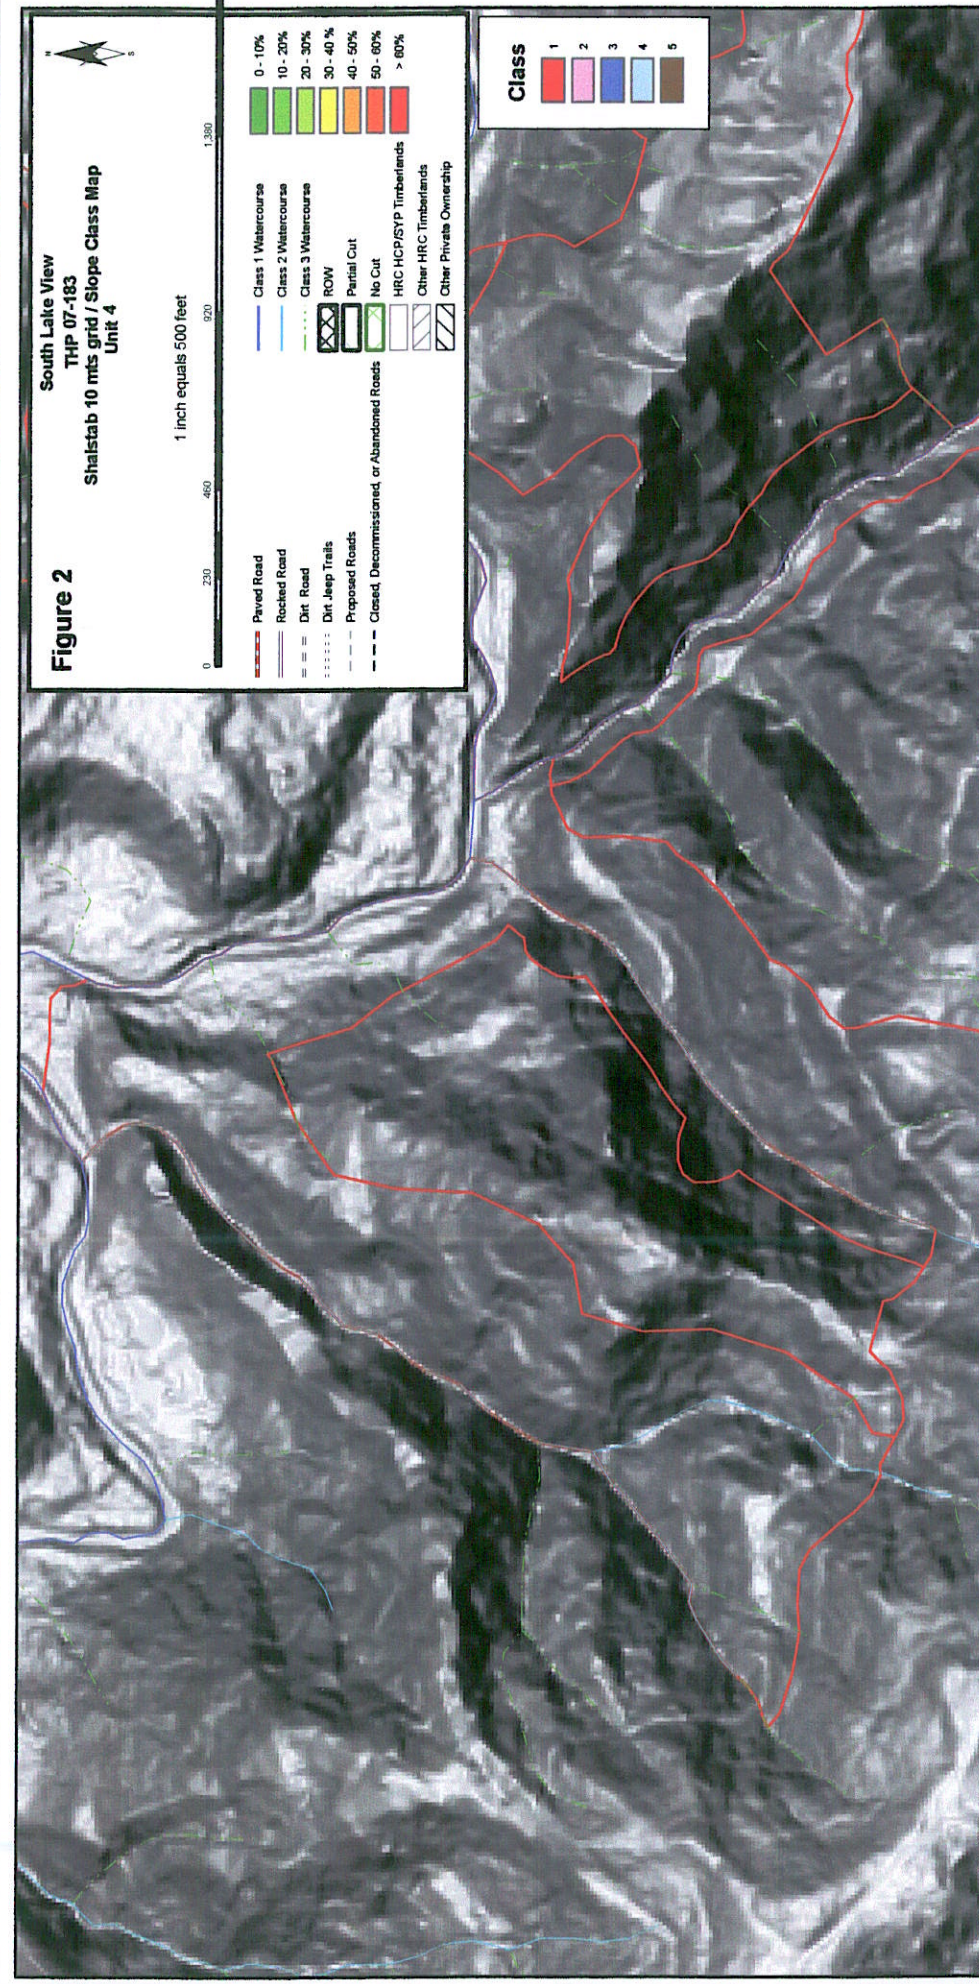
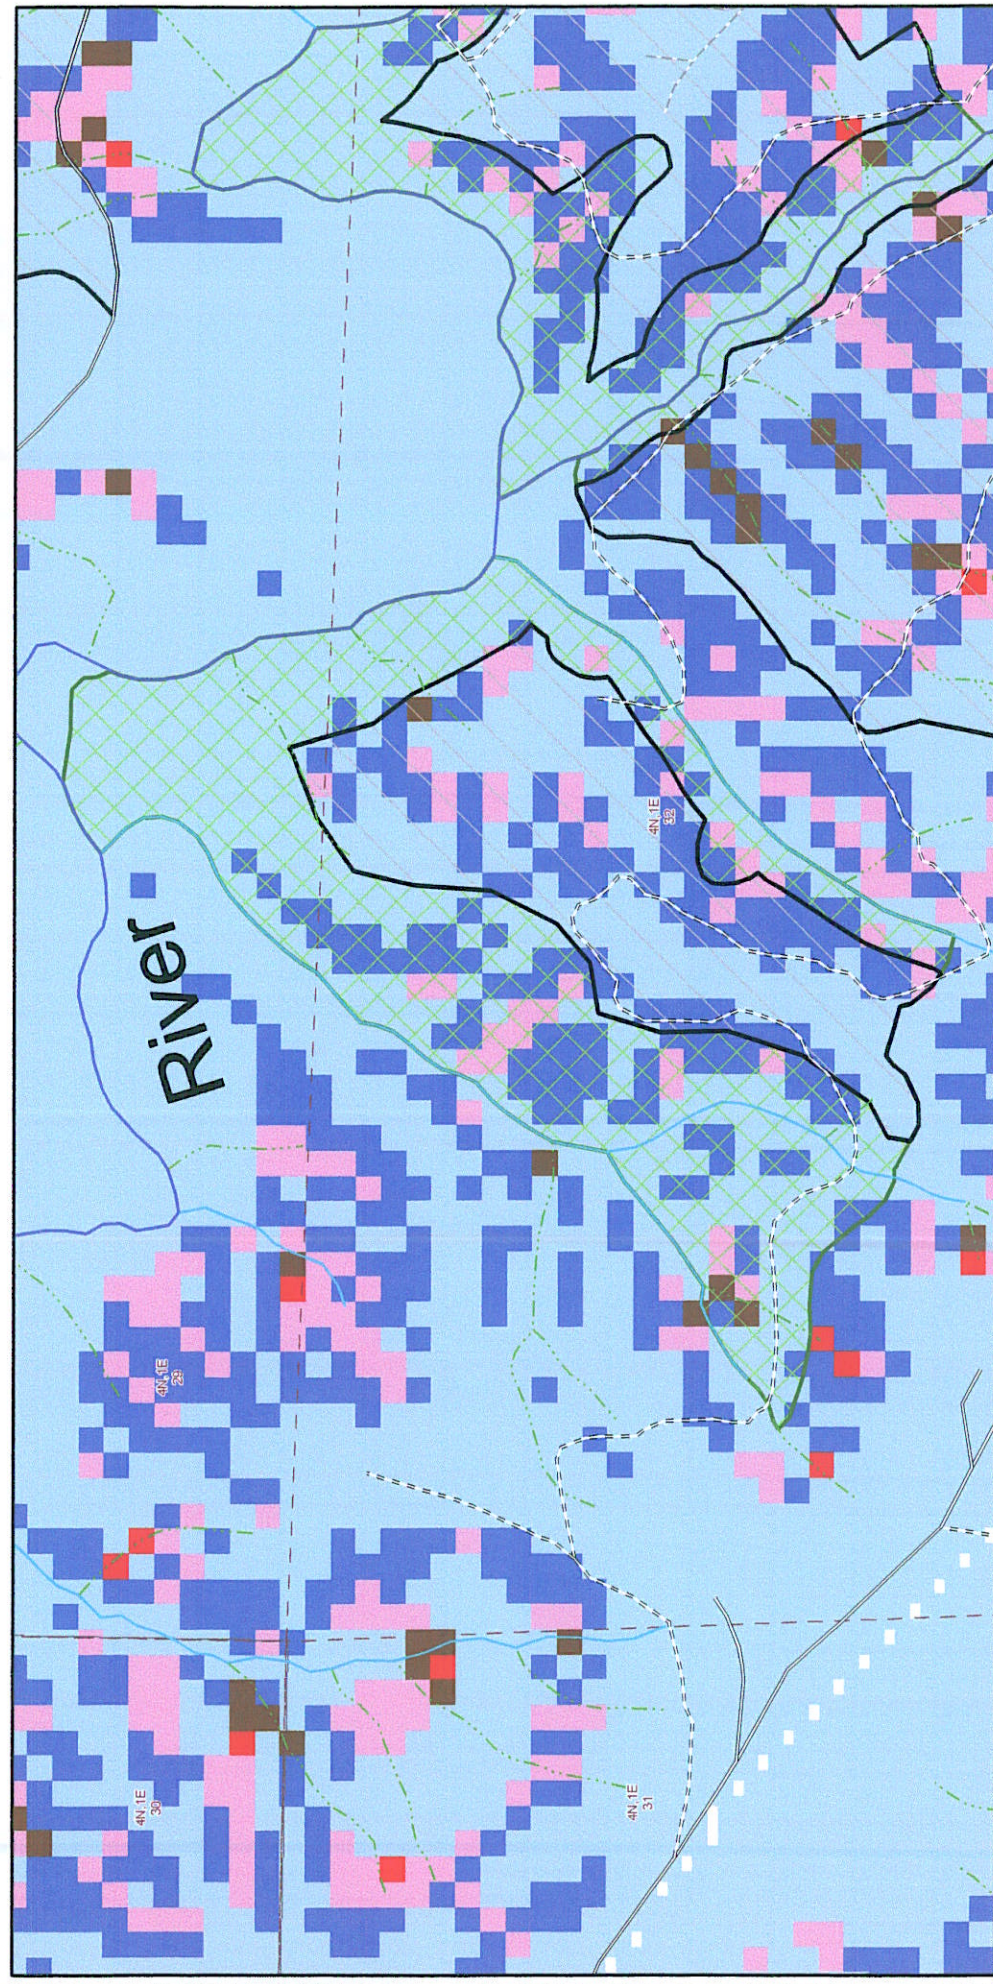
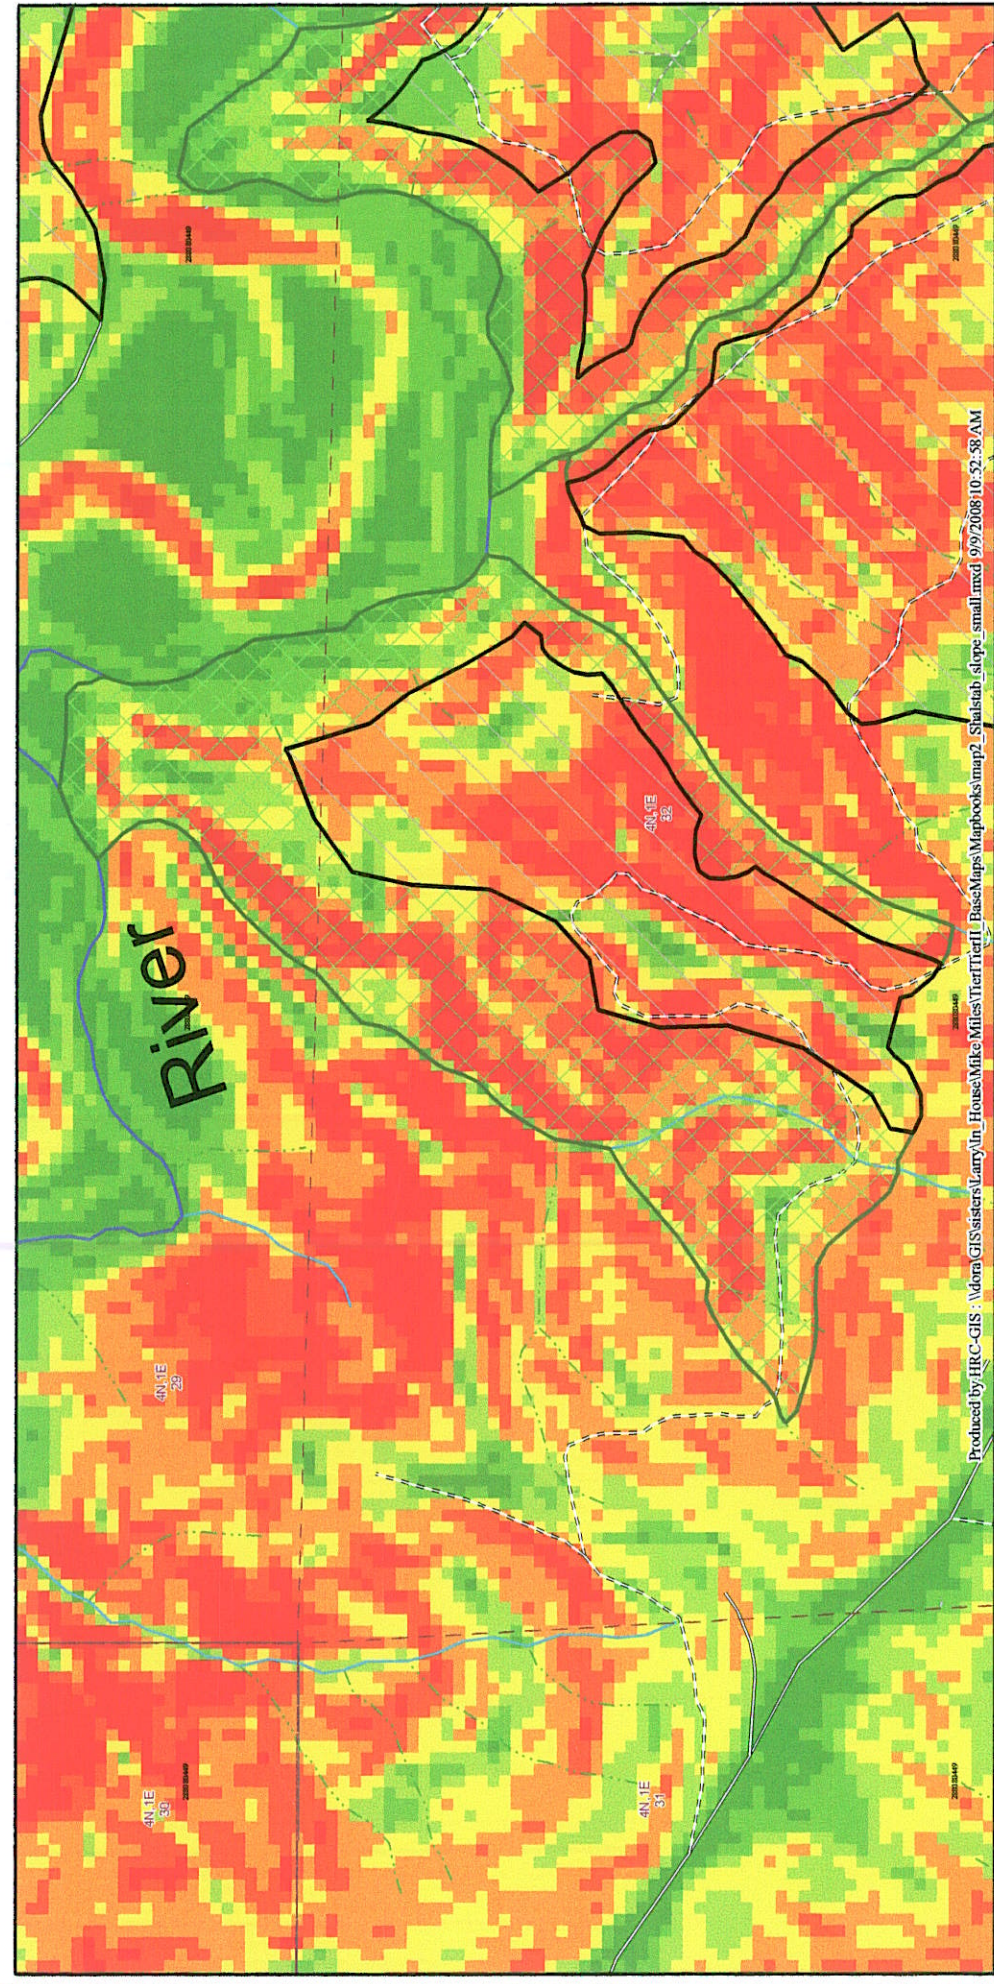
South Lake View
THP 07-183
CGS Map Unit 4

Mass Wasting Potential (MWP) (Figure 4) is modeled as regionally low throughout the unit. Areas of moderate occur where the slopes adjacent the watercourses are steeply inclined. One area of high MWP is modeled where Figure 3 debris slide slopes occur.

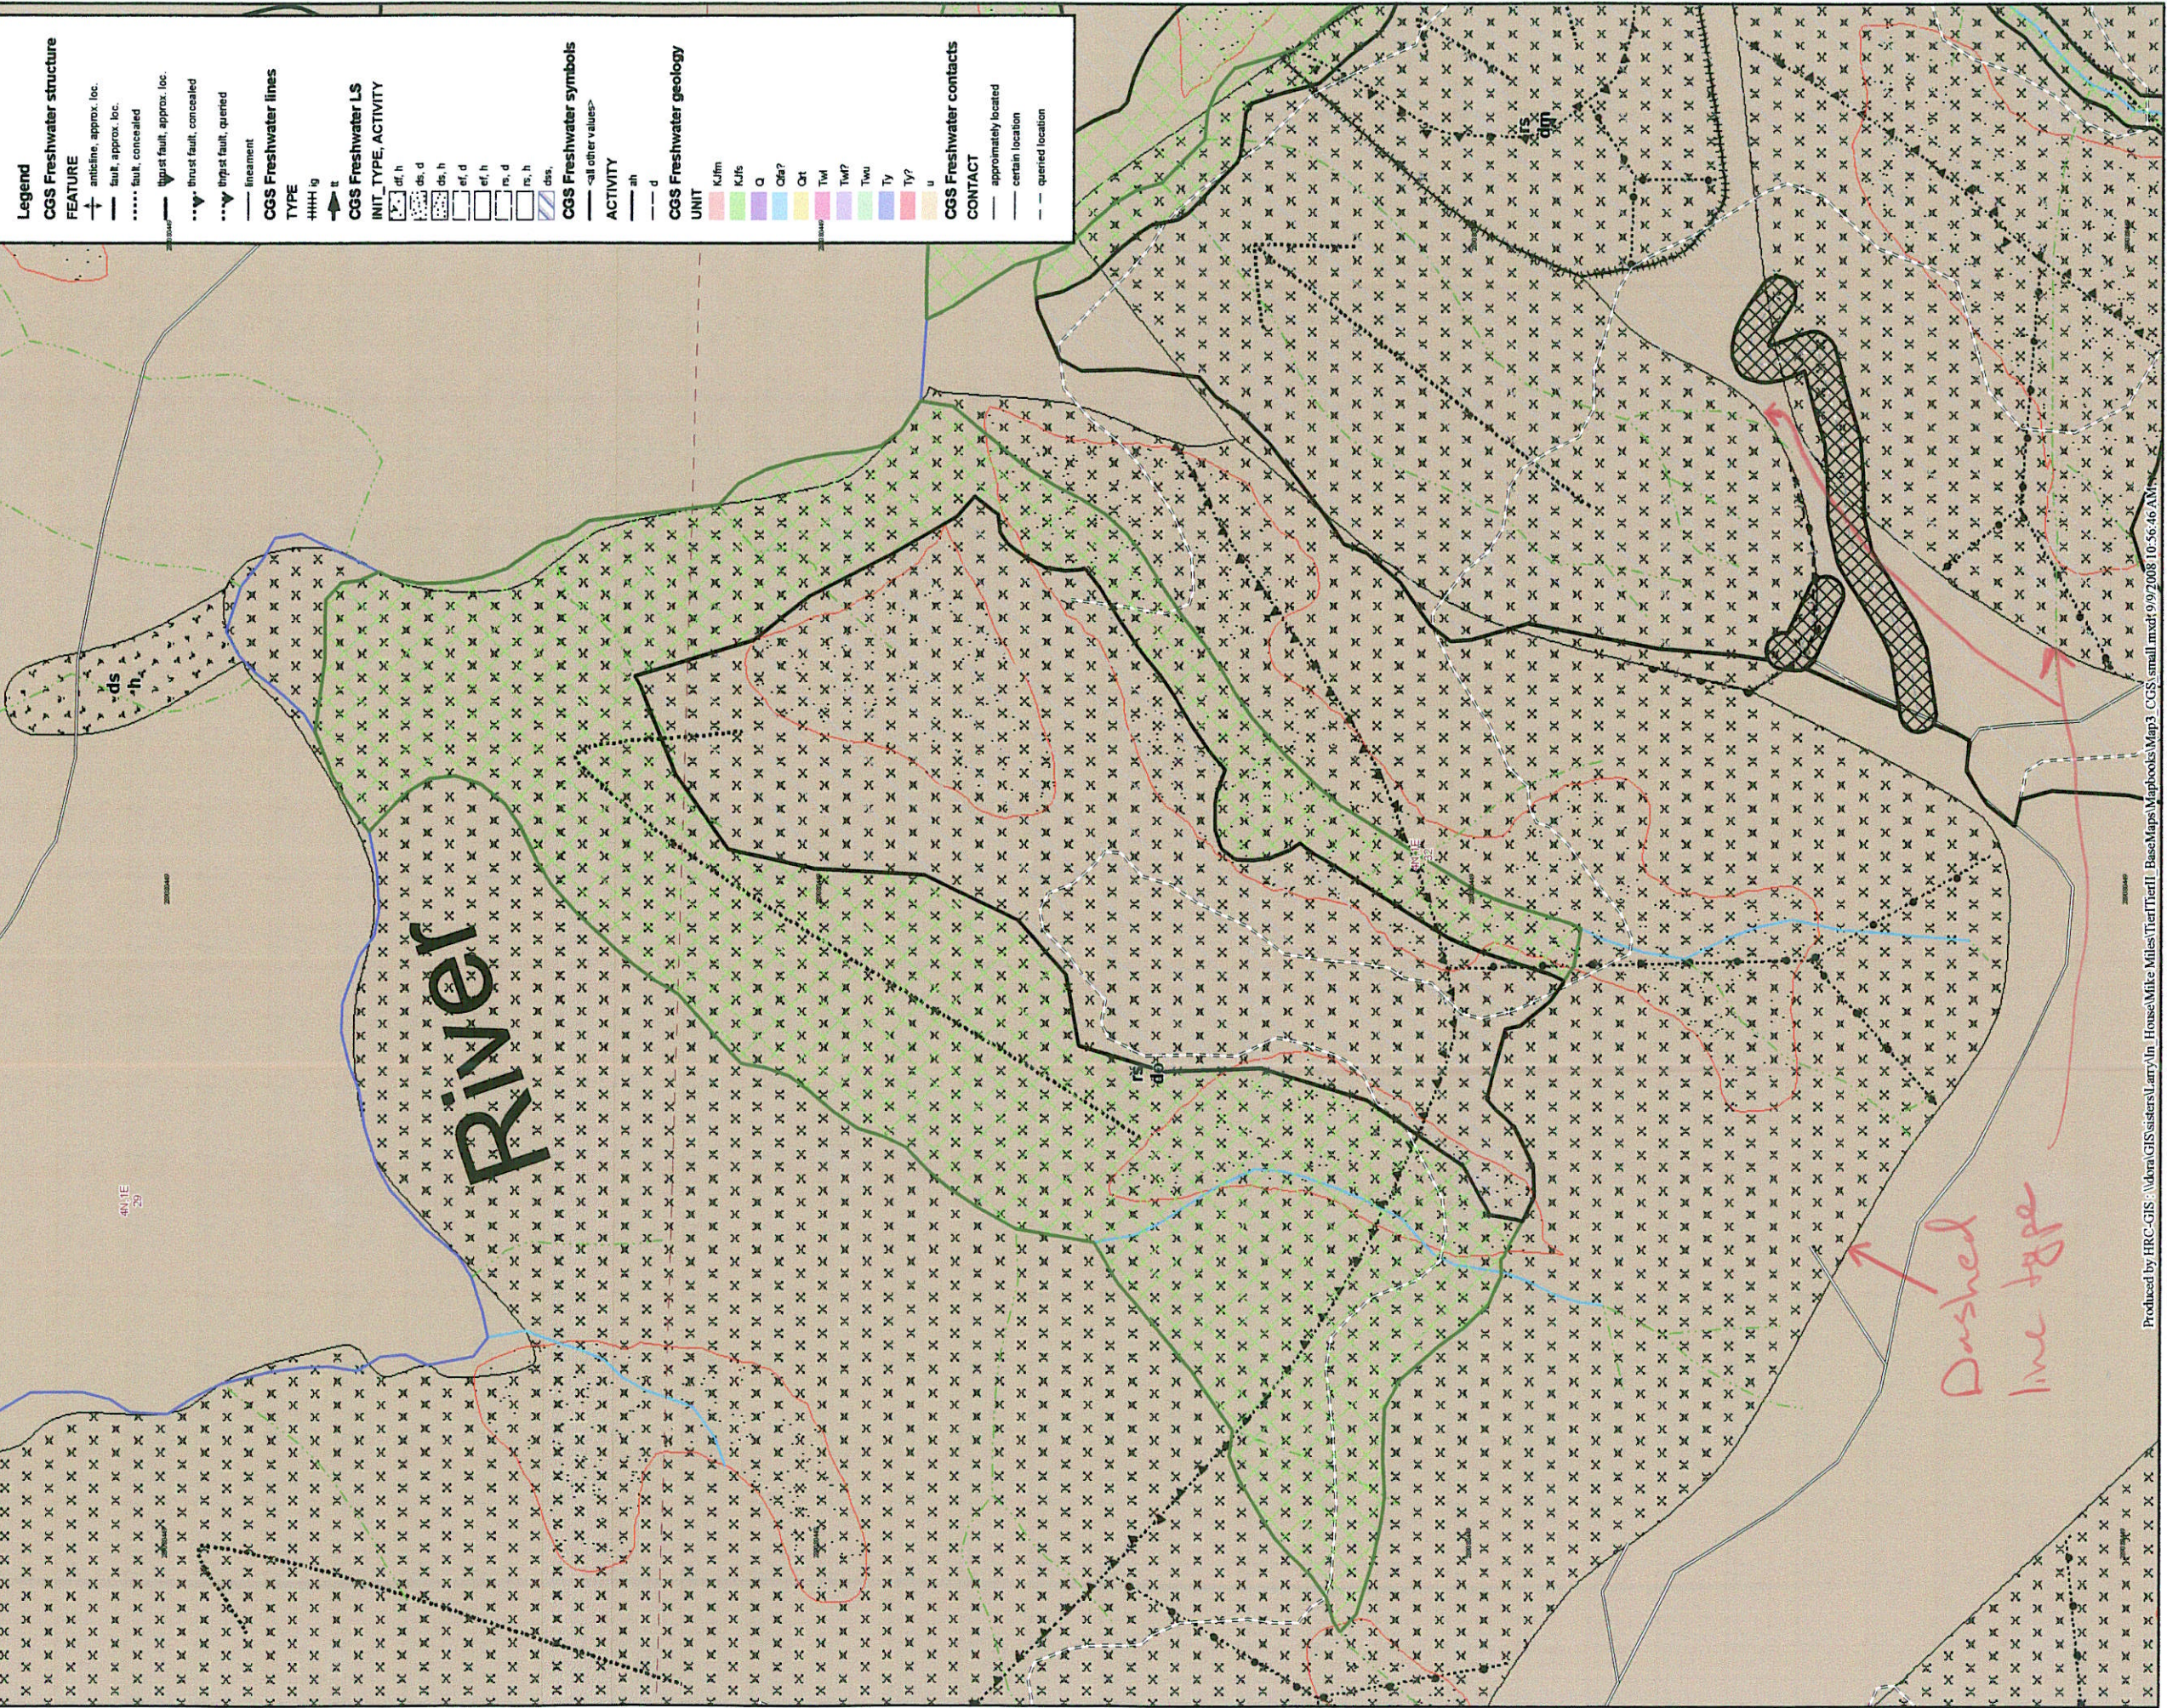
Figure 4

South Lake View
THP 07-183
Mass Wasting Potential
Unit 4

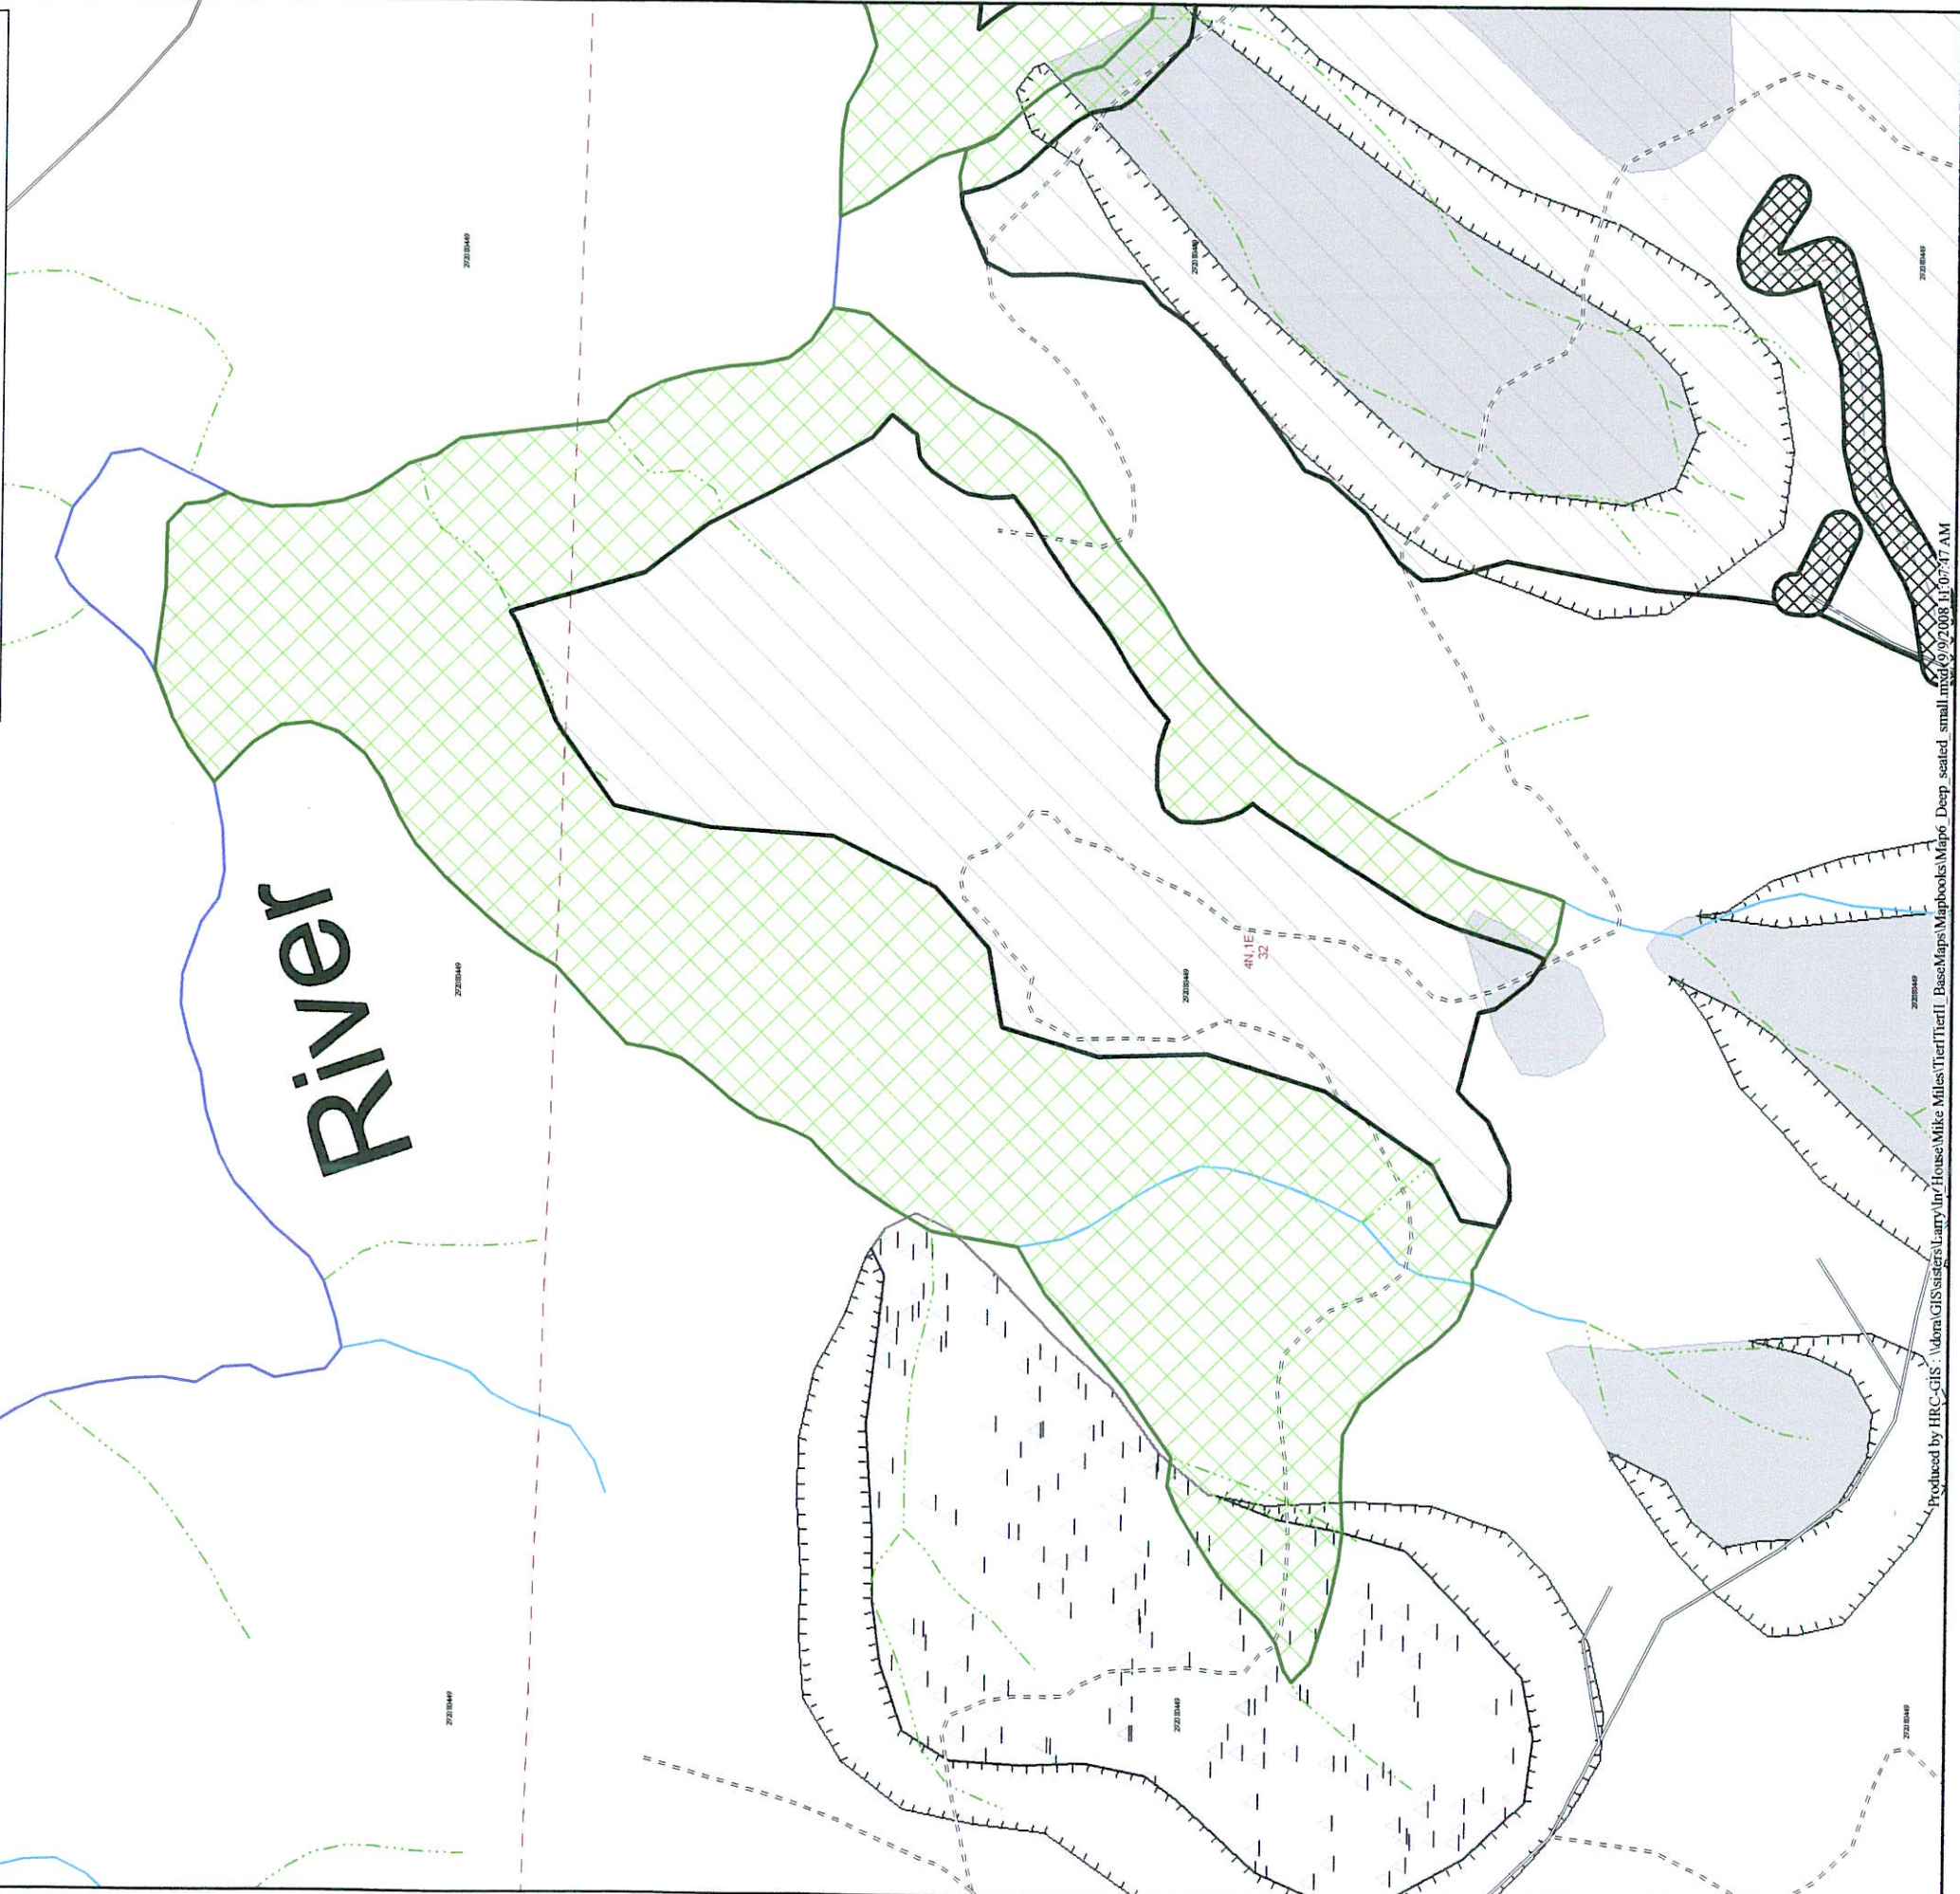
One rotational / translational / earthflow is mapped in the southwestern corner of the unit. This area is within a no harvest zone (Figure 6).

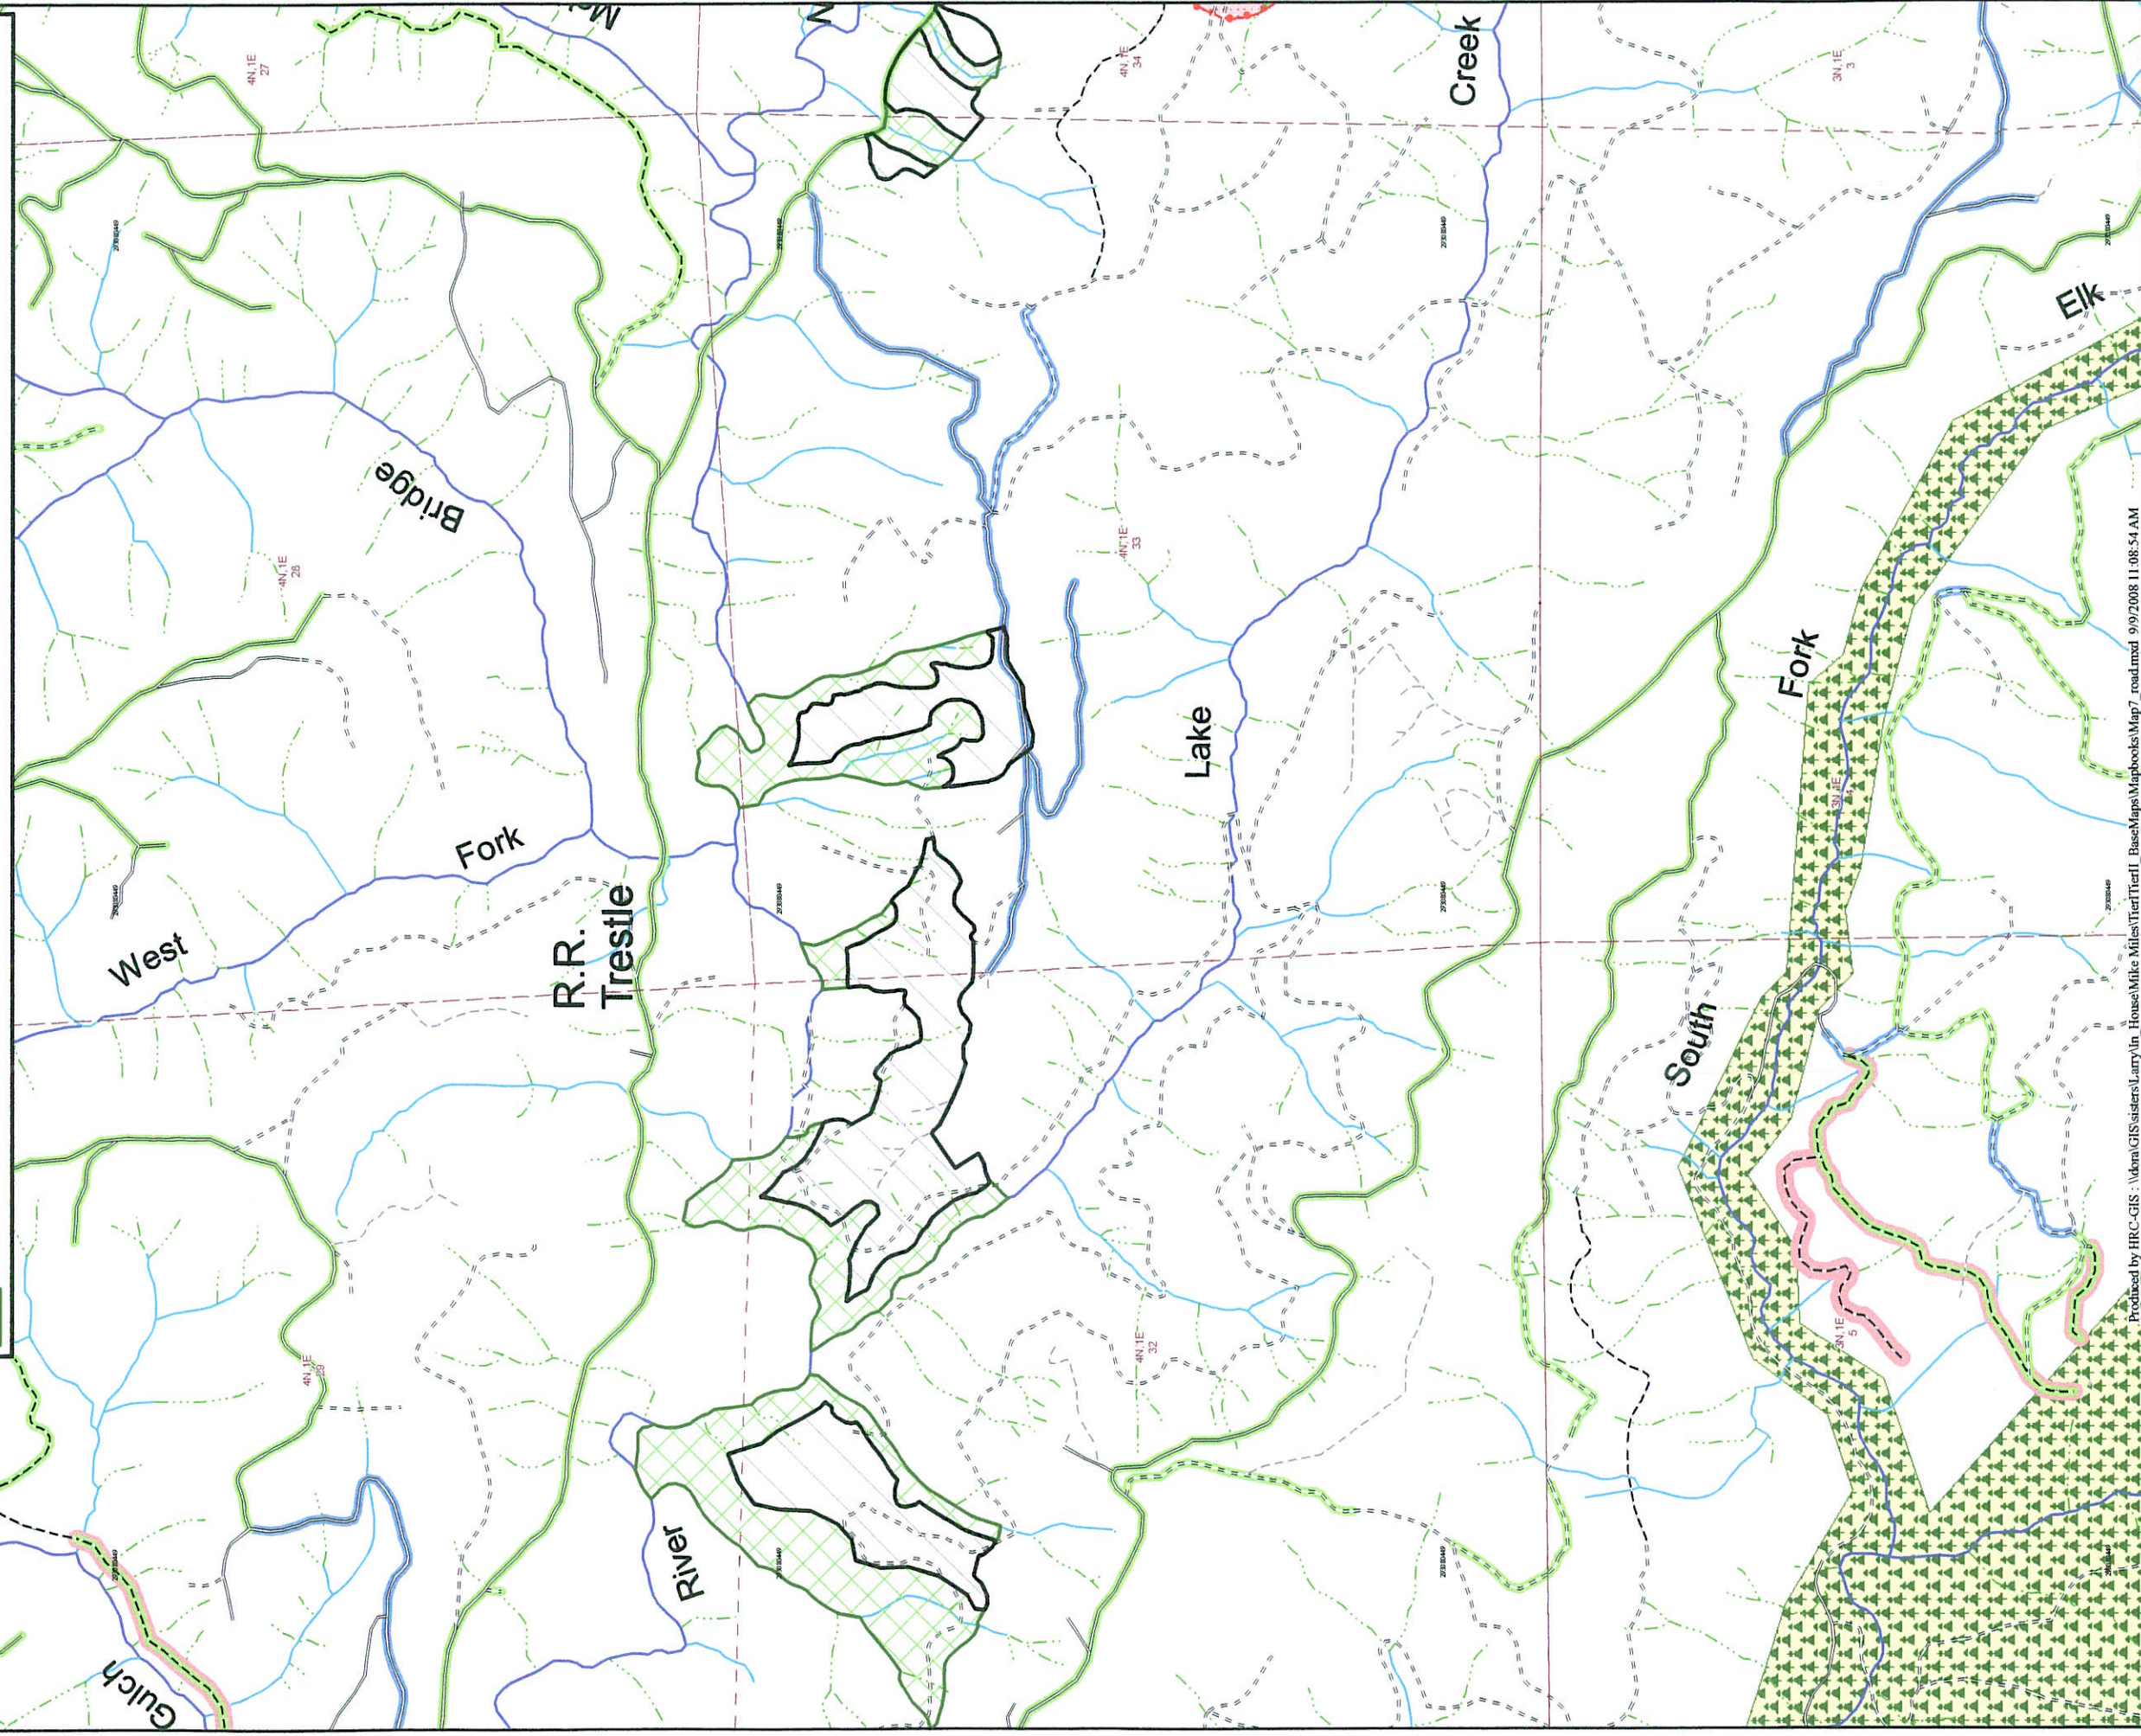
Figure 7

South Lake View
THP 07-183
Road Map
