Subject: Enrollment of THP 1-07-189 HUM (Unit3) in the Elk River WWDR, "Tier II"

THP No. 1-07-189 HUM (Tom Collins) Unit # 3

**THP: Tom Collins    THP 07-189    Unit # 3    April 19, 2010**

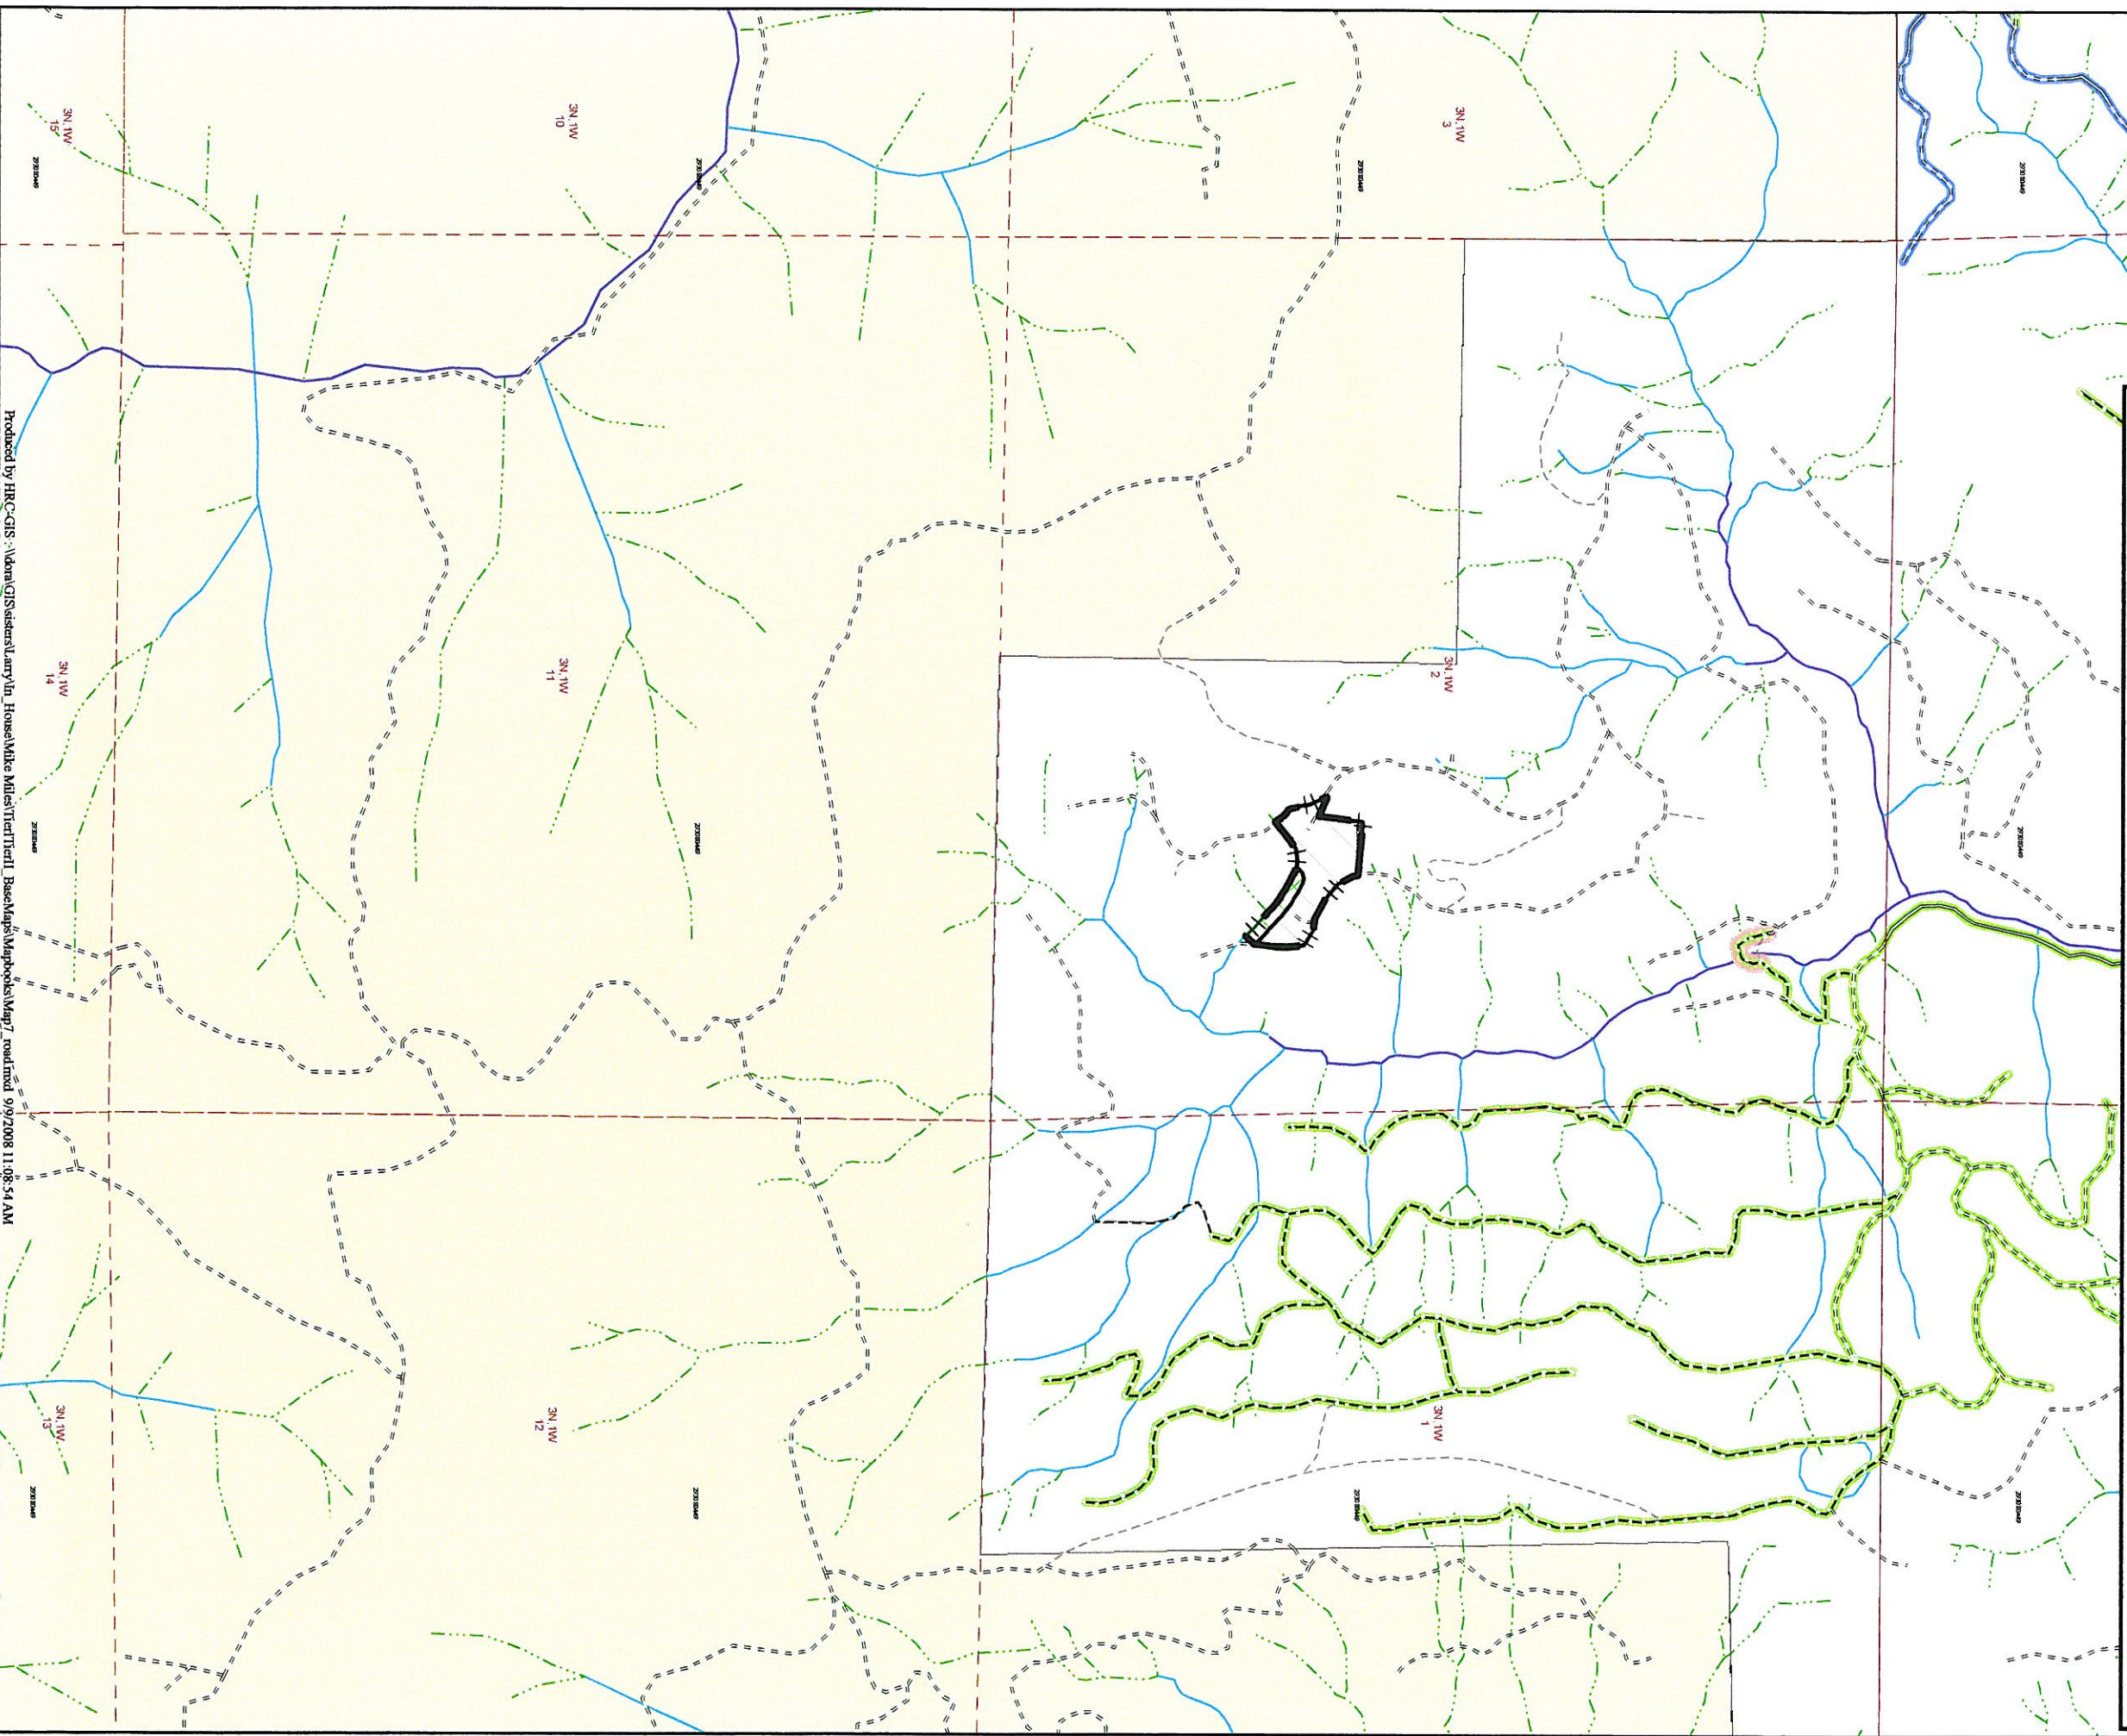
Figure 7

**Tom Collins  
THP 07-189  
Road Map**  
1 inch = 1,000 feet
