Subject: Enrollment of THP 1-08-072HUM (Unit 3) in the Elk River WWDR, "Tier II"

THP: Moss Elk THP 08-072 Unit # 3 3-18-09

Erosion Control Plan (ECP) for Moss Elk THP 1-08-072HUM

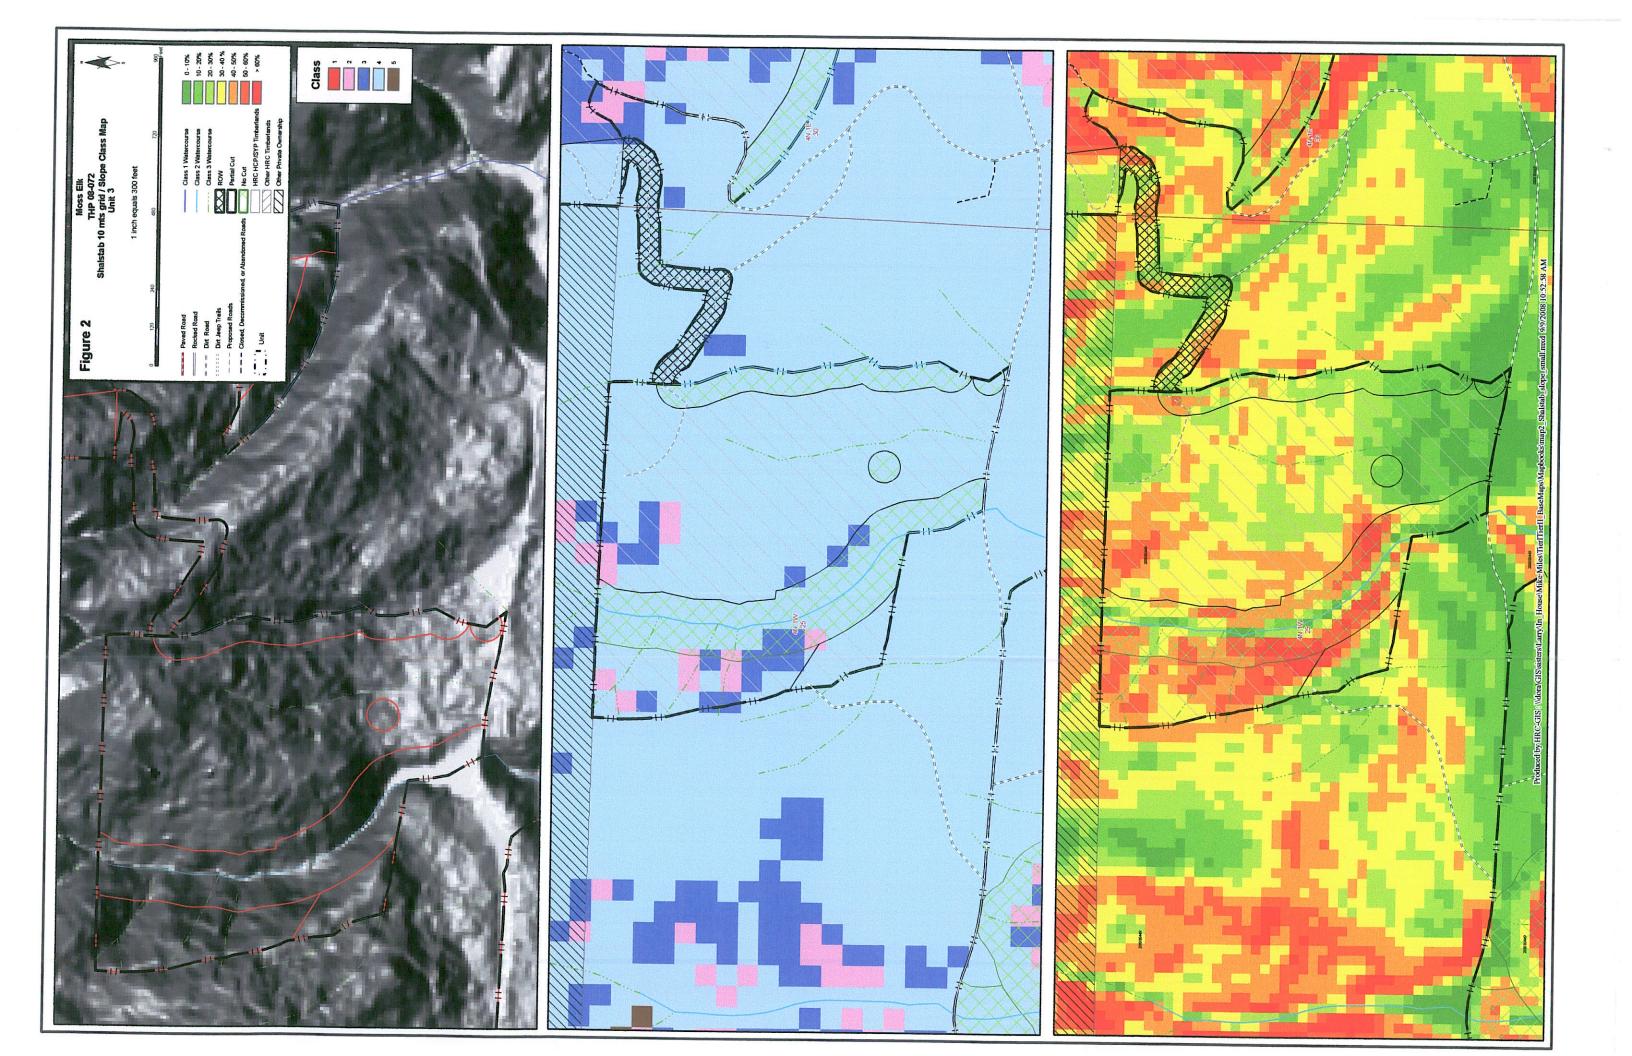
Figure 2 review (Hillslope shade) shows generally smooth, moderate to steeply inclined slopes throughout the unit. A slight resemblance of the Figure 6 landslides east of the unit is observed. The observed morphology could also represent an abandoned terrace.

Elevated values of SHALSTAB are predominantly modeled within the Class III swales the drain to the western Class II watercourse. These areas were not determined as unstable during THP development. Further description of the sites can be found in the THP geology report (SGD, 2008).

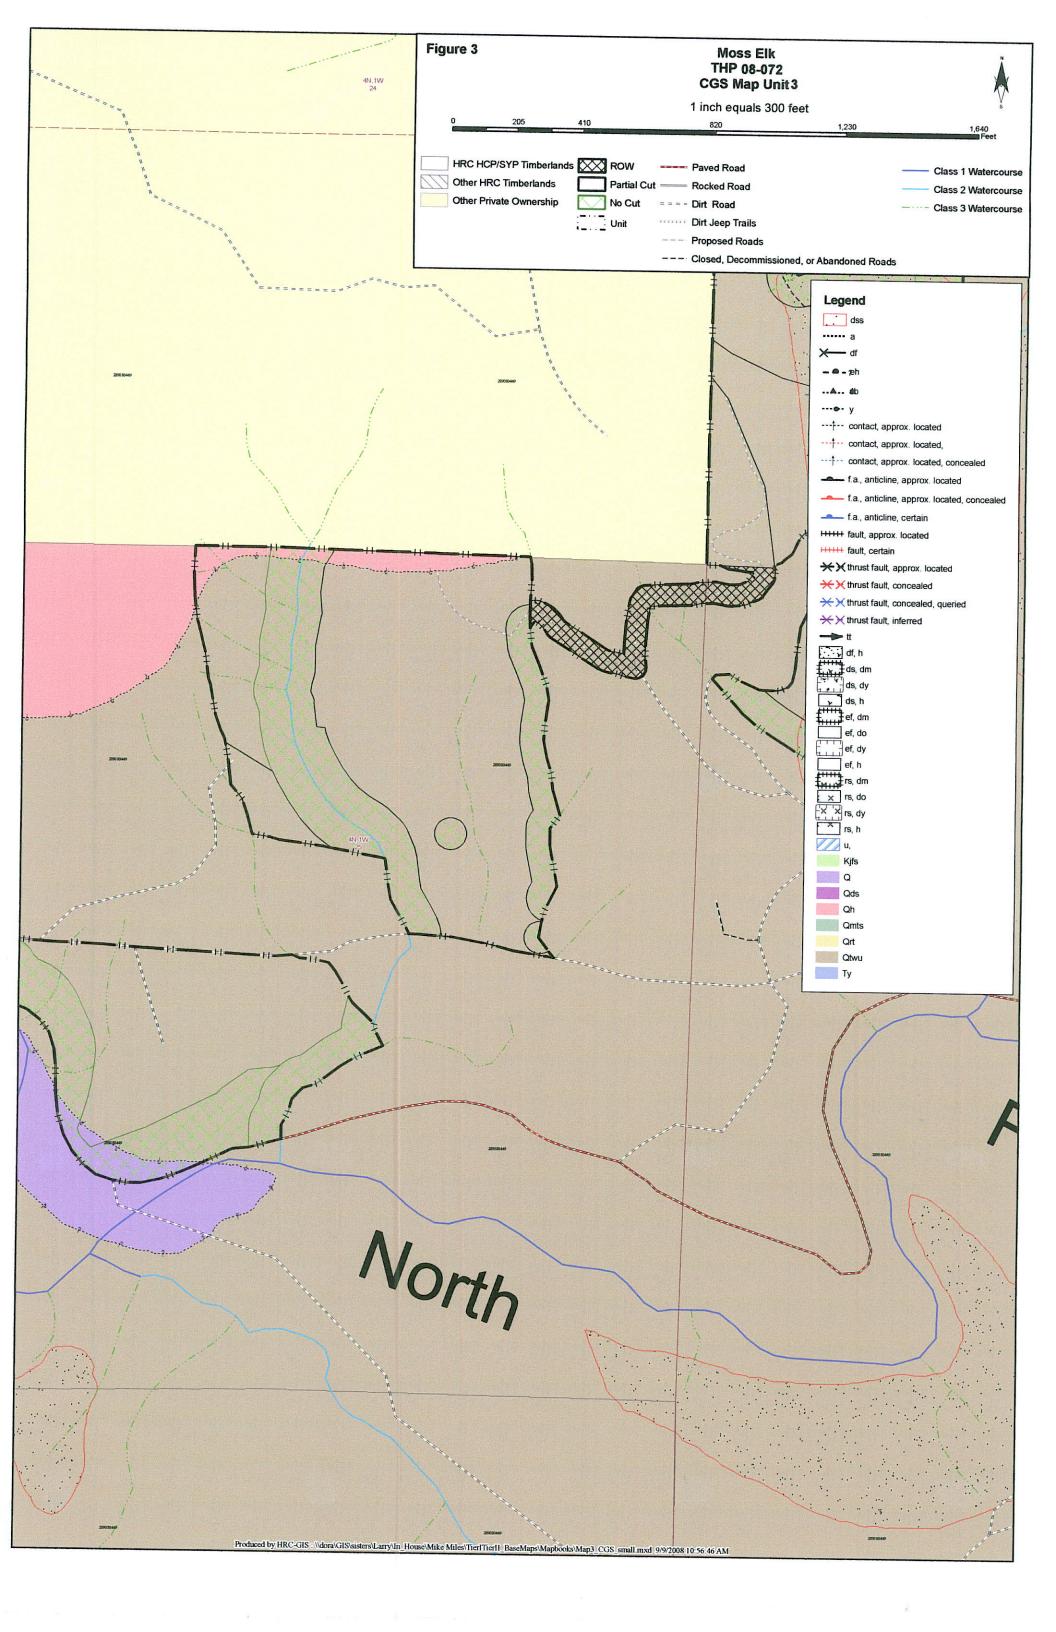
Figure 3 shows the unit to be underlain by undifferentiated Wildcat Group sediments. These sediments are composed of silts, sands, clays, and infrequent gravels that moderately to well consolidated. The slopes are moderate to steeply inclined, include well defined watercourse channels, and exhibit geomorphology suggestive of multiple abandon river terraces. No morphology associated with mass wasting has been mapped by CGS (2005) on Figure 3

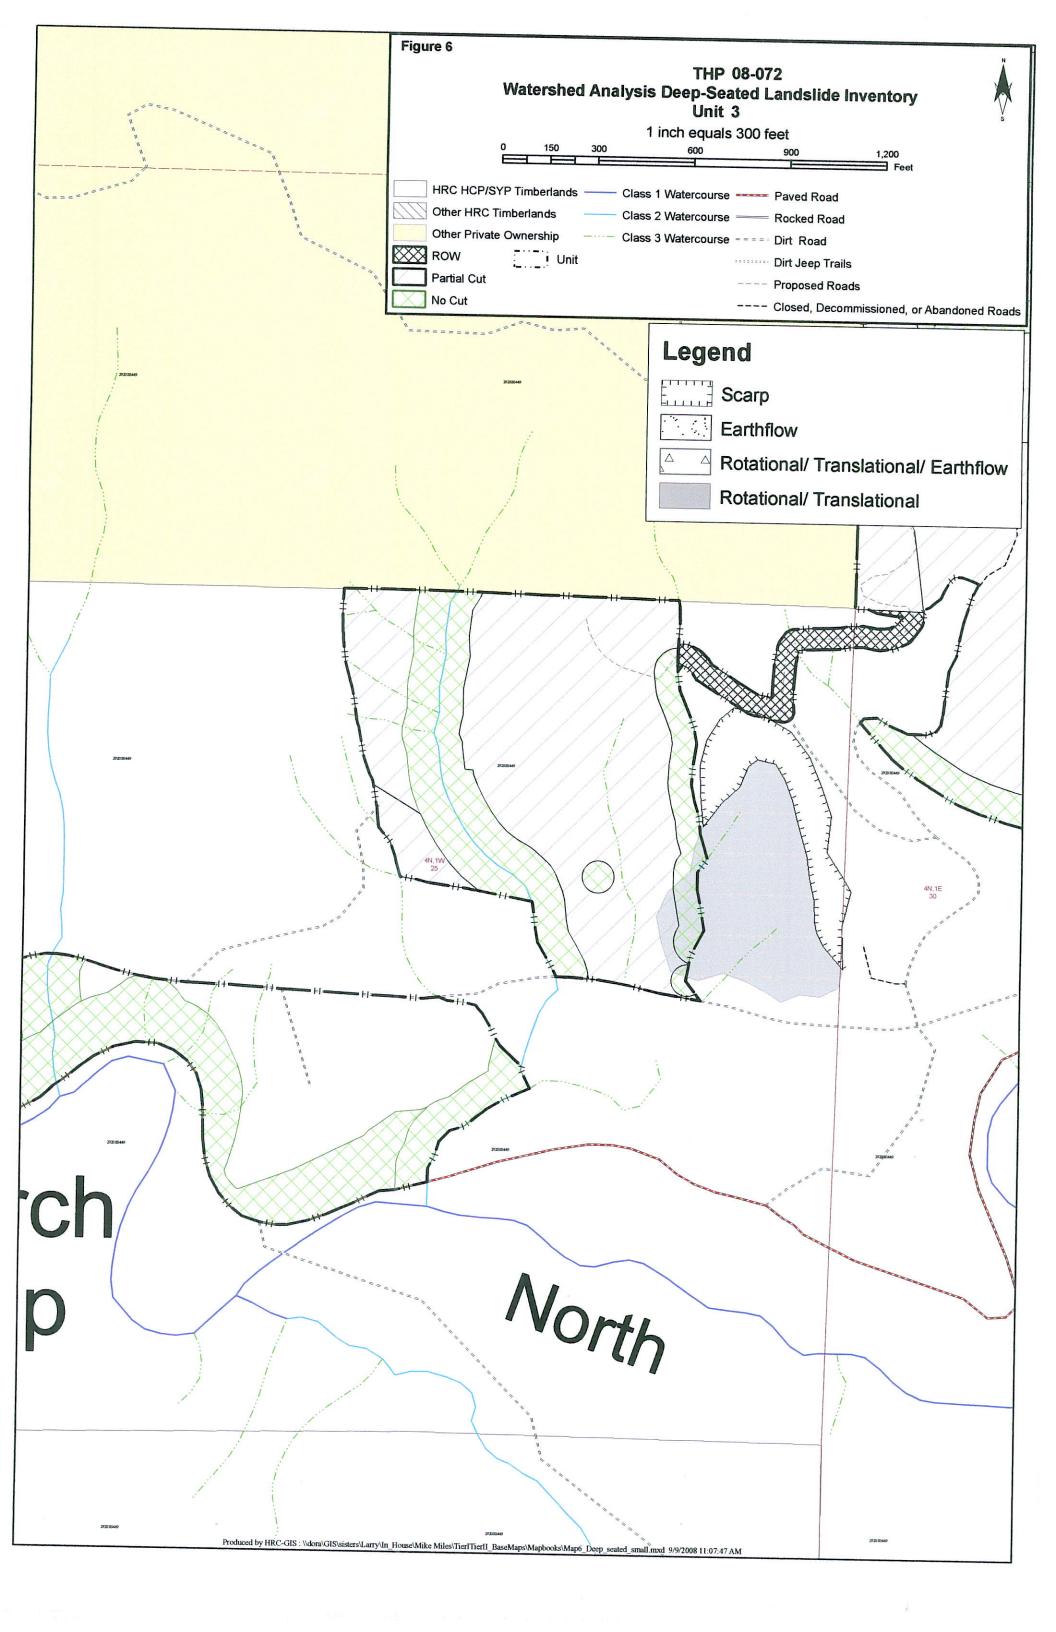
Figure 6 shows one dormant to the east of the unit. Only a portion of the toe deposit is mapped within the unit.
