Subject: Enrollment of THP 1-09-018 HUM (Unit2) in the Elk River WWDR, "Tier II"

**THP: North Ridge THP 09-018 Unit # 2 March 1, 2010**

**THP Unit: # 2**  
**Polygon: 2-1**

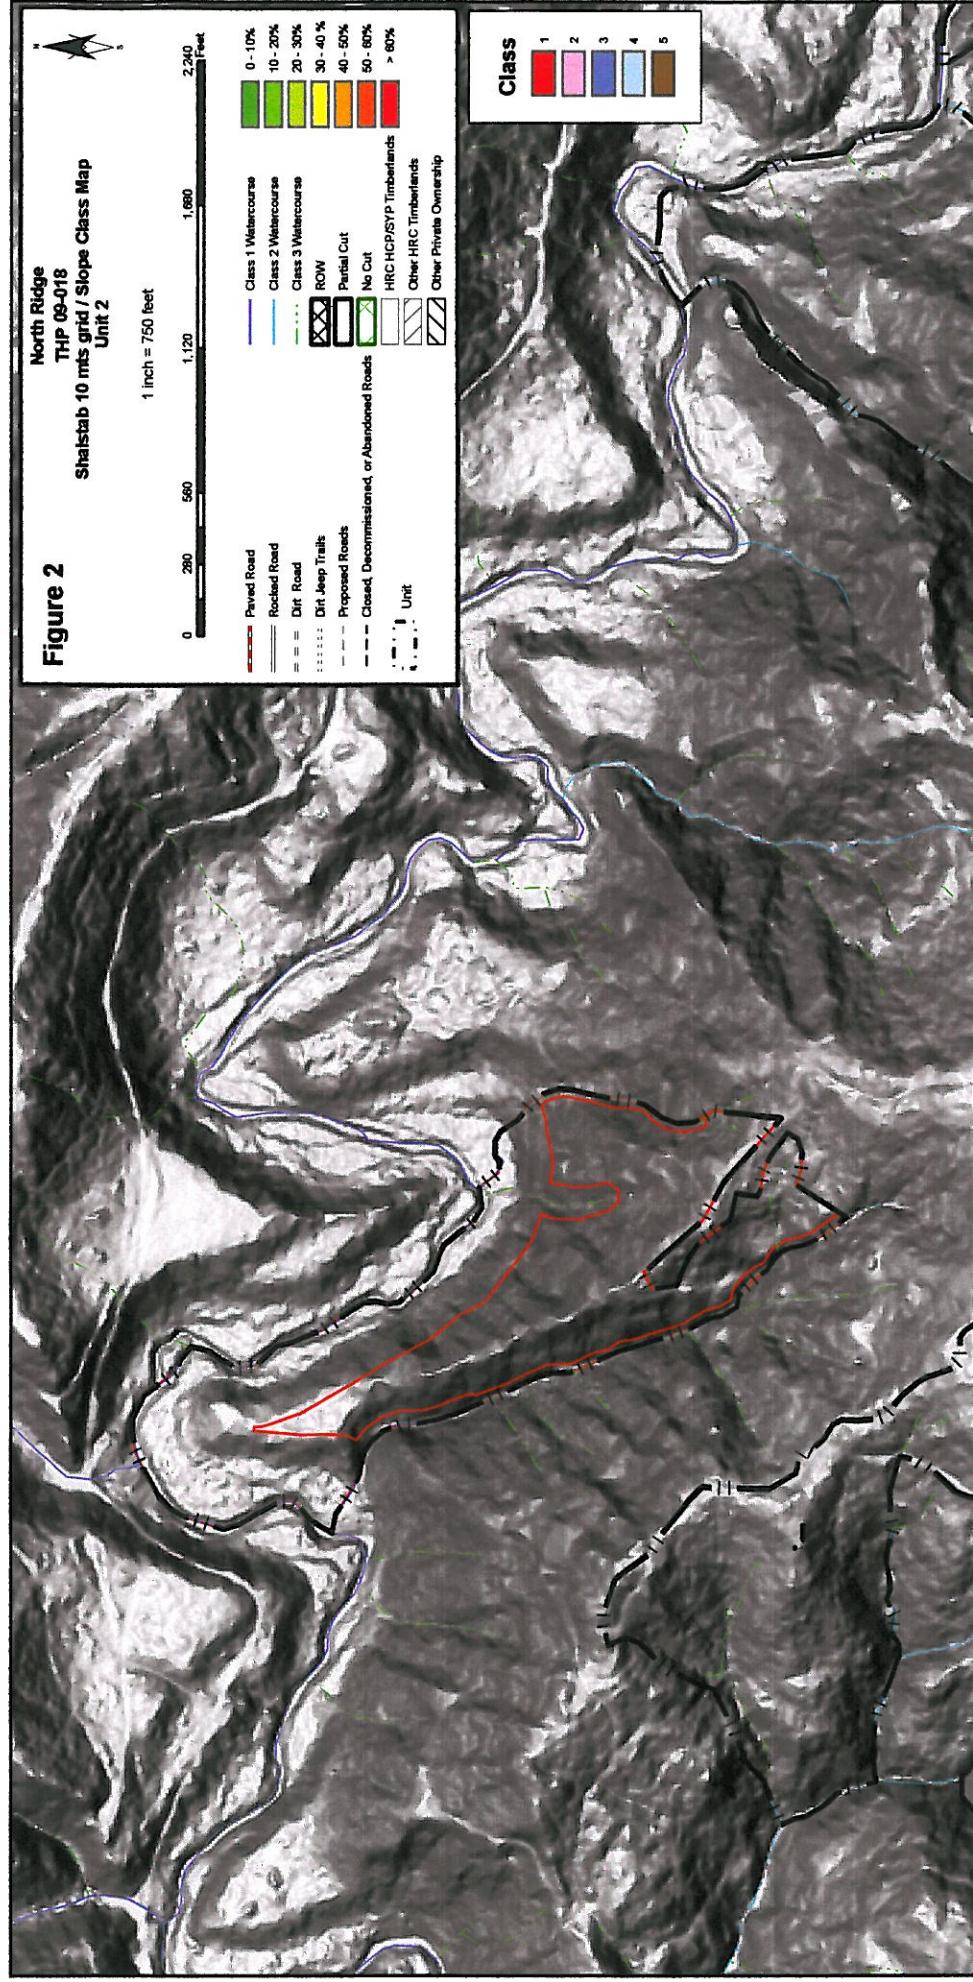
North Ridge  
THP 09-018  
CGS Map Unit 2

Unit 2 is sharply defined northwest trending low relief trending ridge adjacent the North Fork of Elk River. Figure 3 shows the unit to be underlain by undifferentiated Wildcat Group sediments. These sediments are composed of silts, sands, clays, and infrequent gravels that are moderately to well consolidated. The slopes are typically steeply inclined and include moderate to poorly defined watercourse channels. Figure 3 maps debris slide / source areas atop both of the flanking slopes to the ridge.

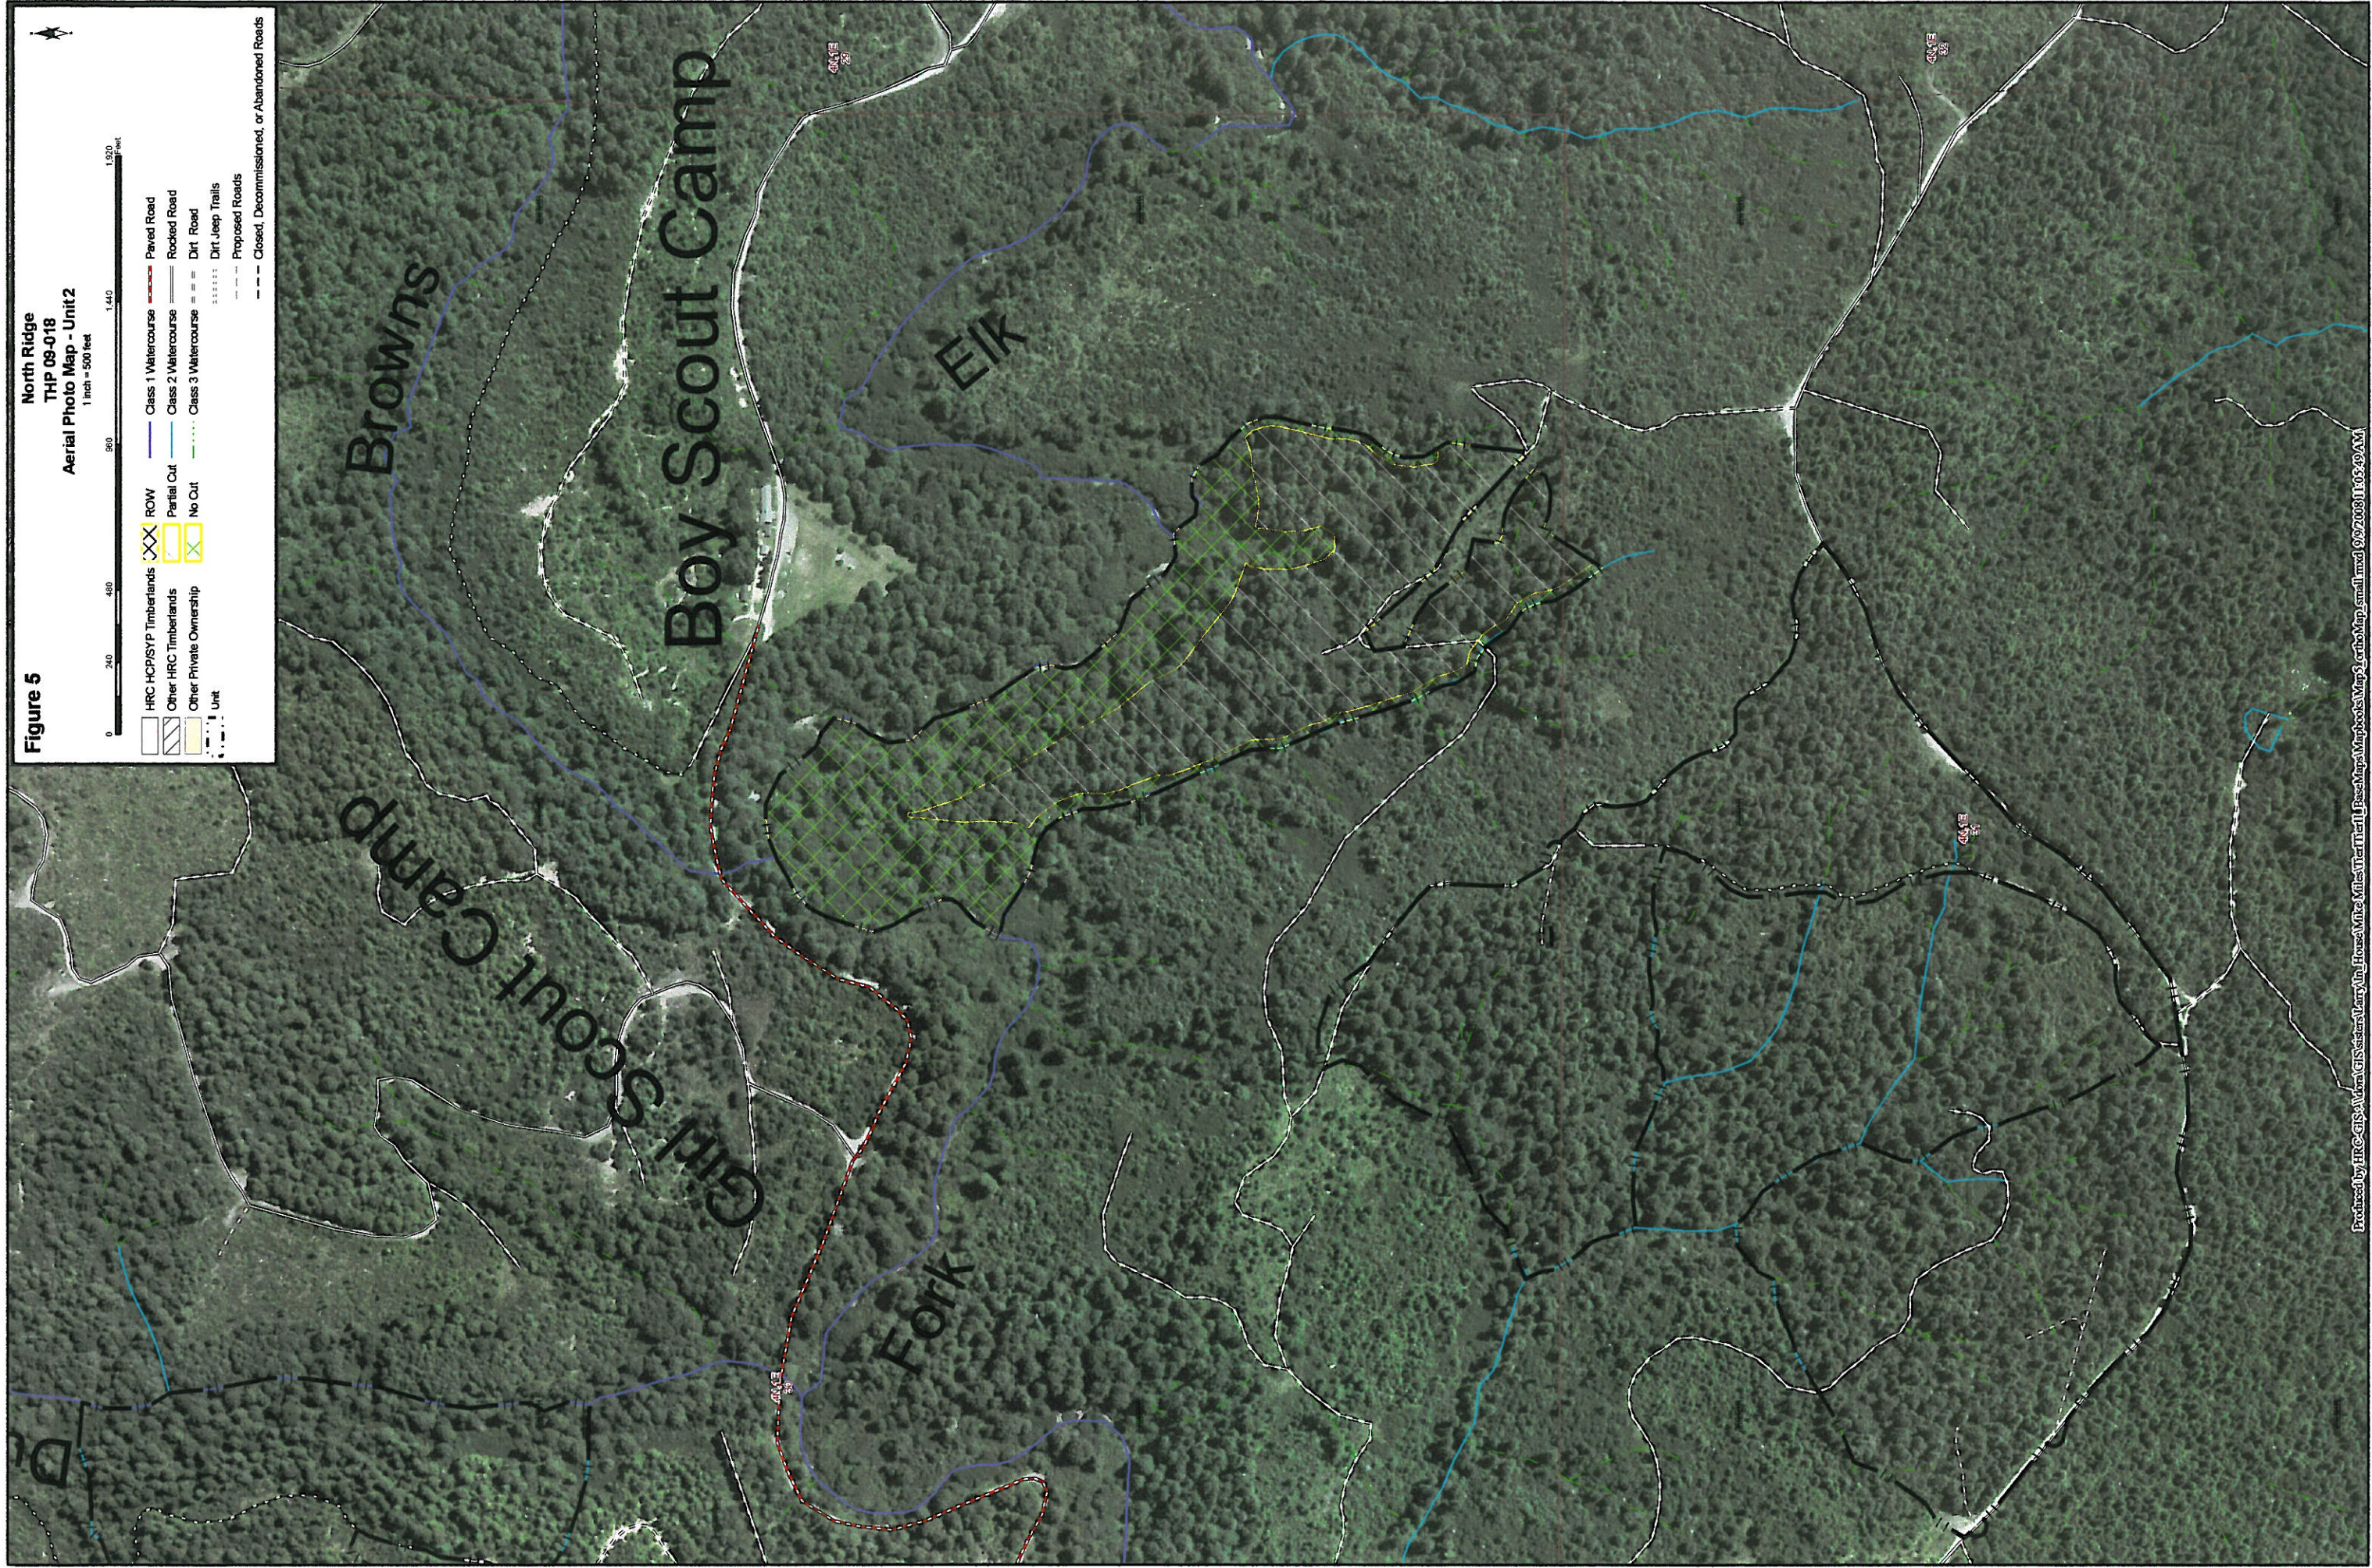
Figure 6

No mass wasting is mapped within the unit from Figure 6.

North Ridge  
THP 09-018  
Watershed Analysis Deep-Seated Landslide Inventory  
Unit 2
