Subject: Application for Coverage of a portion of THP 1-12-017 HUM (Tip Top) under Watershed-Wide Waste Discharge Requirement (WWDR) Order No. R1-2006-0039 / North Fork Elk River WWDR, "Tier II".

TIP TOP LAKE THP, HUMBOLDT COUNTY, CALIFORNIA

UNSTABLE AREAS DISCLOSURE

**Tip Top Lake
THP 1-12-017 HUM
Unit 1**

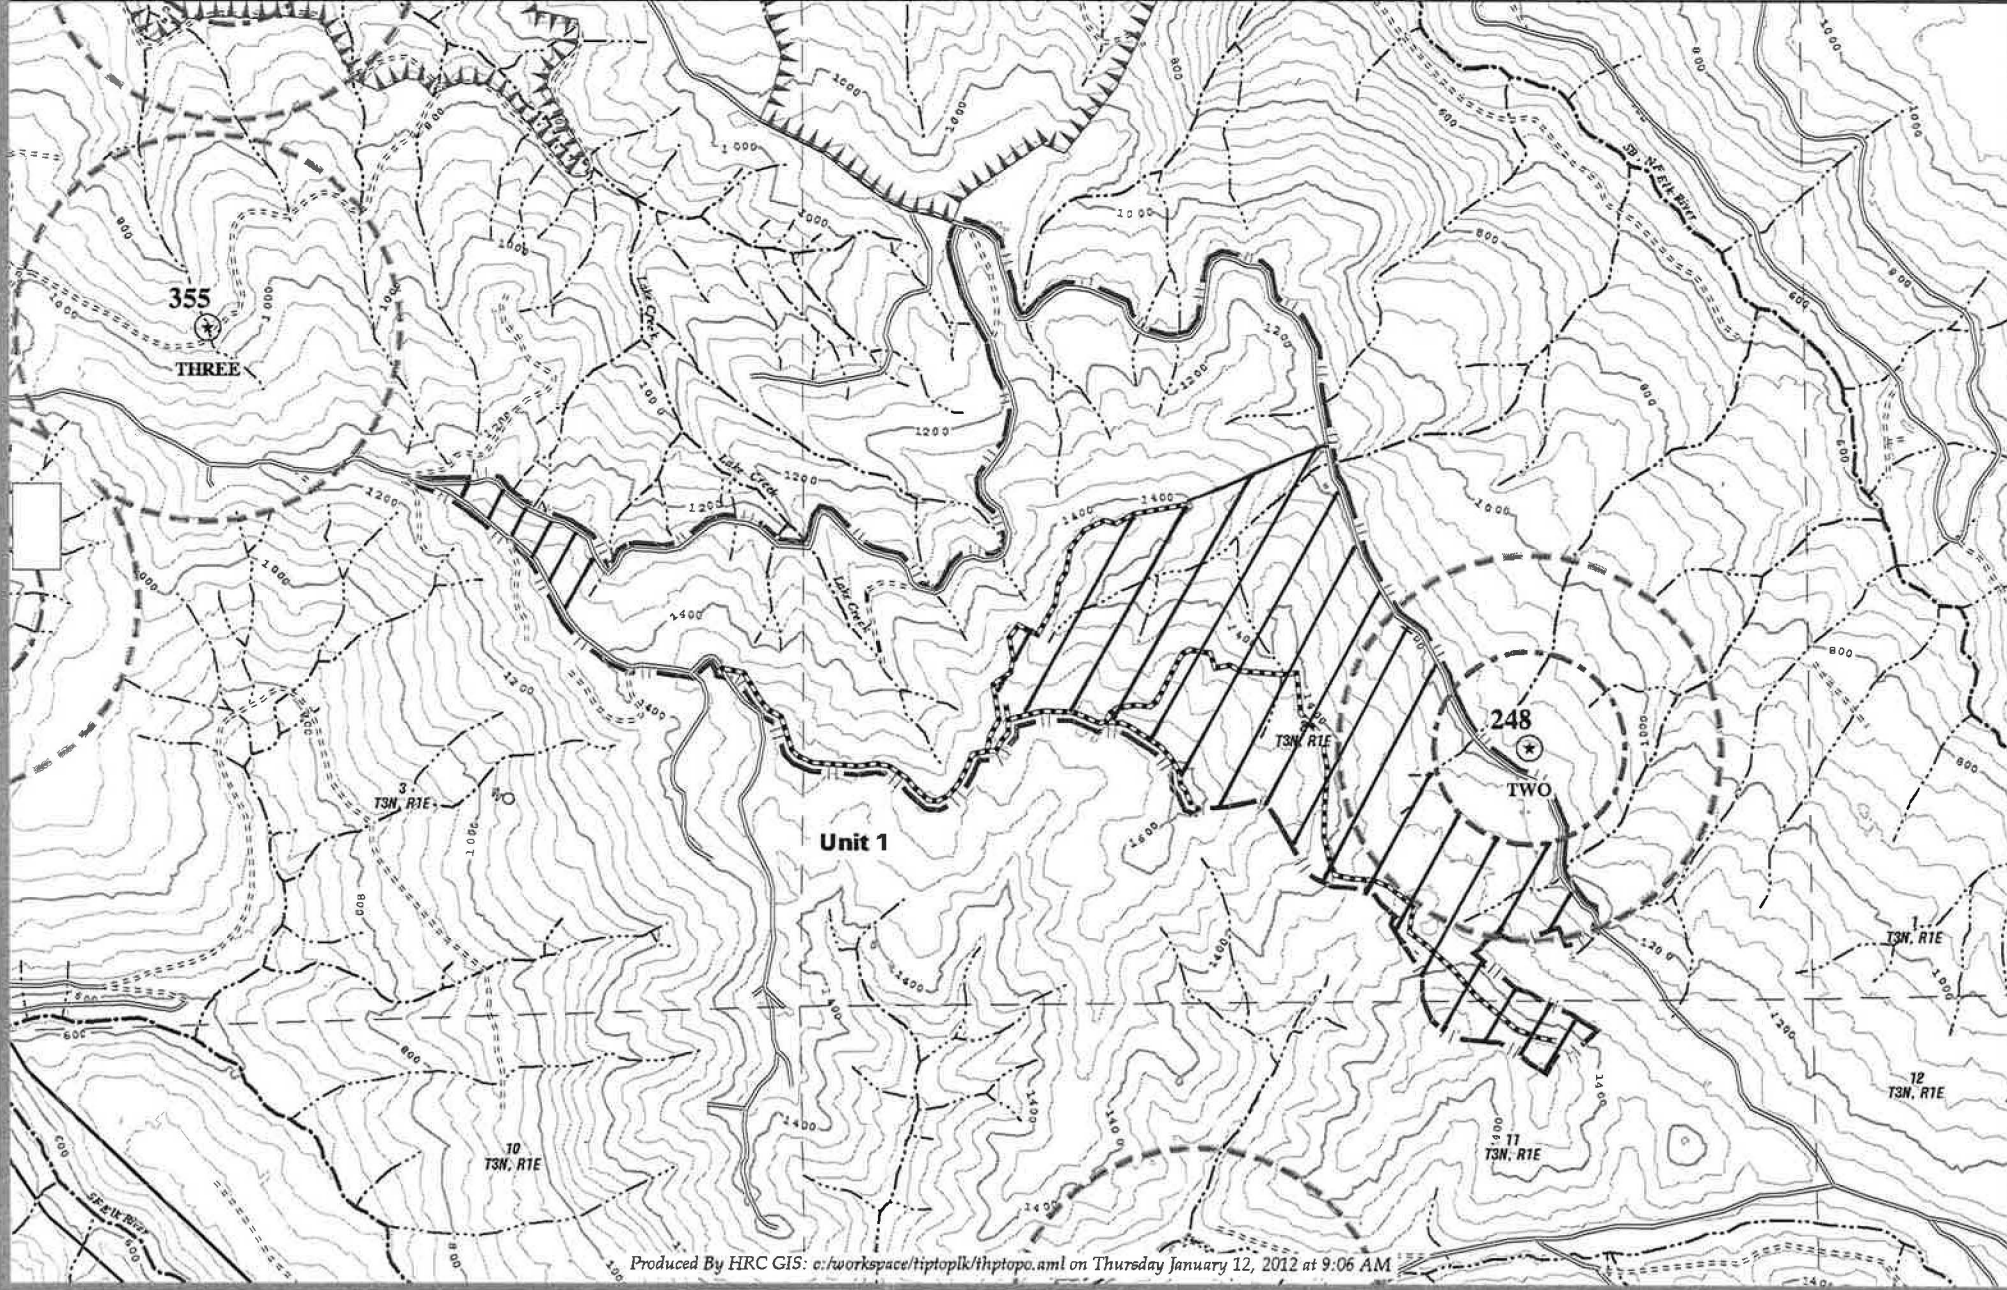
Tip Top Lake
Topographic Map

TIER 2 ENROLLMENT

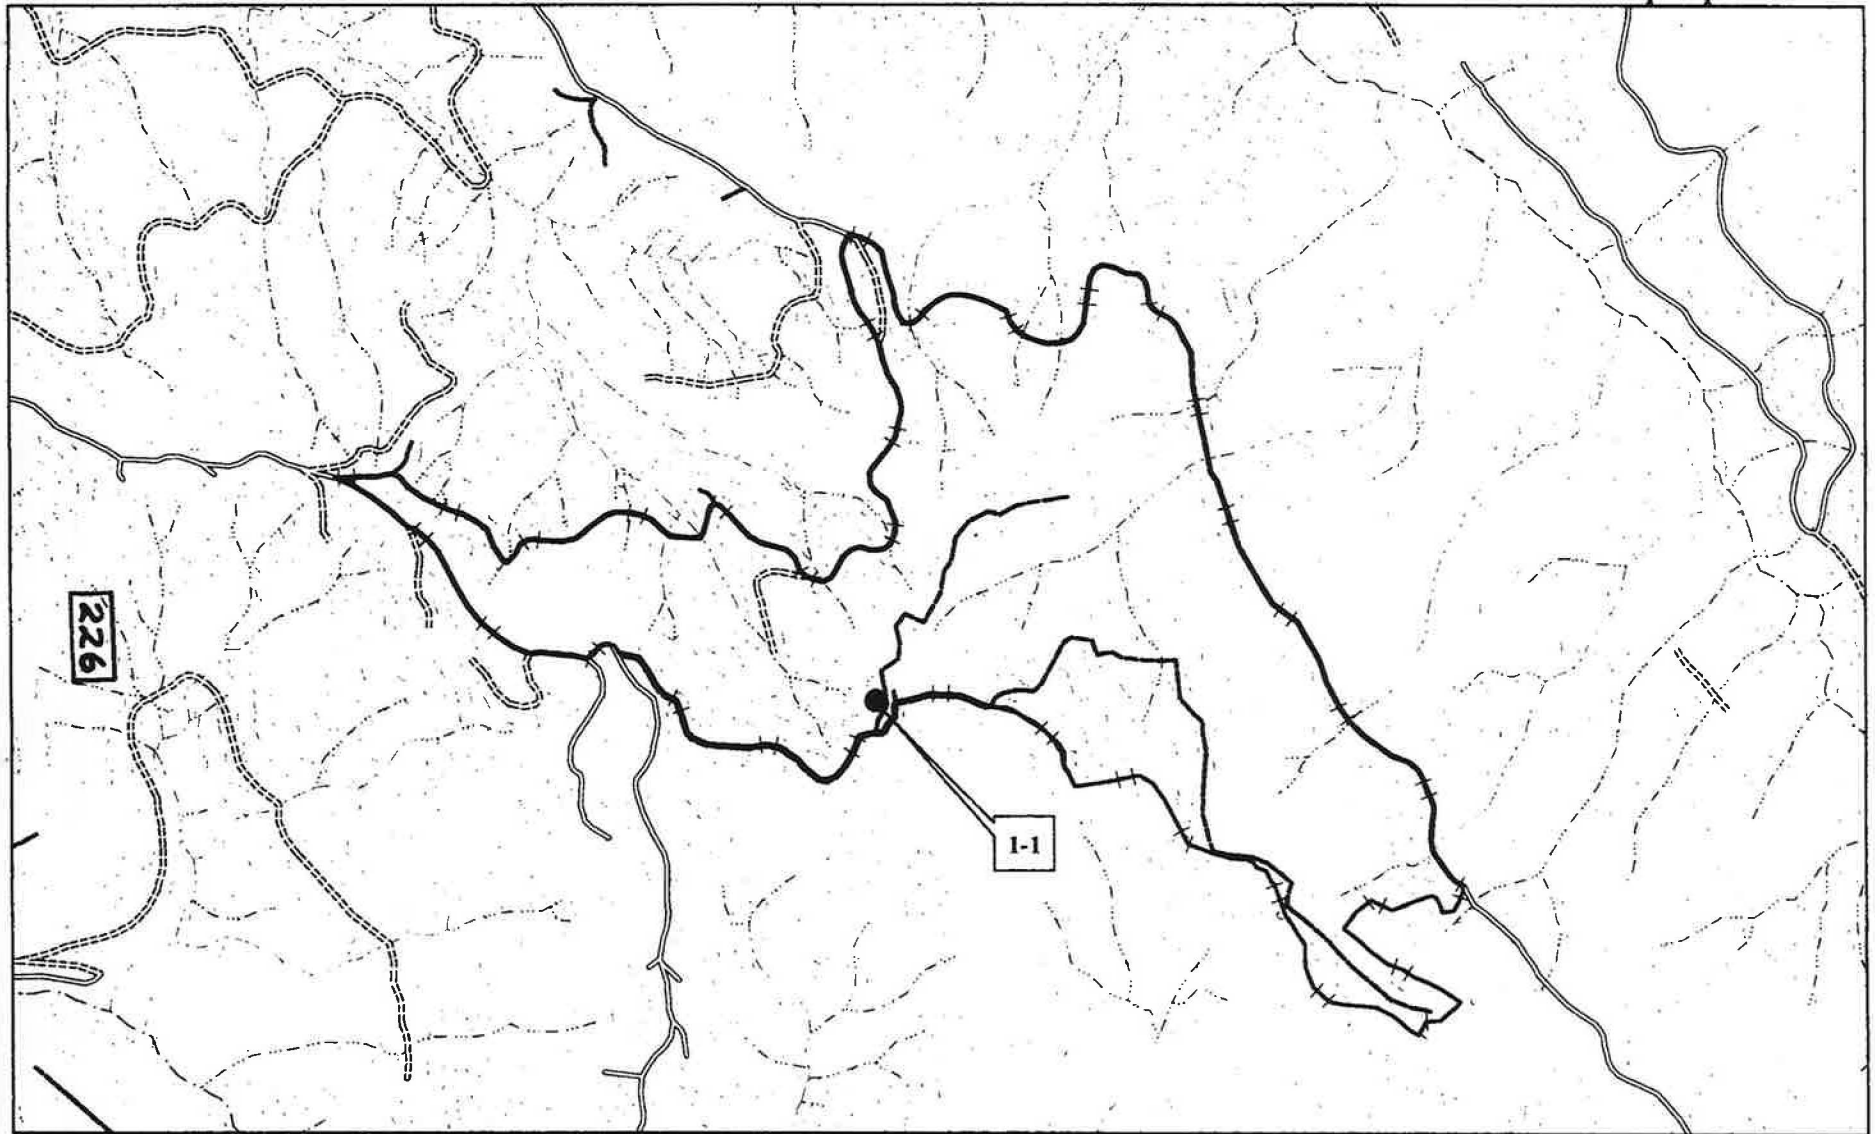
Figure 1: Unstable Areas Map

The Forester identified one small landslide within the unit (Figure 1). The landslide is less than 50 feet in length and width and appears shallow. The nearest watercourse is approximately 200 feet down slope of the landslide.

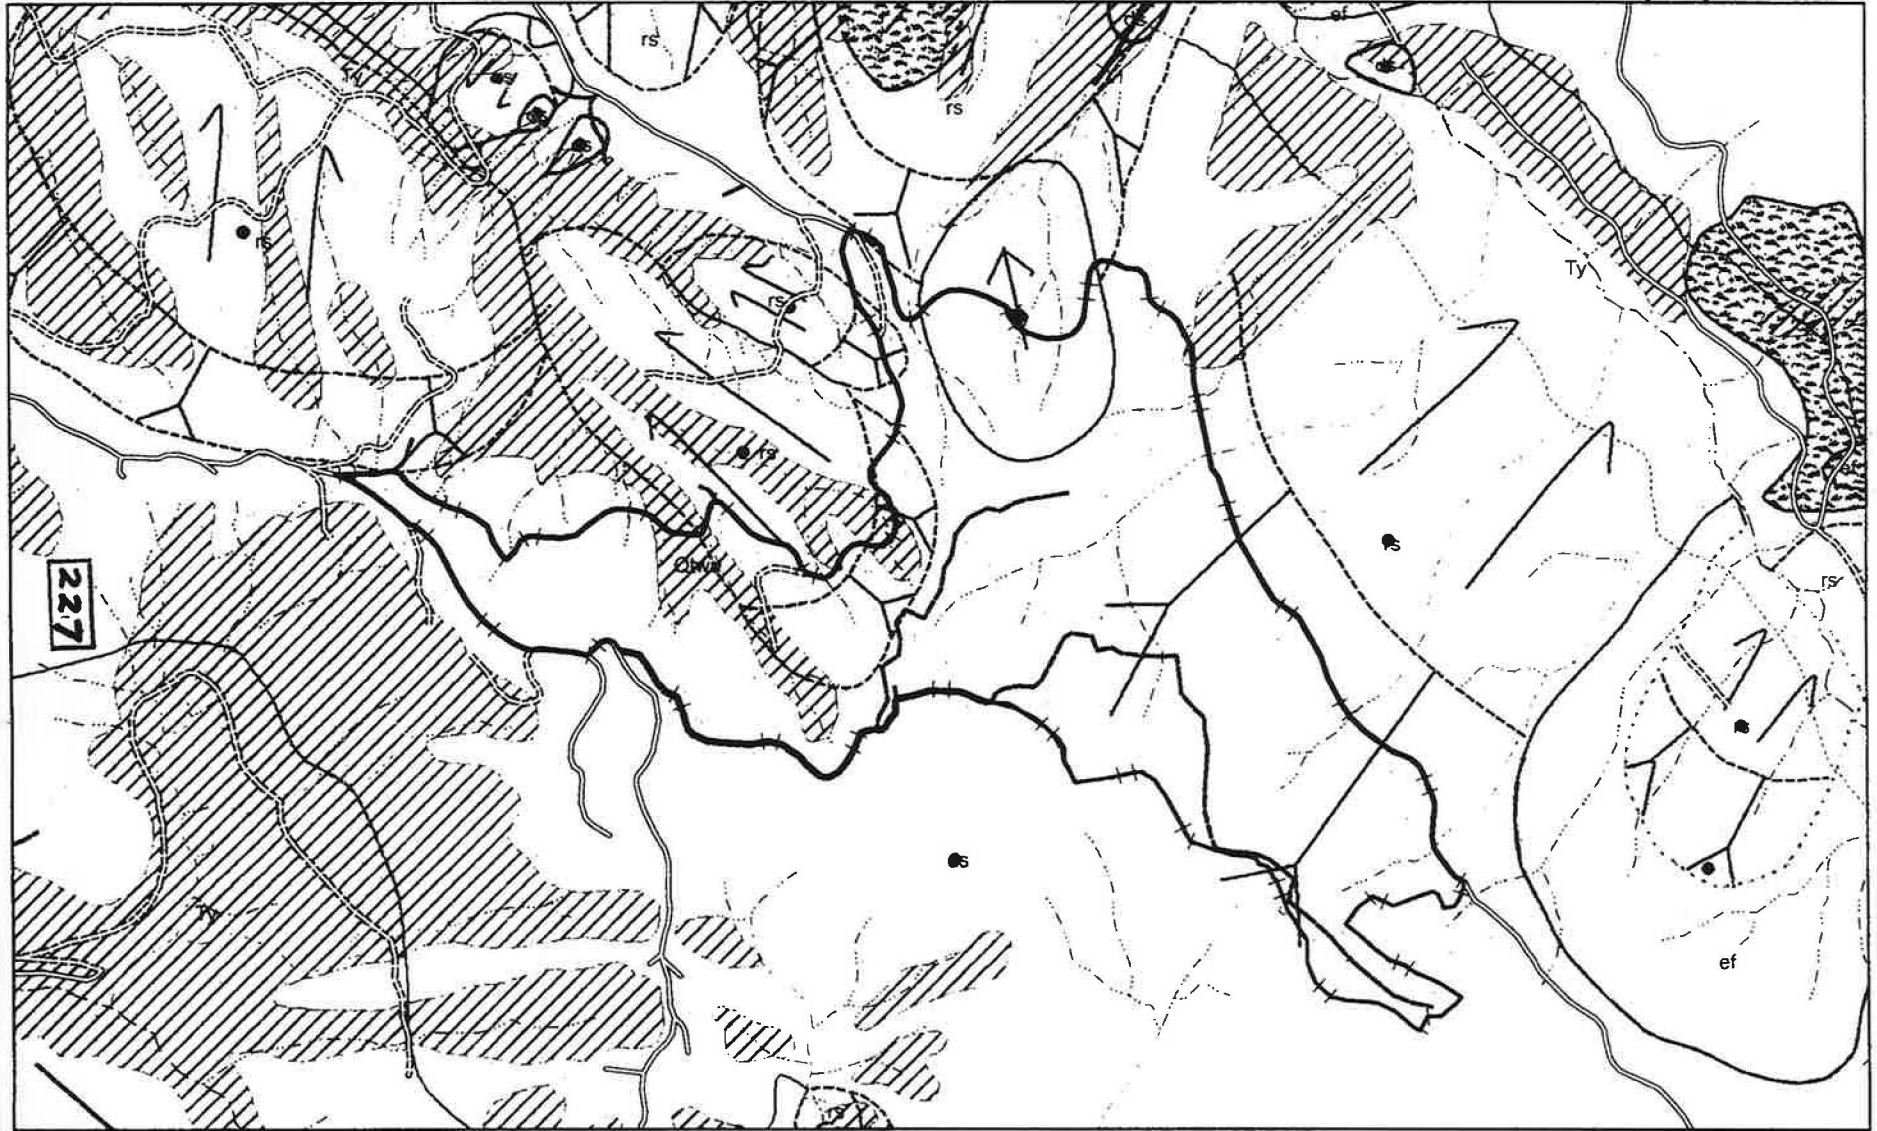
Figure 2: Geologic and Geomorphic Features Related to Landsliding (Marshall and Mendes, 2005)

Consistent with our observations, CGS (2005) maps Undifferentiated Wildcat Group sediments underlying the unit. CGS (2005) maps the upslope extent of four deep-seated landslides within the unit (Figure 2). These landslides are characterized as dormant old to dormant mature rotational landslides and one dormant young earthflow. Based on our review, these entities did not exhibit evidence of adjustment following the initial harvest. Well entrenched Class II watercourses within the western portion of the unit are mapped within debris slide amphitheater slopes I source areas. We did not observe morphology consistent with this in the field.

Consistent with our observations, CGS (2005) maps Undifferentiated Wildcat Group sediments underlying the unit. CGS (2005) maps the upslope extent of four deep-seated landslides within the unit (Figure 2). These landslides are characterized as dormant old to dormant mature rotational landslides and one dormant young earthflow. Based on our review, these entities did not exhibit evidence of adjustment following the initial harvest. Well entrenched Class II watercourses within the western portion of the unit are mapped within debris slide amphitheater slopes / source areas. We did not observe morphology consistent with this in the field.

The stability of the landslide-related landforms (debris slide slopes, translational/rotational landslides, and earthflows) (Figure 3) identified by prior investigators does not appear to have been adversely impacted by past land use activities. HRC Geology Department staff noted that there was no evidence of post-harvest adjustment associated with these features and that there was an absence of landslide morphology relating to recent or historic movement in these areas (HRC, 2012). State regulatory staff concluded that the landslide hazard in polygon 1-1 were appropriately disclosed and mitigated (CGS, 2012).
