Subject: Enrollment of THP 1-05-077 HUM (Unit 4) in the Freshwater Creek WWDR, "Tier II"

THP: Around Gills THP 05-077 Unit # 4 3-10-09

Erosion Control Plan (ECP) for the “Around Gills” THP 1-05-077HUM

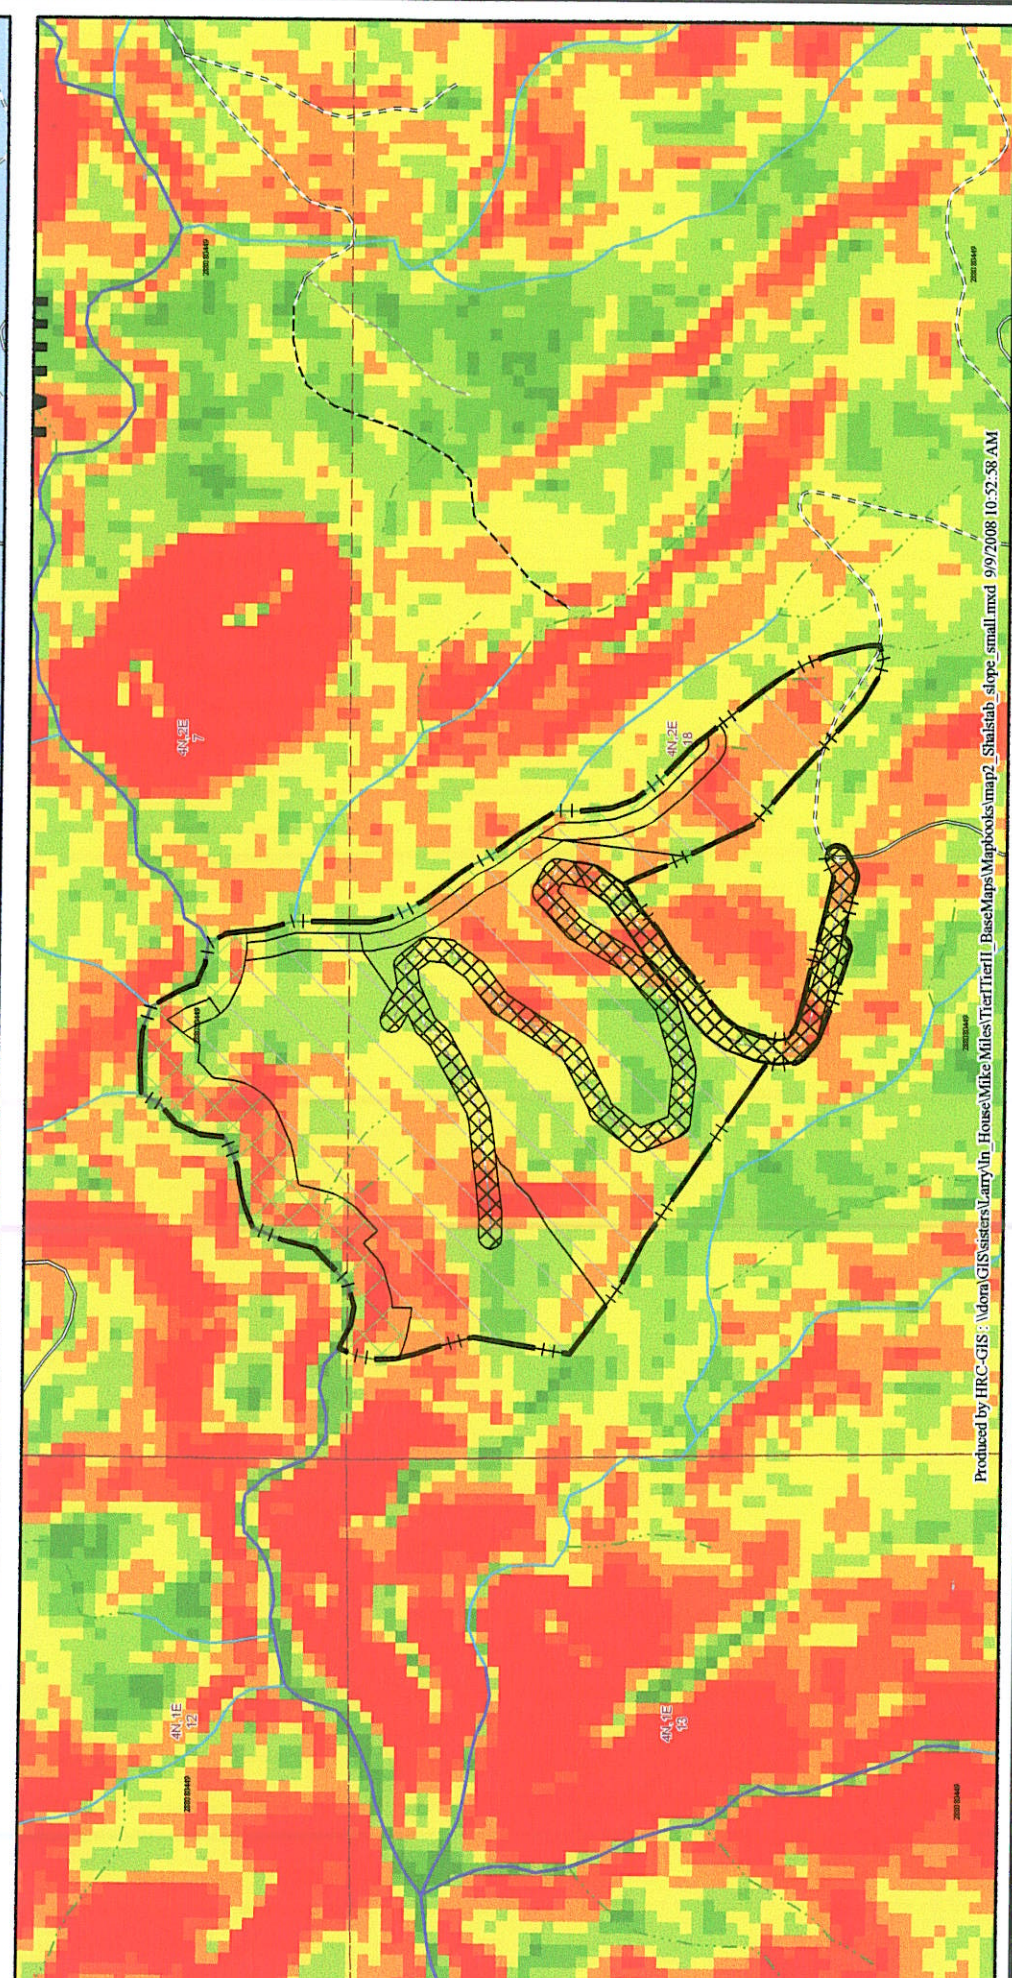
Around Gills
THP 05-077
CGS Map Unit4

The harvest unit occupies predominantly northwest-facing, gentle to moderately inclined, concave and convex slopes underlain by mélange of the Central Belt Franciscan Complex. Figure 3 interprets the right lateral margin of a large dormant earthflow extending into the western portion of the unit. CGS (2005) also maps debris slide slopes adjacent the Class I watercourse that defines the down slope harvest boundary. The debris slide slopes roughly correlate with the Class I RMZ

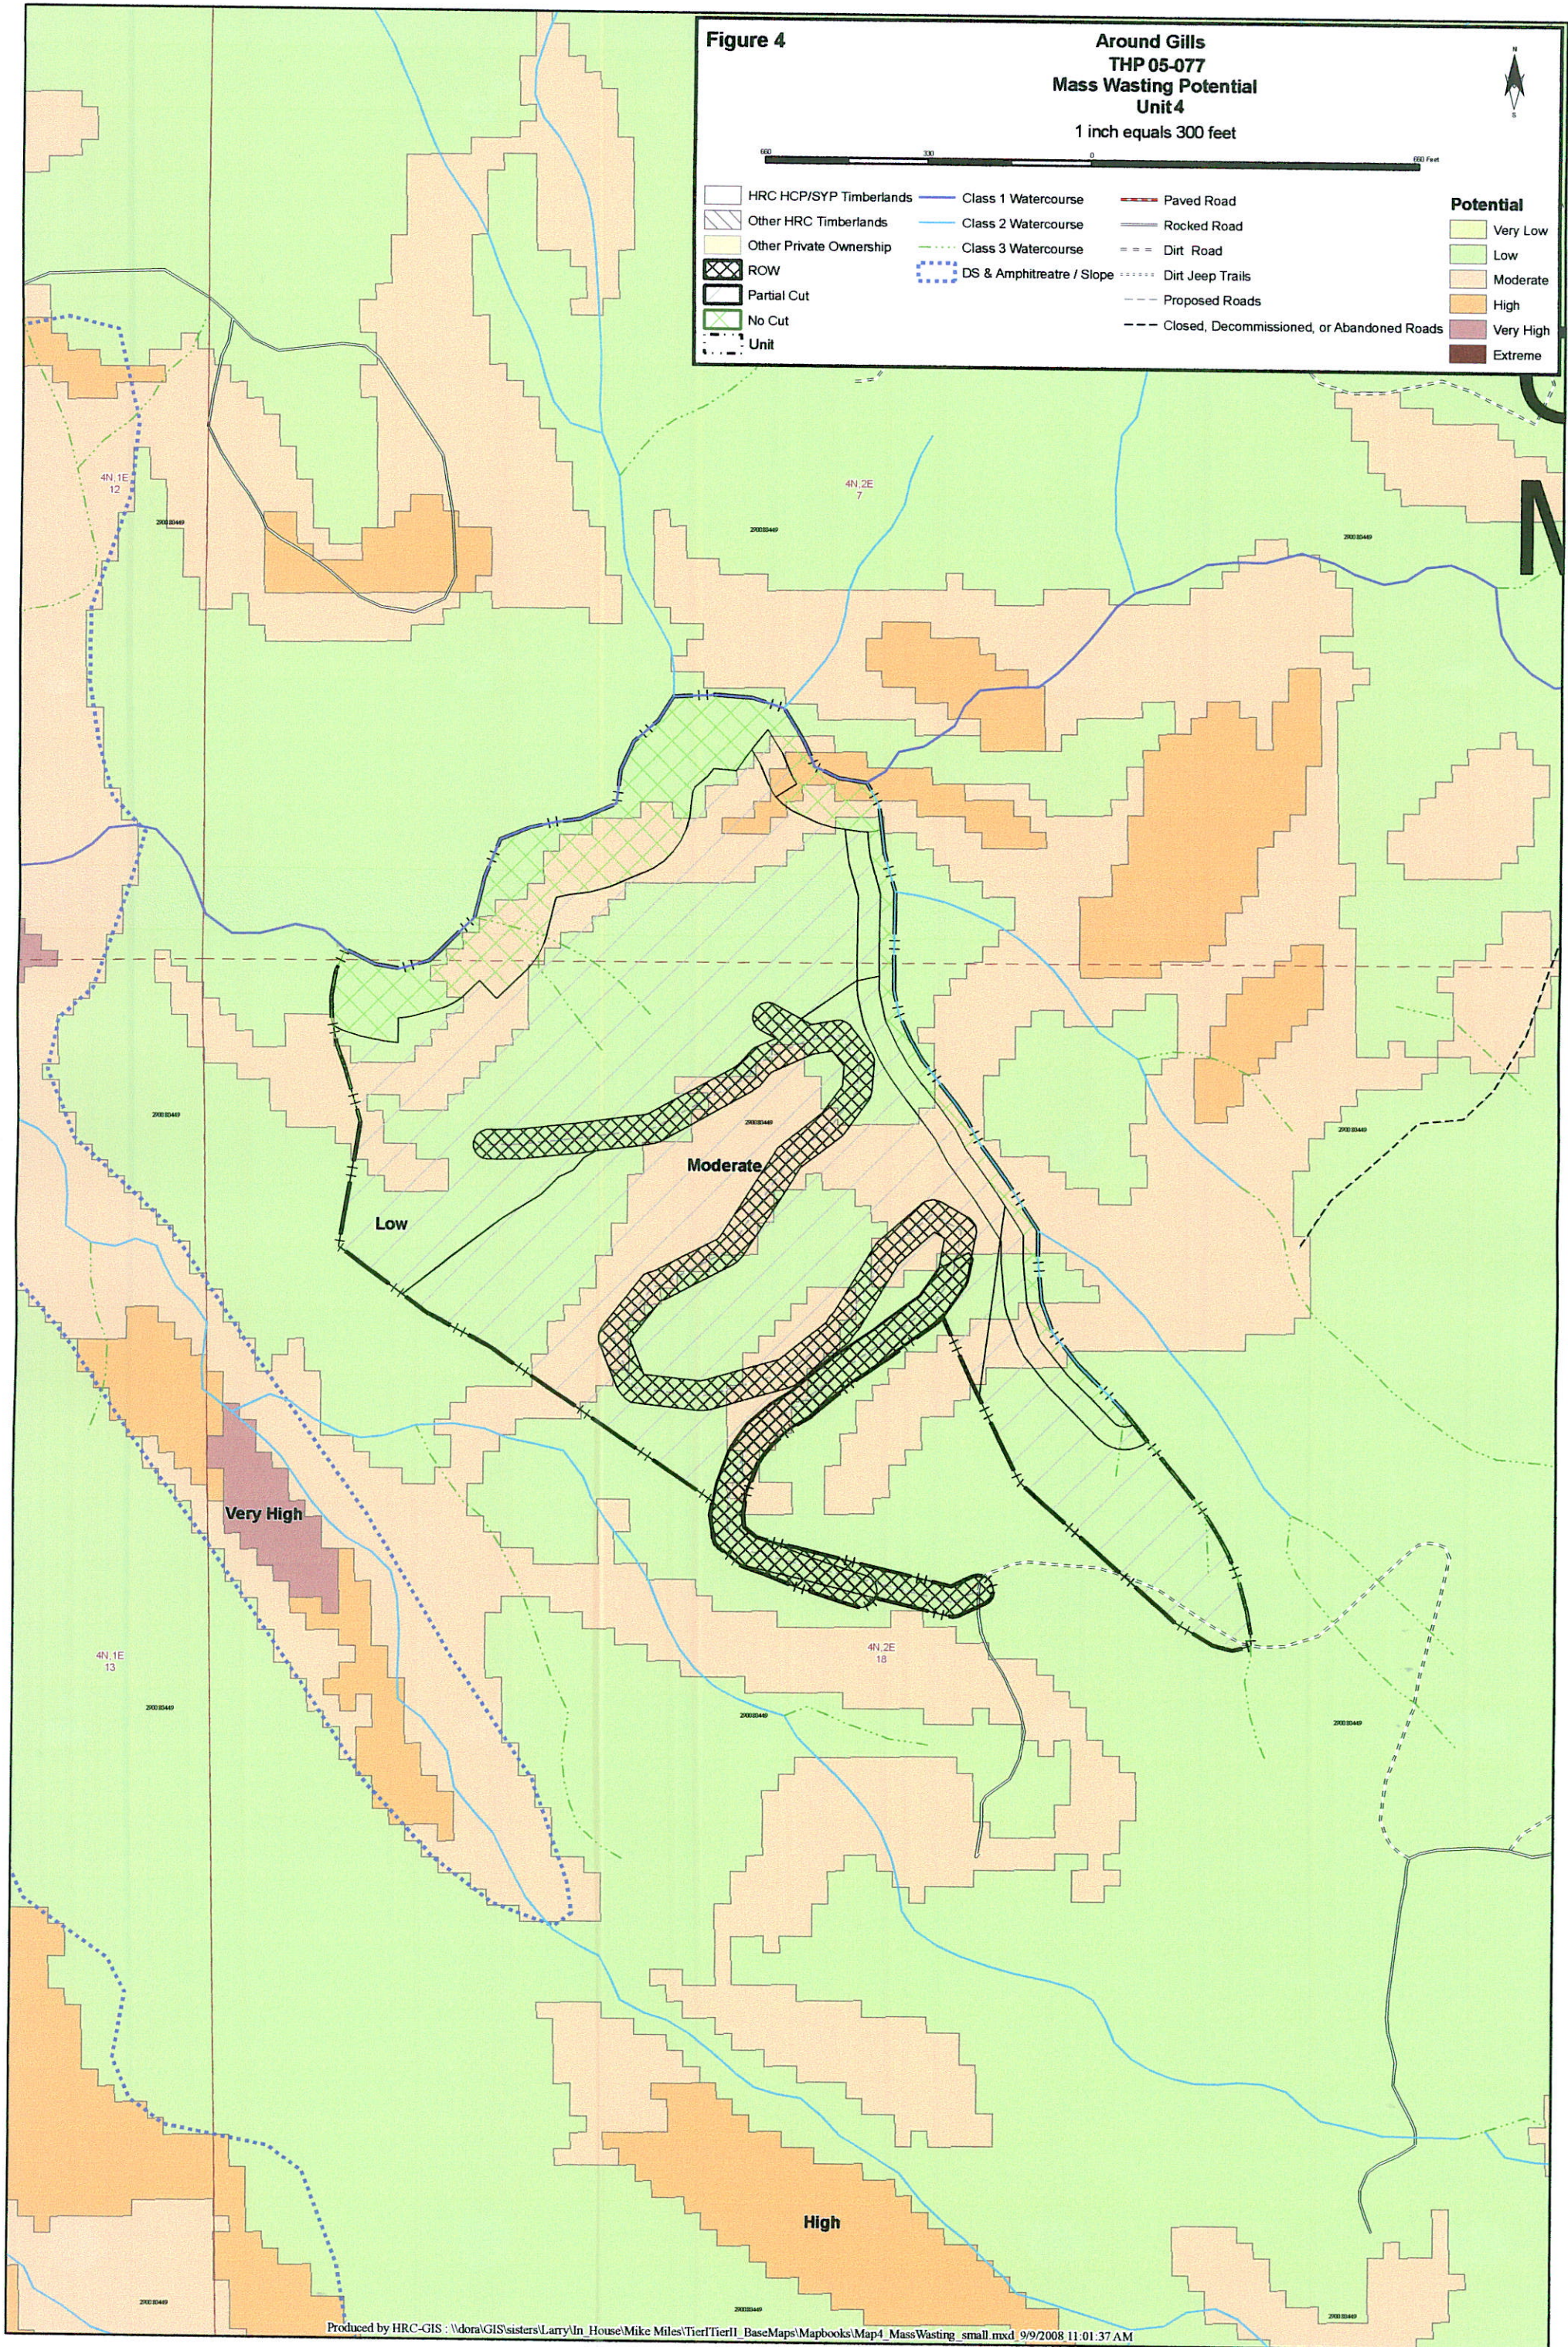
Figure 5

Around Gills
THP 05-077
Aerial Photo Map - Unit 4

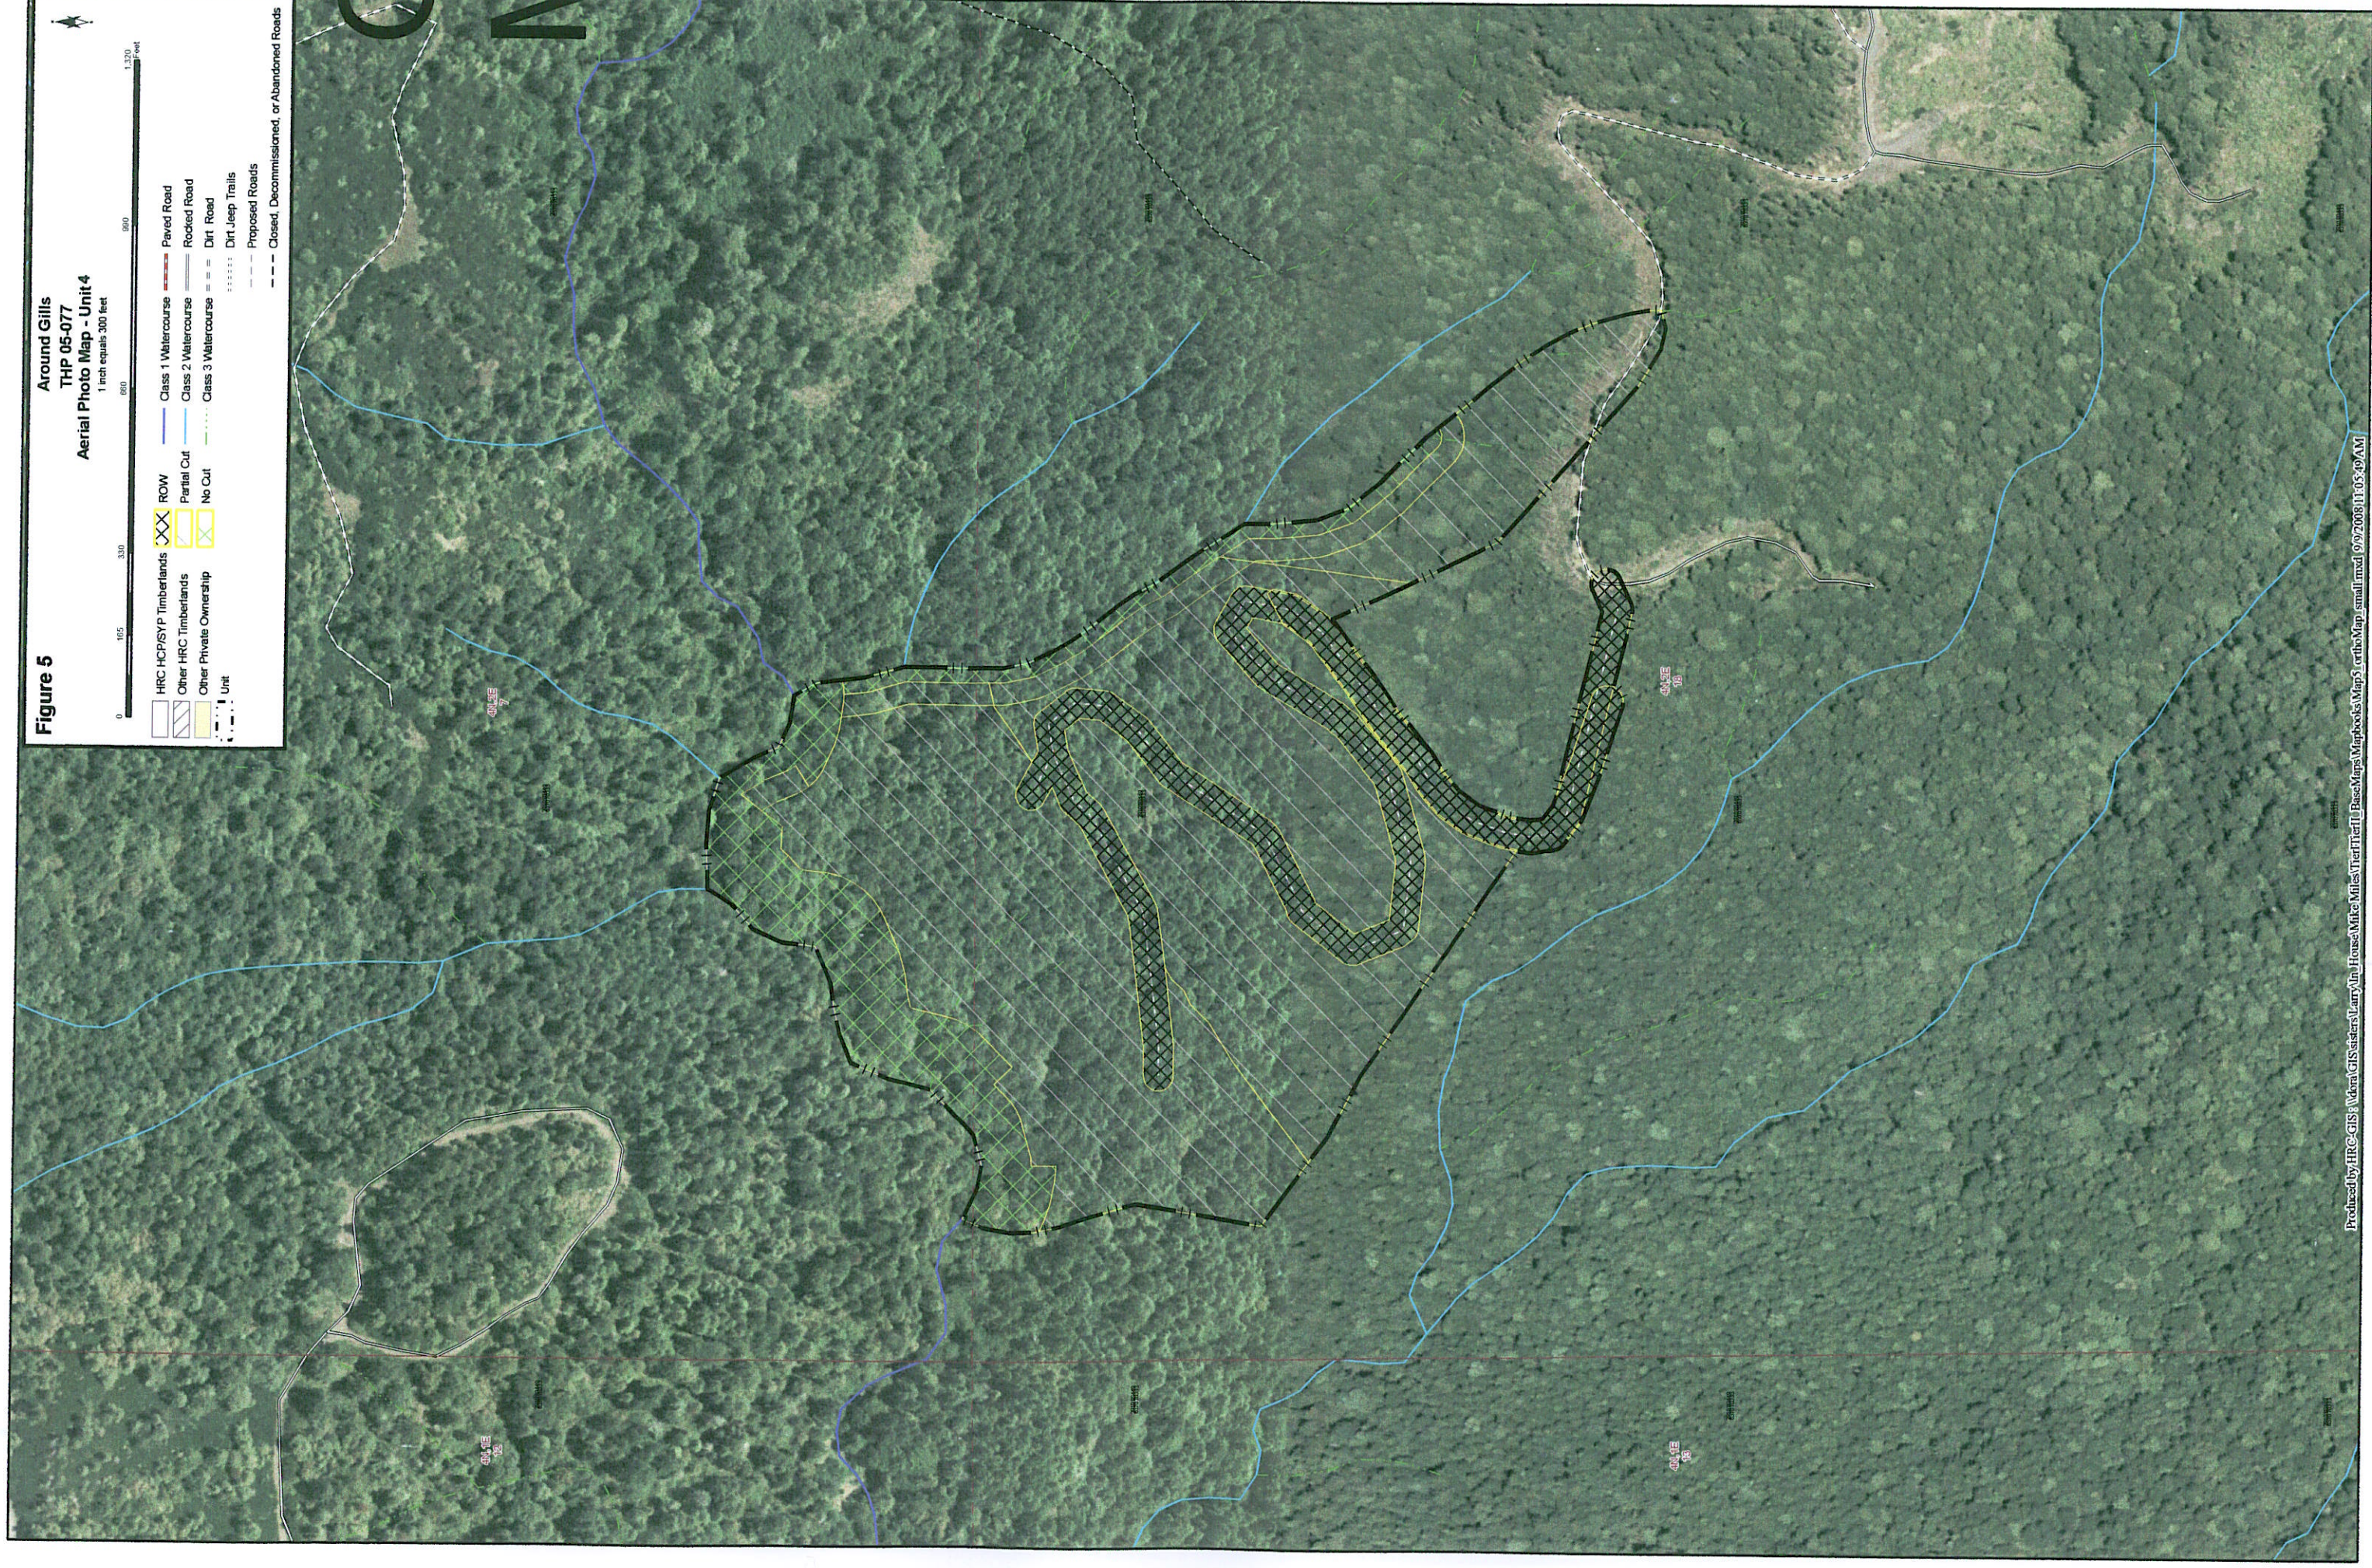
THP 05-077
Watershed Analysis Deep-Seated Landslide Inventory
Unit 4

Watershed Analysis mapping shows the unit to be underlain by a low to moderate hazard deep-seated landslides (Figure 6) within the lower slope elevations of the unit. New road construction is proposed across both of the landslides

Review of Figure 2 (Hillslope Shade) shows the slopes to be regionally smooth yet irregular in surface texture. This expression is typical of weathered mélange. We did not observe clear indication of the Figure 6 mapped landslides within the unit. Should they exist, the failures are considered very old, dormant mature, and not exacerbated by harvest activities.
