Laguna de Santa Rosa – Linkage Analysis for Sediment Impairments (Revised)

January 10, 2020

North Coast Regional Water Quality Control Board

Tetra Tech

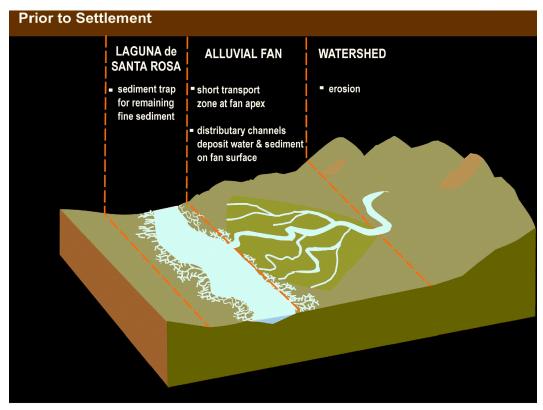
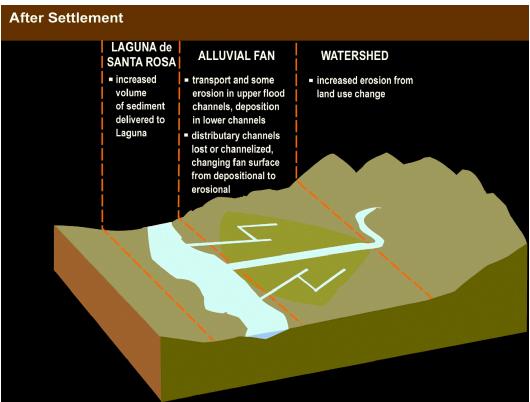
Figure 2-1. Graphical Representation of Sedimentation Processes in the Laguna de Santa Rosa Watershed before and after Settlement (from PWA, 2004a)

A graphical conceptual model of changes in sedimentation processes in the watershed between historic and present day conditions was developed by PWA (2004a) and is reproduced in Figure 2-1.

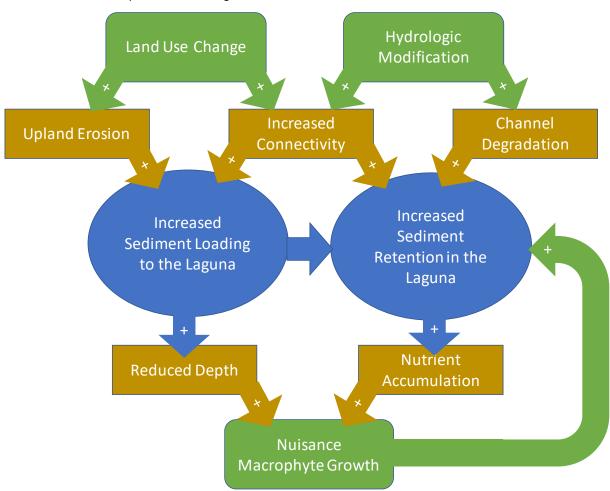
Figure 2-2. Simplified Conceptual Model for Sediment in the Laguna de Santa Rosa

Some of the most important processes related to the sediment impairment of the Laguna de Santa Rosa are summarized in simplified form in Figure 2-2.

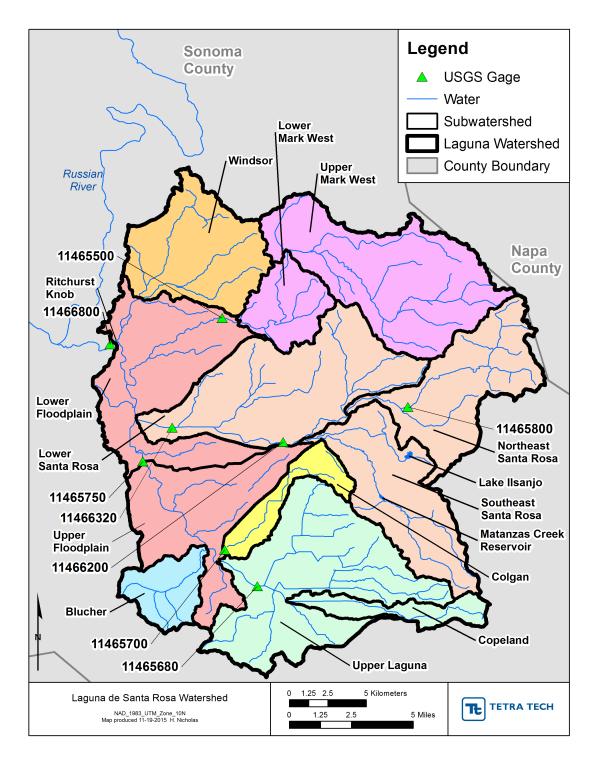
Figure 4-1. Delineation of Subwatersheds and Location of USGS Gages for the Laguna de Santa Rosa Watershed

USGS gages are: 11465500 Mark West Creek nr Windsor, 11465680 Laguna de Santa Rosa at Stony Point Rd., 11465700 Colgan Creek nr Sebastopol, 11465750 Laguna de Santa Rosa nr Sebastopol, 11465800 Santa Rosa Creek nr Santa Rosa, 11466200 Santa Rosa Creek at Santa Rosa, 11466320 Santa Rosa Creek at Willowside Rd., 11466800 Mark West Creek nr Mirabel Heights

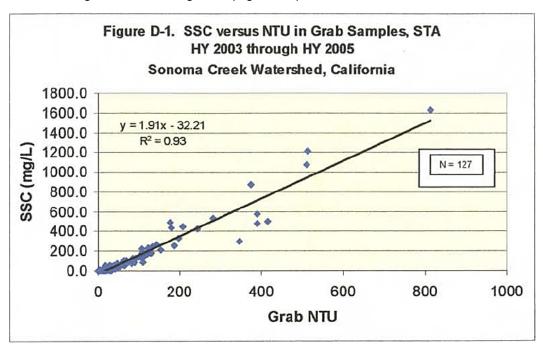
Figure 5-1. Relationship of SSC to Turbidity (NTU) in Sonoma Creek (from Appendix D to Sonoma Ecology Center, 2006)

No field data with paired SSC and turbidity measurements are available for the Laguna watershed. Therefore, we continue to use an alternate method as was done in Tetra Tech (2015): As part of the Sonoma Creek Sediment Source Analysis (Appendix D in Sonoma Ecology Center, 2006), work was undertaken to derive a relationship between suspended sediment concentration (SSC, mg/L) and turbidity (in NTU) based on a relatively strong relationship found in 127 samples taken at the Sonoma Creek continuous monitoring station in Eldridge, CA (Figure 5-1).

As the Sonoma Creek watershed is immediately adjacent to the Laguna de Santa Rosa watershed and shares similar geology this relationship may be relevant and applicable to the Laguna de Santa Rosa observations. One caution is that the PWA turbidity sampling for the Laguna de Santa Rosa watershed used a D & A Instruments – OBS 3 turbidity meter, while the Sonoma Creek work used a HACH 2100p turbidity meter. It is well known that different meters can yield rather different results for turbidity. Experiments undertaken by the Forest Service (Lewis et al., 2007) suggest that results from the 2100p turbidity meter tend to be biased high relative to those obtained with OBS 3. Nonetheless, the SSC-turbidity relationship reported for Sonoma Creek is much lower than that used by PWA (2004a).

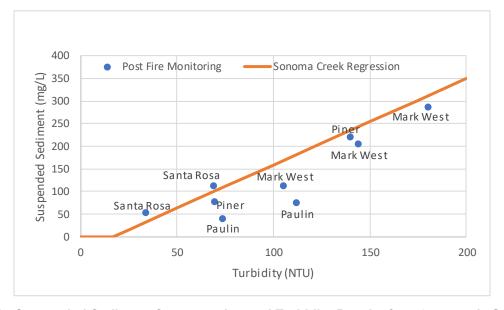
Figure 5-2. Suspended Sediment Concentration and Turbidity Results from Laguna de Santa Rosa Watershed Post-Fire Monitoring

The Regional Water Quality Control Board conducted a special monitoring program after the disastrous Tubbs Fire of 2017 and data from 2017 through 2/1/2019 (personal communication from Rich Fadness, SWAMP Regional Coordinator, North Coast Regional Water Quality Control Board to Jonathan Butcher, Tetra Tech, 7/3/2019). This contains nine paired SSC and turbidity samples in 2019 from Mark West Creek, Piner Creek, Paulin Creek, and Santa Rosa Creek.) These limited results (Figure 5-2) suggest that the Sonoma Creek equation provides a good approximation for the Laguna watershed as well. (They also suggest that there may be site-specific variations in the relationship as the samples from Paulin Creek fall well below the line.)

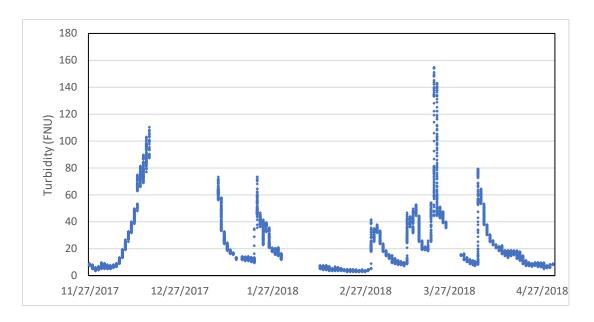
Figure 5-3. Continuous Turbidity Measurements, Mark West Creek near Mirabel Heights, 2017-2018

One other continuous turbidity record in the watershed is available from USGS. This is for Mark West Creek near Mirabel Heights (gage 11466800) and runs from 11/27/2017 to 5/1/2018 at 15 minute intervals (with gaps; Figure 5-3). This reports turbidity as formazin nephelometric units (FNU) rather than NTU and shows a maximum value of 155 FNU. A scatterplot of turbidity versus flow (Figure 5-4) shows the correlation between turbidity and flow is not very strong at this site. As the location is at the downstream exit of the Laguna, turbidity here may also be affected by elevated algae and organic detritus concentrations. There are no SSC or TSS measurements paired with this set of turbidity measurements.

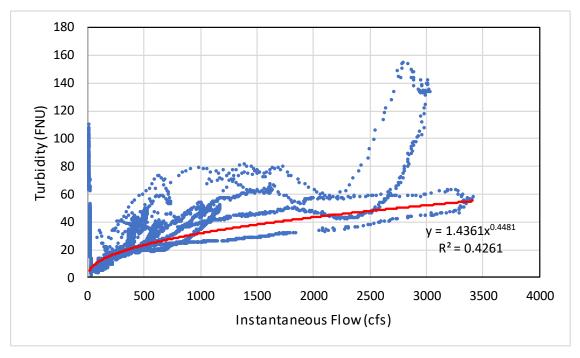
Figure 5-4. Relationship between Turbidity and Flow, Mark West Creek near Mirabel Heights, 2017-2018

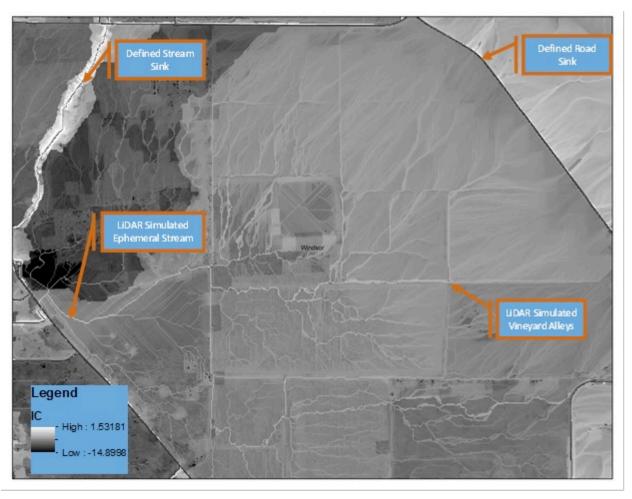
Figure 6-1. Example Connectivity Estimates for Vineyard Area in Windsor Creek Watershed

Borselli and colleagues define IC in two ways, either as connectivity to the nearest perennial stream or other sink (ICchannels) or as connectivity to the watershed outlet (ICout; see D'Haen et al., 2013). In our application we calculate ICchannels and define perennial streams, floodways, and roads as "sinks" as recommended by Borselli et al. (2008). Roads are included because they typically have enhanced conveyances in areas where they are downstream along flow accumulation pathways. ICchannels is used under the assumption that the stream channels transmit all the incoming sediment downstream, consistent with the approach used by Vigiak et al. (2012) and with observations that most upland stream channels in the watershed are either enlarging or at least not aggrading, while transport across the upper Santa Rosa Plain in larger streams is enhanced by the maintenance of floodways. To control for the likelihood that smaller, ephemeral channels may store rather than transmit sediment, the stream sinks used in the analysis are defined from the 1-m digital elevation model (DEM), after smoothing to a 2-m grid to meet computer memory limitations, as corresponding to areas of flow accumulation that have a 5 square kilometer (km²) or greater upstream drainage area. Roads represented as sinks are those defined in the 2010 Tiger roads coverage (U.S. Census Bureau, 2010), which includes most public and private roads and some, but not all private vineyard alleys and farm roads. Private road segments that are not simulated as flow accumulation pathways likely do not have drainage ditches that would define them as a sink. Streams and roads not represented as sinks nonetheless generally receive higher estimates of connectivity based on the definition of IC, which accounts for the ratio of the square root of upstream area to distance to a downstream sink. An example is shown in Figure 6-1.

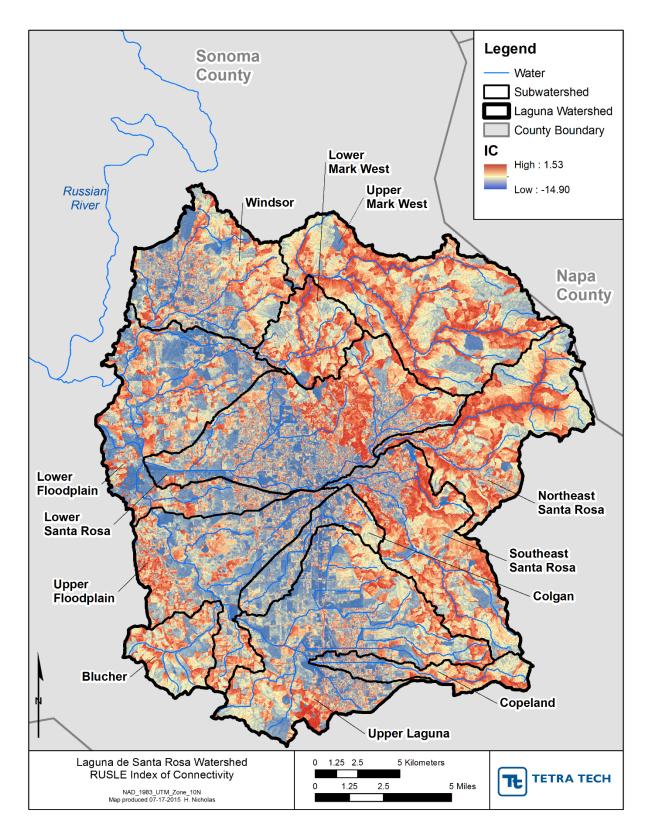
Figure 6-2. Index of Connectivity (IC) for the Laguna de Santa Rosa Watershed

The Connectivity Index ToolBox in ArcGIS (Cavalli et al., 2013, 2014) uses inputs of high-resolution elevation data to estimate an IC grid. For the Laguna watershed, the elevation data is obtained from the 1-m bare earth LiDAR and the surface roughness weighting is based on the C-factor from the SSURGO soils database, as recommended by Borselli et al. (2008). Resulting IC estimates, shown in Figure 6-2, are strongly affected by the presence of roads.

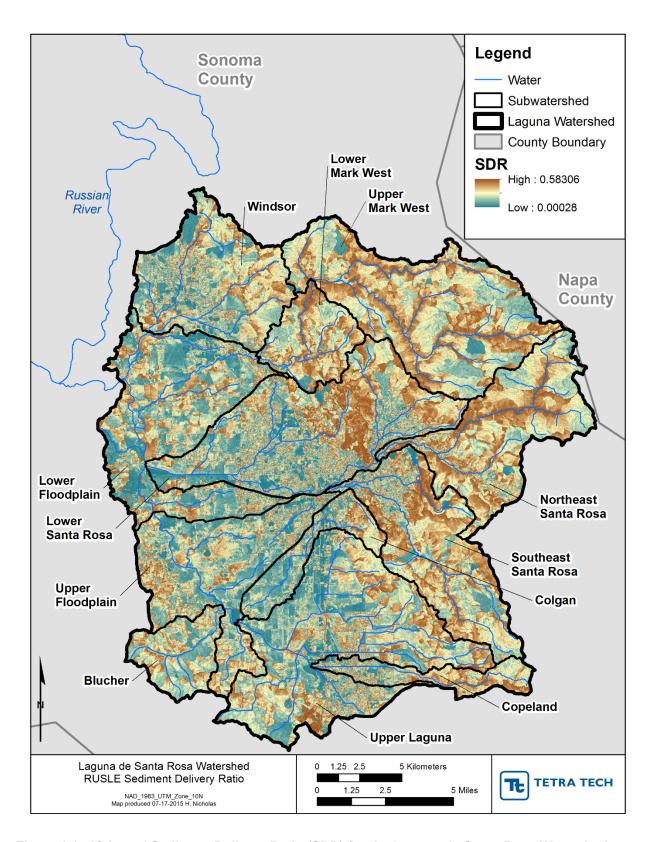
Figure 6-3. IC-based Sediment Delivery Ratio (SDR) for the Laguna de Santa Rosa Watershed

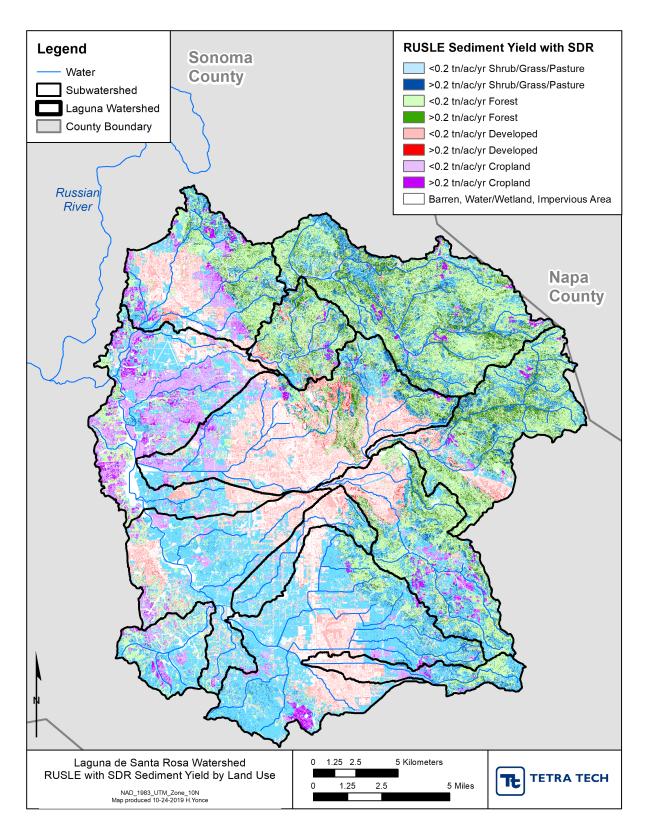
Figure 6-4. RUSLE Sediment Yield Estimates (with IC-based SDR) for the Laguna de Santa Rosa Watershed by Aggregated Land Use

Figure 6-4 shows the location of the upland sediment yields by aggregated land use type across the watershed with bins for higher (> 0.2 t/ac/yr) and lower (< 0.2 t/ac/yr) delivered sediment load highlighted in different color ramps. The summary maps provide an indicator of areas of potentially higher risk of upland sediment loading (see example close-up view from the predicted higher erosion risk area on the north side of Santa Rosa in Figure 6-5). As these estimates are derived from spatial data at varying resolutions and do not take into account site-specific details of land use and stormwater management, results should be treated as qualitative measures of potential sediment loading risk that need to be further confirmed through field inspection.

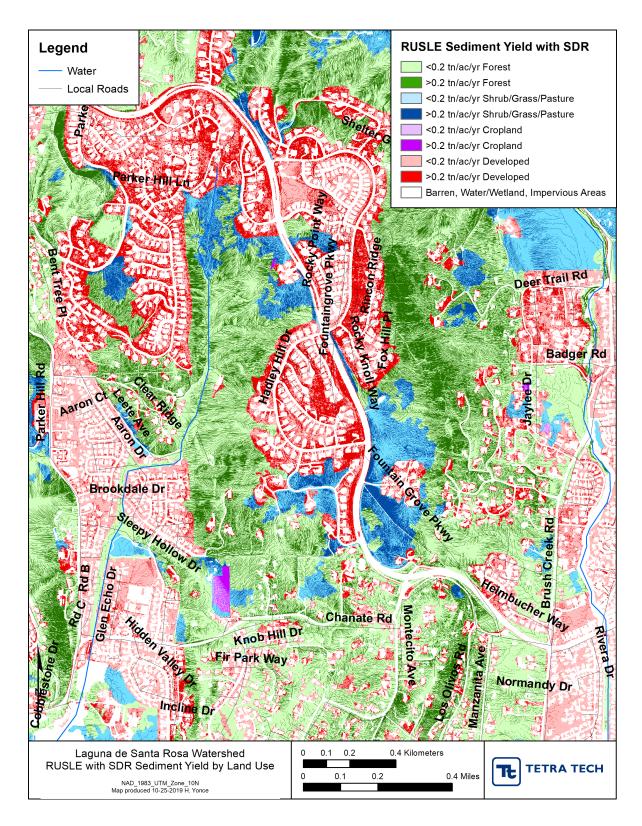
Figure 6-5. Detail from RUSLE Sediment Yield Map, North Side of Santa Rosa, CA

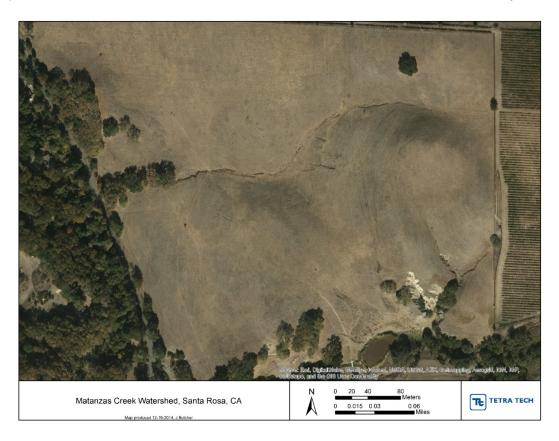
Figure 7-1. Example of Enlarging Gullies upstream of Matanzas Reservoir

The analysis in Section 5.3 suggests that the sediment loading rate to Matanzas Reservoir is higher than the loading rate for the Santa Rosa Creek watershed in general. The additional load in this area is likely associated with channel incision and gully processes. Examination of aerial photography of the Matanzas Reservoir watershed shows clear instances of recent gully development. For example, Figure 7-1 shows several active gullies in a grazed area downstream of a vineyard in this watershed. Such gullies are potential sources of sediment load that are not accounted for in a RUSLE-based analysis.

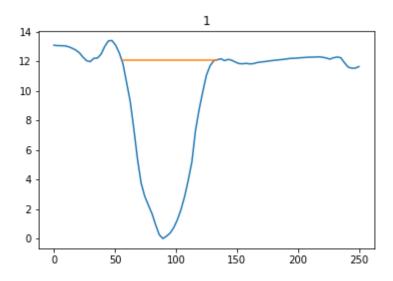
Figure 7-2. Typical LiDAR cross section, Rincon Creek (also known as Brush Creek), tributary to Santa Rosa Creek

A key challenge for applying these equations to LiDAR cross sections is identifying bankfull depth. In the main, channels were found to be incised (e.g., Figure 7-2). Assuming that bankfull depth is equivalent to the visible floodplain elevation (orange line in the figure) is very likely incorrect as this is most probably an abandoned terrace. Incised alluvial channels have a tendency to form a new inner bench floodplain within their terrace banks; however, if present, this was generally not resolvable from the LiDAR. In such cases, the total dimensions of the channel (up to the terrace) are likely to approximate degradation from a relatively stable pre-settlement condition, so the comparison to the regional curves may provide some information on long-term channel changes.

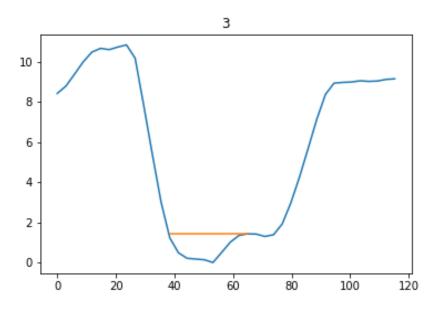
Figure 7-3. LiDAR cross section with visible point bars, Mark West Creek

Proper identification of bankfull elevation is best done in the field and typically is based on the top elevation of point bars and the lowest elevation of woody vegetation, in addition to breaks in slope (Rosgen, 1996). In a few cases, point bars were visible in the LiDAR cross sections (e.g., Figure 7-3)

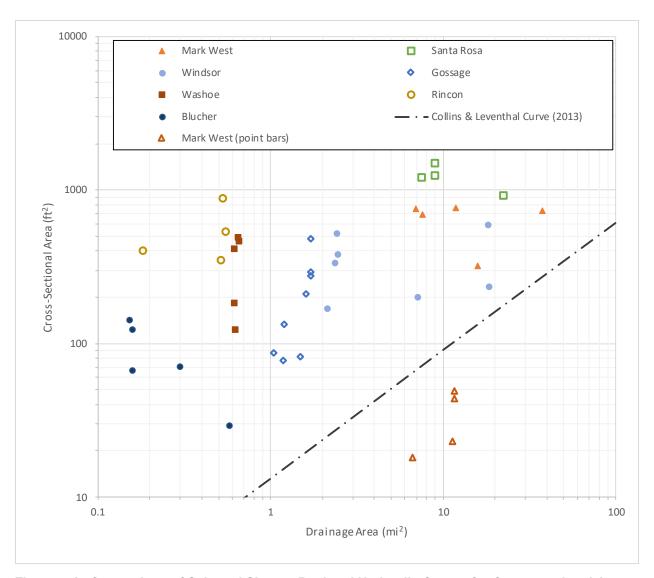
Figure 7-4. Comparison of Selected Sites to Regional Hydraulic Curves for Cross-sectional Area

Cross sectional area when measured to the surrounding terrace was predominantly greater, and often much greater than the bankfull area predicted from the regional hydraulic geometry curves. The width was also greater than expected for stable streams; however, in the few cases where point bars could be clearly identified, both area and width were generally less than predicted from the curves. A summary of the results is presented in Table 7-4. The various cross sections vary in the degree to which even the terrace elevation is clearly visible. Results for cross-sectional area for the more readily interpretable cross sections (Figure 7-4) emphasizes the extent of incision.

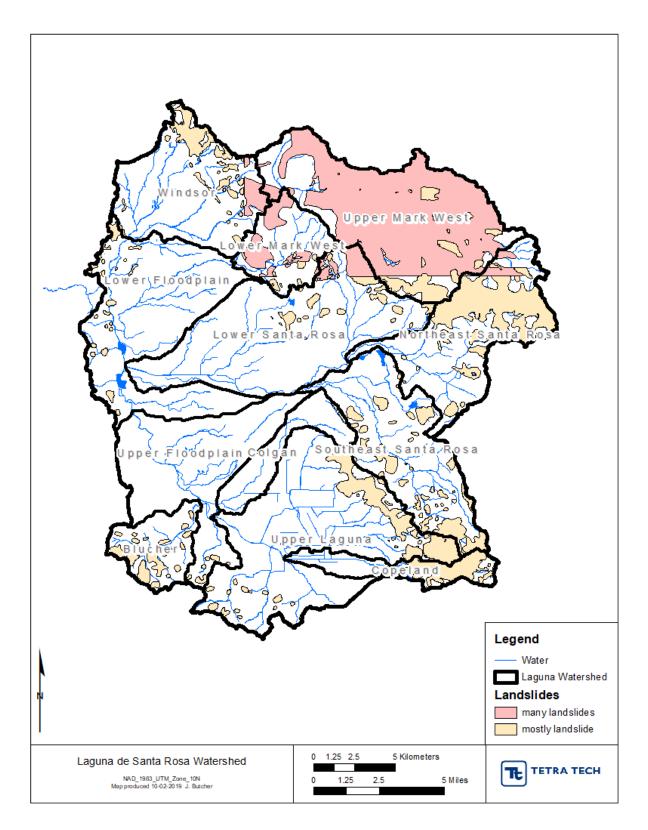
Figure 7-5. Landslide Prevalence in the Laguna de Santa Rosa Watershed (Wentworth et al., 1997)

Note: The Wentworth et al. map was produced from multiple sources collected by varying methods and at different resolutions, which results in some "straight line" discontinuities between the many and mostly landslide areas.

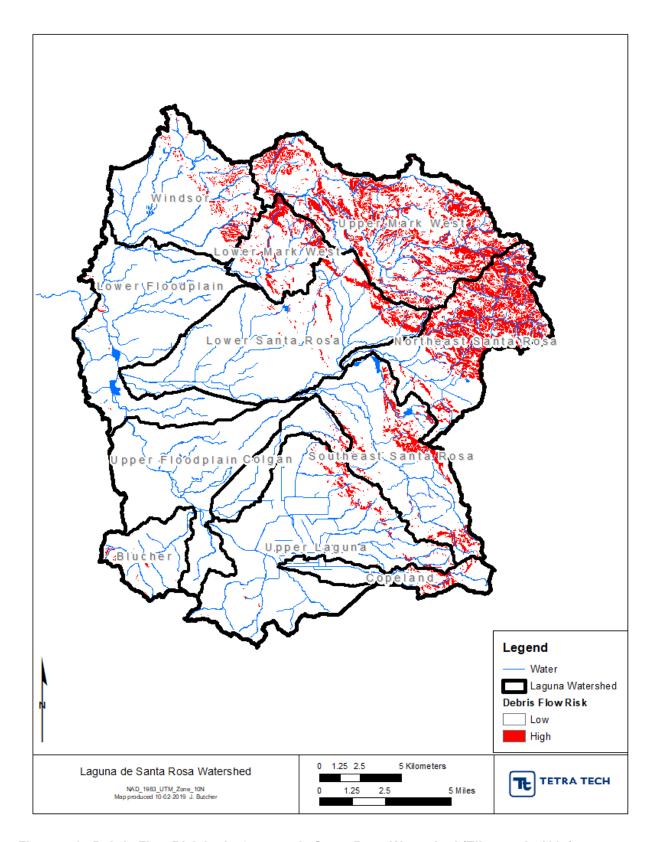
Figure 7-6. Debris Flow Risk in the Laguna de Santa Rosa Watershed (Ellen et al., 1997)

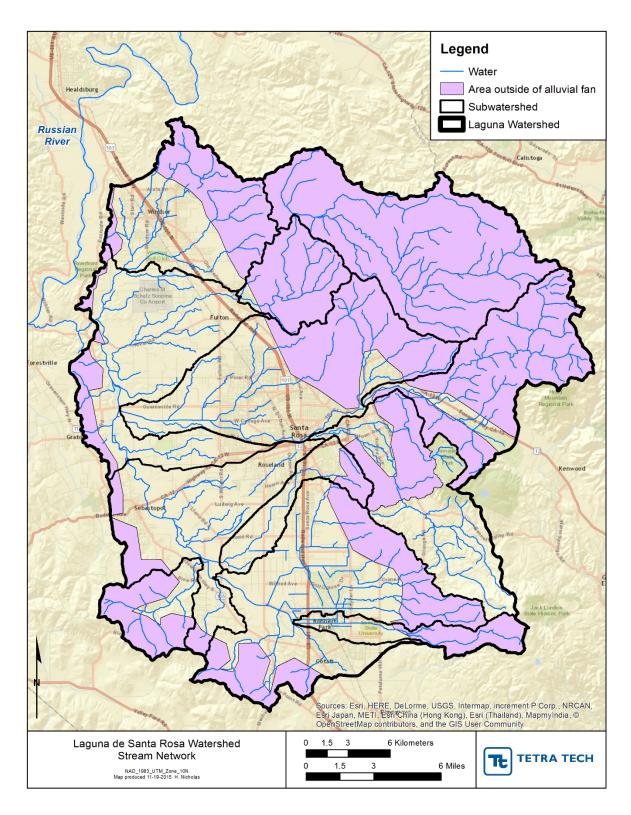
Figure 7-7. Streams Outside Alluvial Fans Evaluated for Colluvial Bank Erosion in the Laguna de Santa Rosa Watershed

Beyond creep rates and applicable depths, a third source of uncertainty is the definition of the stream network to which colluvial erosion applies. The Sonoma Creek TMDL extended the blue-line network to the extent that channels were visible on aerial photographs. This may be too aggressive, as the intent should be to use only the channel length that encompasses streams with sufficient power to be able to readily transport the colluvial bank material. Montgomery and Dietrich (1988) recommend using channels up to the farthest upslope location of a channel with well-defined banks. As a compromise, we used the NHD high-resolution stream lines coverage to define streams where colluvial bank erosion is considered. Such erosion does not occur in the flood plain or alluvial deposits, so the selection is further restricted to those streams that lie in higher relief areas (see the purple shaded area in Figure 7-7). For these streams, the rate of colluvial bank erosion via soil creep was estimated as twice the length (two sides) times the loading rate recommended by Dr. Dietrich, which amounts to 13.62 short tons per stream-mile per year, assuming a sediment bulk density of 1,400 kilograms per cubic meter (kg/m³).

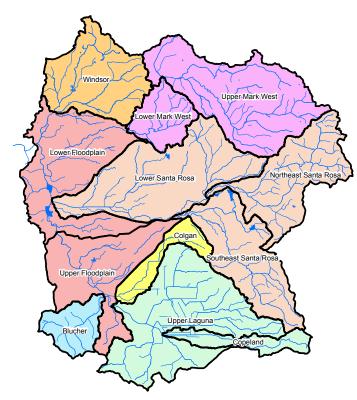
Figure 9-1. Summary of the Laguna de Santa Rosa Sediment Budget for Current Conditions

Despite the acknowledged uncertainties, Table 9-1 provides an internally consistent and reasonable estimate of the current sediment budget in the Laguna de Santa Rosa watershed. The budget components over the whole watershed are summarized on a percentage basis in Figure 9-1. On the source side, the largest contributor to the sediment load to the Laguna de Santa Rosa is estimated to be channel degradation (incision and widening). On the sink side, it is notable that SCWA's current channel maintenance activities currently appear to remove nearly one-quarter of the potential load that would otherwise reach the Laguna de Santa Rosa. These results are similar to, but differ somewhat from those presented in Tetra Tech (2015). Upland erosion is estimated to be somewhat more important as a source in the new analyses (23% versus 19%), while transport out to the Russian River increased from 5% to 14%. These differences are due primarily to the addition of newer flow and sediment data, along with revisions to the cover factor used in the upland RUSLE sediment load analysis.

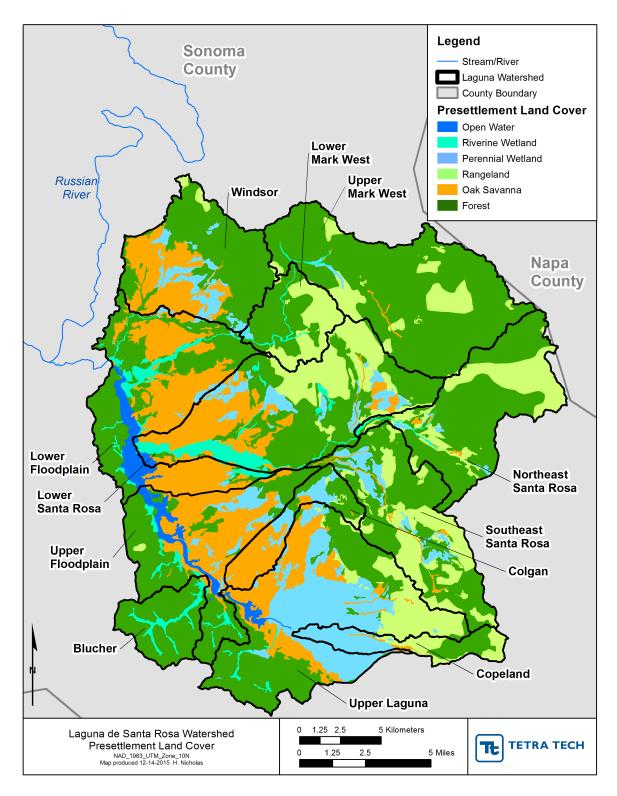
Figure 10-1. Land Cover prior to European Settlement of the Laguna de Santa Rosa Watershed (Butkus, 2011)
