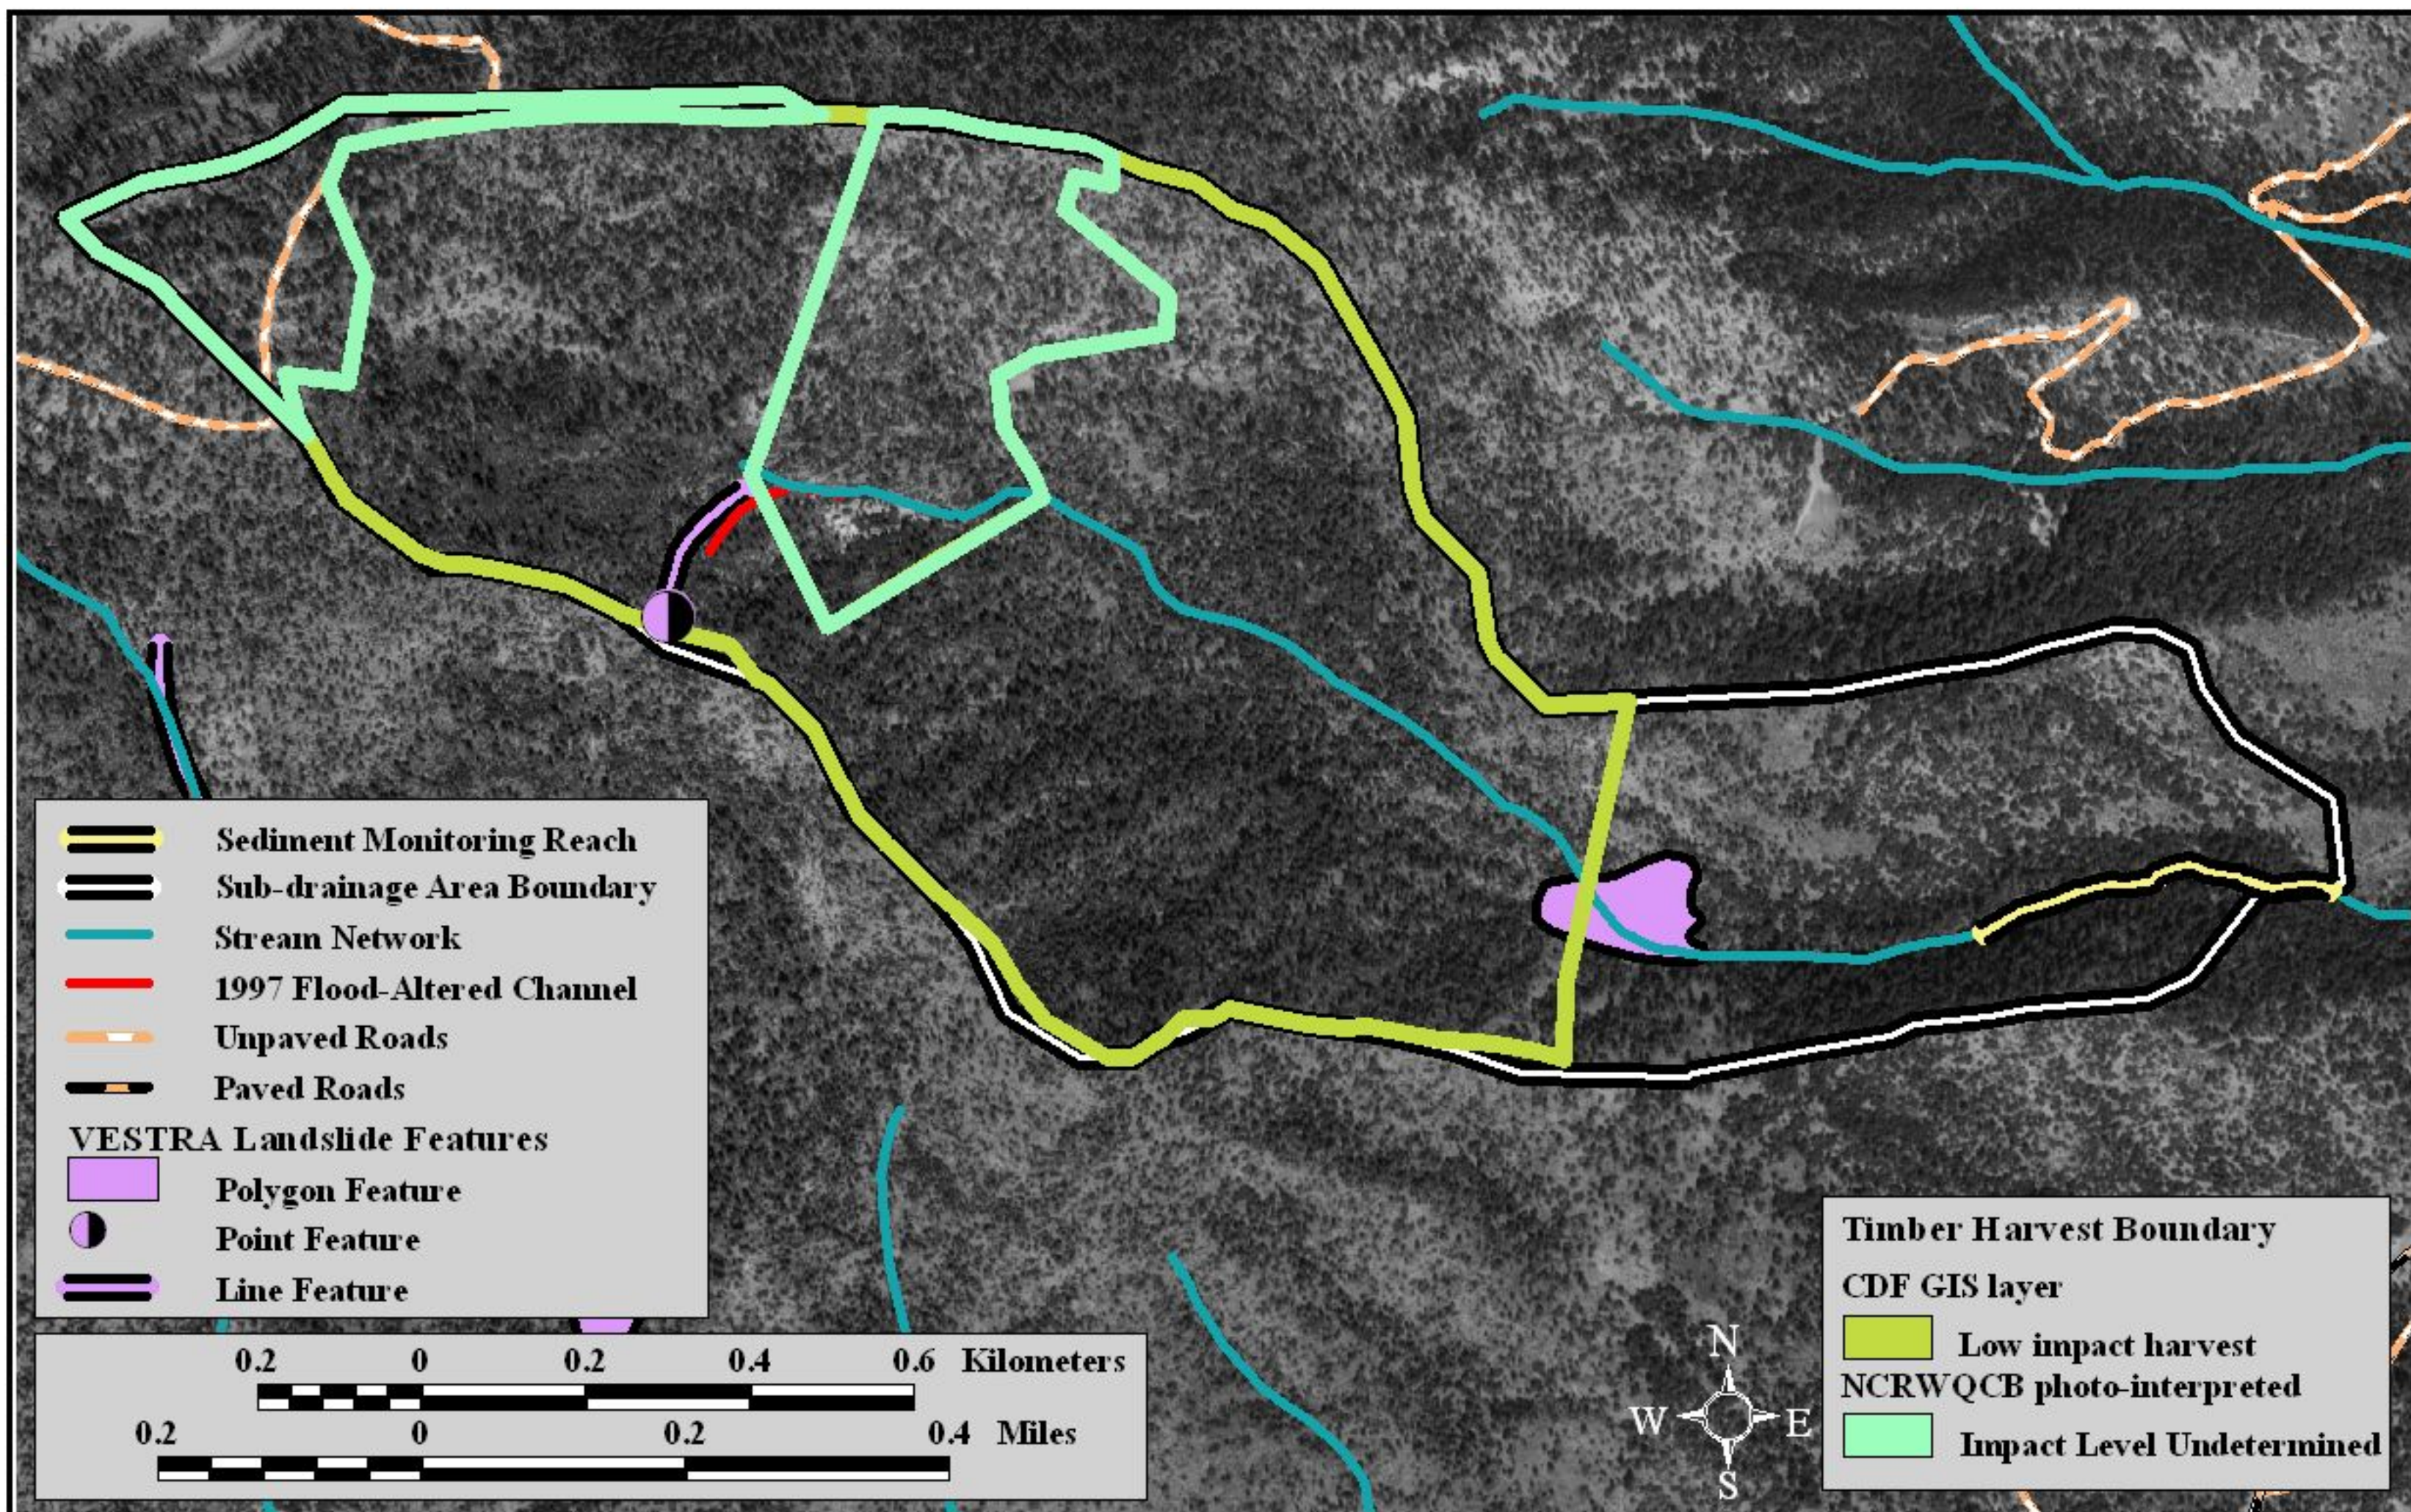
Figure 3.9. Orthophoto with GIS and photointerpretation coverage showing disturbance history in an area where human-caused sediment delivery is interpreted to be in the 25 percent category. Unnamed tributary to Scott River.
