Bodega Harbor Circulation Study

Final Report

March 2004

Linda Rasmussen, John Largier, Melissa Carter
Scripps Institution of Oceanography
University of California, San Diego

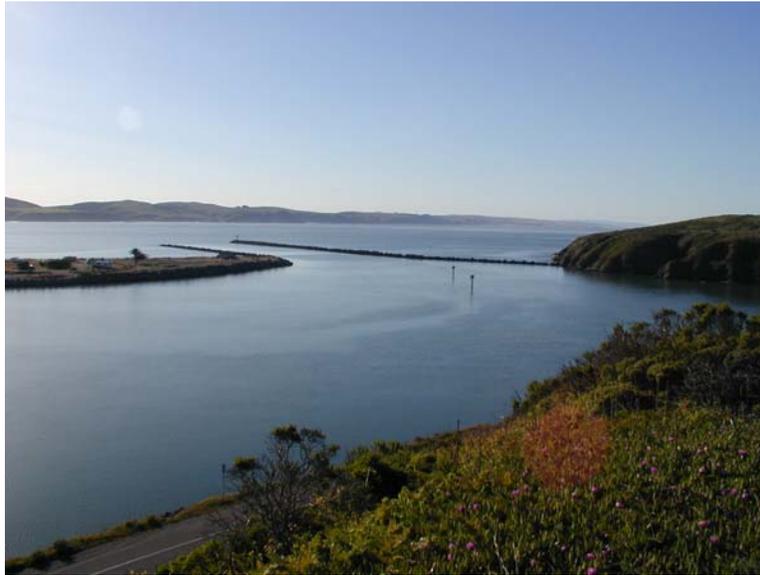
Figure 1. Campbell Cove at entrance to Bodega Harbor.

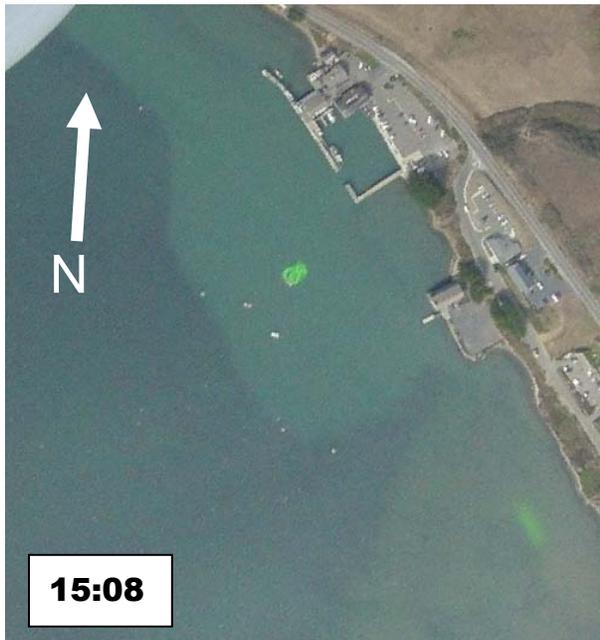
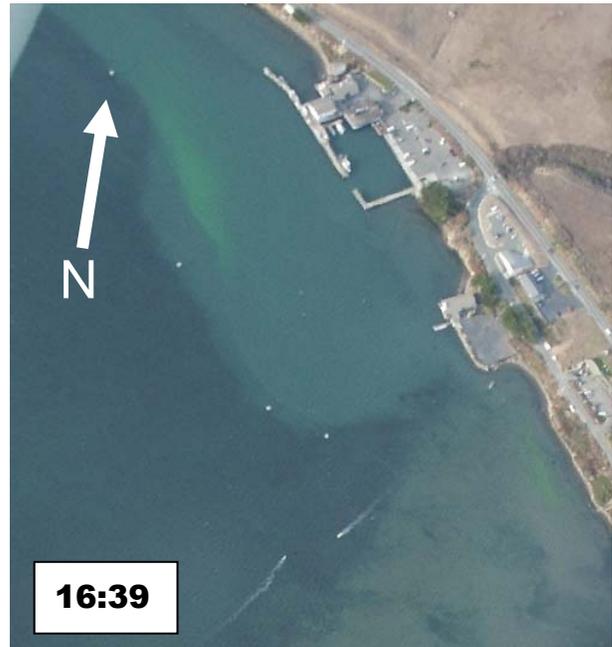
Figure 35. Fluorescein dye experiment, Fall 2003, Bodega Harbor channel end (east). Elapsed time: 91 min. Image location A (see Figure 29).

Dye patches from the rear of the marina generally moved less rapidly and dispersed more than those in the main channel or near the mouth of the harbor. Figure 34 shows the movement and dispersion of dye from the end of the channel during the fall dye release. After about an hour of slow movement down the channel, this patch was no longer detectable due to dilution. The same patch position in fall remained trapped at the channel end (Figure 35).

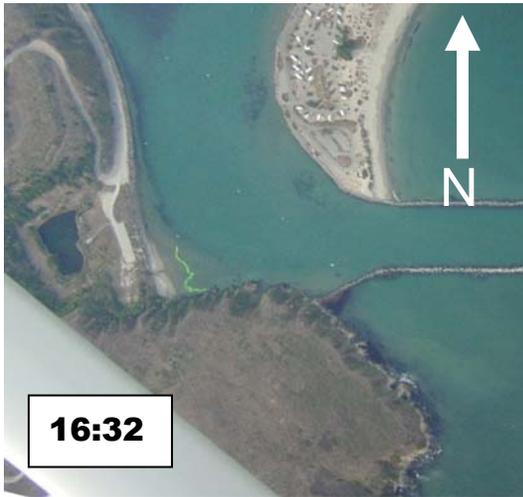
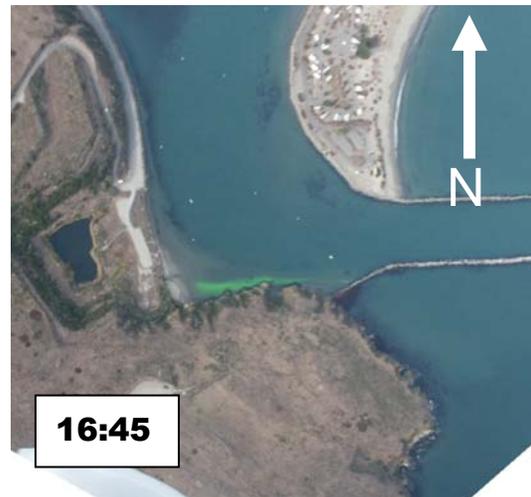
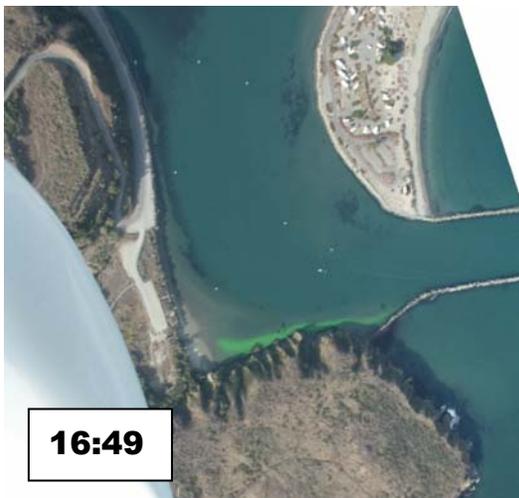
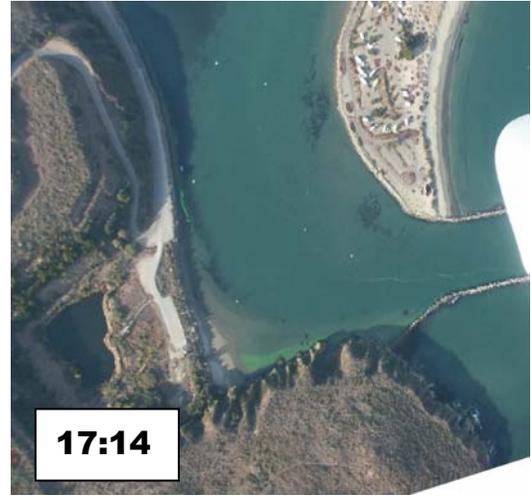
Figure 42. Fluorescein dye experiment, Fall 2003, Campbell Cove. Elapsed time: 42 min. Image location E.

Dye released at or near Campbell Cove displayed a tendency to become trapped at the edges. In the rhodamine dye experiment (see next section) this was observed visually in a large dye patch which was advected up the channel during a flood tide, but left some residual dye along the northwest side of the cove in an area with eel grass. The patch shown above from the Fall experiment was positioned to determine the fate of a contaminant released directly into water at the Campbell Cove beach. As with the rhodamine dye, it persisted at the edge of the cove while dispersing along a thin line into the main channel entrance. No evidence of this patch was visible the following morning. However it is possible that a local contamination source at Campbell Cove could remain concentrated at the shoreline if it was being released continuously or at closely spaced intervals in time. This may be especially true in waters shallower than we were able to sample by boat. In depths less than half a meter, contaminants could become trapped in the boundary layer at the edge of shore and persist for longer periods of time.

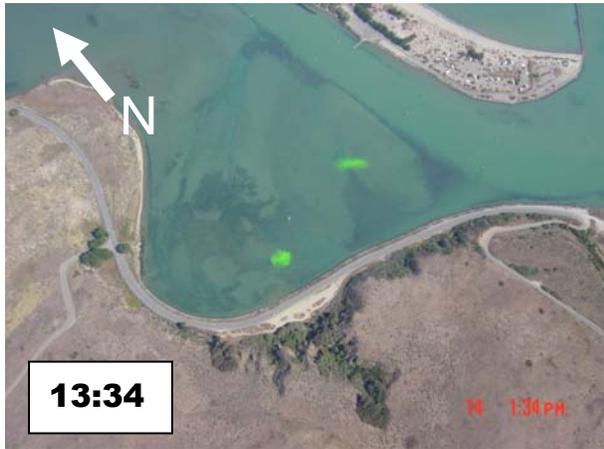
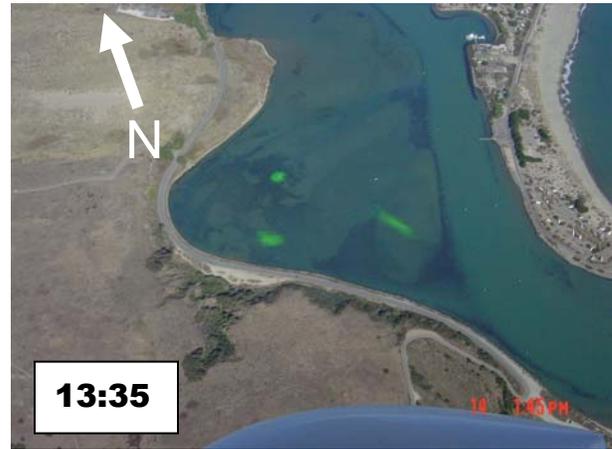
Figure 43. Fluorescein dye experiment, Fall 2003, Gaffney Point tidal flats. Elapsed time: 31 min. Image location F.

Due to concern over bird populations on the harbor tidal flats being a potential source of bacterial contamination at Campbell Cove, dye studies in the fall included fluorescein patches over the main tidal flats to the east of the channel and those near Gaffney Point to the west of the channel. Figure 43 shows dye patches released over the Gaffney Point tidal flats. The concern here was that drainage of the flats at ebb tide might direct tidal flats water to the edge of the flats along the south and into Campbell Cove. The main flow off the tidal flats is directly toward the channel where the patch is quickly dispersed (see image at 14:31). While flowing toward the main channel, the patch nearest the southern edge of the flats did drift shoreward somewhat (Figure 44). However, an hour later (approximately 3 hrs 15 minutes since initial release) all of these three patches have been incorporated into the main channel flow. In the last image of the series (Figure 46) there is no visible trace of the three patches released over the Gaffney Point flats, and no residual dye can be seen at the Campbell Cove beach area. Dye patches introduced at the Campbell Cove beach after the Gaffney Point patches have also been advected out of the area.

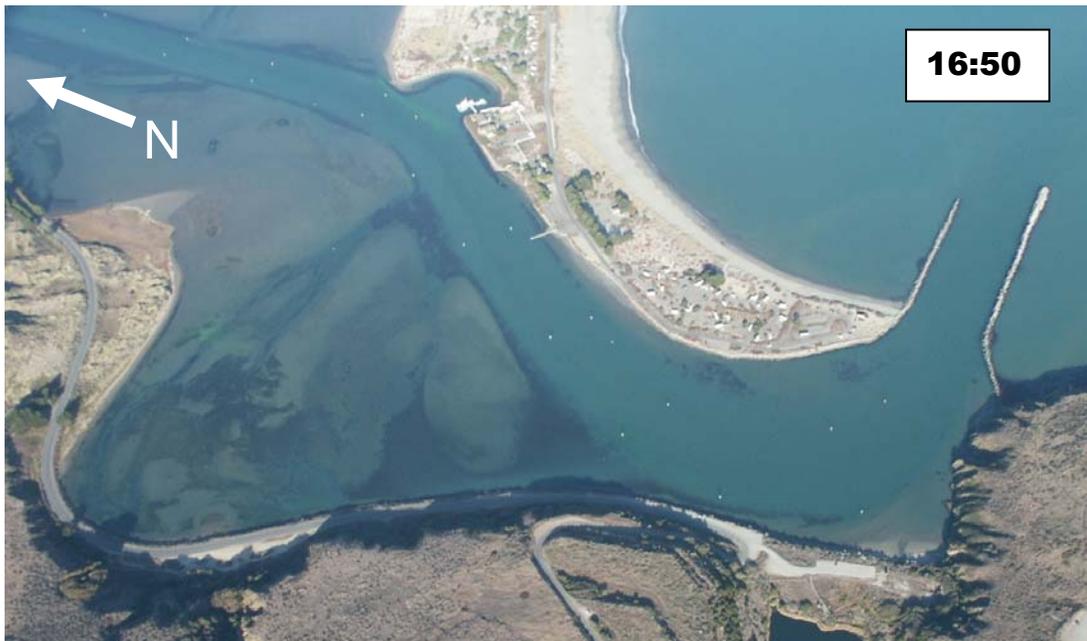
Figure 45. Gaffney Point fluorescein dye experiment, approximately 3.5 hours after initial dye release. Image location F.

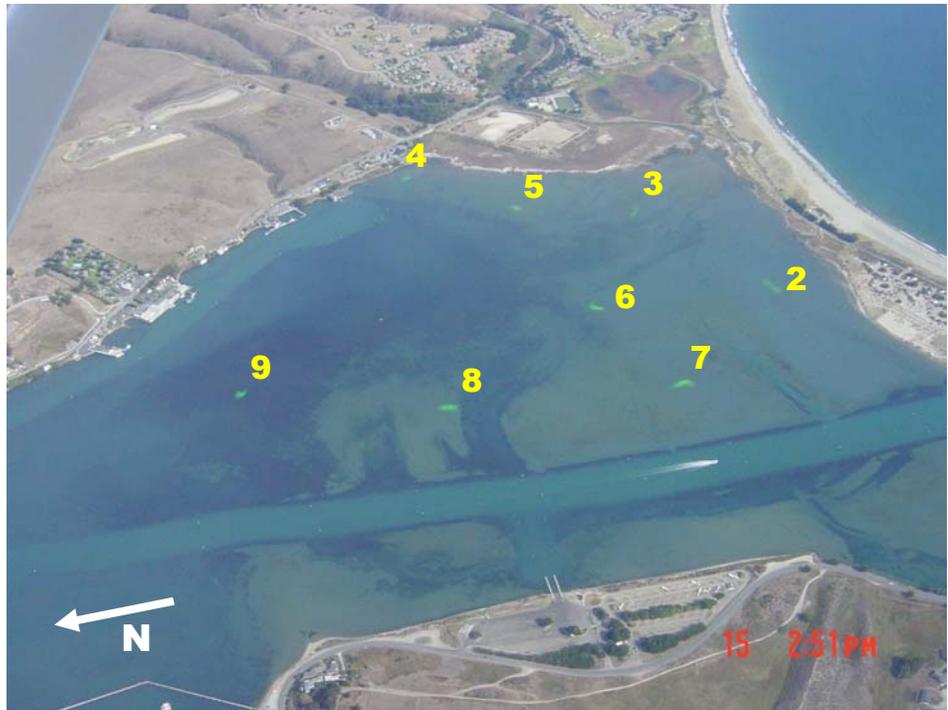
Figure 46. Tidal flats, fluorescein dye experiment, 15 October 2003. Image location G.

The following day a similar experiment was conducted over the main tidal flats west of the channel. (See patch locations, Figure 32.) With the exception of patches released near the end of the channel (rear patches 3, 4, 5) the dye moved off the flats toward the southwest, toward and into the central channel. The rear patches showed little advection, and dispersed in place through the experiment. Patches 9 and 10 at the north of the channel moved slowly southward and toward the central channel, while flow off the flats was most rapid from the southwest portion (patches 1,2,6,7,8). In this region drainage was sometimes directed into small channels within the flats such as that shown in Figure 47; patches 6 and 7 flow into a small channel which empties into the main harbor channel.

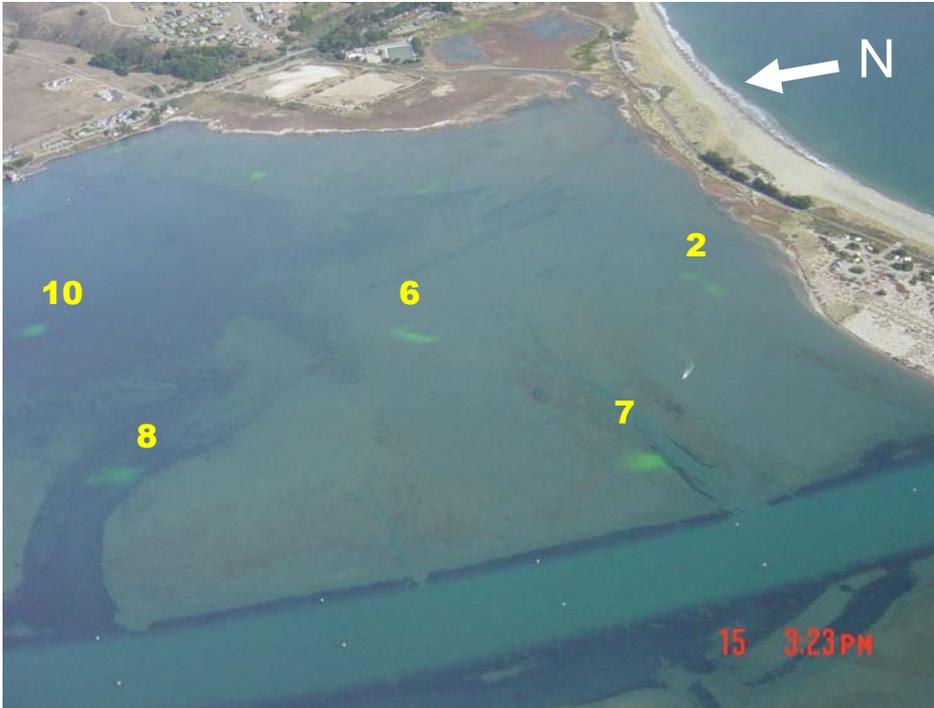
Figure 47. Flow of dye patches (#6 and #7) into small channels on the tidal flats. 15 October 2003. Image location G.

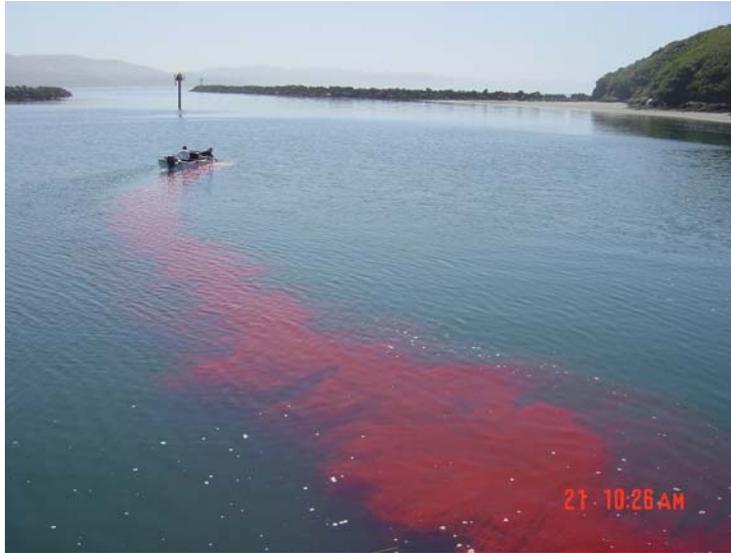
Figure 48. Deployment of rhodamine dye in Campbell Cove, May 2003.

Rhodamine dye experiments were conducted by saturating basins with the red dye in order to determine its persistence in the basin, potential avenues of transport, and dispersion rates. The dye concentrations were measured using boat-mounted fluorometers for continuous underway data, as well as separate casts for vertical profiles through the dye patches.

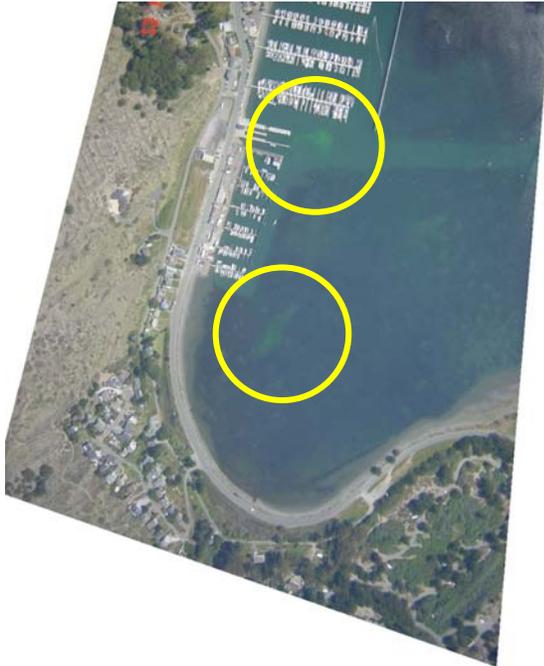
Marina Dye Patches #1 & 2 after 1 hour

T = 62 min (10:14)

Enhanced Image

Dispersion rates measured near the marina are similar to other back bay areas (e.g., Mission Bay, San Diego). Although slower than more energetic mixing regimes, dispersion is the dominant transport mechanism in these areas due to the lack of advection. Within the channel advective transport dominates and makes measurements of dispersion logistically difficult.
