13 Notice of Construction Stormwater and
14 Unauthorized Fill Violations and Requirements
15 for Corrective Actions and Order Requiring
16 Technical Reports on Filled Tributary, October 5,
17 2022 _____

PETITION FOR REVIEW
and
REQUEST FOR STAY

**Subject: Notice of Construction Stormwater and Unauthorized Fill Violations
and Requirements for Corrective Actions**

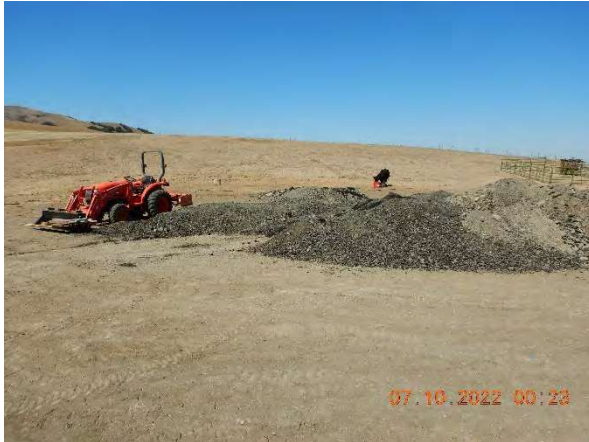
Photo 1

At the entrance to the Property and on Mr. Sellani's parcel, I observed approximately 10 uncovered piles of a light gray earthen material at two locations (Photos 1 and 2). Dr. Starkweather said the material was parking lot asphalt taken from a parking lot in Santa Clara and that he plans to use the material to maintain roads on the ranch.

Approximately four uncovered stockpiles of a light-gray, earthen material were piled near the gate of the property. A tractor with a front-load bucket was parked next to the piles. Dr. Starkweather said that the material came from a parking lot in Santa Clara, and that he plans to use it for road maintenance on the Property.

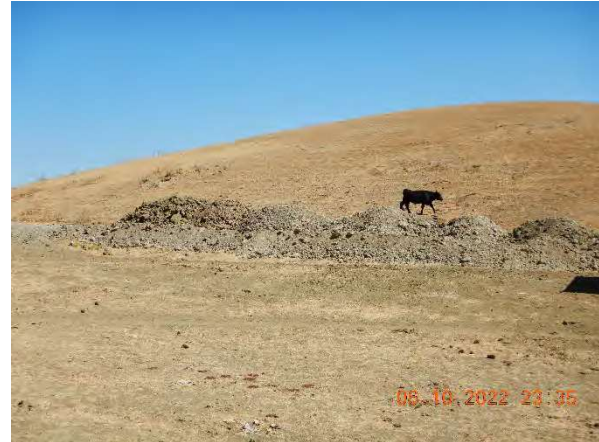
Photo 2

Approximately six uncovered stockpiles were piled on Mr. Sellani's property. The stockpiled material was similar to the light-gray, earthen material piled on Dr. Starkweather's property (Photo 1).

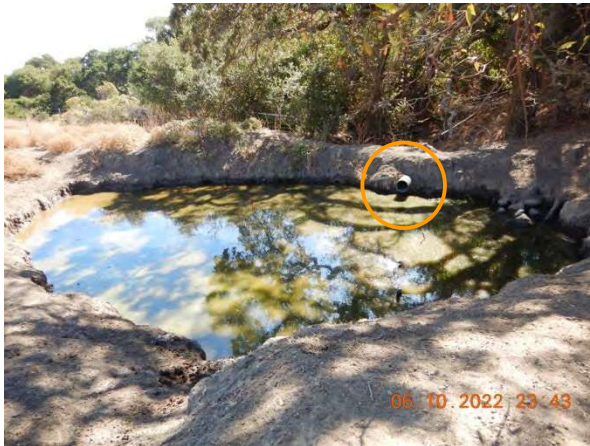
Photo 5

I observed three ponds on the Property, which Figure 1 identifies and names for clarity. Ponds 1 and 2 were adjacent, and Pond 3 was approximately 400 feet downstream of Pond 2 (estimated via Google Earth imagery). I observed loose fine-grained sediment on the ground of the area upgradient of Ponds 1 and 2, and some of it had crossed into the ponds, which were dry at the time (Photos 3 and 4). Pond 3 was approximately 20 feet in diameter, had a berm on the southern side, and was partially filled with water that appeared opaque and stagnant. I observed a pipe in the berm which allows the pond to overflow into a creek downstream of the pond (Photo 5). The creek had a clearly visible

Pond 3, approximately 20 feet in diameter, had a culvert (circled) that would drain pond water to a creek below (Photo 6). The water in the pond was opaque and appeared stagnant.

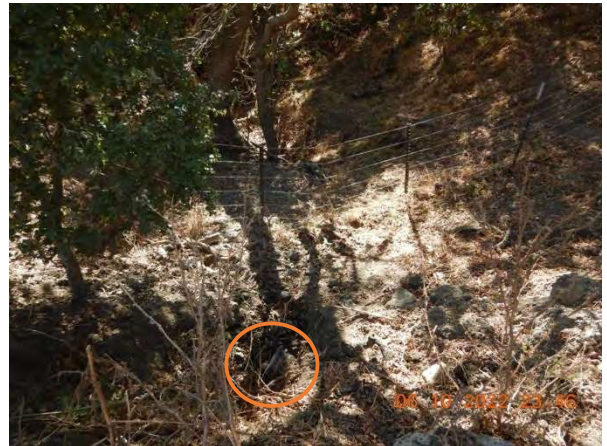
Photo 6

bed and bank and is on a different property, which is indicated by a fence 15 feet downstream of the pond (Photos 6). Kathryn Hart noted that the creek supported riparian habitat with under and overstory vegetation. Dr. Starkweather told me he that he is raising cattle on the property and the ponds are for the cows. Dr. Starkweather said that he is grading the hill above Ponds 1 and 2 to plant a vineyard on the Property and that he plans to hydroseed it to prevent erosion. Grading one or more acre of soil without obtaining coverage under the Construction Stormwater General Permit is a violation of Clean Water Act sections 301 and 402.

The berm for pond 3 was approximately two feet high. A culvert at the bottom of the berm (circled) was aligned with the culvert at the top of the berm (shown in Photo 5). The berm was constructed across a creek near the property line (assumed to be the fence) that had a visible bed and bank.

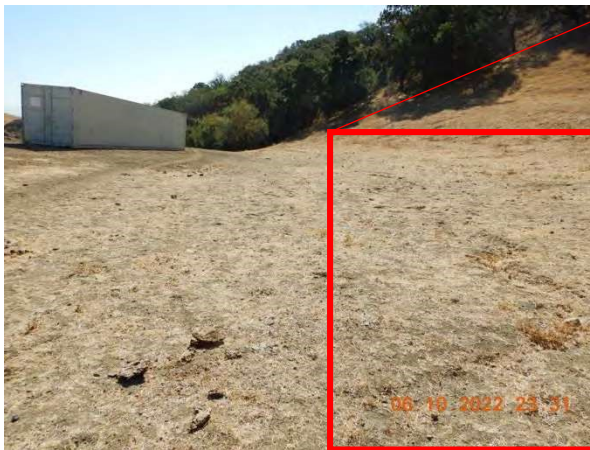
Photo 7a

In the drainage area above Pond 3 I observed a meandering erosional feature that appeared to be a gully or newly forming channel (Photos 7 and 7a). Dr. Starkweather told us he has been managing three landslides on his property and that in 2017 or 2018, during the wet season, the landslides moved several thousand cubic yards of dirt onto the area above Pond 3, which is located on Mr. Sellani's property. He added that he spread the landslide material over that area, filling in the channel that previously drained to Pond 3. According to Dr. Starkweather, the former channel was approximately 12 to 18 inches deep, conveyed water to Pond 3, and that the ongoing erosion in that area is reformation of that channel. The topsoil in the filled area had grain size finer than sand, was a light-gray color, and contained chunks of asphalt (Photo 8). The topsoil in the landslide area uphill of the fill area had grain size finer than sand, was a light-brown color, and was partially covered with vegetation (Photo 9). Discharging fill to waters of the state without submitting a report of waste discharge (ROWD) or the United States without obtaining a Clean Water Act section 404 permit is a violation of Water Code section 13260, Clean Water Act section 301, and the San Francisco Bay Basin Water Quality Control Plan (Basin Plan).

The area above pond 3 had a meandering, erosional feature forming in it.

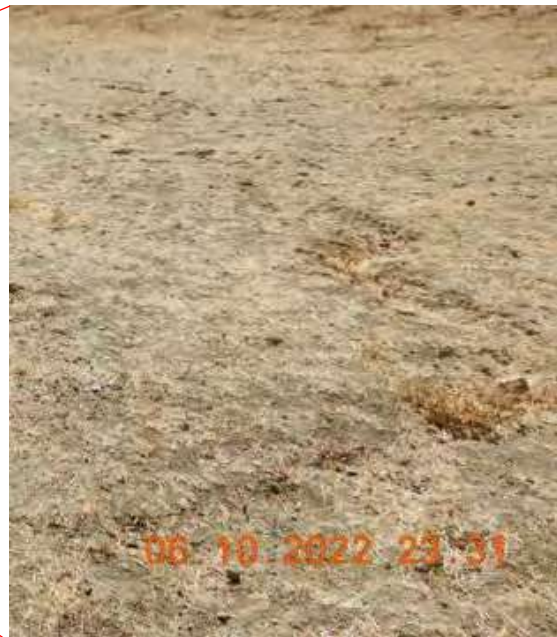
Photo 7b

The erosional feature was approximately a foot wide with shallow banks on each side that were two to three inches deep.

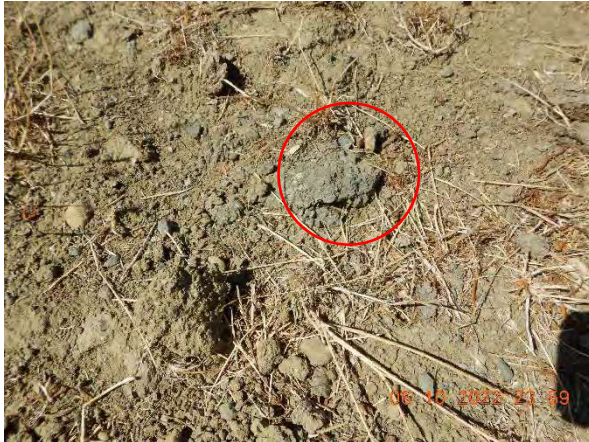
Photo 8

Sediment in the area above pond 3 was gray in color, sandy, and contained chunks of asphalt (circled).

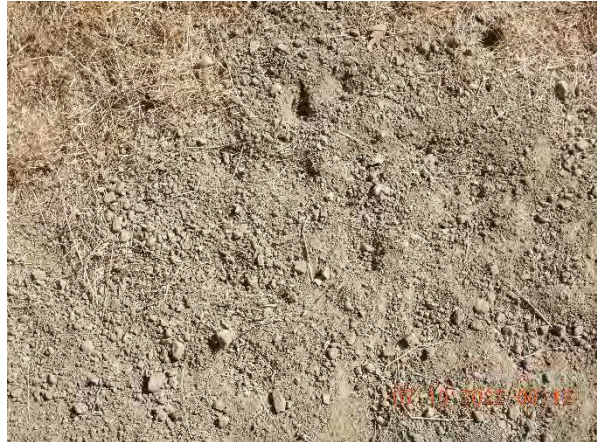
Photo 9

Soil in the landslide area was light brown in color and fine-grained.

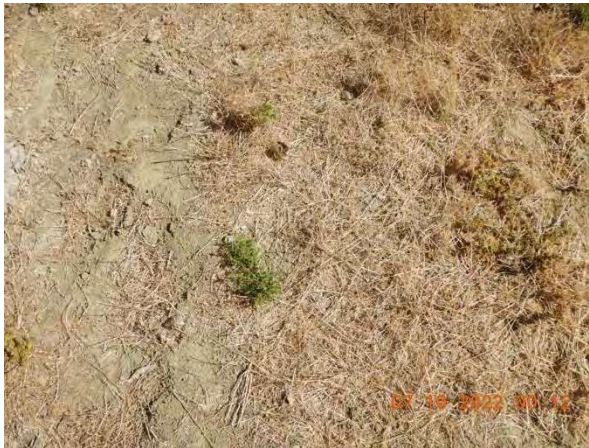
Photo 10

Sediment in the landslide area was partially covered with vegetation.

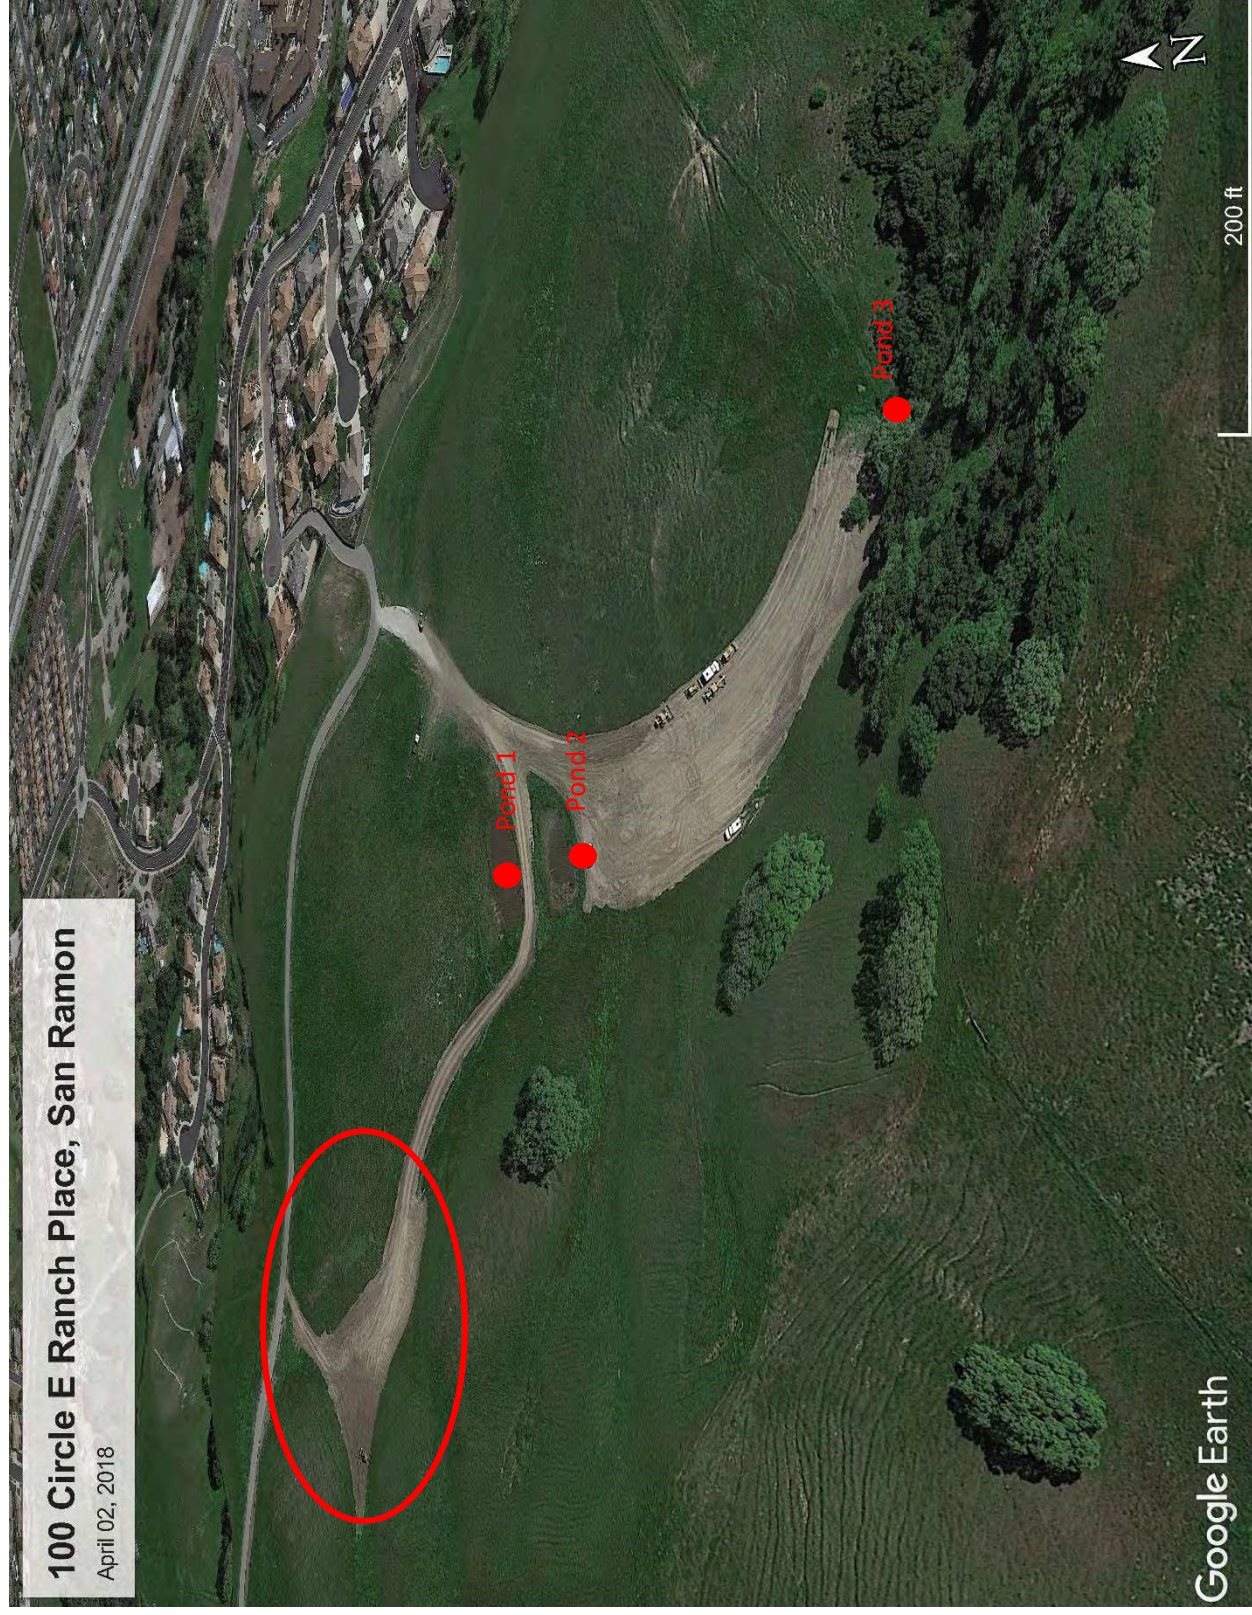
Attachment 4 includes Google Earth photos taken August 31, 2017, April 2, 2018, and June 20, 2019, showing soil disturbance upgradient of Ponds 1 and 2. Attachment 5 includes a Google Earth photo taken in May 2022 that shows disturbed soil upgradient of Ponds 1 and 2 and includes an estimate of the areal extent of disturbed soil, 2.68 acres, calculated by using Google Earth measurement tools. During our October 7, 2022 inspection, Water Board staff observed disturbed soil in areas upgradient of Ponds 1 and 2 (Attachment 2, Figure 1), which Dr. Starkweather informed them was due to grading operations he was performing on the Property.

Image retrieved July 12, 2022. Soil Disturbance area circled in red, and Pond 1, 2, and 3 indicators added by Demir Worthington

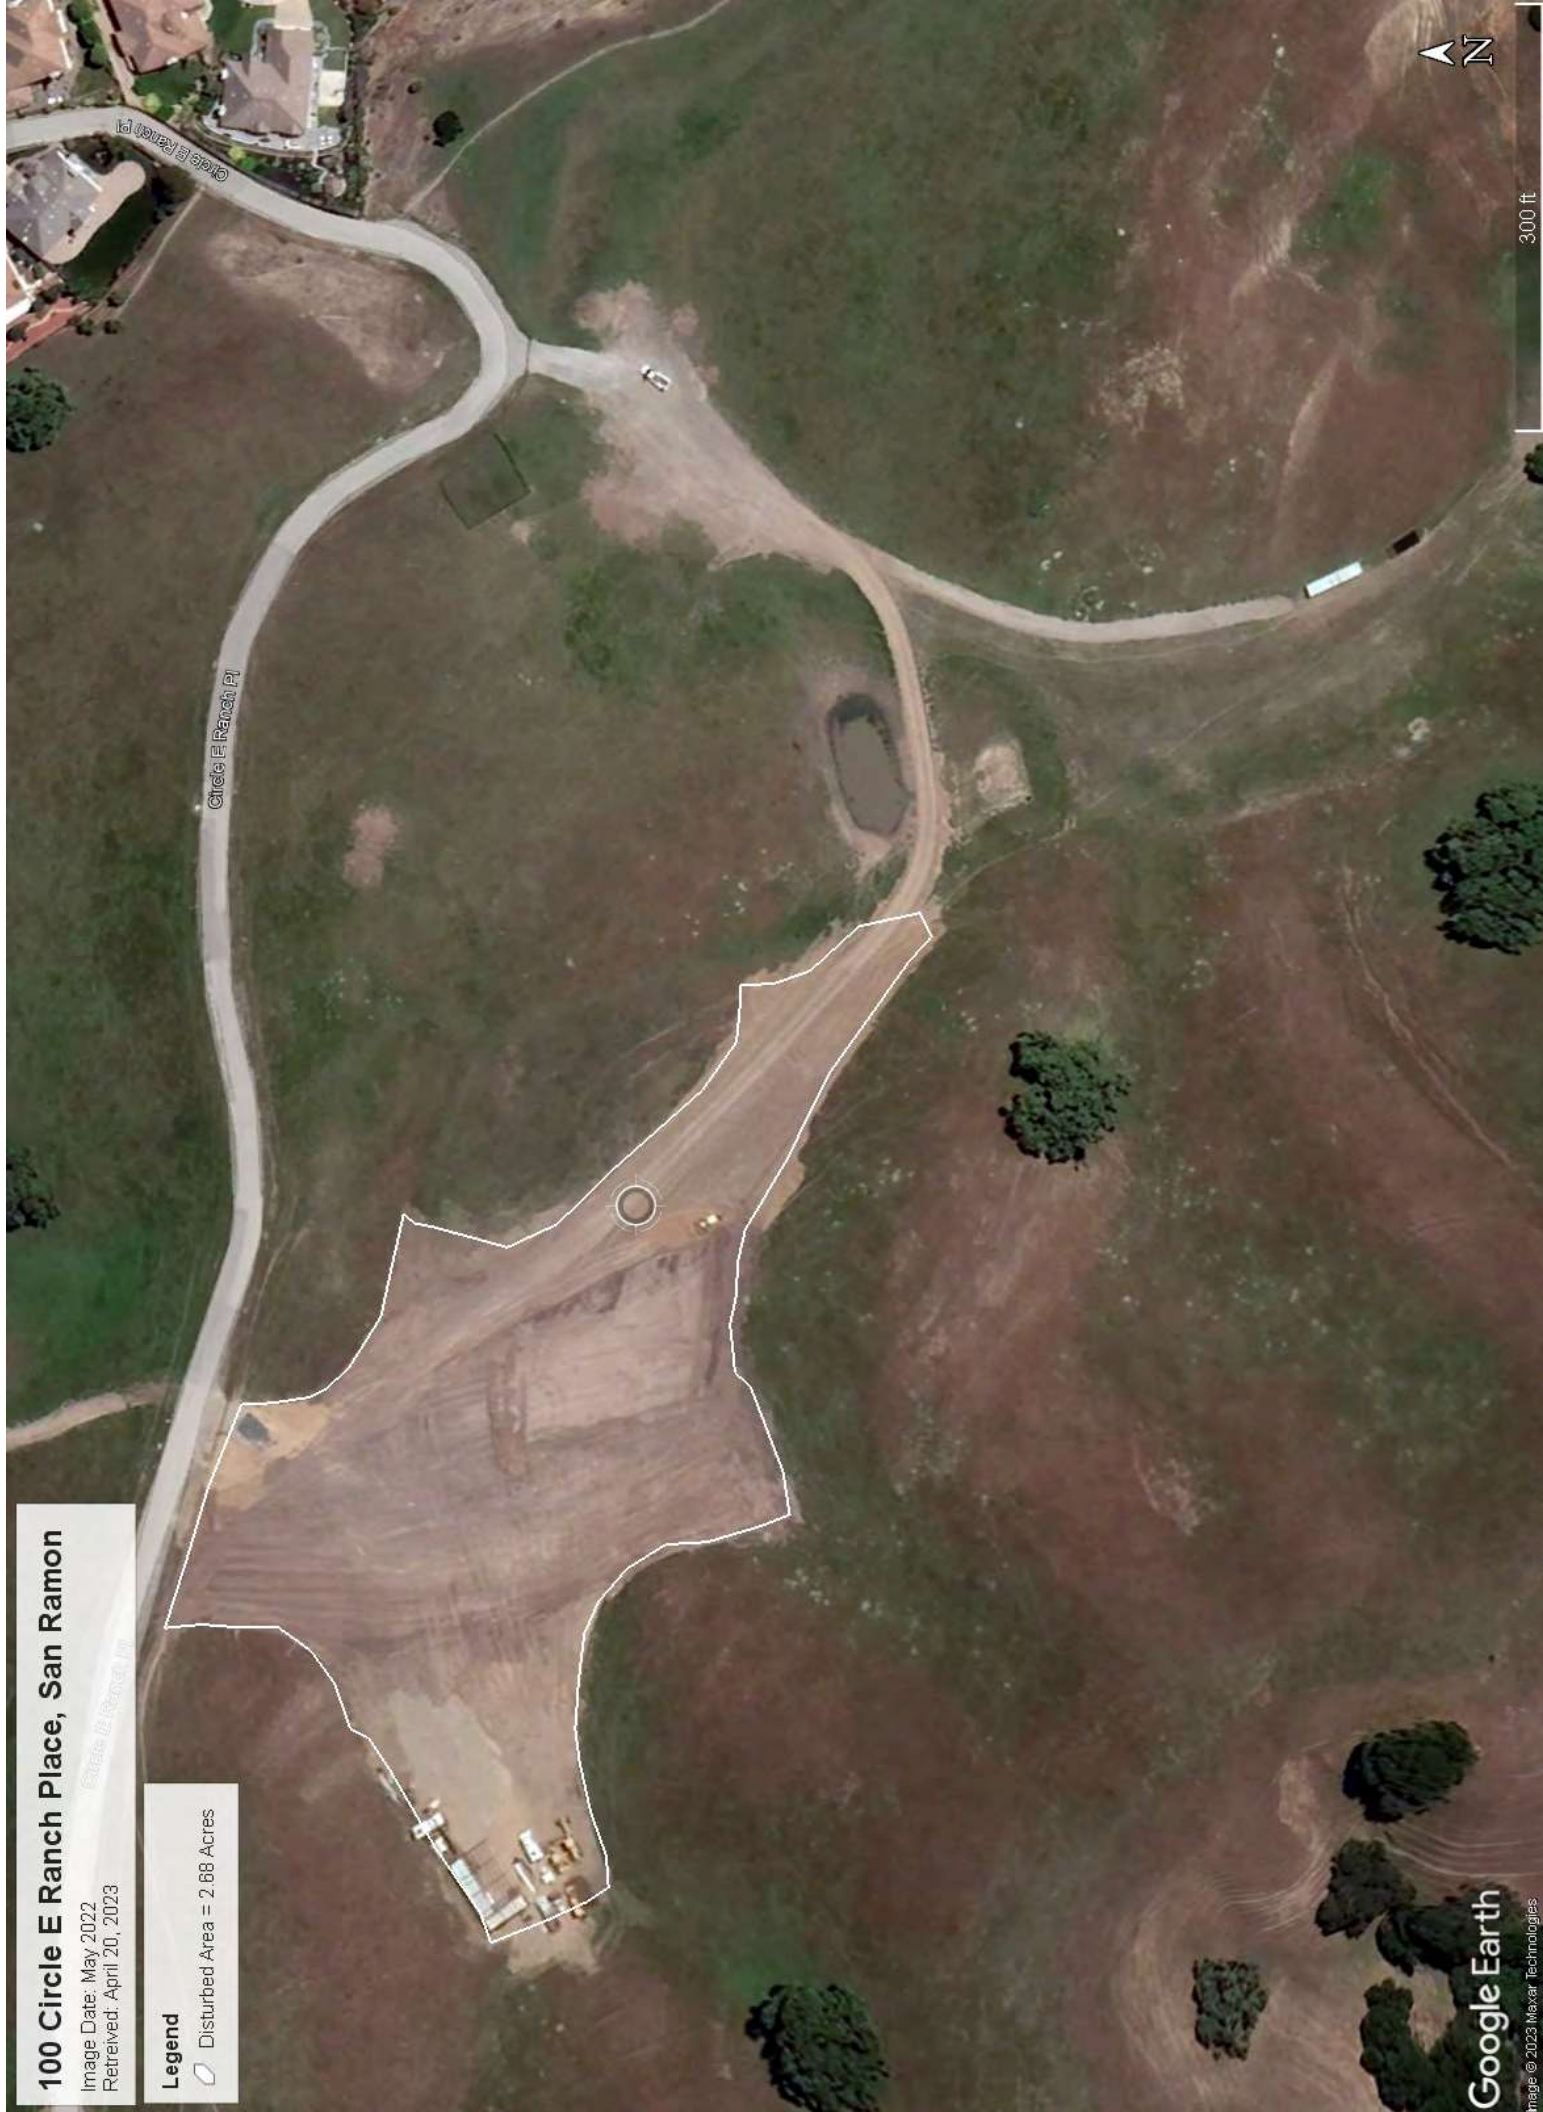
Disturbed Area = 2.68 Acres
