Re: ESJWQC rotating Assessment Monitoring locations in Zone 2

The East San Joaquin Water Quality Coalition (ESJWQC or Coalition) is requesting to remove the monitoring site Yori Grove Drain @ East Taylor Rd from the Coalition's monitoring program and replace this monitoring location with Levee Drain @ Carpenter Rd. This request is based on 1) the actual monitoring site is located on Turlock Irrigation District (TID) Lateral #3, 2) TID Lateral #3 receives drainage all year from various cities including Ceres, Keyes, Denair, and Turlock and any toxicity or chemicals present in the water cannot be attributed to irrigated agriculture and 3) Levee Drain @ Carpenter Rd is more representative of the irrigated agriculture drainage of the area. These points are expanded below.

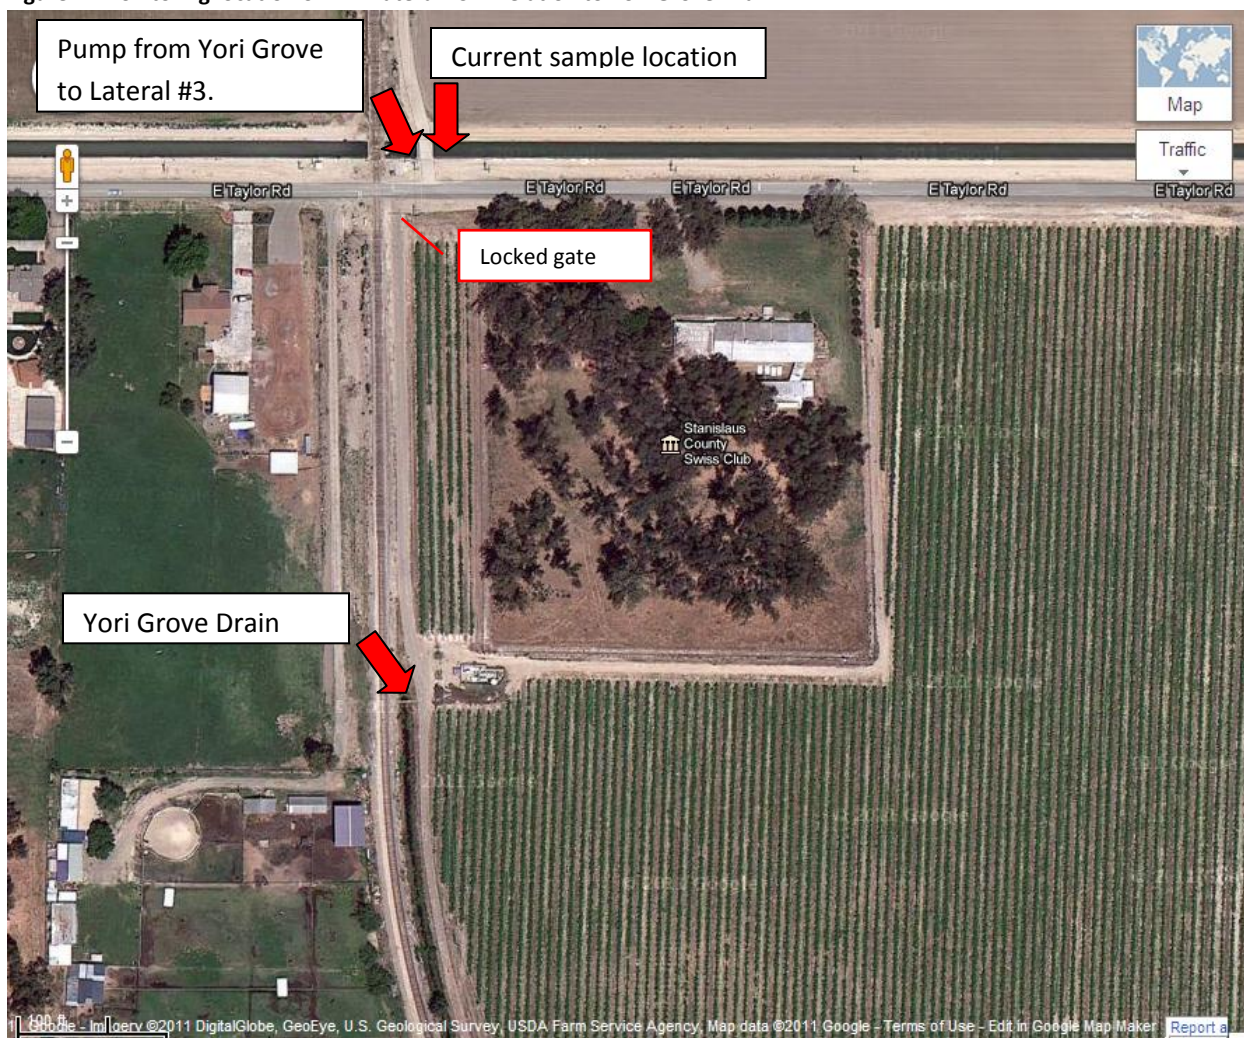
**Figure 1. Monitoring location on TID Lateral #3 in relation to Yori Grove Drain.**

Yori Grove Drain @ East Taylor Rd (target location: N 37.53690, W -120.98346, actual underground location: N 37.53512, W -120.98425) was scheduled for monitoring in 2011-13 and was scouted by sampling crews at the beginning of 2011 prior to monitoring. When the monitoring team scouted Yori Grove Drain, they selected the exact location they believed was Yori Grove Drain based on the GPS coordinates and visible water. They did not realize that Yori Grove Drain ran underground and therefore selected the only visible waterbody at this location which was in fact TID Lateral #3 (N 37.53673, W -120.98410).

locked gate (Figure 1). Discharge from the drain occurs only when there is significant water in the channel and it is then pumped into TID Lateral #3. Very rarely does the pump turn on to pump water into TID Lateral #3 and water from the drain was not being pumped into Lateral #3 when the site was scouted. Therefore, the Coalition has been monitoring TID Lateral #3 which drains a large area of urban and agricultural land to the east of the sampling location. Yori Grove Drain is a small watershed with a limited drainage area that is all agriculture (Figure 2). Although the samplers monitored near Yori Grove Drain, the water they sampled in Lateral #3 represents very different land uses.
