***Water Quality Protection on National Forests in the
Pacific Southwest Region:
Best Management Practices Evaluation Program,
2003-2007***

***USDA Forest Service
Pacific Southwest Region
September 19, 2009***

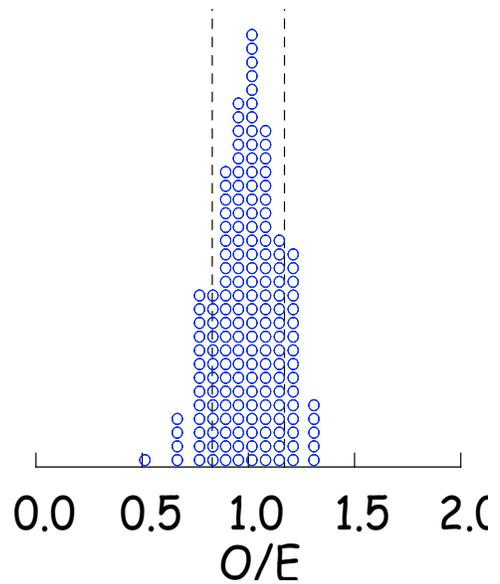
Figure 24. Frequency Distribution of Reference Site O/E values (from Hawkins 2003b)

Mean = 1.01, Standard Deviation = 0.14

10th and 90th percentiles (dashed lines) are often used as thresholds to infer impairment.

10th percentile = 0.83, 90th percentile = 1.17

RIVPACS-type water quality assessments are conducted by comparing taxa expected to occur at a site under relatively undisturbed conditions (E) to those that are actually observed at the site (O). These models have been demonstrated to detect biological impairment from land use activities in watersheds up to approximately 10,000 acres in size. Expected taxa are predicted by multivariate statistical models based on invertebrate data and other physical and chemical parameters collected from high quality “reference” streams. The O/E ratio is the proportion of taxa measured at a site to those that should occur in the absence of significant anthropogenic disturbance. Consequently, O/E ratios near a theoretical mean of 1.0 represent high biological integrity and values significantly less than 1.0 indicate possible impairment (Hawkins 2003a and 2003b).

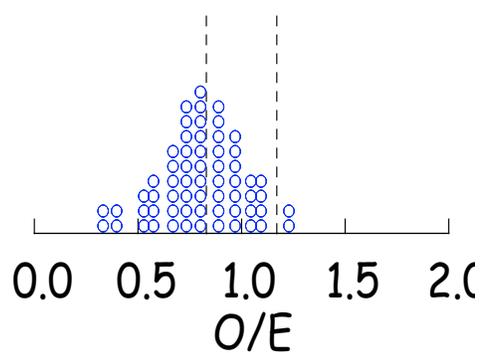
Figure 26. Frequency Distribution of Test Site O/E Values (from Hawkins 2003b)

Mean = 0.81, Range = 0.33 – 1.25.

The model was then tested against 52 test (i.e., potentially impaired) sites and was shown to discriminate between reference and test sites (Figures 25 and 26). Beyond this development and testing, the model has been applied as part of the monitoring component of the Heavenly Valley TMDL Implementation Plan (Section 3.9). It is also being applied, along with the B-IBI described in Section 3.1.2, as part of a University of California, Santa Barbara monitoring project on the Los Padres National Forest.

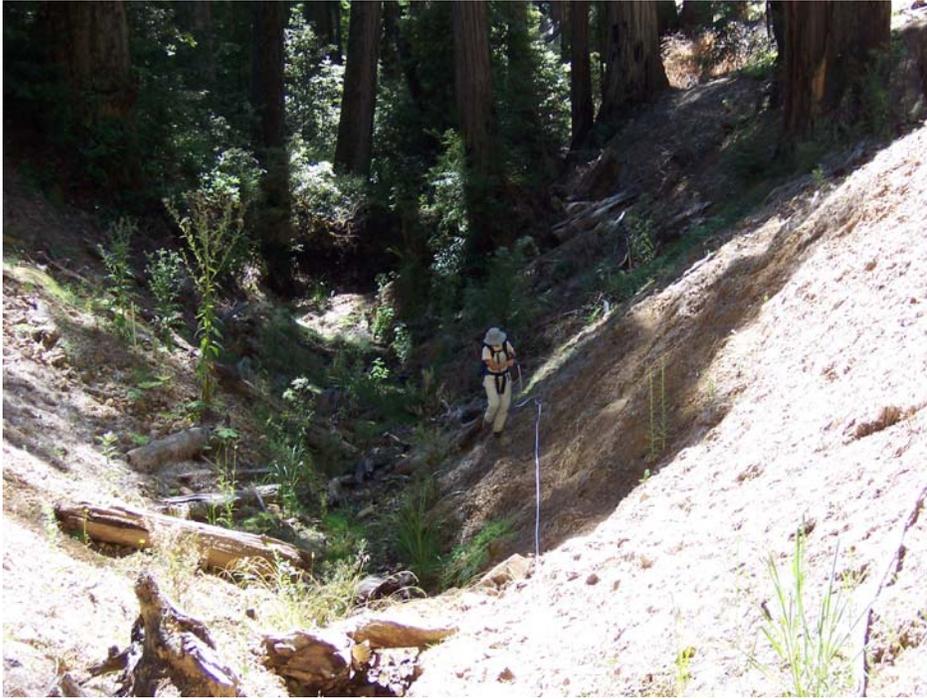
Appendix A. Headwaters Forest road r01, crossing 3 photo, September 15, 2004.

Headwaters Road r01, crossing 3 Data Collected 9/15/04 Years Since Decommissioning: 2 Rock Type: Wildcat Formation Watershed Area (km ²): 0.06 Secondary erosion control on banks: straw Secondary erosion control in channel: small logs					
		RB surf area (m ²)	LB surf area (m ²)	bank lower (m)	bank surf. erosion (m ³)

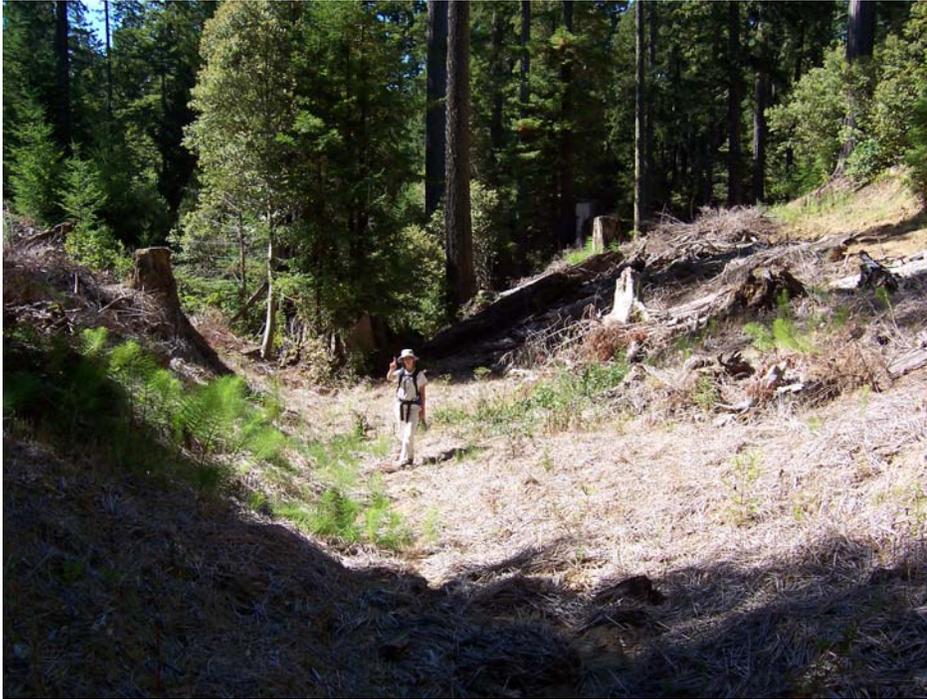
Appendix E. Headwaters Forest road r01, crossing 1 photo, September 15, 2004.

Headwaters Road r01, crossing 1 Data Collected 9/15/04 Years Since Decommissioning: 1 Rock Type: Wildcat Formation Watershed Area (km ²): 0.02 Secondary erosion control on banks: logs, slash, straw, stumps Secondary erosion control in channel: straw					
		RB surf area (m ²)	LB surf area (m ²)	bank lower (m)	bank surf. erosion (m ³)

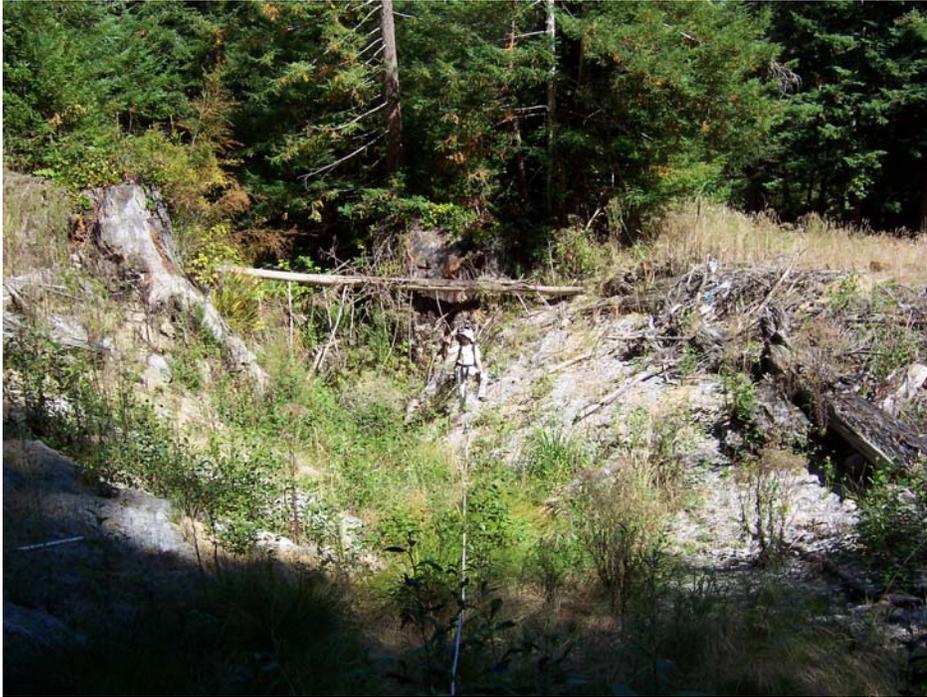
Appendix G. Headwaters Forest road r07, crossing 3 photo, September 4, 2004.

Headwaters Road r07, Crossing 3 Data Collected September 4, 2004 Years Since Decommissioning: 2 Rock Type: Wildcat Formation Watershed Area (km ²): 0.05 Secondary erosion control on banks: straw, logs Secondary erosion control in channel: none apparent					
		RB surf area (m ²)	LB surf area (m ²)	bank lower (m)	bank surf. erosion (m ³)

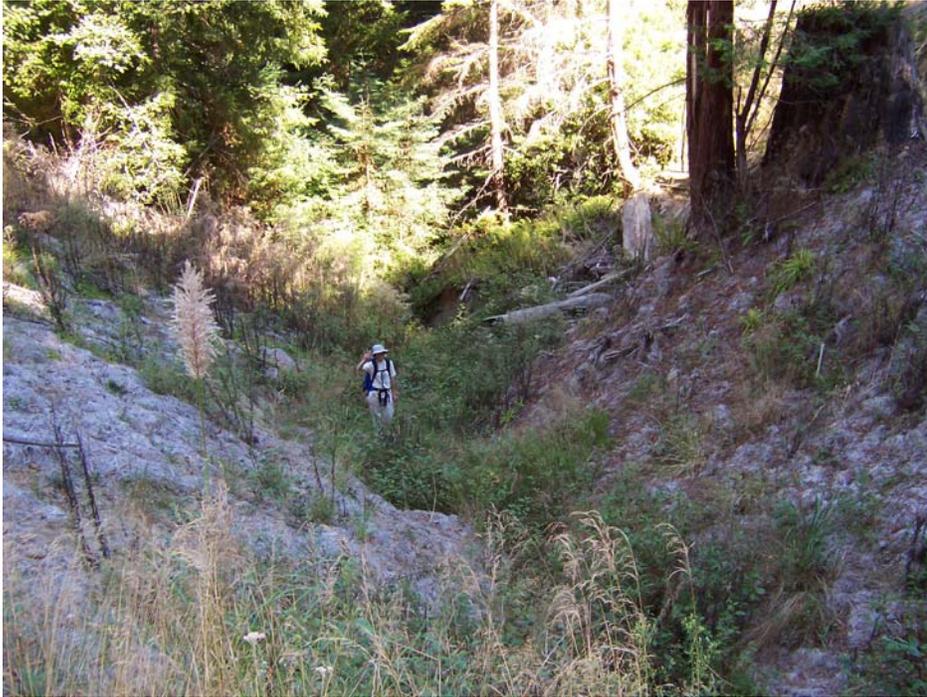
Appendix I. Headwaters Forest road r07, crossing 2 photo, September 4, 2004.

Headwaters Road r07, Crossing 2 Data Collected September 4, 2004 Years Since Decommissioning: 2 Rock Type: Wildcat Formation Watershed Area (km ²): 0.04 Secondary erosion control on banks: straw, some excavated wood Secondary erosion control in channel: none apparent					
		RB surf area (m ²)	LB surf area (m ²)	bank lower (m)	bank surf. erosion (m ³)

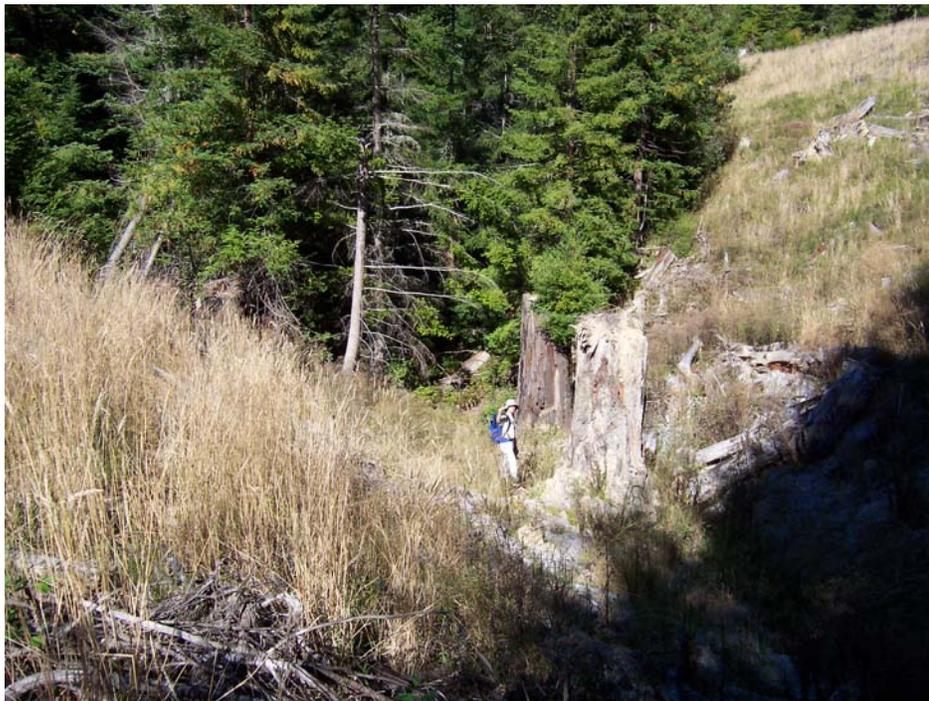
Appendix K. Headwaters Forest road r07, crossing 1 photo, September 4, 2004.

Headwaters Road r07, Crossing 1 Data Collected September 4, 2004 Years Since Decommissioning: 2 Rock Type: Wildcat Formation Watershed Area (km ²): 0.02 Secondary erosion control on banks: straw, some excavated wood Secondary erosion control in channel: none apparent (two stumps left in excavated channel)					
		RB surf area (m ²)	LB surf area (m ²)	bank lower (m)	bank surf. erosion (m ³)

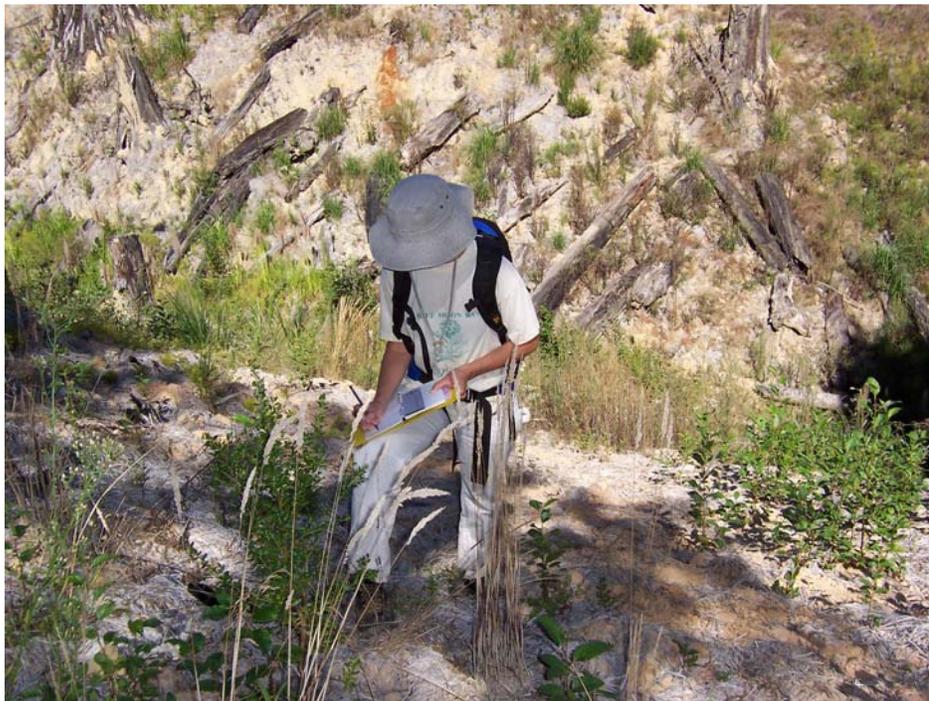
Appendix M. Headwaters Forest road r10, crossing 2 photo, September 5, 2004.

Headwaters Road r10, Crossing 2 Data Collected September 5, 2004 Years Since Decommissioning: 2 Rock Type: Yager Formation Watershed Area (km ²): 0.05 Secondary erosion control on banks: straw, logs Secondary erosion control in channel: some logs from the banks fallen into channel					
		RB surf area (m ²)	LB surf area (m ²)	bank lower (m)	bank surf. erosion (m ³)

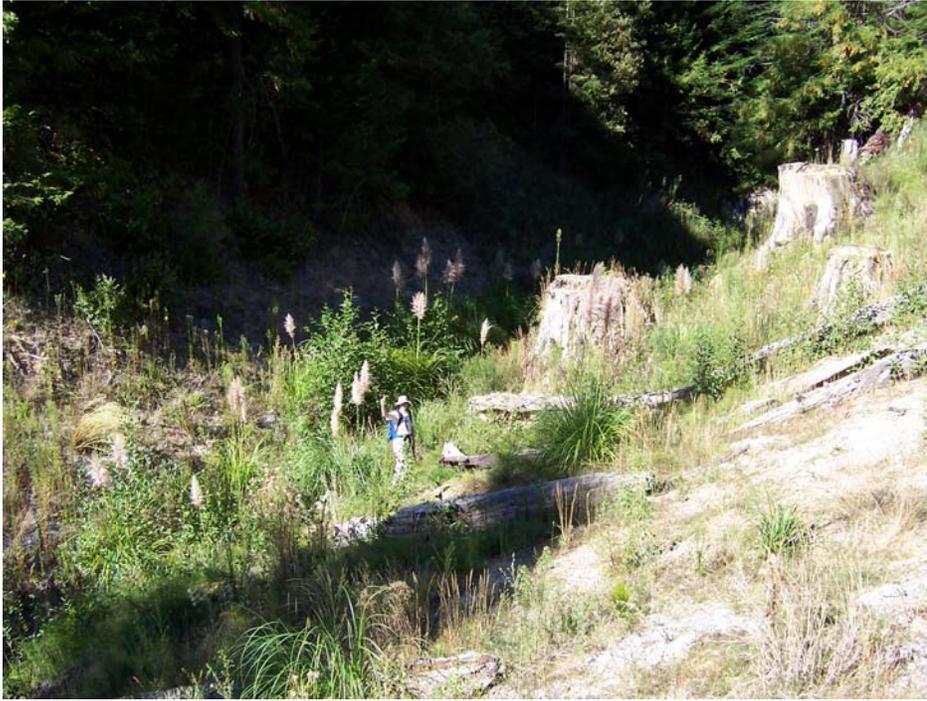
Appendix O. Headwaters Forest road r10, crossing 1 photo, September 5, 2004.

Headwaters Road r10, Crossing 1 Data Collected September 5, 2004 Years Since Decommissioning: 2 Rock Type: Yager Formation Watershed Area (km ²): 0.12 Secondary erosion control on banks: straw, logs Secondary erosion control in channel: none apparent					
		RB surf area (m ²)	LB surf area (m ²)	bank lower (m)	bank surf. erosion (m ³)

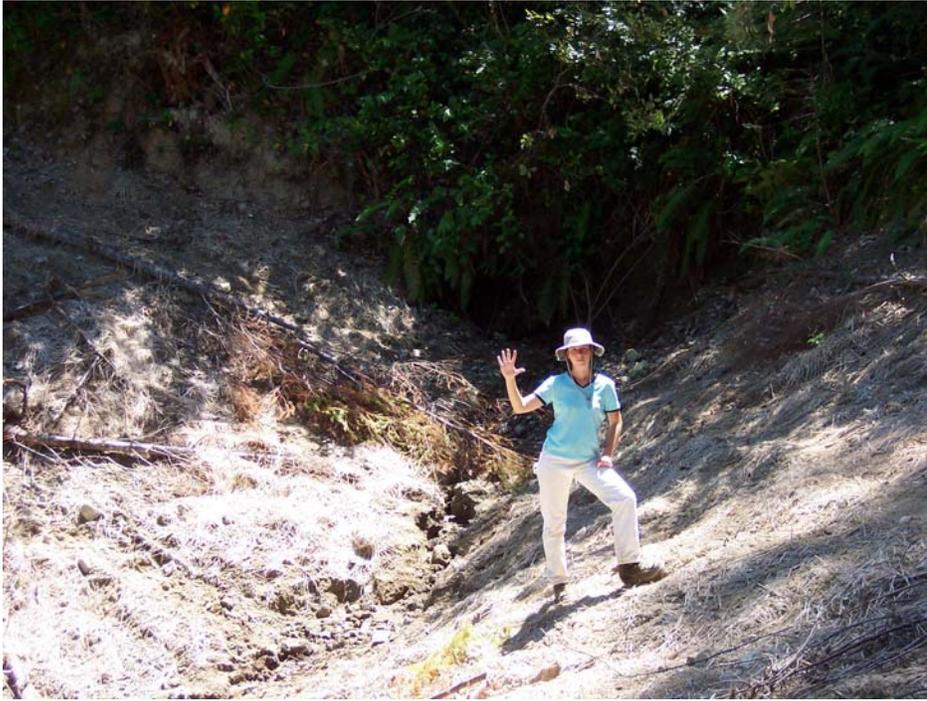
Appendix Q. Klamath Forest road 12N13, crossing 5 photo, July 24, 2004.

Klamath Road 12N13, Crossing 5 Data Collected July 24, 2004 Years Since Decommissioning: 1 Rock Type: Decomposed Granite Watershed Area (km ²): 0.08 Secondary erosion control on banks: straw Secondary erosion control in channel: none apparent					
		RB surf area (m ²)	LB surf area (m ²)	bank lower (m)	bank surf. erosion (m ³)

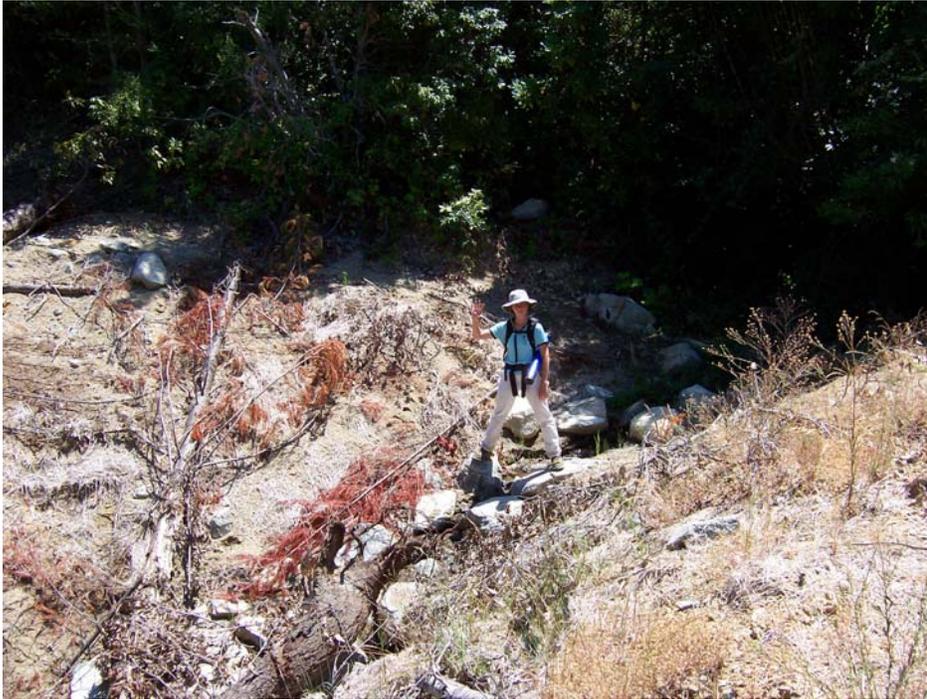
Appendix S. Klamath Forest road 12N13, crossing 4 photo, July 24, 2004.

Klamath Road 12N13, Crossing 4 Data Collected July 24, 2004 Years Since Decommissioning: 1 Rock Type: Decomposed Granite Watershed Area (km ²): 0.08 Secondary erosion control on banks: branches, straw Secondary erosion control in channel: boulders					
		RB surf area (m ²)	LB surf area (m ²)	bank lower (m)	bank surf. erosion (m ³)

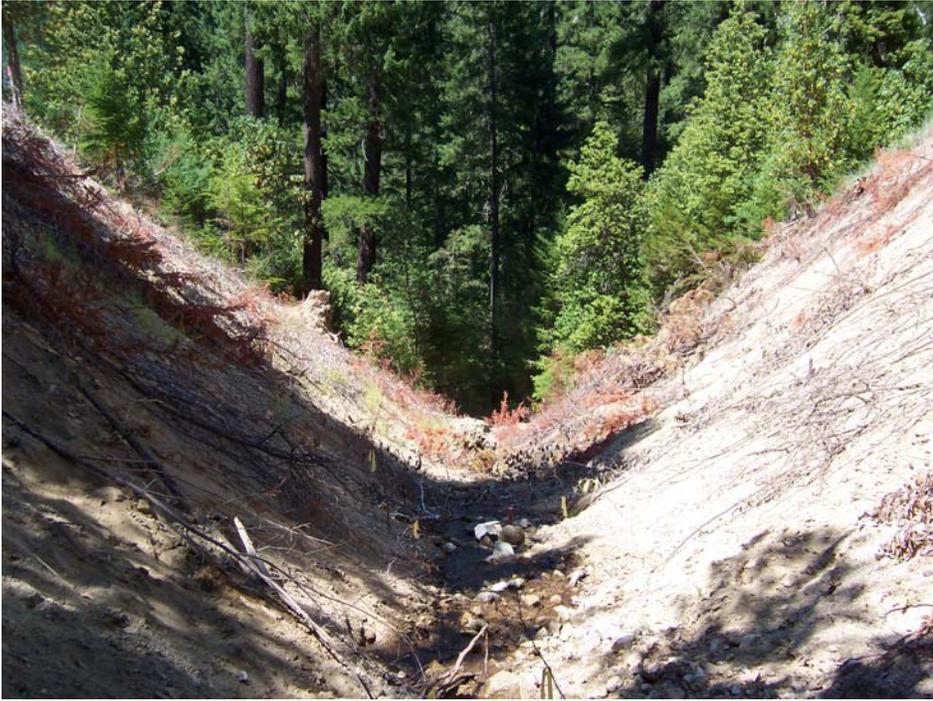
Appendix U. Klamath Forest road 12N13, crossing 3 photo, July 24, 2004.

Klamath Road 12N13, Crossing 3 Data Collected July 24, 2004 Years Since Decommissioning: 1 Rock Type: Decomposed Granite Watershed Area (km ²): 0.12 Secondary erosion control on banks: branches Secondary erosion control in channel: cobbles					
		RB surf area (m ²)	LB surf area (m ²)	bank lower (m)	bank surf. erosion (m ³)

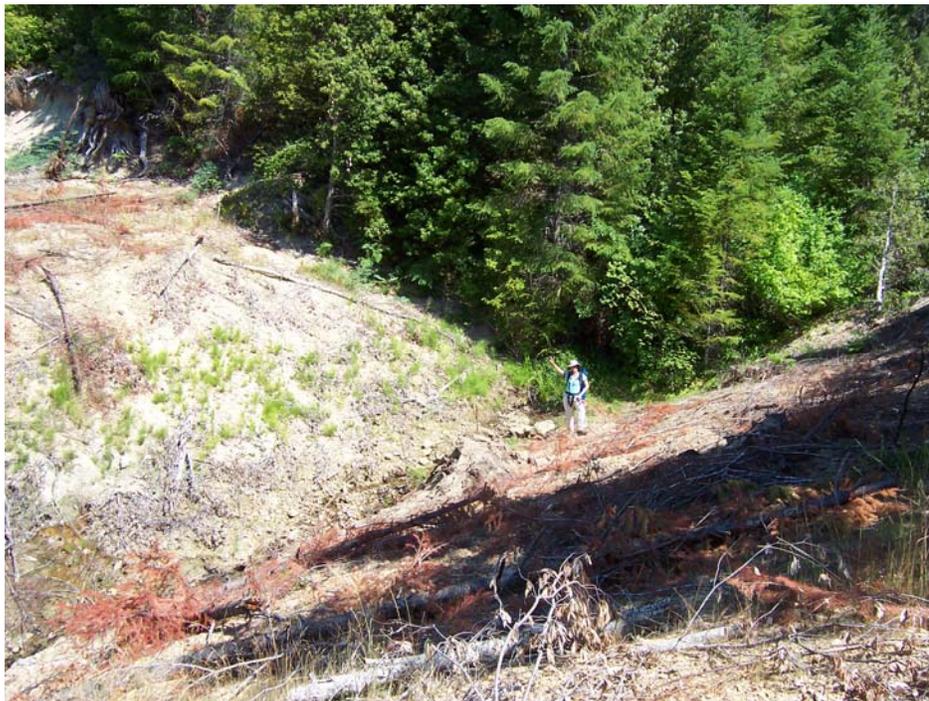
Appendix W. Klamath Forest road 12N13, crossing 2 photo, July 24, 2004.

Klamath Road 12N13, Crossing 2 Data Collected July 24, 2004 Years Since Decommissioning: 1 Rock Type: Decomposed Granite Watershed Area (km ²): 0.20 Secondary erosion control on banks: branches, trees planted Secondary erosion control in channel: none apparent					
		RB surf area (m ²)	LB surf area (m ²)	bank lower (m)	bank surf. erosion (m ³)

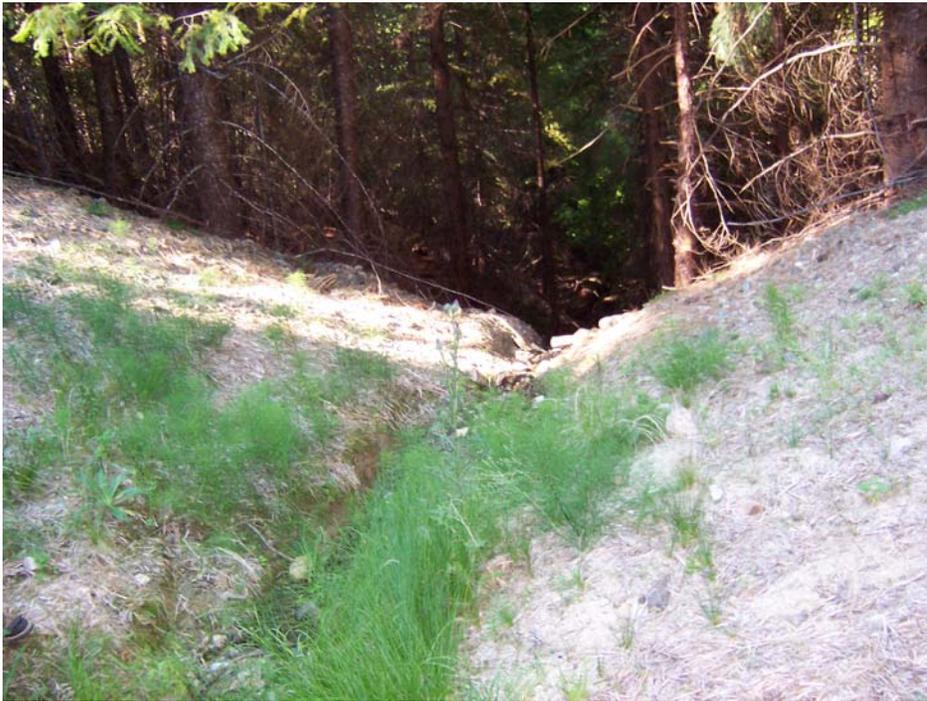
Appendix Y. Klamath Forest road 13N10, crossing 5 photo, August 18, 2004.

Klamath Road 13N10 , Crossing 5 Data Collected August 18, 2004 Years Since Decommissioning: 2 Rock Type: Decomposed Granite Watershed Area (km ²): 0.08 Secondary erosion control on banks: straw Secondary erosion control in channel: none apparent					
		RB surf area (m ²)	LB surf area (m ²)	bank lower (m)	bank surf. erosion (m ³)

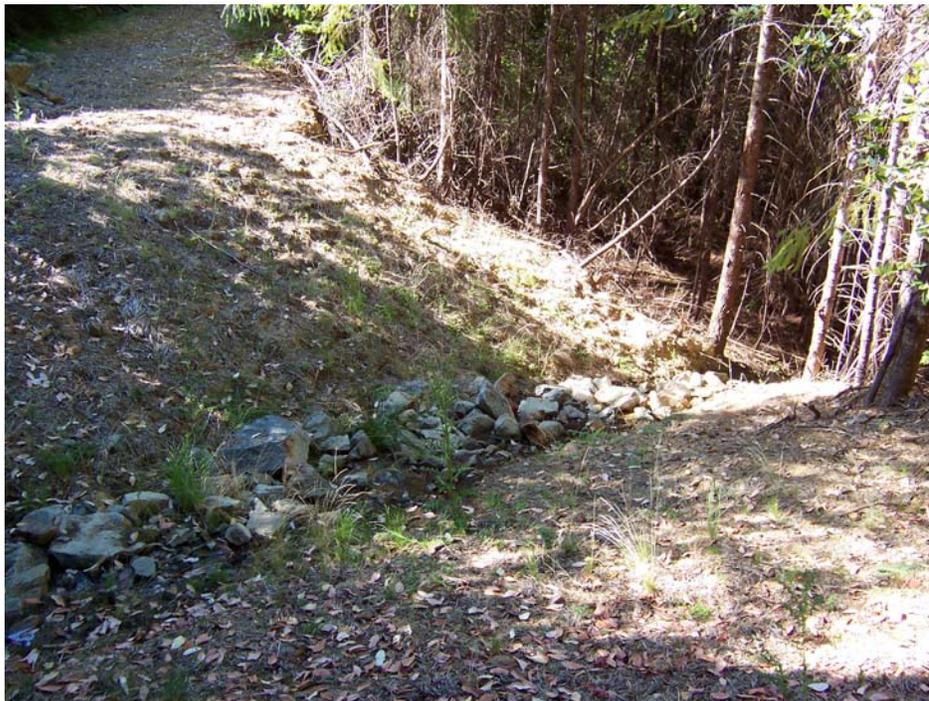
Appendix AA. Klamath Forest road 13N10, crossing 4 photo, August 18, 2004.

Klamath Road 13N10 , Crossing 4 Data Collected August 18, 2004 Years Since Decommissioning: 2 Rock Type: Decomposed Granite Watershed Area (km ²): 0.35 Secondary erosion control on banks: straw Secondary erosion control in channel: small boulders					
		RB surf area (m ²)	LB surf area (m ²)	bank lower (m)	bank surf. erosion (m ³)

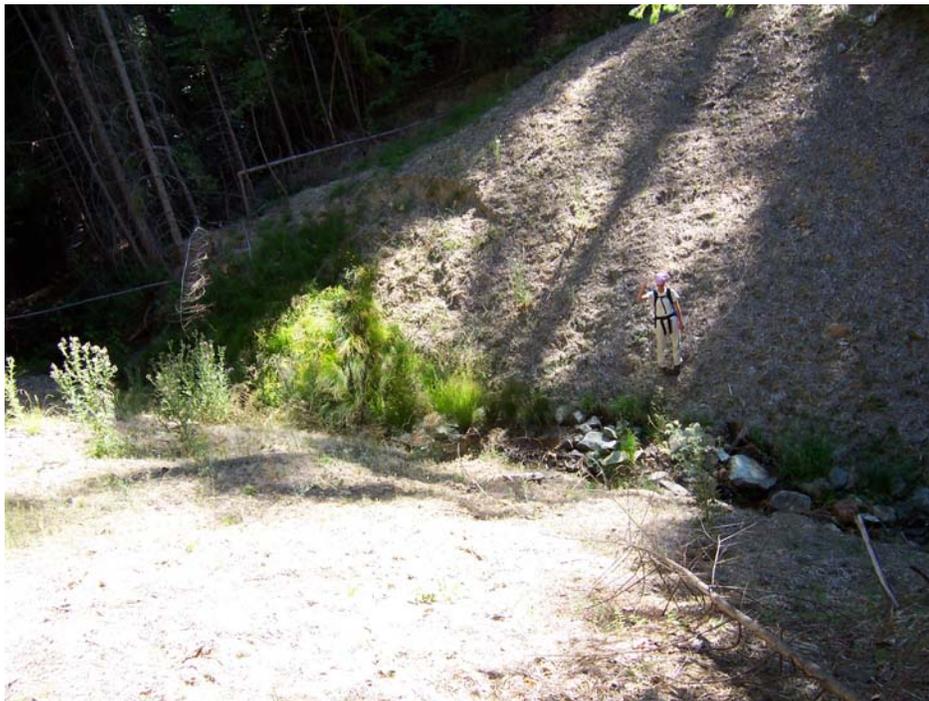
Appendix CC. Klamath Forest road 13N10, crossing 3 photo, August 18, 2004.

Klamath Road 13N10 , Crossing 3 Data Collected August 18, 2004 Years Since Decommissioning: 2 Rock Type: Decomposed Granite Watershed Area (km ²): 0.44 Secondary erosion control on banks: straw Secondary erosion control in channel: small boulders					
		RB surf area (m ²)	LB surf area (m ²)	bank lower (m)	bank surf. erosion (m ³)

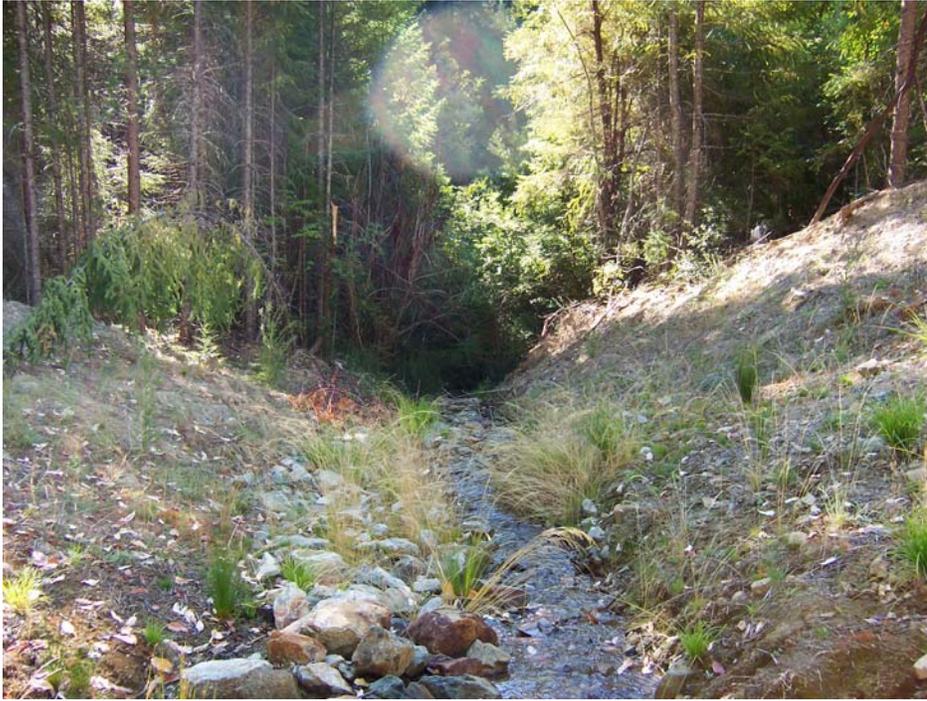
Appendix EE. Klamath Forest road 13N10, crossing 2 photo, August 18, 2004.

Klamath Road 13N10 , Crossing 2 Data Collected August 18, 2004 Years Since Decommissioning: 2 Rock Type: Decomposed Granite Watershed Area (km ²): 0.19 Secondary erosion control on banks: straw Secondary erosion control in channel: boulders/cobbles (only part way across)					
		RB surf area (m ²)	LB surf area (m ²)	bank lower (m)	bank surf. erosion (m ³)

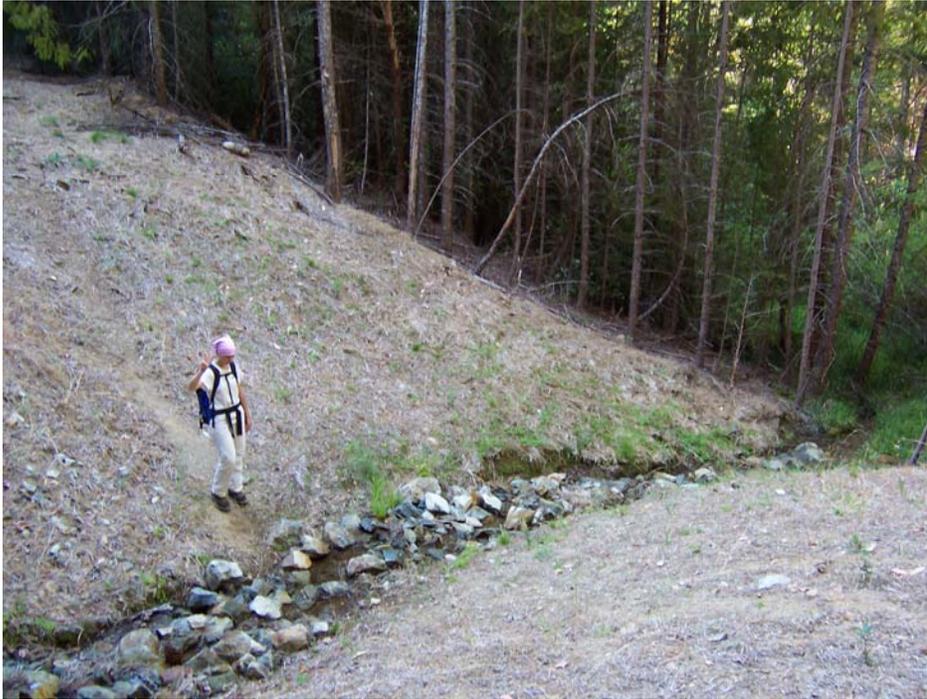
Appendix GG. Klamath Forest road 13N10, crossing 1 photo, August 18, 2004.

Klamath Road 13N10 , Crossing 1 Data Collected August 18, 2004 Years Since Decommissioning: 2 Rock Type: Decomposed Granite Watershed Area (km ²): 0.12 Secondary erosion control on banks: straw, slash Secondary erosion control in channel: some small boulders					
		RB surf area (m ²)	LB surf area (m ²)	bank lower (m)	bank surf. erosion (m ³)

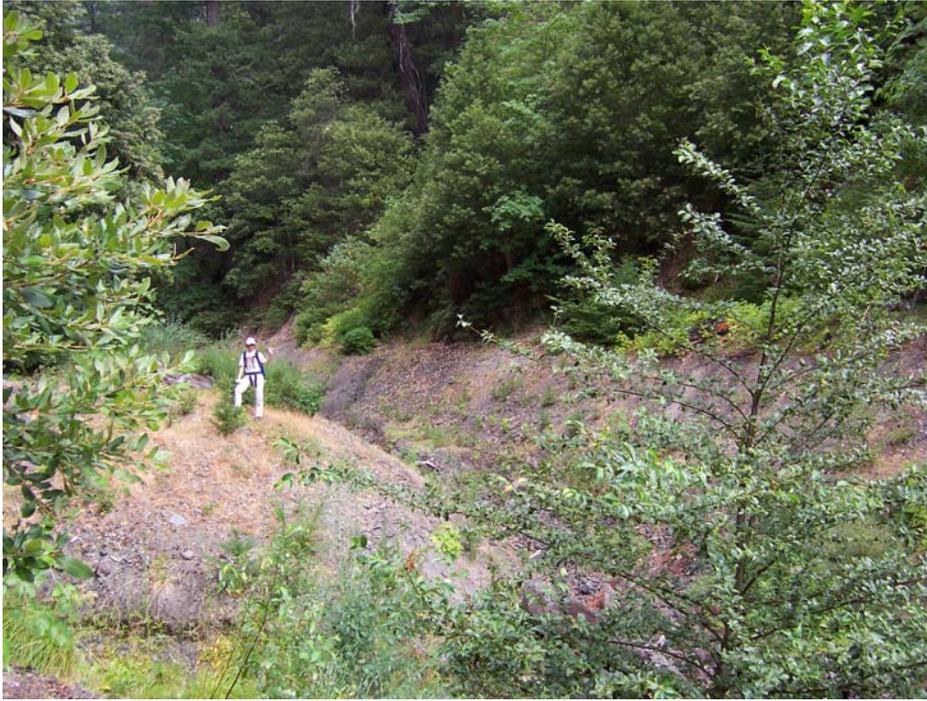
Appendix II. Six Rivers Forest road 5N04, crossing 3 photo, August 22, 2004.

Six Rivers Road 5N04, Crossing 3 Data Collected August 22, 2004 Years Since Decommissioning: 2 Rock Type: Galice Formation Watershed Area (km ²): 0.19 Secondary erosion control on banks: straw Secondary erosion control in channel: some logs					
		RB surf area (m ²)	LB surf area (m ²)	bank lower (m)	bank surf. erosion (m ³)

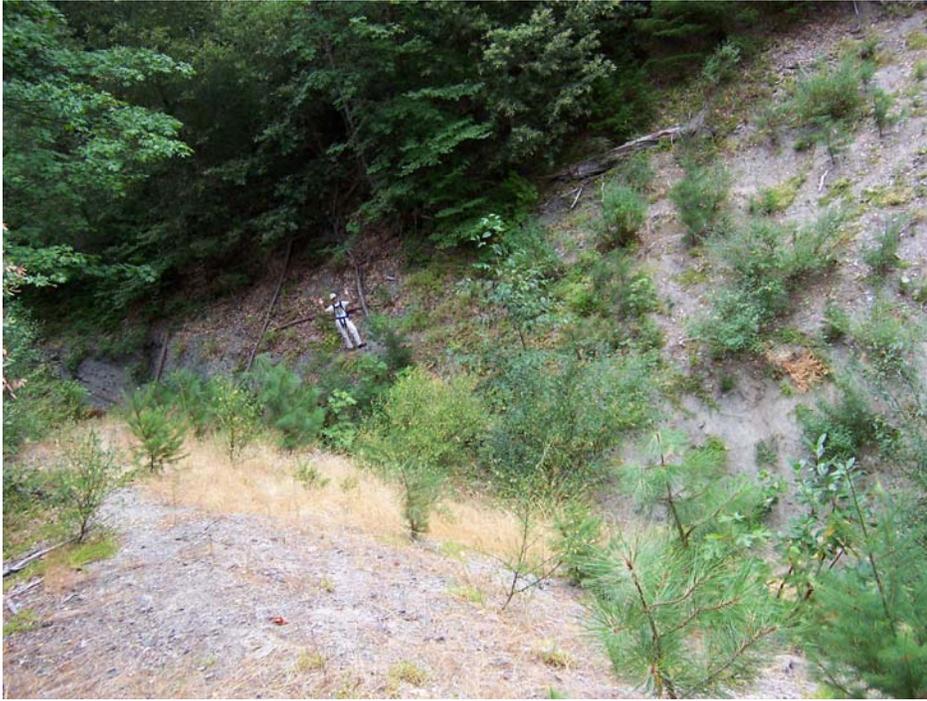
Appendix KK. Six Rivers Forest road 5N04, crossing 2 photo, August 22, 2004.

Six Rivers Road 5N04, Crossing 2 Data Collected August 22, 2004 Years Since Decommissioning: 2 Rock Type: Galice Formation Watershed Area (km ²): 0.15 Secondary erosion control on banks: few trees planted Secondary erosion control in channel: none apparent					
		RB surf area (m ²)	LB surf area (m ²)	bank lower (m)	bank surf. erosion (m ³)

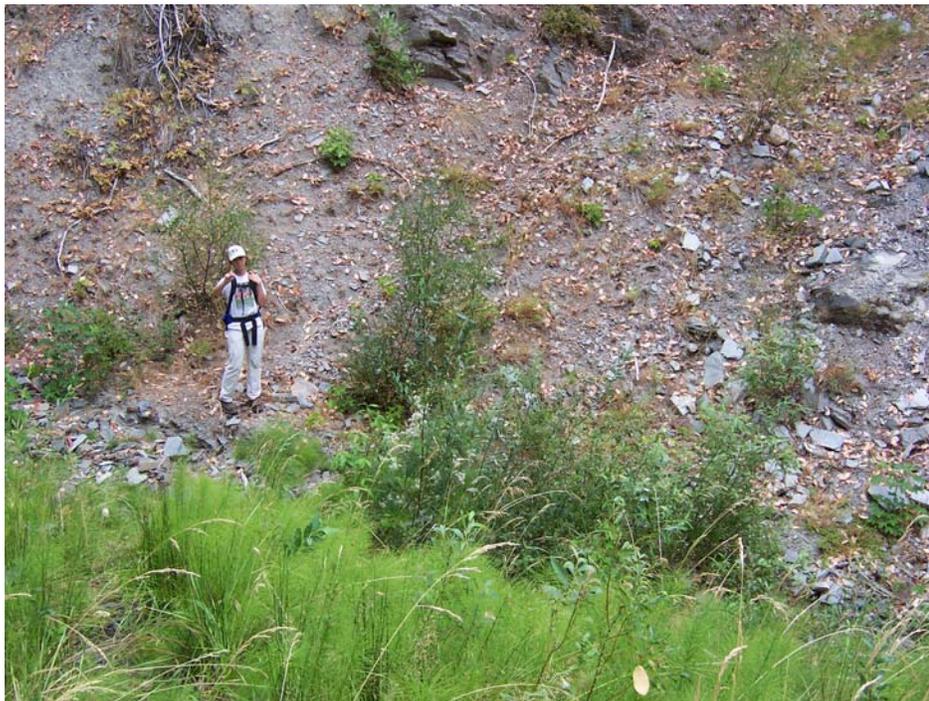
Appendix MM. Six Rivers Forest road 5N04, crossing 1 photo, August 22, 2004.

Six Rivers Road 5N04, Crossing 1 Data Collected August 22, 2004 Years Since Decommissioning: 2 Rock Type: Galice Formation Watershed Area (km ²): 0.21 Secondary erosion control on banks: few trees planted Secondary erosion control in channel: none apparent					
		RB surf area (m ²)	LB surf area (m ²)	bank lower (m)	bank surf. erosion (m ³)
