**PROJECT:**  
**SOUTH FORK WAGES CREEK**  
**STREAMFLOW AND SEDIMENT TRANSPORT MONITORING**

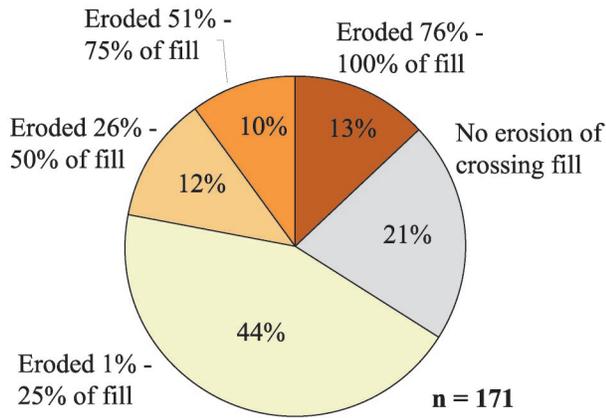
Figure 5. Proportion of road-stream crossing fill eroded where streamflow overtopped the road. From: Furniss et al. (1996).

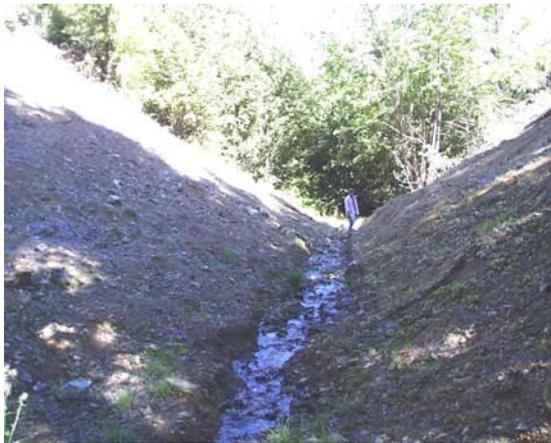
Photo 5: Typical large size restored stream crossing - 5N13B.

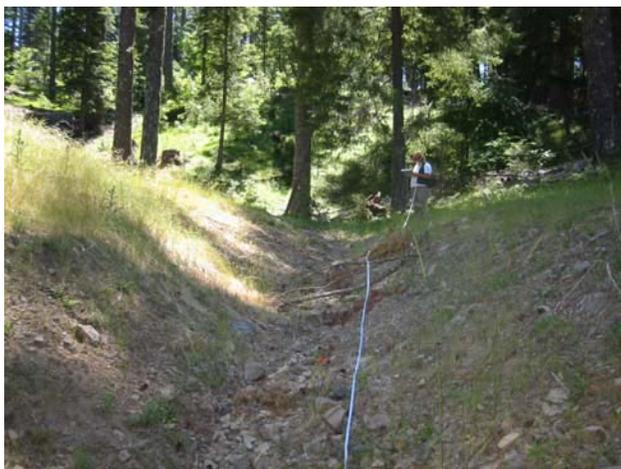
Photo 6: Typical small to moderate size stream crossing excavation - Road 2N14H.

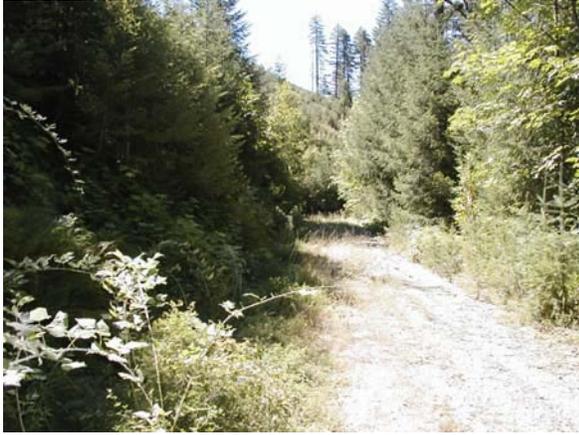
Photo 7: Untreated roadbed on decommissioned road.

Photo 7 shows a typical untreated roadbed left between restored stream crossings. Photo 8 is an example of road prism outsloping where slope stability was a concern.

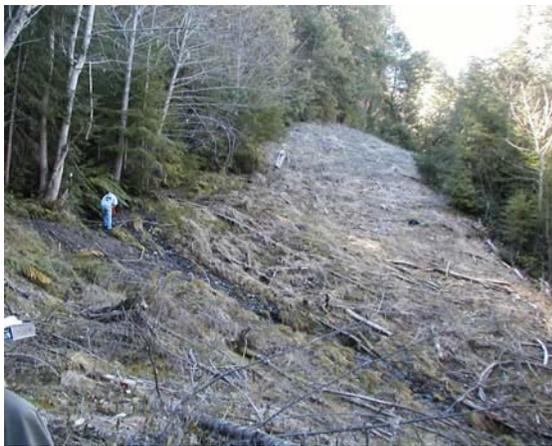
Photo 8: Outsloping associated with unstable roadbed.

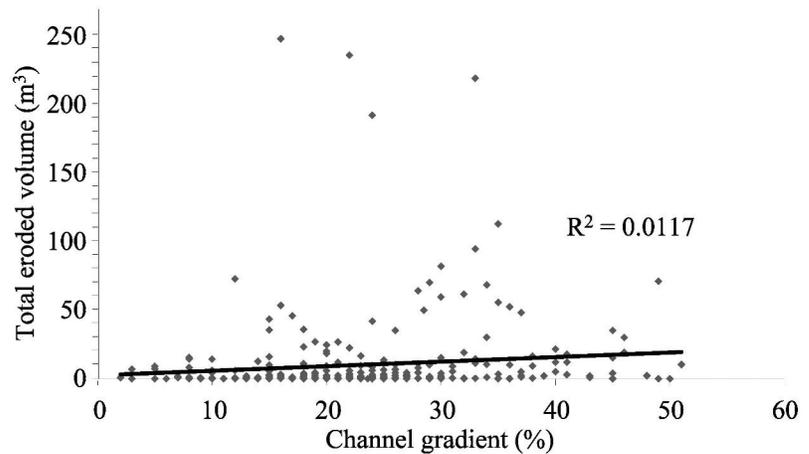
Figure 6. Channel gradient regressed against total erosion.

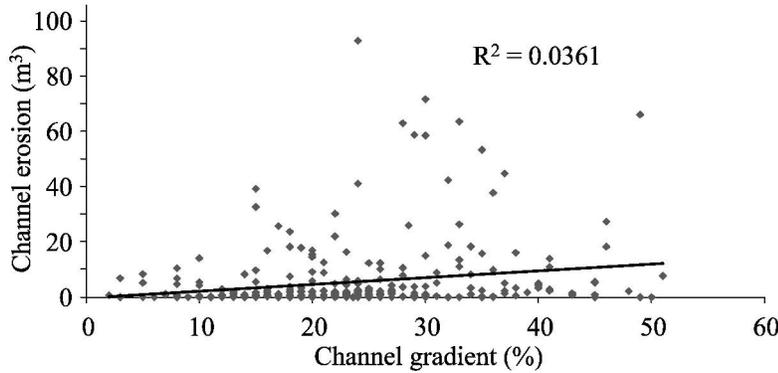
Figure 7. Channel gradient regressed against channel erosion.

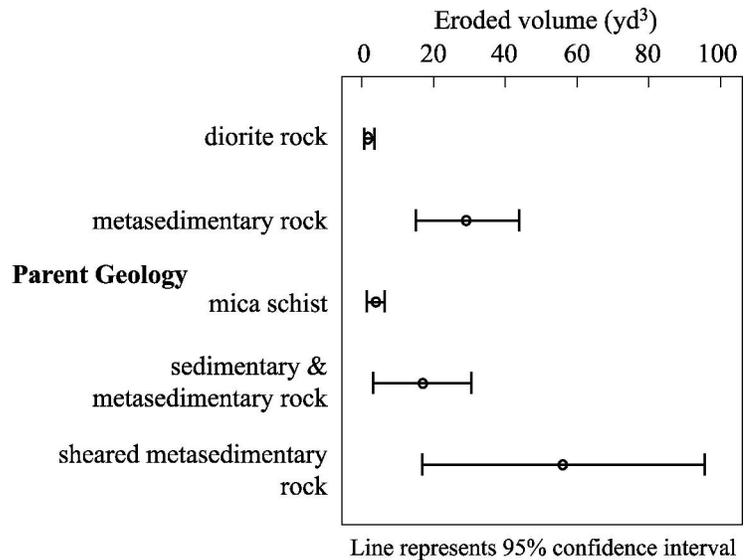
Figure 8. Means test between eroded volume and parent material.

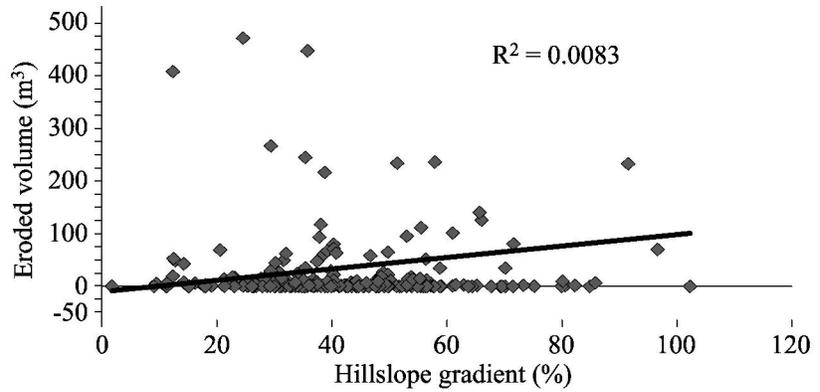
Figure 9. Hillslope gradient regressed against eroded volume.

stream channel dissects and stream power was defined as drainage area times channel slope. No correlation was observed between either hillslope gradient (Figure 9) or stream power (Figure 10) and the amount of observed erosion. This was surprising, especially in the case of stream power which had been found to be a good predictor of erosion in the Franciscan terrain of Redwood Creek by Madej (2001). A multiple regression was conducted on post-treatment erosion, excavated volume, and drainage area on decommissioned stream crossings in Six Rivers. These variables were significantly related ( $n = 52$ ,  $r^2 = 0.55$ ,  $p = 0.0001$ )

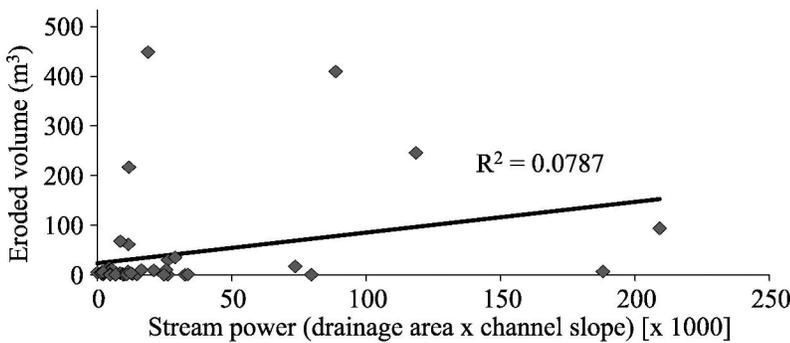
Figure 10. Stream power regressed against eroded volume.

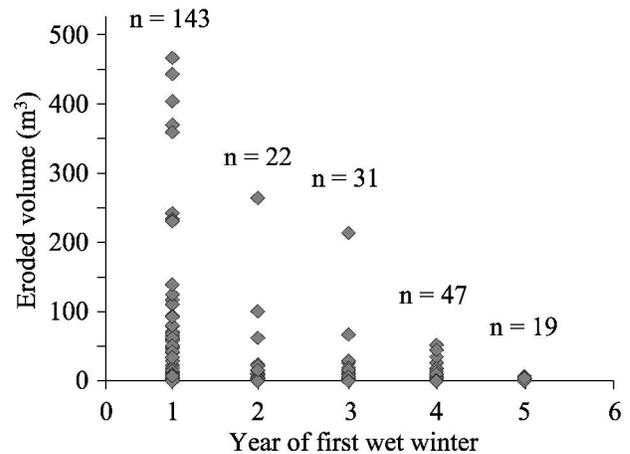
Figure 11. Erosion related to the year of the first wet winter after decommissioning.

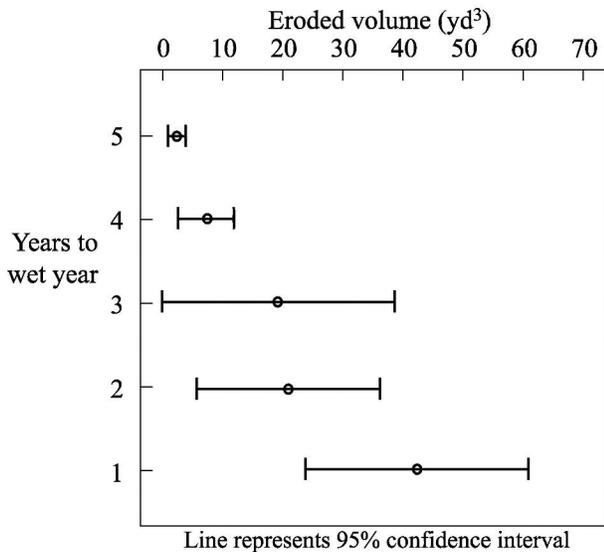
Figure 12: Means test between eroded volume and years to first wet year.

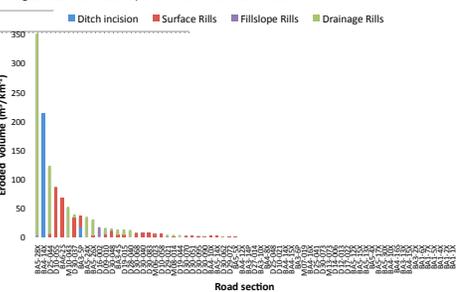
Figure 4. Eroded volume by road section for untreated roads.

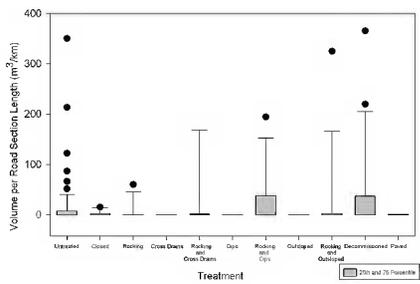
Figure 5. Box plots of eroded volume for each surveyed road section by treatment.

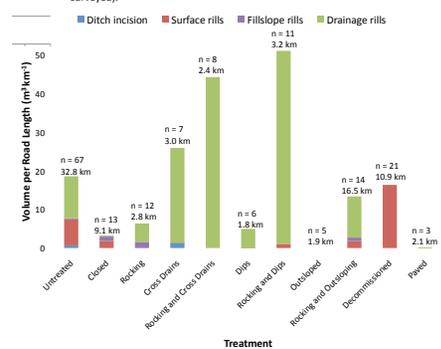
Figure 6. Eroded volume by source for each treatment (n is the number of sections surveyed).

Drainage rills accounted for 61% of the total eroded volume. Surface rilling was the next most important erosion process that accounted for 34% of the total eroded volume and was the sole source decommissioned roads. Ditch incision was only important for some untreated road a small component of the eroded volume on some of the untreated roads (Figure 4 and 6) and roads with additional cross drain installation (Figure 6). Fill-slope rills were rare and contributed very little to the total eroded volume (Figure 6).

Another factor that needs consideration is that incised ditches, fill-slope rills and drainage rills surveyed in this study may have developed on roads before treatments were implemented. This native surface, in-sloped and cross-drained configuration is vulnerable to surface erosion and more effectively delivers concentrated runoff from the road prism. Drainage rills were found to be the primary erosion mechanism, and since none of the treatments alter these features and their associated connectivity these features may be inherited from the pre-treatment road configuration (Figure 6). This may have resulted in roads that received rocking and additional cross drain installation, rocking and additional dip installation, and rocking with out-sloping having eroded volumes greater than the roads with only those constituent treatments (Figure 6).

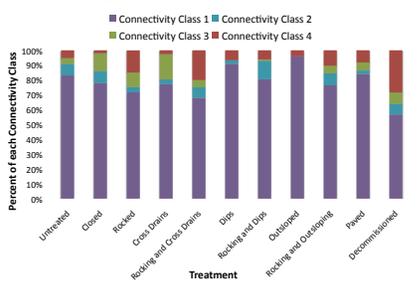
Figure 7. Percentage of each connectivity class for each treatment.

Only 5.3% of the 33 km of untreated roads surveyed had a rill or sediment plume that extended to a stream channel (connectivity class 4 on Figure 7). The decommissioned roads had the highest road-stream connectivity (28% of the surveyed length).

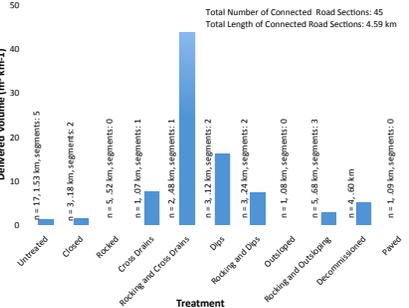
Figure 8. Sediment delivered to connected streams per surveyed length for each treatment (n = the number of producing and connected road sections).

For the untreated roads the mean volume of delivered sediment was 1.6 m<sup>3</sup> km<sup>-1</sup> (Figure 8). One road section that was rocked with additional cross drain installation caused this treatment to have the greatest delivery of 43.6 m<sup>3</sup> km<sup>-1</sup> (Figure 8). Roads with additional dip installation had an estimated mean sediment delivery of 16 m<sup>3</sup> km<sup>-1</sup> (Figure 8), although this was only found on 2 road sections. Treatments with moderate sediment delivery were additional cross drain installation, rocking with additional dip installation, and road decommissioning (Figure 8). The other treatments had little or no sediment delivery (Figure 8).

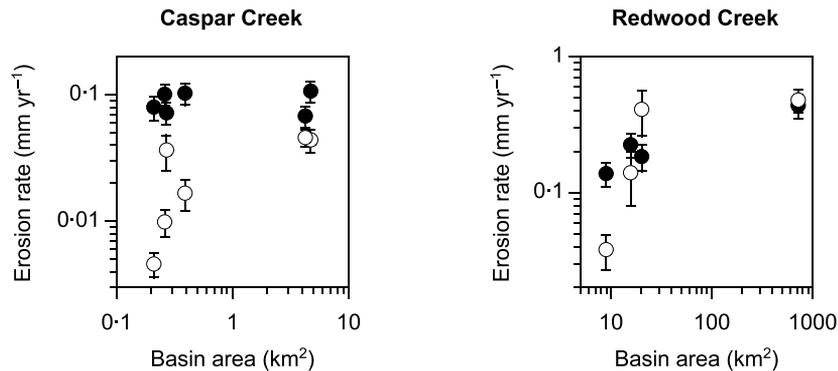
**Figure 2.** Erosion rates at Caspar Creek and Redwood Creek, averaged over millennial timescales (filled circles) and over decadal timescales (open circles). Uncertainties are one standard error.

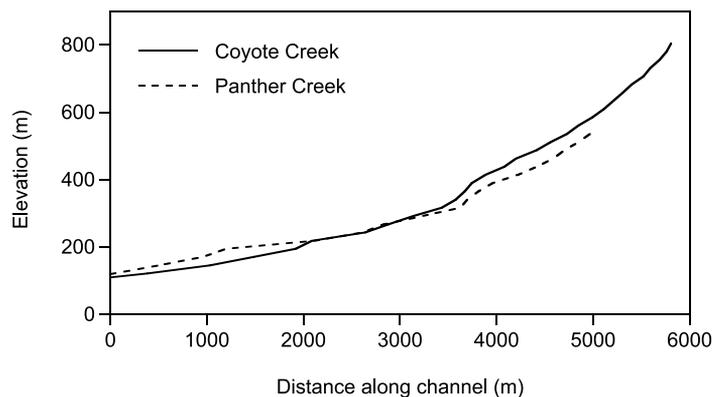
**Figure 3.** Longitudinal profiles of Coyote Creek and Panther Creek, determined from 1:24 000 USGS topographic maps. The horizontal axis is distance from the main stem of Redwood Creek, measured along the channel. Mean channel gradients are c. 0.12 at Coyote Creek and c. 0.08 at Panther Creek.

According to our Redwood Creek  $^{10}\text{Be}$  measurements, Coyote Creek, Panther Creek and Little Lost Man Creek are eroding more slowly than Redwood Creek basin as a whole, implying that the unsampled tributaries of Redwood Creek must be eroding more quickly, on average, than the three tributaries we sampled. It would not be surprising to find that the fastest erosion rates are concentrated farther south than the tributaries we sampled, since Redwood Creek is much steeper near its southernmost headwaters, and the higher elevations there may be subject to enhanced physical weathering due to more intense freeze–thaw cycles. Mean hillslope gradients vary little from site to site (Table I), and so are probably not the main cause of variation in denudation rates. Lithology has been shown to regulate bedrock river incision rates (*e.g.* Sklar and Dietrich, 2001), but its influence on hillslope denudation rate is not apparent in our  $^{10}\text{Be}$  measurements. For example, Coyote Creek cuts through incoherent sandstone and mudstone, and Panther Creek incises the Redwood Creek Schist (Harden *et al.*, 1981), yet their millennial-scale denudation rates agree with each other within error. This agreement in denudation rates at Panther Creek and Coyote Creek might be a result of main stem forcing, since these tributaries enter the main stem of Redwood Creek at about the same location (Figure 1). If the morphologies of Panther Creek and Coyote Creek are both adjusted to produce incision rates that match Redwood Creek's incision rate, then the steepness of these tributaries should reflect differences in bedrock strength – that is, the tributary in the stronger lithology should be steeper than the tributary in the weaker lithology. However, the mean channel gradient at Coyote Creek is *c.* 0.12, and at Panther Creek it is *c.* 0.08 (Figure 3). This would seem to suggest

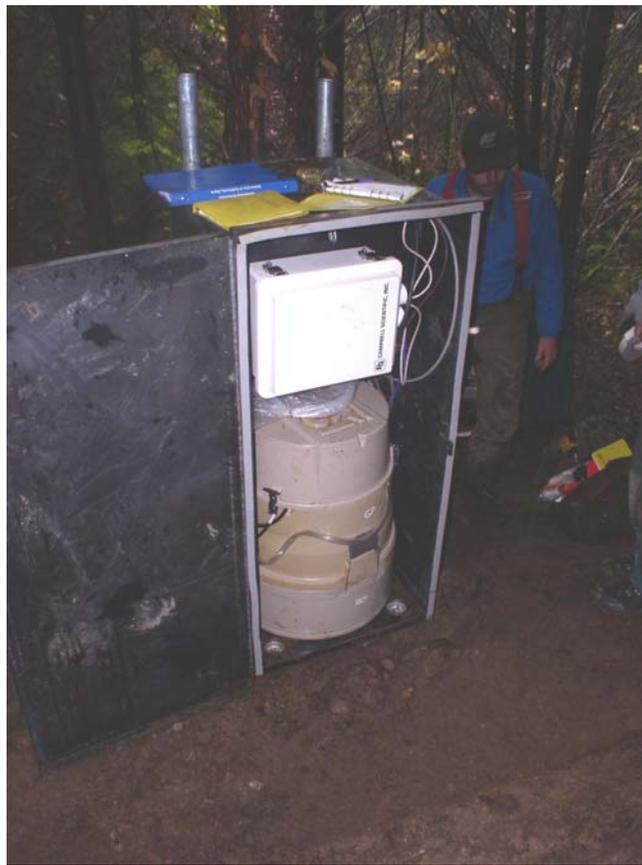
Photo 1. Steel Enclosure installed at Rock Creek.

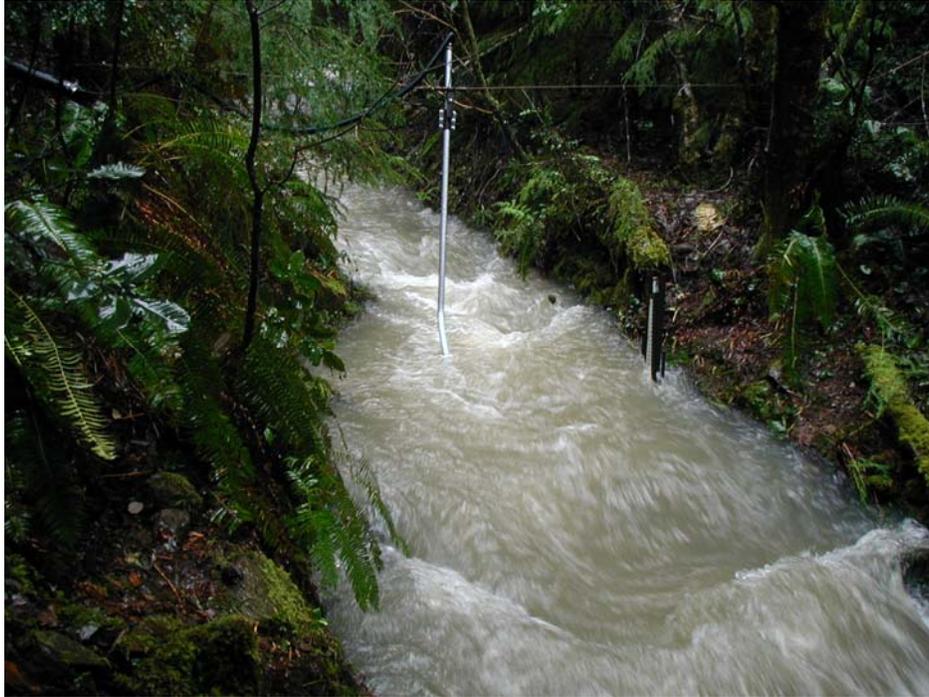
Photo 4. SF Wages above Center Gulch on 2/17/04 with a discharge of ~55 cfs. In this photo turbidity probe readings are being affected by turbulence. Boom has since been moved towards the right bank and out of the turbulence.

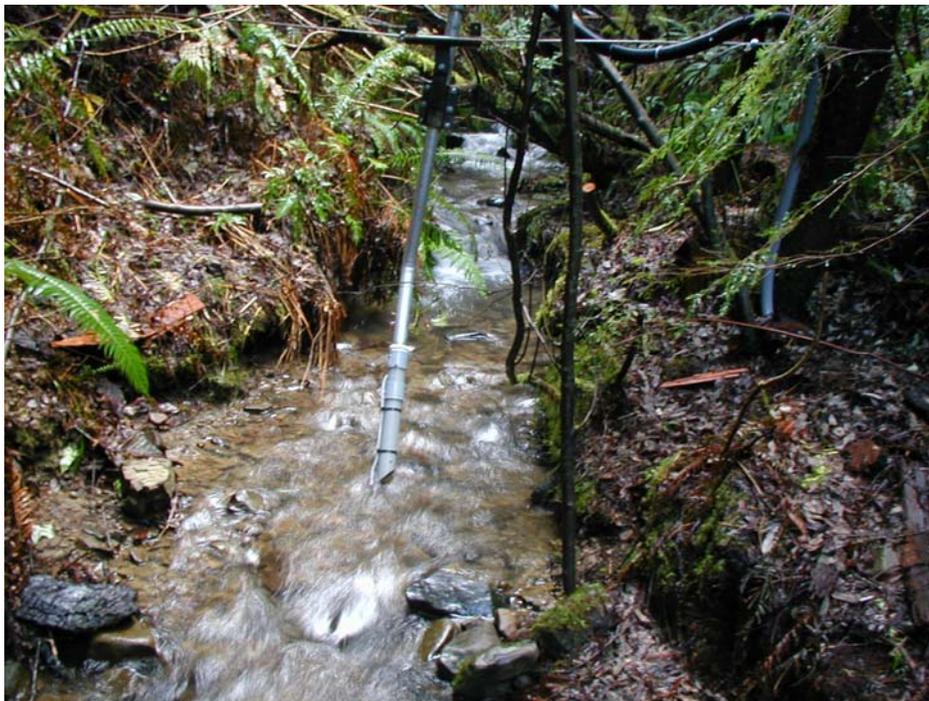
Photo 5. Center Gulch on 01/06/04 with a discharge of <1 cfs. Photo taken before boulders were added to channel in order to backwater turbidity probe.

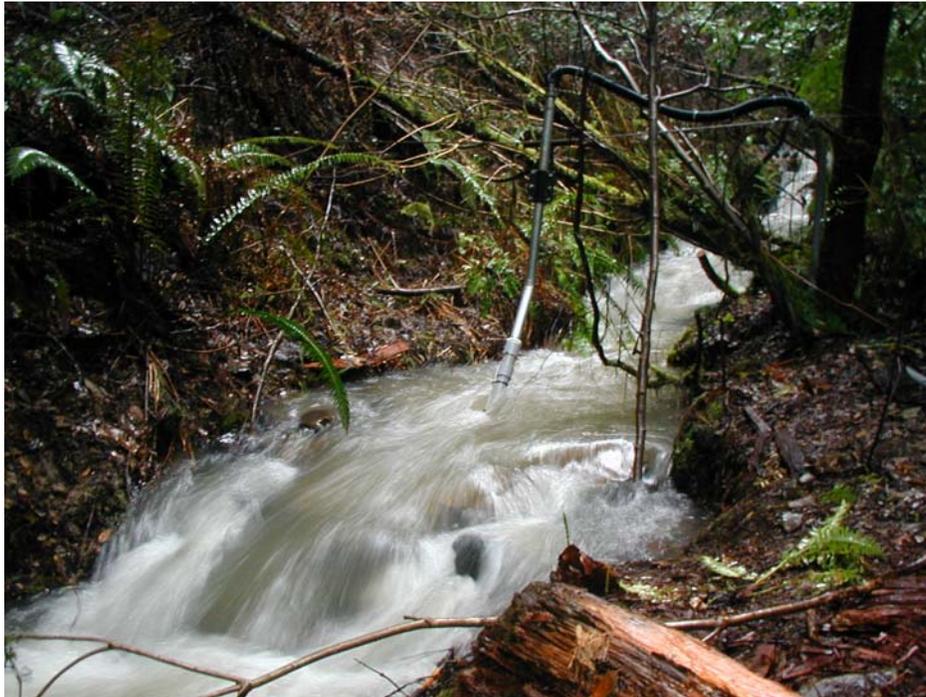
Photo 6. Center Gulch on 02/17/04 with a discharge of ~13 cfs. Photo taken after boulders were added to channel in order to backwater turbidity probe.

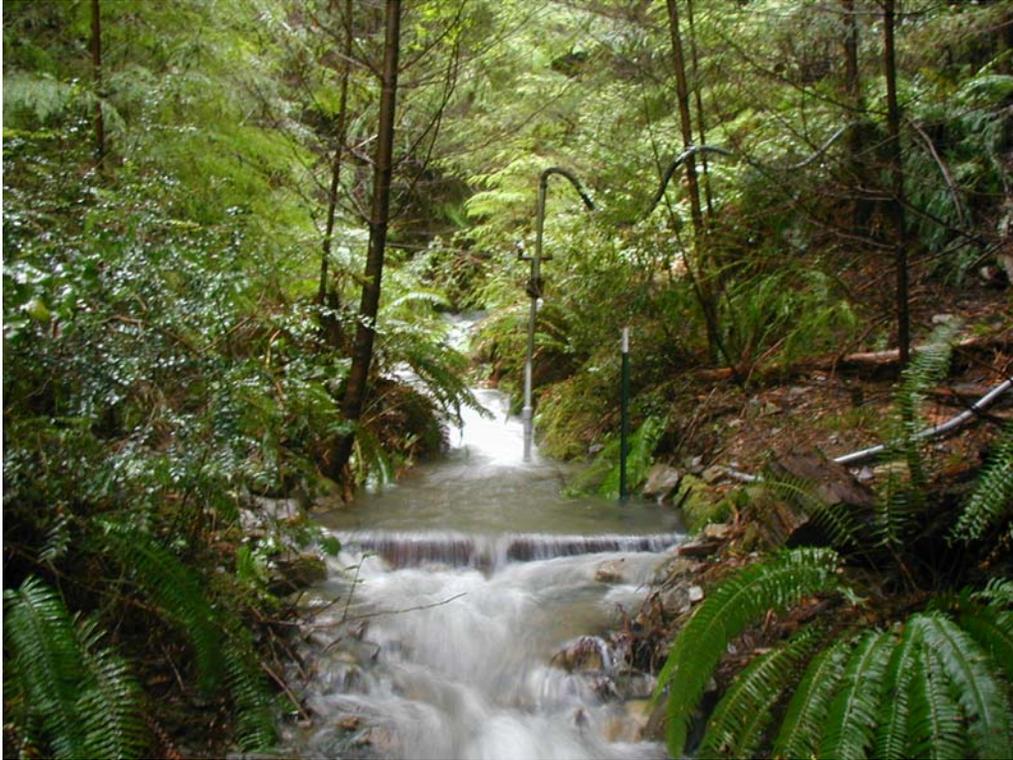
Photo 8. Wood above SF Wages on 2/17/04 with a discharge of ~5 cfs. In this photo turbidity probe readings are being affected by turbulence. Boom has since been moved towards the right bank and out of the turbulence.

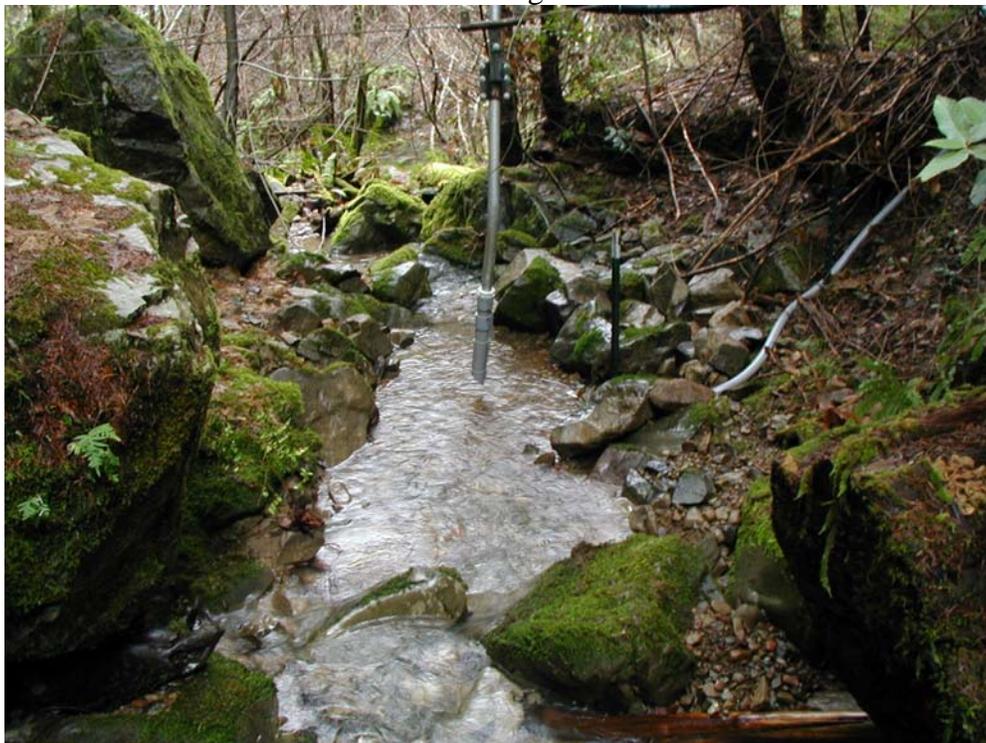
Photo 9. Rock Creek on 01/06/04 with a discharge of <1 cfs. Photo taken after channel shape had been modified by placement of large boulders.

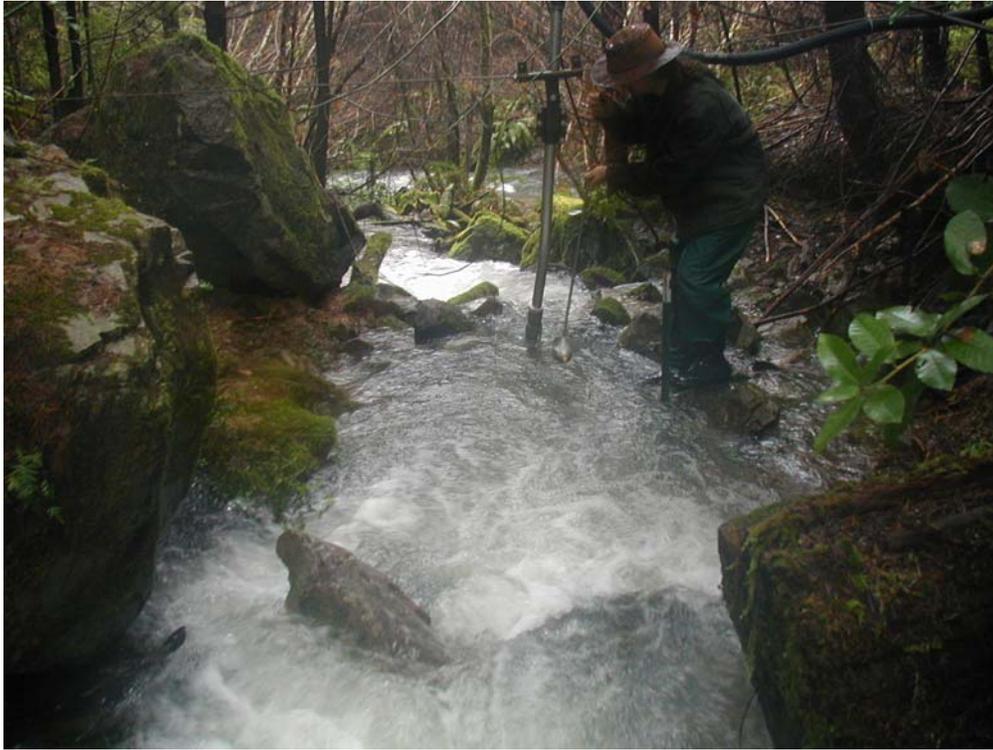
Photo 10. Rock Creek on 2/17/04 with a discharge of ~14 cfs. Hydrologist is performing DIS sediment sample with a DH-48.

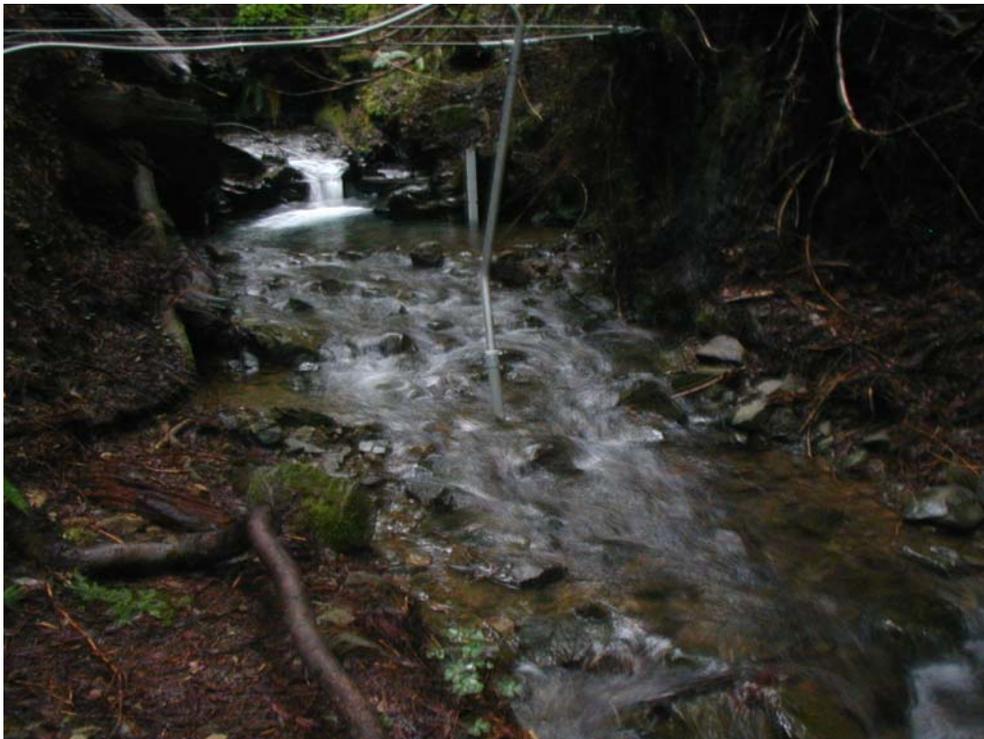
Photo 11. SF Wages above Rock Creek on 1/07/04 with a discharge of ~2.5 cfs. Photo taken before large boulders were added to channel.

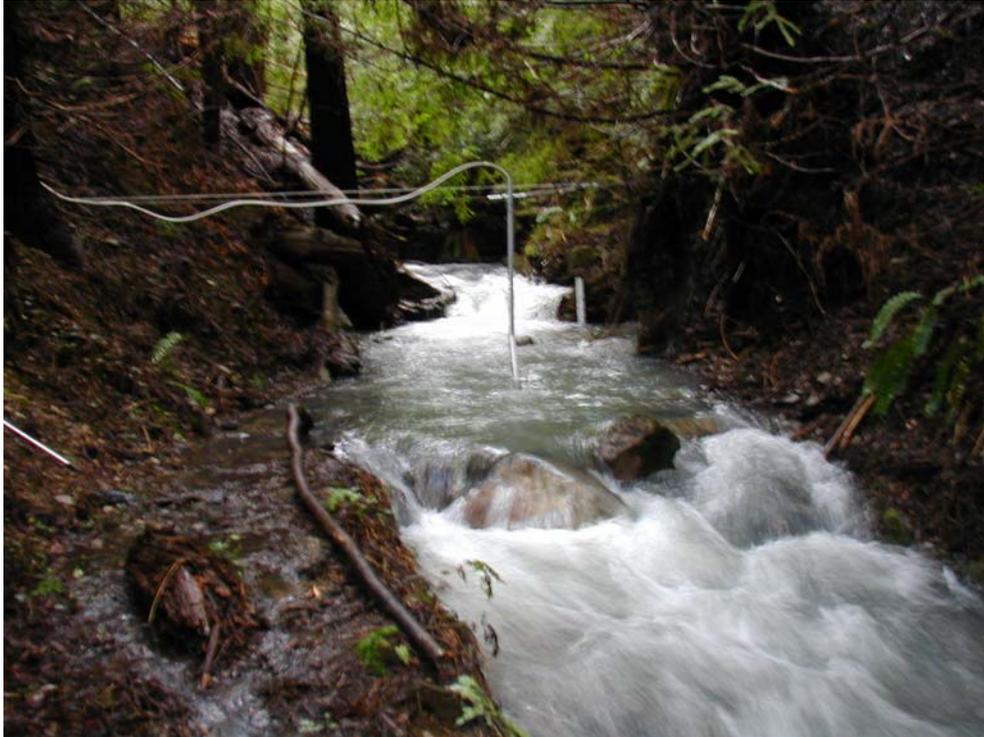
Photo 12. SF Wages above Rock Creek on 2/18/04 with a discharge of ~17 cfs. Note that large boulders placed in channel are working well at backwatering the turbidity probe.

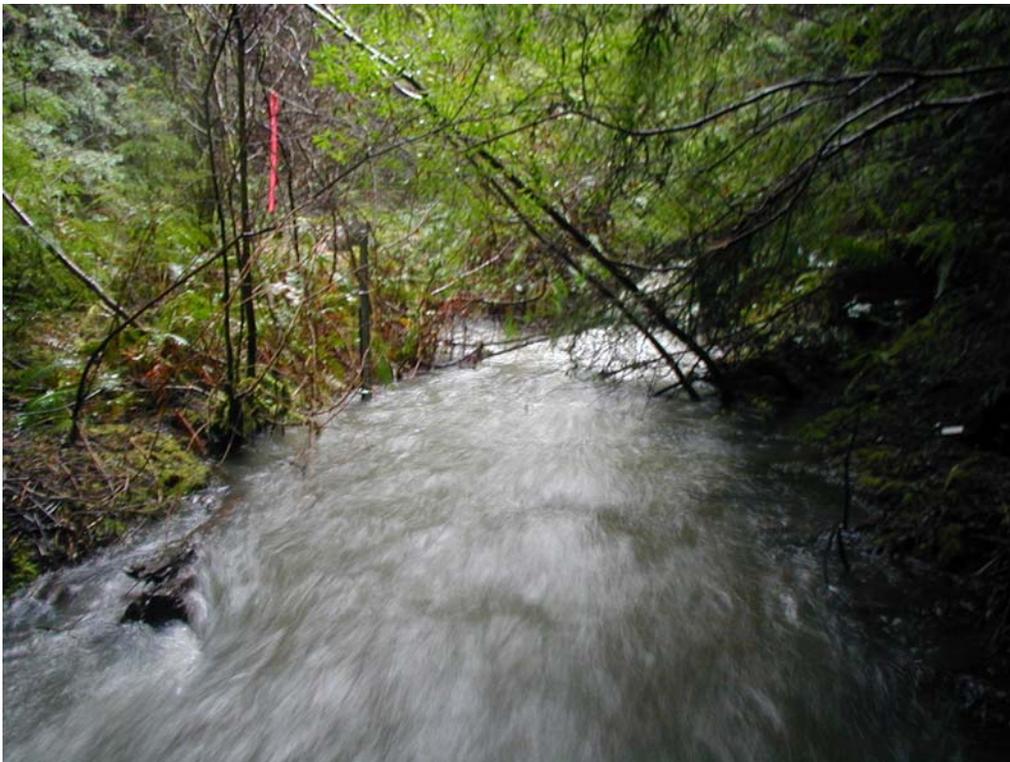
Photo 13. SF Wages above Wood Creek on 2/17/04 with a discharge of ~ 35 cfs. Note Crest Gage on right bank.

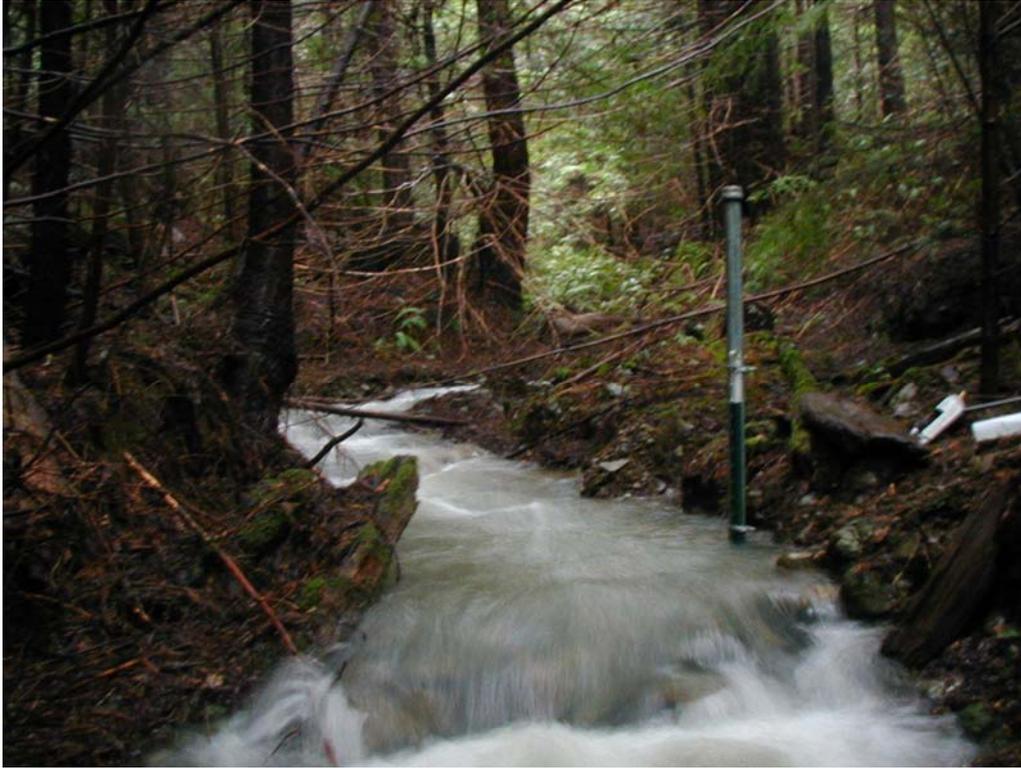
Photo 14. Grey Creek on 2/17/04 with a discharge of ~8 cfs. Note Crest Gage on left Bank. A rock weir was built to allow stage measurements.

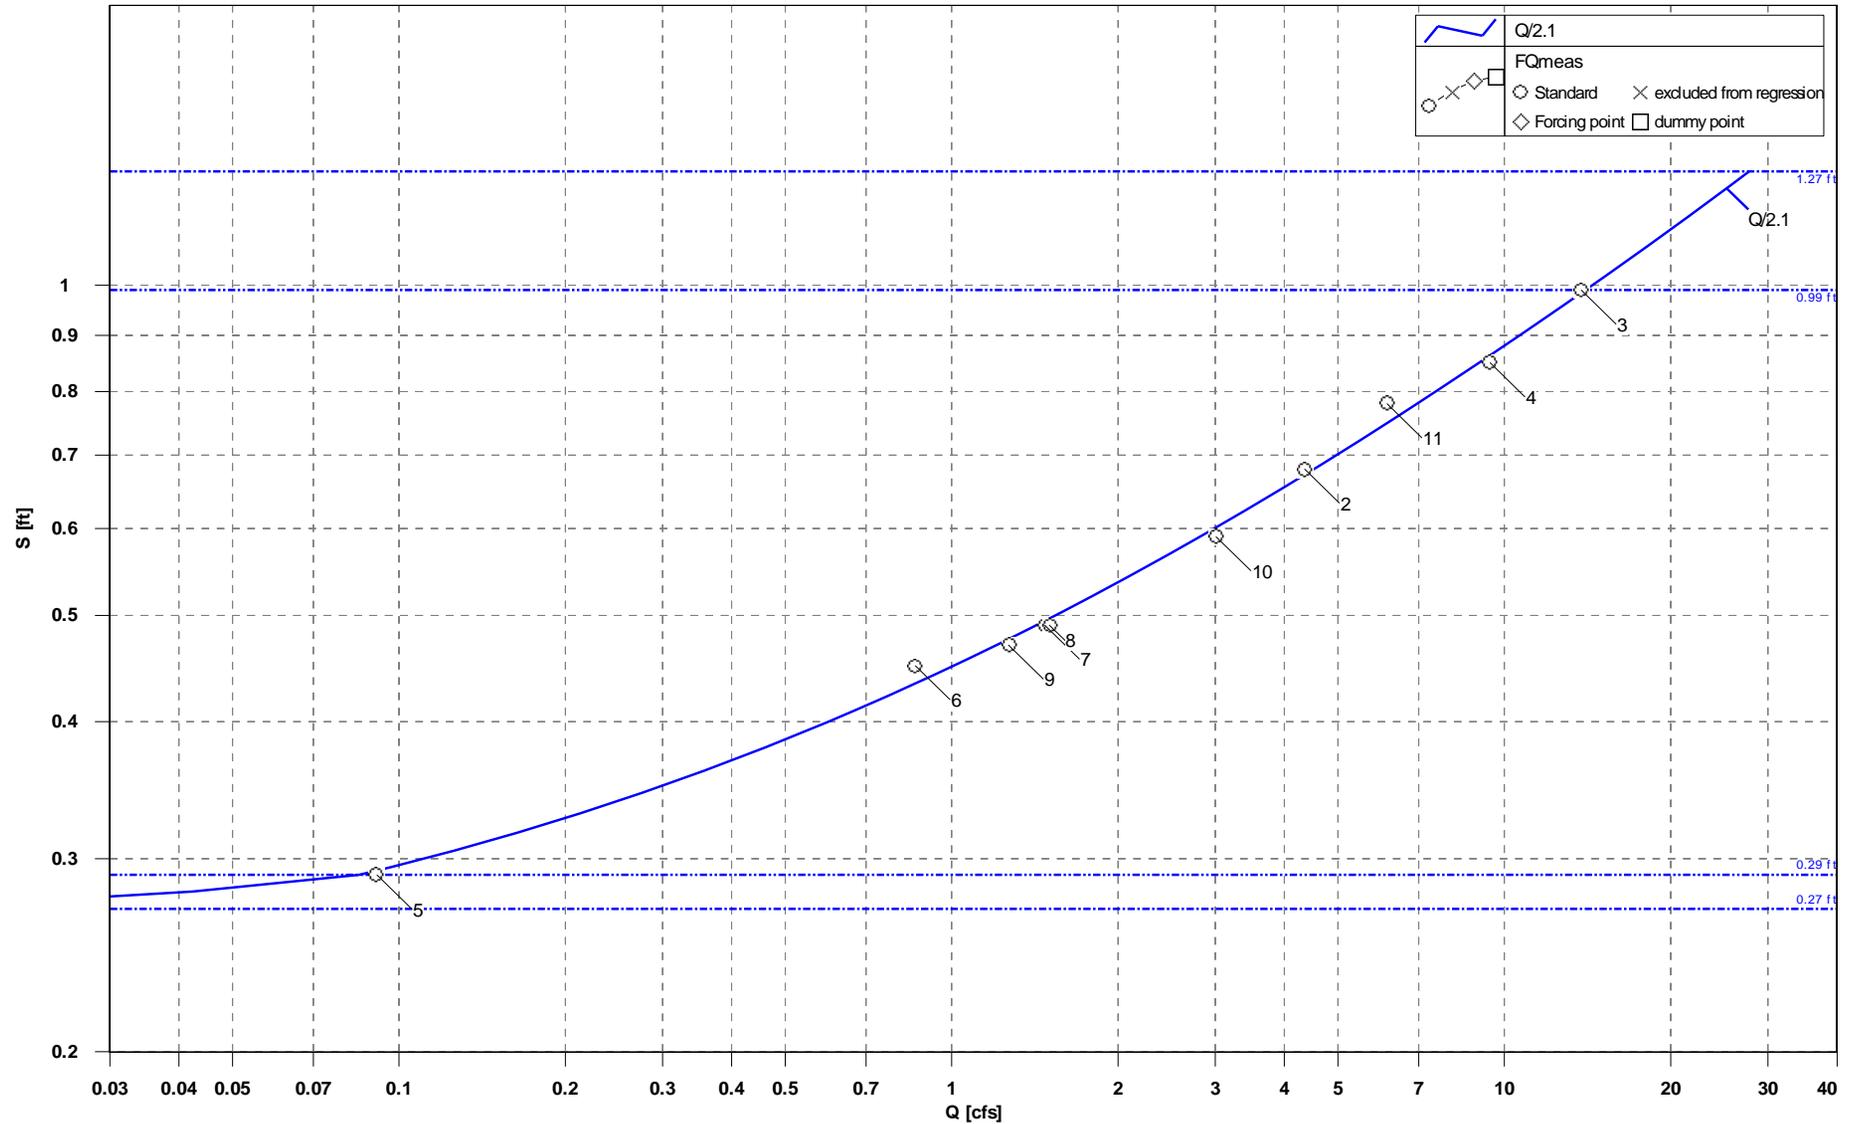
**CENTER GULCH ABOVE SOUTH FORK WAGES CREEK  
Discharge Rating Curve 2.1**

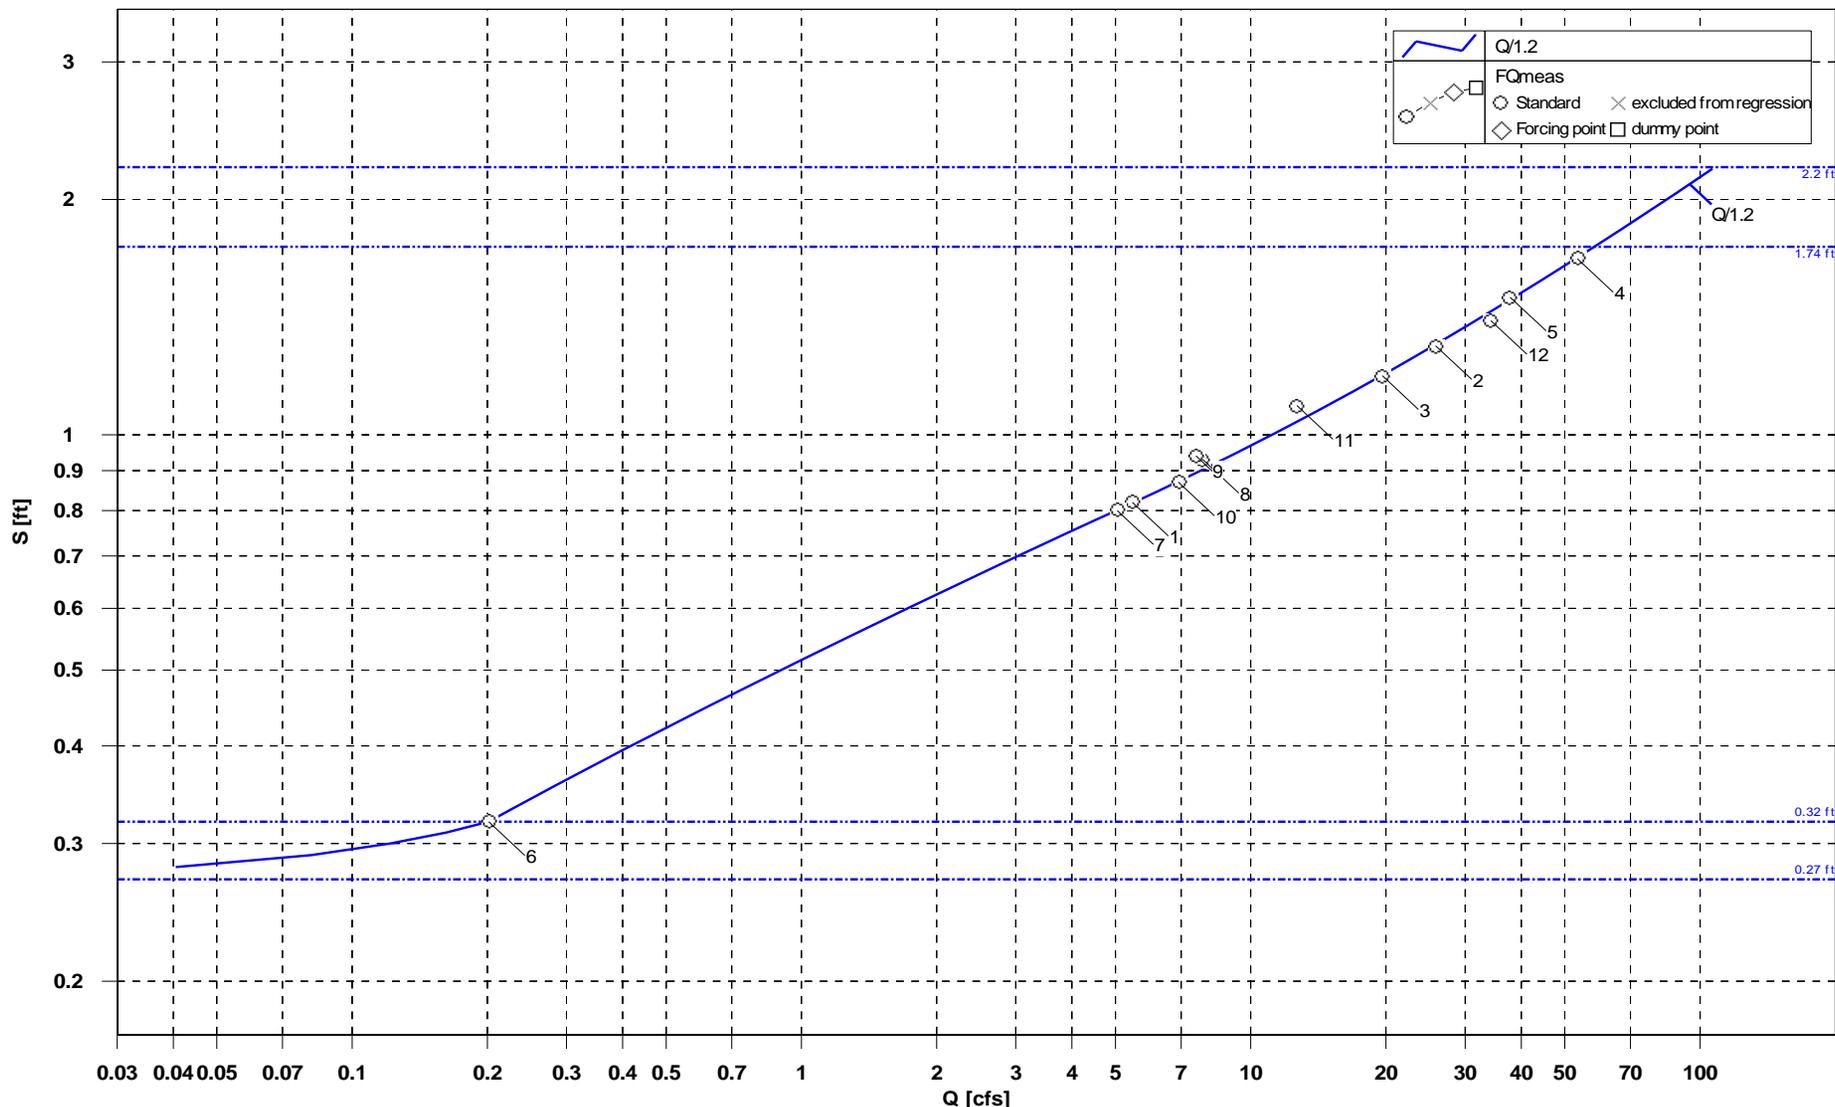
## SOUTH FORK WAGES CREEK ABOVE CENTER GULCH Discharge Rating Curve 1.2
