PROJECT:
SOUTH FORK WAGES CREEK
STREAMFLOW AND SEDIMENT TRANSPORT MONITORING

WY 04-05
APPENDIX
C-2

**GREY CREEK ABOVE SOUTH FORK WAGES CREEK
Discharge Rating Curve 1.2**

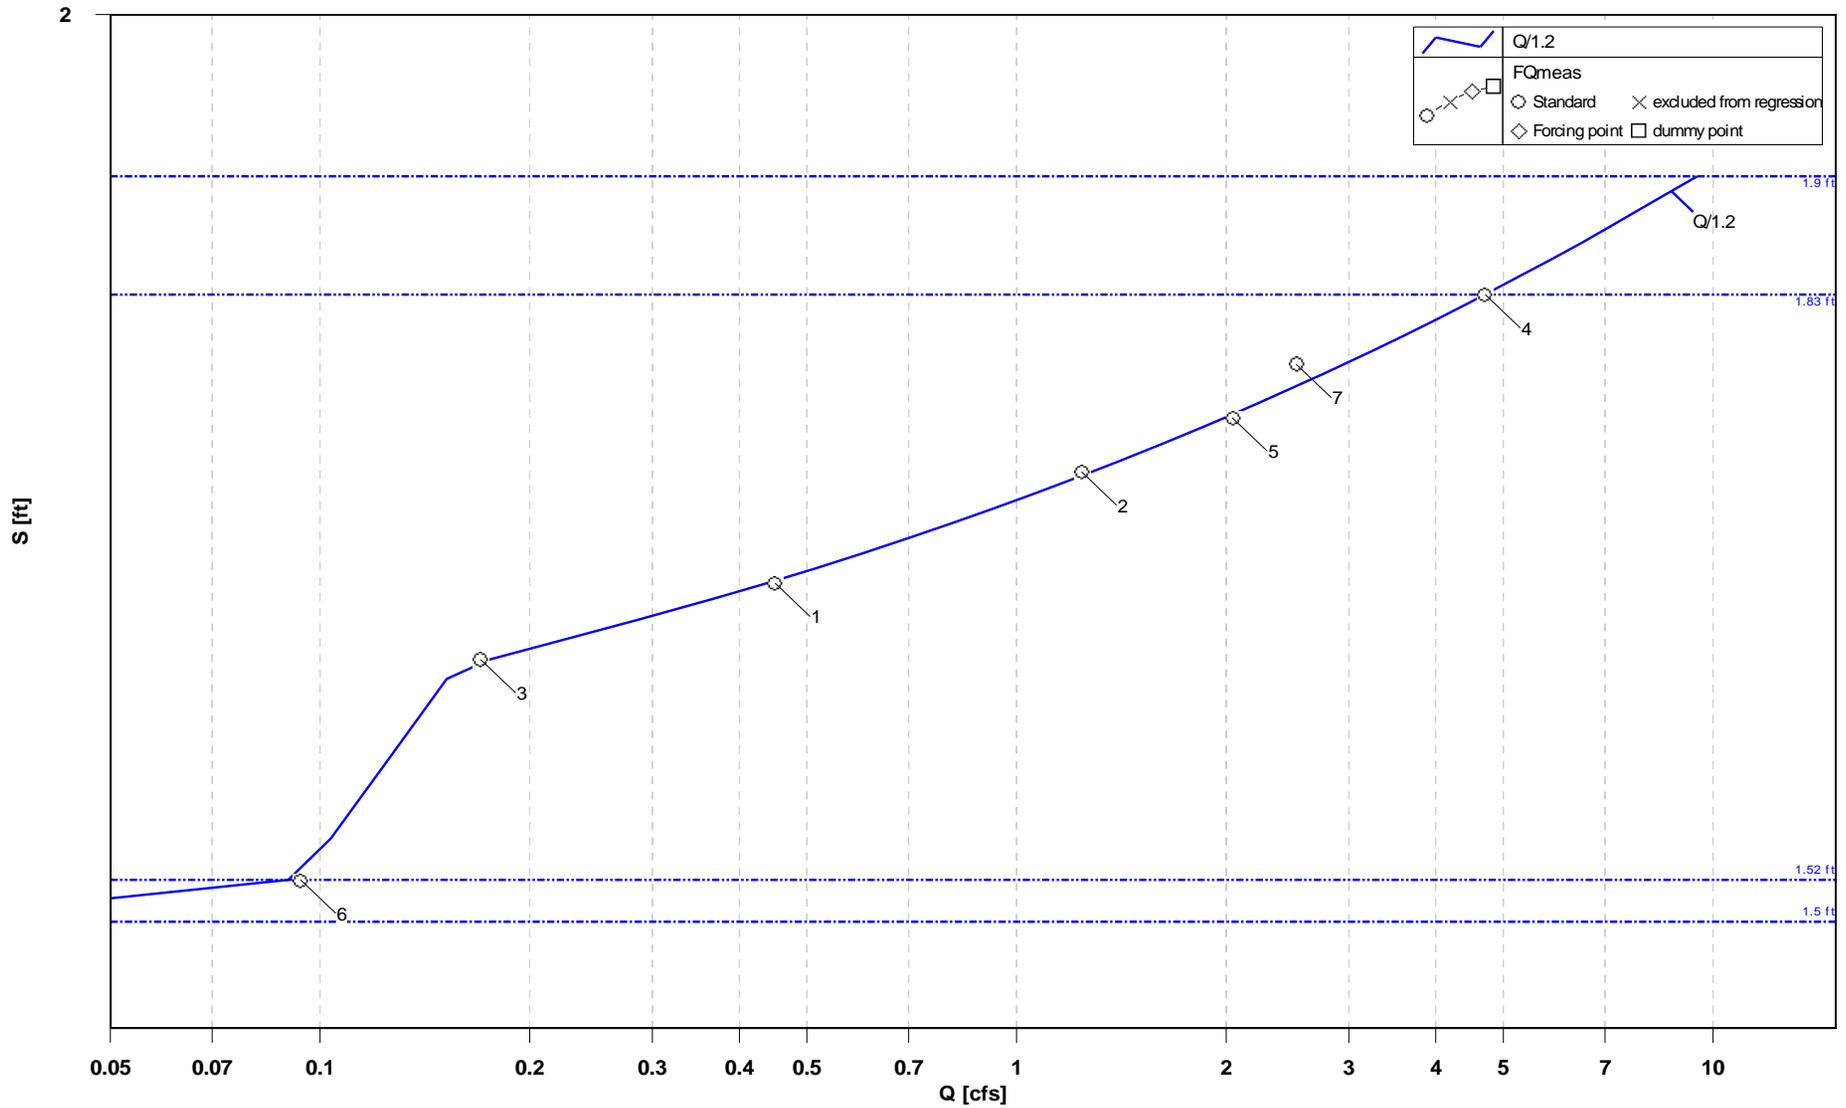
**WOOD CREEK ABOVE SOUTH FORK WAGES CREEK
Discharge Rating Curve 1.2**

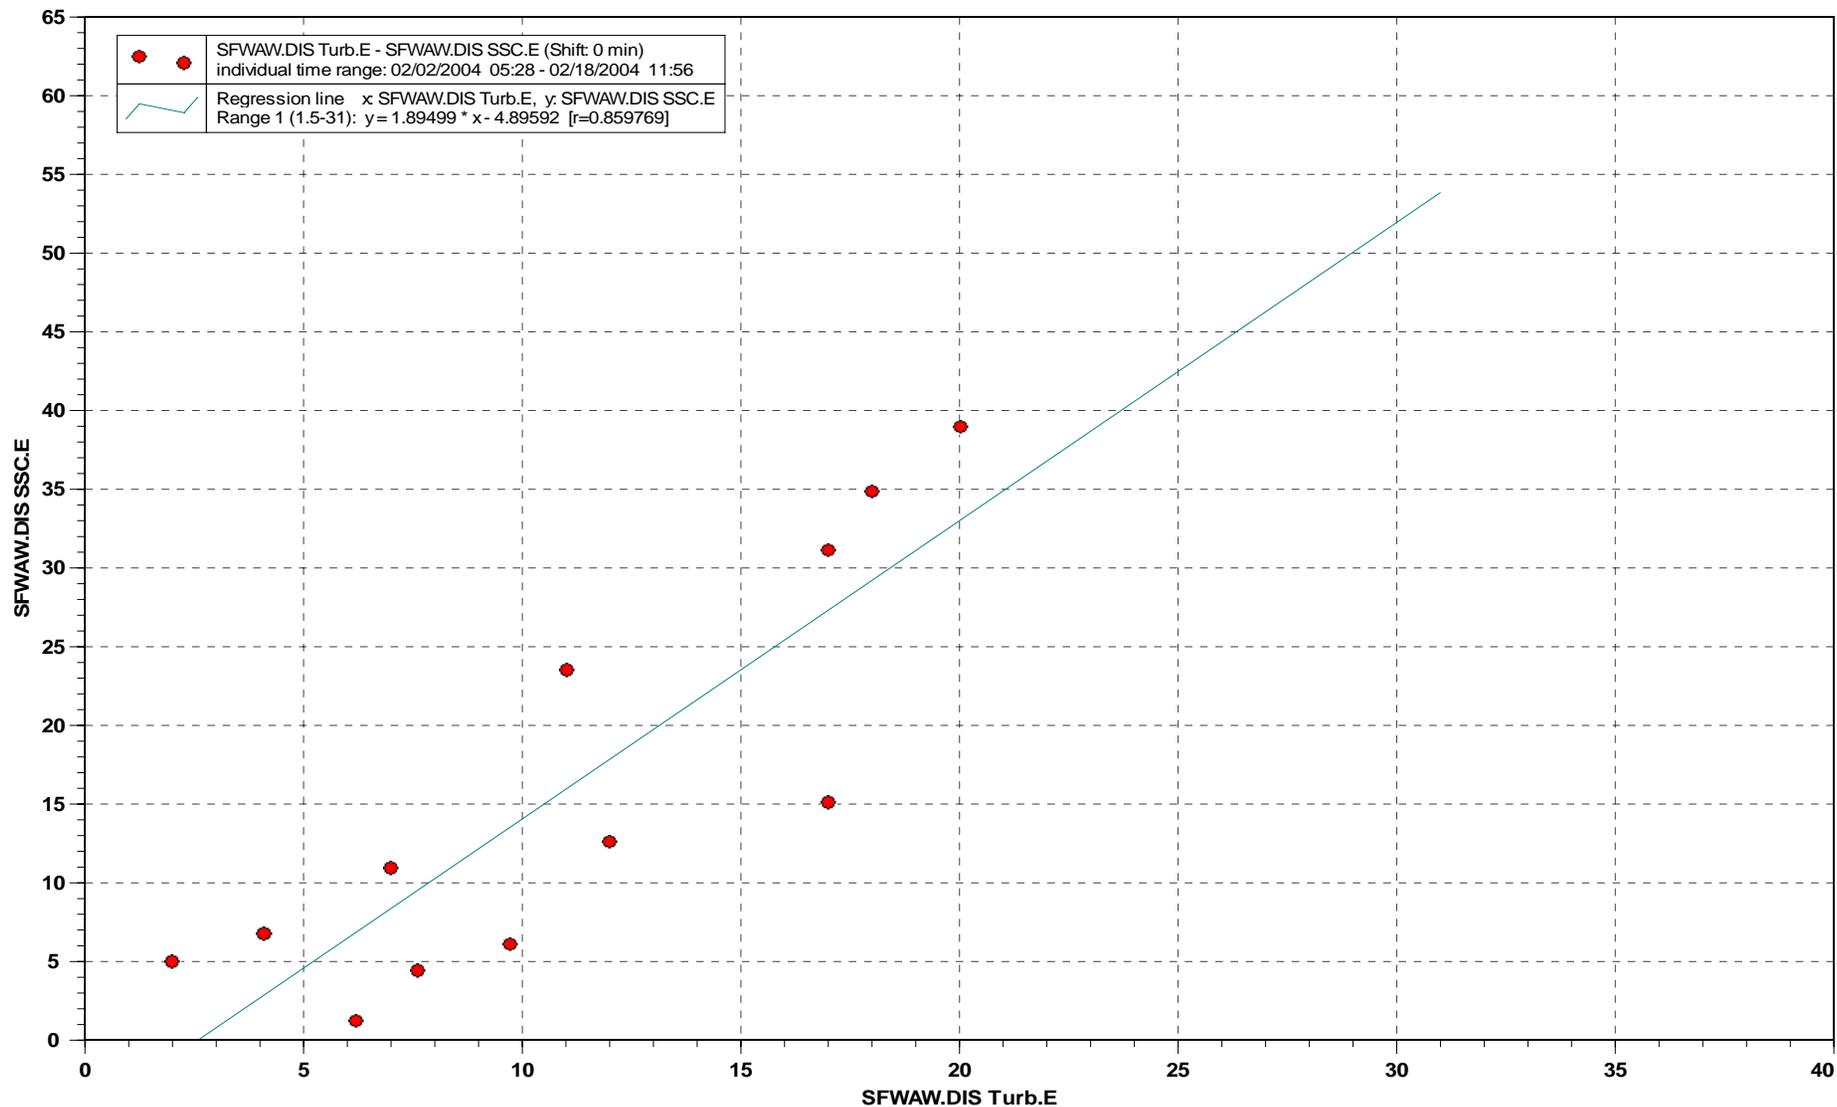
SOUTH FORK WAGES CREEK ABOVE WOOD CREEK
Depth-Integrated Turbidity vs Depth-Integrated SSC

● SFWAW.DIS Turb.E - SFWAW.DIS SSC.E (Shift: 0 min)
 individual time range: 02/02/2004 05:28 - 02/18/2004 11:56
— Regression line x SFWAW.DIS Turb.E, y SFWAW.DIS SSC.E
 Range 1 (1.5-31): $y = 1.89499 * x - 4.89592$ [r=0.859769]

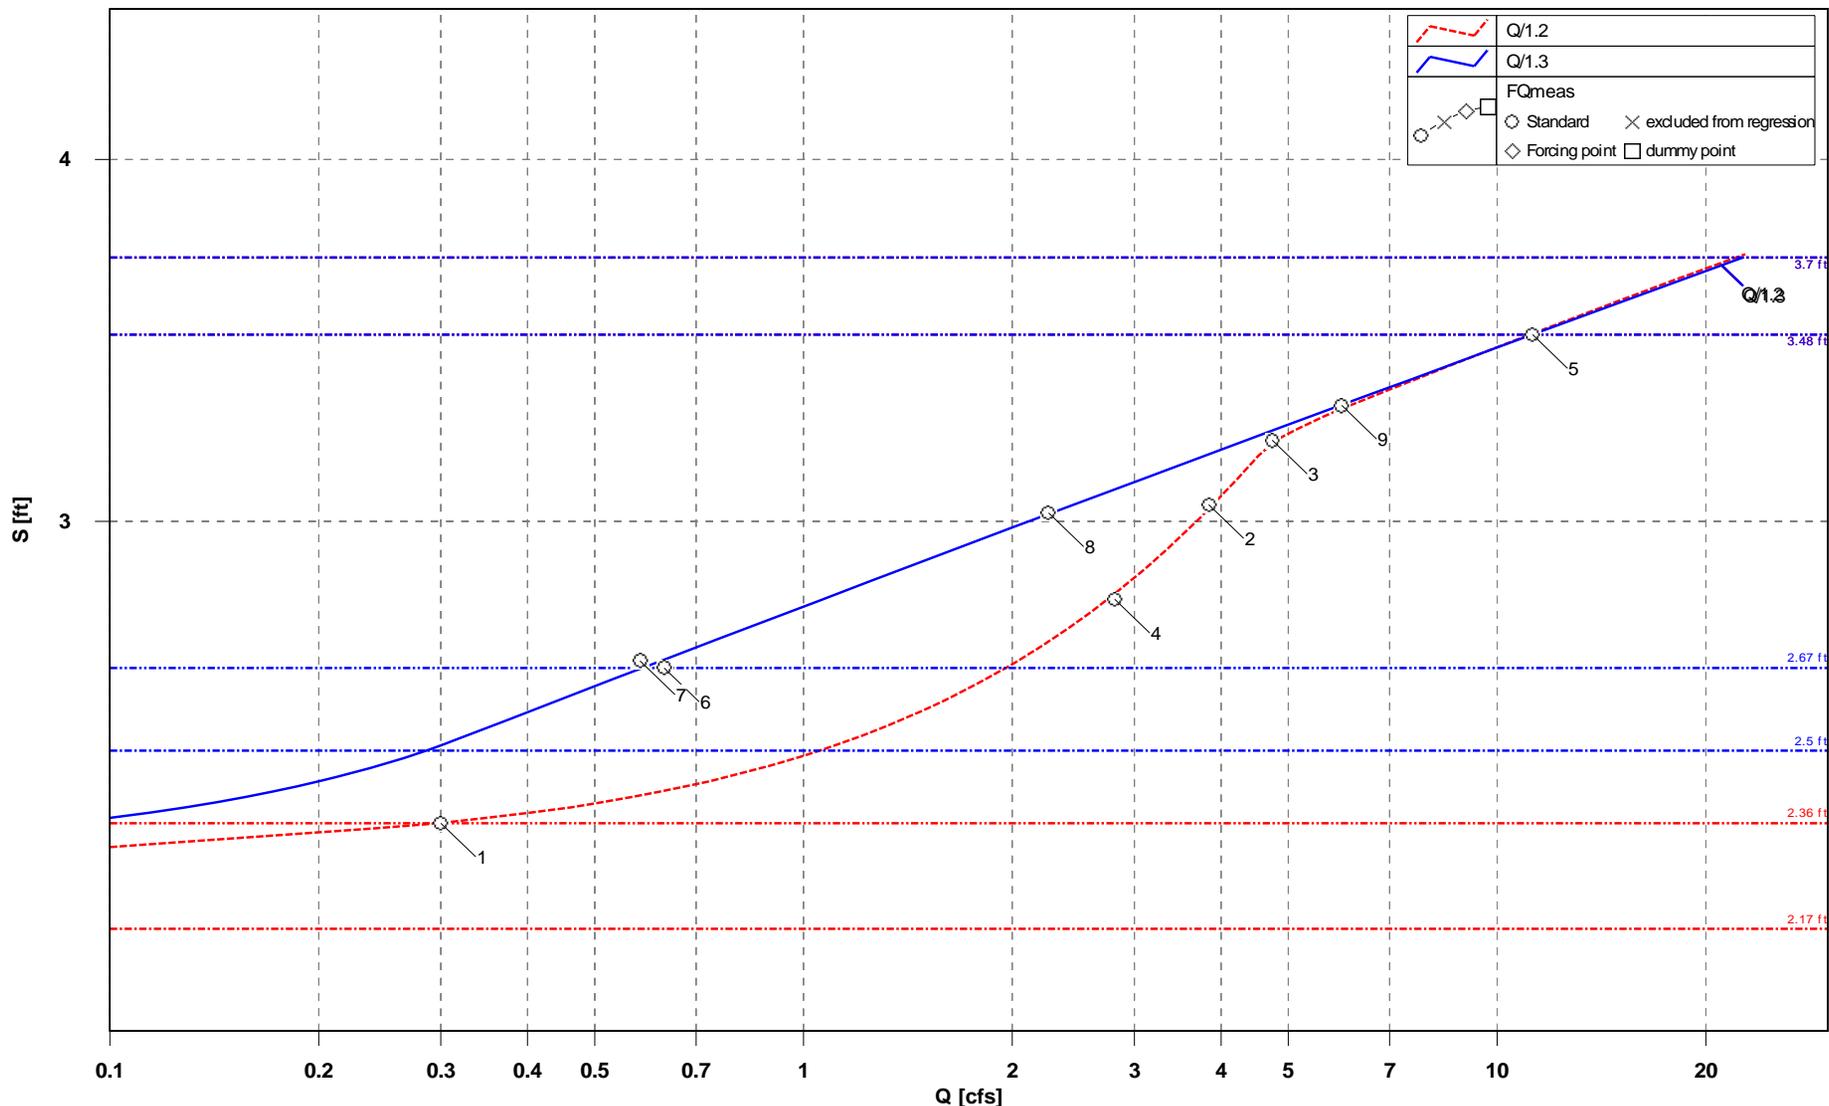
ROCK CREEK ABOVE SOUTH FORK WAGES CREEK Discharge Rating Curves 1.2 & 1.3

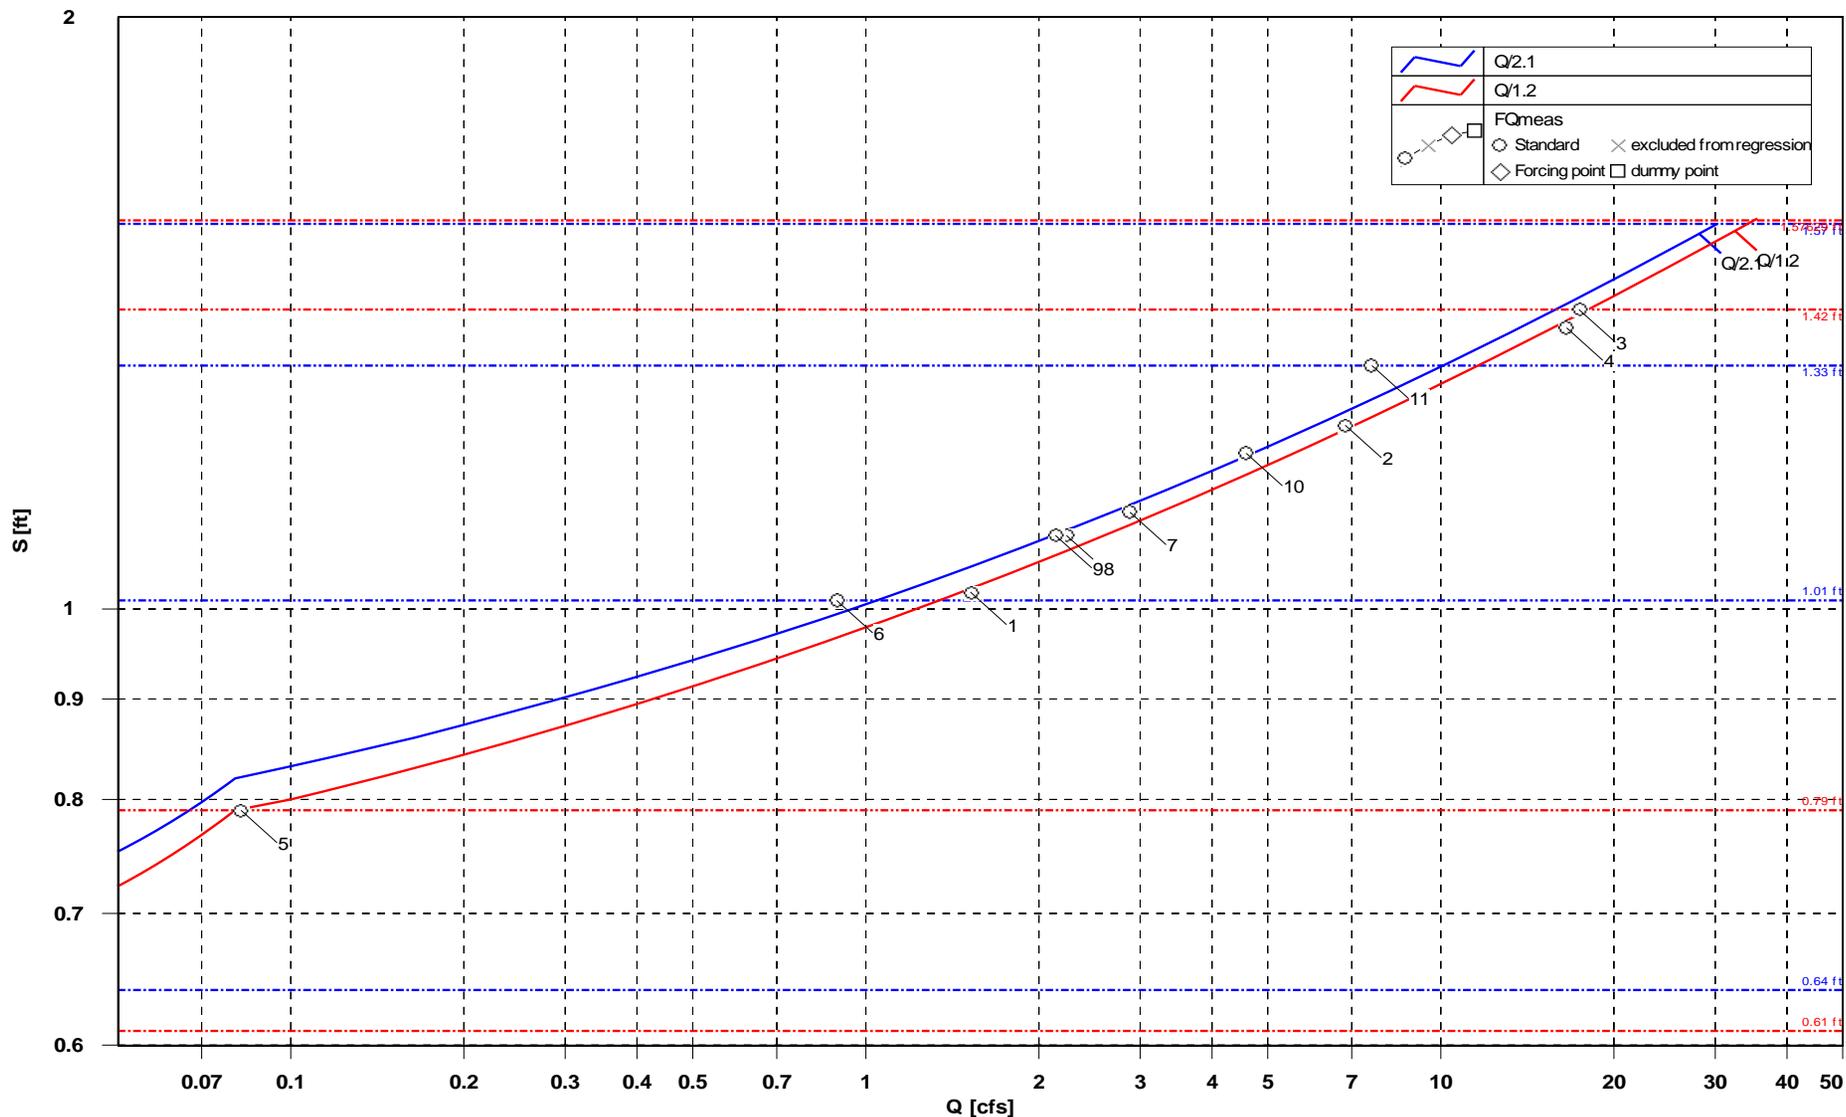
SOUTH FORK WAGES CREEK ABOVE ROCK CREEK Discharge Rating Curves 1.2 and 2.1

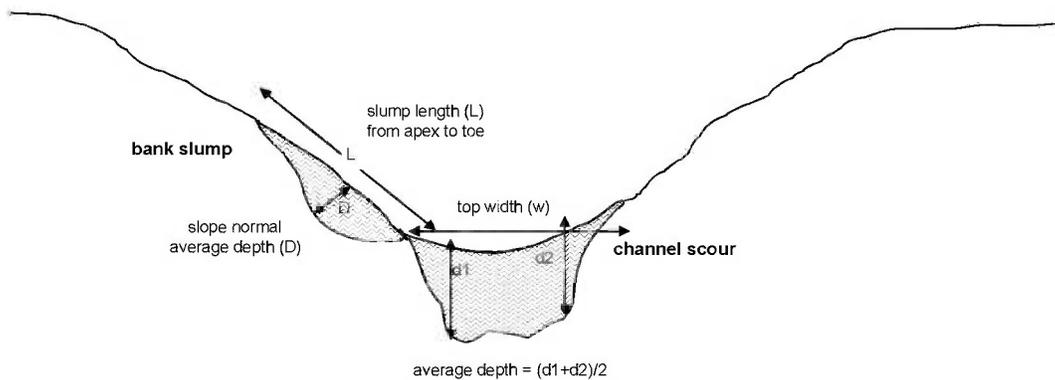
Figure 2. Void measurement technique as viewed in cross section. Source: Klein (2003), used with permission.

The void or volume of bank slumps was calculated by multiplying area (A , above) by average depth (Figure 2, D , feet). Average depth of the failure void was measured or, if the slump mass was still there, visually estimated in the field as the depth perpendicular to the adjacent slopes (“slope normal”). Volume was reported in cubic yards. The percentage of slump volume actually delivered to the channel was estimated for each feature.

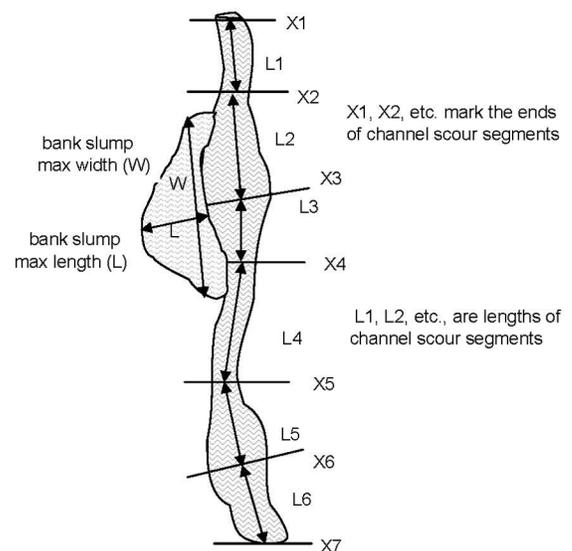
Figure 3. Void measurement technique as viewed from above. Source: Klein (2003), used with permission.

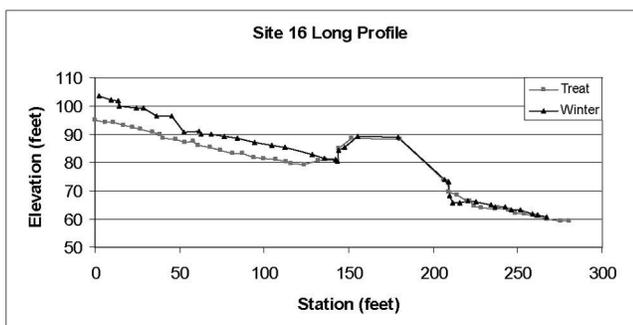
Figure 4. Longitudinal profile of site 16 (see Table 5) at Hoopa showing up to 8 ft of aggradation upstream of inlet due to a large landslide. The crossing structure and fill are located approximately at stations 150–200 ft.

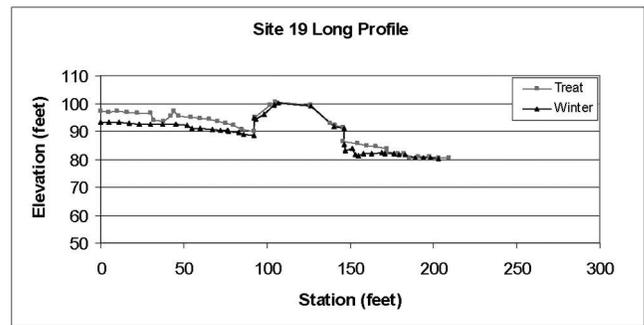
Figure 5. Long profile of site 19 (see Table 5) at Hoopa showing scour above and below the culvert caused by temporary plugging of the culvert and subsequent clearing. The crossing structure and fill are located approximately at stations 100–150 ft. A constructed water drafting pool was located at station 50 ft.

At site 19, it appeared that the sediment pulse temporarily plugged the culvert and caused erosion both upstream and downstream when it finally released (Figures 5 and 6). None of the changes at the Hoopa sites appeared to be caused or aggravated by upgrading. Madej (2001) made similar observations at decommissioned crossings in Redwood National Park and similarly did not attribute the observed changes to the treatments. The relatively severe rainfall conditions experienced at Hoopa (Table 4, events in

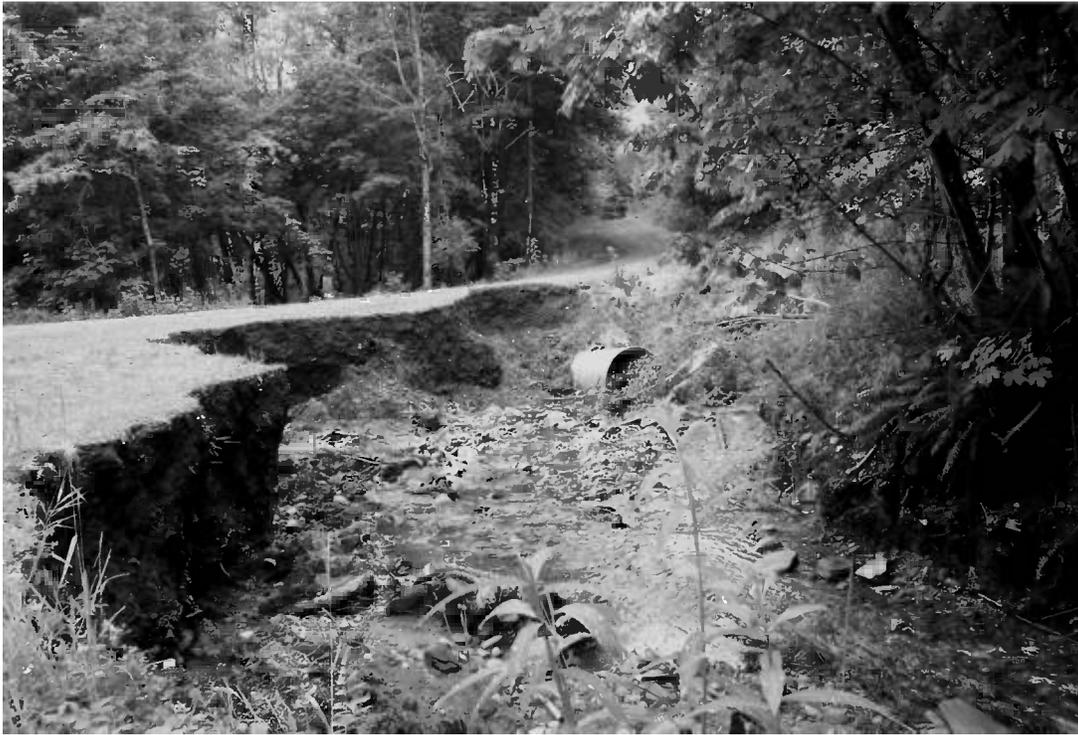
Figure 6. Erosion of road fill at site 19 at Hoopa caused by temporary culvert plugging from landslide debris and sediment. Incision occurred downstream as well.

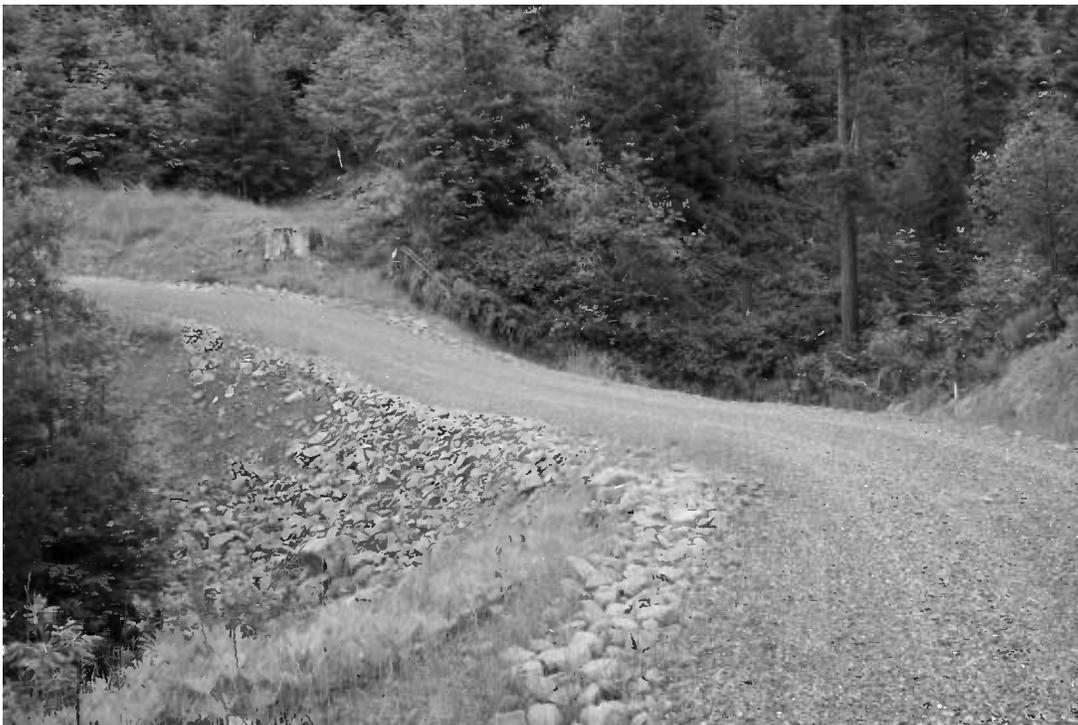
Figure 7. Typical crossing and road installation, PALCO lands, Humboldt County. Design features include alignment and slope of culvert conforming to the natural channel, extensive armoring to prevent fill slope and channel erosion, and provision of a "critical dip" in the road surface to prevent diversion of flow down the road if the culvert plugs. All exposed soils were treated with straw mulch and grass seeding to prevent erosion.

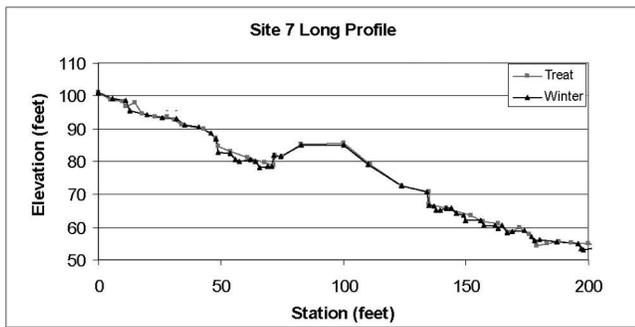
Figure 8. Profile showing incision above and below an upgraded stream crossing at site 7. XS indicates the locations of measured cross sections. Note that cross section locations alone have not captured the changes in the channel. TOP and BOT indicate the limits of excavation upstream and downstream, respectively.

form, flat channel bottoms created upstream and downstream from crossings by construction were simply “roughened” by the actions of various flows over the winter (see Figure 8, downstream section). At many of the study sites, it was not considered feasible to fully excavate fill and debris associated with past logging and transportation systems. As a consequence, some observed incisions represented evacuation of that stored material rather than changes to the native stream bed. Efforts taken to reduce the movement of stored material included armoring of potential head cuts and channel beds.

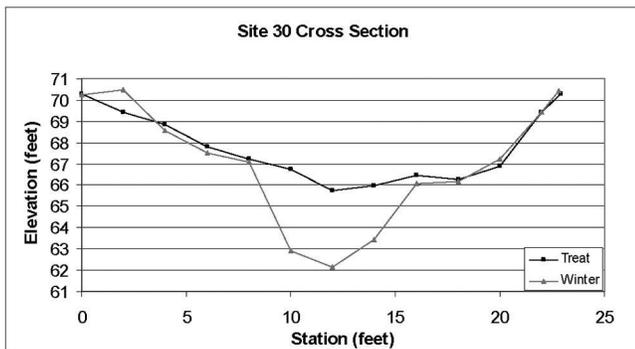
Figure 9. Cross section below upgraded crossing indicating incision of approximately 4 ft at the thalweg.

Few cross sections were located in places that coincided with significant incision or deposition. Those that did were found at sites where longitudinal profiles indicated the most erosion (Figure 9). Cross sections alone were not close enough to capture channel changes. The longitudinal profile was a superior method for measuring changes to the channel bed.

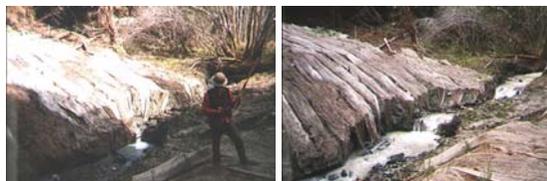
Above: CX-4 before and after the 44-yr peakflow of March-99. Left: CX-7 and below: CX-13 after the same storm.

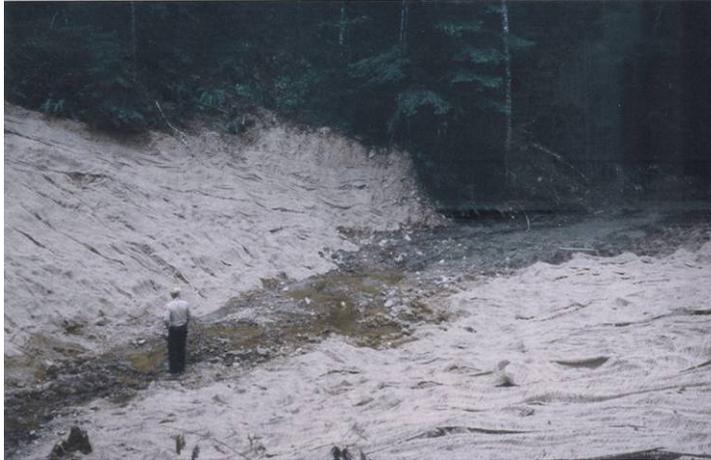
Figure 2. Excavated crossing CX-21 with jute netting on side slopes, November 1998.

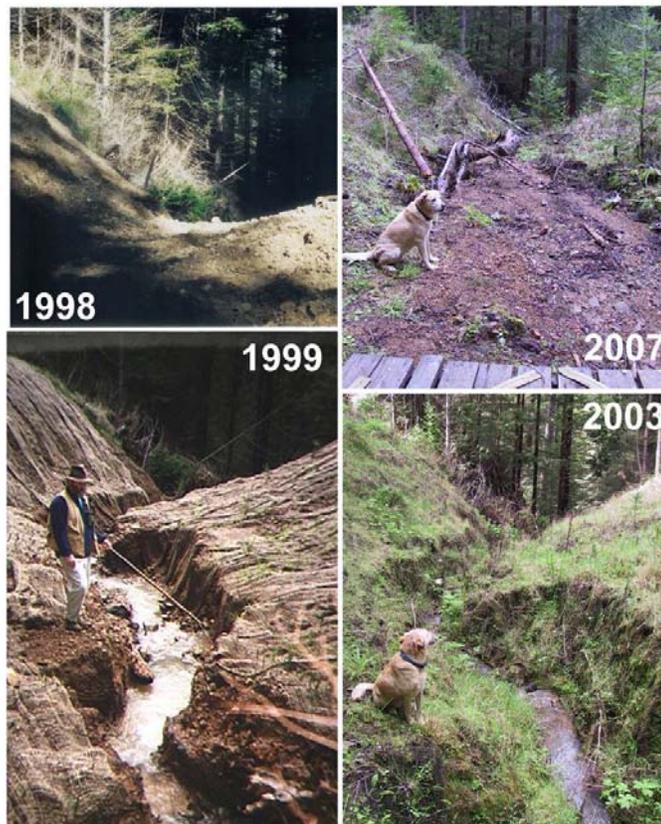
Figure 3. Treated crossing CX-7 eroded severely and has yet to stabilize. In 2006, a debris flow deposit filled much of the void.

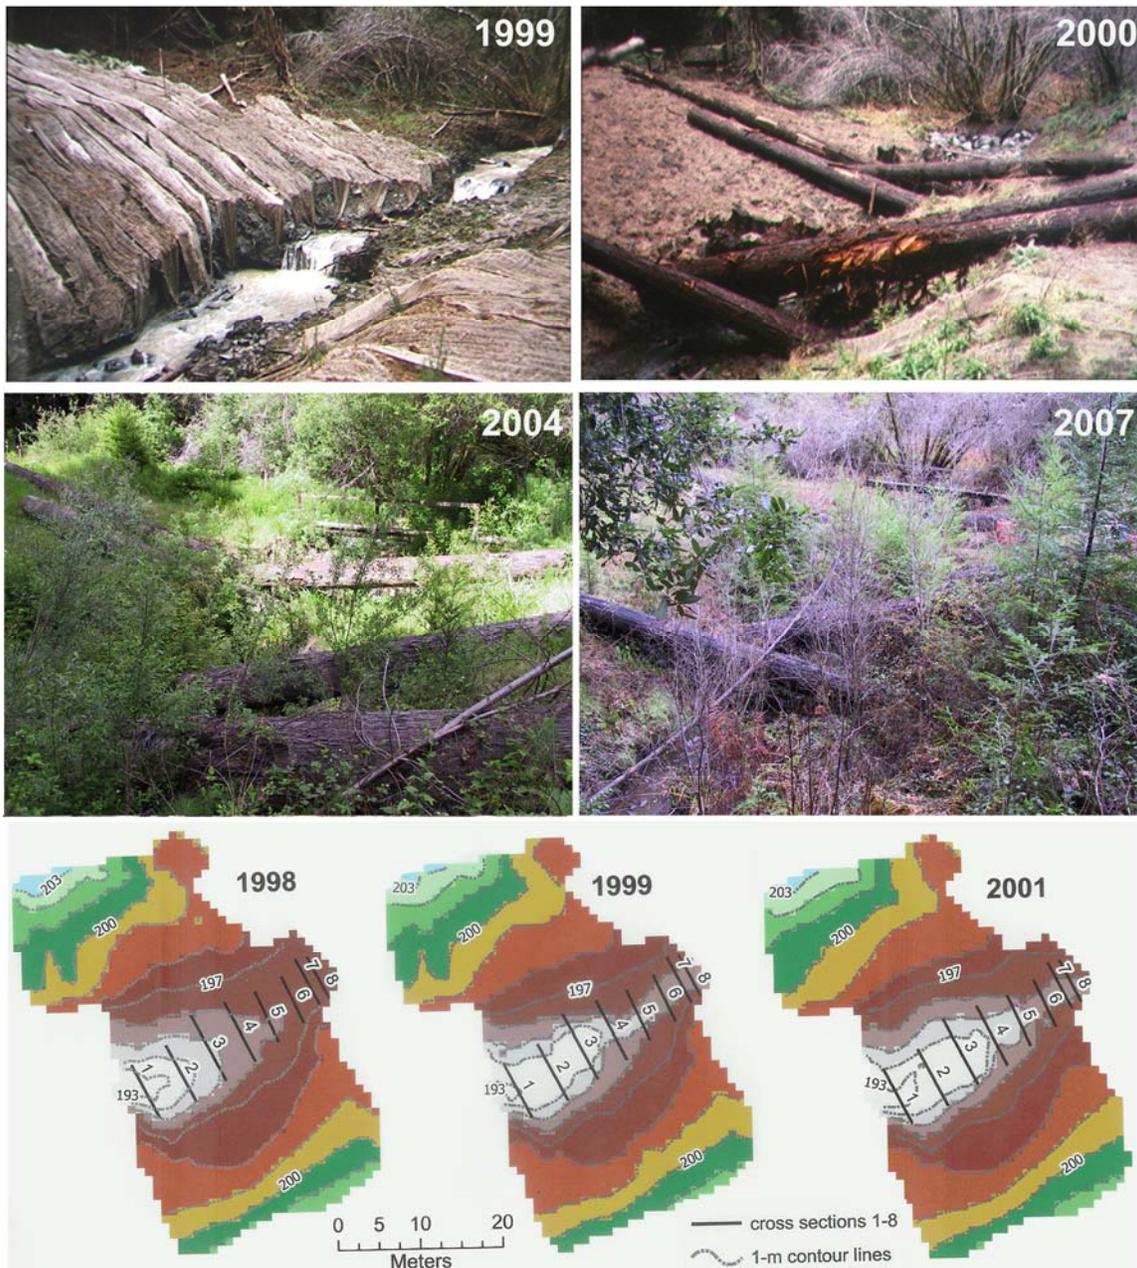
Figure 4. Photographs show channel adjustments and revegetation occurring between 1999 and 2007 at the large watercourse crossing (CX-4) on road 600. Surveyed grid elevations indicate almost 2 m (7 ft) of downcutting. Although further headcutting was halted by the boulder armoring done in 1999 and the placed redwood stumps have re-rooted, channel widening due to bank sloughing has continued.

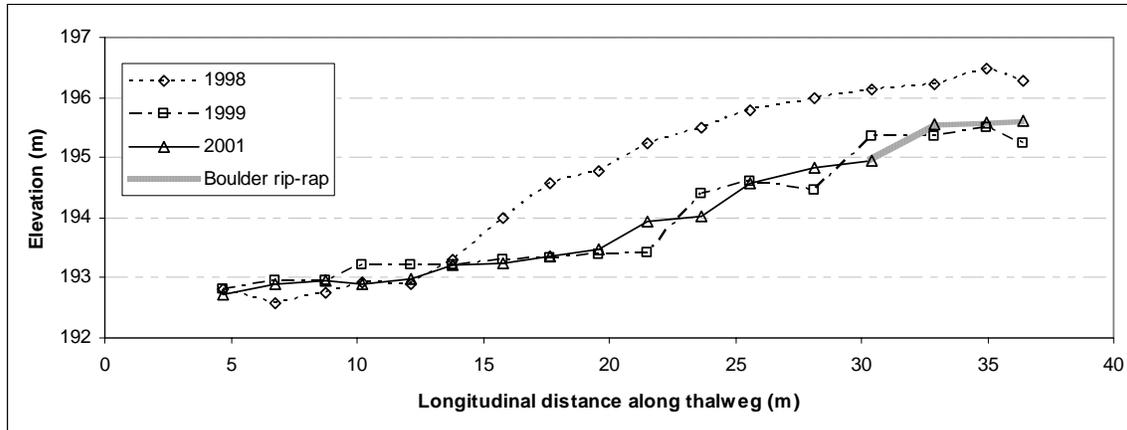
Figure 5. Surveyed longitudinal profile of the thalweg at crossing CX-4.

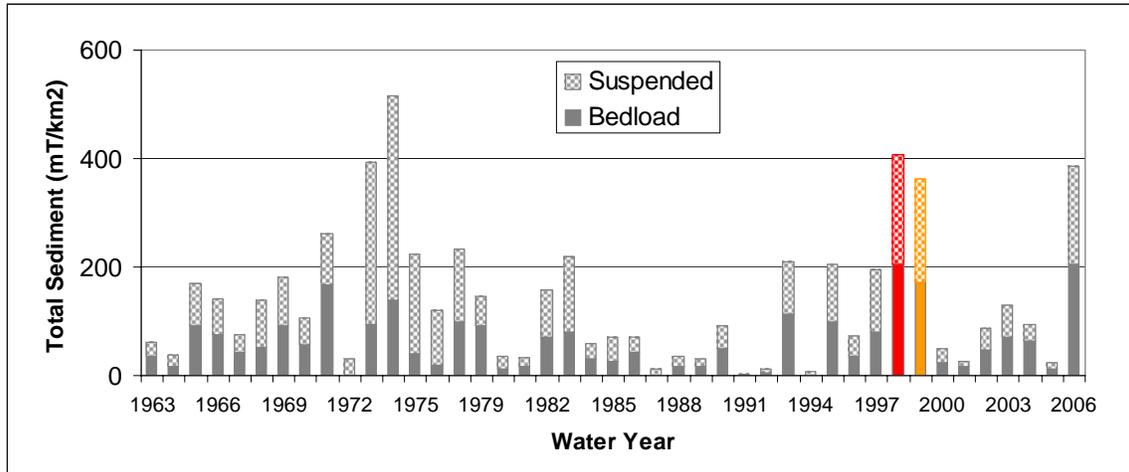
Figure 6. Total annual sediment yield for the South Fork Caspar Creek watershed 1963-2006. High yields from 1973-1975 reflect tractor logging impacts in the South Fork watershed (Rice and others 1979). High sediment yields in water year 1998 (shown in red) resulted from numerous landslides; high sediment yields in water year 1999 (shown in orange) resulted from road decommissioning work and landslide material which continued to be transported downstream. (2006 suspended load estimate is preliminary).
