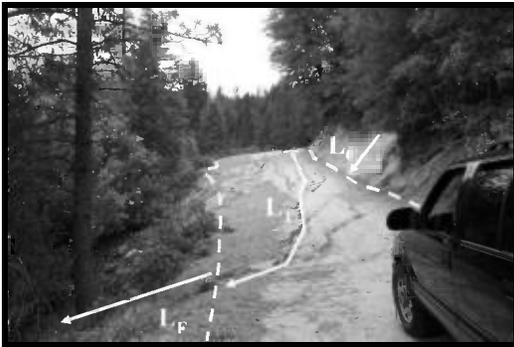
Figure 1. A picture of a reconstructed outsloped native surface road on a highly erodible, weathered granodioritic hillslope in northern California, USA. The road prism is comprised of the cutslope, travelway, and fillslope, and the arrows show the potential length of overland flow for each of these pathways. Note how the rill networks on the travelway concentrate the road surface runoff before it is discharged onto the fillslope. The extensive rilling is due to poor compaction during road reconstruction.

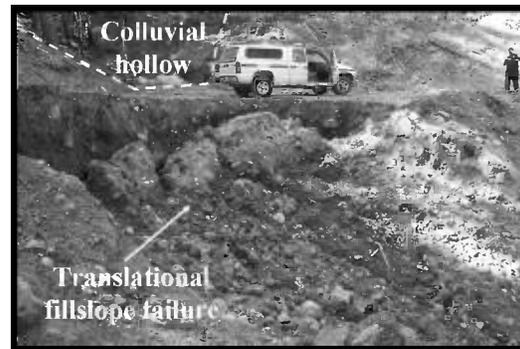
Figure 5. A translational fillslope failure directly below a colluvial hollow. Colluvial hollows concentrate SSF, so placing fill material in these landforms can increase the likelihood of landsliding.

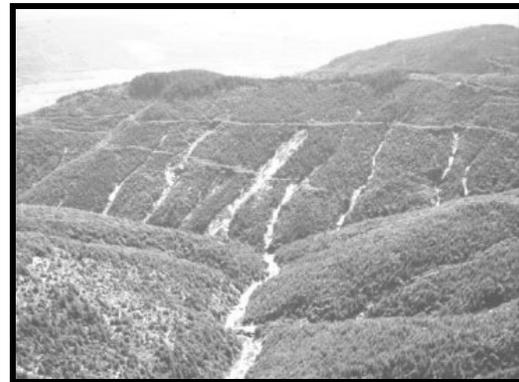
Figure 6. Road-induced debris flows in northwest Washington state, USA. The debris flows initiated in the colluvial hollows on the upper road were triggered by road runoff, and these triggered the failures at the road-stream crossings on the lower road. This sequence has been defined as a “disturbance cascade” (Wemple et al., 2001). The road was built prior to the implementation of best management practices and large fill volumes were placed within colluvial hollow and inner gorge landforms (WA DNR, 1983).

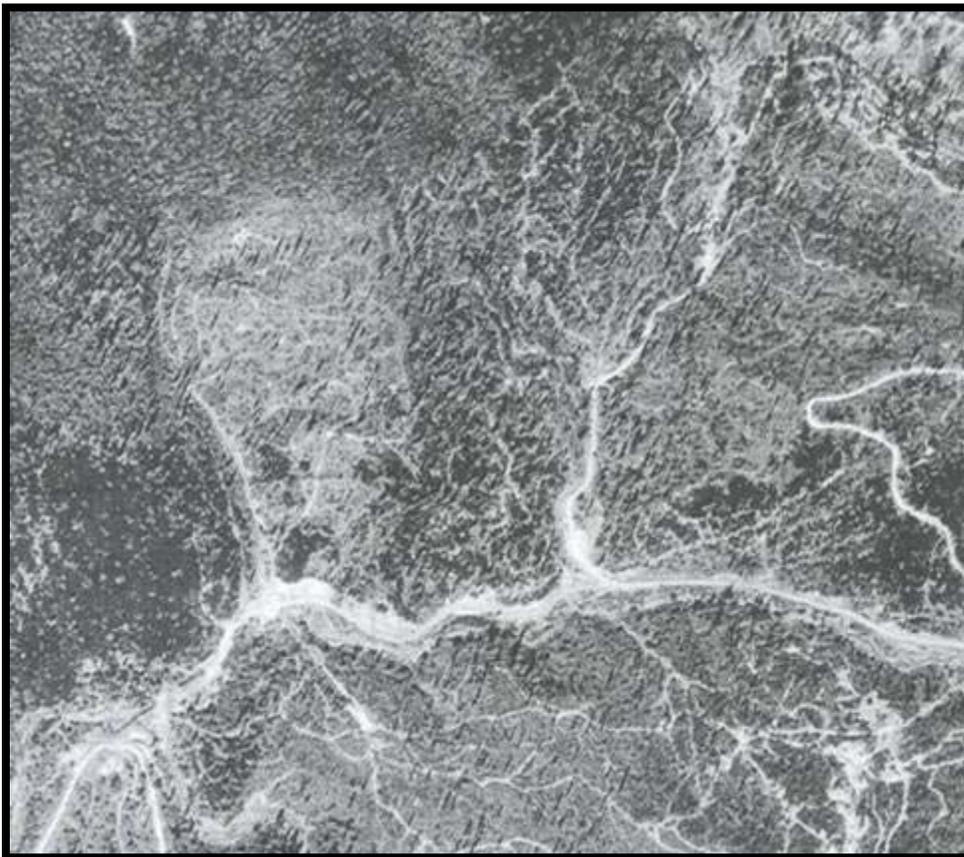
Figure 4. Corrigan Creek Area, 1954

Although there are no written records of exactly what occurred in those years, aerial photos give a pretty good idea (Figure 4). In subsequent years there have been a number of additional entries, but due to better forest practices and the implementation of the California Forest Practice Rules, none have been nearly as devastating (Figure 5).

Features reflecting these operations can be clearly seen both on the ground and on the maps. There is a relatively extensive road network around Corrigan Creek, and old landings, steam crossings, etc. can be found in multiple locations.

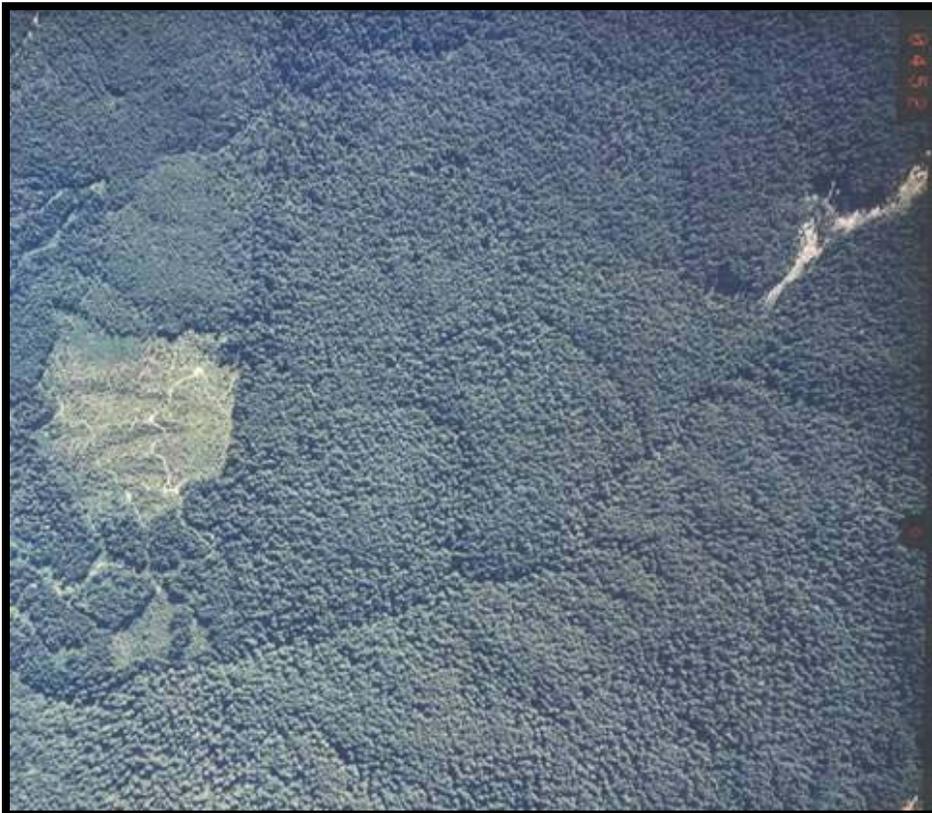
Figure 6. Little South Fork Area, 2003

The history of the upper portion of Little South Fork is quite different. The area escaped harvest during the time Corrigan Creek was logged, most likely because of its remote location and steep terrain. It was scheduled to be harvested during the early 90s, but it was purchased from PALCO and placed in the protection as a reserve by the Bureau of Land Management. A road was built by PALCO which ended near the headwaters of Little South Fork, but was decommissioned and restored in 2003 by the BLM. This road can be seen at the right of the photograph in figure 6. The Little South Fork Watershed is comprised of late seral old growth redwood, and is managed to promote and maintain its complexity by the BLM.

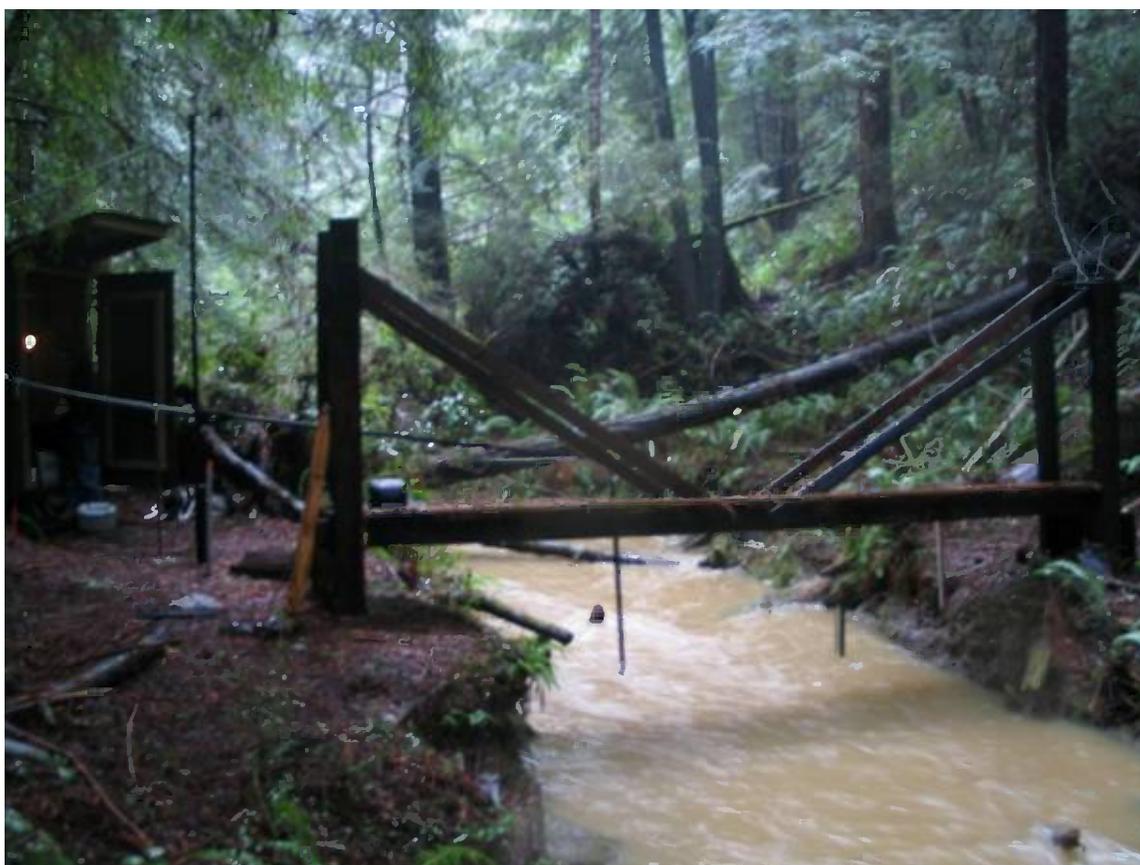
Figure 3. Sampling station located on Corrigan Creek.

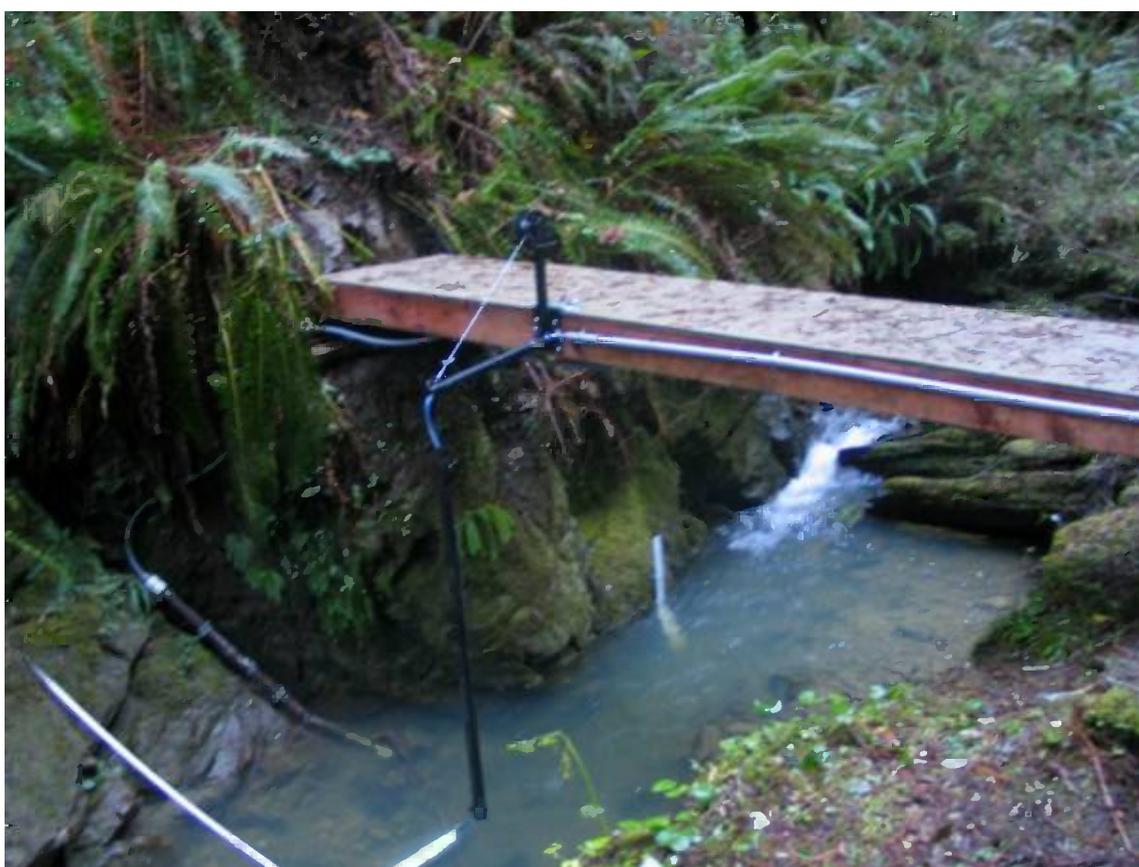
Figure 4. Sampling station located on Little South Fork Elk River.

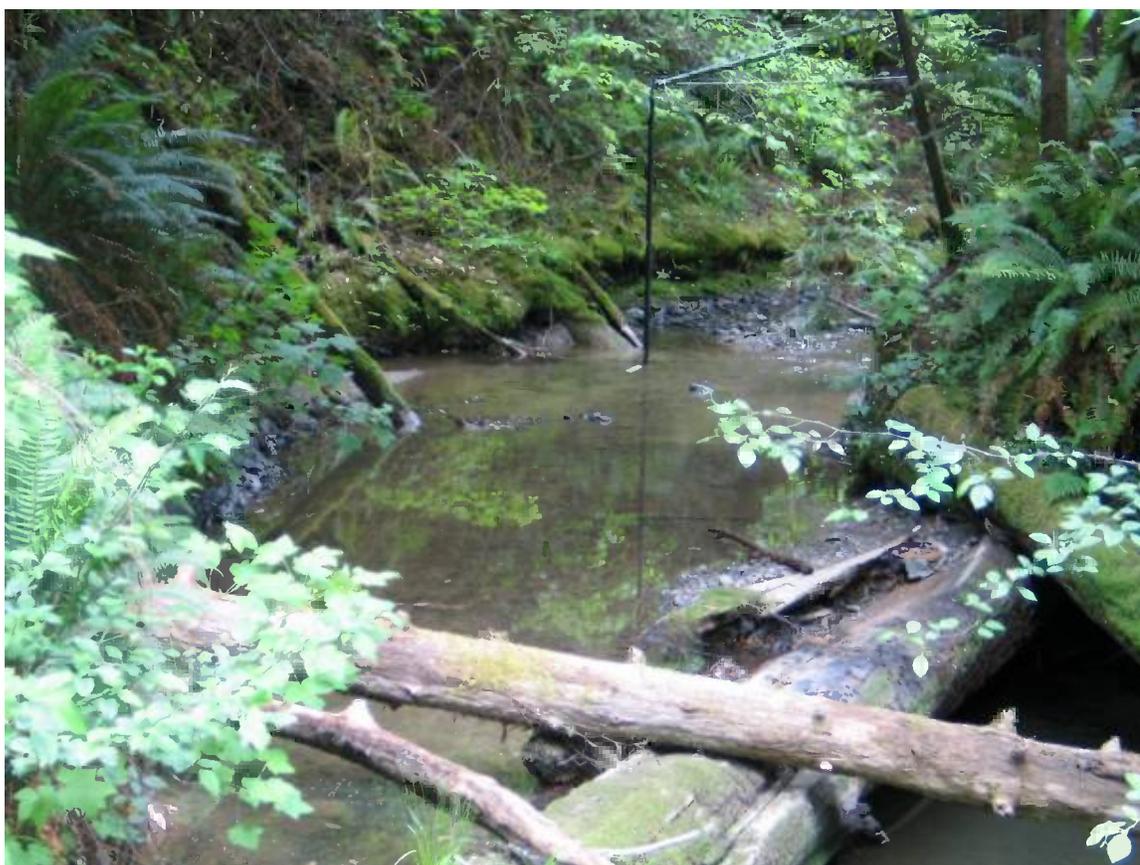
Figure 5. Sampling station located on South Branch North Fork Elk River.

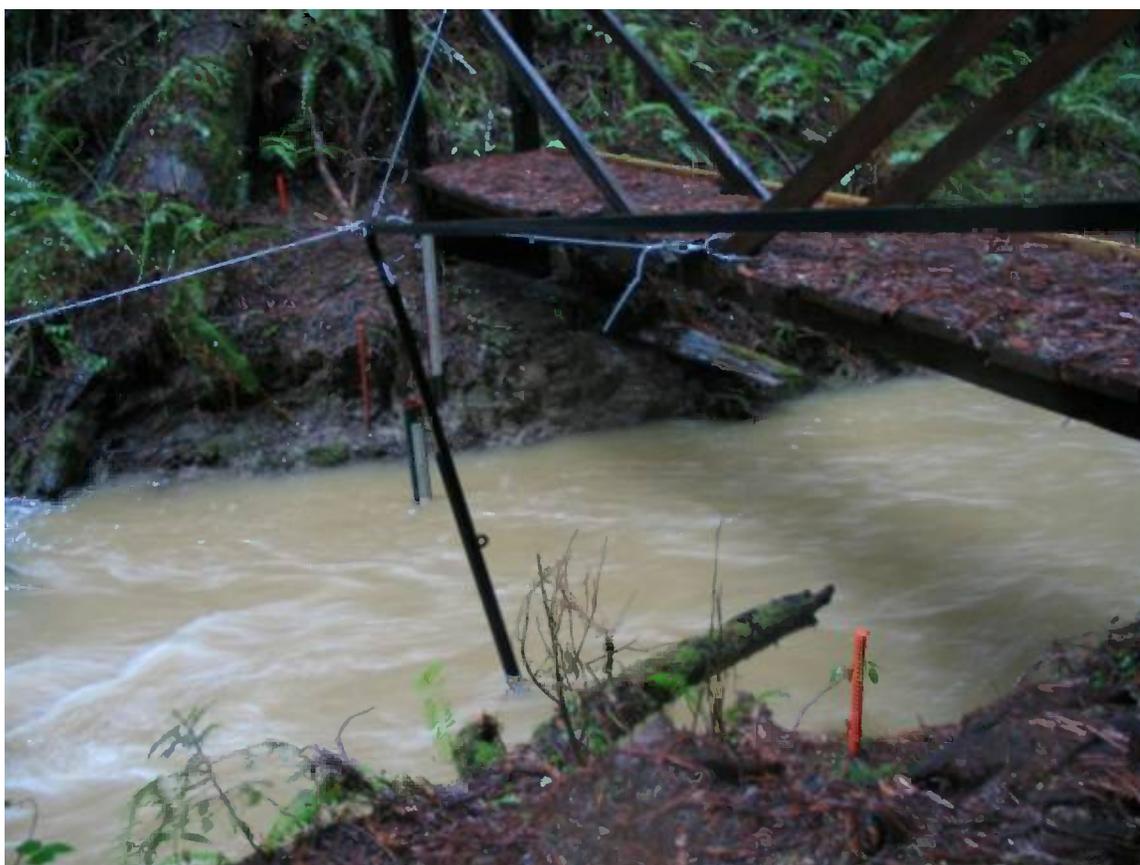
Figure 6. Bank mounted sampling boom articulating downstream during a high flow event on Corrigan Creek.
