8 **CALIFORNIA STATE WATER RESOURCES CONTROL BOARD**

9  
10 In the Matter of Cleanup and Abatement Order  
11 No. RI-2014-0018

**PETITION FOR REVIEW**  
**Cal. Water Code §13320**

# **Exhibit C**

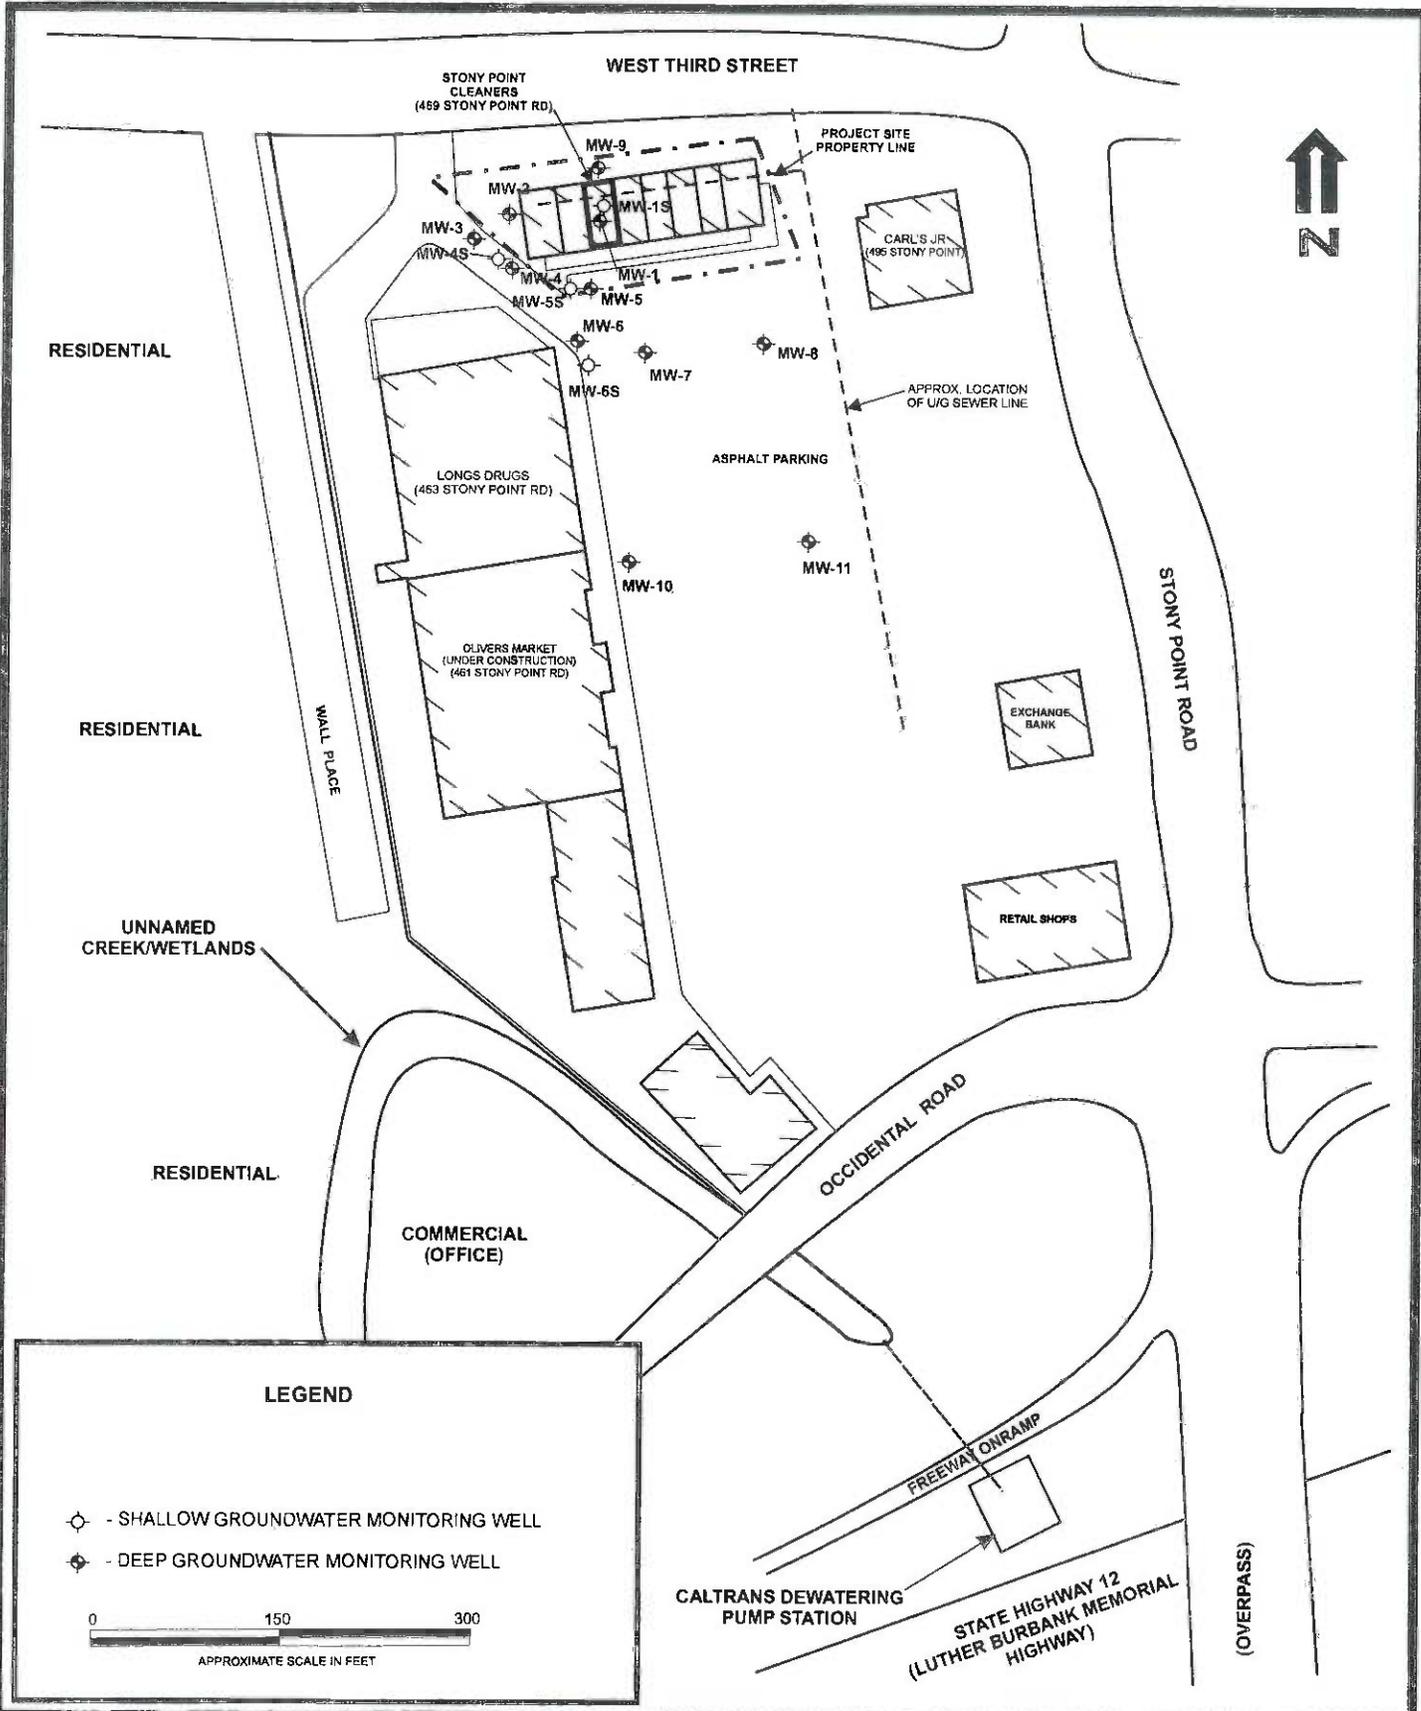
DESIGNED BY:	CHECKED BY: JEG	<b>SITE PLAN</b>	DATE: 09/04/2013	FIGURE: 2
DRAWN BY: MAR	SCALE:		<b>GRIBI</b>	
PROJECT NO:	469 STONY POINT ROAD SANTA ROSA, CALIFORNIA

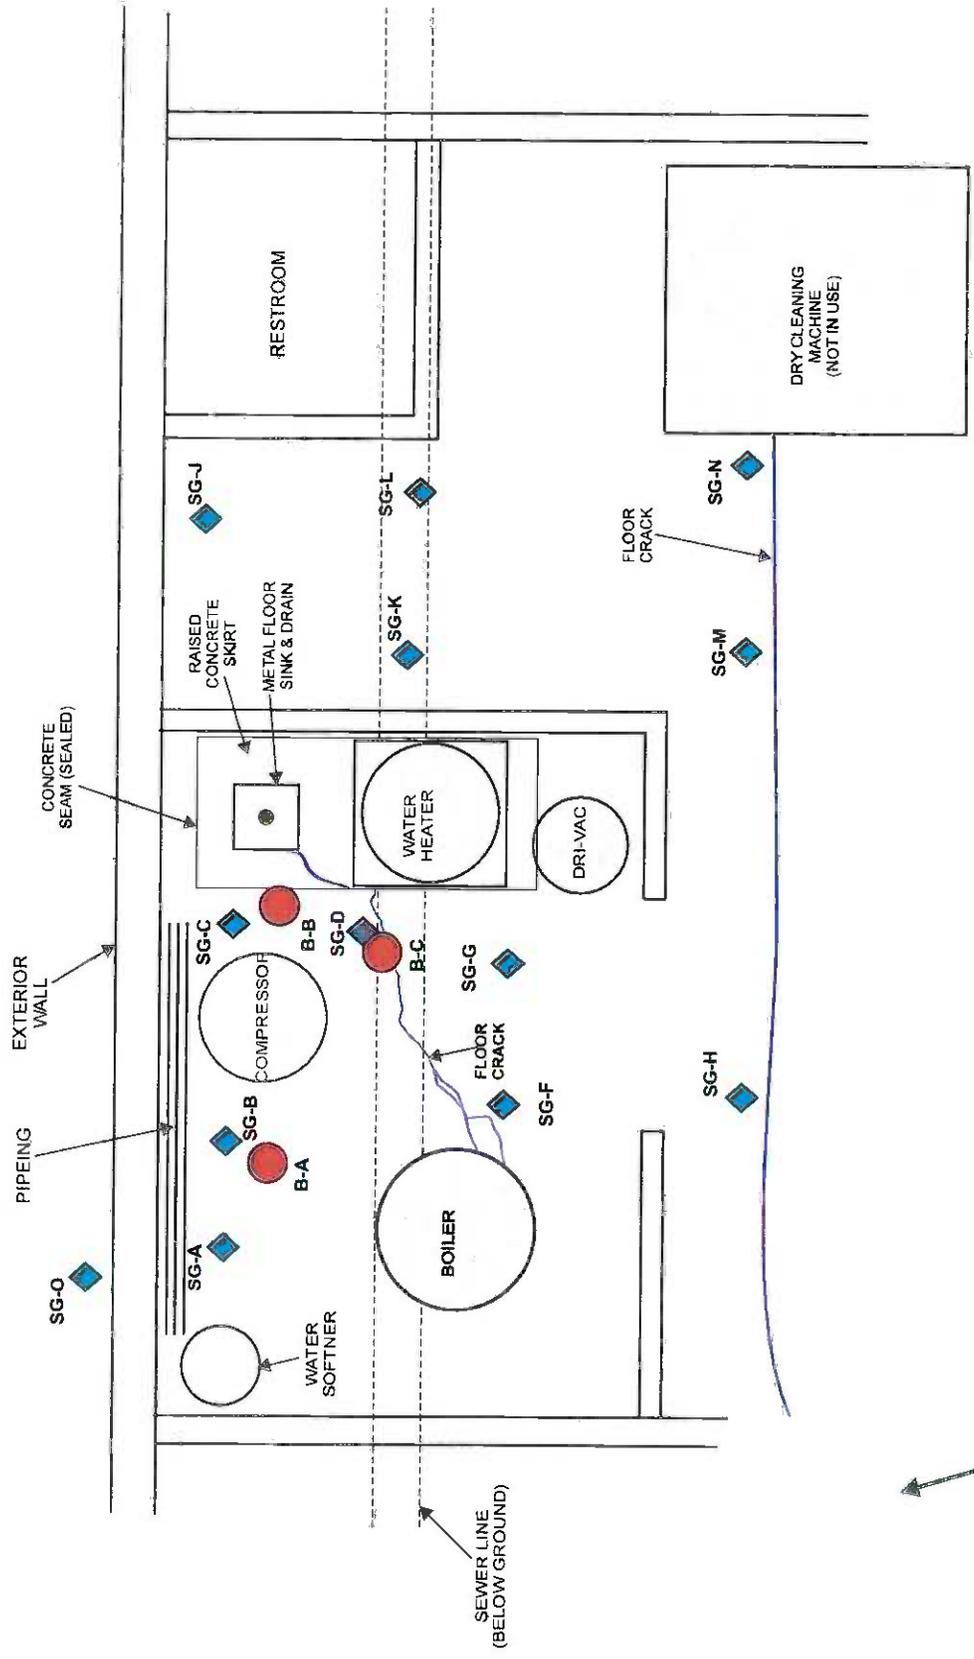
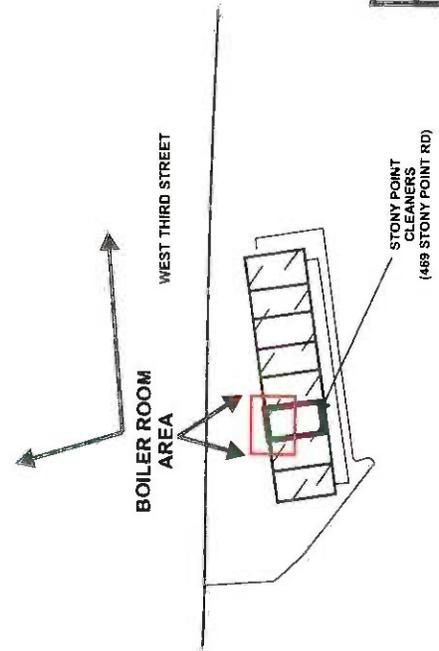
- SOIL GAS SAMPLE LOCATION
- SOIL SAMPLE LOCATION

DESIGNED BY:	RB	SCALE:	
DRAWN BY:	RB	PROJECT NO.:	
<b>BOILER ROOM INVESTIGATION PLAN</b>			
STONY POINT CLEANERS 469 STONY POINT ROAD SANTA ROSA, CALIFORNIA			
DATE: 09/04/2013	FIGURE: 3

The report describes and documents the collection of eleven soil gas samples and seven soil samples from three shallow borings in the boiler room area at the north end of the Stony Point Cleaners facility. The source area investigation was recommended in the semi-annual groundwater monitoring report submitted to the Regional Board in April 2013 and was considered an extension of the remedial investigation (RI) work in progress under a June 18, 2010 RI workplan. At the Regional Board's request, a detailed scope of work was submitted to the Regional Board on August 1, 2013, by way of notification. The investigation results were needed for a mandatory settlement conference held on August 12, 2013, in connection with the ongoing litigation over liability.

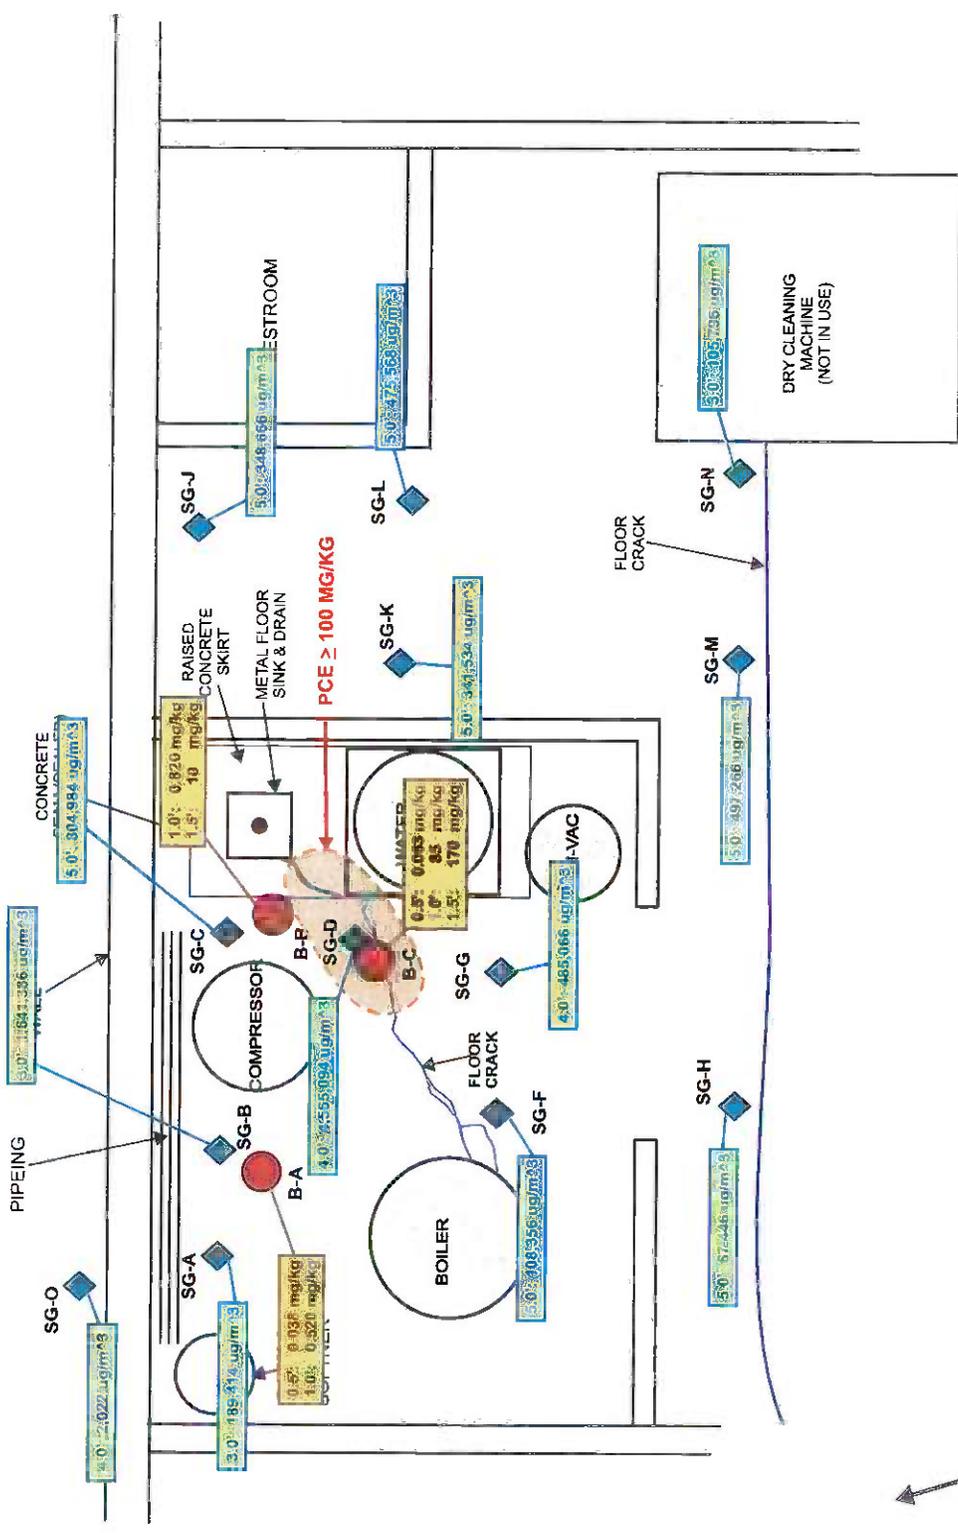
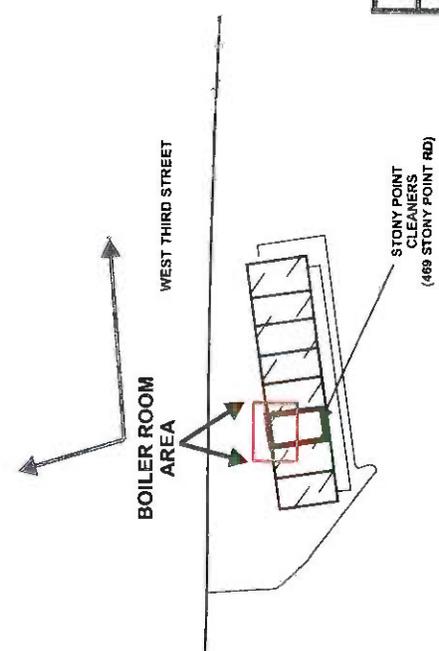
SOIL GAS SAMPLE LOCATION  
 SOIL SAMPLE LOCATION

DESIGNED BY:	SCALE:	DATE: 09/04/2013	FIGURE: 4
DRAWN BY: RB		SOIL & SOIL GAS PCE RESULTS	
PROJECT NO.:		STONY POINT CLEANERS 469 STONY POINT ROAD SANTA ROSA, CALIFORNIA

ug/m<sup>3</sup> at SB-D, located directly in front of the floor drain and intercepting an open crack in the floor. The median concentration for the eleven samples was 341,534 ug/m<sup>3</sup>. Relative to the median, the following results indicated three possible points of discharge:

- **2 feet southwest of the floor sink/drain:** SG-D at 4,565,094 ug/m<sup>3</sup>, adjacent to the crack in the floor;
- **6 feet west of boiler room floor sink/drain:** SG-B at 1,641,386 ug/m<sup>3</sup>); and.
- **1 foot west of the floor sink/drain:** SG-C, at 804,984 ug/m<sup>3</sup> located just a few feet north of SG-D.

Highly elevated PCE concentrations were encountered in soil samples collected at 1.0 foot and 1.5 feet below ground surface in boring B-C, located at the floor crack just southwest of the sink/drain. A moderate PCE concentration was encountered at 1.5 feet in depth in boring B-B, located immediately west of the floor sink/drain. Boring B-B is little more than a foot away from B-C and from the floor crack, and the PCE contamination at B-B is considered to be associated with the same discharges via the crack.

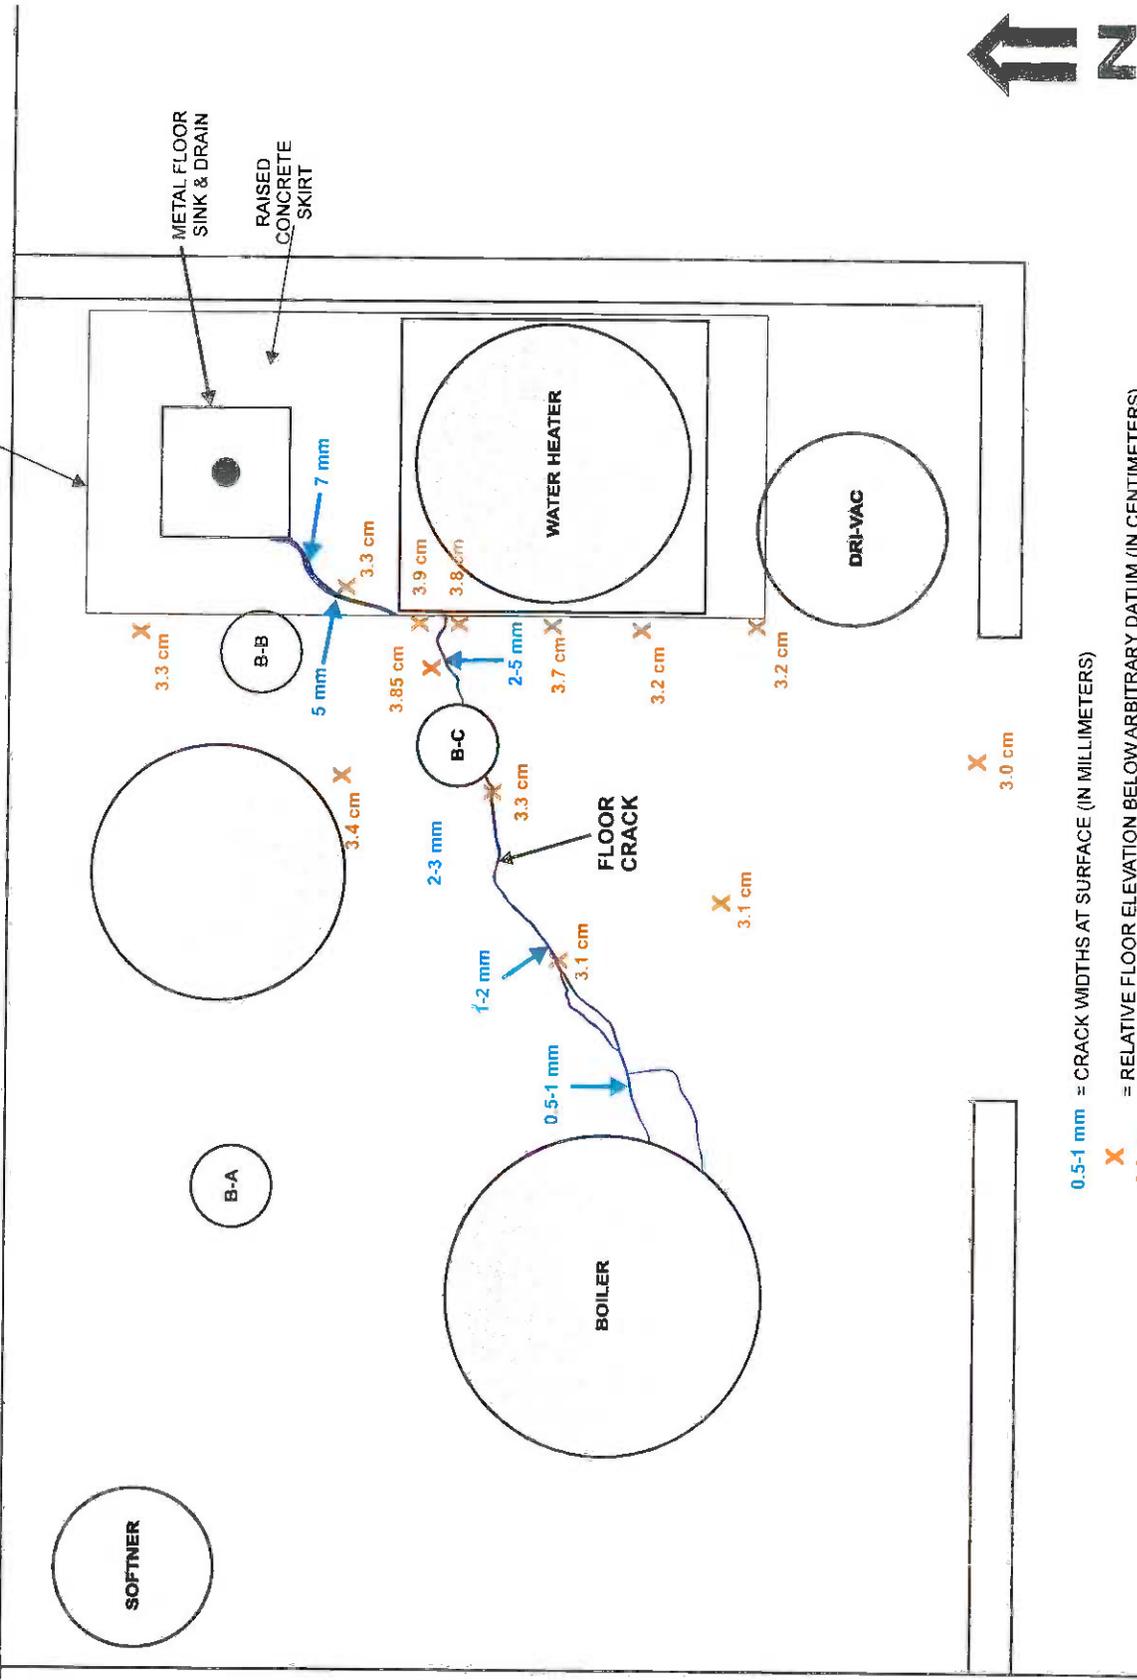
CONCRETE SEAM (SEALED)

0.5-1 mm = CRACK WIDTHS AT SURFACE (IN MILLIMETERS)  
 X = RELATIVE FLOOR ELEVATION BELOW ARBITRARY DATUM (IN CENTIMETERS)  
 3.0 cm

DESIGNED BY:	CHECKED BY: JEG	FLOOR ELEVATIONS & CRACK WIDTHS	DATE: 09/04/2013	FIGURE: 5
DRAWN BY: RB	SCALE:			
PROJECT NO.:		STONY POINT CLEANERS 489 STONY POINT ROAD SANTA ROSA, CALIFORNIA

Widths of the southwesterly floor crack, which are shown on Figure 5, vary from 0.5 millimeter (mm) to approximately 7 millimeters. The crack is widest, at about 7 mm, just southwest of the sink/drain and generally decreases in width away from the sink/drain area. A feeler gauge was extended into the cracks and generally extended more than two inches into the crack in the thickest locations. Also, the photos of the B-C boring location, taken on August 9 after coring through the concrete, clearly show that the crack extends fully through the 4-inch thick slab. The measured crack widths, which are typically greater than 2 mm, are classified by U.S. General Services Administration (GSA) standards as wide.<sup>1</sup> Crack widths increase moving toward the floor sink/drain.

Relative floor elevations were measured to the nearest millimeter using a laser level. These measurements, which are shown on Figure 5, indicate a low spot in the floor between the compressor and the sink/drain area, just northwest of the floor crack. Also, the southeast side of the floor crack is approximately 1 mm higher than the northwest side of crack. The overall elevation differences in the boiler room are generally less than 5 mm.

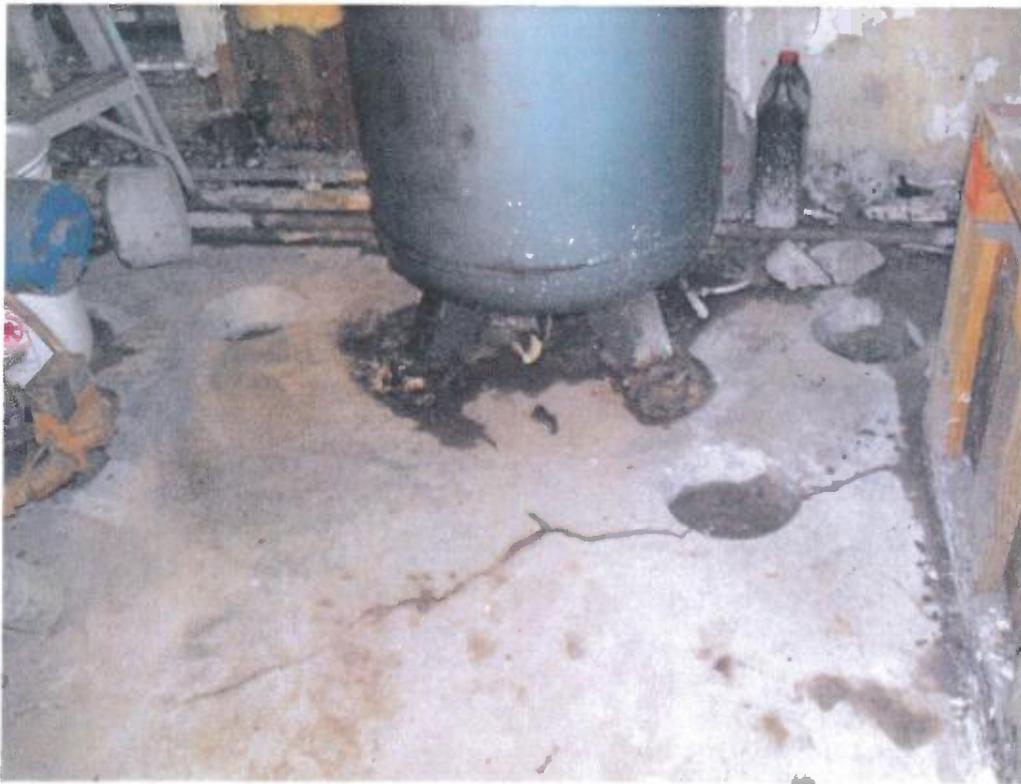
During soil sampling on August 9, 2013, Gribi Associates inspected the floor drain and associated floor crack in the northeast corner of the boiler room. Photo 1 in Attachment B shows boring B-C intercepting the crack. The crack radiates from the southwest corner of the floor sink/drain and extends southwesterly about six feet toward the boiler.

**Photo 1:** View of three soil borings in boiler room. B-A on left, B-B on upper right, and B-C on lower right side of photo. Floor crack at B-C readily visible on left side of photo.

Given the presence of the boiler, compressor, and water heater, all of which are very heavy, and stemming from the fact that the crack emanates from the corner of the floor sink/drain saw cut and runs diagonally away from the cut, the crack is presumed to fall under the category of tension cracking according to GSA classification. Thus, we conclude that the crack was caused by cutting out sections of rebar in an area of heavy load in installing the floor drain/sink and connecting it to the sanitary sewer line that runs under the building. This crack was observed to contain water, even though the surrounding floor was dry, clearly indicating that a nearby upstream section of the crack is actively draining the water currently leaking on the boiler room floor (see Attachment B Photo 1).

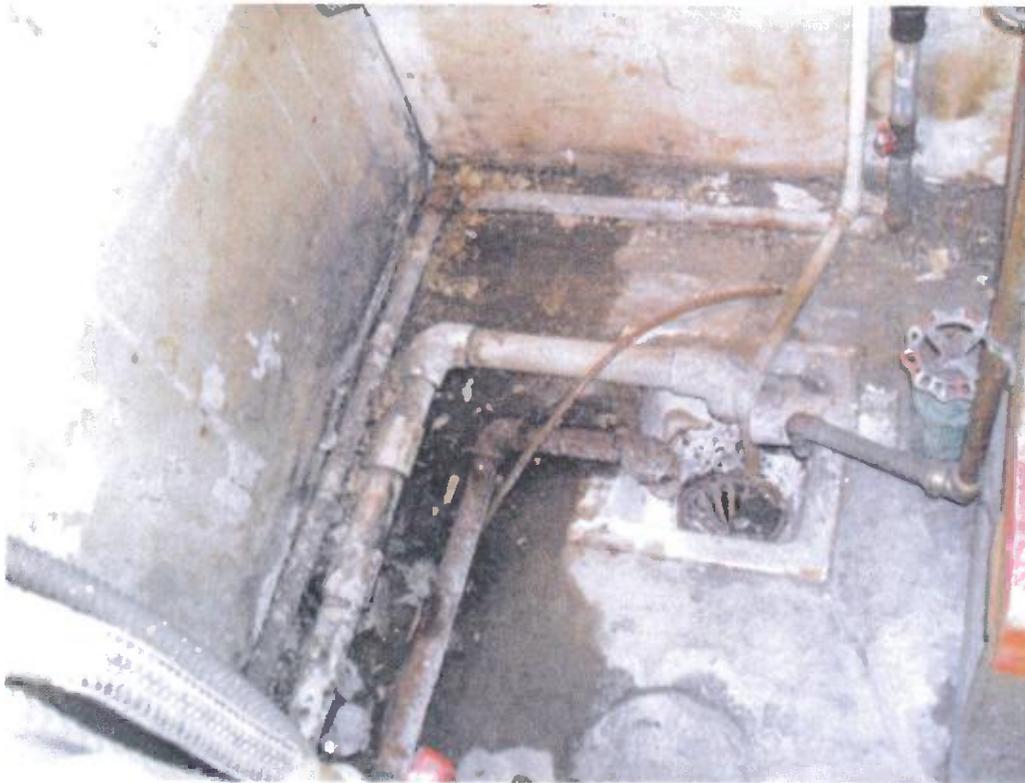
The sink/drain area is raised approximately 1.5 inches above the surrounding floor surface. The sink/drain is constructed of metal, and a fairly significant gap is present at the southwest corner of the sink, where the concrete lip appears to have degraded away from the metal sink. The crack that propagates southwest from the southwest edge of the metal sink begins where this concrete degradation has occurred. This crack appears to end at the sealed concrete seam and moves “en-echelon” approximately four inches southward before again beginning to propagate southwestward.

**Photo 2:** View of floor sink/drain area. Note crack in concrete on lower right side of photo, emanating from corner of sink. Boiler water collects along left wall because there are no breaches in concrete at that location (crack area is normally dry).

2. Using a U.S. government slab construction classification system, the crack is considered wide and is tentatively identified as a tension crack that was caused by breaching the rebar in installing the floor drain/sink in an area of very heavy load. On this basis, it is assumed to date to the time of dry cleaning tenant improvements.

10. The unintended discharges resulted from the failure to seal the boiler room floor before dry cleaning operations commenced in 1981, followed by repeated exposure to the same harmful conditions. The discharges could have been prevented by sealing the floor with a thick coat of epoxy resin.

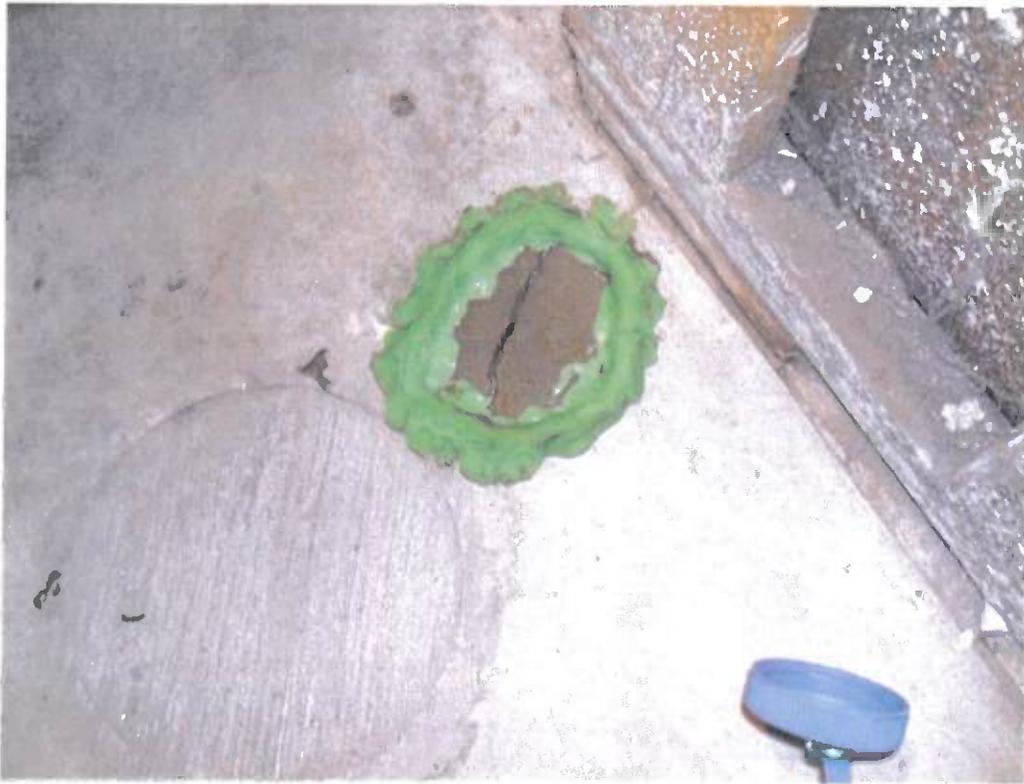
The initial pour test involved constructing a small (6-inch length) basin over the crack using modeling clay, then pouring 200 to 300 milliliters (ml) of water into the basin, and timing the water discharge into the crack. Results of this test were that the water discharged into the crack almost immediately and that, upon addition of more water, the crack continued to accept water. In this case, 300 ml of water discharged into the crack in less than 30 seconds.

**Photo 3:** View of pour test in clay basin, just southwest of sink/drain area (boring B-C on lower left side of photo). Open crack, where water fell through crack, is visible in lower portion of basin.

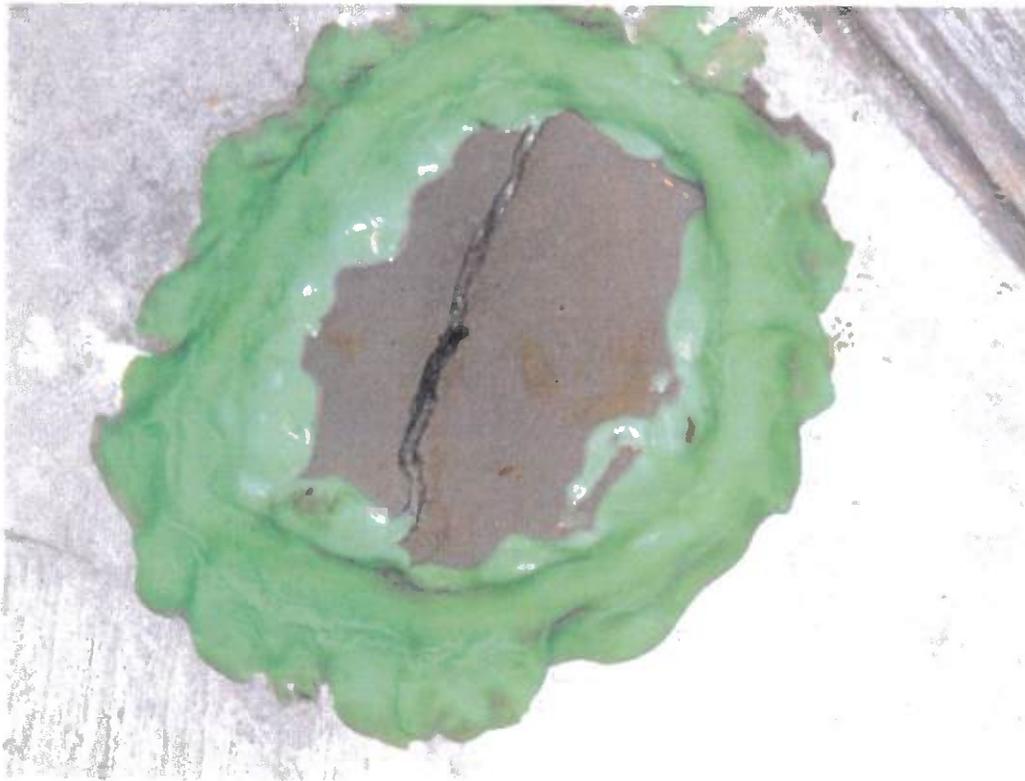
**Photo 4:** Close-up view of pour test in clay basin, just southwest of sink/drain area. Again, open crack, where water fell through crack, is visible on lower side of photo.

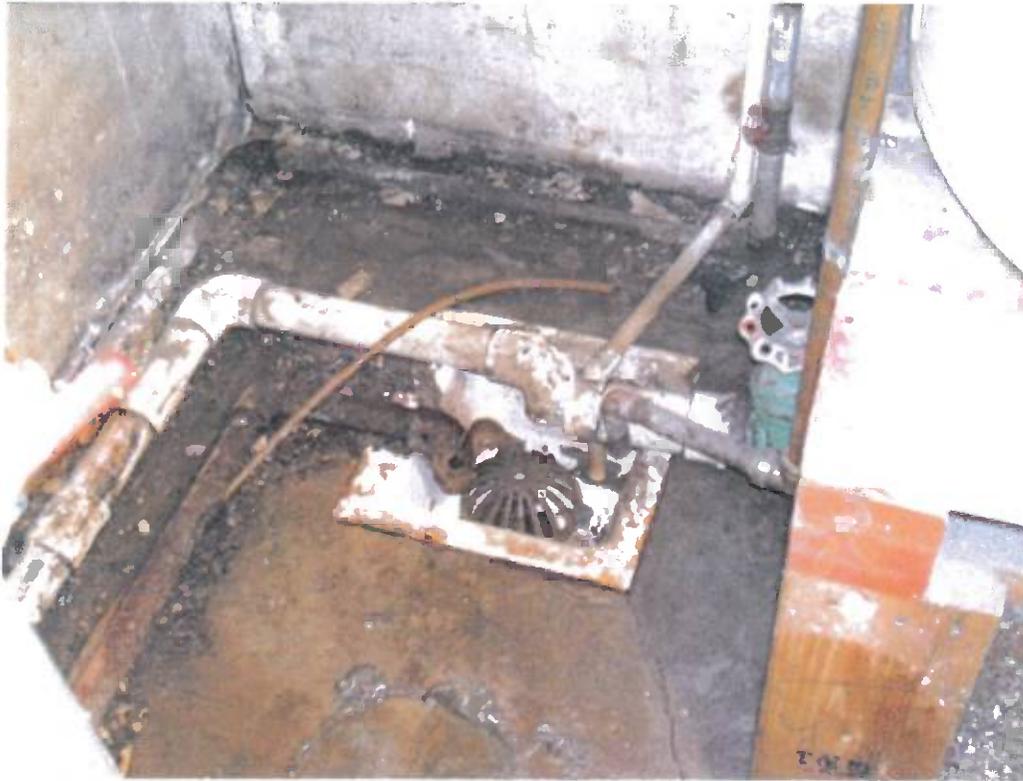
The second pour test involved pouring 4 to 5 gallons of water onto the boiler room floor at the southwest edge of the sink/drain, and tracking flow and discharge visually. Results of this test were that water entered the section of the crack between the water heater and boring B-C, as well as the area of the crack just southwest from B-C, rapidly and steadily. In this case, most of the 4 to 5 gallons of water were absorbed into the floor crack within 3 to 4 minutes.

**Photo 5:** View of sink/drain area during 5-gallon pour test. Note crack on lower right side of photo does not have free water (water has infiltrated into crack).

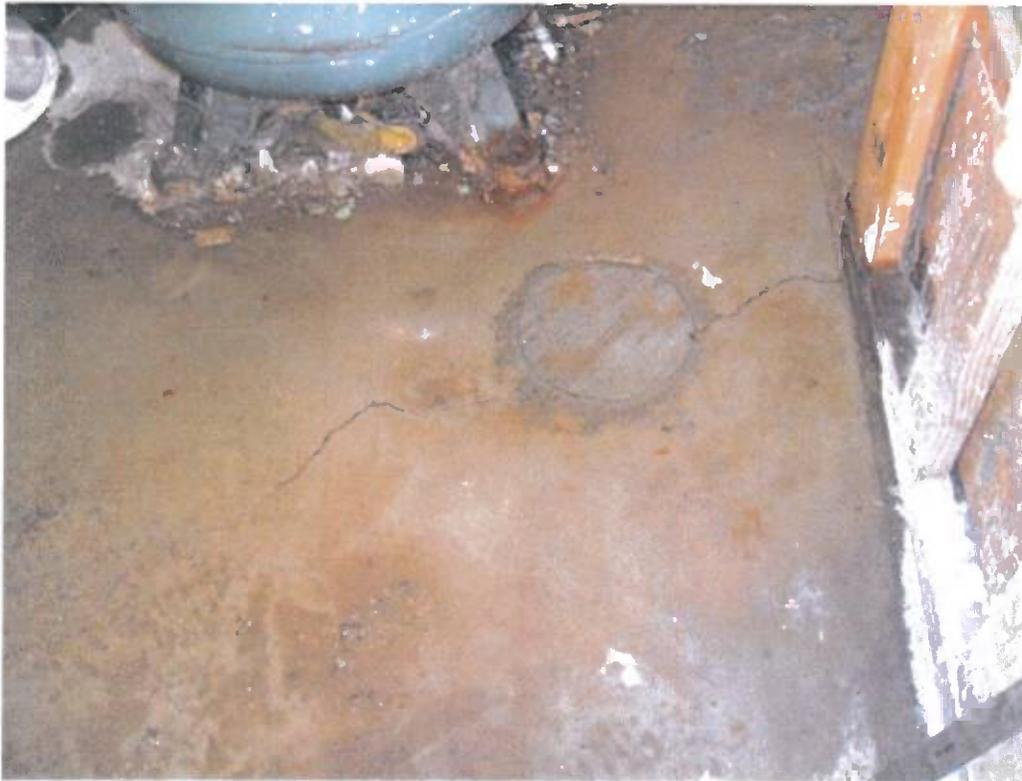
**Photo 6:** View of crack following 5-gallon pour test. Note width of crack and lack of pooled water. Also, some small white flecks are visible in crack, having got caught as water fell into crack.
