**Waste Discharge Requirements
and
Water Quality Certification
Oak to Ninth Project
City of Oakland, Alameda County**

**Assessment of the Habitat Value of Pier Pilings
(Zabin, 2011)**

**An Assessment of the Habitat Value of Pier Pilings at the Ninth Avenue Wharf and
Vicinity and Recommendations for the Oak to Ninth Project**

May 15, 2011

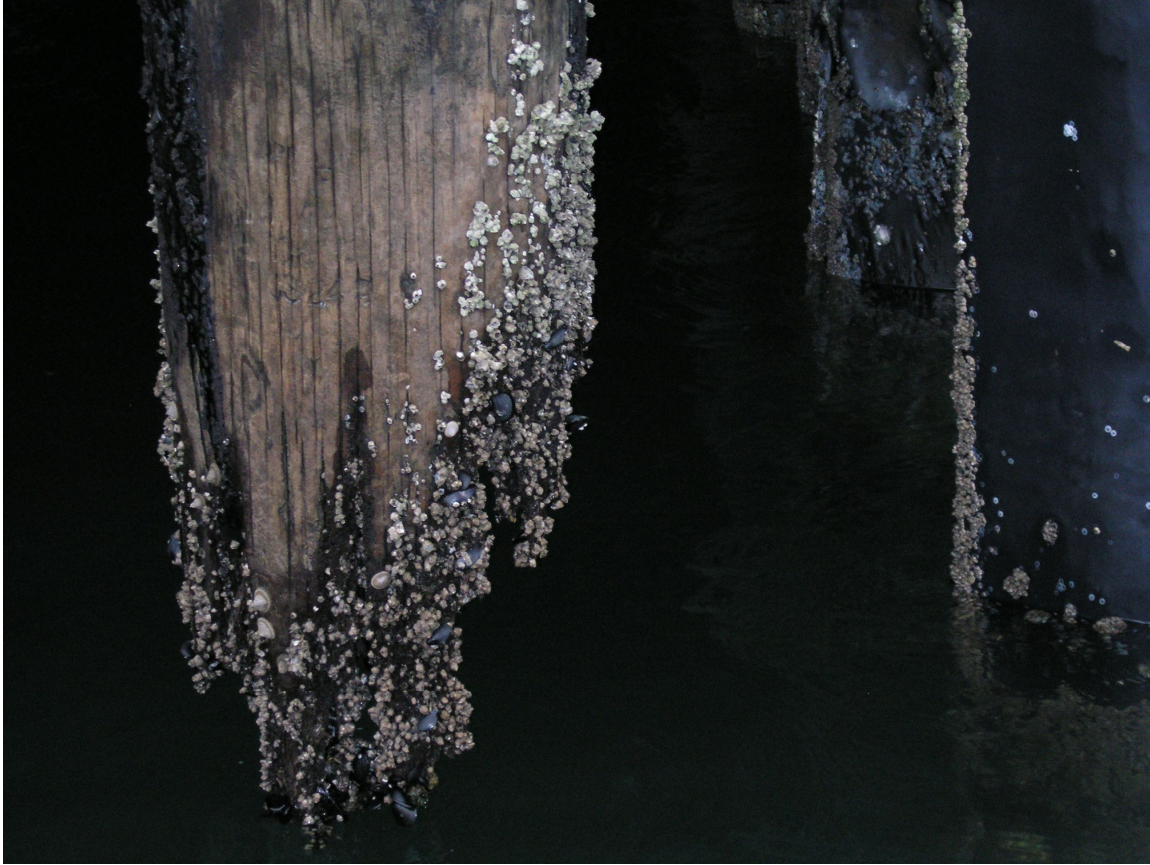
On the whole, the pilings near Shoreline Park West were in a state of disrepair. Many were broken and hanging loose from the pier; in other cases only submerged stumps remained (Fig 1). Some of the pilings had been wrapped with PVC. It was difficult to tell whether all of the pilings had a creosote coating, but many of the ones we saw clearly had some creosote (Fig 2).

Figure 1. Broken pilings, hanging from the pier, were typical at the Ninth Avenue Wharf.

The proposed removal of pilings and wharf structures at Shoreline Park West and the Ninth Avenue Wharf will provide two ecological benefits: (1) removing a source of toxic material and (2) eliminating a habitat for non-native species. These improvements will also return this segment of shoreline to a more aesthetically pleasing and natural configuration and increase its use by native birds and wildlife.

3. Removal of creosote pilings may resuspend toxins. Recommendations for removal methods that minimize release of toxins are discussed in two recently released reports: Removal of Creosote-Treated Pilings and Structures from San Francisco Bay (Werme et al. 2010) and San Francisco Bay Subtidal Habitat Goals Report (California State Coastal Conservancy and Ocean Protection Council et al. 2010).

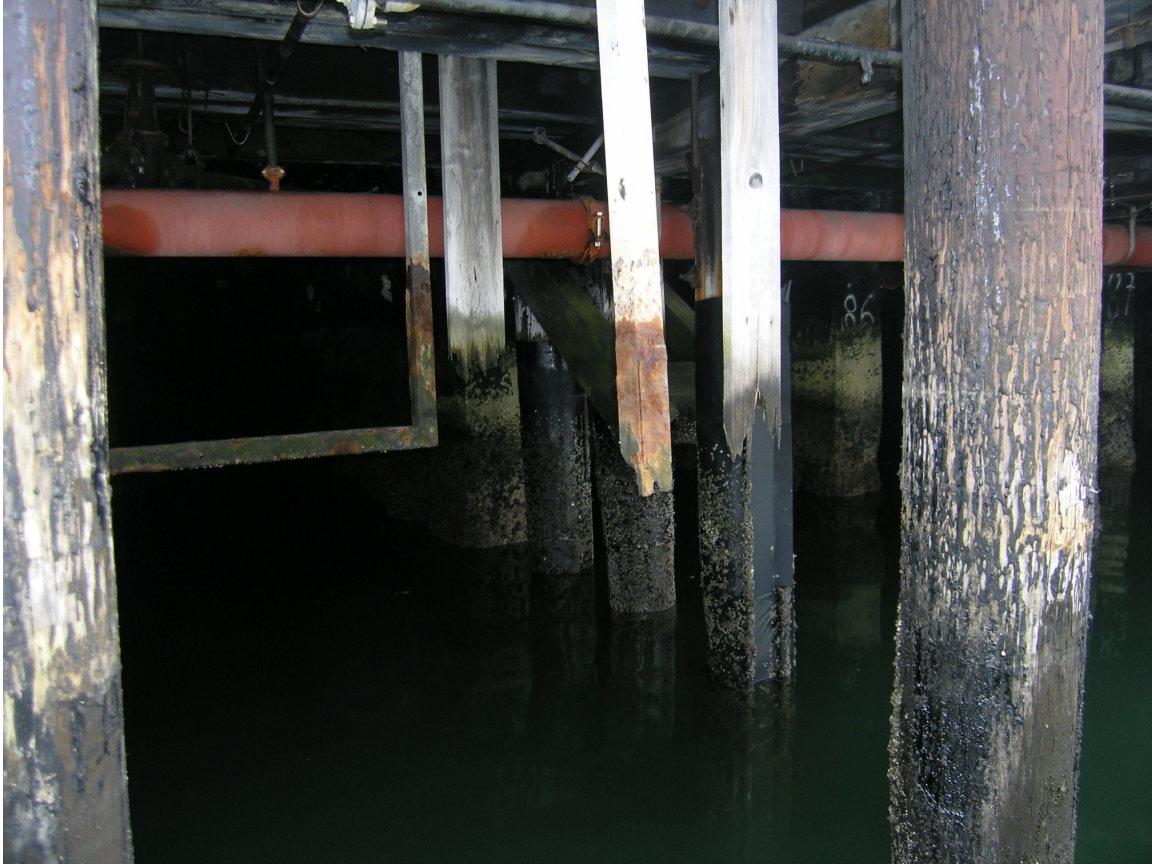
Figure 2. Many of the pilings at the Ninth Avenue Wharf are coated in creosote.

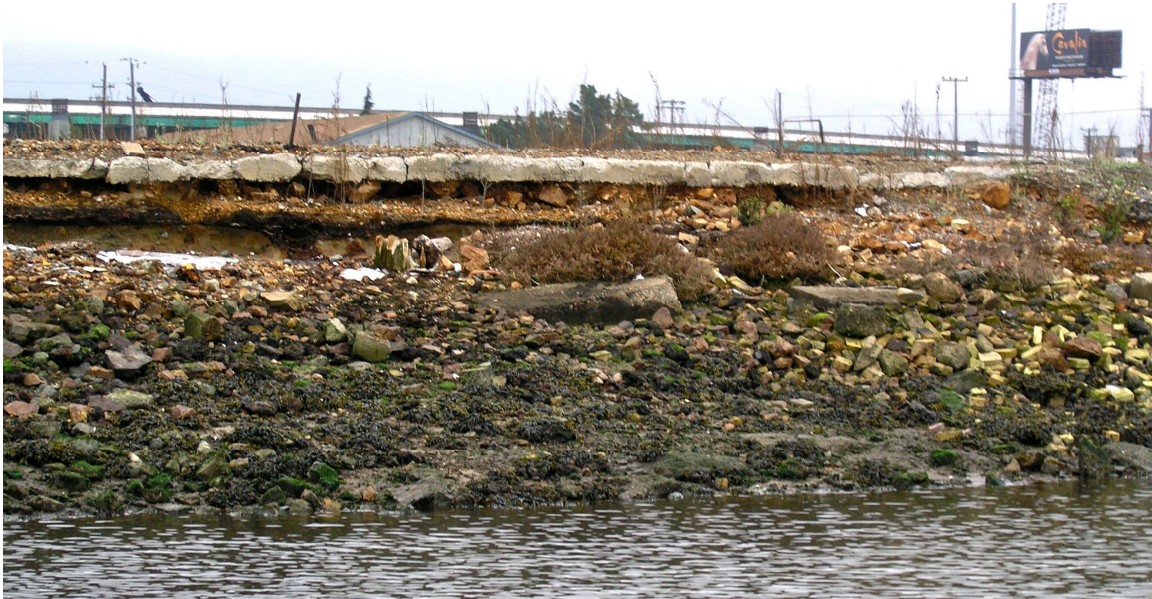
Macroalgal cover appeared to be limited to small patches of *Ulva* spp. and small amounts of a tufty red alga tentatively identified as the non-native *Caulacanthus okamurae*. A native red alga *Gratelopia lanceolata* and a non-native *Lomentaria hakodatensis* were found on the buoy we inspected, but not on the pilings. These species are common on floating docks throughout the Bay (pers. obs.). The native brown rockweed *Fucus distichus* was abundant on the shoreline rip-rap in the areas surrounding the pilings (Fig. 3), but was not found on the pilings themselves.

Figure 3. The native brown rockweed *Fucus gardneri* is plentiful in the intertidal zone rip-rap at the site.

2. Where replacement of existing rip-rap and other hard intertidal structures is planned, take actions to preserve the *Fucus* currently growing along the shoreline edges. Such actions could include incorporating pieces of the existing rip-rap with *Fucus* attached to them into the new seawall, or transplanting adults following methods such as those being developed by Peter Raimondi's laboratory (University of California, Santa Cruz). Fleshy macroalgae like *Fucus* provide habitat for native fish, invertebrates and other algae, and may facilitate other organisms such as native oysters in the intertidal zone by mitigating heat stress (see Whittaker et al. 2010 and references therein). Populations of *Fucus* may be difficult to regain once lost, as their propagules have a limited dispersal distance (Sousa 1984, Stekoll and Deysher 1996).

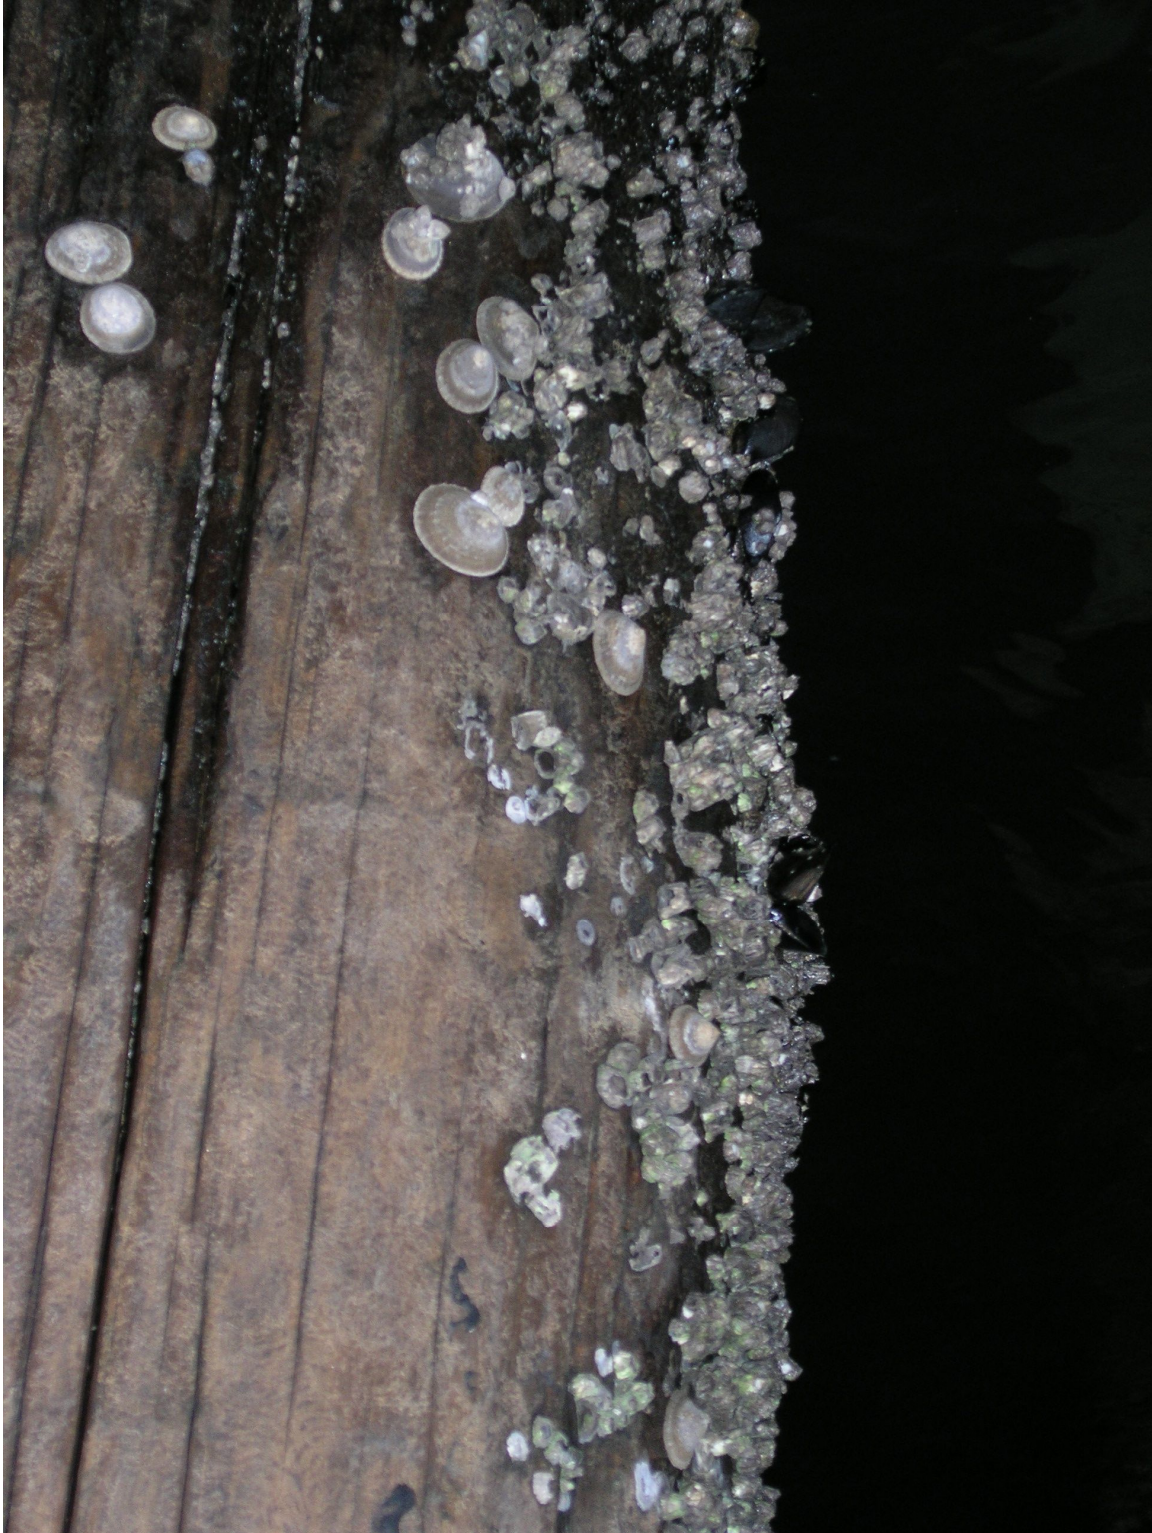
Invertebrate animals were the numerically dominant organisms on the pilings. Barnacles (*Balanus crenatus* and *Amphibalanus amphitrite*) were by far the most abundant organisms (in

the 100s-1000s of individuals/piling) above and just below the waterline. Mussels (*Mytilus* spp.), native oysters (*Ostrea lurida*) and limpets were also common (10s of individuals/piling) (Fig. 4). Large numbers (100s of individuals) of the large non-native solitary tunicate *Styela clava* were found on some of the pilings; there were also a few pilings that had significant cover of the non-native colonial tunicate *Didemnum* sp.

Figure 4. Barnacles dominate the pilings in the high intertidal zone at the site; native oysters, mussels and limpets are also present.

1. Where feasible, extend the placement of suitable heterogeneous hard substrate (such as stone rip rap, preferably native source, or Reef Balls¹) from the shoreline into the shallow subtidal (2-3 m below MLLW). This will provide habitat for native shoreline species dependent on hard substrate. Such substrate could be incorporated into the shoreline erosion protection design and could be integrated in a living shoreline approach that includes shoreline softening and restoration of native upland and marsh vegetation.
