**CALIFORNIA REGIONAL WATER QUALITY CONTROL BOARD  
SAN FRANCISCO BAY REGION**

In the matter of:	)	
	)	
<b>TOWN OF HILLSBOROUGH,</b>	)	<b>SETTLEMENT AGREEMENT AND</b>
<b>SAN MATEO COUNTY</b>	)	<b>STIPULATION FOR ENTRY OF</b>
	)	<b>ADMINISTRATIVE CIVIL LIABILITY</b>
<b>September 16-17, 2015</b>	)	<b>ORDER</b>
<b>Unauthorized Discharge into San</b>	)	
<b>Mateo Creek</b>	)	<b>ORDER</b>
	)

**SUBJECT:** Inspection of Town of Hillsborough Unauthorized Chloraminated Potable Water Discharge to San Mateo Creek that Caused Fish Kill, San Mateo County

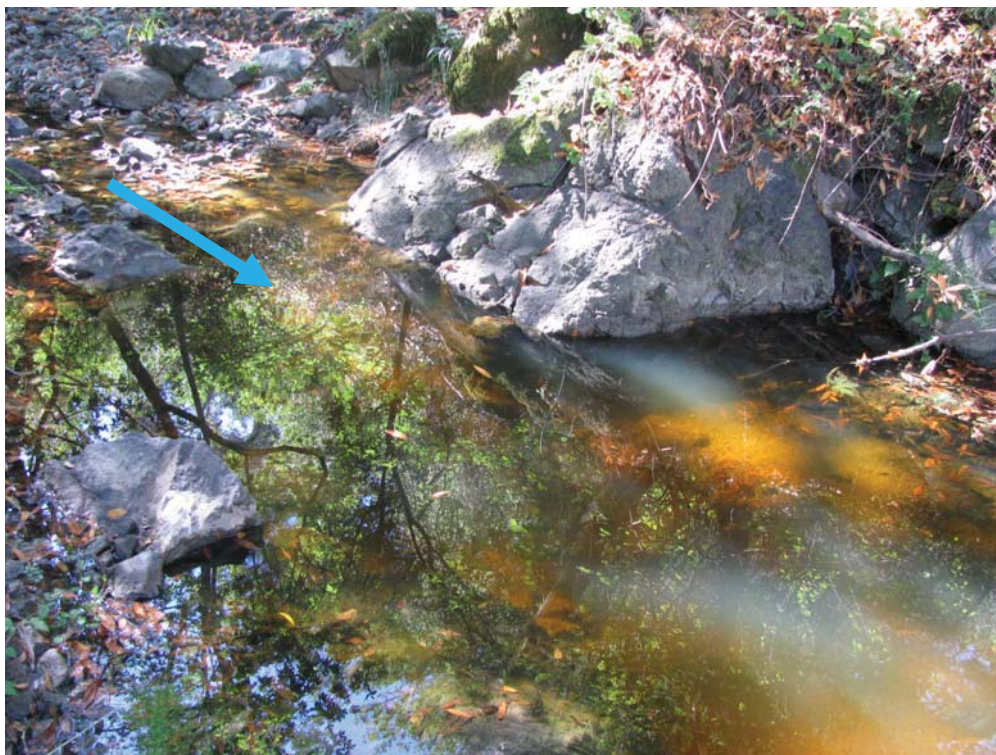
**Photograph 1:** Polhemus Creek pool immediately down slope of Cal Water 2013 discharge point. Regional Water Board staff observed fish in the pool (9-18-2015 HTK)

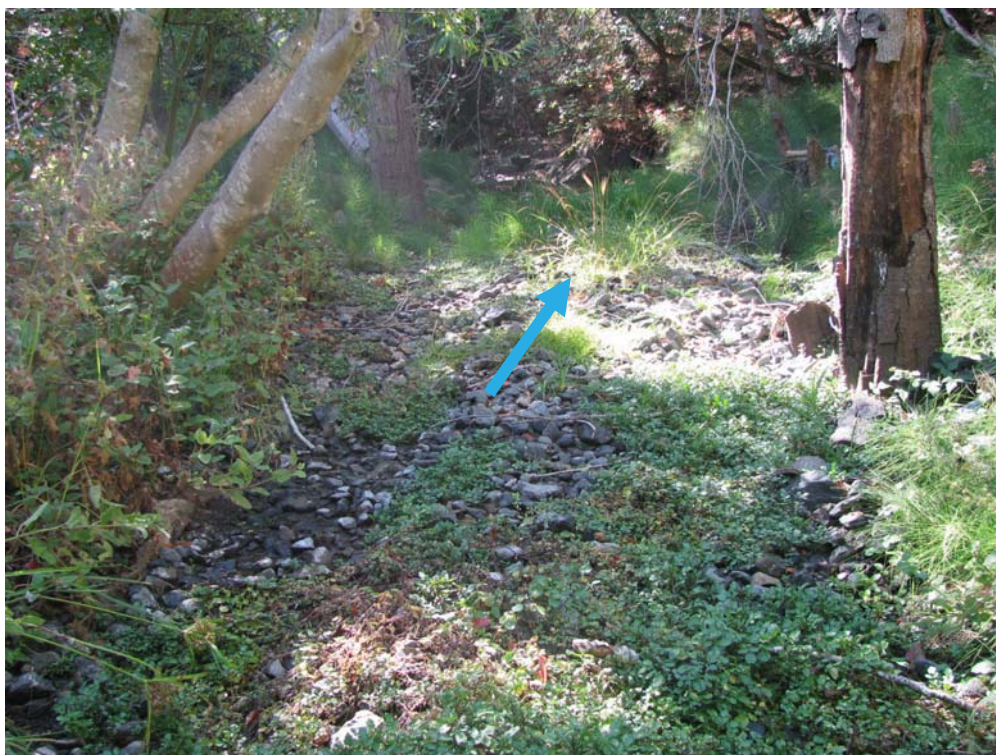
**Photograph 2:** Polhemus Creek looking downstream towards the confluence with San Mateo Creek - observed dry creek segment (9-18-2015 HTK)

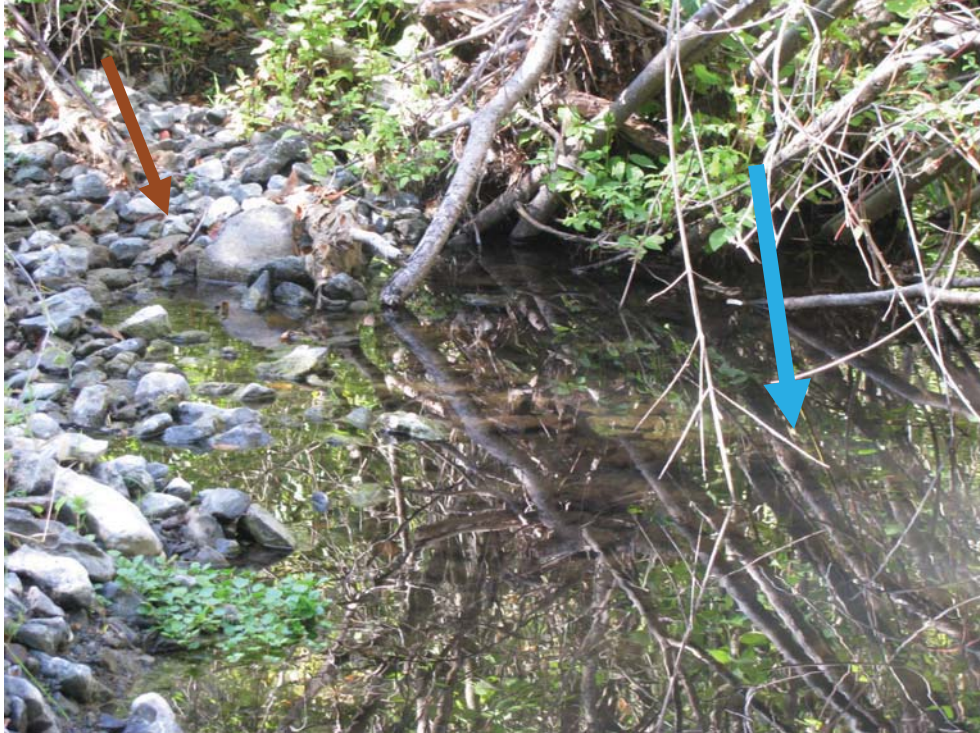
**Photograph 3:** Confluent of Polhemus Creek with San Mateo Creek – no signs of discharge observed – brown arrow on the left of the photograph shows no water flow from Polhemus Creek and blue arrow on the right of the photograph shows water flow coming from upper San Mateo Creek (9-18-2015 HTK)

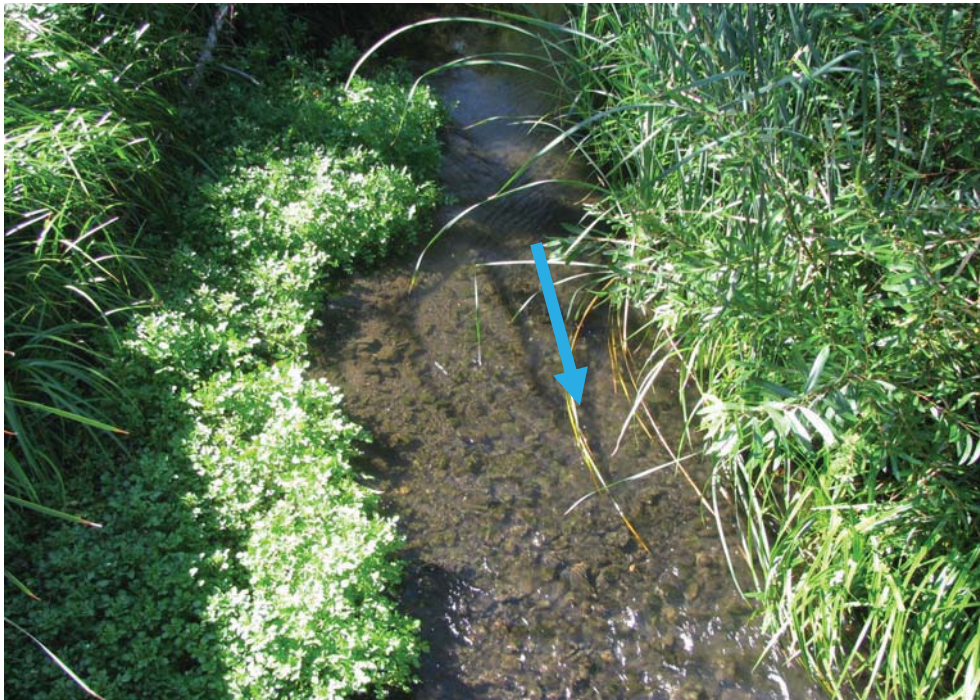
**Photograph 4:** San Mateo Creek looking upstream from Crystal Springs Road Bridge downstream of the confluence - no signs of discharge or disturbance (9-18-2015 HTK)

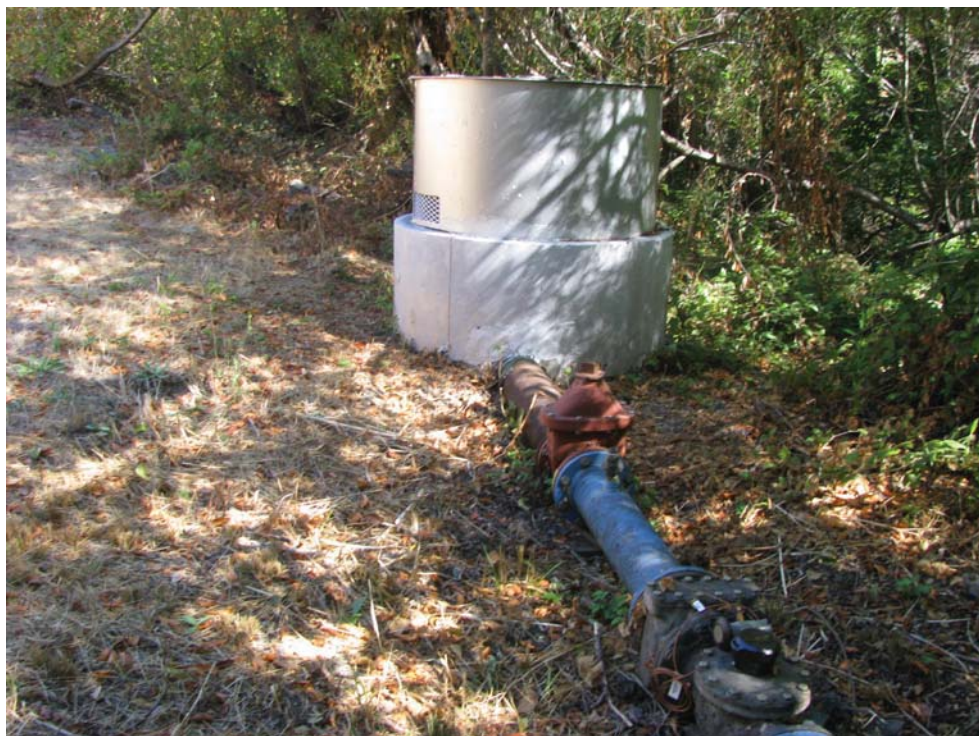
**Photograph 5:** Town of Hillsborough's water pipe connected to SFPUC water system (9-18-2015 HTK)

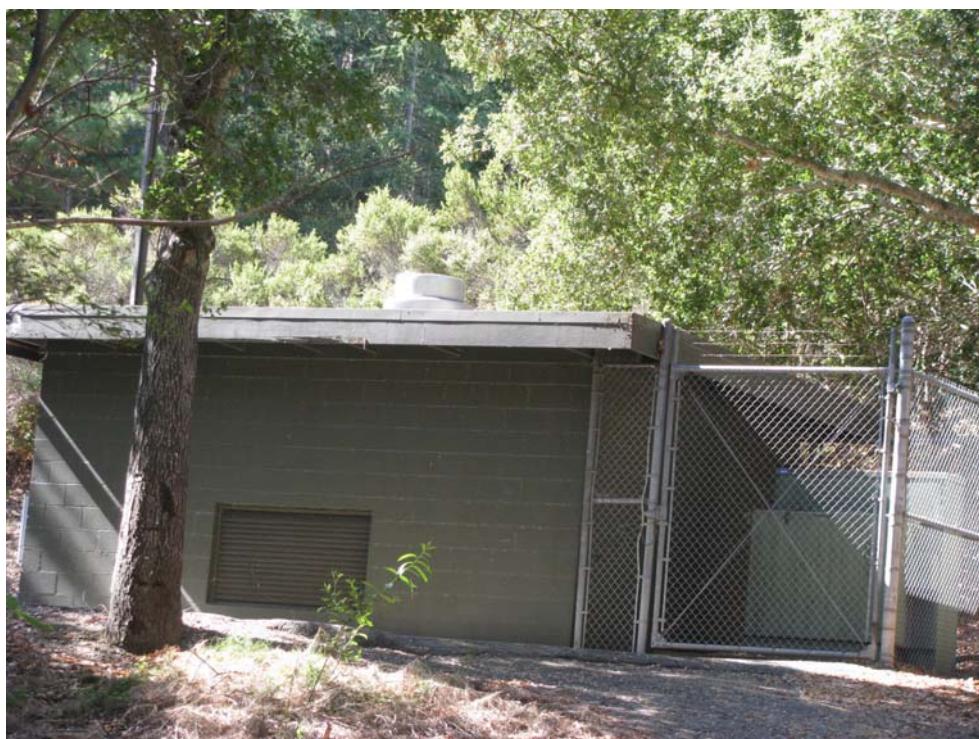
**Photograph 6:** Town of Hillsborough's Tartan Trail Pump Station (9-18-2015 HTK)

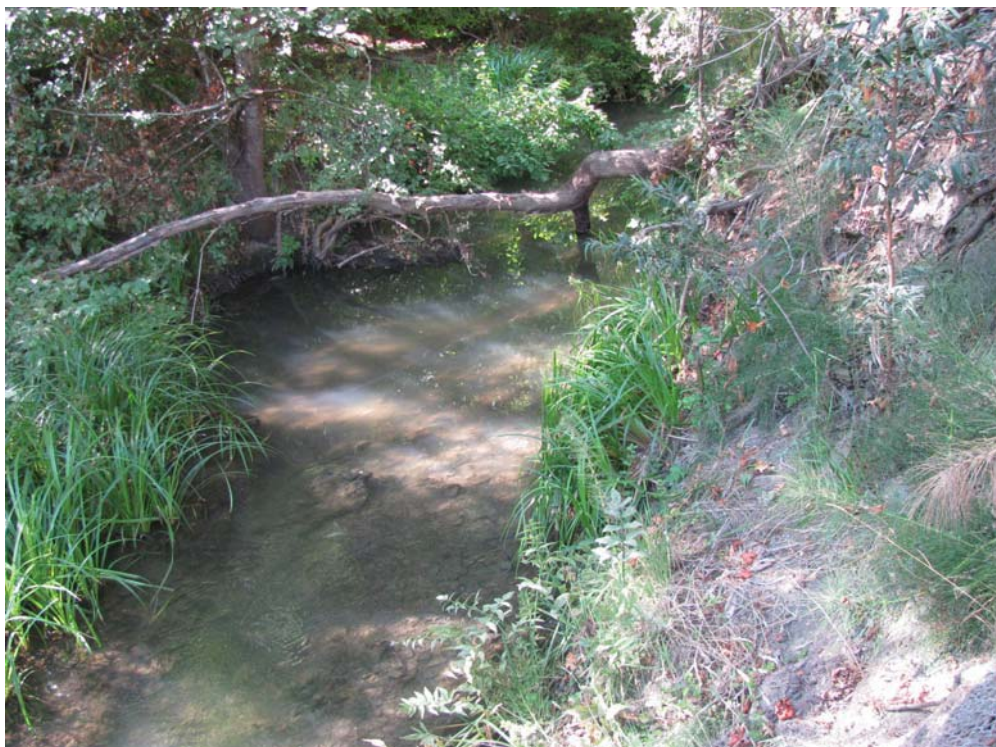
**Photograph 7:** San Mateo Creek immediately downstream of the discharge entered the Creek - observed fine sediment deposition in creek bed as the result the water looks less clear than upstream water showing on Photograph 4 above (9-18-2015 HTK)

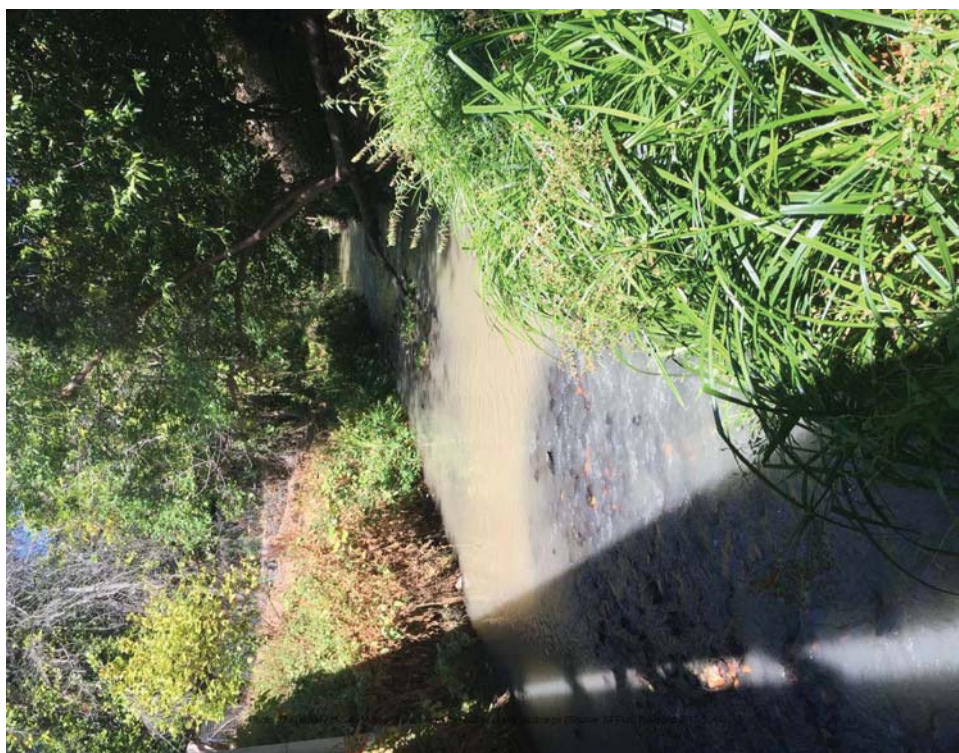
**Photograph 8:** Turbidity in San Mateo Creek downstream of the discharge outfall (Courtesy: SFPUC biologist 9-17-2015)

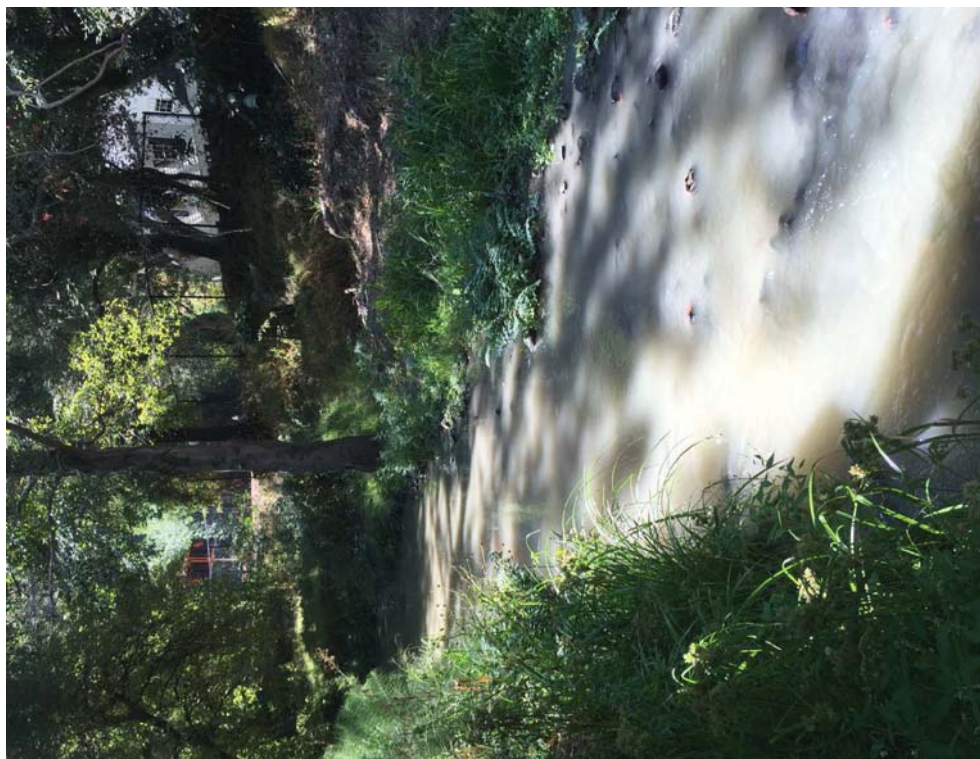
**Photograph 9:** Turbidity in San Mateo Creek downstream of the discharge outfall (Courtesy: SFPUC biologist 9-17-2015)

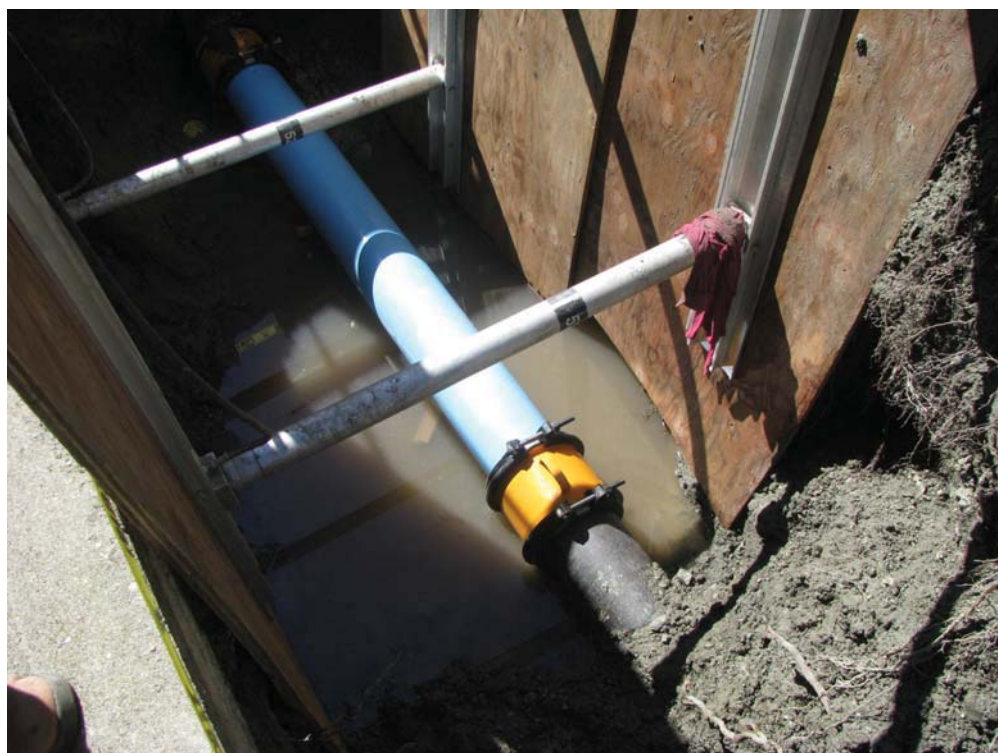
**Photograph 10:** Excavated discharge location showing a repaired 8-inch water main pipe about 6 feet below grade (9-18-2015 HTK)

17	9/17/2016	Dark	6:30	8:30:00 AM	CD arrived on scene	DB -Shoring being installed		
18	9/17/2016	Cloudy	7:00	7:00:00 AM	DB Cont. to dig, locate extent of crack, approx. 6' long longitudinal crack on bottom of pipe	CD - assisted in taking over repairs		
19	9/17/2016	Cloudy	7:30	7:30:00 AM			CD - directed PR to collect Bac-t samples after break was repaired	
20	9/17/2016	Cloudy	8:00	8:00:00 AM	DB - Other workers arrived on scene to assist with repair and take over traffic control/Assist with set up of shoring	JM arrived on scene and assisted with Traffic controls and to asses the situation		
21	9/17/2016	Cloudy	8:30	8:30:00 AM water shut down	CD - Assist with exposing pipe and finding the end of the cracked pipe	DB - Gary F, Dave B, & Matt V. left the job site to go home and get some rest	CD - Used ditch pump while vacuum truck was full and had to dump- sewer main to far away and in traffic lane to discharge to. CD - took a CL2 reading at the inlets within the controlled area, the reading indicated the water entering the SD inlets had a CL2 reading of .00

22	9/17/2016	Cloudy	9:00	9:00:00 AM	CD - Crew began to cut out the cracked pipe	CD - Preparation of new pipe-PVC pipe. The new section of pipe and the fittings are cleaned and disinfected with a solution of water and 12.5% chlorine . The pipe and fittings are placed in a bucket and swabbed with a brush.	CD - took a CL2 reading at the inlets within the controlled area, the reading indicated the water entering the SD inlets had a CL2 reading of .00 CD - The remaining Chlorine liquid used to clean the pipe and fittings is removed by the vacuumed truck. The chlorinated water is disposed of in the sewer at the PW yard when the material in the truck is decanted.	
23	9/17/2016	Cloudy	9:30	9:30:00 AM	CD - Crew cut out cracked section of pipe 7 ft. long. The crews install a new pipe plastic pipes with two Romac couplings.		CD - took a CL2 reading at the inlets within the controlled area, the reading indicated the water entering the SD inlets had a CL2 reading of .00

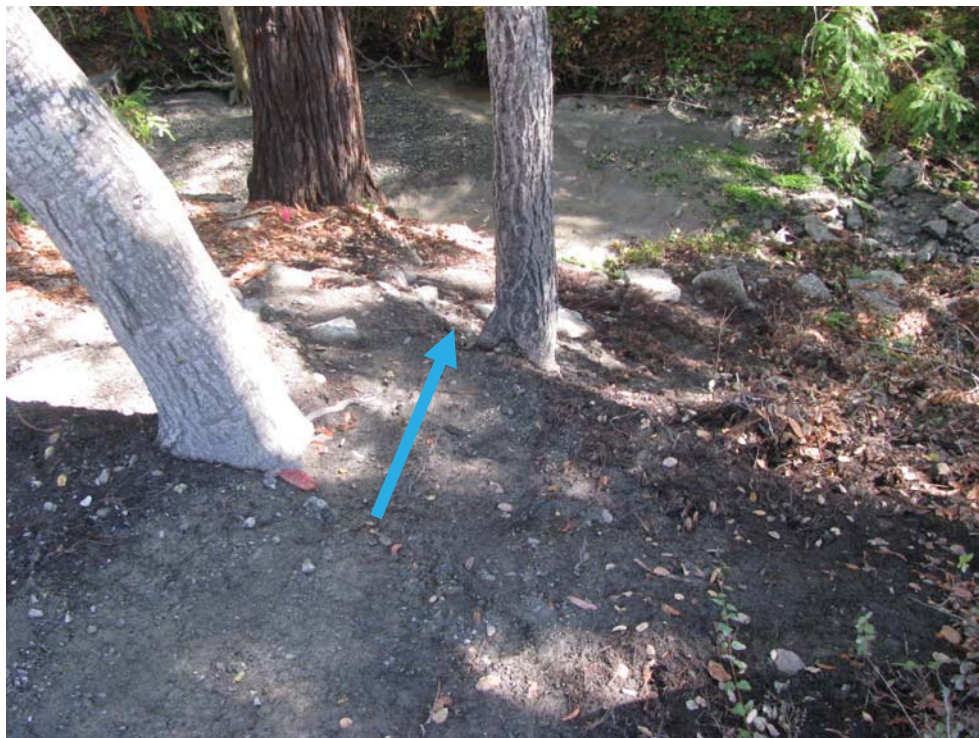
**Photograph 11:** Observed wetted surface a sign of land overflow entering an open unnamed drainage downstream of the discharge point (9-18-2015 HTK)

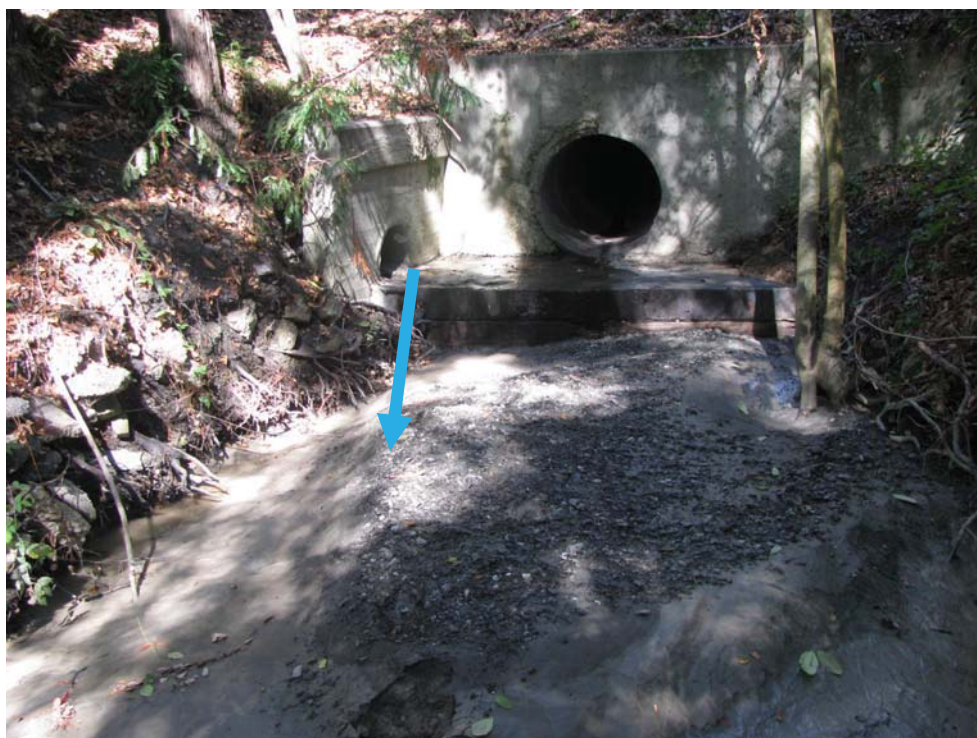
**Photograph 12:** Discharge also entered the unnamed open drainage from the smaller culvert on the left side of the photograph (9-18-2015 HTK)

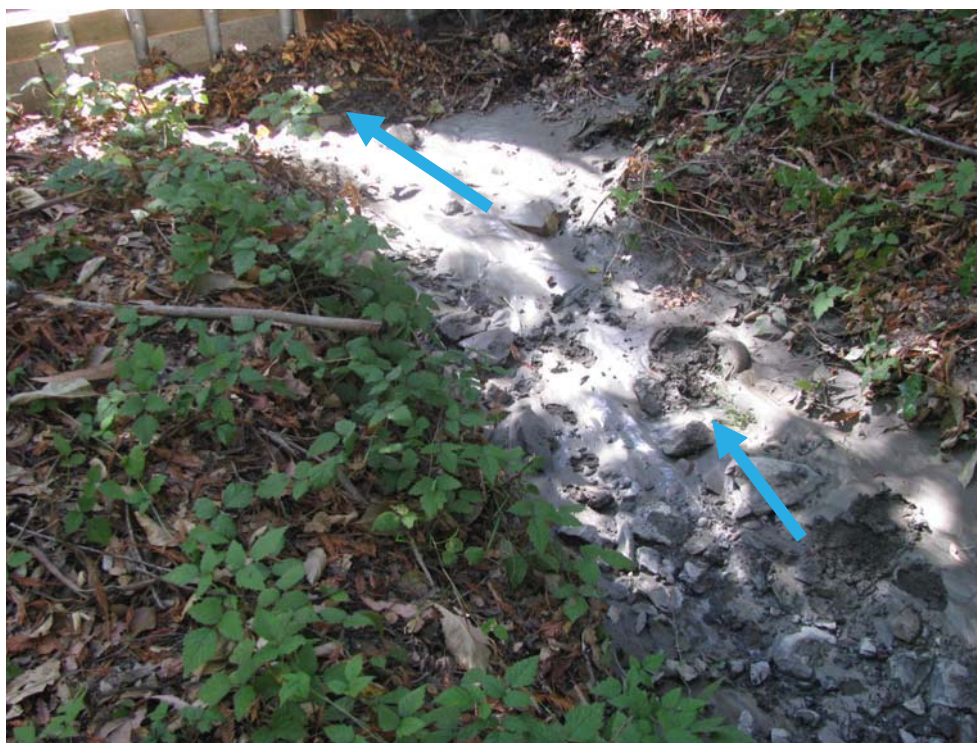
**Photograph 13:** Sediment deposition behind a trash and woody debris interceptor along the unnamed open drainage (9-18-2015 HTK)

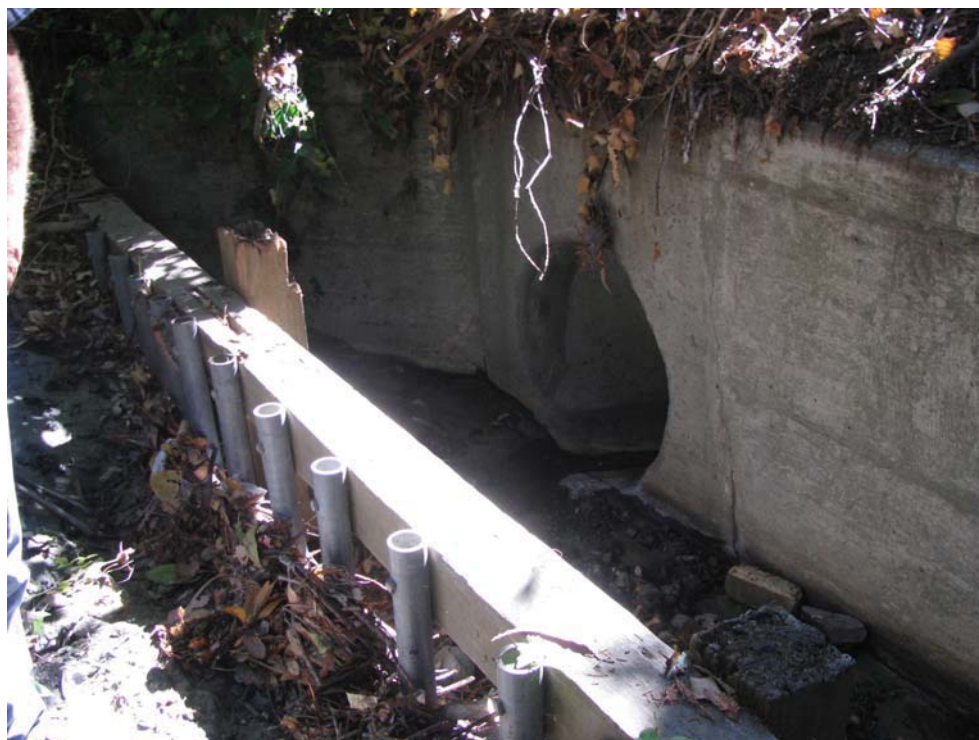
**Photograph 14:** Trash and woody debris interceptor and an inlet of about 3,100 feet long concrete drainage pipe that daylights at San Mateo Creek (9-18-2015 HTK)

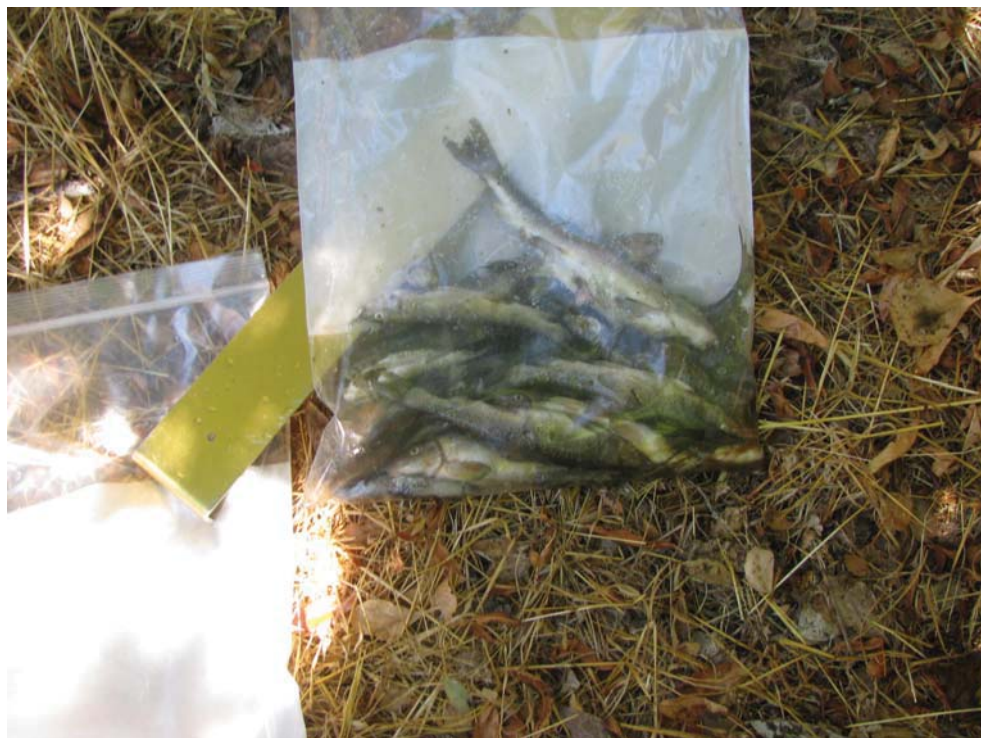
**Photographs 15:** Sacramento suckers and one sculpin collected by DFW wardens on September 18, 2015 (9-18-2015 HTK)

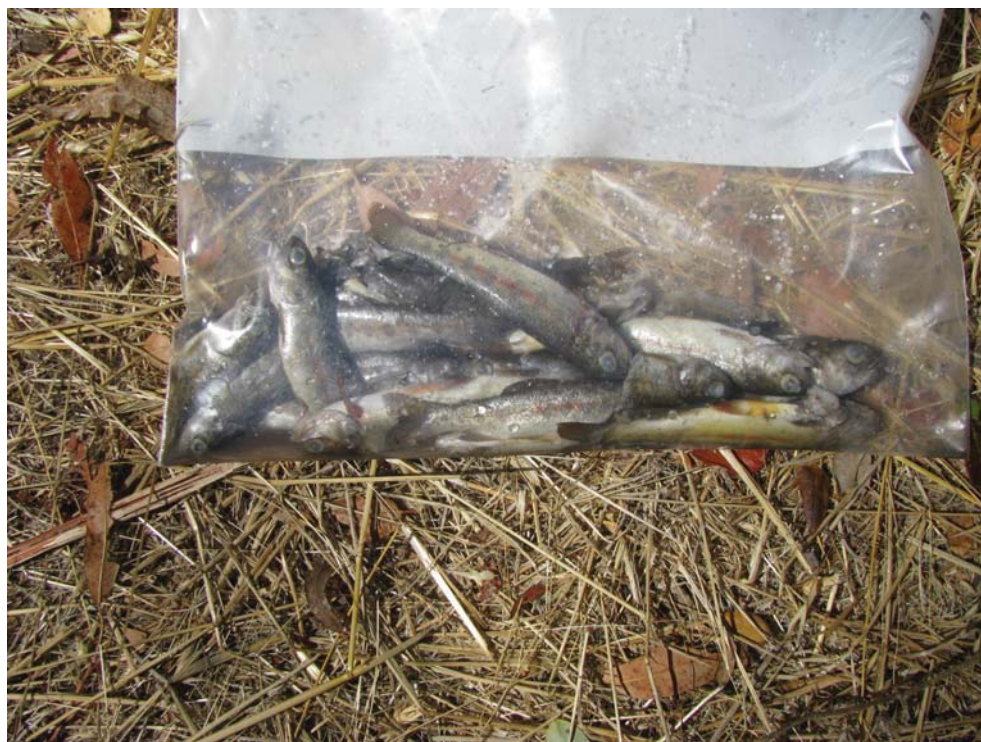
**Photograph 16:** Rainbow trout/Steelhead collected by DFW wardens on September 18, 2015 (9-18-2015 HTK)

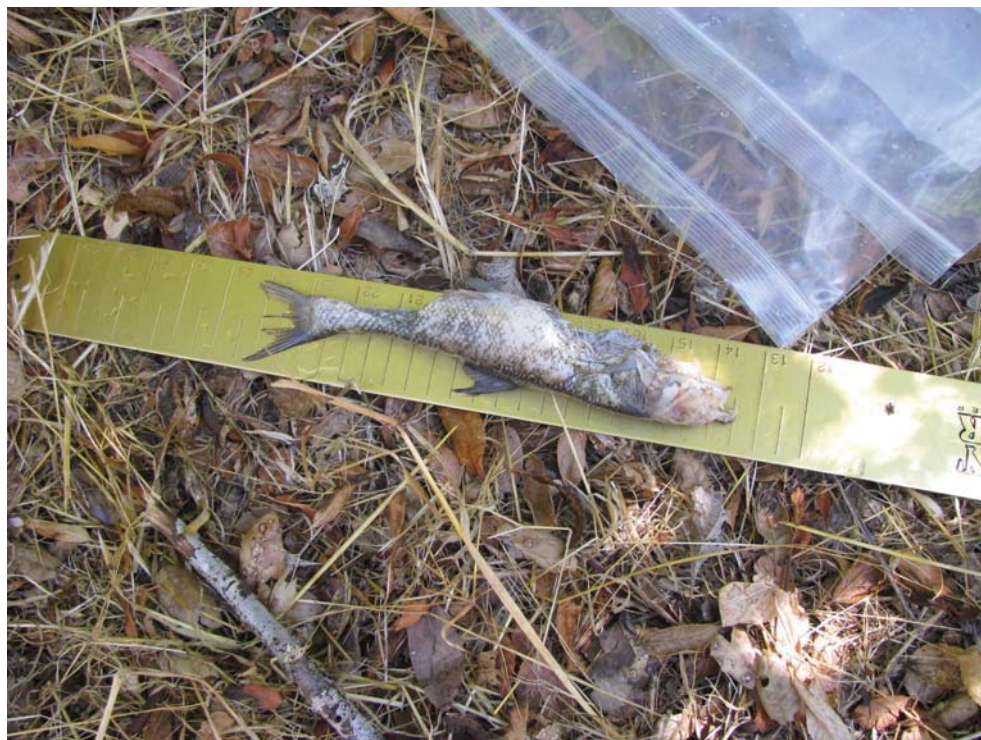
**Photograph 17:** Sacramento sucker scavenged by crayfish about 500 yards from the discharge outfall and collected by DFW wardens on 9-18-2015 (9-18-2015 HTK)
