**CALIFORNIA REGIONAL WATER QUALITY CONTROL BOARD
SAN FRANCISCO BAY REGION**

In the matter of:)	
)	
TOWN OF HILLSBOROUGH, SAN MATEO COUNTY)	SETTLEMENT AGREEMENT AND STIPULATION FOR ENTRY OF ADMINISTRATIVE CIVIL LIABILITY
)	
September 16-17, 2015)	ORDER
Unauthorized Discharge into San Mateo Creek)	
)	ORDER NO. R2-2017-1028

SUBJECT: Inspection of Town of Hillsborough Unauthorized Chloraminated Potable Water Discharge to San Mateo Creek that Caused Fish Kill, San Mateo County

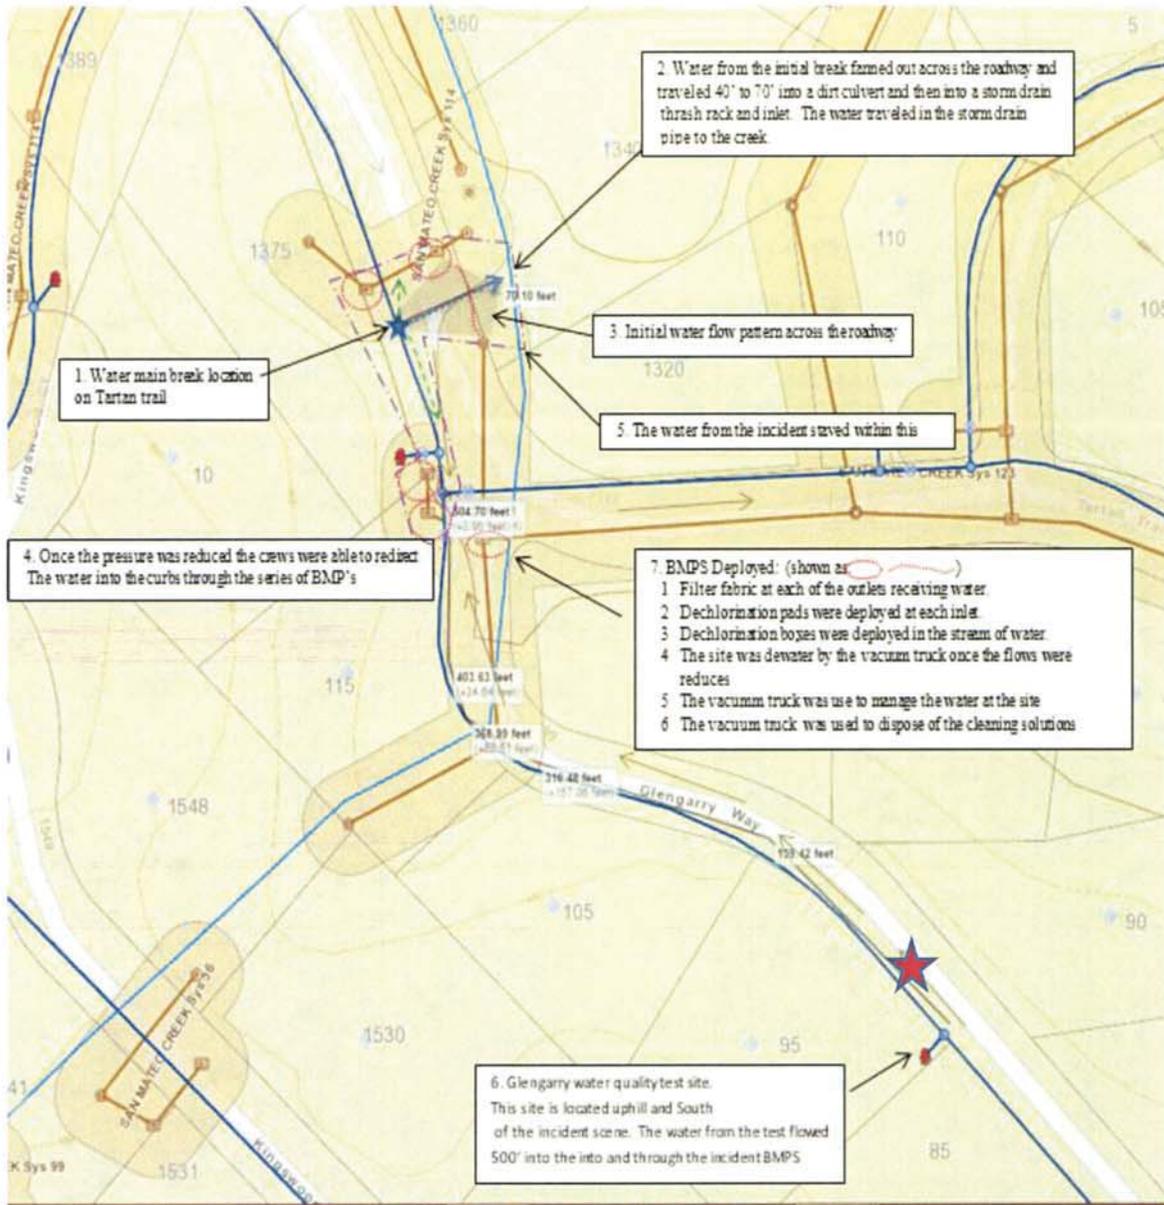
1. Water main break location on Tartan trail. Originated from an 8" cast iron water main (ID # WSMn16H15)
2. Water from the initial break fanned-out across the roadway and traveled 40' to 70' into a dirt culvert and then into a storm drain trash rack/ inlet. The water then traveled into the storm drain system to the creek.

3. Indicates the initial uncontrolled water flow pattern across the roadway. BMP's were placed in the wide spread flow.
4. Once the pressure was reduced the crews were able to redirect the water flow to the street curbs and through a series of BMP's (dechlorination devices)

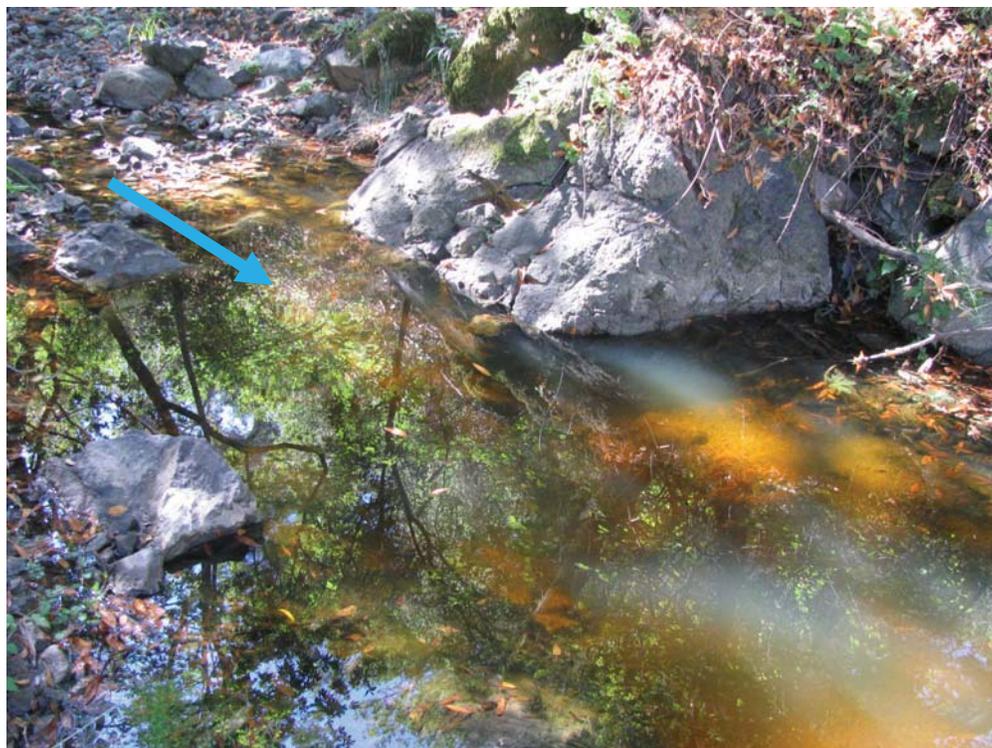
Photograph 1: Polhemus Creek pool immediately down slope of Cal Water 2013 discharge point. Regional Water Board staff observed fish in the pool (9-18-2015 HTK)

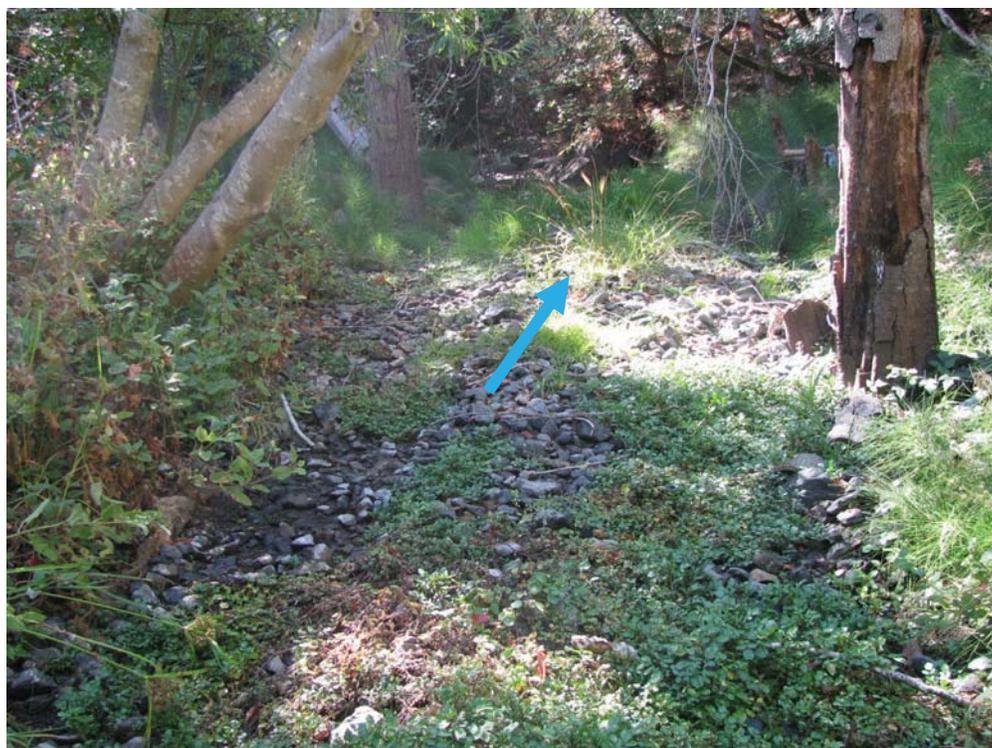
Photograph 2: Polhemus Creek looking downstream towards the confluence with San Mateo Creek - observed dry creek segment (9-18-2015 HTK)

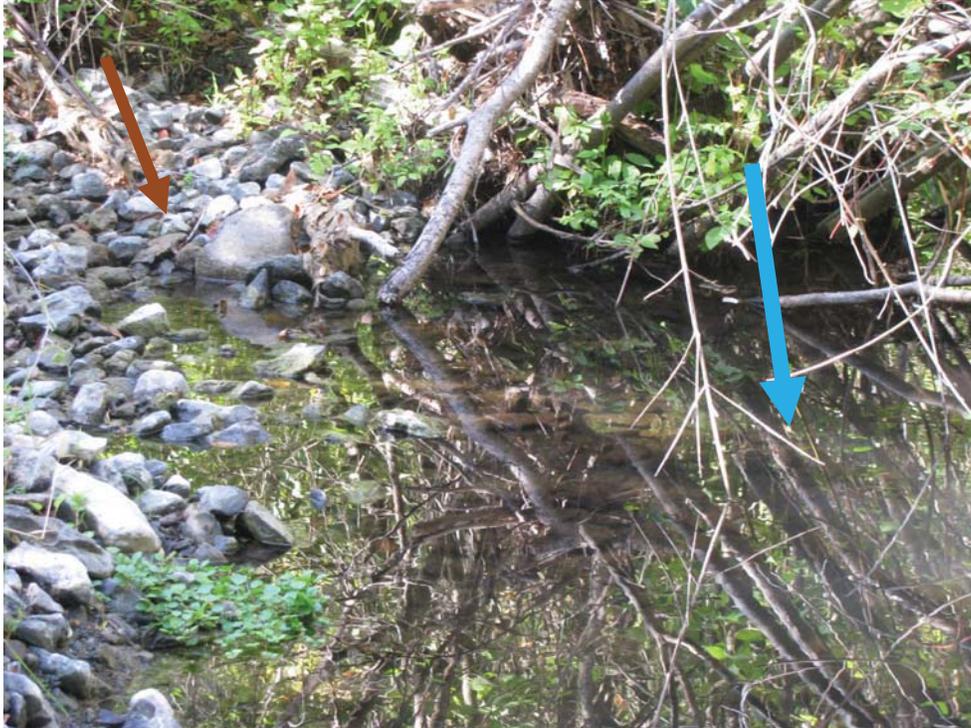
Photograph 3: Confluent of Polhemus Creek with San Mateo Creek – no signs of discharge observed – brown arrow on the left of the photograph shows no water flow from Polhemus Creek and blue arrow on the right of the photograph shows water flow coming from upper San Mateo Creek (9-18-2015 HTK)

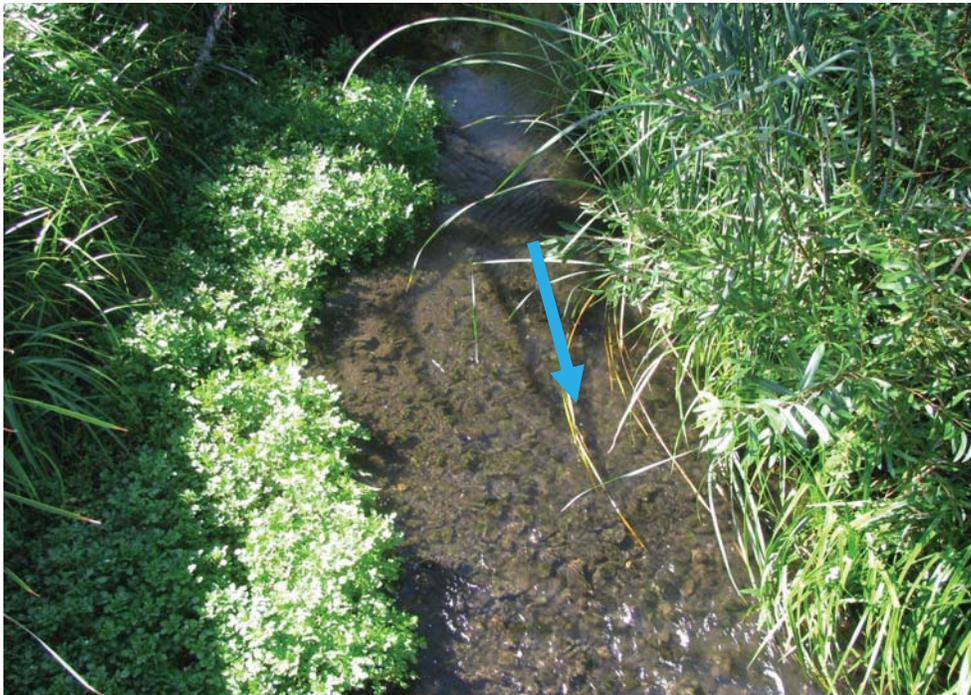
Photograph 4: San Mateo Creek looking upstream from Crystal Springs Road Bridge downstream of the confluence - no signs of discharge or disturbance (9-18-2015 HTK)

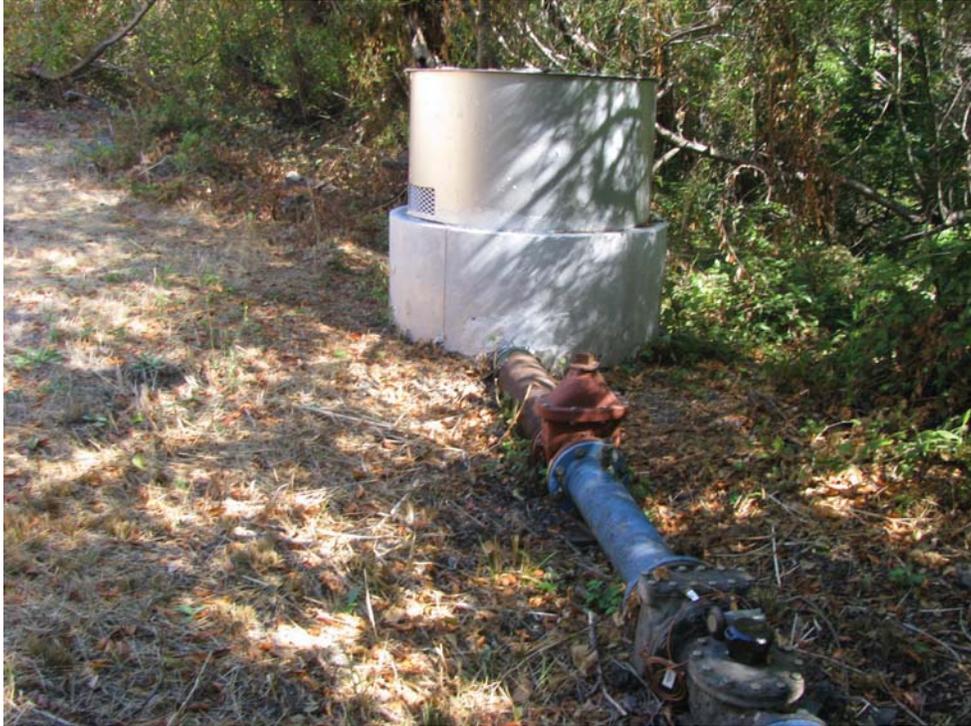
Photograph 5: Town of Hillsborough's water pipe connected to SFPUC water system (9-18-2015 HTK)

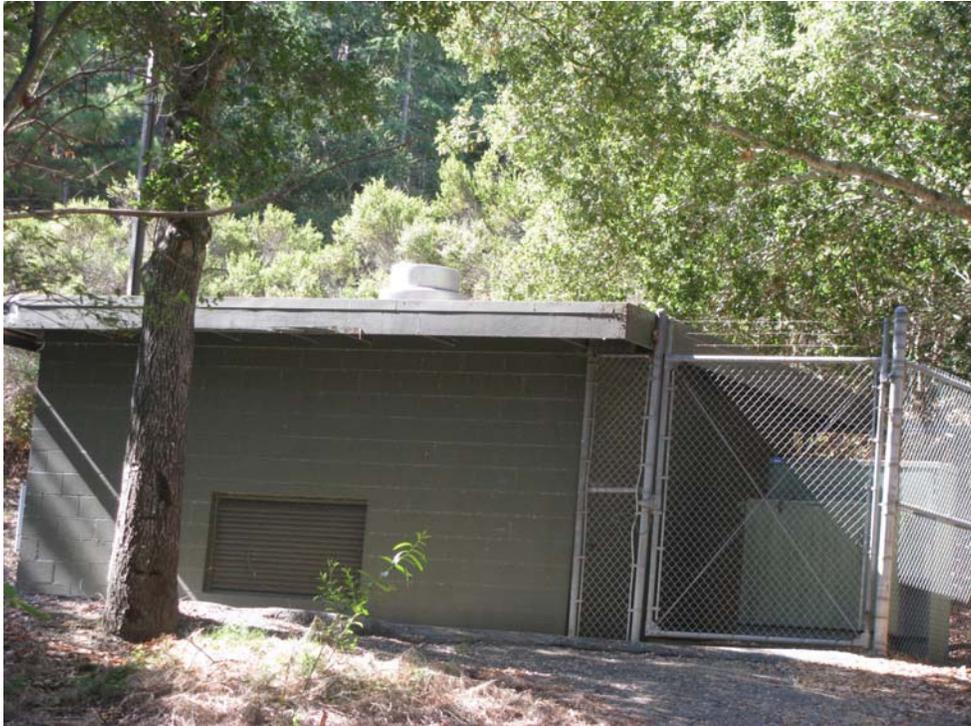
Photograph 6: Town of Hillsborough's Tartan Trail Pump Station (9-18-2015 HTK)

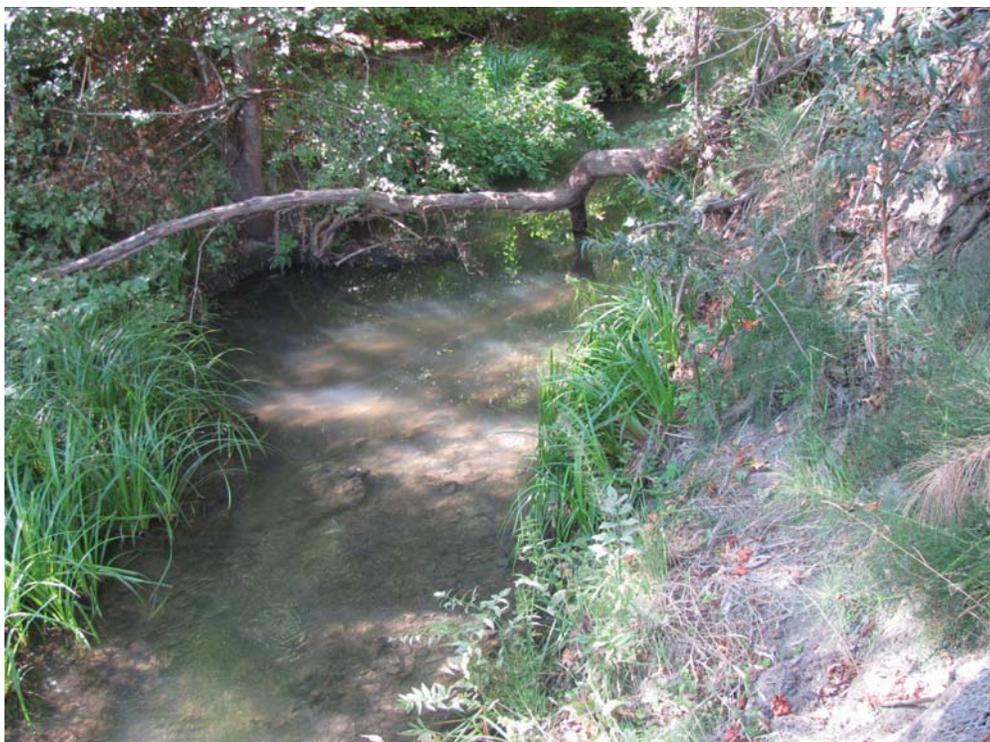
Photograph 7: San Mateo Creek immediately downstream of the discharge entered the Creek - observed fine sediment deposition in creek bed as the result the water looks less clear than upstream water showing on Photograph 4 above (9-18-2015 HTK)

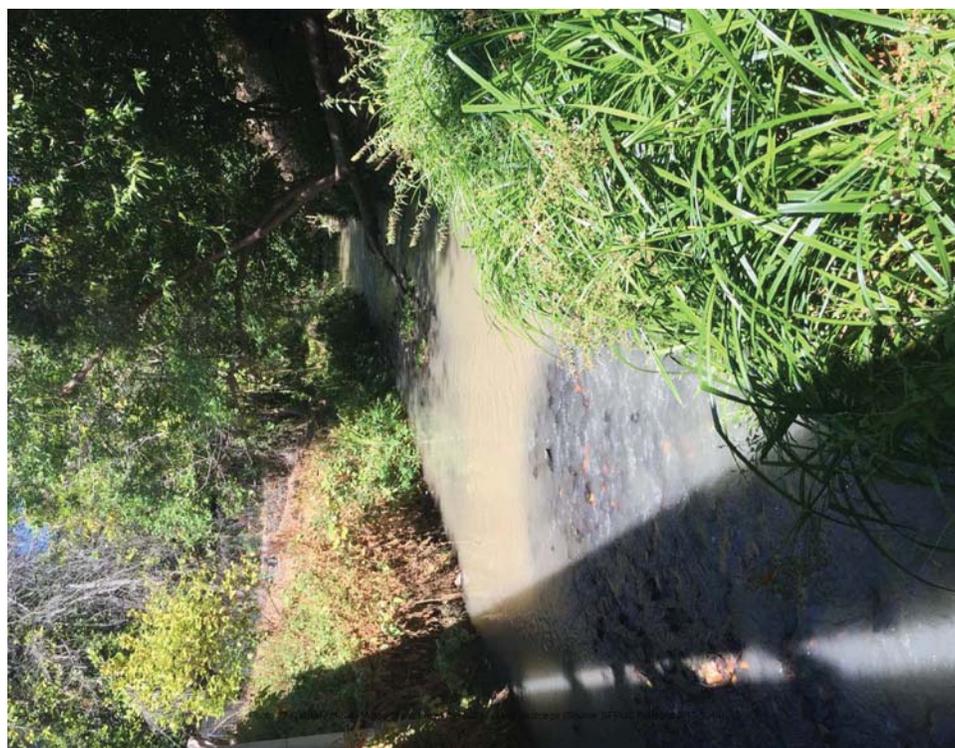
Photograph 8: Turbidity in San Mateo Creek downstream of the discharge outfall (Courtesy: SFPUC biologist 9-17-2015)

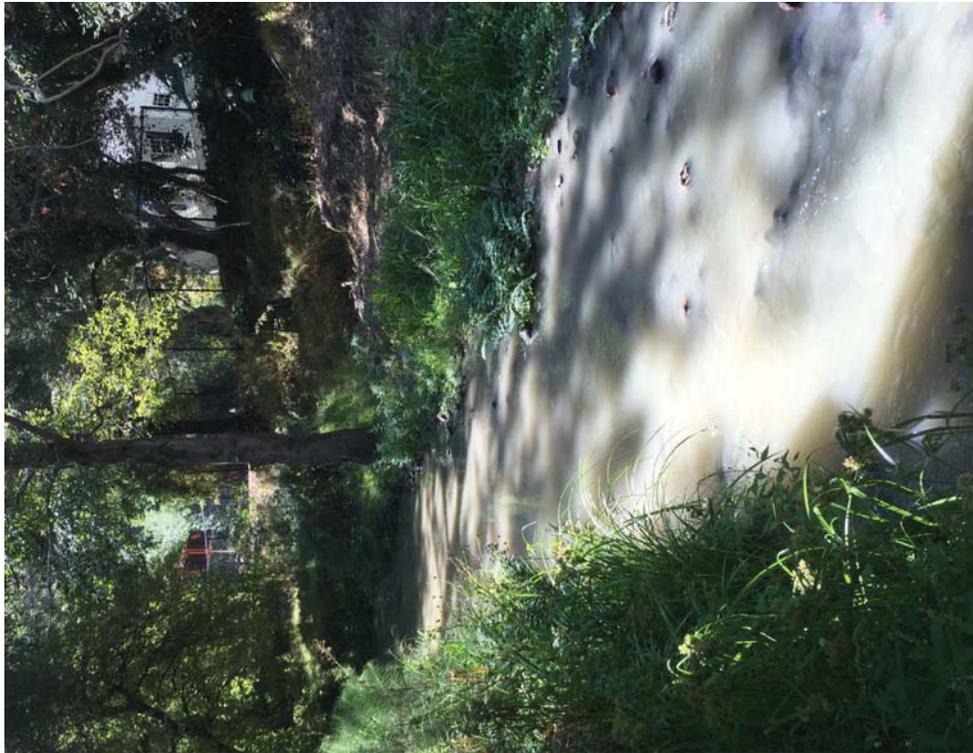
Photograph 9: Turbidity in San Mateo Creek downstream of the discharge outfall (Courtesy: SFPUC biologist 9-17-2015)

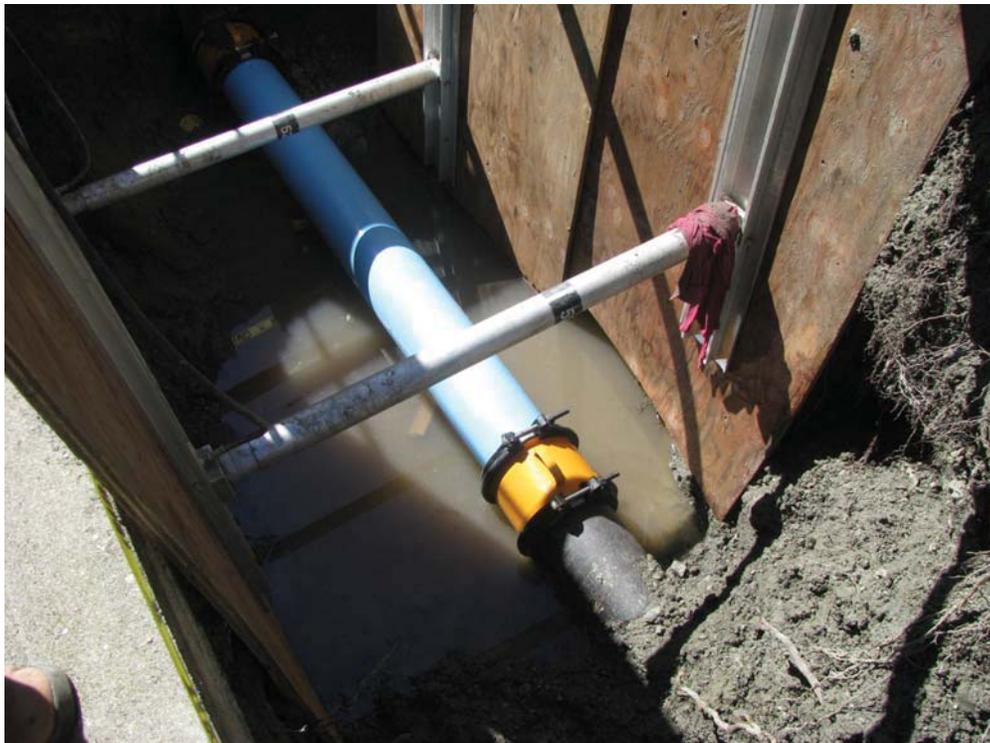
17	9/17/2016	Dark	6:30	6:30:00 AM	CD arrived on scene	DB -Shoring being installed		
18	9/17/2016	Cloudy	7:00	7:00:00 AM	DB Cont. to dig, locate extent of crack, approx. 6' long longitudinal crack on bottom of pipe	CD - assisted in taking over repairs		
19	9/17/2016	Cloudy	7:30	7:30:00 AM				CD - directed PR to collect Bac-t samples after break was repaired
20	9/17/2016	Cloudy	8:00	8:00:00 AM	DB - Other workers arrived on scene to assist with repair and take over traffic control/Assist with set up of shoring	JM arrived on scene and assisted with Traffic controls and to asses the situation		
21	9/17/2016	Cloudy	8:30	8:30:00 AM *shut down*	CD - Assist with exposing pipe and finding the end of the cracked pipe	DB - Gary F, Dave B, & Matt V. left the job site to go home and get some rest		CD - Used ditch pump while vacuum truck was full and had to dump- sewer main to far away and in traffic lane to discharge to. CD - took a CL2 reading at the inlets within the controlled area, the reading indicated the water entering the SD inlets had a CL2 reading of .00

Photograph 10: Excavated discharge location showing a repaired 8-inch water main pipe about 6 feet below grade (9-18-2015 HTK)

22	9/17/2016	Cloudy	9:00	9:00:00 AM	CD - Crew began to cut out the cracked pipe	CD - Preparation of new pipe-PVC pipe. The new section of pipe and the fittings are cleaned and disinfected with a solution of water and 12.5% chlorine . The pipe and fittings are placed in a bucket and swabbed with a brush.		CD - took a CL2 reading at the inlets within the controlled area, the reading indicated the water entering the SD inlets had a CL2 reading of .00 CD - The remaining Chlorine liquid used to clean the pipe and fittings is removed by the vacuumed truck. The chlorinated water is disposed of in the sewer at the PW yard when the material in the truck is decanted.
23	9/17/2016	Cloudy	9:30	9:30:00 AM	CD - Crew cut out cracked section of pipe 7 ft. long. The crews install a new pipe plastic pipes with two Romac couplings.			CD - took a CL2 reading at the inlets within the controlled area, the reading indicated the water entering the SD inlets had a CL2 reading of .00

24	9/17/2016	Cloudy	10:00	10:00:00 AM	CD Leak repaired begin filling water main- turn on valve at 1415 Tartan Trail The new section of the pipe was cleaned and disinfected inside the open trench	CD- assigned crew to start clean up and blow off homes when water starts to flow		CD - directed Paul Race to collect bac-t samples in area of leak.
25	9/17/2016	Cloudy	10:30	10:30:00 AM	CD - Used zone valve on Inverness to assist with recharging the system for the delivering of water			CD - 50 Inverness-attached a diffuser to hydrant below zone valve. CD - took a CL2 reading the reading was .00
26	9/17/2016	Cloudy	11:00	11:00:00 AM	CD - continue to fill main, crews are cleaning site	CD - Direct crew to flush homes and system		PR - began flushing at 85 Glengarry (controlled discharge)through a diffuser which flowed down to the catch basin which had BMP's in place (Dechlor, filter, rock bags) Flowed at 150 GPM. Paul's flushing complete at 11:25am pH =9.60, Total chlorine = 0.22 mg/L, NTU = 2.64 NOTE: This test was taken upstream from the incident, the sample was taken within 20' of the diffuser discharge because of the steep location. The discharge water from the hydrant continued to flow from the test site 500' into the incident site where is runs thought the BMP's.

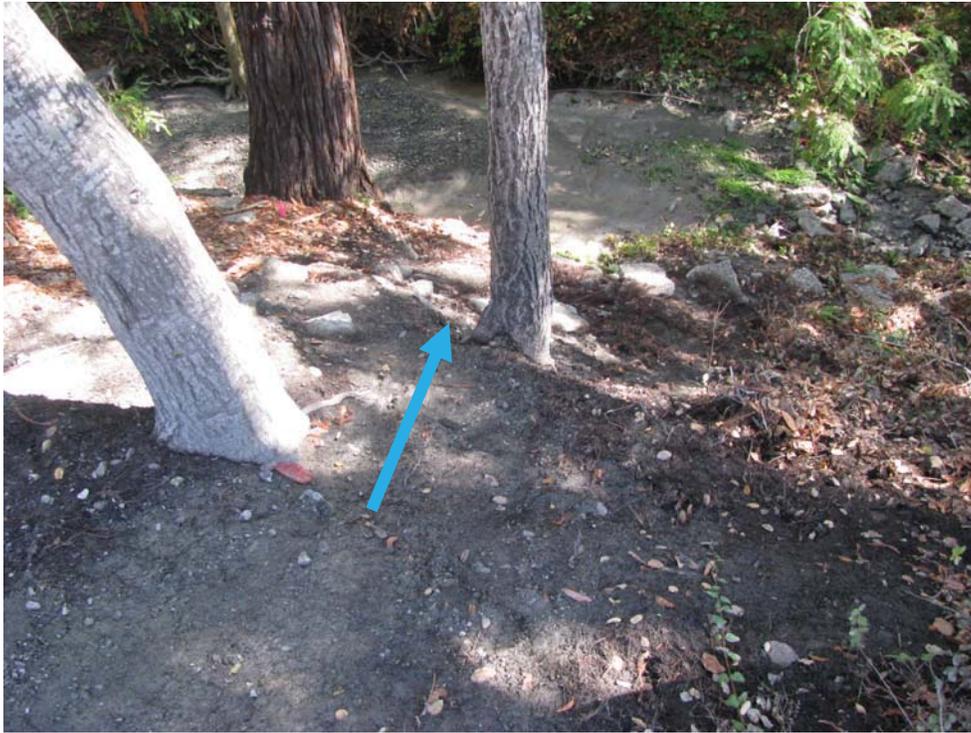
Photograph 11: Observed wetted surface a sign of land overflow entering an open unnamed drainage downstream of the discharge point (9-18-2015 HTK)

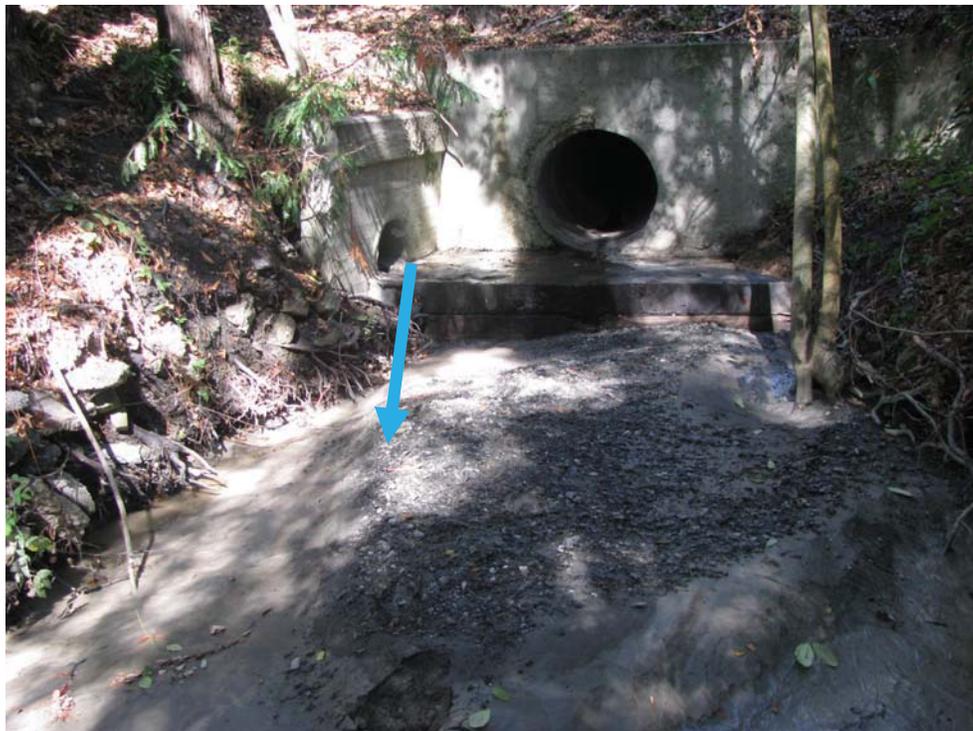
Photograph 12: Discharge also entered the unnamed open drainage from the smaller culvert on the left side of the photograph (9-18-2015 HTK)

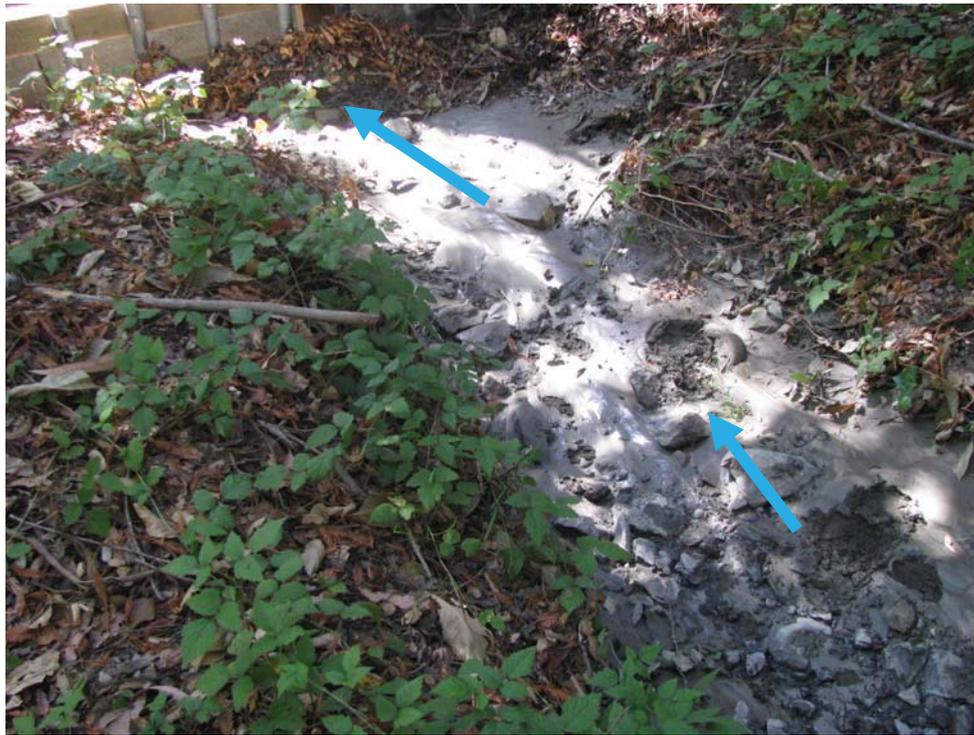
Photograph 13: Sediment deposition behind a trash and woody debris interceptor along the unnamed open drainage (9-18-2015 HTK)

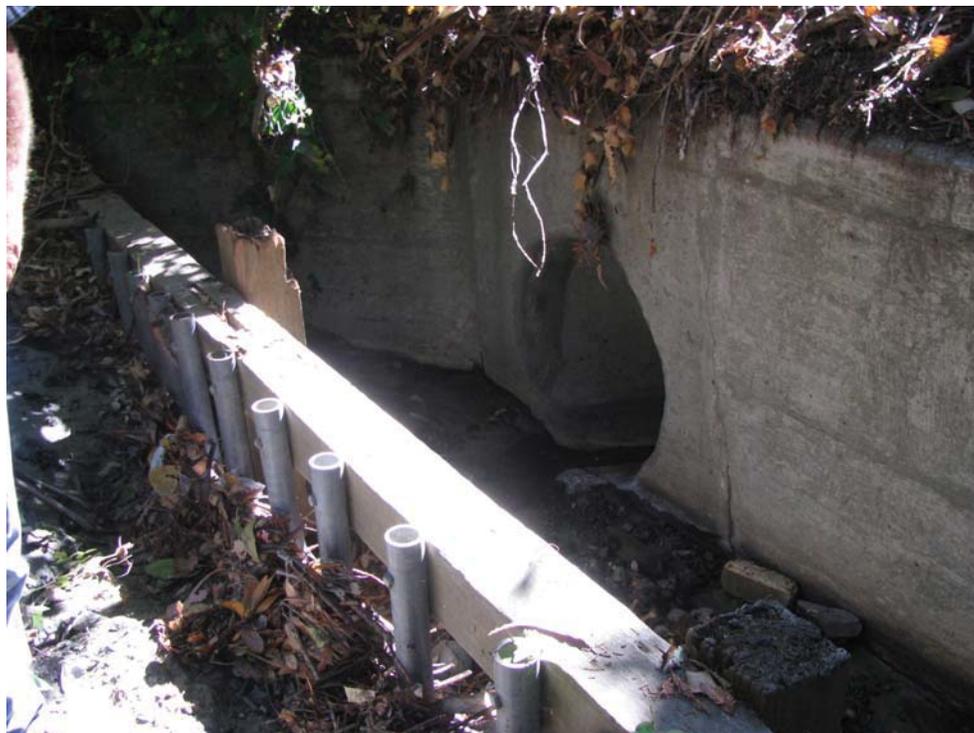
Photograph 14: Trash and woody debris interceptor and an inlet of about 3,100 feet long concrete drainage pipe that daylights at San Mateo Creek (9-18-2015 HTK)

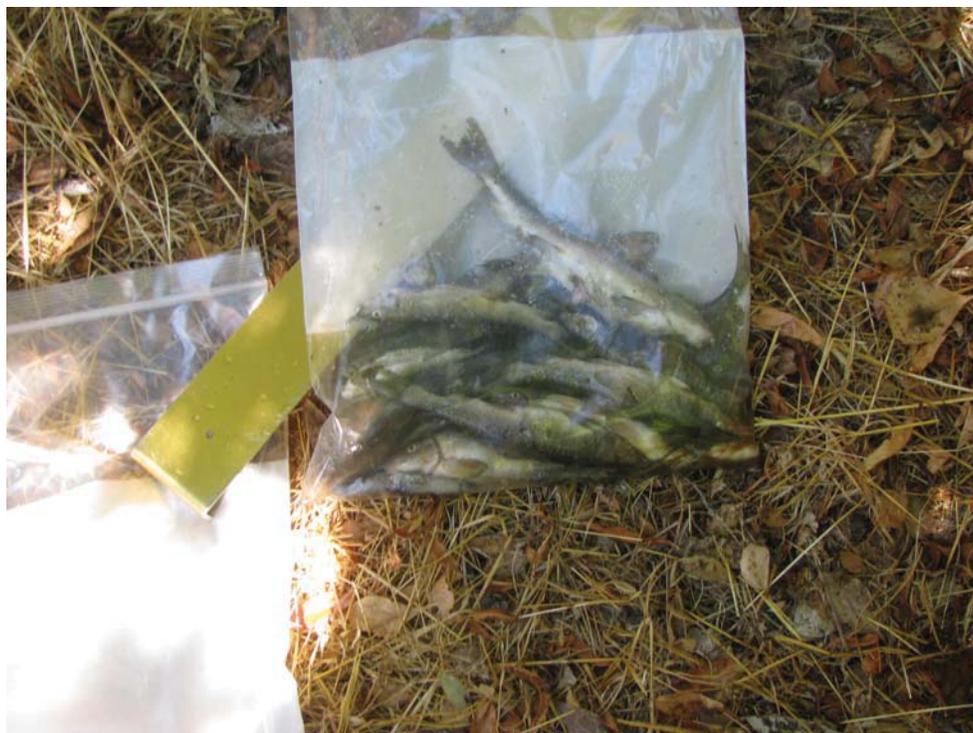
Photographs 15: Sacramento suckers and one sculpin collected by DFW wardens on September 18, 2015 (9-18-2015 HTK)

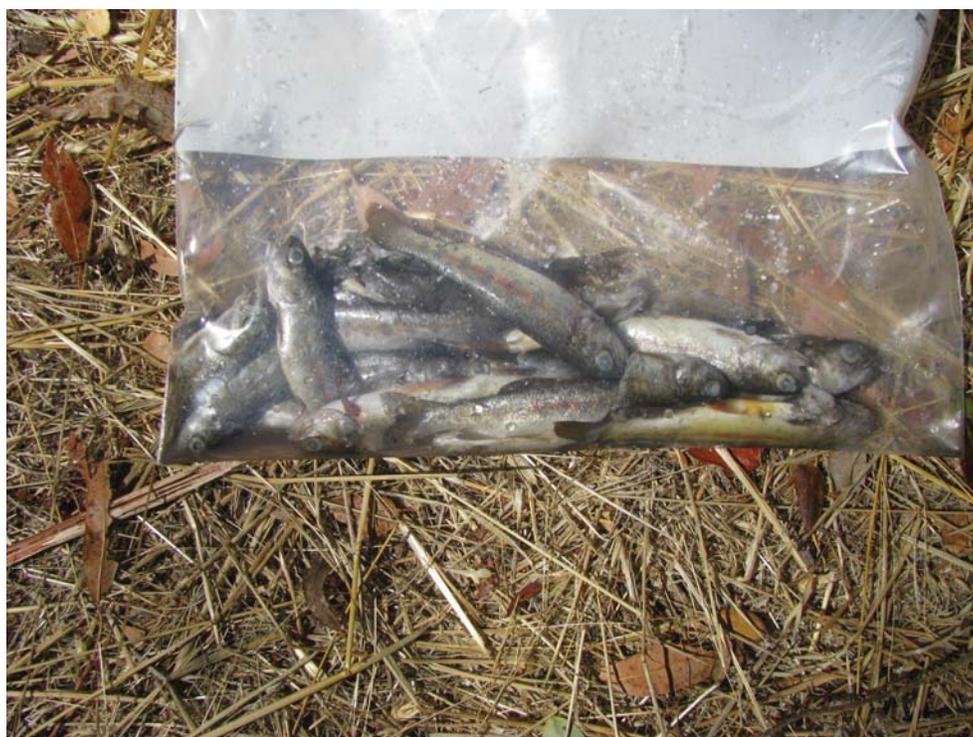
Photograph 16: Rainbow trout/Steelhead collected by DFW wardens on September 18, 2015 (9-18-2015 HTK)

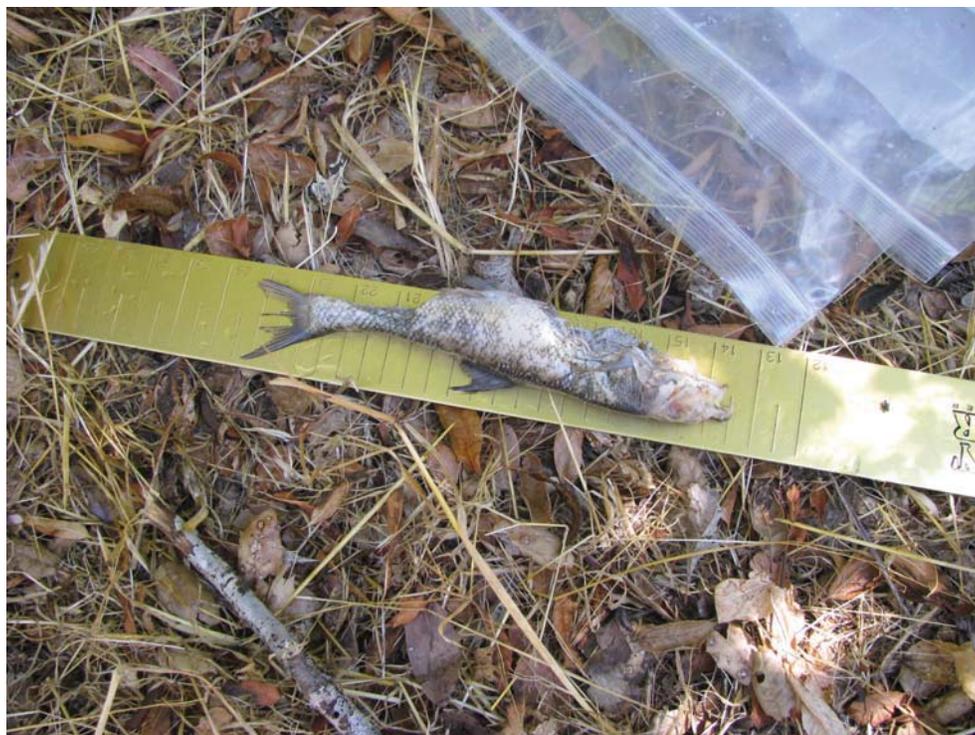
Photograph 17: Sacramento sucker scavenged by crayfish about 500 yards from the discharge outfall and collected by DFW wardens on 9-18-2015 (9-18-2015 HTK)
