San Francisco Bay Regional Water Quality Control Board

FROM: Carrie M. Austin, P.E.
Project Manager, Guadalupe River Watershed Mercury TMDL
PLANNING/TMDL DIVISION

SUBJECT: Transmission of data from XRF Survey of Almaden Quicksilver County Park on August 14, 2018

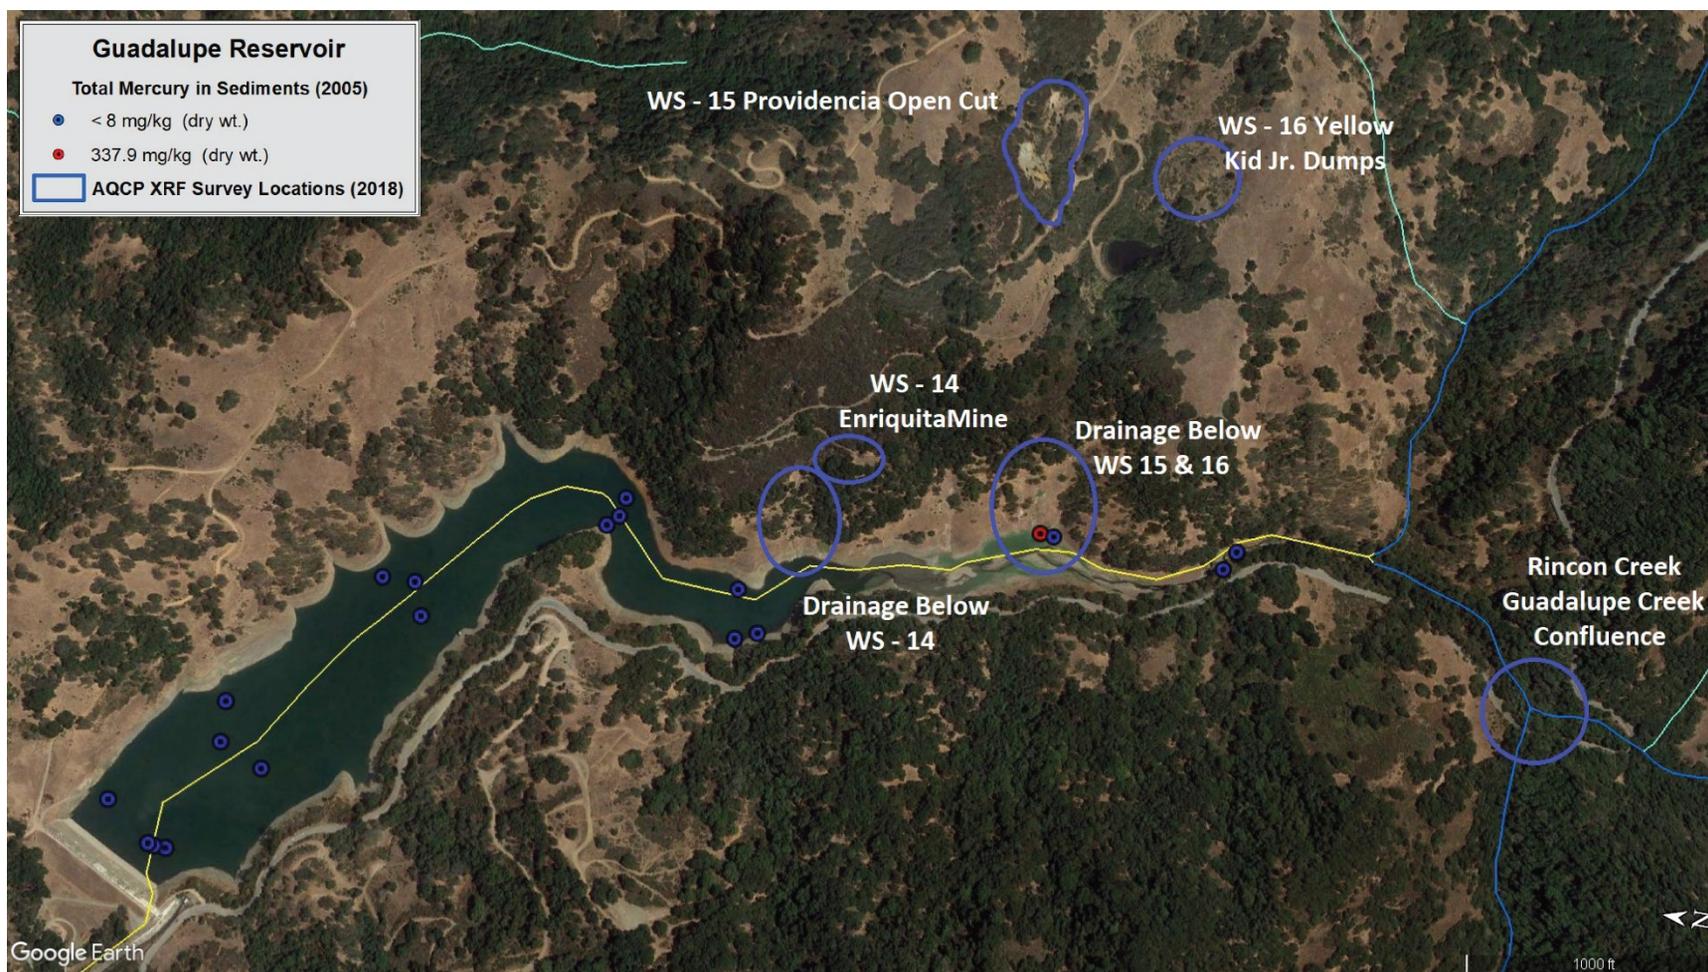
Figure 1. XRF sample locations August 14, 2018 and Guadalupe Reservoir 2005 bottom sediment mercury

Sample locations were selected to represent a range of historical mining influence that could be sampled in a single day. Therefore, locations were selected at the upstream portion of Guadalupe Reservoir. In 2005, mercury concentrations (mg/kg dry wt) in Guadalupe Reservoir bottom sediment generally ranged between 0.42 to 7.29 (blue dots), with one extreme value of 337.9 (red dot at sample location GR-6-A). The reservoir extreme value is located downstream of sample locations Drainage Below WS-15 & WS-16, and WS-16 Yellow Kid Jr. Dumps.

Figure 1 is a map of the six 2018 XRF sample locations, and Table 2 provides detailed descriptions and representative photos of each location.

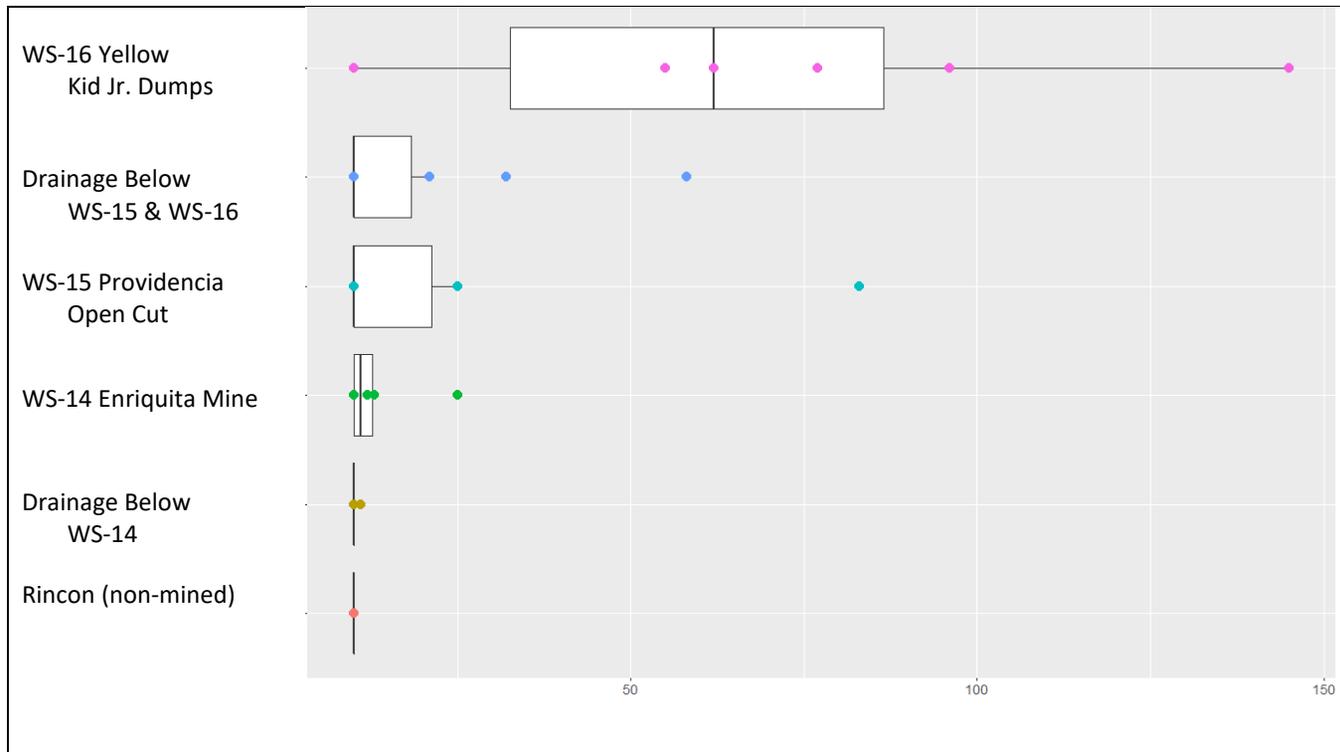
Figure 2. XRF mercury results (mg/kg) by location

WS-16 Yellow Kid Jr. Dumps has the highest mercury concentrations and they are statistically significantly higher than the XRF detection limit of 10 mg/kg. Enriquita Mine was previously remediated. The mercury concentration downstream of these two mine features (Drainage Below WS-15 & WS-16) is not significantly different from 10 mg/kg.

Table 4 provides the results of a non-parametric statistical analysis that was performed to determine if the mercury concentration at each location was significantly different from the detection limit. (It is preferable to perform a statistical analysis to determine if the mercury concentration is significantly different between locations, but the high number of non-detects prevents this analysis.) For the statistical analysis, non-detects were evaluated at the detection limit of 10 mg/kg. The results of one-sample Wilcoxon tests that compared mercury concentration data for each location to 10 mg/kg (the limit of detection). The hypothesis is that the median of data is less than or equal to 10 mg/kg, and the alternative hypothesis is that the median is greater than 10 mg/kg. Statistical test results are interpreted by p-values, where p-values less than 0.05 are significant [the chance of wrongly rejecting the null value are 5%]; p-values between 0.05 and 0.1 are evidence for significant difference; and p-values equal to or greater than 0.1 are not significant. The range of mercury concentrations by location are illustrated on Figure 2.

The analysis shows that mercury concentrations of the mining waste at WS-16 Yellow Kid Jr. Dumps is statistically significantly higher than 10 mg/kg, and there is evidence that mercury concentrations at both the Drainage Below WS-15 & WS-16 location and previously remediated WS-14 Enriquita Mine location are also higher than 10 mg/kg.

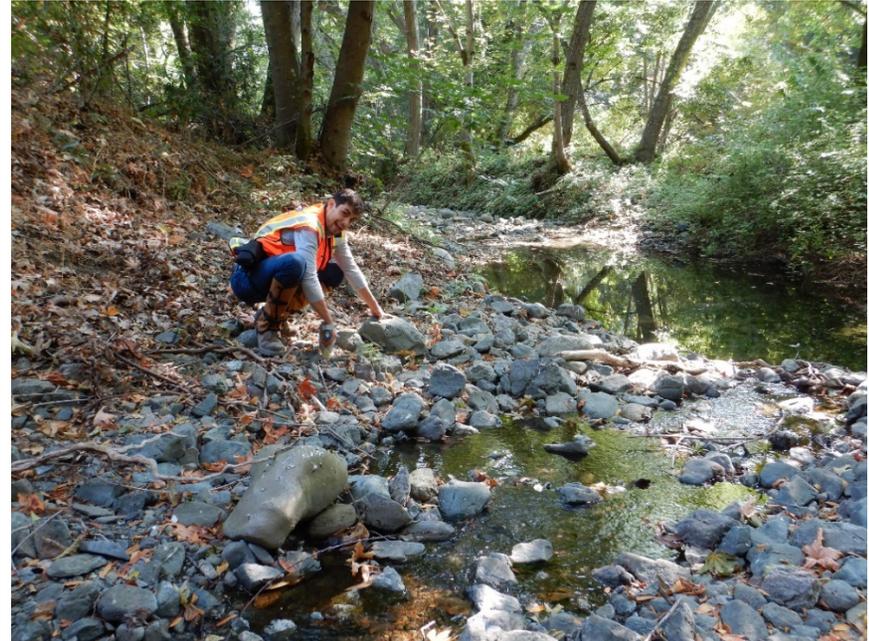
“Rincon”: Confluence of Rincon and Guadalupe Creeks;
southeast side of culvert/bridge on Hicks Road

This first site was chosen to represent mercury concentrations from the non-mined portion of watershed draining to Guadalupe Reservoir. These creeks drain Mt. Umunhum from an area that was not mined nor used as a staging area for mining activities. Soils could potentially be elevated in mercury from deposition of mercury vapors from ore processing at Guadalupe Mine located nearby (downstream of Guadalupe Reservoir). Foreground is Rincon Creek; samples were taken from both banks of Rincon Creek just above the confluence with Guadalupe Creek, so these sample locations are likely flooded by both creeks during high flows.

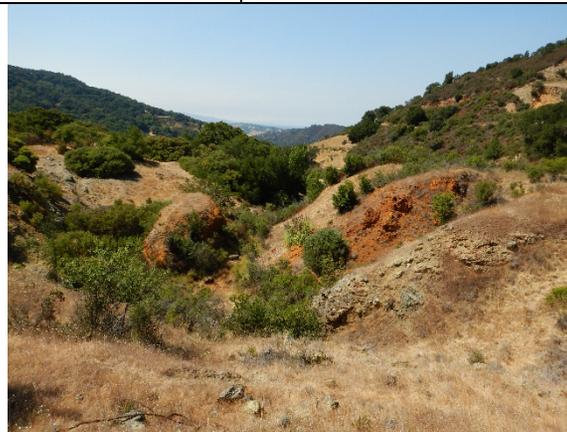
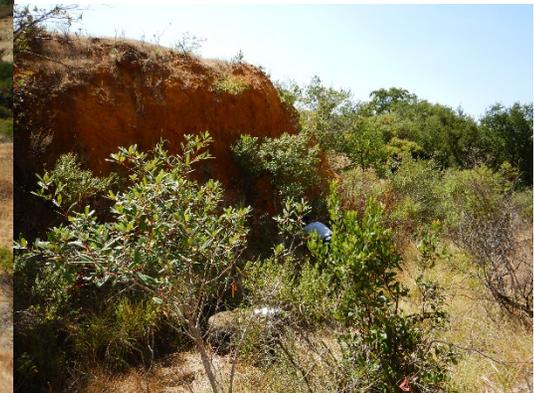
Yellow Kid Jr. Dumps WS16

This site was chosen to represent mercury concentrations in erodible fines at a mine site upslope from Guadalupe Reservoir. It appears that a stream bisects a potential calcine pile, and that the stream has already eroded the middle portion of the pile.

Mercury transport is a combination of erosion potential and mercury concentration. Table 2 describes the visual assessment of erosion potential of the sample locations and Table 4 provides a summary of the mercury concentrations. WS-16 Yellow Kid Jr. Dumps has the greatest risk of mercury discharge to Guadalupe Reservoir of the locations sampled. This risk is due to both high erosion potential and elevated mercury concentrations. Moreover, as shown on Figure 1, WS-16 Yellow Kid Jr. Dumps is located upstream of the only mercury hot spot identified in Guadalupe Reservoir in 2005. However, at an intermediate location along the drainage (Drainage Below WS-14) mercury was not statistically significantly different from 10 mg/kg.

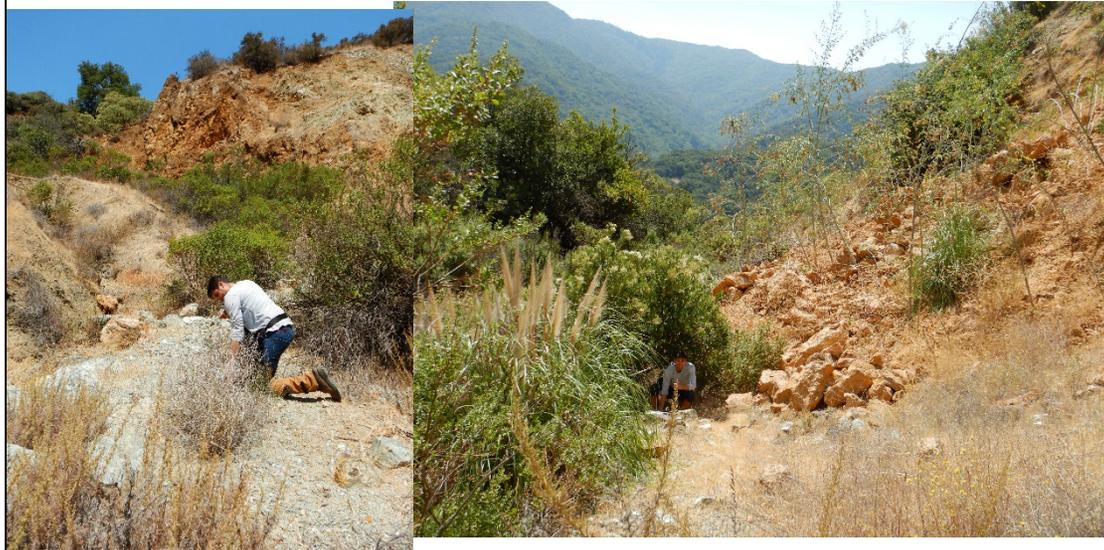
Providencia Open Cut, Pond, and Waste Piles
Downstream WS15

This site was chosen to represent mercury concentrations in erodible fines at a mine site upslope from Guadalupe Reservoir.

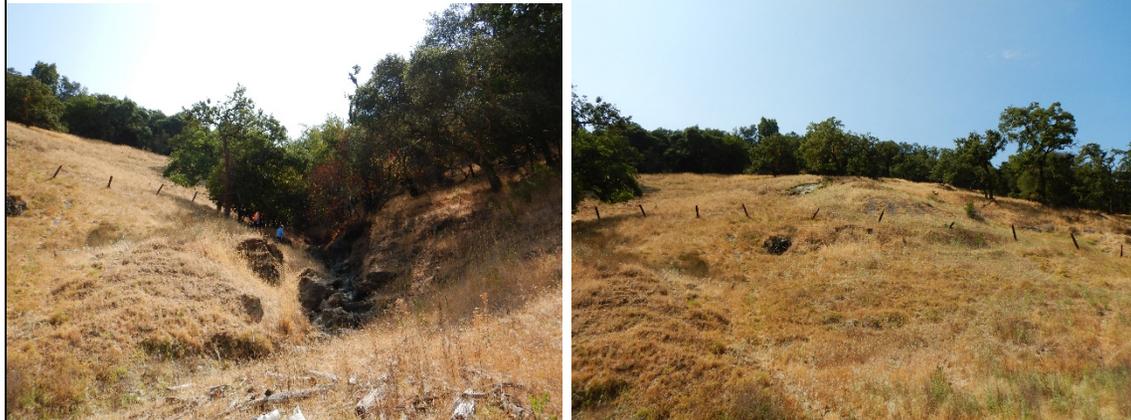
Drainage Below WS-15 & WS-16

This site was chosen to represent mercury concentrations in erodible fines below an identified mine feature and above reservoir high water mark. URS 2011 Report, Table 1, describes WS15 as having waste piles downstream. This sample location is downstream of waste piles and above reservoir.

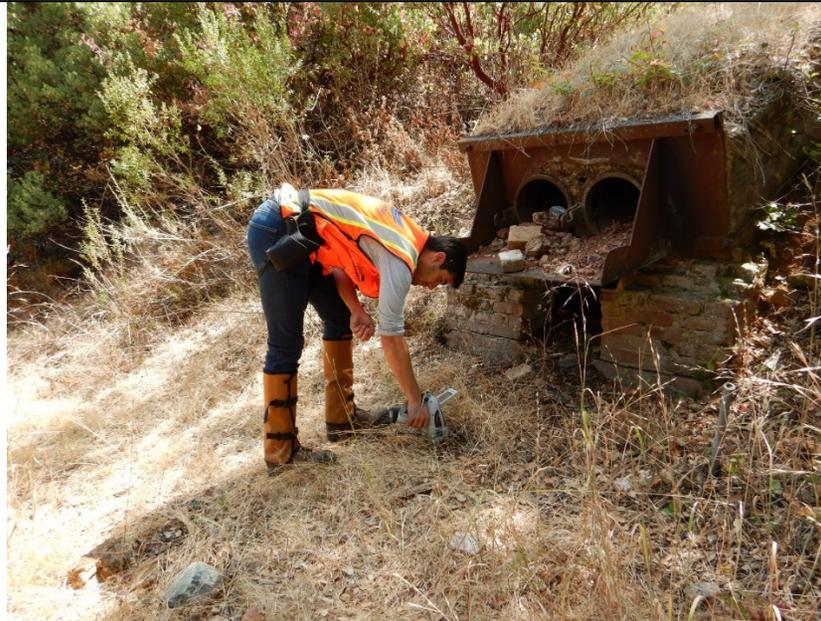
Enriquita Mine WS14

This site was chosen to represent mercury concentrations in erodible fines at a mine site upslope from Guadalupe Reservoir. The Enriquita mine site was remediated previously.

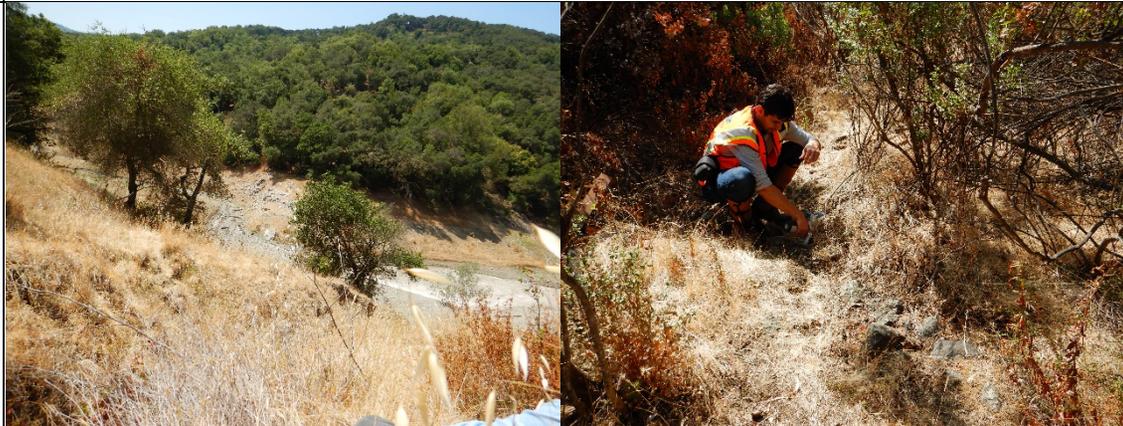
Drainage below WS14

This site was chosen to represent mercury concentrations in erodible fines below an identified mine feature and above reservoir high water mark. (Enriquita mine site was remediated previously.)
