San Francisquito Creek Watershed Analysis and Sediment Reduction Plan FINAL REPORT

San Francisquito Creek
Joint Powers Authority

nhc northwest
hydraulic
consultants
Leaders in water resource technology

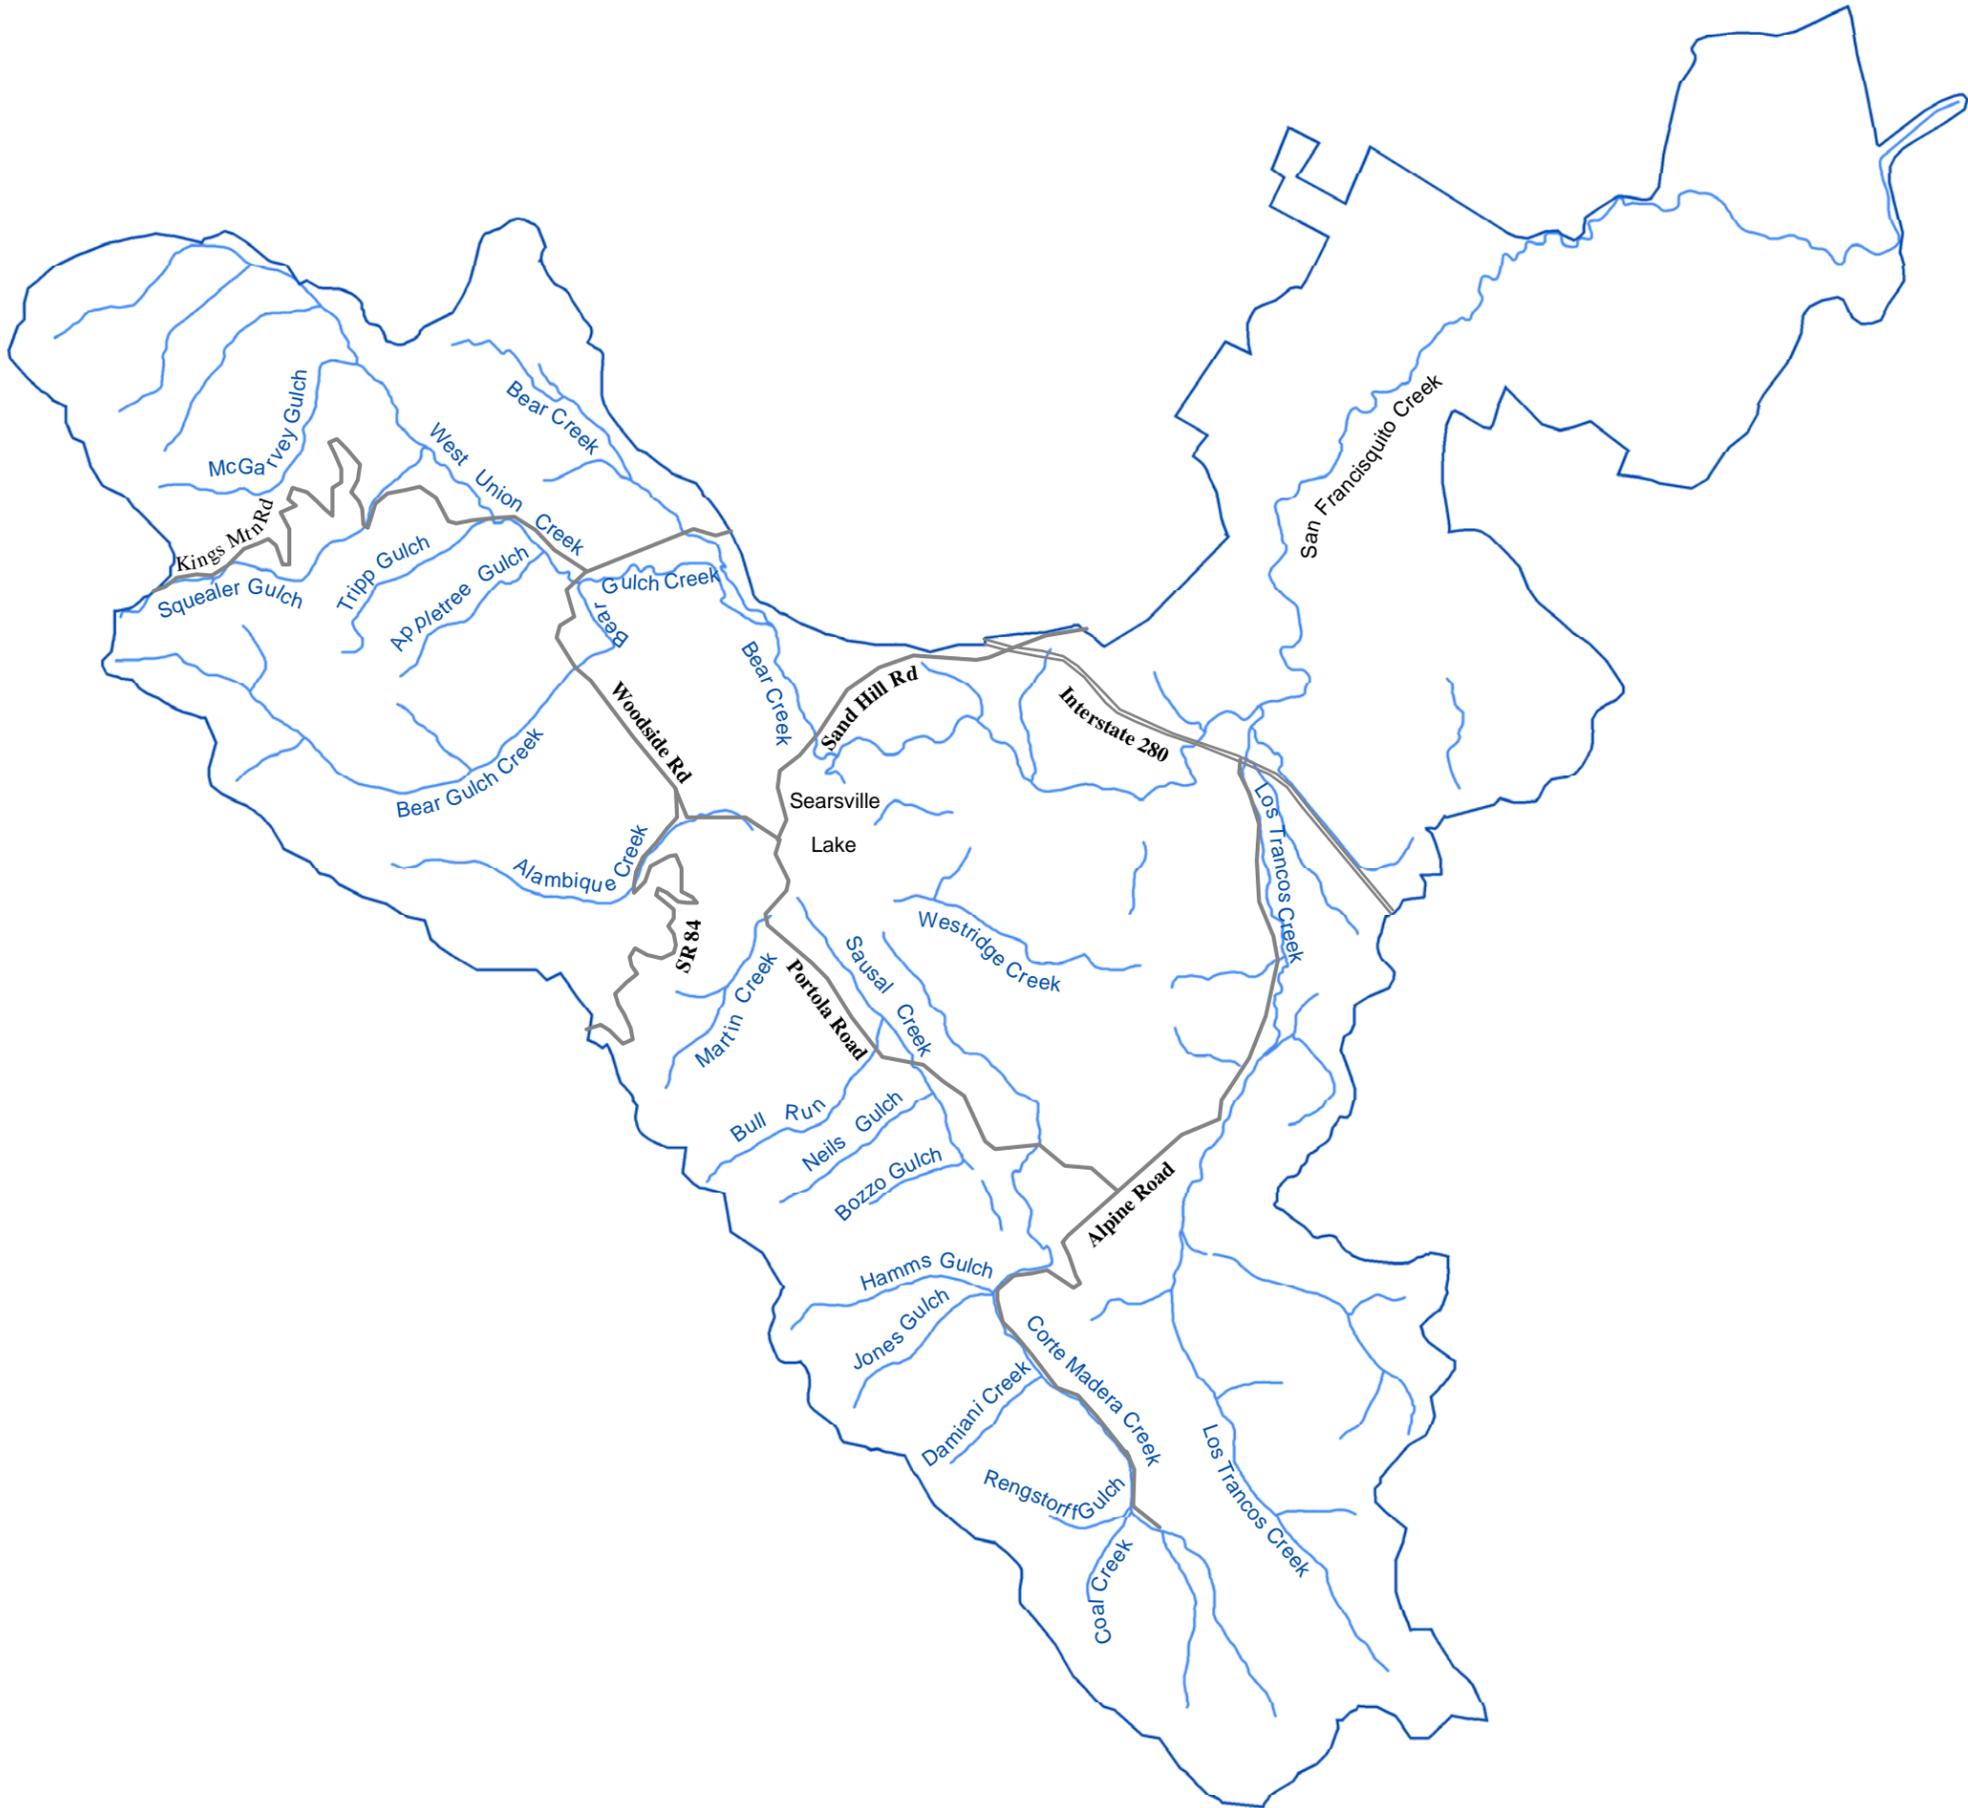
Figure 1 San Francisquito Creek Watershed Study Area

The San Andreas Fault Zone (SAFZ) is the most prominent feature in the San Francisquito Creek watershed, bisecting the watershed along a northwest-southeast direction (Figure 1). The steep, upper watershed lies southwest of the SAFZ in the northern Santa Cruz Mountains, whereas more gradually sloping areas lie to the northeast (Figure 3). Unstable slopes and active landsliding are predominantly found southwest of the SAFZ (Wentworth *et al* 1997). This area corresponds to the Santa Cruz Mountain Upland erosional and depositional province of Brown and Jackson (1973).

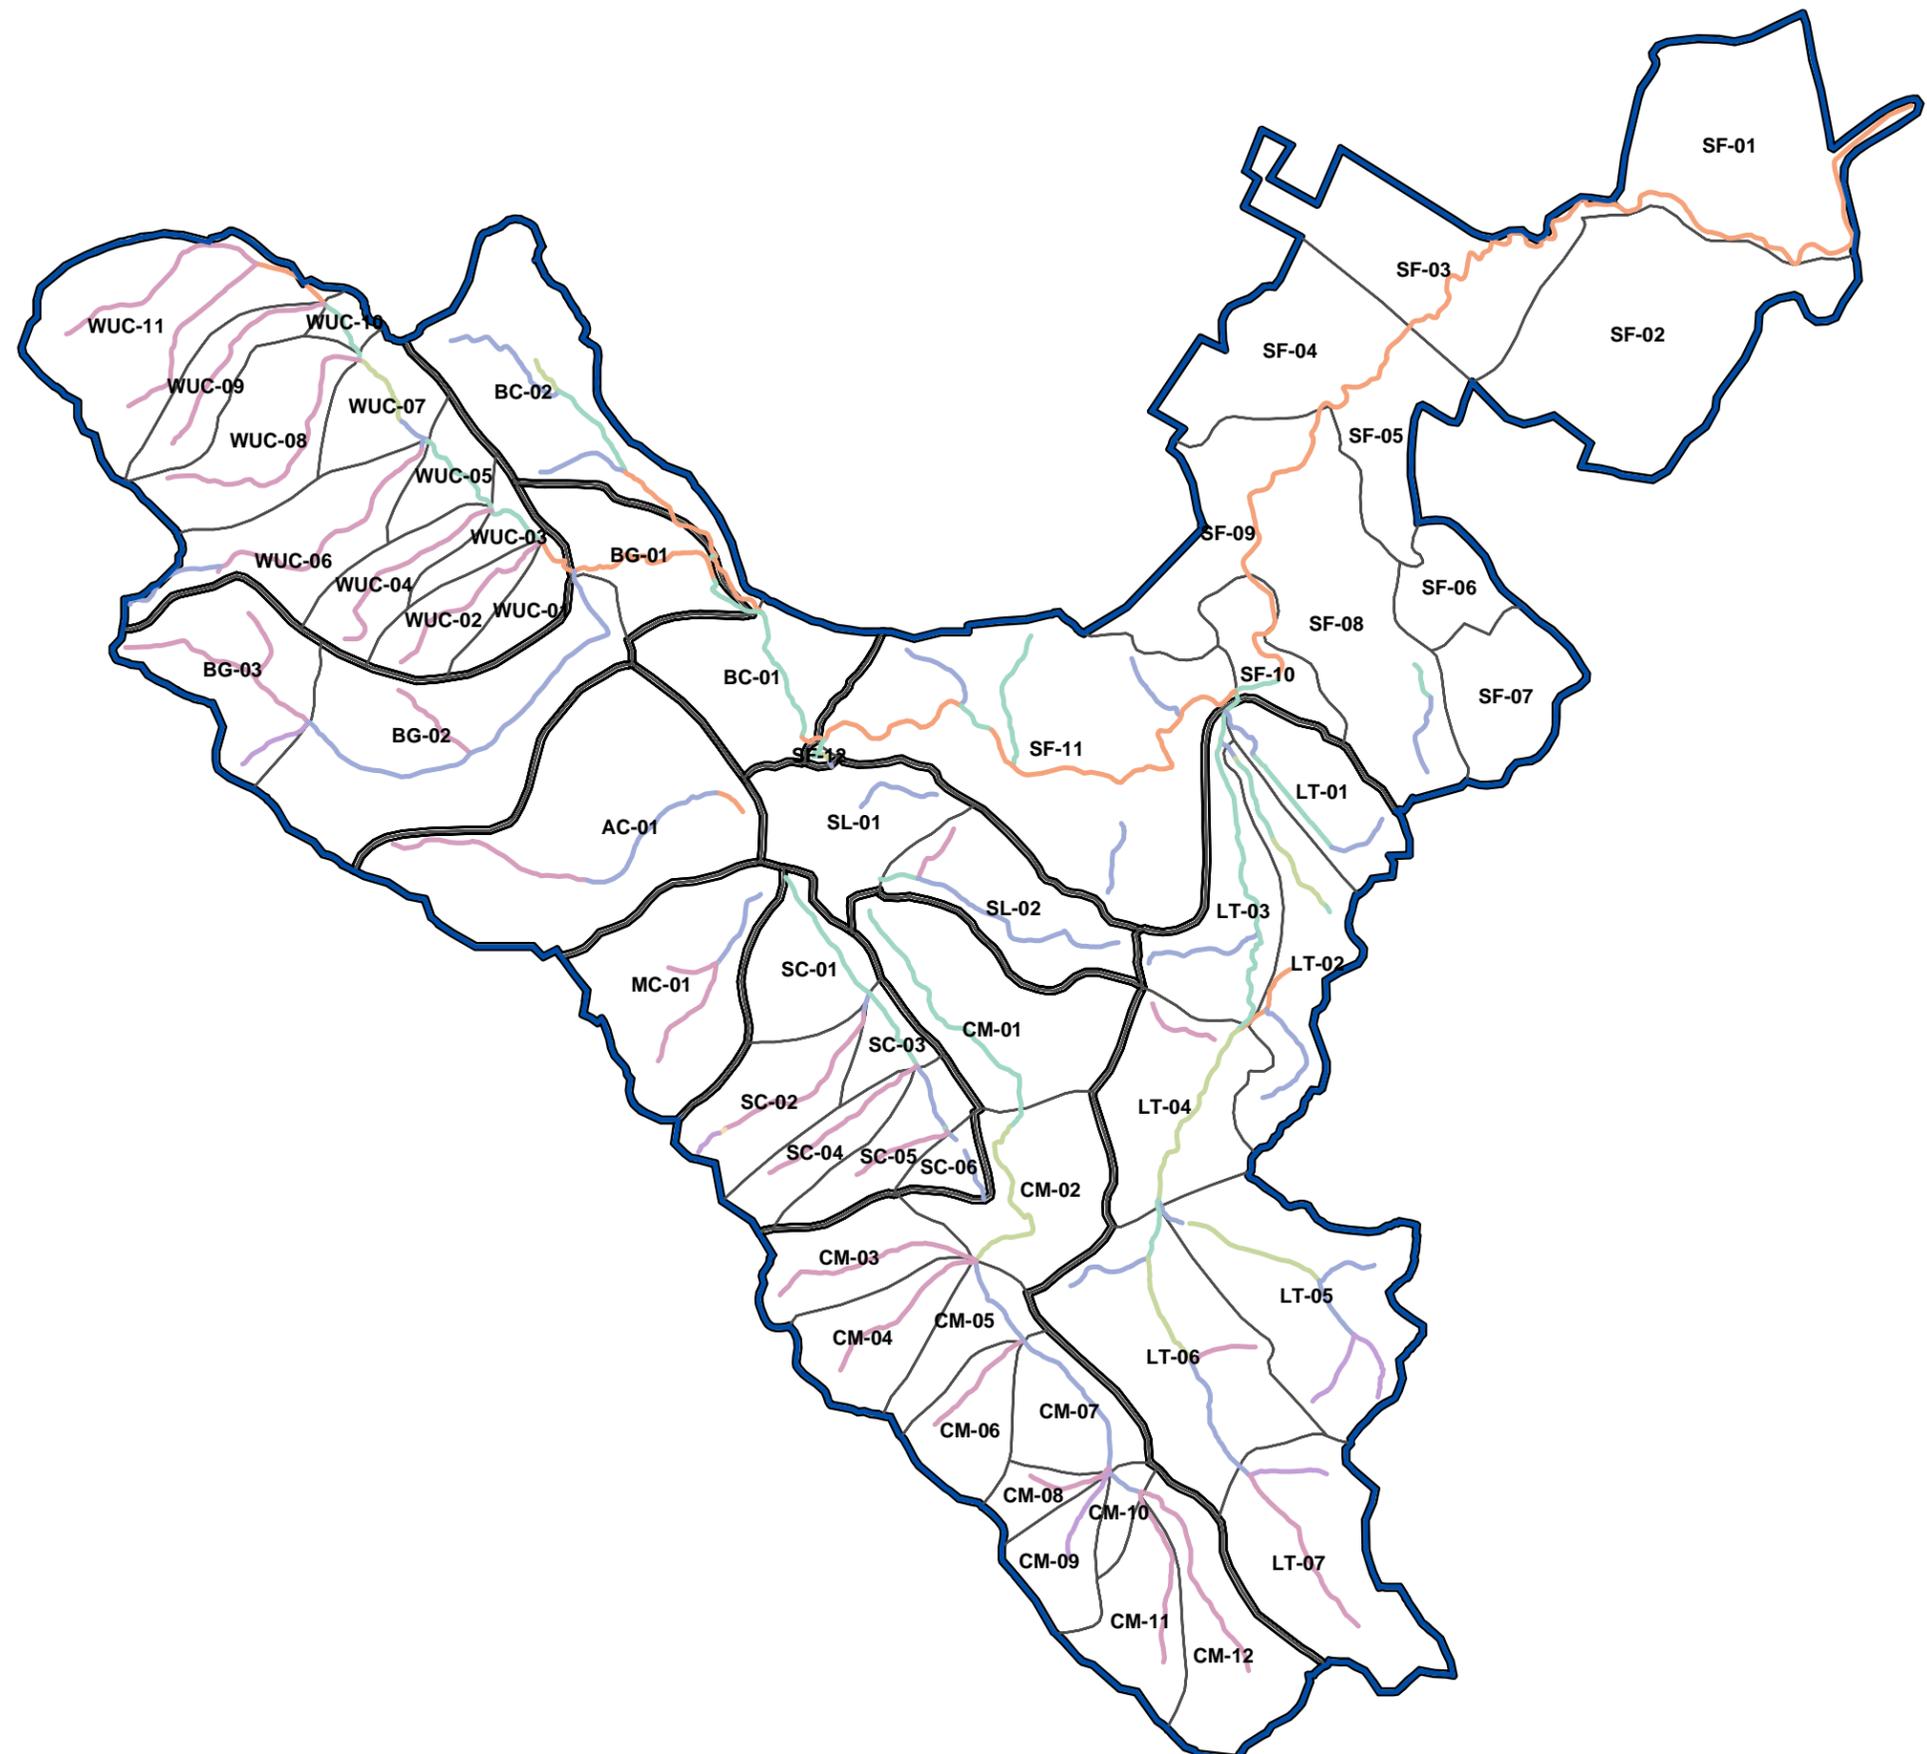
Figure 5 Channel Types using the Montgomery - Buffington Classification - San Francisquito Creek Watershed

Figure 5 classifies the streams channels in GIS database into the different Montgomery-Buffington types based on channel slope and stream observations from other report and field visits. The Existing Conditions Memorandum provides further details on the classification method and the correspondence between the predicted classes and the observed stream morphology.

The Montgomery-Buffington system identifies three main morphologic scales; the watershed, the valley segment and the channel reach. Watersheds are divided into hillslope and valley segments; valley segments are then divided into colluvial, bedrock and alluvial types. Colluvial segments store sediment derived from hillslopes by creep, tree throw and slope failure, occur in upper watersheds, and are often dominated by debris flow or landslide processes. Sediment transport capacity generally exceeds sediment supply in bedrock segments, exposing bedrock along the channel bed. Alluvial segments are those where streams flow in a self-formed channel through their own deposits.

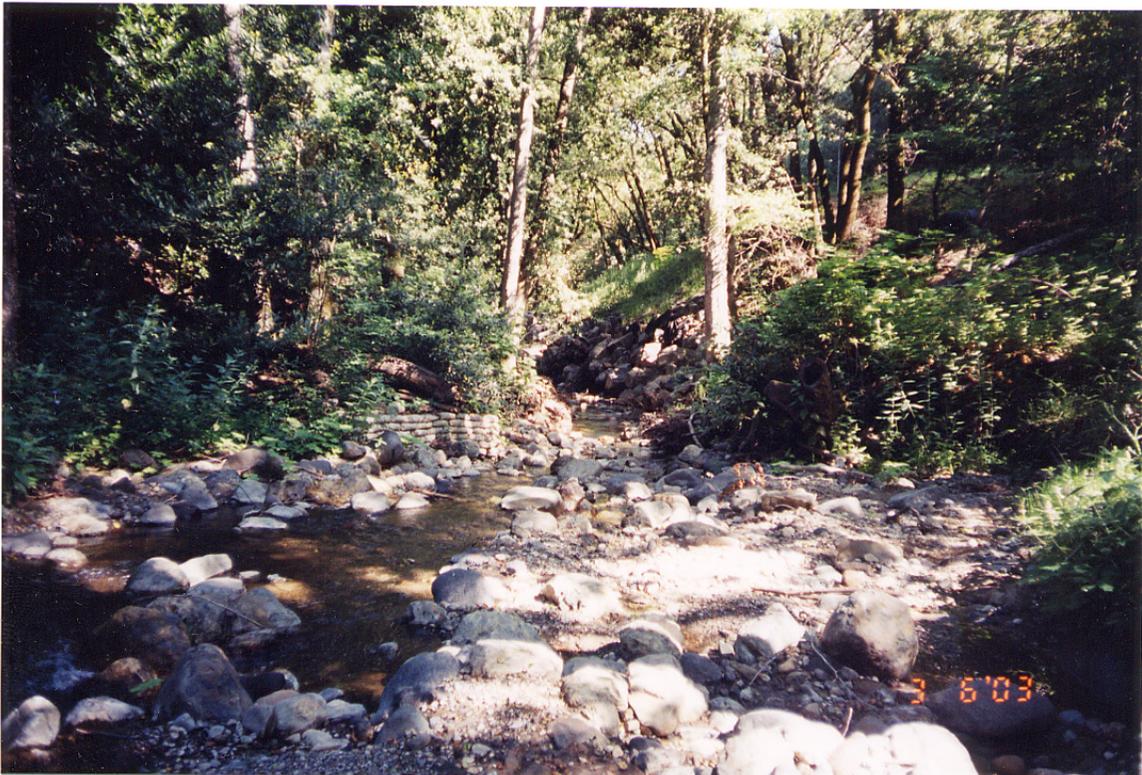
LOOKING D/S BELOW BRIDGE - CONCRETE WITH
SEDIMENT DEPOSITS

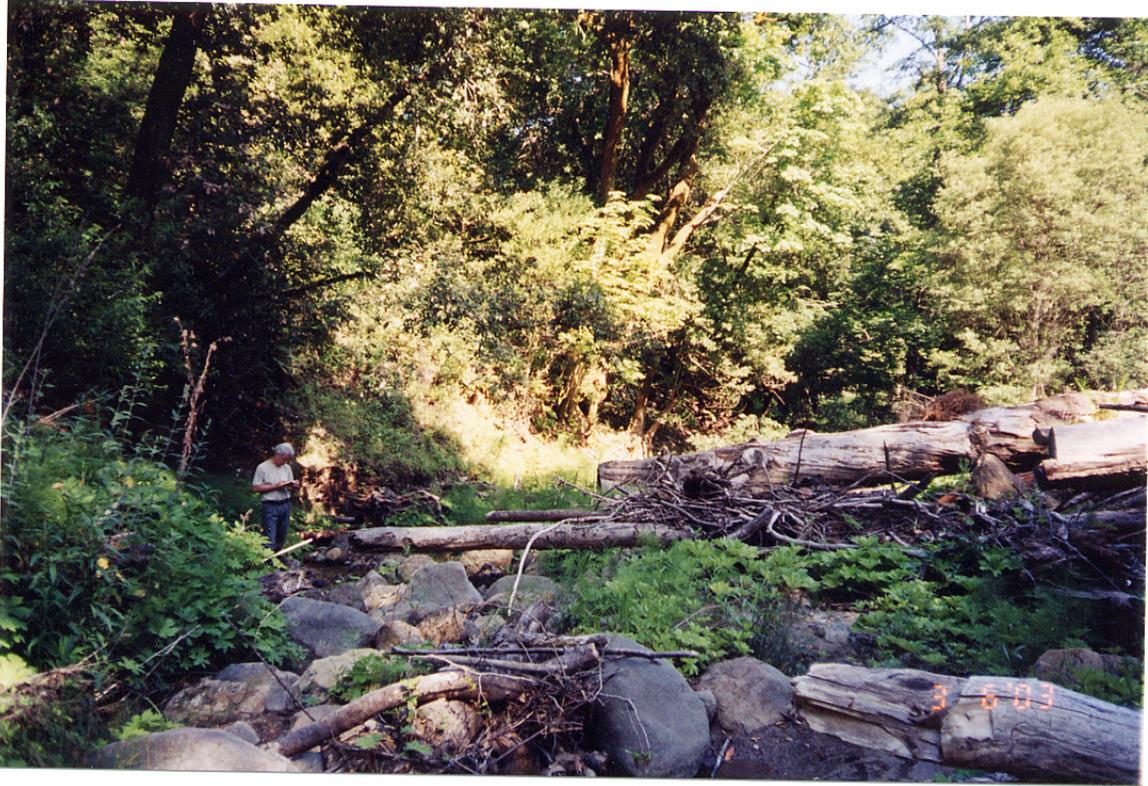
CORTE MADENA AT MOUTH OF DAMIANI CK (CM#5)

VIEW NEAR FRONT OF DF DEPOSIT

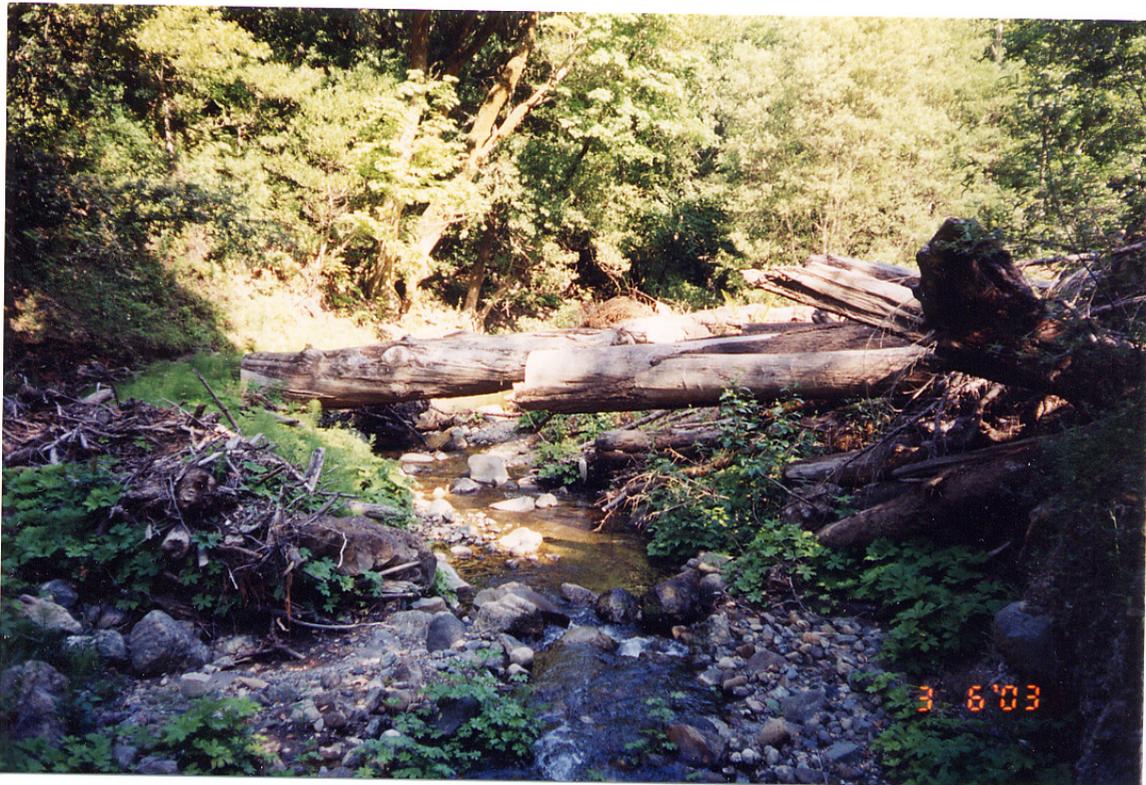
NEW CHANNEL OF CM CREEK THROUGH DEPOSIT
- BREACHED LOG JAM

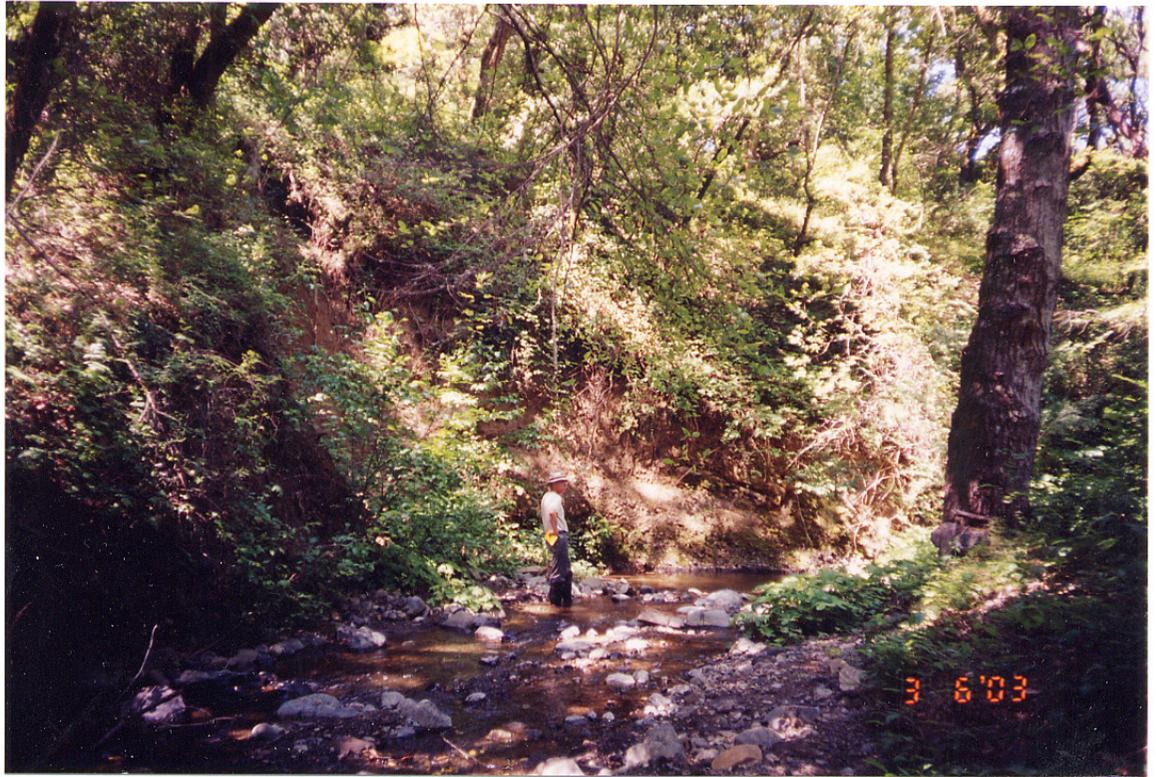
CORTE MADENA U/S OF HAMMS CK. (CM#11)

LOOKING DOWNSTREAM
FAILURE ON LEFT
BANK

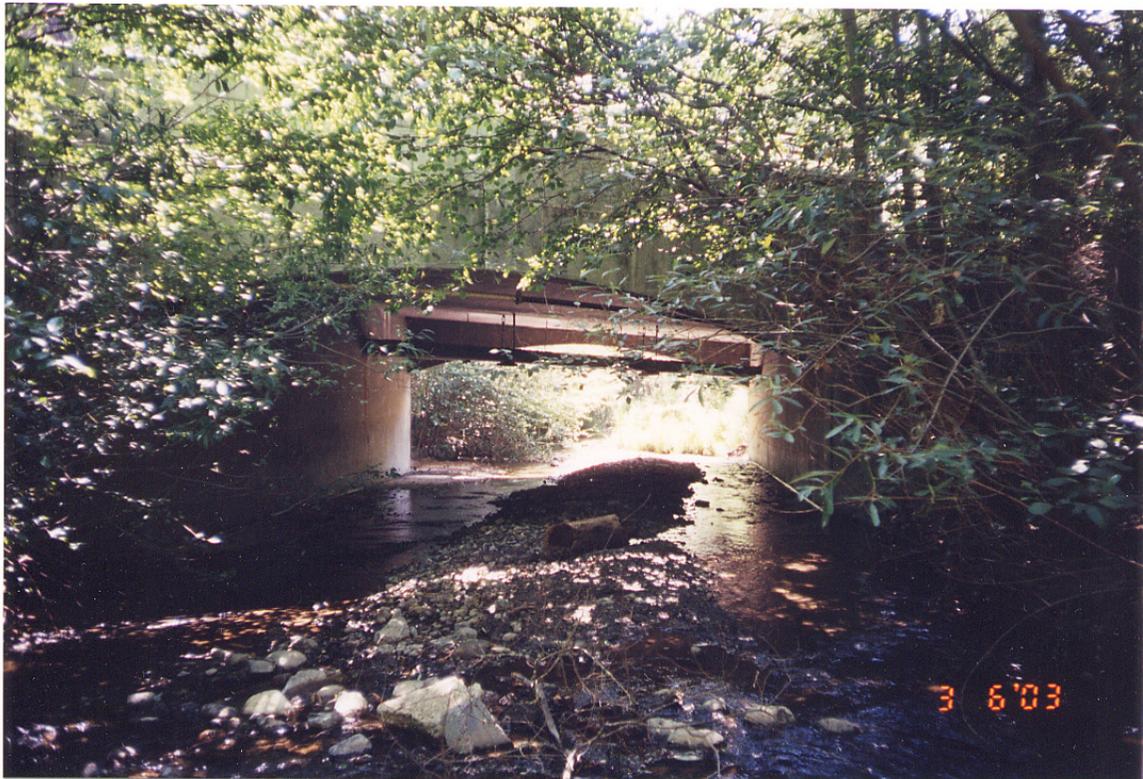
LOOKING ^UD/S TO BRIDGE - AGGRADATION ON CB

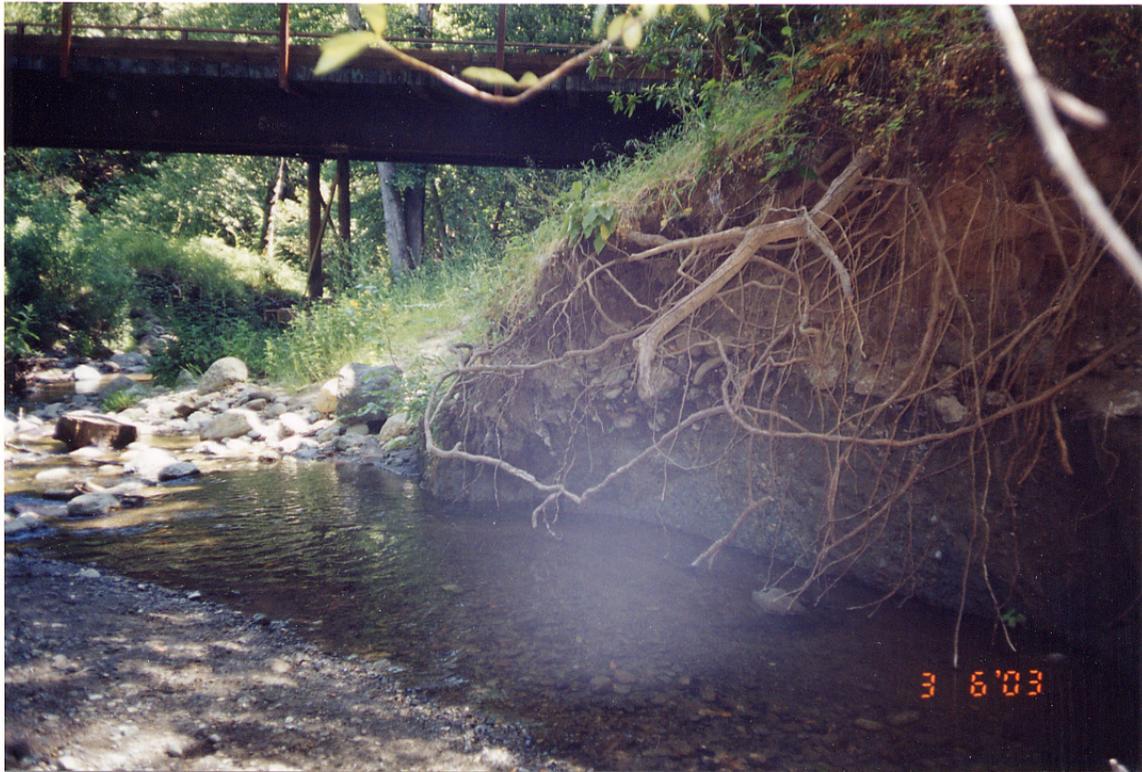
CORTE MADERA CR AT WINDY HILL PRESERVE BRIDGE
(CM #6)

ERODING RB UPSTREAM OF BRIDGE

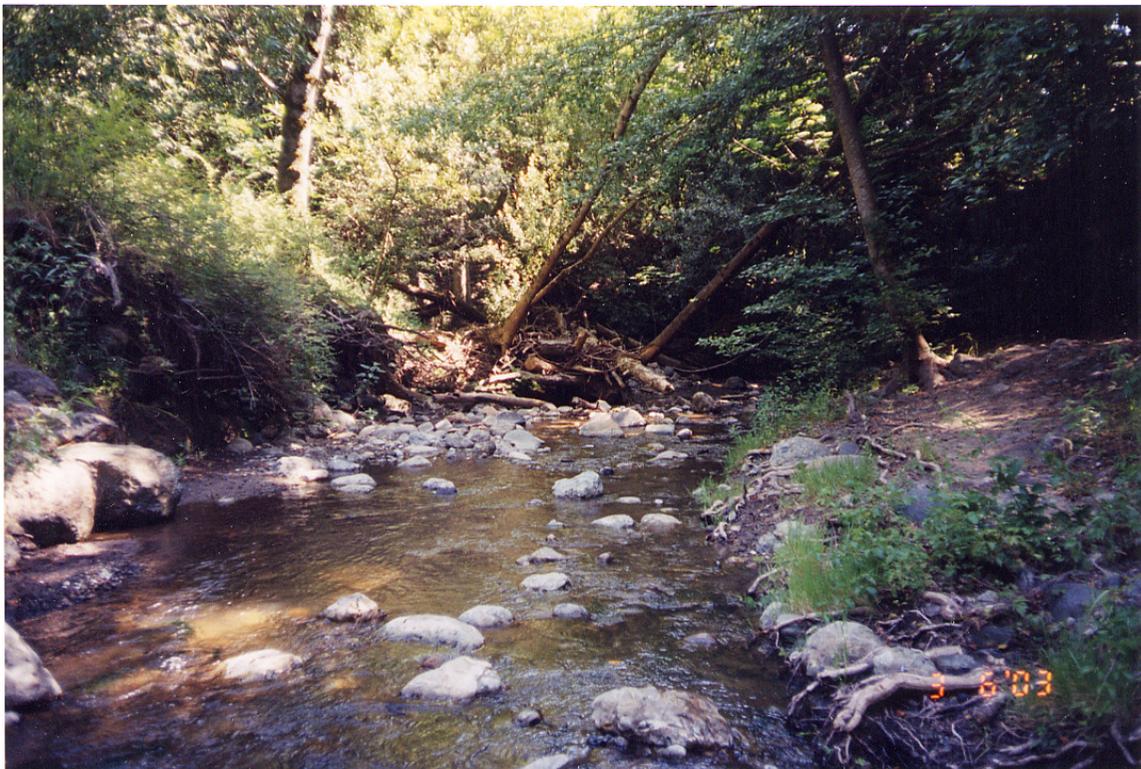
LOOKING DK - MINOR BANK EROSION - LOG JAM.

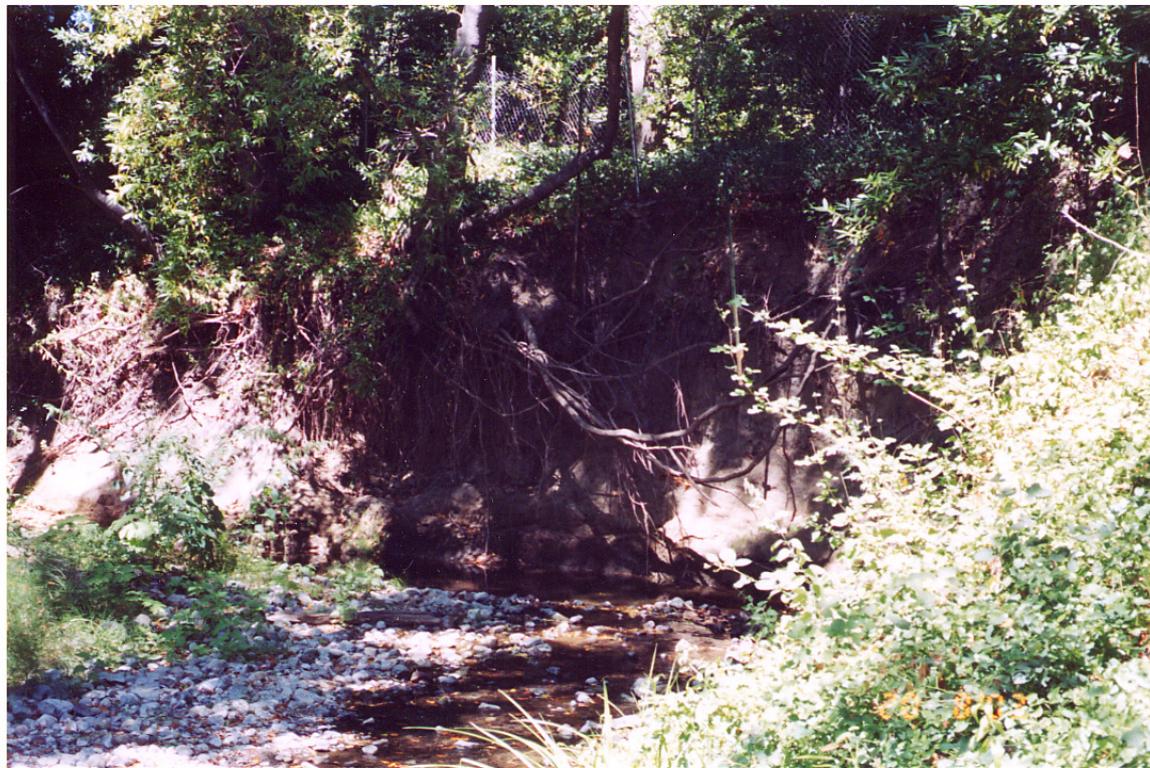
CORTE MADURA CK D/S OF WESTRIDGE ROAD

D/S VIEW OF ERODING BANK IN LEFT BEND

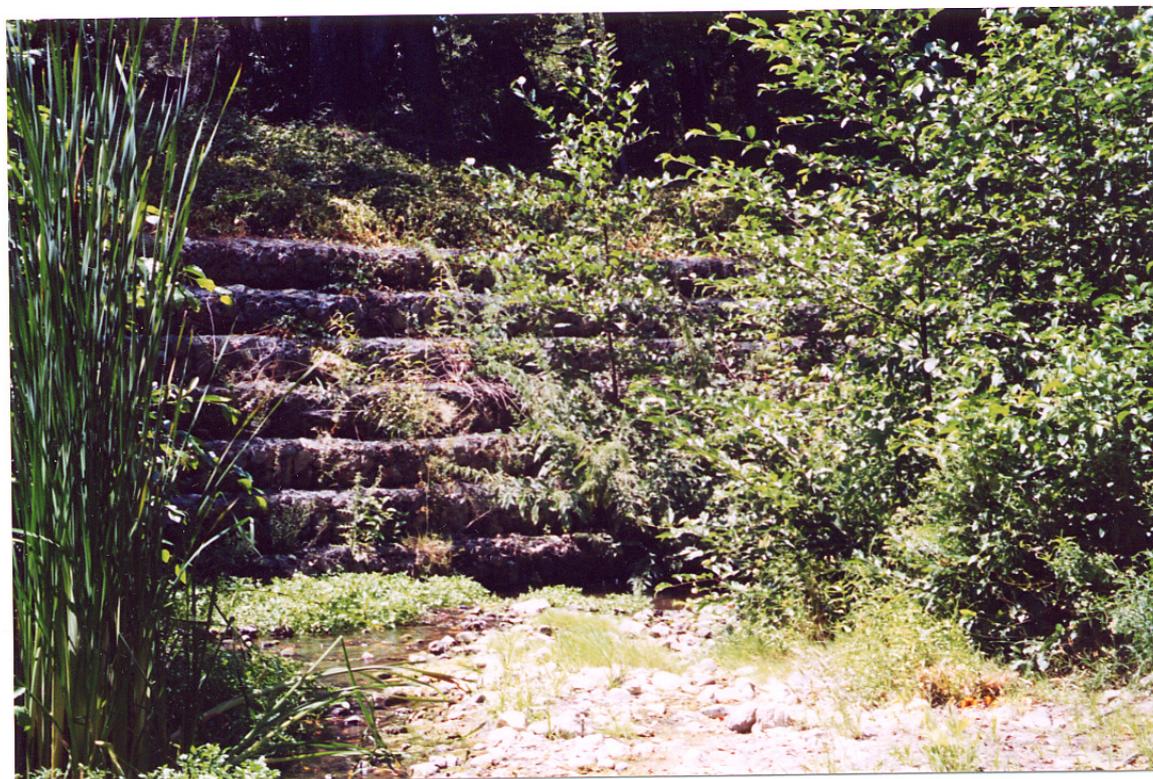
D/S VIEW OF GABION WALL IN BEND (RIGHT)

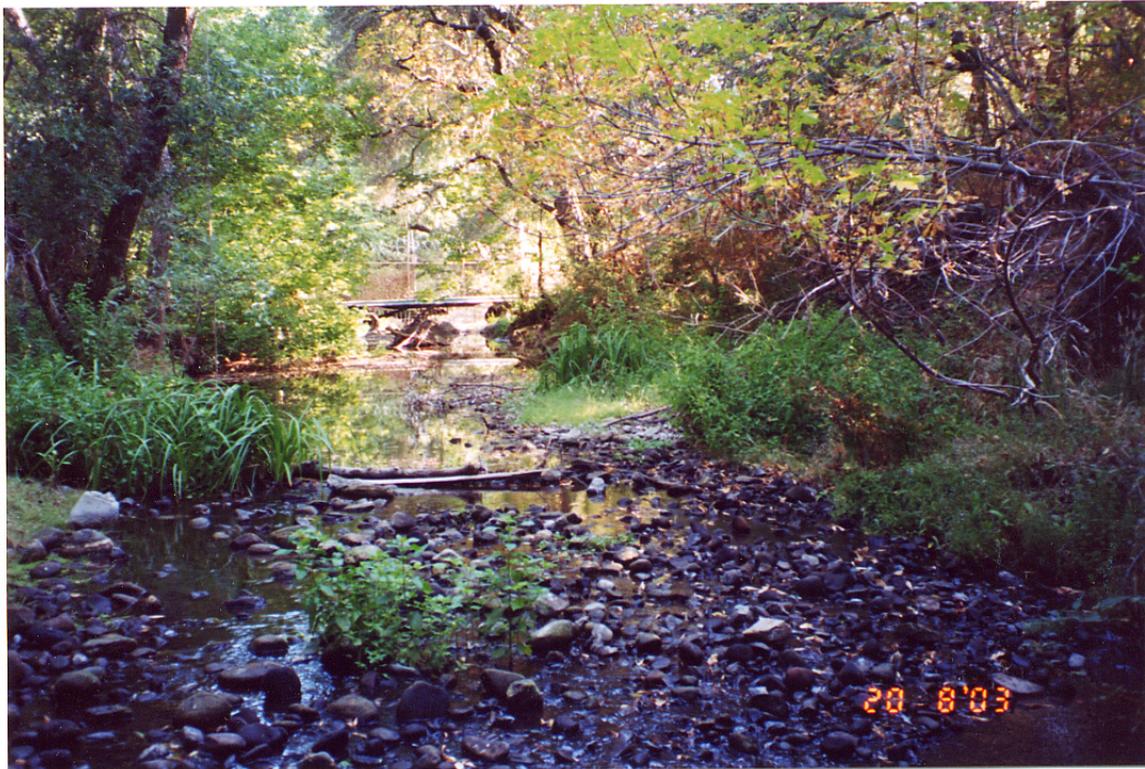
ROLL #
1-5

LOOKING U/S TO SAND HILL ROAD - POOL BELOW
BRIDGE FILLED WITH SAND + PEBBLES

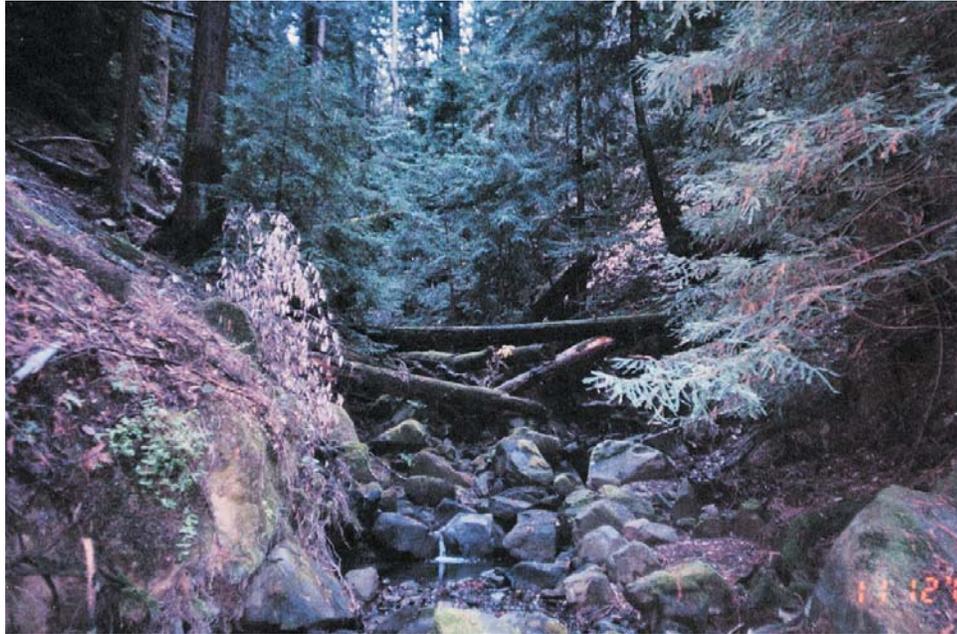
Site 13 Alambique Creek near Alambique Trail, about 1.5 miles from parking lot trail head in Wunderlich Park, looking upstream at bank slump failure

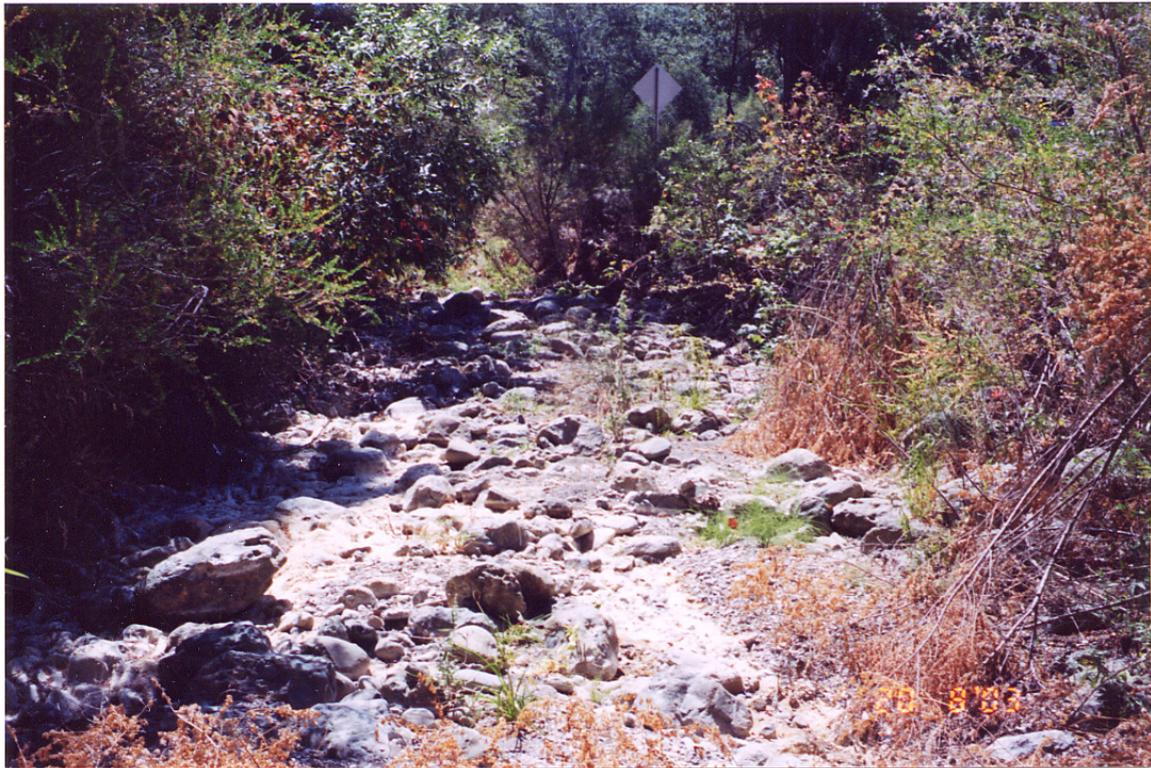
LOS TRANCOS CK AT 2ND CROSSING OF LOS TRANCOS RD

VIEW U/S ABOUT 100 FEET ABOVE BOX CULVERT
NOTE PILES OF SAND + PEBBLES

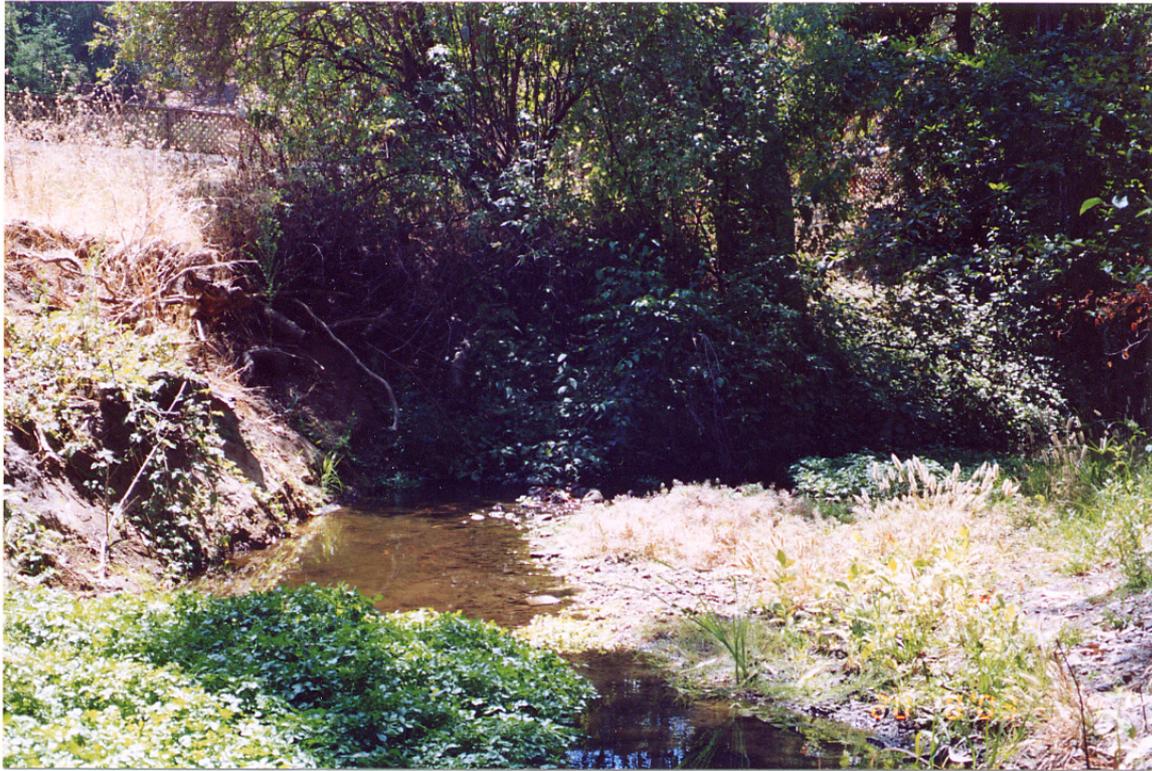
LOS TRANCOS CK AT ANASTRADERO ROAD

LOOKING U/S ABOVE BRIDGE - EROSION BANK
ON OUTSIDE OF BANK

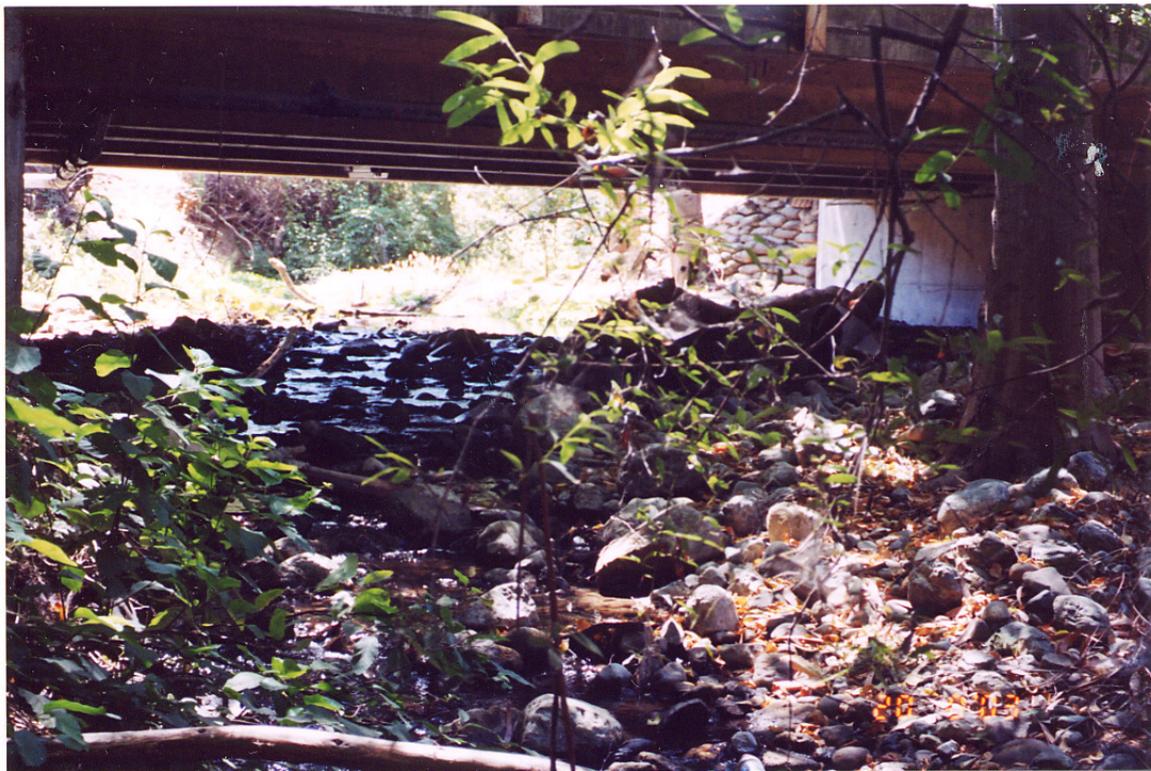
LOOKING U/S THROUGH BRIDGE - CORBBLE BANK
ON RIVER LEFT + SANDSTONE PAGES

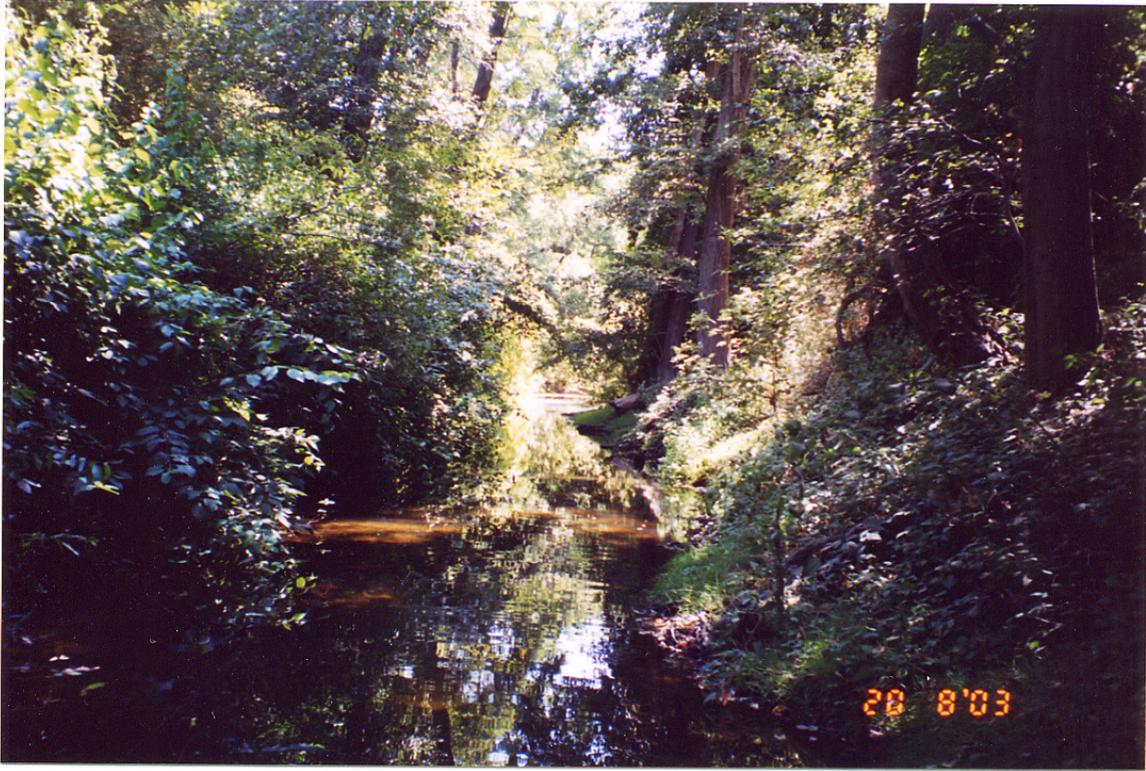
SAN FRANCISCO QUILT CREEK AT WEBB RANCH

LOOKING DIS FROM BENEATH BRIDGE - SAND IN POOL

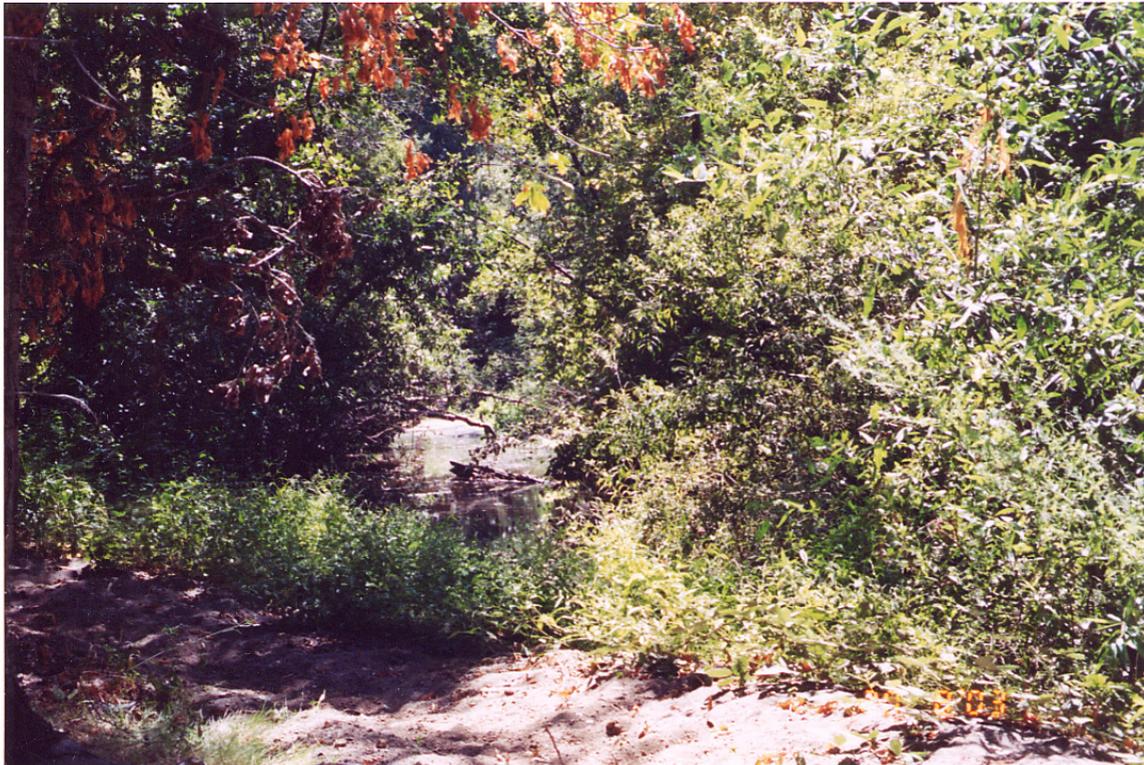
PHOTO AT 200' UP OF BRIDGE - SAND AT FLOODPLAIN AND FULING CHANNEL.

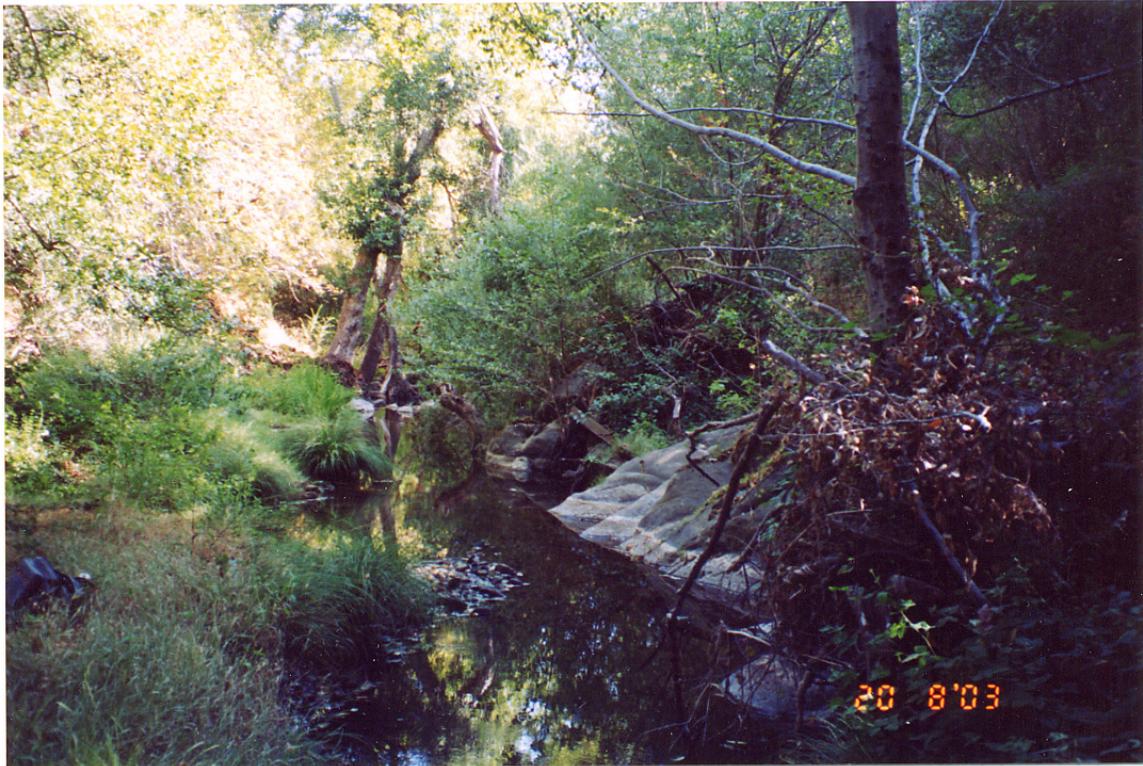
SAN FRANCISCO CK D/S OF BEAR CREEK

LOOKING D/S PAST CONCRETE FORD - BEDROCK
ON RB TO +6 FEET
