San Francisquito Creek Watershed Analysis and Sediment Reduction Plan FINAL REPORT

San Francisquito Creek
Joint Powers Authority

nhc northwest
hydraulic
consultants
Leaders in water resource technology

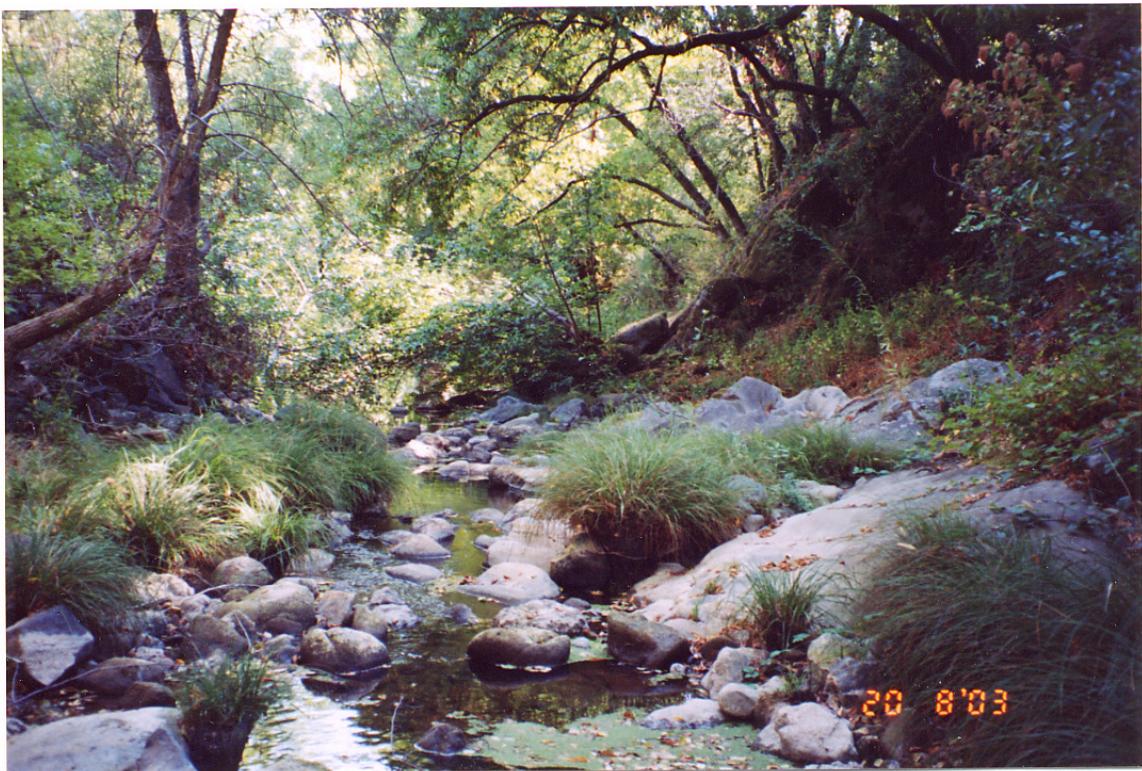
LOOKING D/S ABOUT 200' D/S OF FORD
BEDROCK + COARSE ARMOR.
