## DESIGN EXAMPLES—SECTION 3

### 3.0 CASE STUDY—WILLOW CREEK

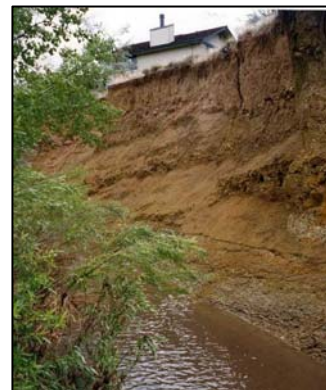
Photo 1. Cliff Created by Erosion from Creek

Willow Creek meanders through a natural open space park in Southern Arapahoe County (Figure 1). The low-flow channel carries about 200 cfs, and almost the entire open space is within the 100-year floodplain. The basin tributary to Willow Creek is 8.10 square miles; the lower portion is fully developed and the upper portion is actively being developed. Because of the changes in the basin runoff characteristics, Willow Creek is experiencing higher low-flow volumes. Frequent storms and increased base flows have created a 30-foot-high vertical cliff where the open space borders a residential development. If nothing was done, the house at the top of the cliff was in imminent danger (Photo 1).

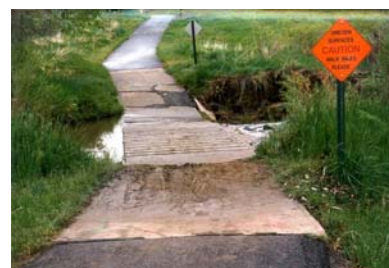
Photo 2. Existing "Texas" Low-flow Crossing

The realignment of the creek shortened the total length of channel and increased its slope. Two grouted boulder grade control structures, with 1-foot drops, were incorporated as permanent “hard” improvements to establish a stable channel slope of 0.5% (for bioengineered channels a milder slope of 0.3 to 0.4% is normally recommended by the District). Adjacent to the grade control structures, box culvert/pedestrian bridges were built to replace the existing slippery “Texas” low-flow crossings, which had been high

maintenance for South Suburban as well as being a safety hazard (Photos 2 & 3).

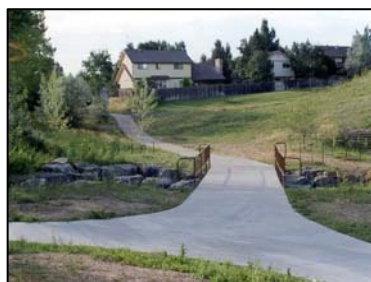
Photo 3. New Grouted Boulder Structure & Pedestrian Bridge

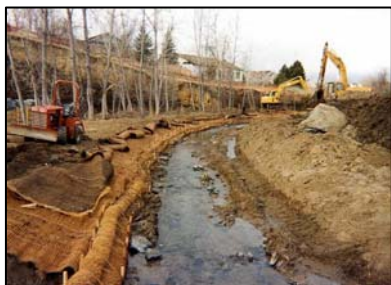
Photo 4. Biolog & Erosion Mat Installation

blanket, line the edge of the new low-flow channel between the bridges. The biologs were partially buried, staked, tied, and overlapped so that they could not be dislodged during a storm event. Willow stakes were also planted through them. Permanent erosion control mat was placed on the bank above the biologs (Photo 4). The inner bank of the meander was covered with a plastic permanent “enkamat” geotextile, designed to trap sediment that is washed around the bend and encourage wetland and riparian plant growth (Figures 4, 6, & 7).

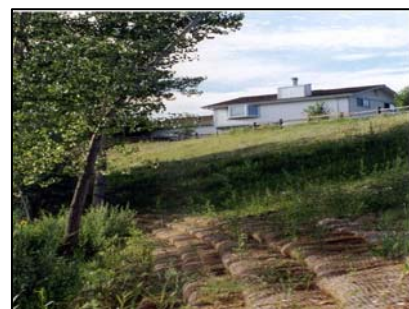
Photo 5. Reconstructed Slope with Wrapped Soil Lifts at Toe

Bioengineering techniques were also used to stabilize and help establish vegetation on the 2:1 fill slope of the 30-foot vertical cliff. Extra stabilization was needed at the toe of the new slope to protect up to the 100-year water surface elevation. Six layers of wrapped soil lifts made of a double layer of coir fabric encasing a 6-inch lift of soil protects the soil from erosion at the toe of the slope while still allowing vegetation to grow (Photo 5 & 9). The upper portion of the

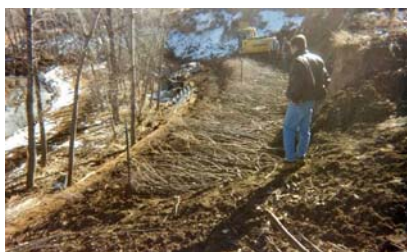
Photo 6. Construction of Brush Layering

slope is a test area for both brush layering and traditional erosion control matting. For the brush layering, Wenk specified that willow and cottonwood branches be placed horizontally in the slope with about 3 inches of the tips sticking out. These little “fingers” of the mostly dead branches collect leaves and natural debris while breaking up the water that trickles down the slope, preventing rill erosion (Photo 6). The brush layering was used on half of the new fill slope, and the other half received a temporary erosion control blanket. These two methods will be compared over the years to see if one is more successful than the other (Photo 7 and Figure 5).

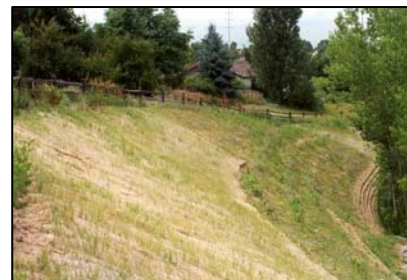
Photo 7. Completed Slope with Brush Layering, Erosion Mat, and Wrapped Soil Lifts

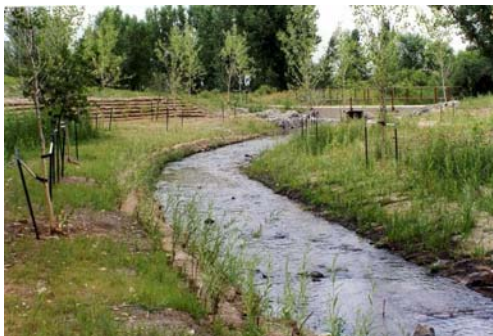
Photo 8. Complete Channel with Plantings

The channel edges and the wrapped soil lifts were then planted with willow stakes. Cottonwood whips were also planted within the meander and around the check structures (Photo 8). All the willow stakes, the cottonwood whips, and even the brush for the brush layering were harvested from the immediate area.

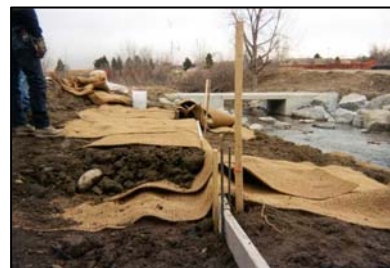
Photo 9. Construction of Wrapped Soil Lifts

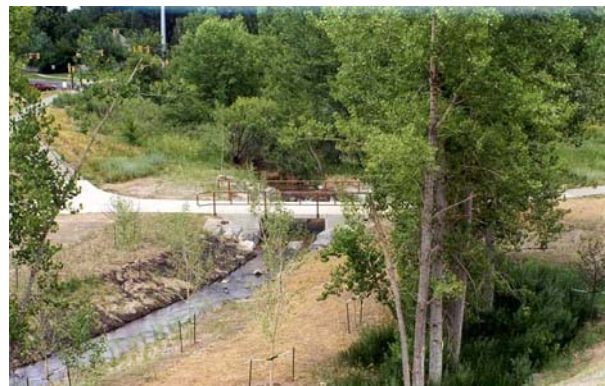
Photo 10. Relocated Channel & New Pedestrian Bridge
